**CITY OF ALLEGAN
CITY COUNCIL STUDY SESSION MEETING
Monday, October 9, 2023, 5:30PM
City Council Chambers - 231 Trowbridge Street
Allegan, Michigan**

SUBJECT: PaSER 10-Year Road Strategies Reports

**DAM SAFETY INSPECTION REPORT
ALLEGAN CITY DAM – DAM ID NO. 489
KALAMAZOO RIVER
ALLEGAN COUNTY – SECTION 28, T 02N, R 13W**

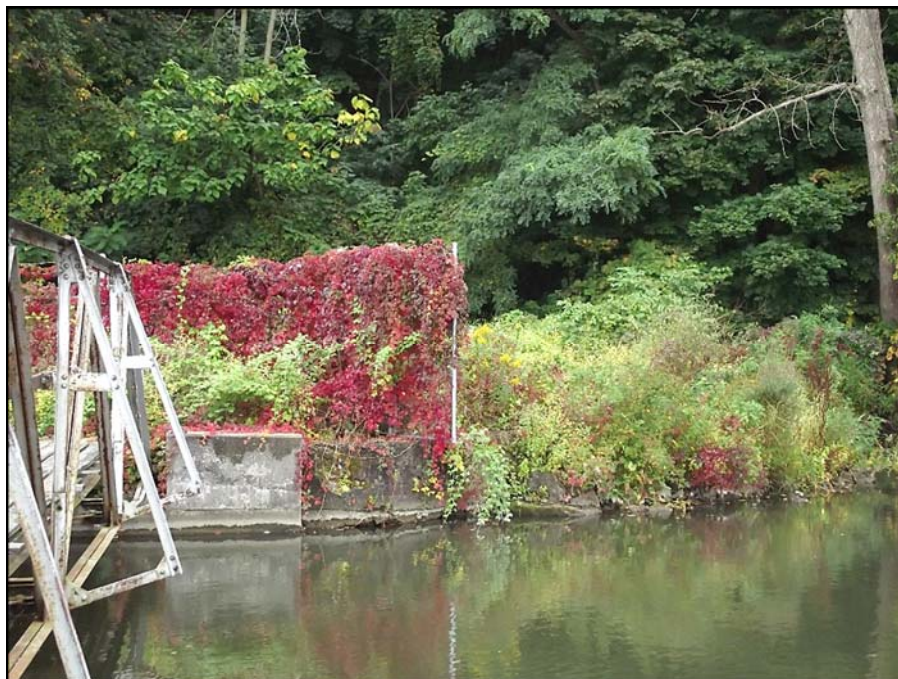
The right earthen embankment was inaccessible on the date of this inspection due to closure of the catwalk over Spillway Bays #1 and #2 following the 2017 structural analysis completed by LFA. City staff indicated that there is no reasonable access to the right embankment since the catwalk has been closed off. As such, the embankment is not currently being maintained. From a distance, small trees and brush were observed to be growing over the entire right embankment. Repairs or replacement of the catwalk should be implemented as soon as reasonably possible so the right embankment can be cleared and thoroughly inspected. After clearing, both embankments should be mowed a minimum of two times per year to prevent further establishment of woody vegetation and to facilitate visual inspection.

**Photograph 7 – Upstream face of right embankment viewed from left
Note that deterioration of the catwalk prevents access**

1. Repair or replace the catwalk structure over Spillway Bays #1 and #2 as soon as possible so the right embankment can be properly maintained and thoroughly inspected. City staff stated that there is no reasonable access to the right embankment since the catwalk has been closed off.

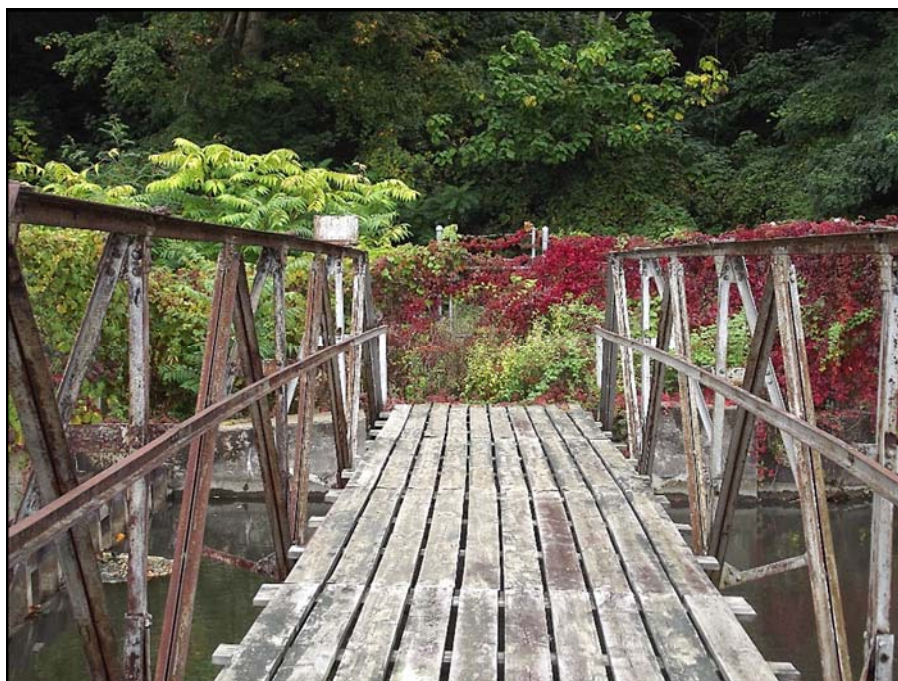
**Photograph 8 – Right embankment crest viewed from left
Note that deterioration of the catwalk prevents access**

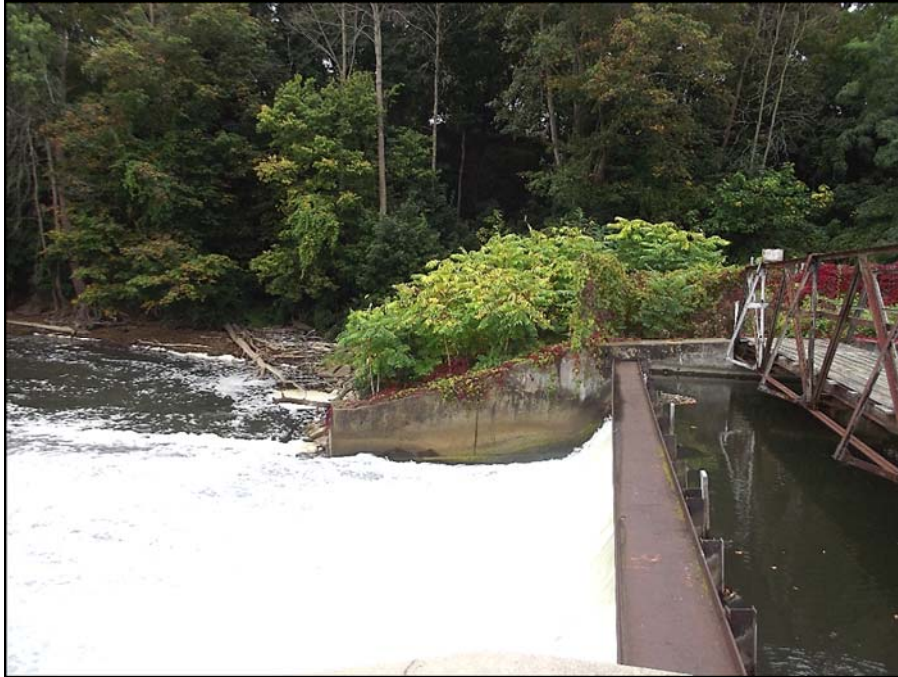
**Photograph 9 – Downstream face of right embankment viewed from left
Note that deterioration of the catwalk prevents access**

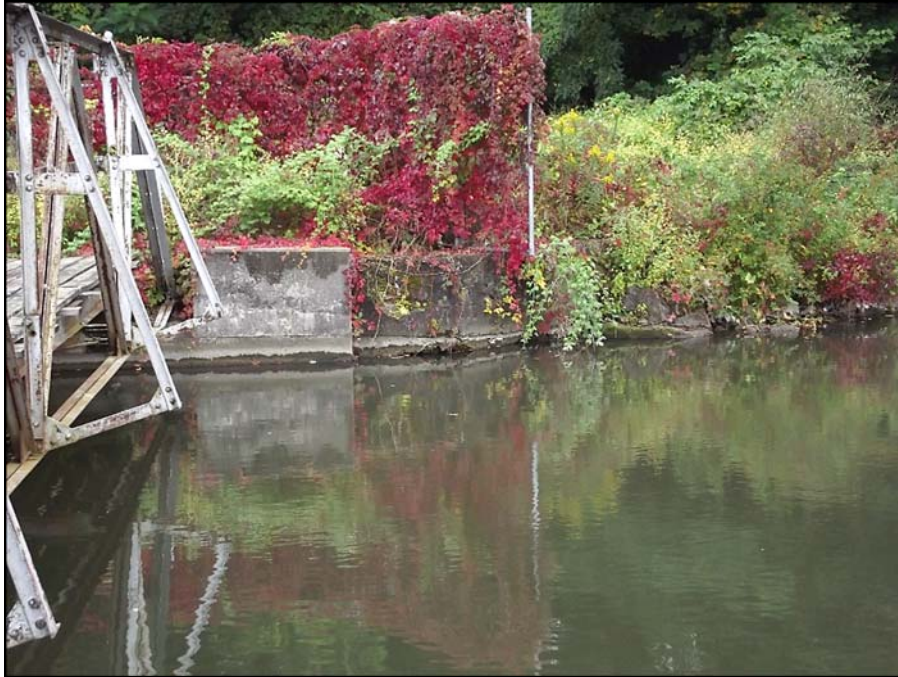
**Photograph 11 – Upstream right abutment wall
Note the overgrowth of vegetation and spalled concrete**

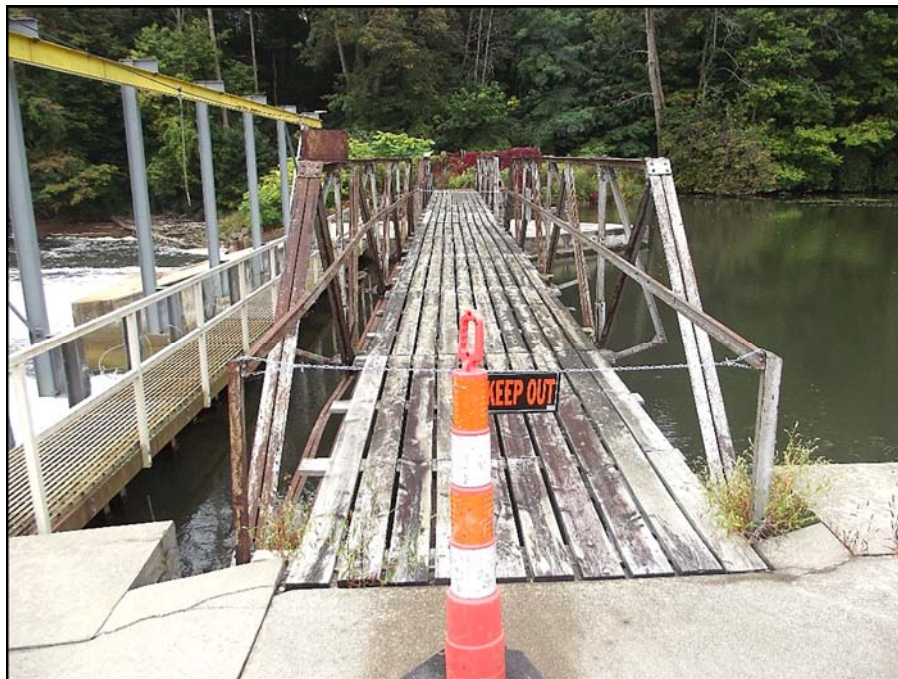
Deterioration of the catwalk has advanced to the point that City staff, at the advice of their consultant and insurance company, have prohibited access. As such, there is currently no way to access the right portion of the principal spillway or right earthen embankment for operation of the stoplogs or maintenance. Repairs or replacement of the catwalk should be implemented as soon as possible to restore access Spillway Bay #1 and the right earthen embankment.

**Photograph 18 – Catwalk over Spillway Bays #1 and #2
Note access has been prevented due to
deterioration of the structure**

3. Repair or replace the right catwalk structure of the principal spillway as soon as possible.
4. Continue to have the abandoned powerhouse inspected by a structural engineer until repair, replacement, or removal can occur. Provide inspection reports to the Dam Safety Program as they become available.

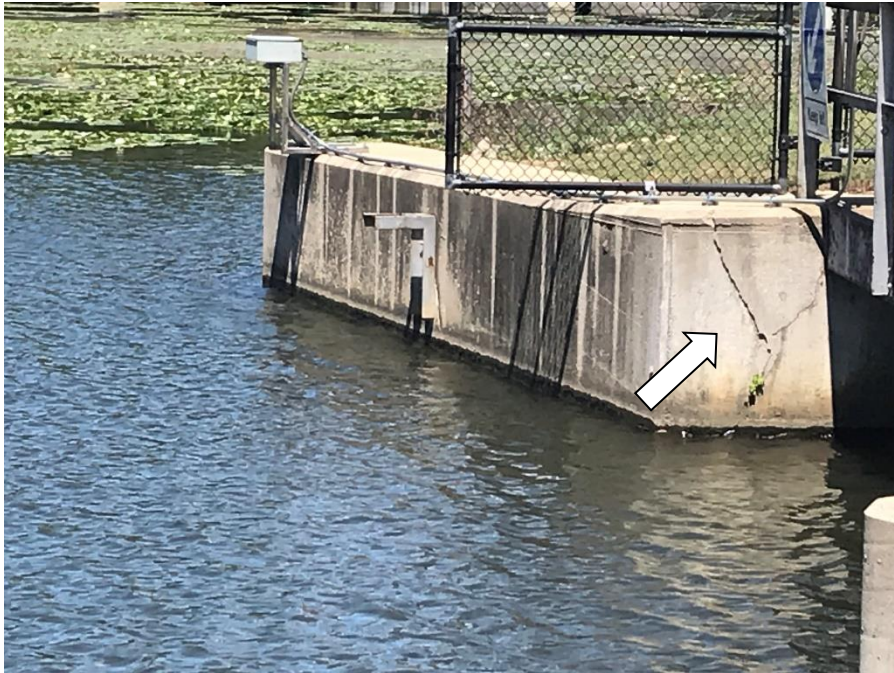
**Photograph 11 – Upstream left abutment wall
Note the cracks near the catwalk connection**

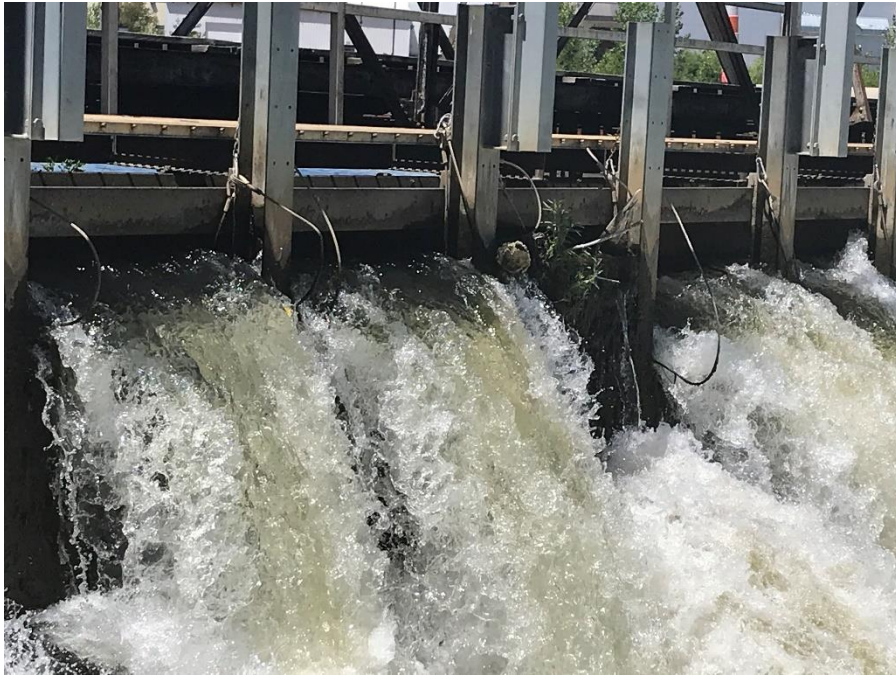
**Photograph 21 – Stoplog and hoist cables viewed from downstream
Note the significant leakage between stoplogs**

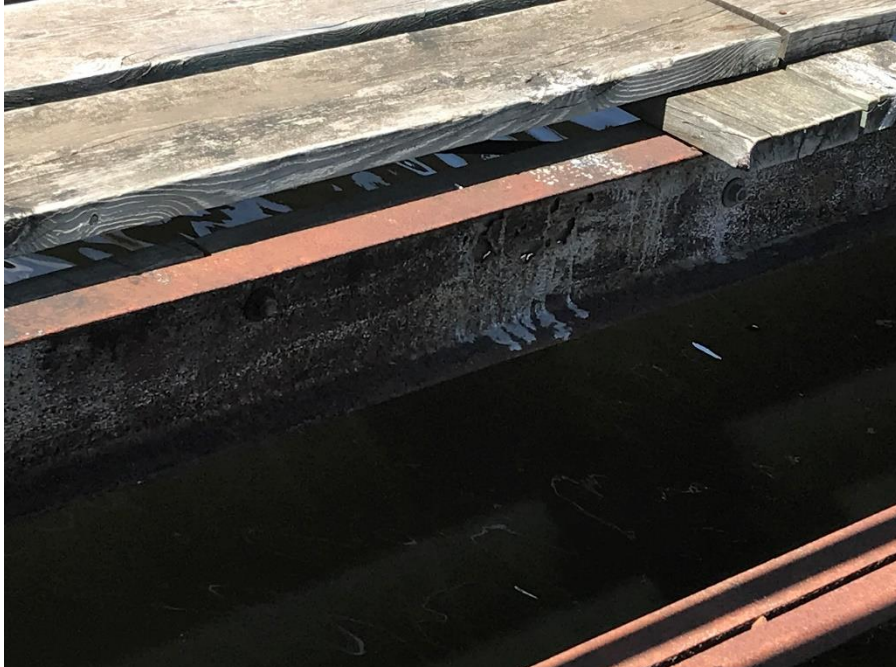
Photograph 24 – Deteriorated beam of catwalk

2. Repair or replace the deteriorated catwalk structure of the principal spillway such that operation of the right stoplog section and access to the right earthen embankment are achieved. This recommendation is repeated from the 2017 inspection report and should be completed as soon as possible.

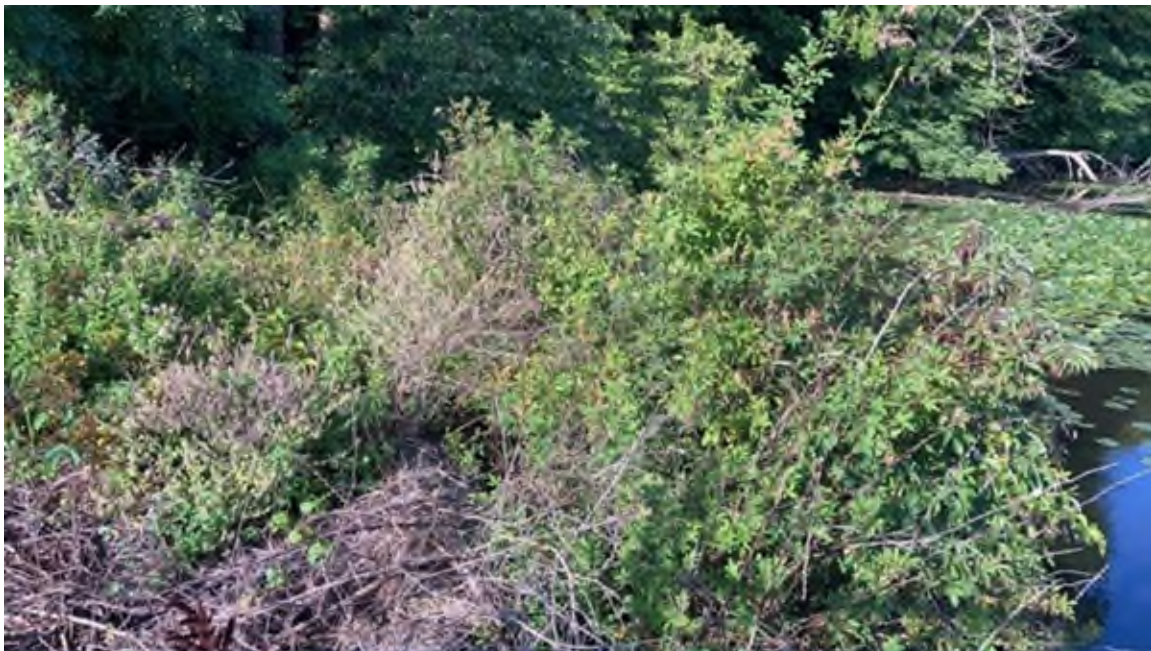
Photo #2 - Upstream slope right embankment, note brush growth

1. Continue current efforts to clear all trees and brush from the earthen embankments. This recommendation is repeated from previous inspection reports and should be completed as soon as possible. After clearing, the embankments should be mowed a minimum of two times per year to prevent future establishment of woody vegetation and to facilitate visual inspection.

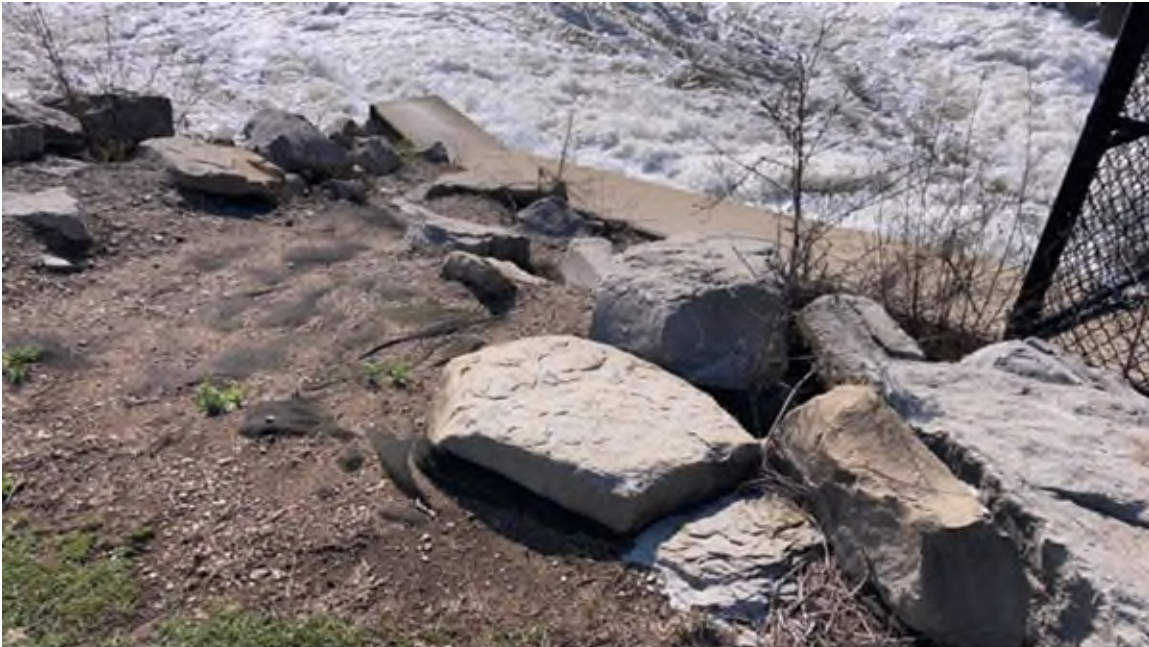
Photo #39 - Downstream slope of left embankment adjacent to spillway. Note exposed fabric where armoring is missing

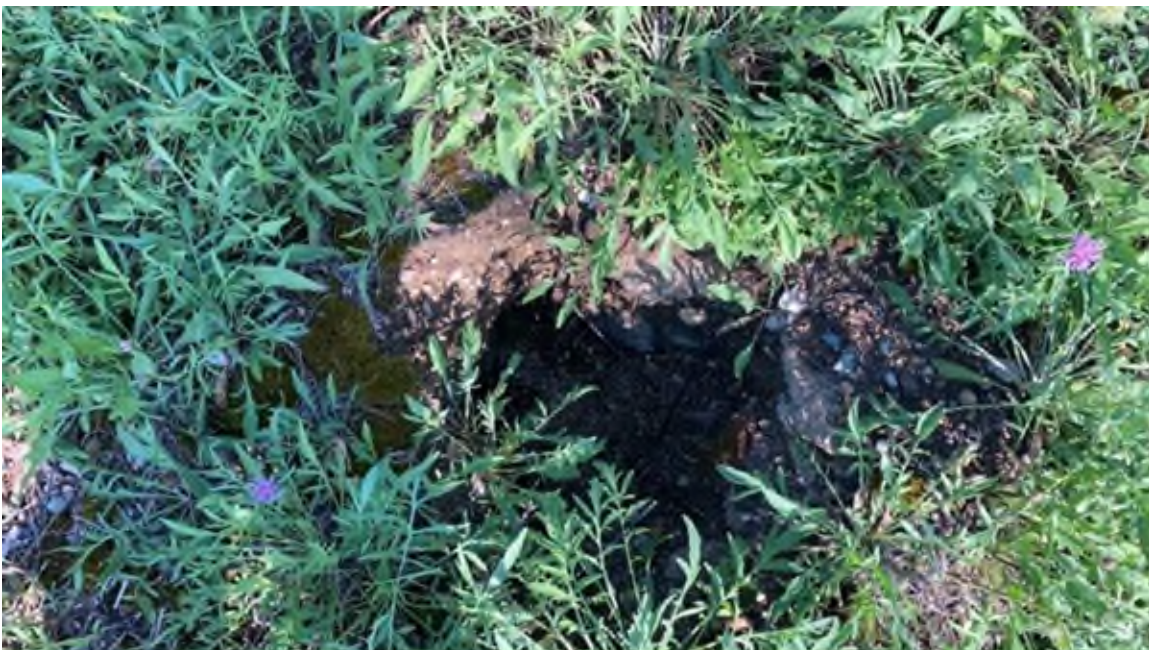
Photo #52 - Burrow or sinkhole on left embankment adjacent to millrace

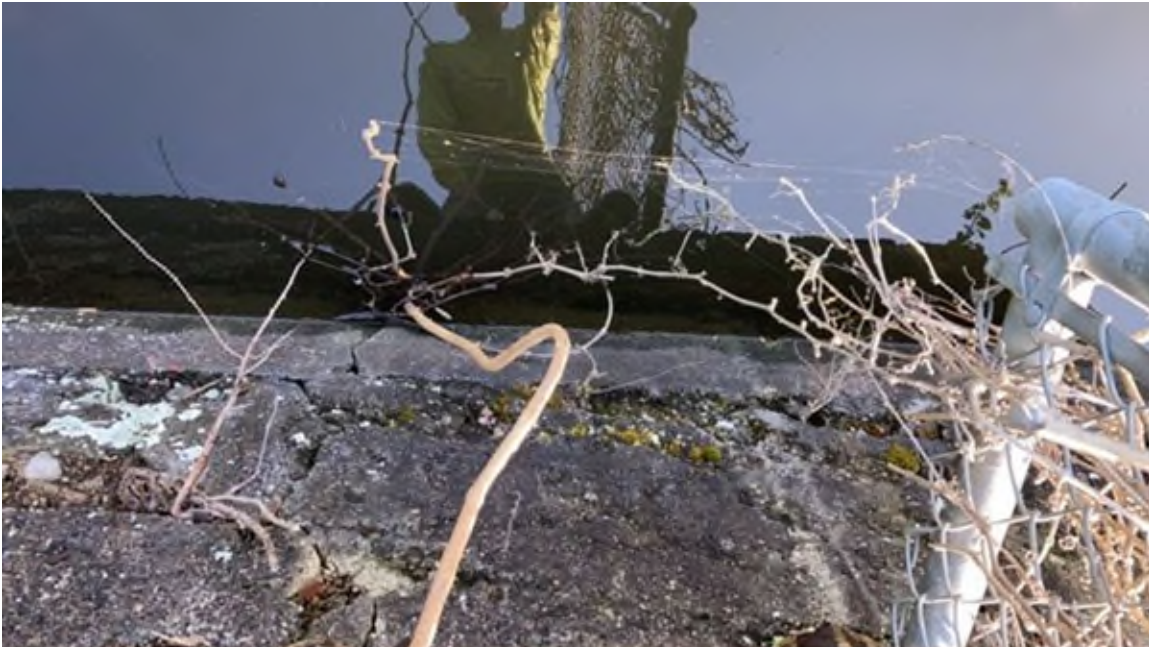
Photo #53 - Spillway right upstream abutment wall. Note concrete deterioration

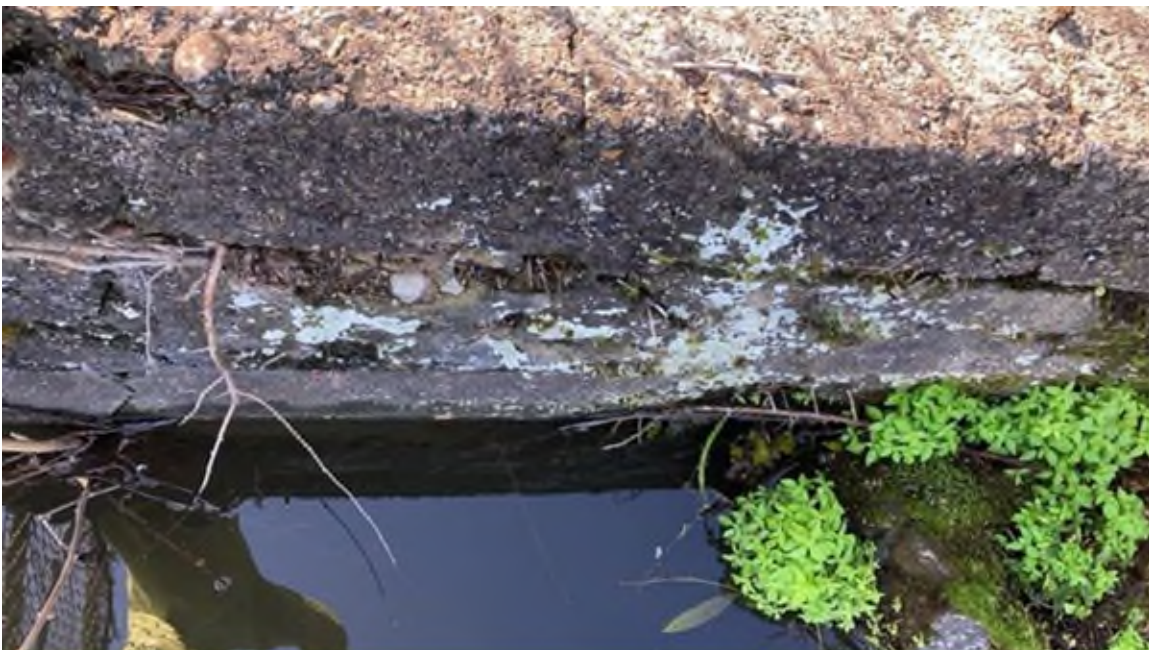
Photo #54 - Spillway right upstream abutment wall. Note concrete deterioration

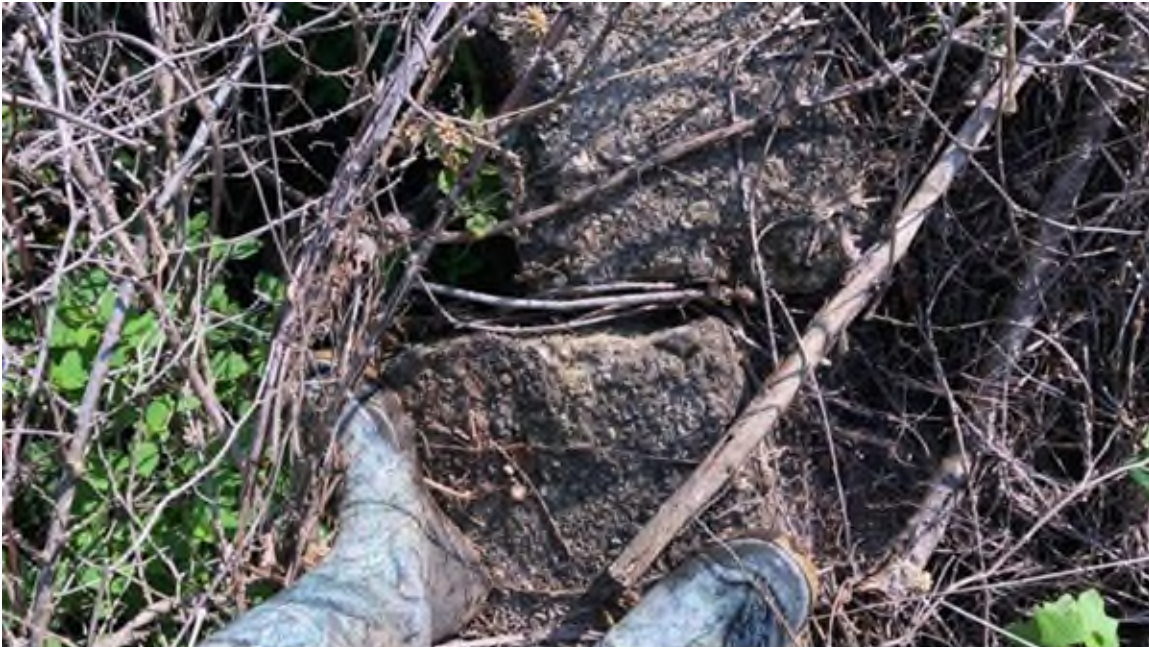
Photo #55 - Spillway right upstream abutment wall. Note concrete joint displacement

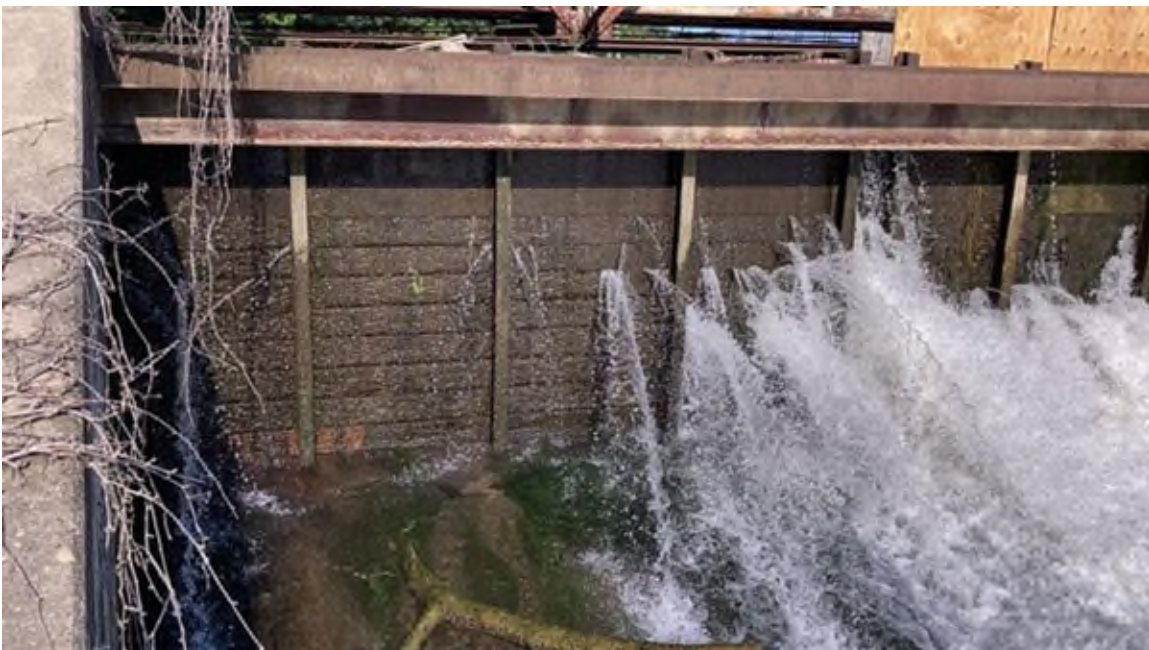
Photo #60 - Wooden stoplogs of bay #1, significant leakage observed

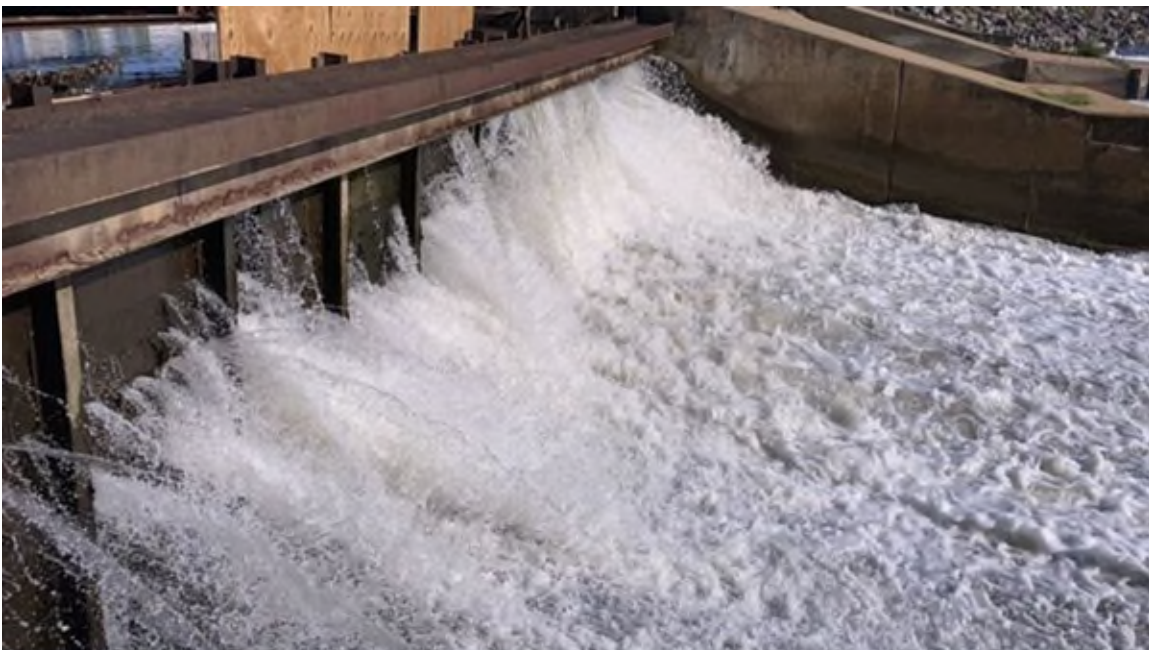
Photo #62 - Wooden stoplogs of bay #1, significant leakage observed

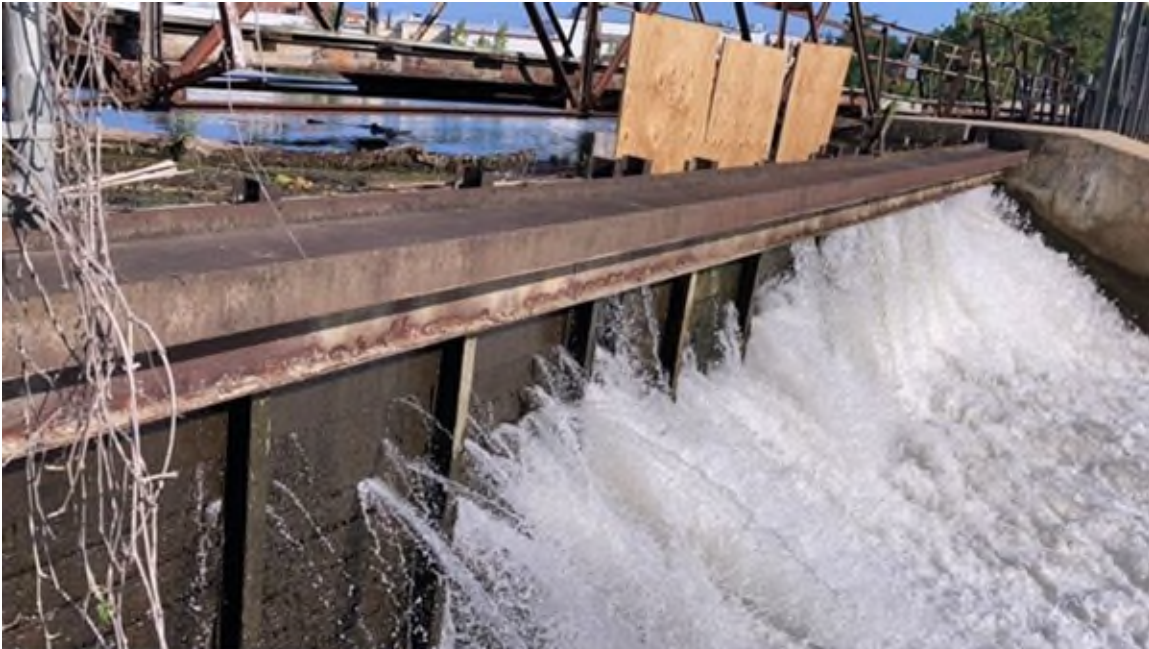
Photo #63 - Spillway bay #1. Beam at top of stoplog grooves appears slightly sagged

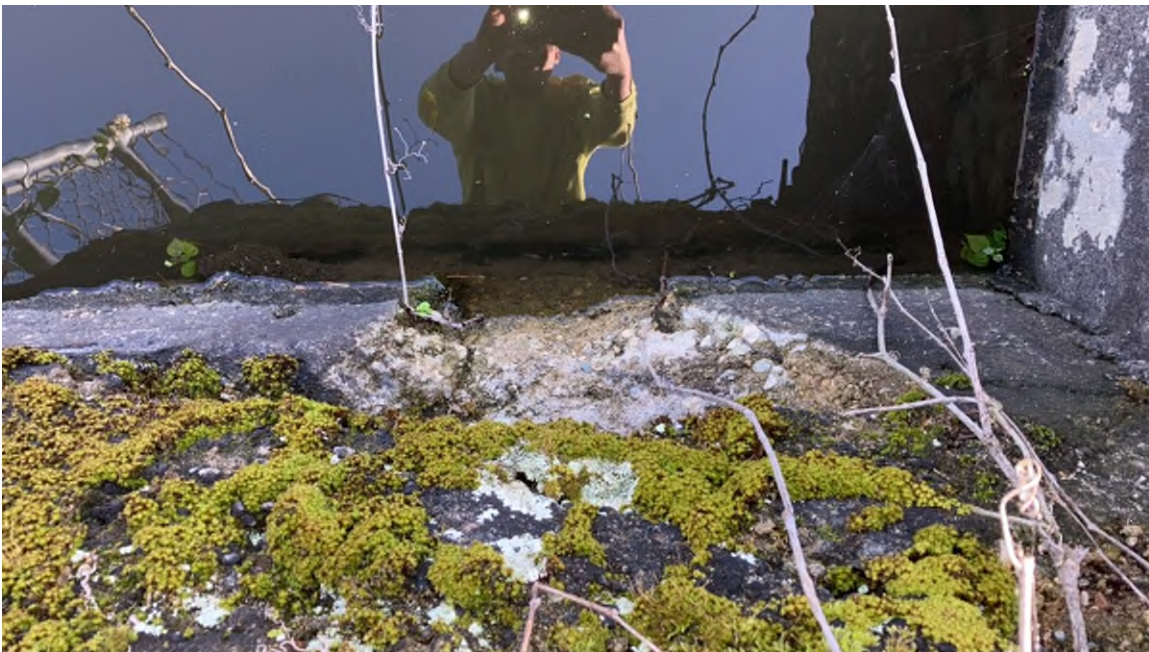
Photo #64 - Right upstream spillway abutment wall. Note some loss of concrete

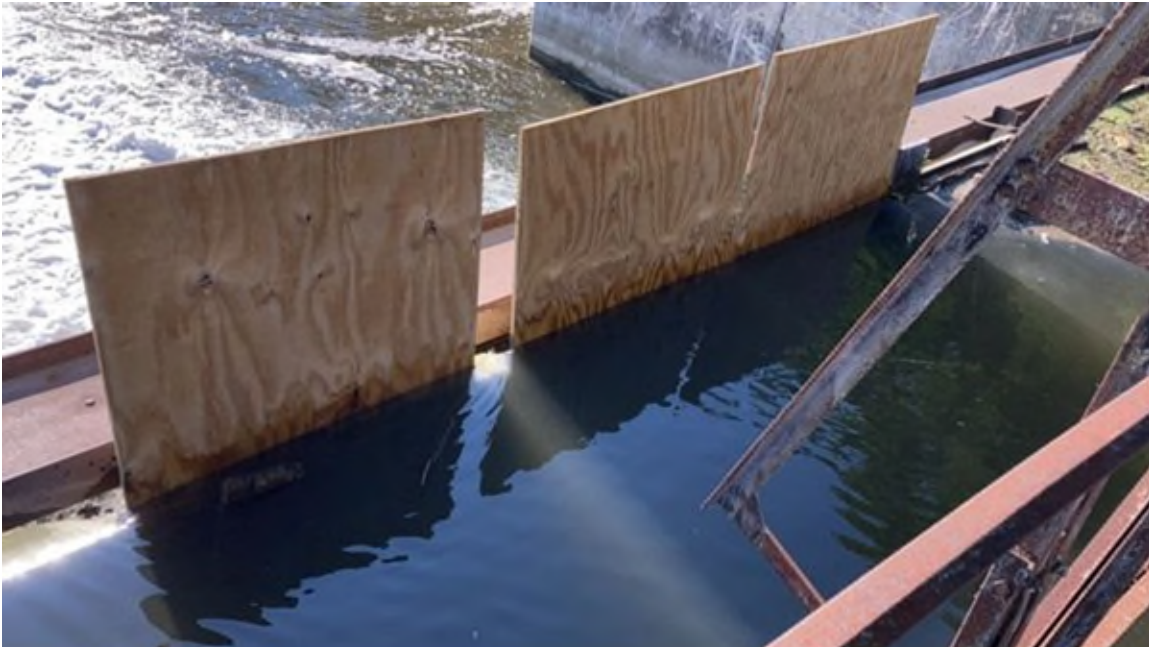
Photo #67 - Plywood placed upstream of some leaking stoplogs in spillway bay #1

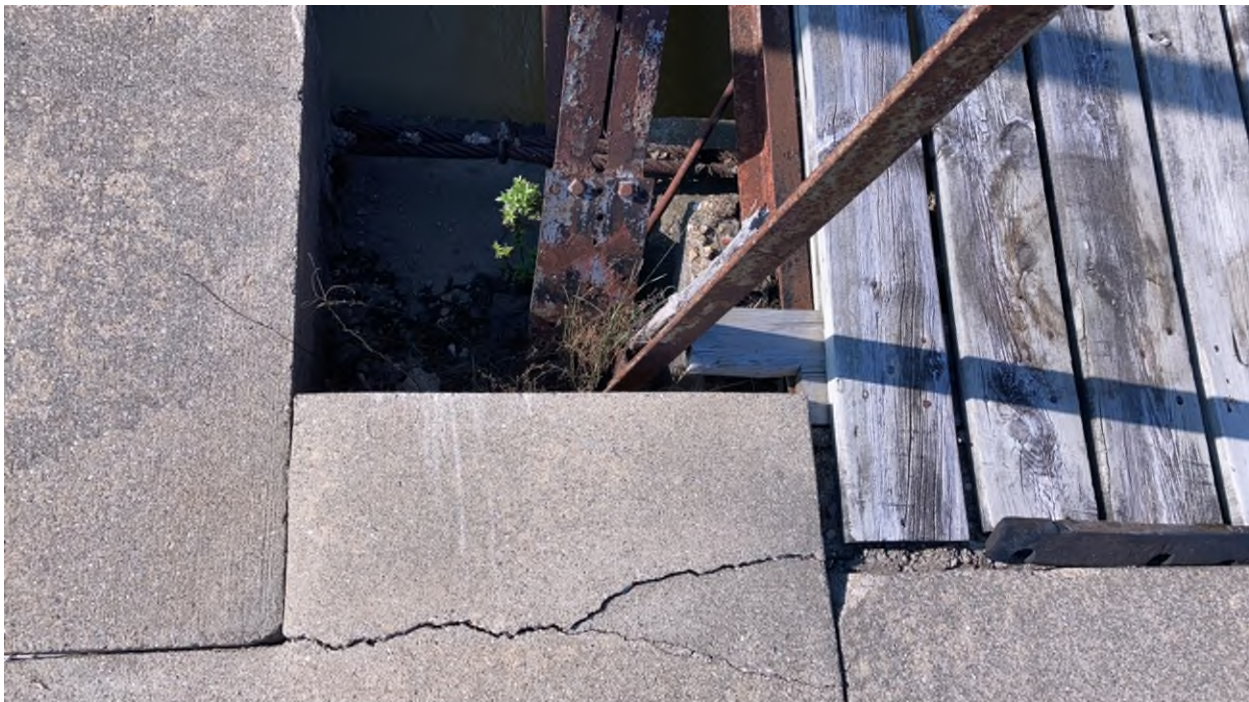
Photo #86 - Left end of walkway bridge, cracking concrete

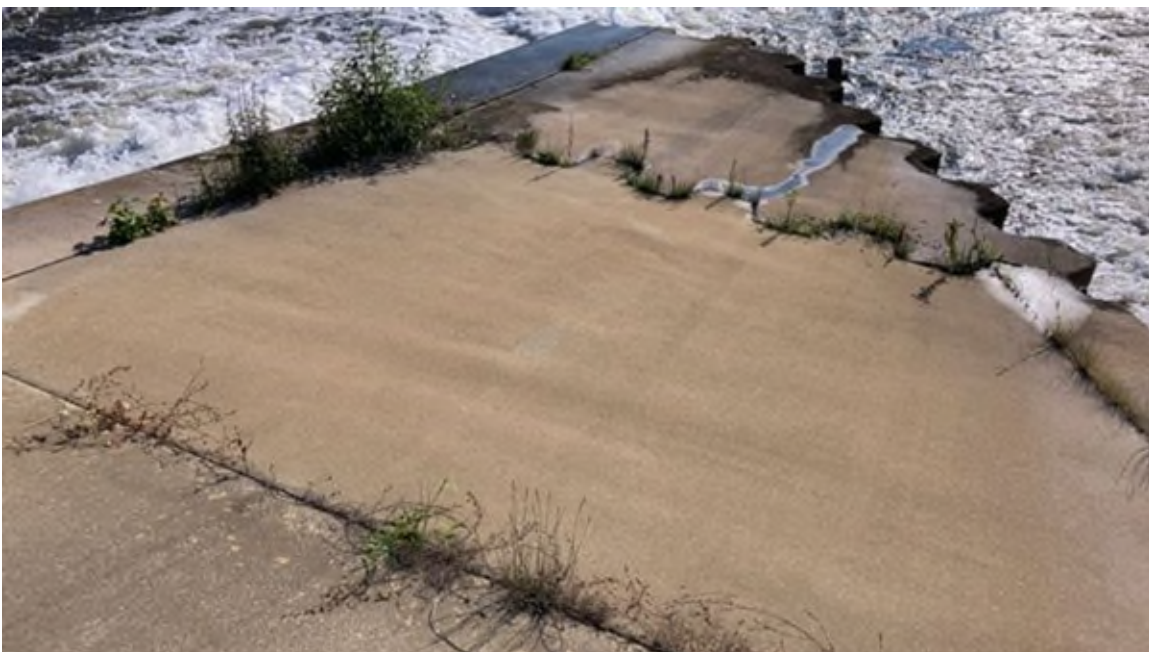
Photo #94 - Downstream needle section between spillway bays #2 and #3. Note some vegetation growing within joints and sheetpile interface with water seeping down

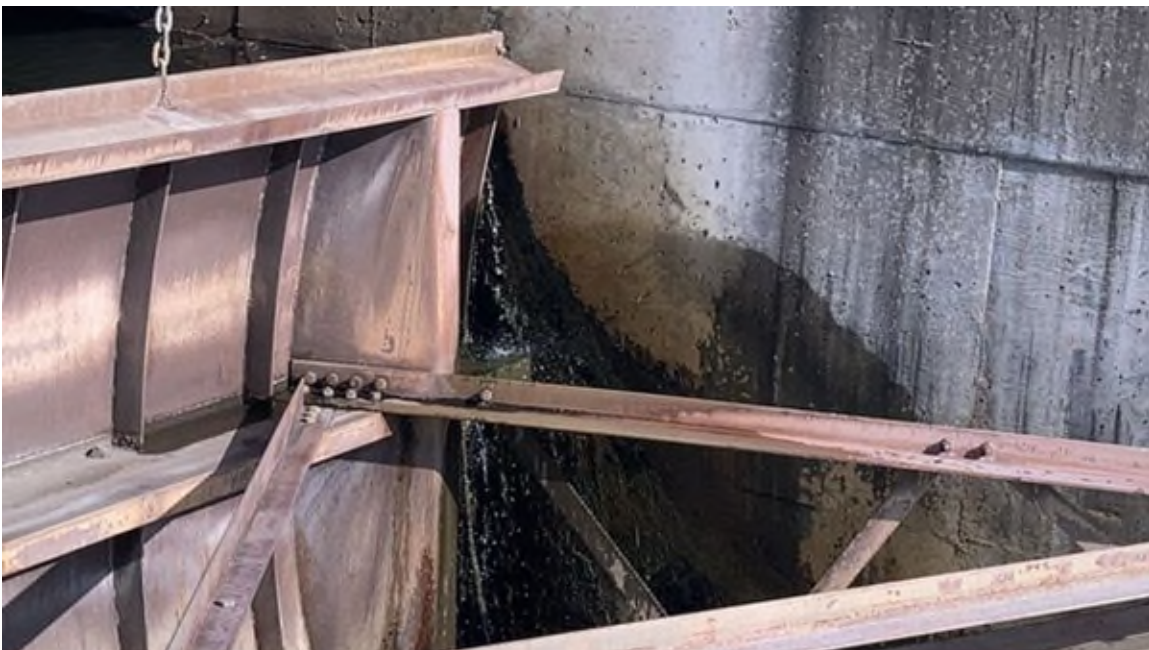
Photo #102 - Minor leakage along left side of spillway bay #3

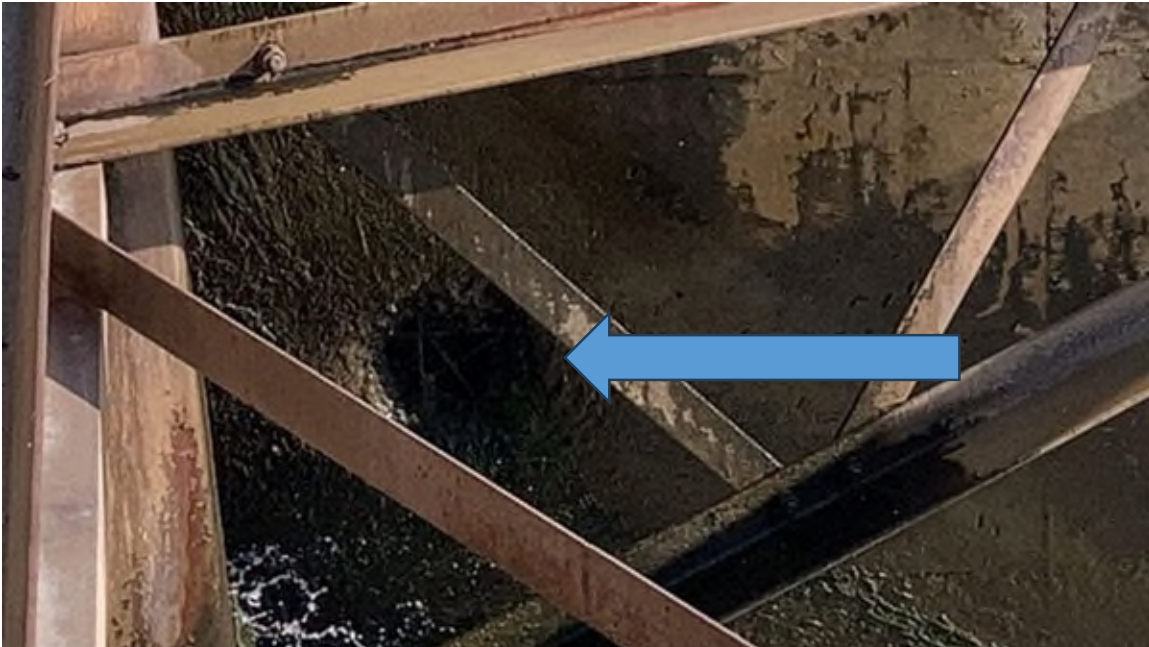
Photo #103 - Hole in left wall of spillway bay #3

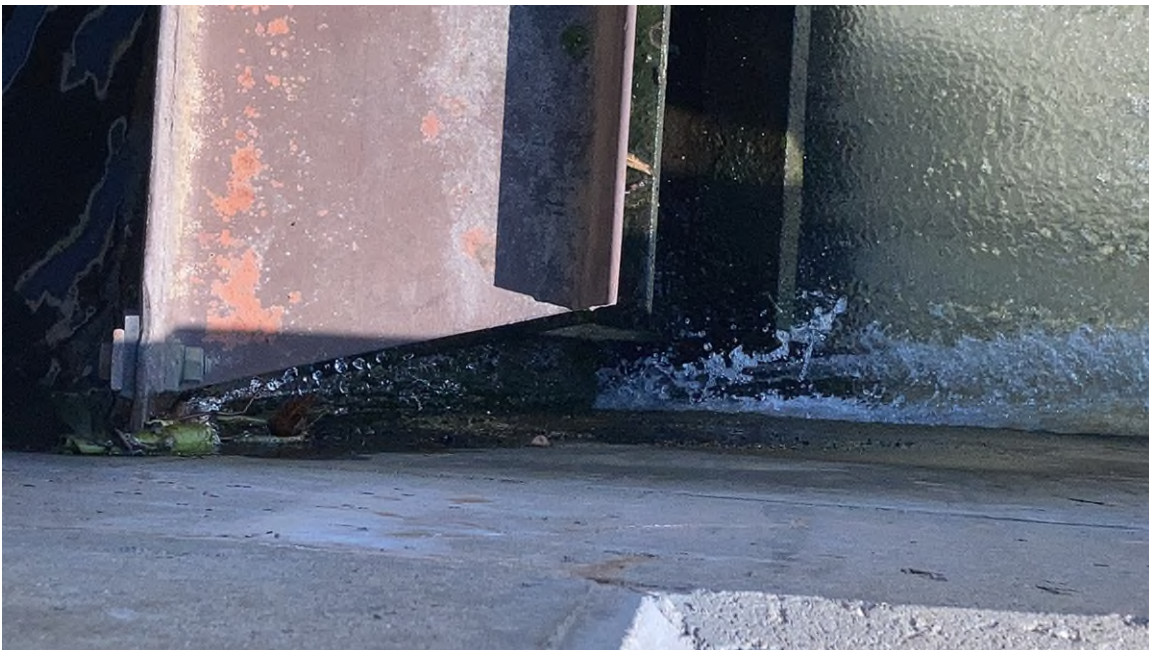
Photo #104 - Minor leakage on right side of spillway bay #3 gate

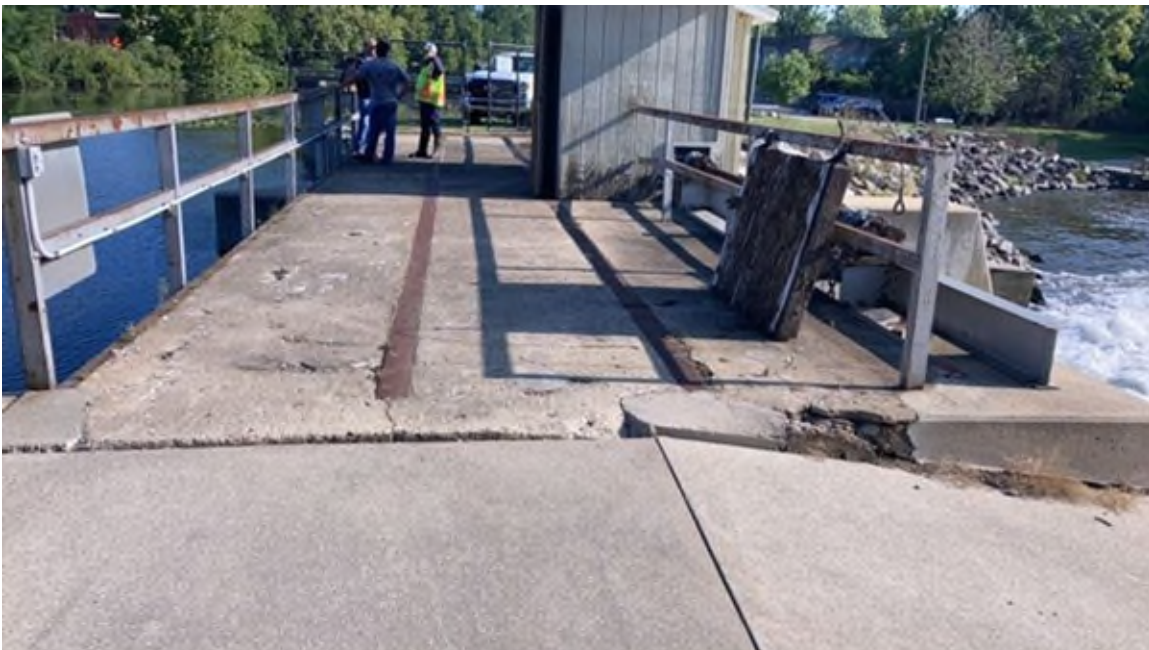
Photo #106 - Deck over spillway bays #3 and #4. Note deteriorating concrete on downstream (right in photo) side of deck at joint with abutment

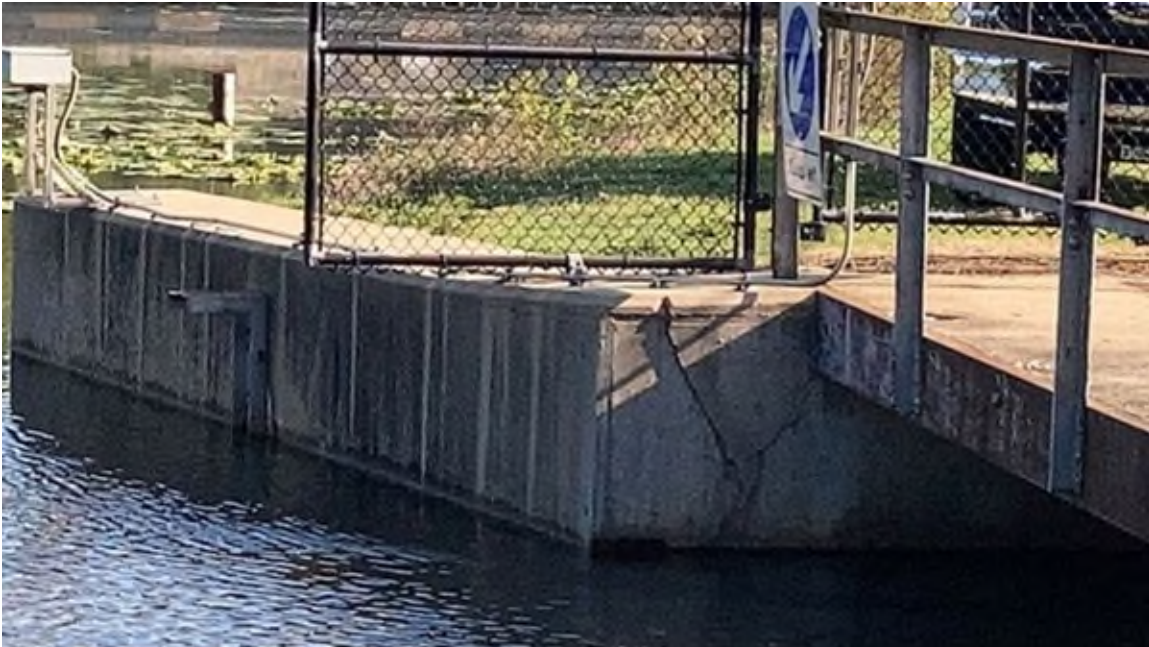
Photo #109 - Spillway bay #4 left upstream abutment. Note cracking

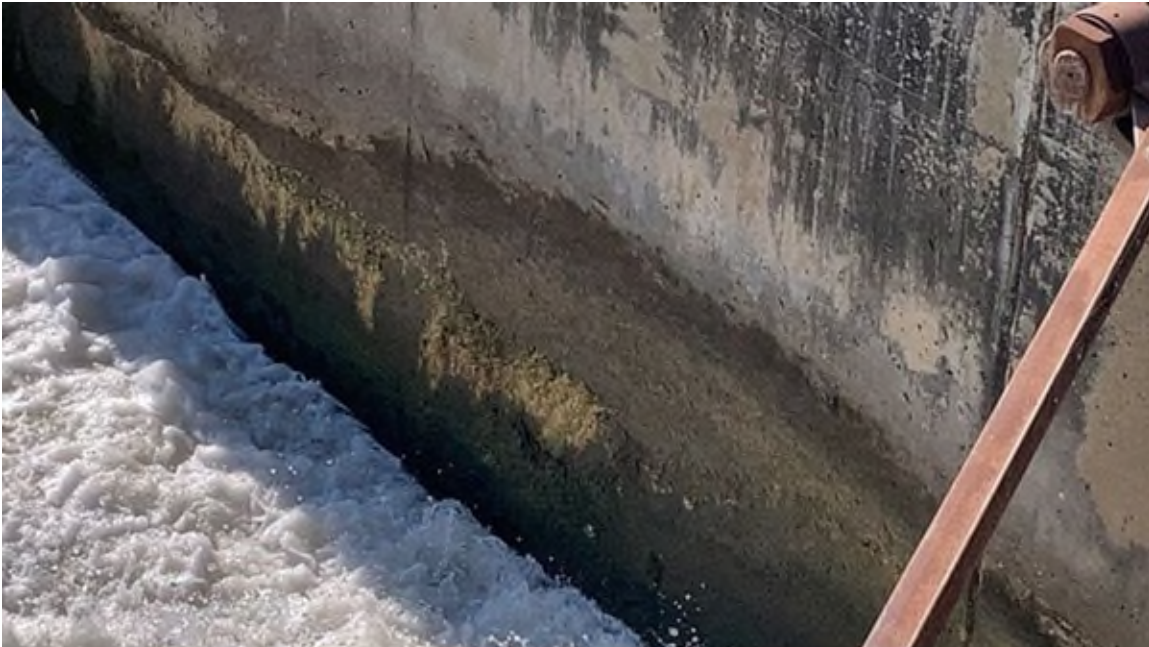
Photo #111 - Minor spalling on spillway bay #3 right downstream side

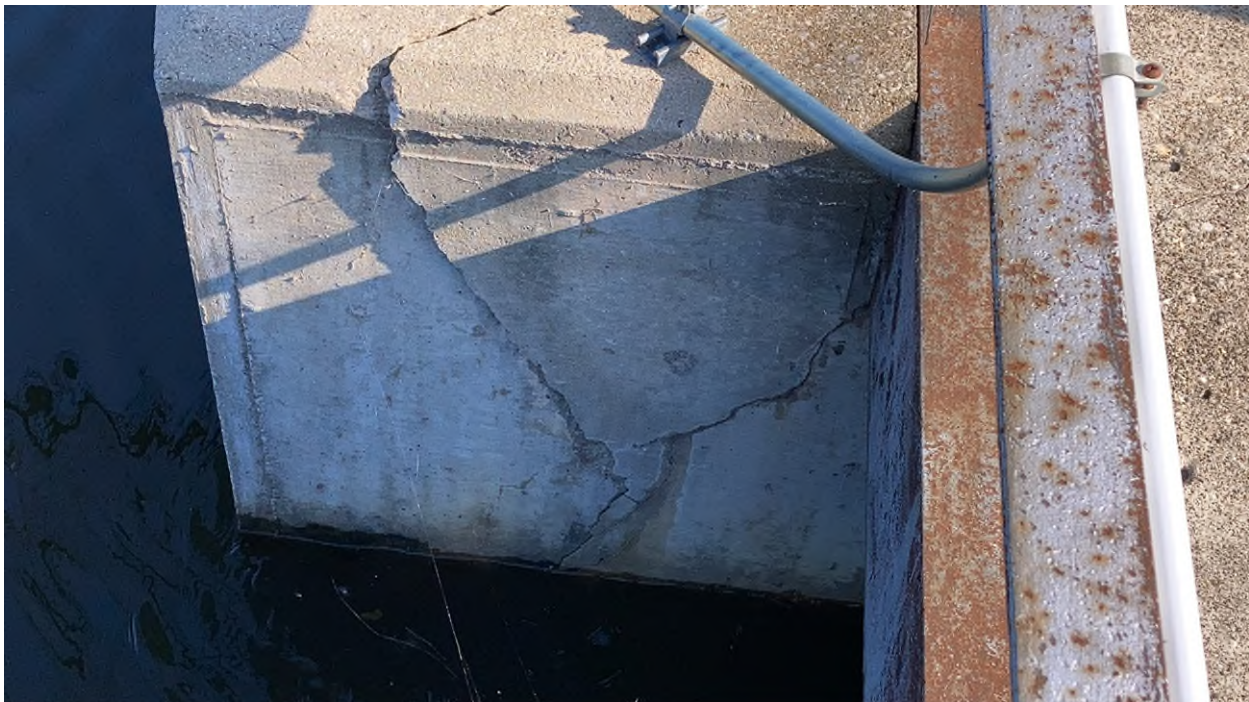
Photo #118 - Cracking on spillway bay #4 left upstream abutment

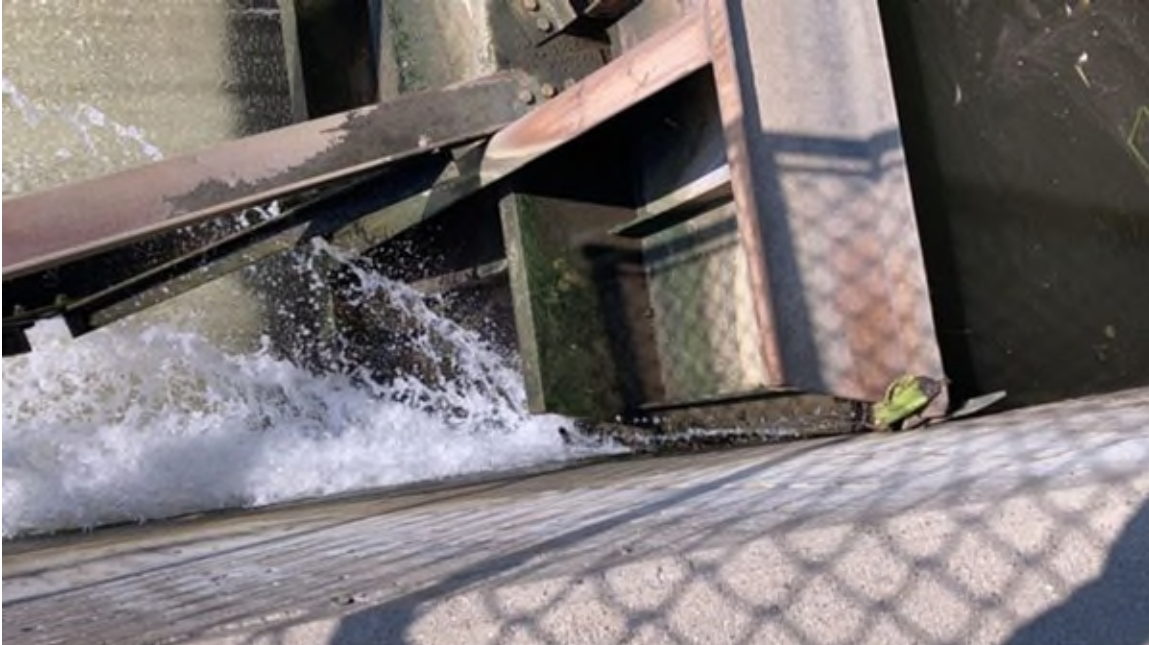
Photo #123 - Leakage at left edge of spillway bay #4 gate

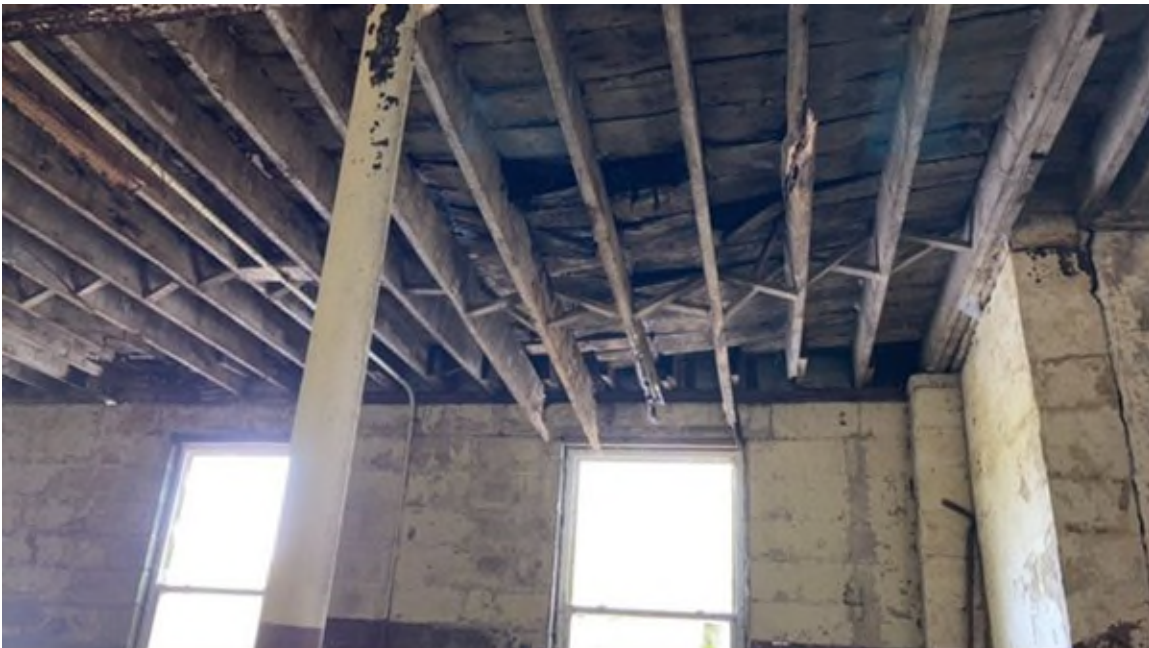
Photo #156 - Failing ceiling on left side of powerhouse
