**CITY OF ALLEGAN
CITY COUNCIL STUDY SESSION MEETING
Monday, October 9, 2023, 5:30PM
City Council Chambers - 231 Trowbridge Street
Allegan, Michigan**

SUBJECT: PaSER 10-Year Road Strategies Reports

**DAM SAFETY INSPECTION REPORT
ALLEGAN CITY DAM – DAM ID NO. 489
KALAMAZOO RIVER
ALLEGAN COUNTY – SECTION 28, T 02N, R 13W**

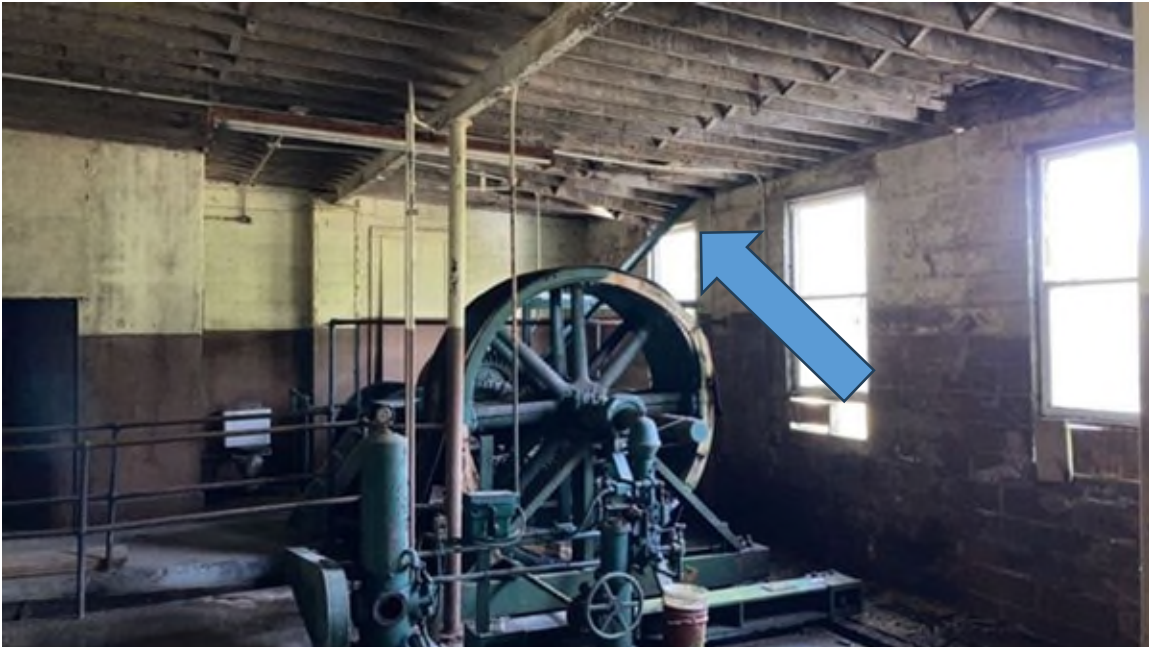
Photo #157 - Failing ceiling on left side of powerhouse
