RE: Riverside Bridge Cost Estimate

Re: Updated Draft Proposal for Design Engineering Services:
Riverside Bridge Rehabilitation Project

Subject: Village of Beverly Hills
Riverside Bridge Deck Investigation

HRC Job No. 20200667

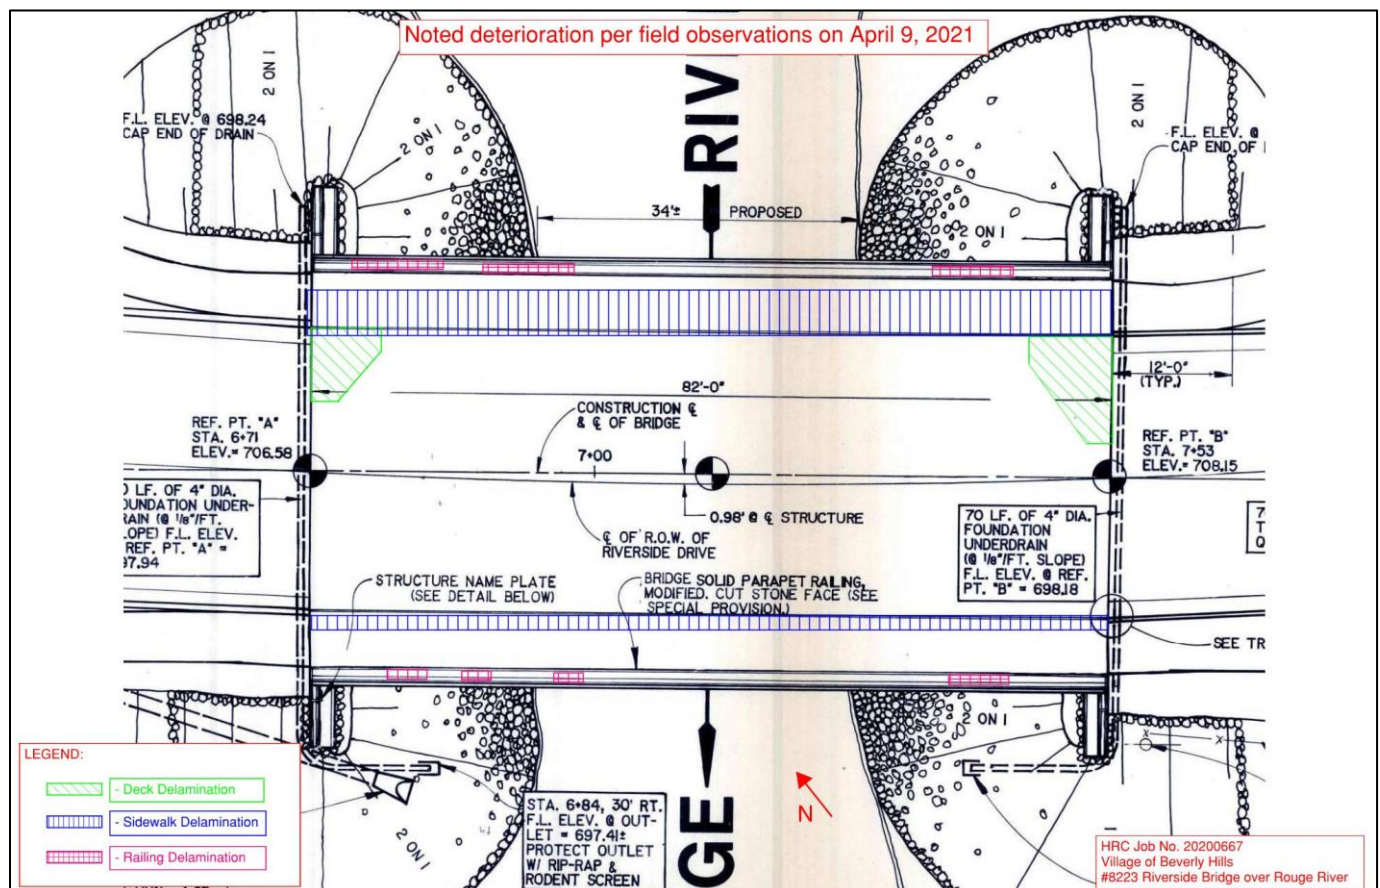
- Cracking, deterioration, and delamination of the deck noted in the northeast and northwest quadrants.
 - Northeast quad approximately 70 square feet
 - Northwest quad approximately 45 square feet
- Cracking located along the deck and approach joint was noted.
- Significant deterioration and delaminations noted in the upstream sidewalk. Totalling approximately 328 square feet.
- Deterioration and delamination noted along the deck joint of the downstream sidewalk. Totalling approximately 82 square feet.
- Efflorescence along the box beam underside below the upstream sidewalk.
- Cracking and spalling along the top of the concrete railing.
 - Upstream rail approximately 26 linear feet.
 - Downstream rail approximately 16 linear feet.
- Overall good condition of the underside of all box beams.
- Efflorescence and cracking in post-tensioned grout pockets.

Figure 1: Locations of significant cracking and delamination of the deck, sidewalk and railing.

1. Replace cracked and delaminated concrete deck in the northeast and northwest quadrant along the approach joint. During removal operations the box beam top flanges should be evaluated.
2. Replace cracked and delaminated concrete sidewalks.
3. Hot-pour seal the sidewalk/deck joint and each approach joint.
4. Apply a silane-based penetrating sealant to all exposed surfaces of the concrete deck, sidewalk, and railing to seal all cracks.
5. Replace cracked and spalled concrete along top of bridge railing.
6. Replace deteriorated grout in post-tensioned pockets.
7. Above noted repairs should be combined into a bridge maintenance project.

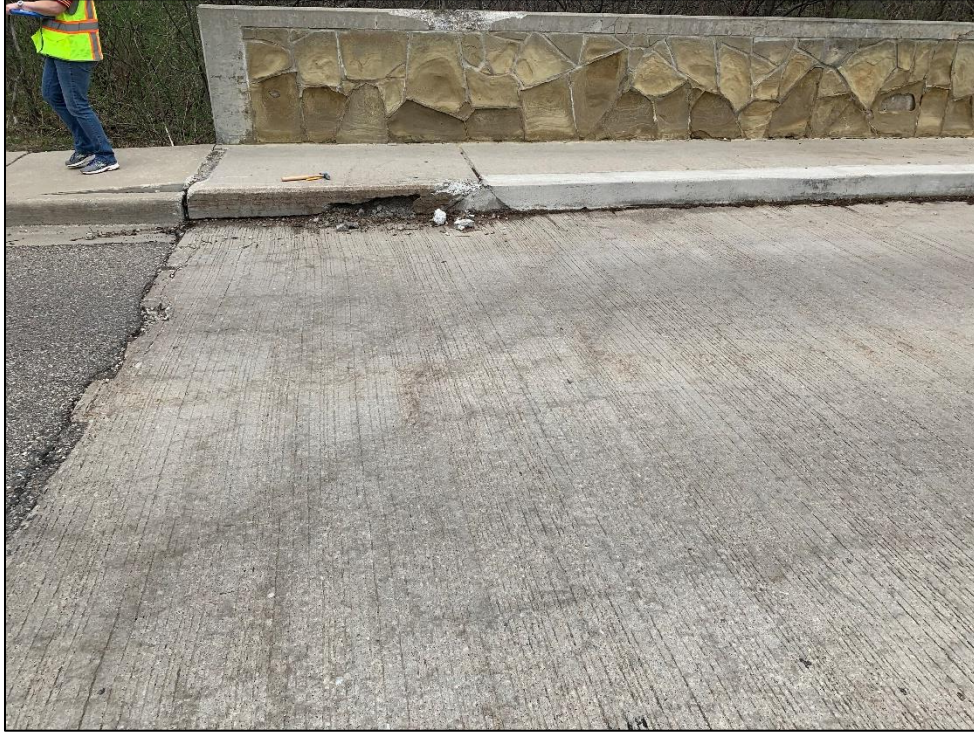
Photo 1: Deck cracking, sidewalk deterioration, and railing spalls in Northwest quad.

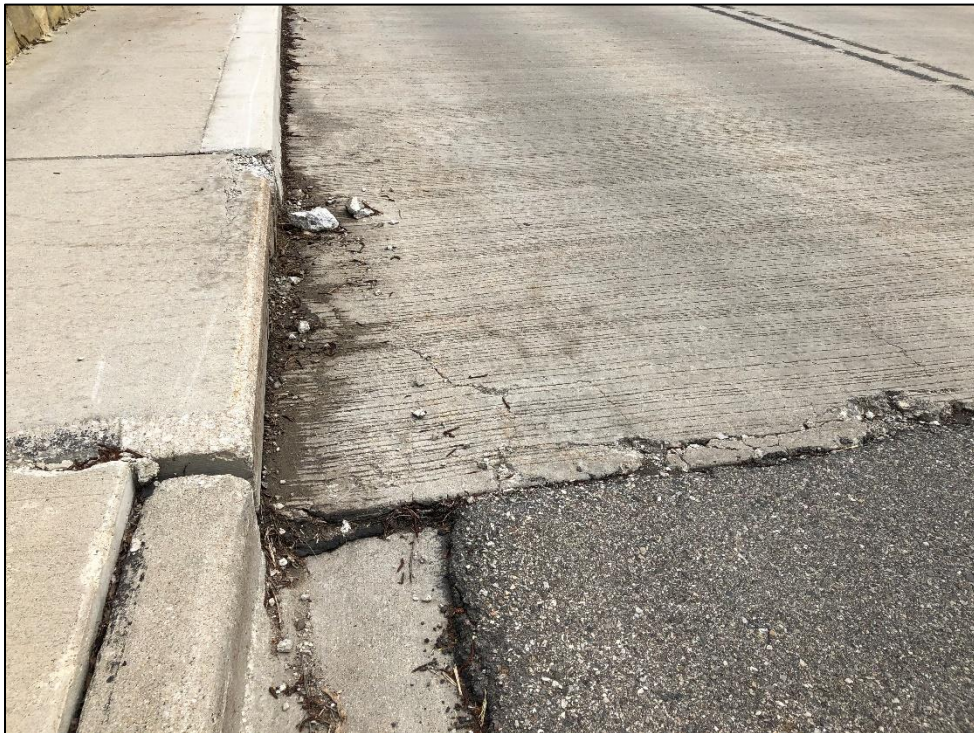
Photo 2: Deck cracking and sidewalk deterioration in Northwest quad.

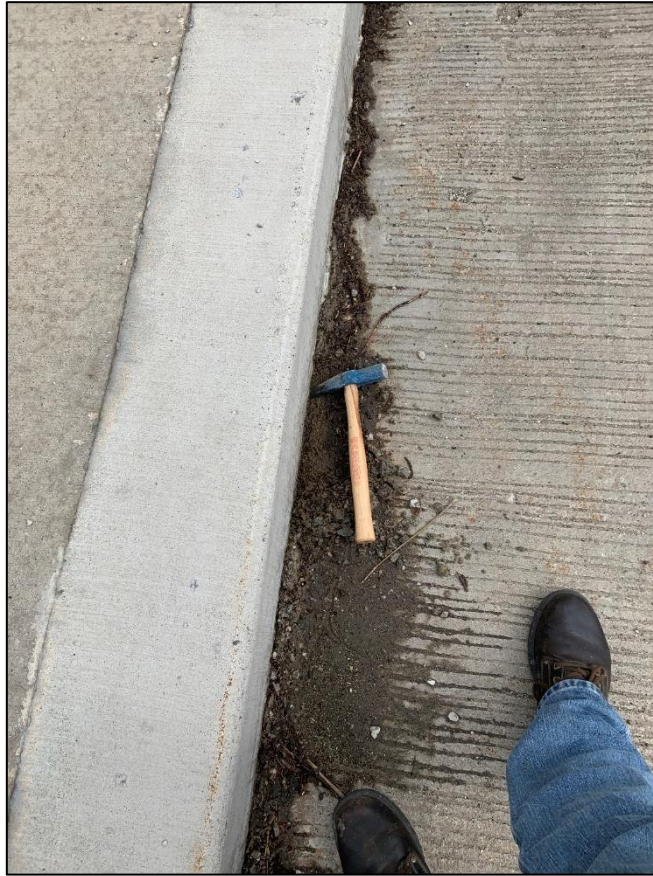
It appears that water has migrated under the concrete sidewalk along the sidewalk/deck joint and due to freeze-thaw cycles

has caused the concrete sidewalk surface to deteriorate, scale and delaminate from the deck. It appears that water has migrated under the concrete deck along the approach joints and due to freeze thaw cycles, has cause the concrete deck surface to delaminate from the box beams. It is our opinion that the deterioration is likely limited to the concrete deck and sidewalk and does not extend into the top flange of the box beam. The efflorescence noted along the box beam joints indicates the water is likely pooling under the sidewalk and deck and migrating through the box beam joints. The box beams were noted to be in good condition but if the water migration is not addressed, further deterioration of the box beams is expected.

Photo 3: Sidewalk deterioration along deck joint.

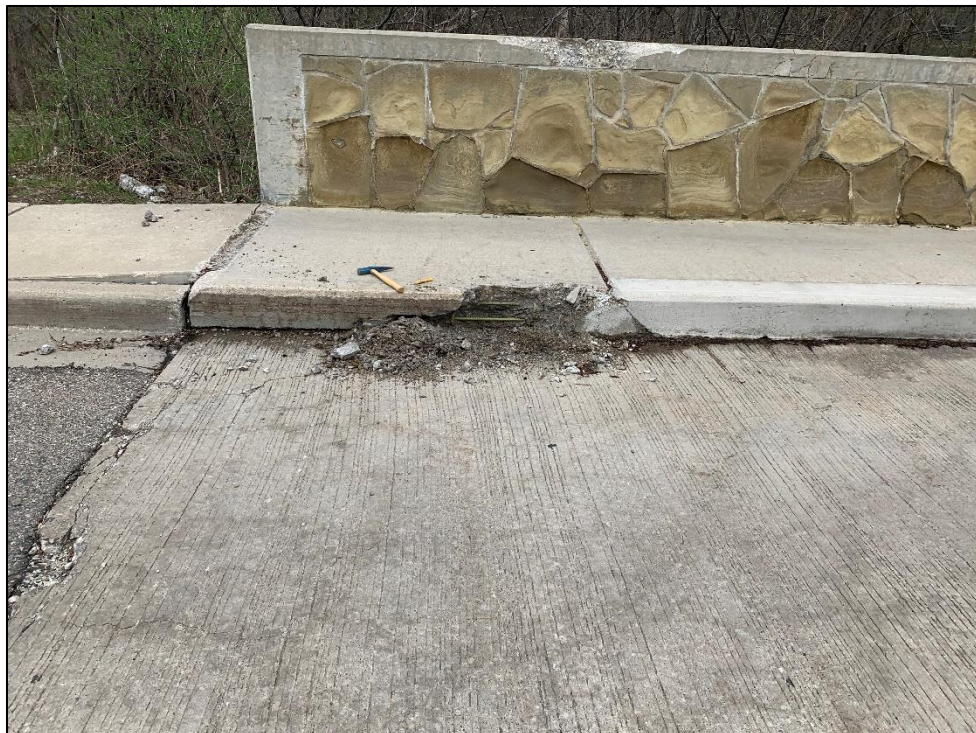
Photo 4: Exposed reinforcement in sidewalk

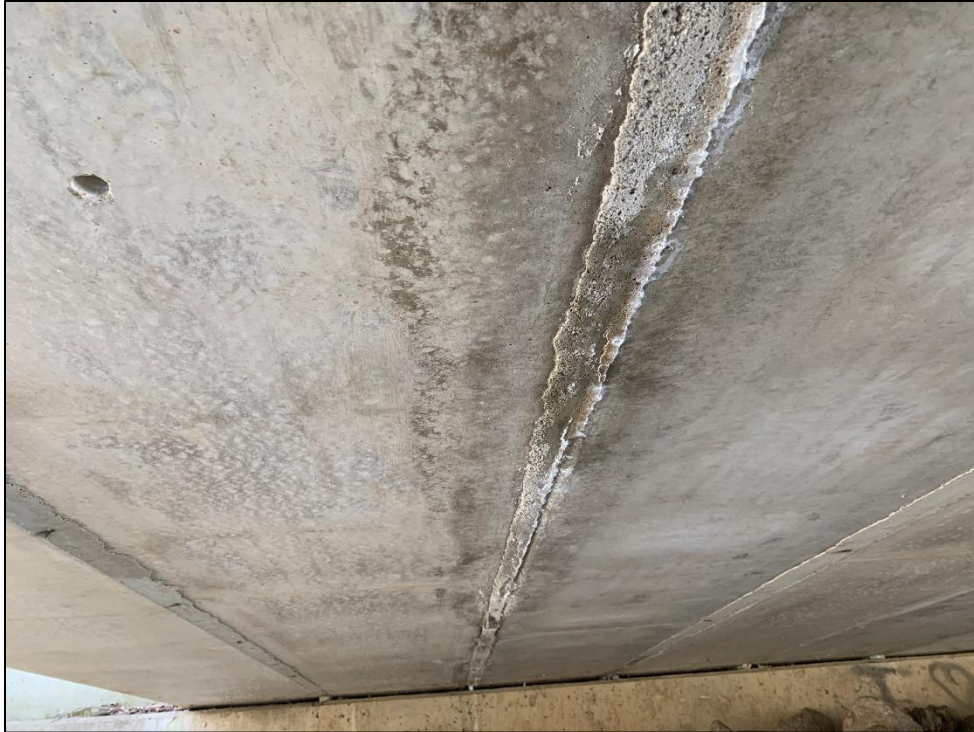
Photo 5: Efflorescence and minor beam cracking 2nd joint from upstream fascia beam, below the sidewalk.

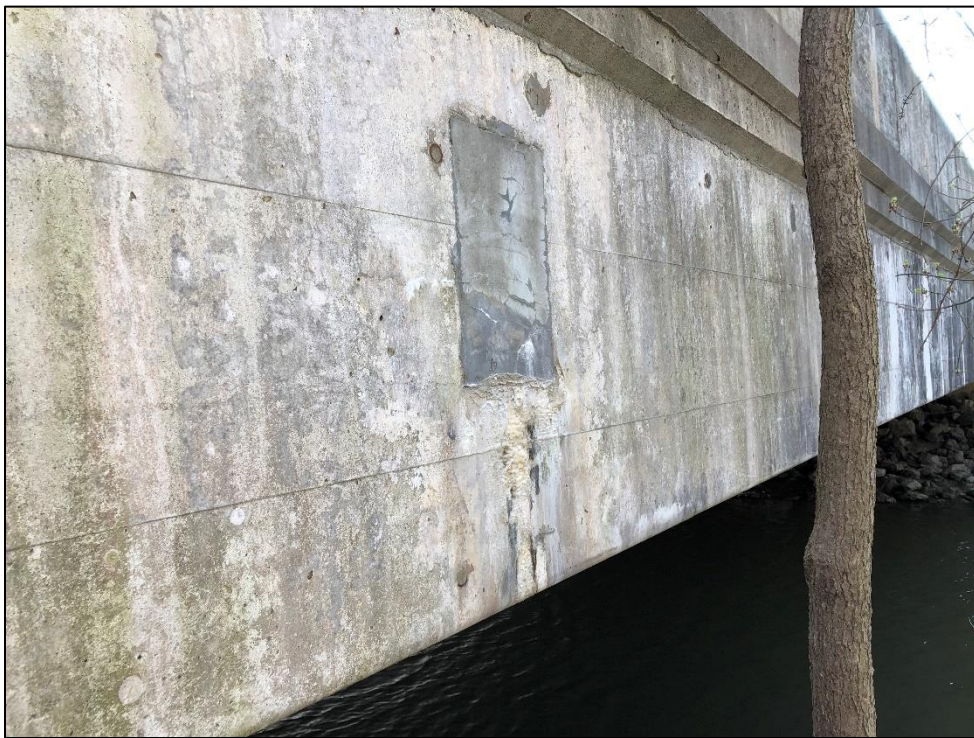
Photo 6: Efflorescence and cracking in post-tensioned grout pocket.
