## ***ENGINEER'S REPORT***

# **DRAINAGE DISTRICT NO. 5 TILE REPAIR BREMER COUNTY, IOWA**

**PROJECT NO: E22159**

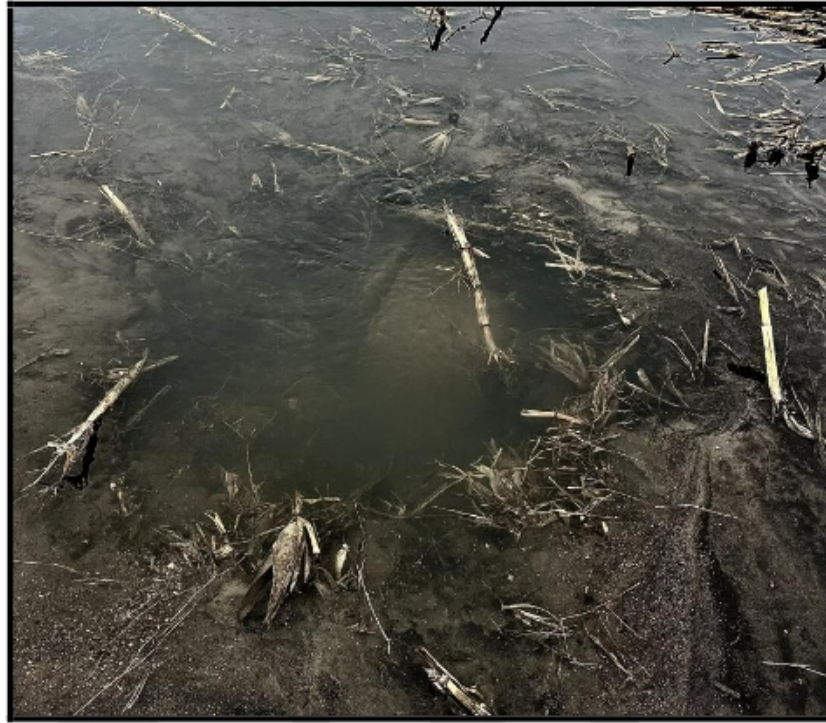
At the locations of the Main Tile blowouts in Section 16, we note that the tile has less than 1 foot of cover (depth of soil over the top of the pipe). The distance between the lowermost and uppermost tile blowouts observed is 86 feet.

On the day of site visit (Feb. 28, 2023) we observed water standing in the field where the tile blowouts are located. Crane Creek was in flood condition. Backpressure on the tile was causing water to “push”

out of the tile at the blowout locations. This is a side-effect of the lack of cover over the tile, as the water can easily push through the shallow layer of soil above the tile to get to the surface. This action can also cause the tile joints to push apart, as can freeze/thaw action near the outlet. The picture below shows a tile blowout, underwater.

Cover issues are not isolated to the portion of the Main Tile experiencing blowouts. In looking at the original Main Tile profiles, the first approximately 6,000 feet of tile (36" – 26" diameter) was installed with an average of about 1.5 feet of cover (from about 8" to 30"). For a district tile we typically recommend no less than 2.5 feet of cover under normal conditions, and at least 3 feet of cover where the ground is likely to subside (peat ground) or erode (surface waterway). At these shallow depths of cover we would expect that approximately 20-30% of the wheel load of passing equipment would be transmitted to the tile. The tile was installed over 100 years ago, and has held up quite well. But we do expect this to continue to be a problem into the future. Tile installed in the early 1900's was only expected to last for 50 years and has already long outlasted its life expectancy.

The area with blowouts would be repaired using new 36" diameter reinforced concrete pipe (RCP) with rubber gaskets at the joints, and fill (1-2 feet) would be hauled in to increase the amount of cover over the tile in the area of repair. This would be the least costly option. If the remainder of the Main Tile in the area is in good condition this would be the best option. However, if the tile is in poor condition, if the tile joints have separated, or if there is very little cover in other areas additional repairs could be necessary in the future. We would not recommend the use of dual-wall HDPE for this option because of the limited amount of cover, as it is much more susceptible to deflection and failure than RCP.

In our opinion, the cost of relocating and/or lowering the first approximately 2,300 feet of the Main Tile is cost prohibitive. Therefore, we recommend that Option 1 be pursued. Repairs can be completed in the area of the recent blowouts, and fill hauled in for a reasonable price, presuming the tile outside the area of the recent blowouts is in good condition. At the writing of this draft report the extent of the outlet channel cleaning that is necessary is unclear, but we believe at a minimum the tree saplings should be removed, as they are creating an obstruction.

This report confirms the need for drainage repairs within Drainage District No. 5. We recommend replacing the existing concrete 36" diameter tile in the area of blowouts (approximately 100 feet) with 36" diameter reinforced concrete pipe (2000D). We also recommend placing topsoil fill over the tile in the area of the repair (plus a couple hundred feet in each direction) to increase the cover over the tile, which is now approximately 1 foot or less. Because the existing Main Tile has nearly adequate capacity, repairing and replacing tile as needed is a worthwhile investment. The estimated project cost for the repairs is \$44,000 or an average of \$23/acre in the district. By Iowa Code repairs are required.

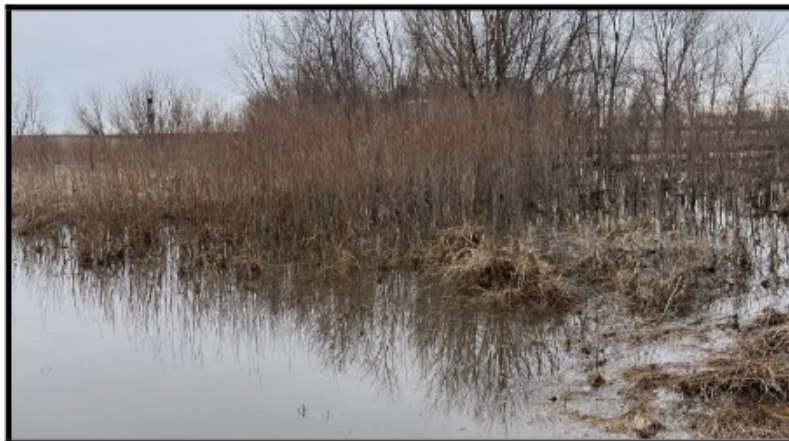
**B. Main Tile Outlet Channel:**

It appears that the Main Tile outlets to a side-channel of Crane Creek. It is about 400 feet in length from the tile outlet to Crane Creek. On the February 28, 2023 site visit we noted that there is a potential restriction of flow in the outlet channel. More survey is needed to check elevations, but a thick growth of tree saplings was present in the bottom of the channel. The channel may need to be cleaned out as part of this repair work.
