ENGINEER'S REPORT

DRAINAGE DISTRICT NO. 5 MAIN TILE REPAIR OR IMPROVEMENT BREMER COUNTY, IOWA

PROJECT NO: E22159

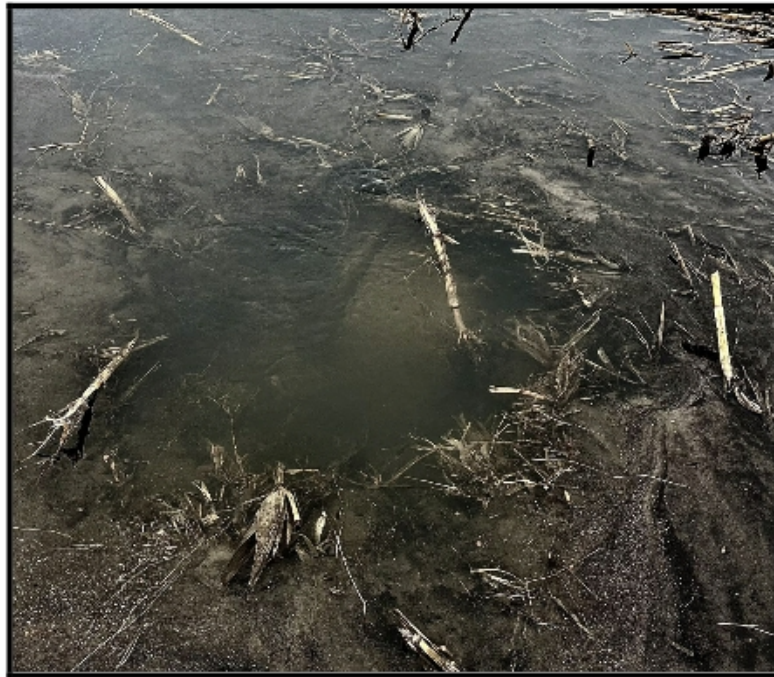
On the Feb. 28th site visit we observed water standing in the field where the tile blowouts are located. Crane Creek was in flood condition. Backpressure on the tile was causing water to "push" out of the tile at the blowout locations. This is a side-effect of the lack of cover over the tile, as the water can easily push through the shallow layer of soil above the tile to get to the surface. This action can also cause the tile joints to push apart, as can freeze/thaw action near the outlet. The picture below shows a tile blowout underwater. We note that the tile is not necessarily broken at every blowout location; however, it is at a minimum pushing water out onto the farmland, and at other times sucking soil into the tile. This is a problem that needs to be addressed.

On the March 13th site visit the field was no longer flooded, and we were able to identify several additional blowouts/suck holes in the Main Tile. We note that the tile has less than 1 foot of cover (depth of soil over the top of the pipe). The distance between the lowermost and uppermost tile blowouts observed is approximately 900 feet.

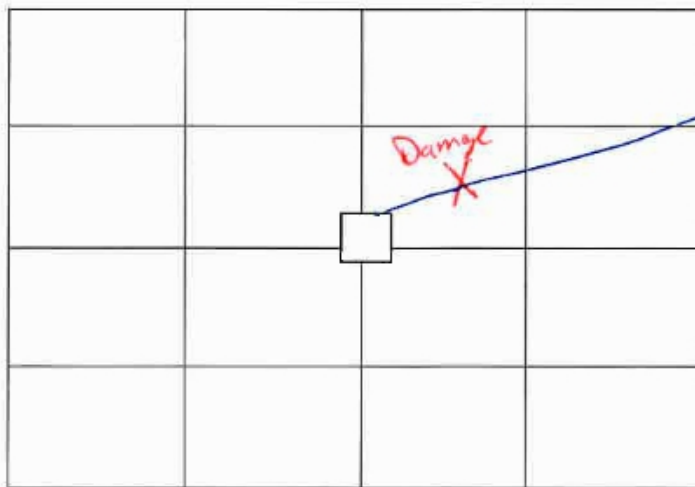
Please give description of the problem: Several sinkholes over 36" main

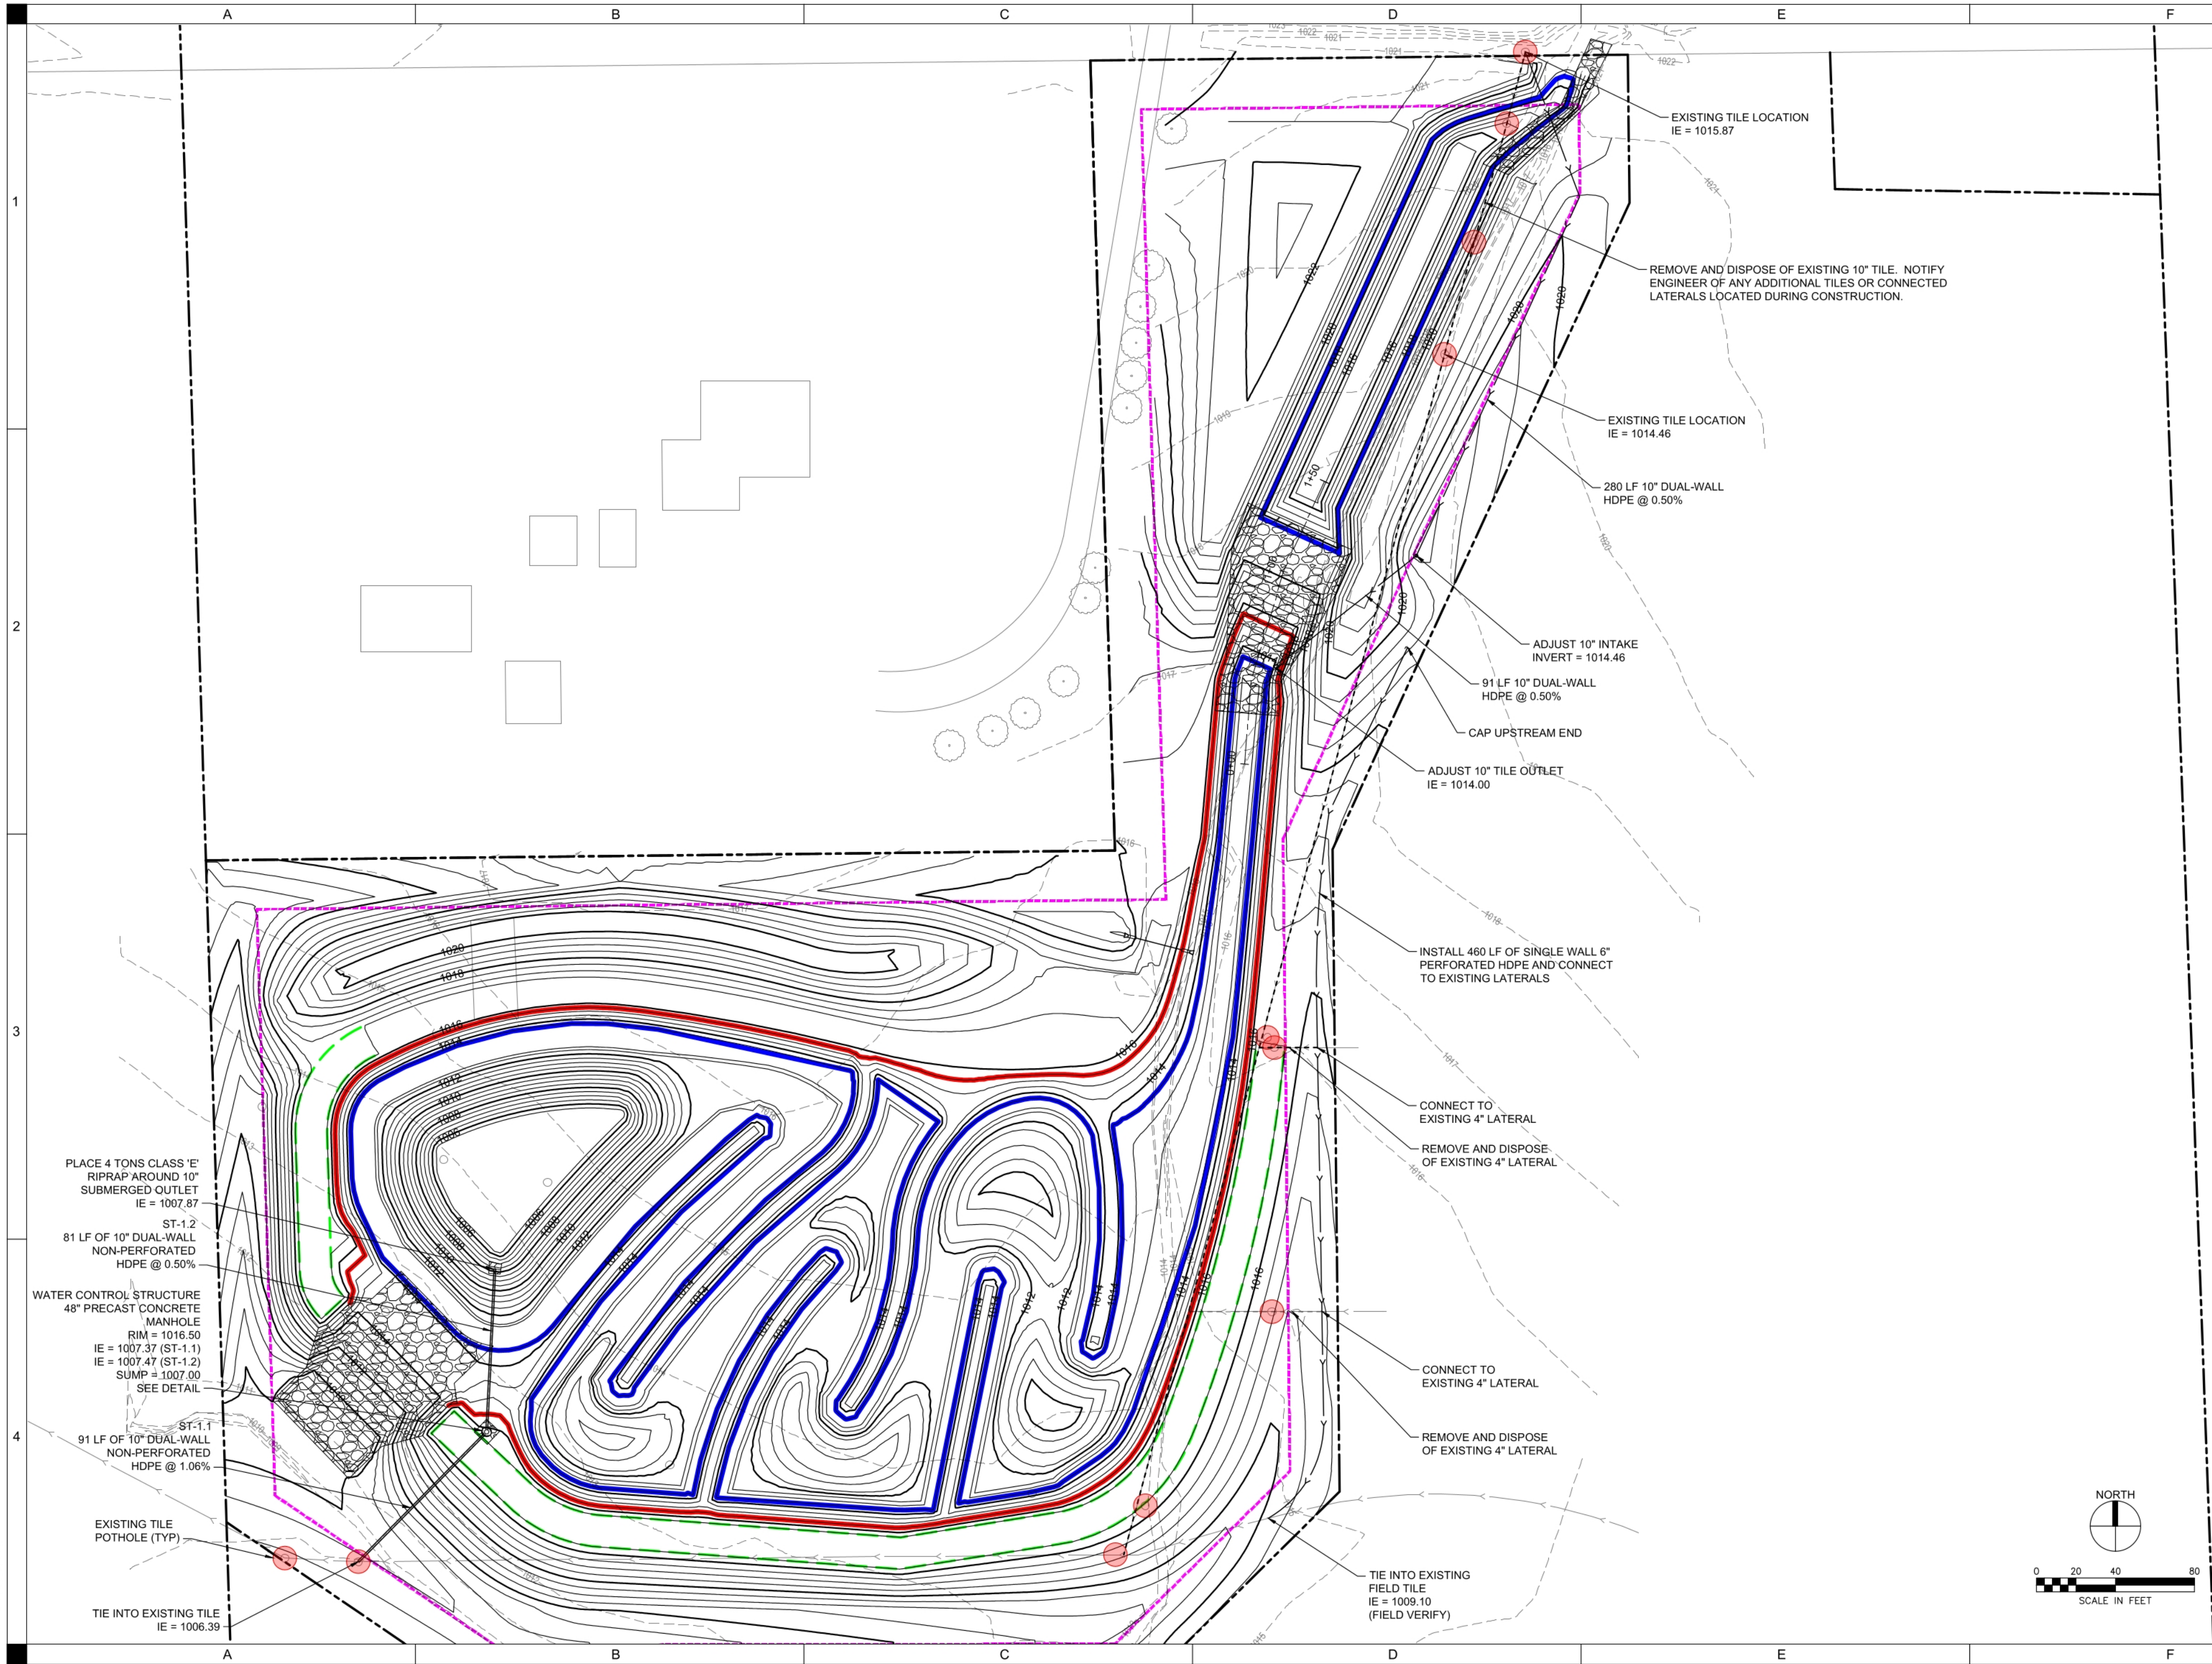
TILE ADJUSTMENTS

As part of our investigation of the capacity of the existing tile system of Drainage District No. 5, we investigated a stormwater wetland that was constructed in 2018 in the area of the Sub-Main 5 tile. See enclosed plan sheets. Sub-Main 5 Lateral 1 tile was removed. At the upper end of the original lateral, a 10" dual-wall HDPE pipe was installed to route the flow to the downstream side of a rock letdown structure upstream of the wetland. The lower portion of the Sub-Main 5 Lateral 1 tile was replaced with

a 6" single-wall HDPE pipe that connects into the Sub-Main 5 tile. As a result of the project, we consider Sub-Main 5 Lateral 1 tile to be abandoned.

There is a water control structure at the downstream side of the wetland, which is the outlet for the wetland. From the control structure the water flows through a 10" diameter dual-wall HDPE pipe to the 12" diameter Sub-Main 5 tile. It was noted as part of the project that site topography limited the ability to provide significant detention for large flood events. As such, the design flows into and out of the wetland are orders of magnitude greater than the design capacity of the existing tile. If the tile is overloaded, the wetland will overflow, and water will go down a rock chute and continue westward via a series of surface waterways to Crane Creek along a similar path as the Main Tile.
