## Pavement Management Plan

Town of China Grove

### 2024 Pavement Management Plan

KCA Project Number: 005-202318.00

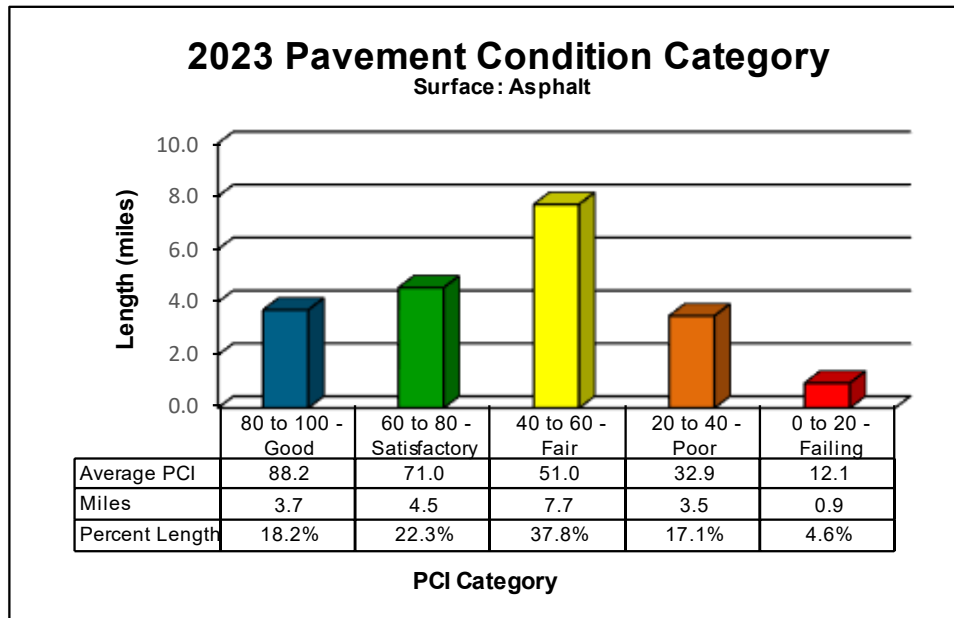
Figure 2: PCI Distribution

After the final importation of distress data, the PCI is calculated within PAVER for each sample. The results are then extrapolated to each section. **Map 2 in Appendix A** shows the geographic distribution of PCI scores across the Roadway Network. The average PCI for all China Grove Streets in 2023 is **58**. Based on length of each street segment and the calculated PCI, 18.2% of China Grove's asphalt network is in **Good** condition, 22.3% is in **Satisfactory** condition, 37.8% is in **Fair** condition, 17.1% is in **Poor** condition, and 4.6% are **Failing**.

Pavement Condition Rating	Sections	Length (miles)	Pavement Area (SF)	Average PCI
80 to 100 - Good	38	3.7	460,464	88.2
60 to 80 - Satisfactory	45	4.5	622,090	71.0
40 to 60 - Fair	68	7.7	982,103	51.0
20 to 40 - Poor	36	3.5	435,302	32.9
0 to 20 - Failing	10	0.9	109,206	12.1
	197	20.4	2,609,166	57.5

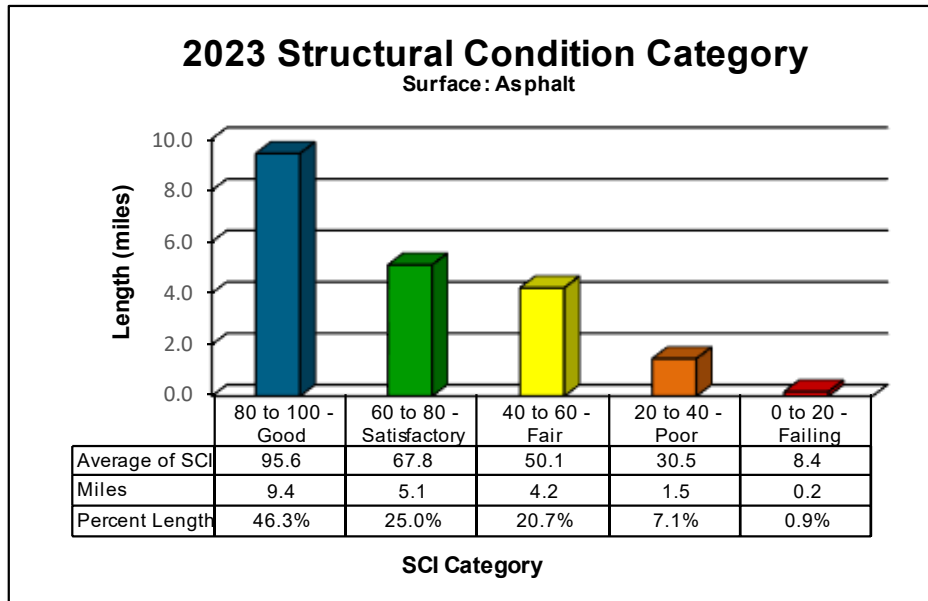
Figure 3: SCI Distribution

Structural Condition Rating	Sections	Length (miles)	Pavement Area (SF)	Average SCI
80 to 100 - Good	94	9.4	1,216,798	95.6
60 to 80 - Satisfactory	51	5.1	676,705	67.8
40 to 60 - Fair	35	4.2	519,539	50.1
20 to 40 - Poor	14	1.5	176,370	30.5
0 to 20 - Failing	3	0.2	19,754	8.4
	197	20.4	2,609,166	74.4

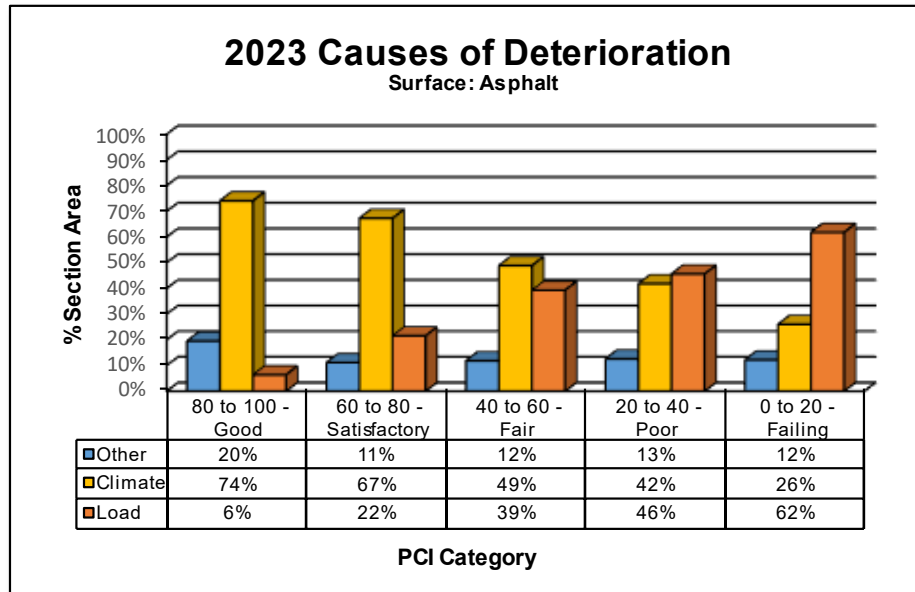
Figure 4: Causes of Asphalt Deterioration

For the China Grove streets, 74% of the overall condition of the pavement can be attributed to climate and durability issues with the remaining 26% attributed to load or other issues.

As will be discussed later in this report, one method to help reduce the effects of weathering and raveling is using preventive treatments such as a rejuvenator. The purpose of a rejuvenator is to soften the stiffness of the oxidized pavement surface and re-introduce maltenes to extend the life of the pavement.

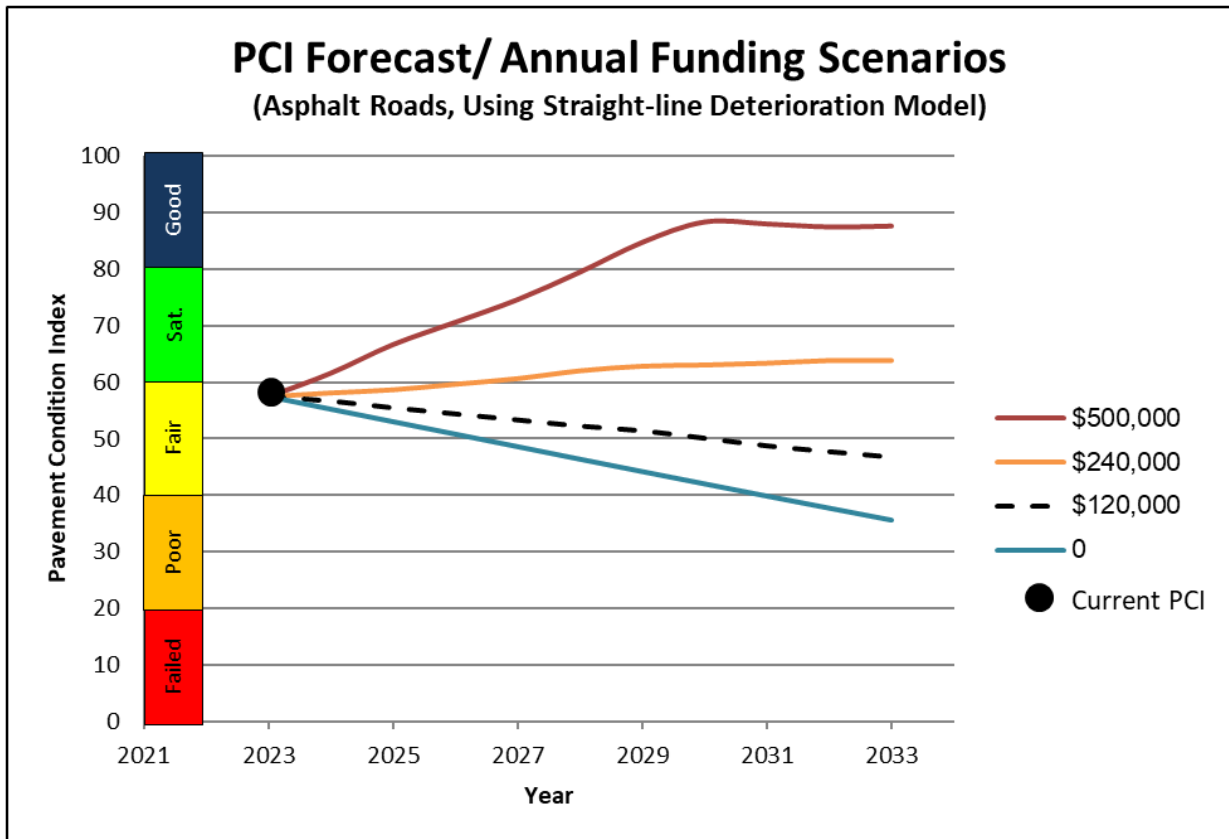
Figure 7: Budget / PCI Forecast

Four different budget scenarios are presented below and provide an envelope of expected results based on potential funding levels. A \$0-based scenario represents a “do nothing” option. \$120,000 is the current budget China Grove Staff has for pavement management, \$240,000, and \$500,000 scenarios are also evaluated. Each forecast scenario assumes that 100% of the annual funding is applied to Major Maintenance & Rehabilitation (M&R) and Major Global Preventive. Based on the analysis, the network condition can be expected to deteriorate from current conditions if the funding level remains at \$120,000 annually. Conversely, an increase of the network PCI can be expected if the funding is increased to \$240,000 or more annually. The model predicts funding of \$500,000 will raise and maintain the PCI in the *Good* range.

It is recommended to seek or raise funding to \$240,000 per year. This realistic minimum would increase the current average PCI, moving Pavement Maintenance in a positive direction. The results of the funding evaluations are presented in Figure 7 below.
