# REVISED ENGINEER'S REPORT ON REPAIRS TO MAIN TILE SUBDISTRICT NO. 1 DRAINAGE DISTRICT NO. 9 FRANKLIN COUNTY,

**CGA**  
ENGINEERS • LAND SURVEYORS

**Revised Engineer's Report on Repair to  
Main Tile of Subdistrict No. 1  
of Drainage District No. 9  
Franklin County, Iowa**

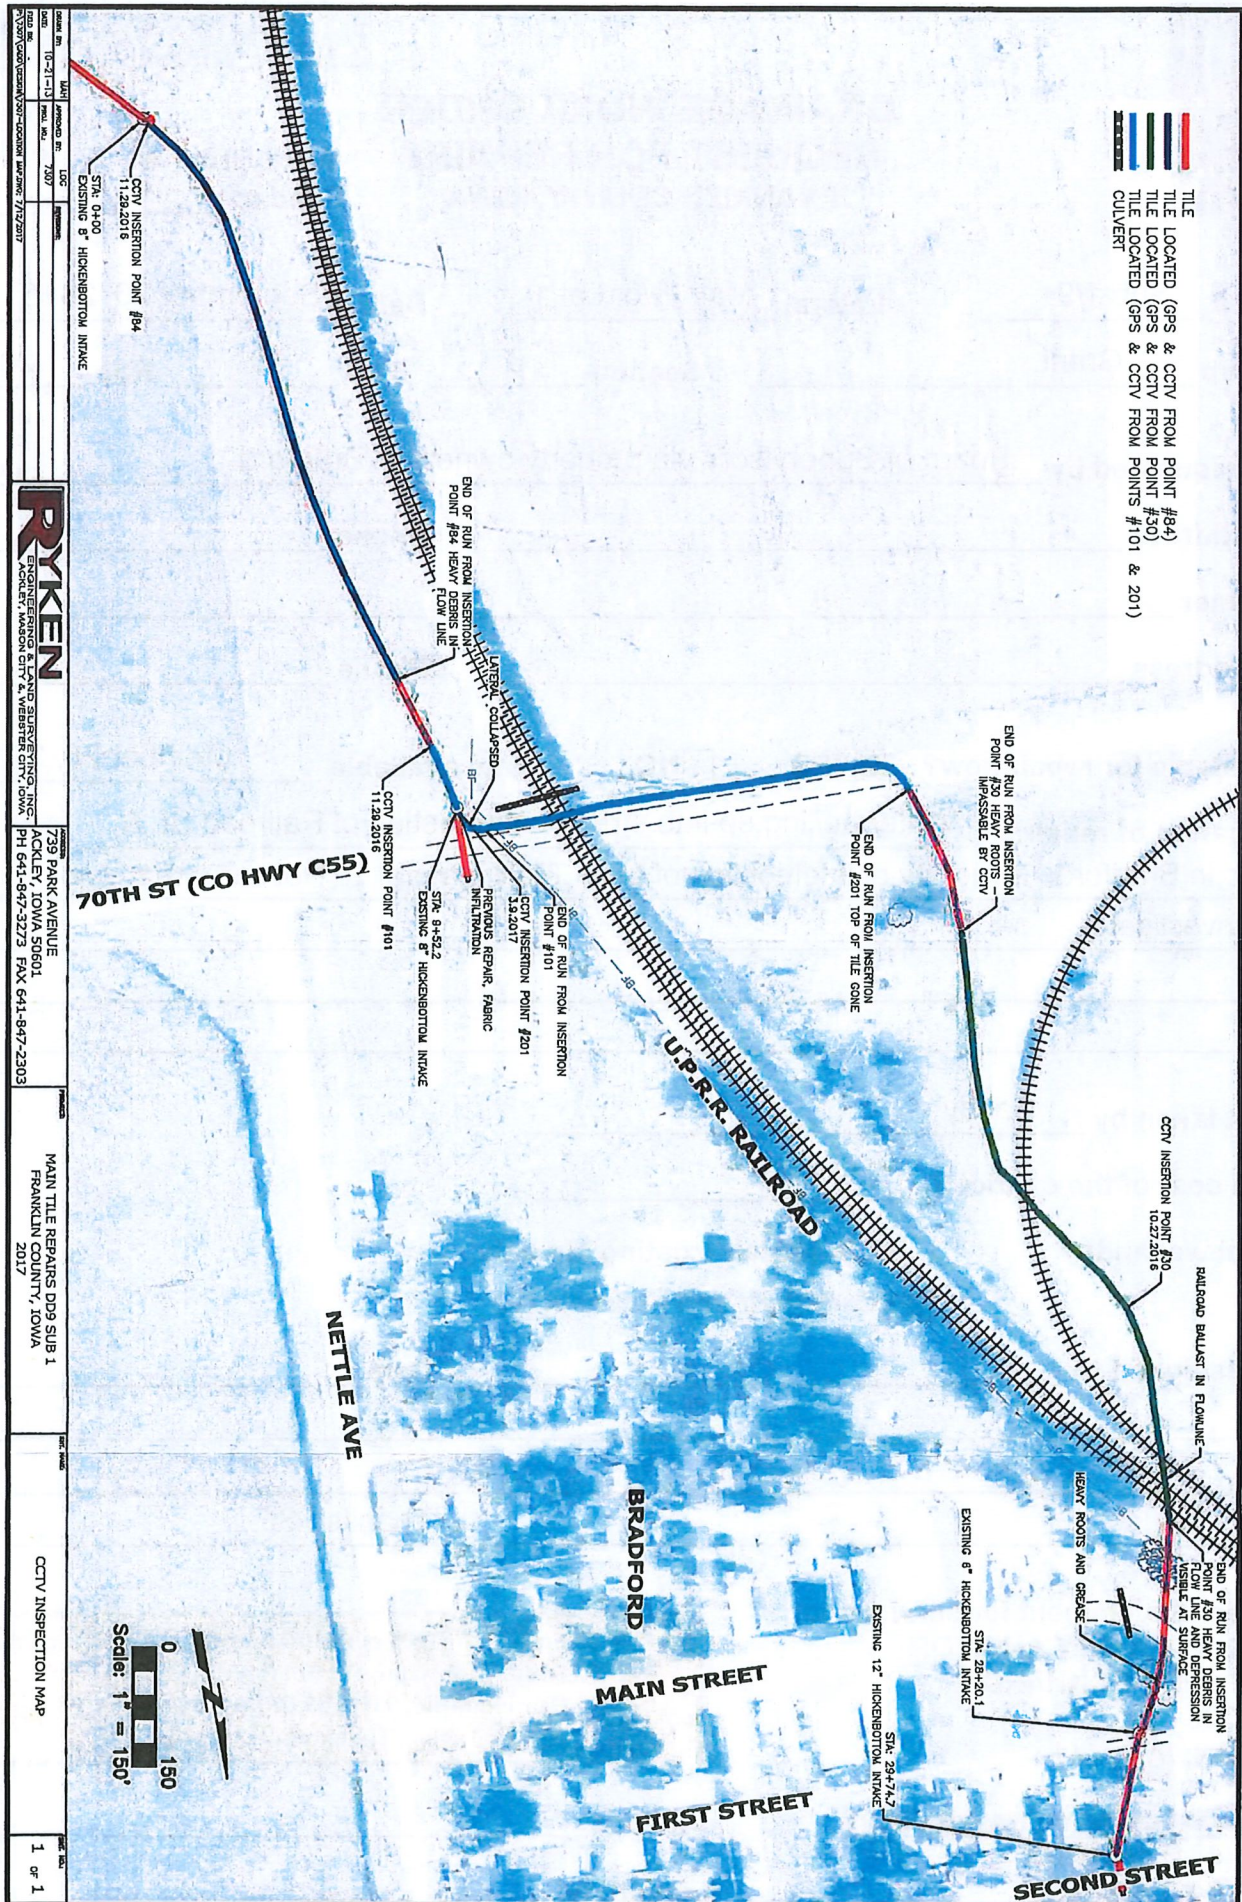
CCTV INSPECTION MAP

Landowners in SE¼ Section 6, Township 90 North, Range 20 West reported water boiling up into the street at intersection of Railroad Street and Main Street in Bradford. To investigate situation, performed following actions (reference map for locations and dates):

- Excavated at existing intake on south side of 1<sup>st</sup> Street east of Railroad Street and found 12" VCP district tile ½ full with slow flowing water. Tile has heavy roots and grease (from sewage discharges) restricting flow. Replaced tile that was removed.

- Excavated at point #30 on west side of railroad tracks north of coop spur track and found 14" VCP district tile ½ full with slow flowing water. Tile is cracked, but round.

- Performed 270' of CCTV inspection upstream and found following:
    - 13 offset joints
    - 13 offset joints with void or soil visible
    - 2 chipped pipe

- 1 protruding tile connection
    - Crossing at UPRR is steel pipe, but tile is about ¾ full of rock (including railroad ballast in flowline)
    - Depression is visible at ground surface on east side of UPRR

- CCTV could not continue due to rock in flowline
  - Performed 536' of CCTV inspection downstream and found following:
    - 21 offset joints
    - 25 offset joints with void or soil visible

- 1 chipped pipe
    - 2 holes/broken pipe previously repaired with tile batts
    - 6 locations with rock/debris in flowline
    - 3 locations with egg shaped pipe

- 1 location with large amount of roots
    - CCTV could not continue due to roots in flowline

- Excavated at point #84 (existing intake in field) on east side of railroad tracks south of County Highway C55 and found 15" VCP district tile ¼ full with slow flowing water. Tile is cracked, but round.
  - Performed 775' of CCTV inspection upstream and found following:
    - 9 offset joints
    - 9 offset joints with void or soil visible
    - 7 locations with rock/debris in flowline
    - 6 locations with egg shaped pipe
    - 1 location with 'V'ed top pipe
    - CCTV could not continue due to debris/rock in flowline

- Excavated at point #101 on east side of railroad tracks south of County Highway C55 and found 15" VCP district tile ¼ full with slow flowing water. Tile is cracked, but round.

- o Performed 151' of CCTV inspection upstream and found following:

- 4 offset joints with void or soil visible
- 1 location with rock/debris in flowline
- 3 holes/broken pipe previously repaired with tile batts
- 3 locations with egg shaped pipe
- 1 previous repair with single wall HDPE
- 1 previous repair with dual wall HDPE
- 1 location of previous repair with engineering fabric restricting the flow in the tile
- CCTV could not continue due to debris/rock in flowline

- Excavated at point #210 on east side of railroad tracks just south of County Highway C55 and found 15" VCP district tile ½ full with slow flowing water. Tile is cracked, slightly egg-shaped, and ¼ full of rock/debris.

- o Jet cleaned repeatedly upstream, performed 587' of CCTV inspection upstream and found following:

- 13 offset joints
- 12 offset joints with void or soil visible
- 3 locations with rock/debris in flowline
- 3 locations with egg shaped pipe
- 5 locations with 'V'ed top pipe
- 1 protruding tile connection
- 1 location with top of tile missing
- CCTV could not continue due to broken tile in flowline

Based on the above, it is obvious that portions of the district tile are at the end of their useful life and others are restricted by outside influences (i.e. tree roots and sanitary discharges). Based on this, I would recommend either of the following:

1. Repair the above mentioned highlighted issues (including tree removal) on the district tile and jet clean the areas with debris.  
OR
2. Replace the entire district tile along its current route or a different route to avoid railroad crossings.
