INDEPENDENT ROOFING CONSULTANTS

Reference: Roofing Evaluation
894-896 Lakeport Blvd.
Lakeport, CA 95453

1.00 ABSTRACT

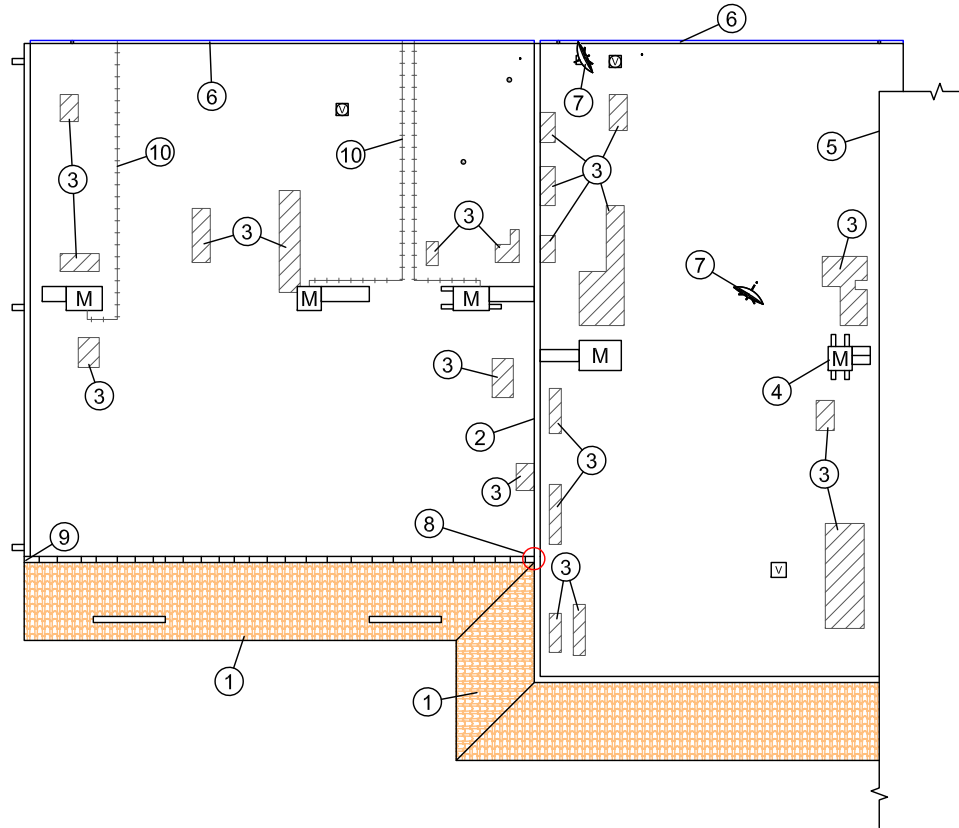
ROOF PLAN - 2023 Roofing Evaluation

1. TILE MANSARD.
2. DIVIDER WALL.
3. PREVIOUS MEMBRANE REPAIR.
4. NEW MECHANICAL UNIT.
5. COUNTERFLASHING METAL AT BASE OF WALL.
6. GUTTER ASSEMBLY.
7. SATELLITE DISH.
8. BIRD DAMAGE TO PREVIOUS TILE REPAIR.
9. DEGRADED ROOF CEMENT AT TILE TERMINATION.
10. CONDENSATE DRAIN LINE.

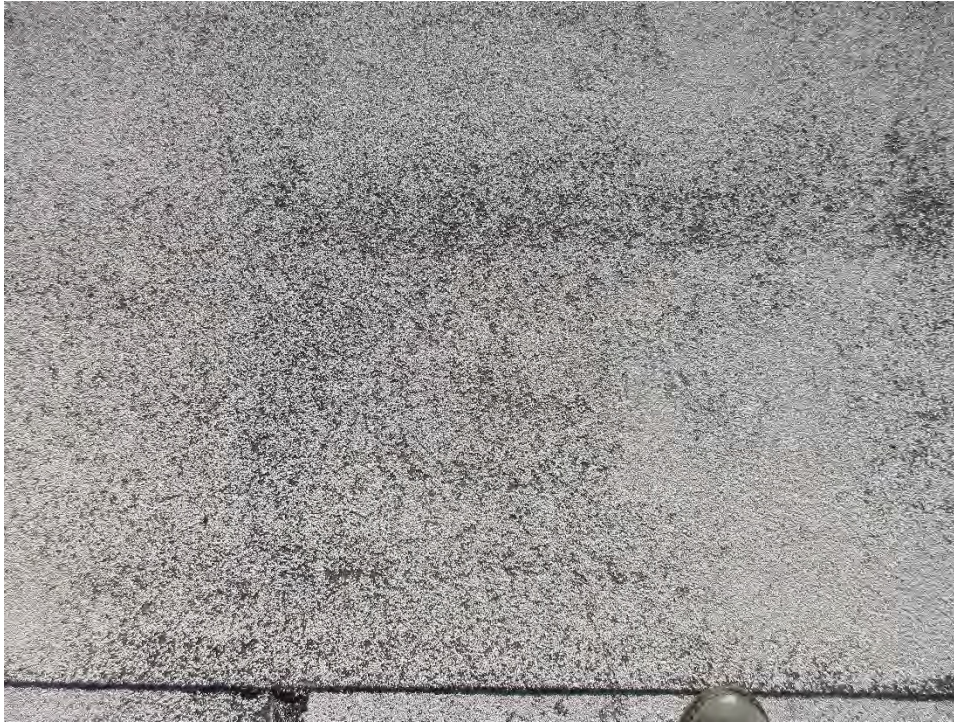
Photograph #7

- C. Minor granular-surfacing loss was noted in isolated locations. **Monitor on an annual basis for scrim exposure. If encountered address with a three-course repair consisting of roofing cement and fiberglass reinforcement fabric. Complete each repair by broadcasting ceramic roofing granules into the exposed cement to refusal.**

Minor granular
surfacing loss.

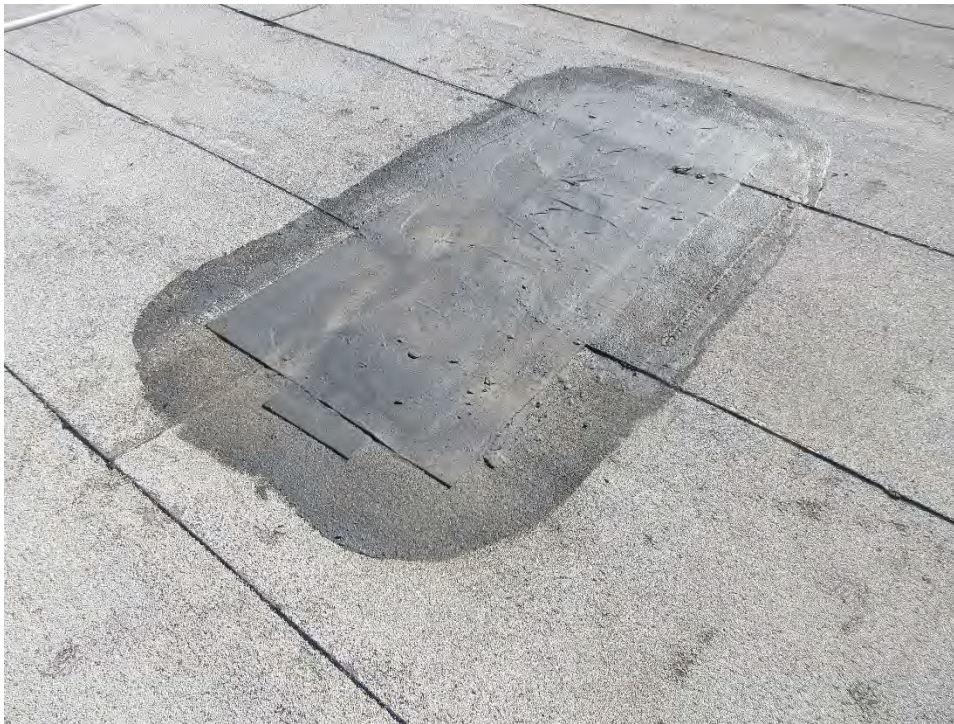
Photograph #8

- D. Various repairs to the cap sheet surface were noted consisting of APP modified material and an emulsion coating. Minor peeling of the emulsion coating was identified in several locations. **Remove loose materials, prime each location and apply new emulsion coating.**

Previous
membrane
repair.

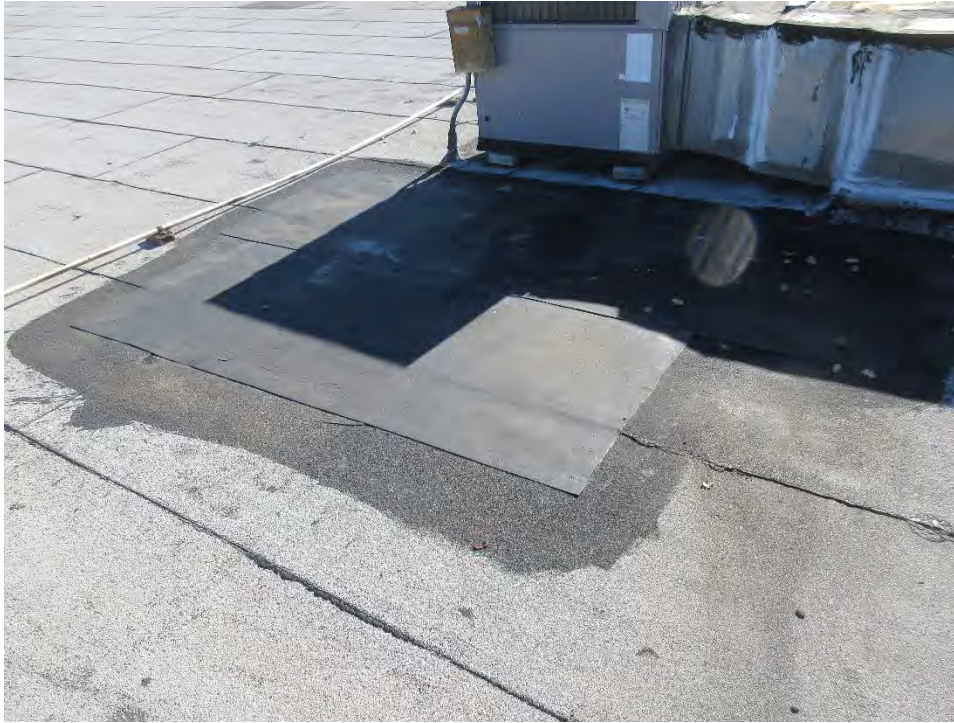
Photograph #9

Previous
membrane
repair.

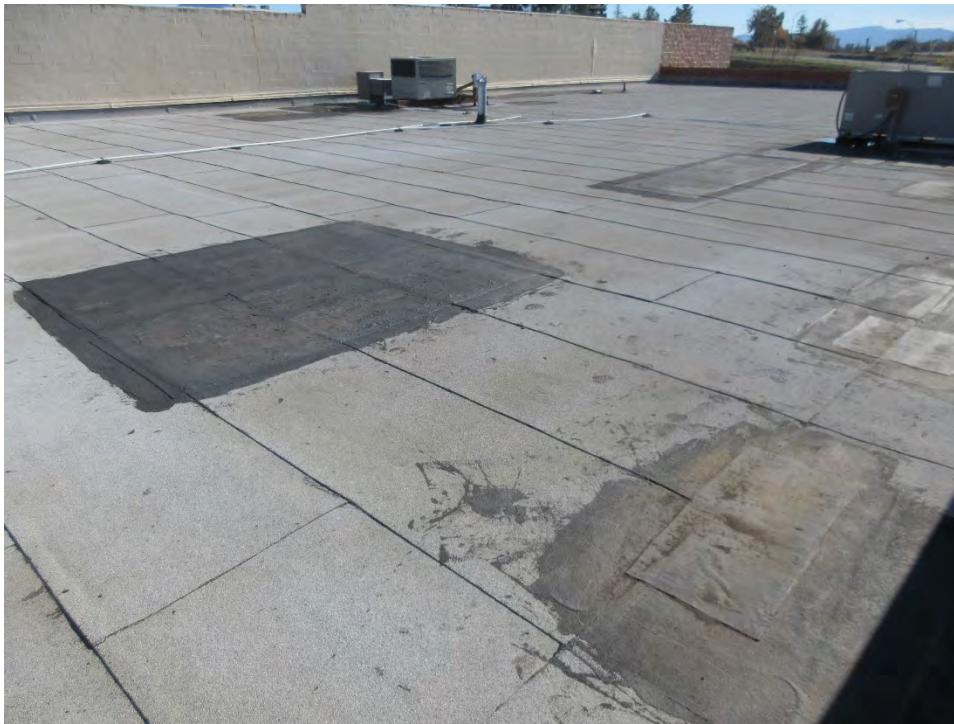
Photograph #10

Previous
membrane
repair.

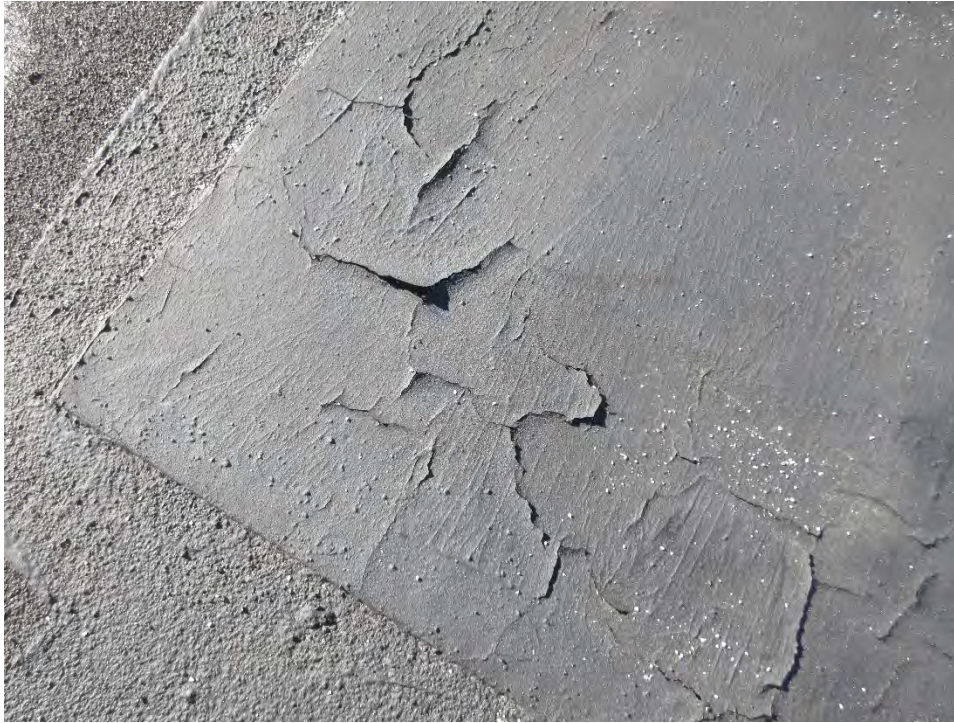
Photograph #11

Minor peeling of the emulsion.

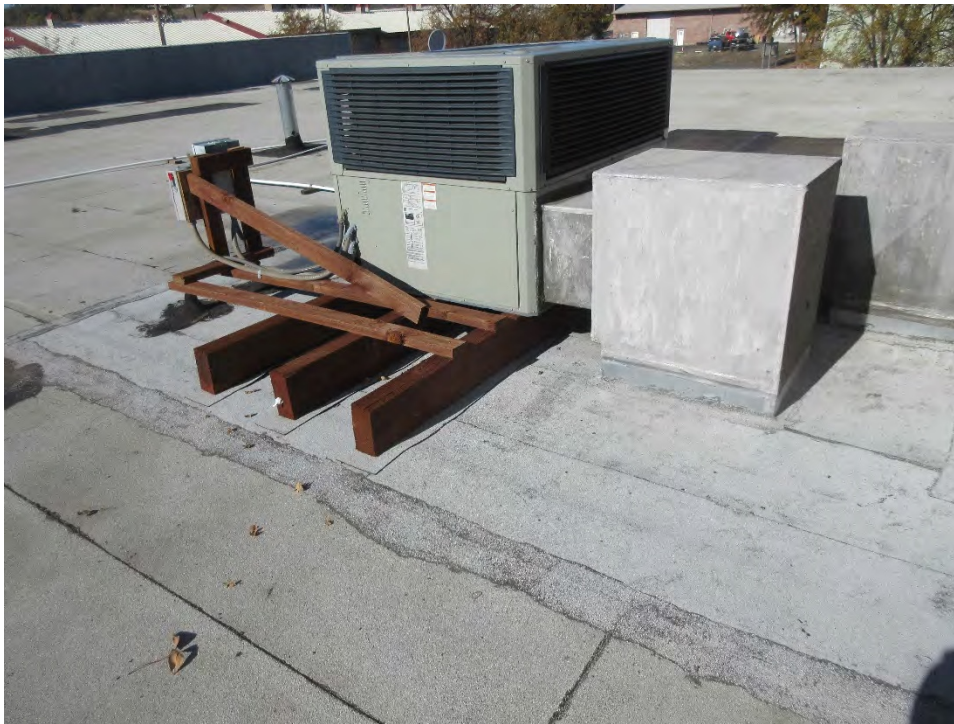
Photograph #12

- E. A newer HVAC unit is in place along the east perimeter. This unit is supported by pressure-treated wood members placed on proper roof protection material.

Newer mechanical unit installed.

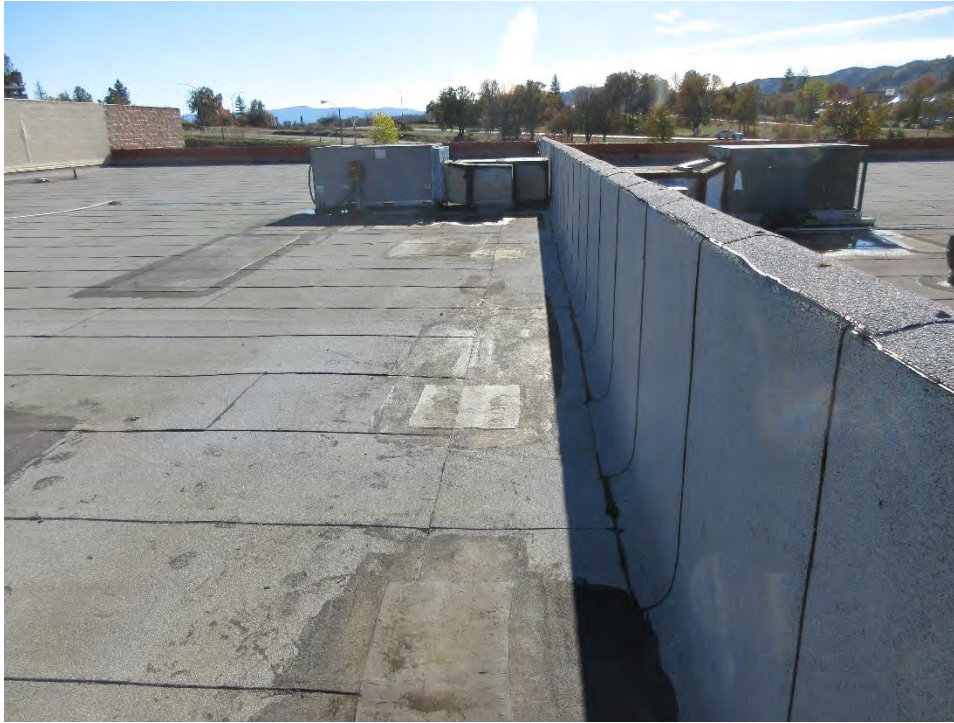
Photograph #13

- F. The Main Roof is divided into 2 sections by a short parapet wall, which is covered by a wall covering assembly consisting of a fiberglass cap sheet set into hot asphalt over a fiberglass base sheet mopped to the concrete wall surface. This assembly wraps the top of the parapet wall to create a monolithic, watertight assembly. This same assembly is in place along the west perimeter wall.

Divider wall.

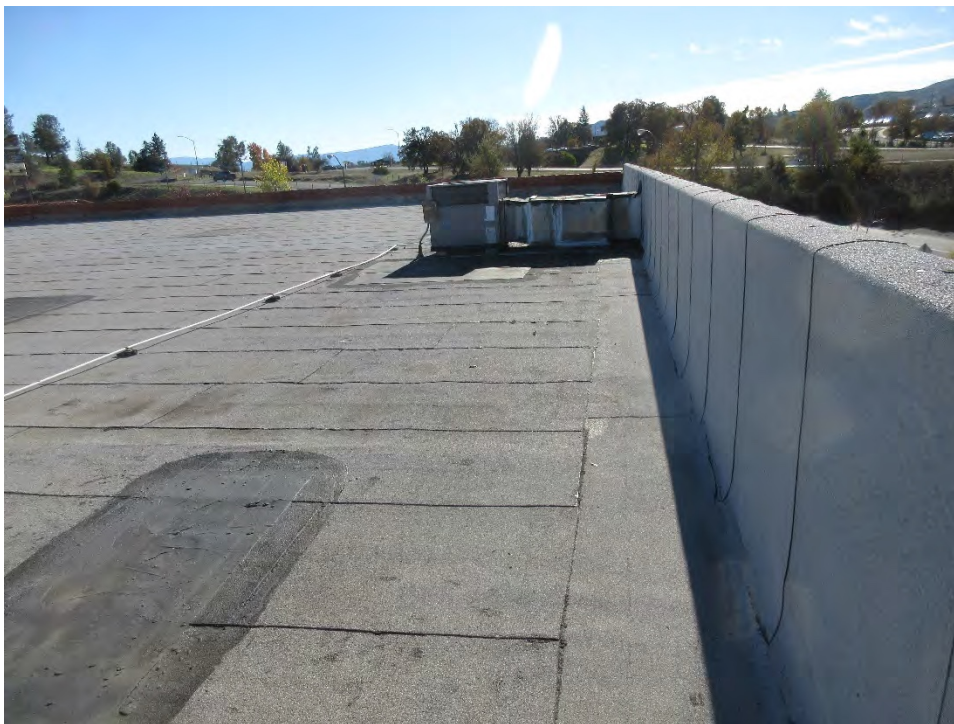
Photograph #14

West wall
covering.

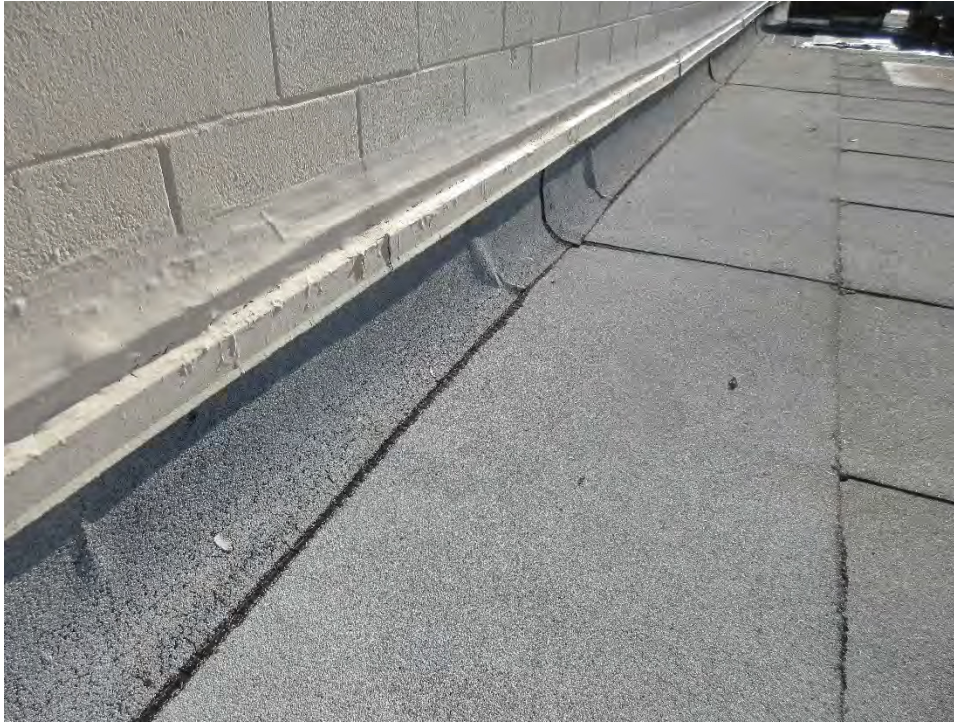
Photograph #15

- H. A surface-mounted metal counterflashing is in place along the east wall to cover the top of the base flashing assembly. Sealant along the top of the counterflashing was found in good condition at this time. The base flashing assemblies along the south perimeter are terminated beneath the Tile Mansard ridge to protect the base flashing termination.

Base flashing at base of east wall. Note counterflashing metal.

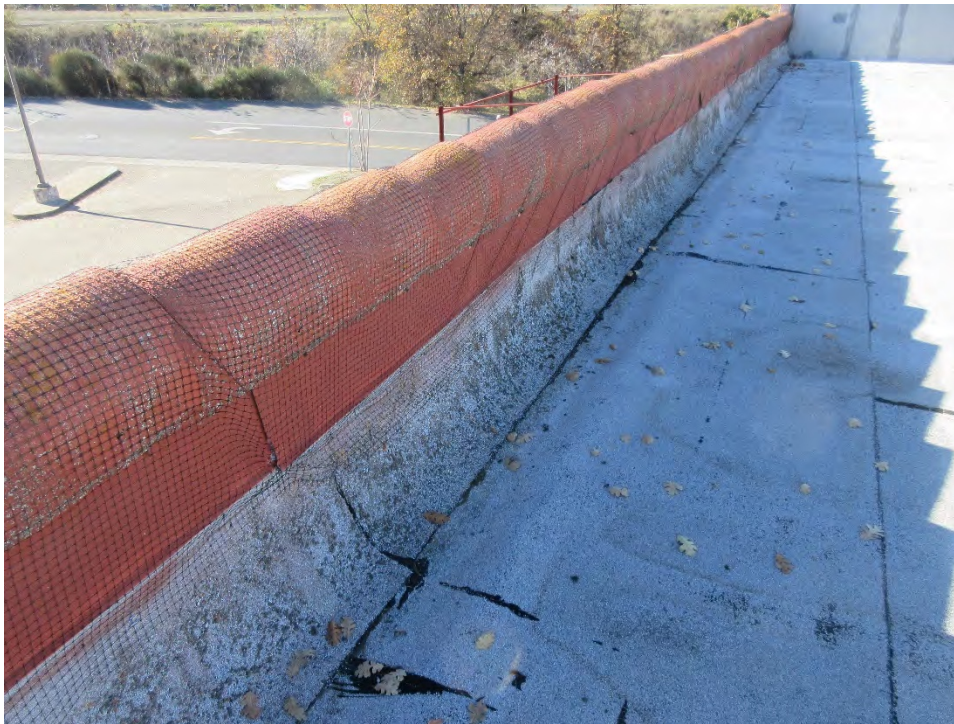
Photograph #16

- G. The base flashing assembly along the east perimeter consists of a granular-surfaced SBS modified sheet set into hot asphalt over a mopped base sheet. The same assembly was utilized at south perimeters although the base sheet was nailed to a plywood substrate along the base of the Tile Mansard.

Base flashing at south perimeter.

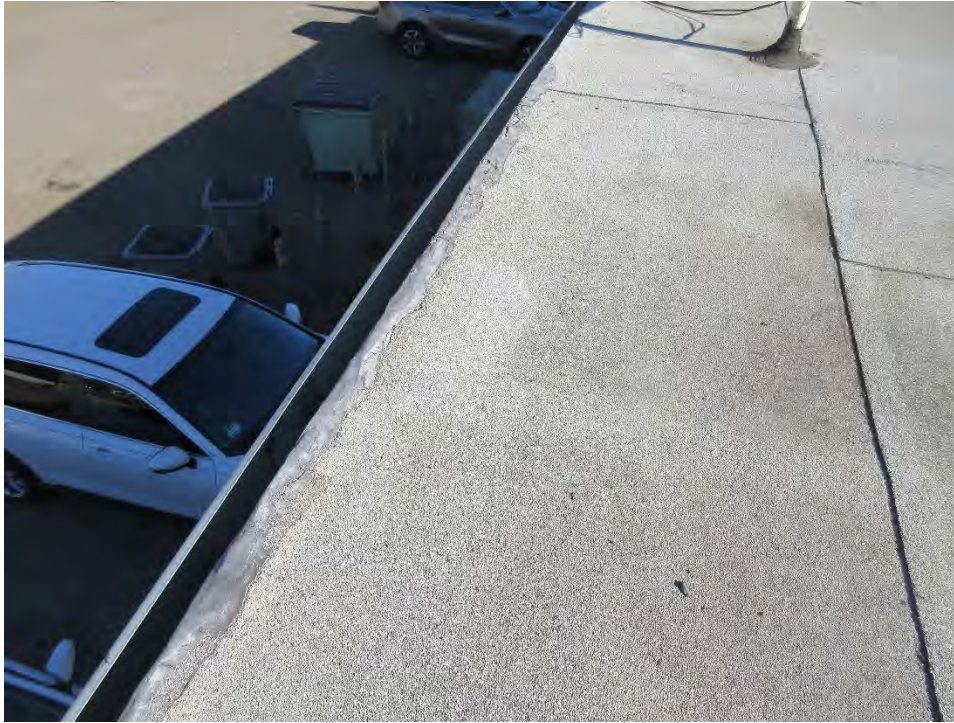
Photograph #17

- I. Drainage is accomplished by moderate slope to gutter assemblies positioned along the north perimeter. Other than minor silt build-up gutter assemblies were found in serviceable condition at this time.

Gutter example.

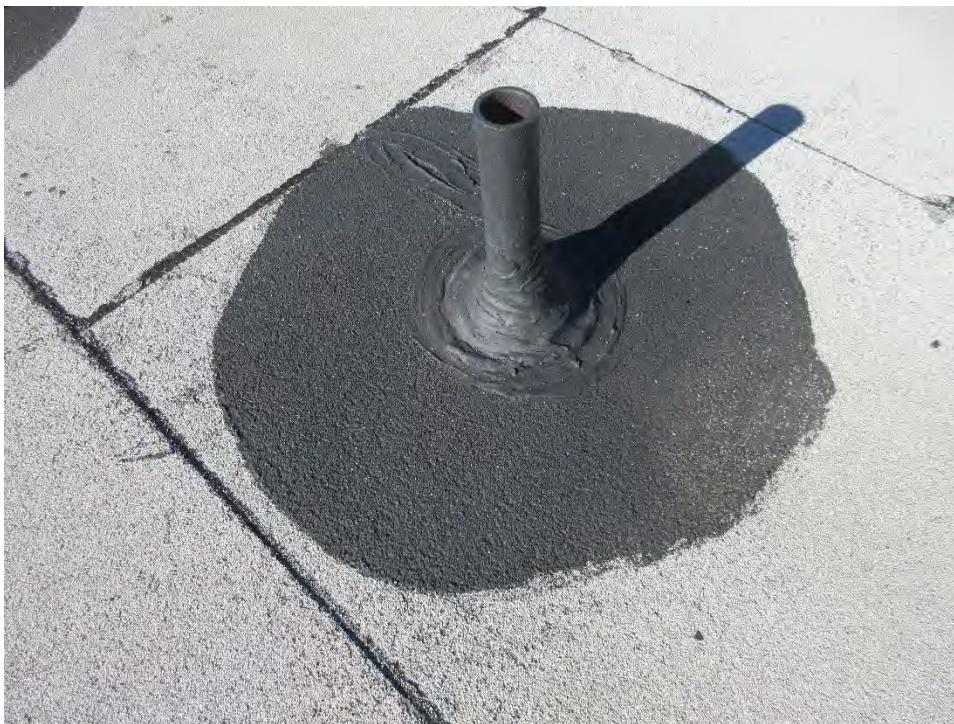
Photograph #18

- J. Plumbing and conduit penetrations have been addressed with galvanized cone flashings incorporated into the roofing system and further sealed with an emulsion coating. Roof penetrations were found in a watertight condition at this time.

Typical penetration
flashing.

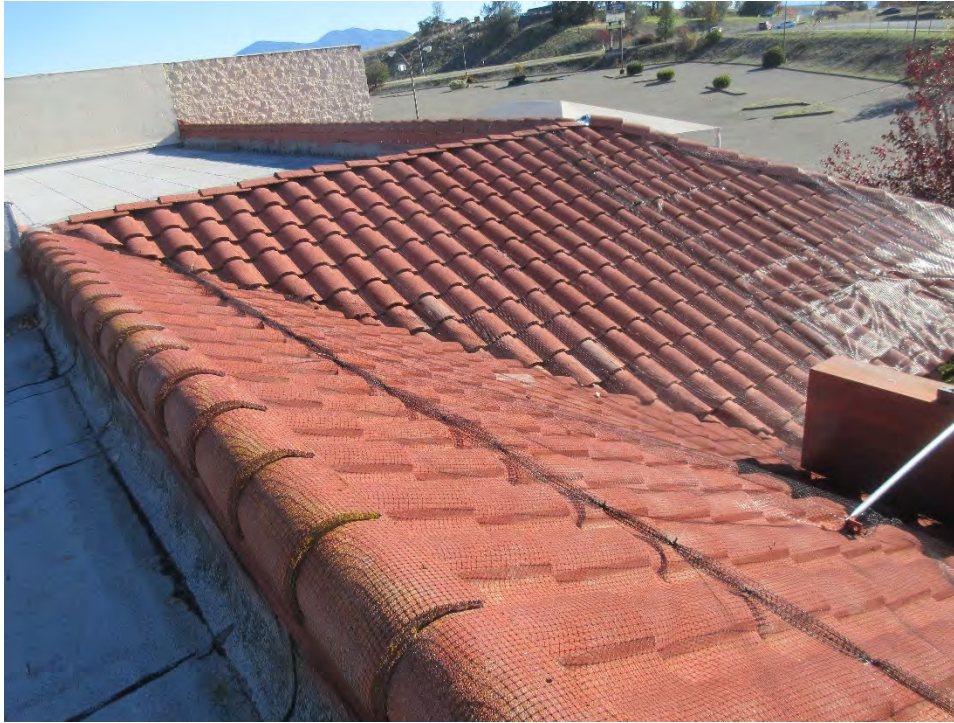
Photograph #19

Tile mansard.

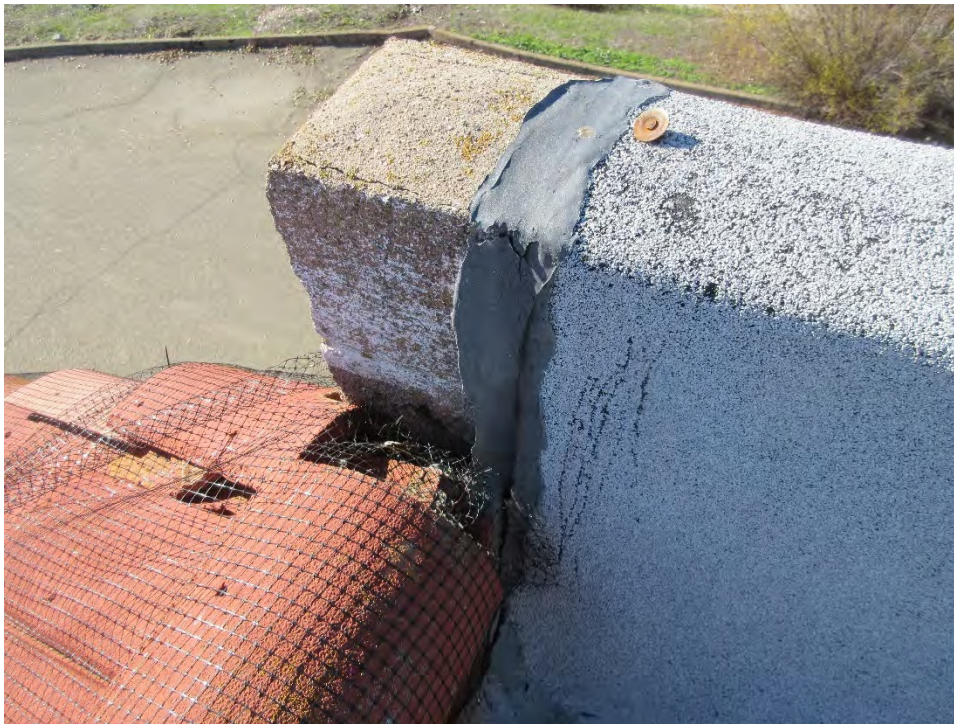
Photograph #20

Degraded roof
cement at tile
termination.

- A. The overall tile system was found in good condition with minor repairs required.
- B. Degraded roof cement was identified in one corner location. **Remove all degraded material and replace with brush-grade urethane sealant to create a watertight condition.**
- C. One tile termination has been sealed with an aluminum-surfaced, self-adhering flashing tape that has been damage by bird activity. Unfortunately, birds are attracted to the shiny surface of the tape. **Remove present tape remnants and replace with a self-adhering, black polymer tape, such as Eternabond.**

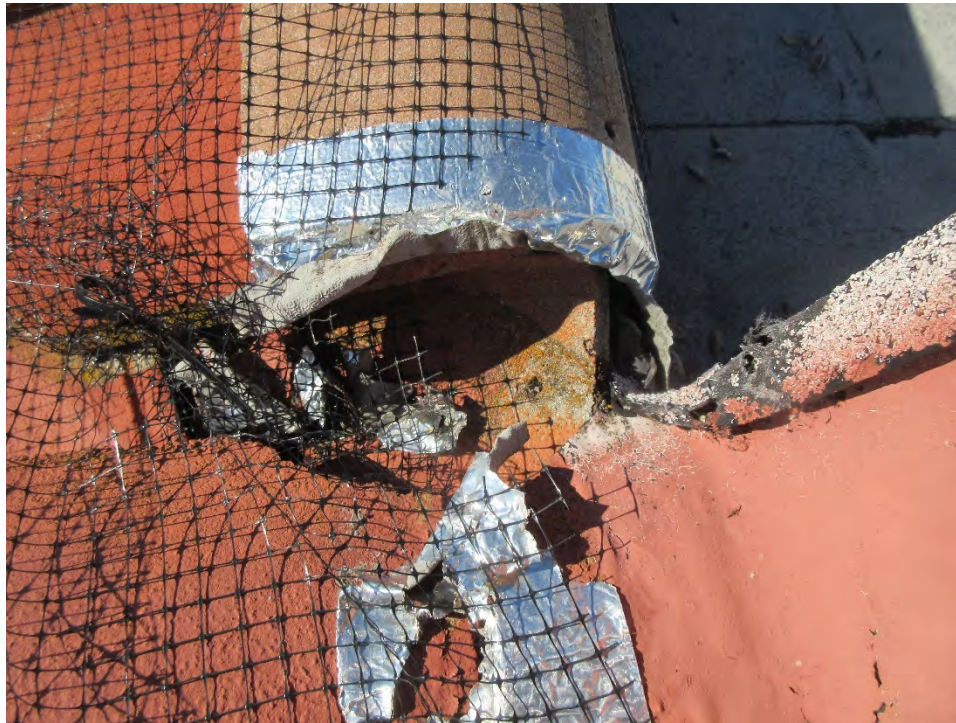
Photograph #21

Bird damage to
foil-tape repair.

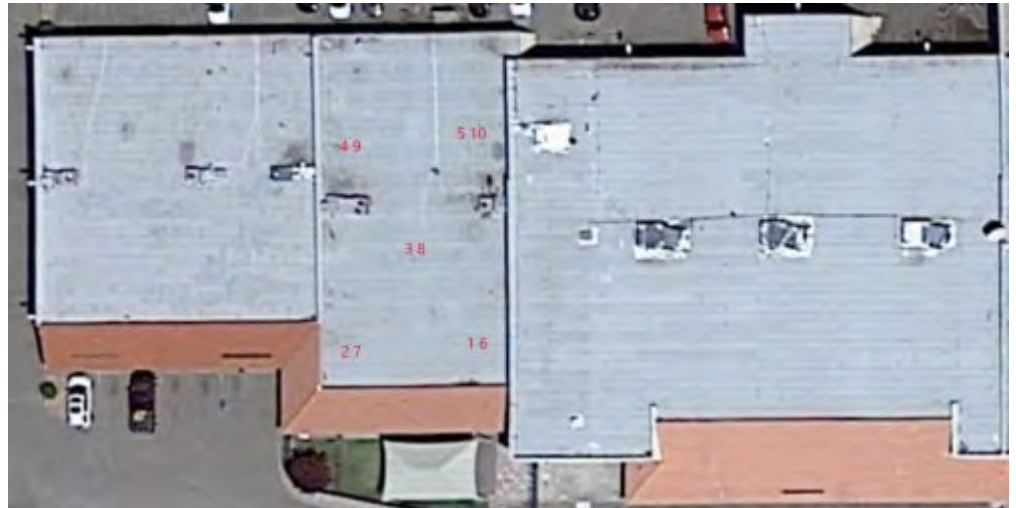
888 LAKEPORT BOULEVARD -
BUILDING 2

TEST LOCATION NUMBER	PULL VALUE (LBF)	FASTENER TESTED	PENETRATION (IN)	BIT DIAMETER (IN)	COMMENTS
1	394	OMG Heavy Duty #14	1"		
2	407	OMG Heavy Duty #14	1"		
3	294	OMG Heavy Duty #14	1"		
4	336	OMG Heavy Duty #14	1"		
5	251	OMG Heavy Duty #14	1"		
6	309	OMG Extra Heavy Duty	1"		
7	309	OMG Extra Heavy Duty	1"		
8	306	OMG Extra Heavy Duty	1"		
9	336	OMG Extra Heavy Duty	1"		
10	313	OMG Extra Heavy Duty	1"

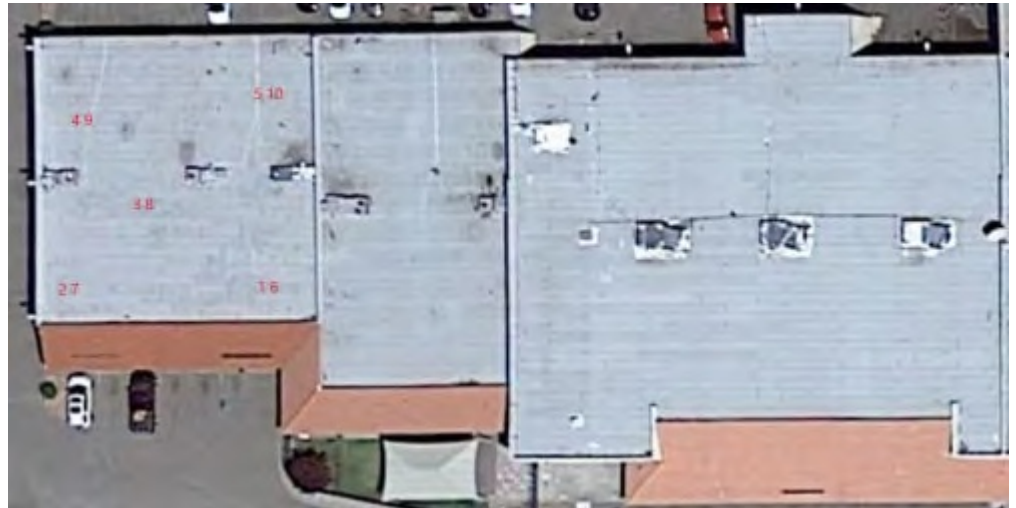
888 LAKEPORT BOULEVARD -
BUILDING 1

TEST LOCATION NUMBER	PULL VALUE (LBF)	FASTENER TESTED	PENETRATION (IN)	BIT DIAMETER (IN)	COMMENTS
1	691	OMG Heavy Duty #14	1"		Beam
2	417	OMG Heavy Duty #14	1"		
3	242	OMG Heavy Duty #14	1"		
4	284	OMG Heavy Duty #14	1"		
5	267	OMG Heavy Duty #14	1"		
6	372	OMG Extra Heavy Duty	1"		
7	317	OMG Extra Heavy Duty	1"		
8	263	OMG Extra Heavy Duty	1"		
9	305	OMG Extra Heavy Duty	1"		
10	334	OMG Extra Heavy Duty	1"
