## REGULAR MEETING OF THE LAKEPORT CITY COUNCIL

- VI. **PUBLIC HEARING:**
  - A. Vista Point Shopping Center: Hold a nuisance abatement hearing and adopt a Resolution declaring the primary structure (872-896a Lakeport Blvd) of the Vista Point Shopping Center a public nuisance, order the property owner to abate all identified nuisance conditions within 30 days, and, in the event the nuisances are not timely abated, empowering staff with authority to abate the nuisances, the costs of which may become a special assessment upon the parcel.

Vista Point Shopping Center (Vista Point), situated at 872-896a Lakeport Boulevard, has been under the ownership of Donica LLC since its acquisition in 2007. On July 14, 2022, City staff initiated a Code Enforcement Case (#2022-00046) to address a series of code violations at the property. While items from the initial Code Enforcement case remain outstanding, City staff has presented subsequent code enforcement matters to Donica LLC for resolution. Unfortunately, over the past eighteen months, City staff's persistent efforts to bring Vista Point into compliance have yielded minimal progress in addressing a growing list of violations.

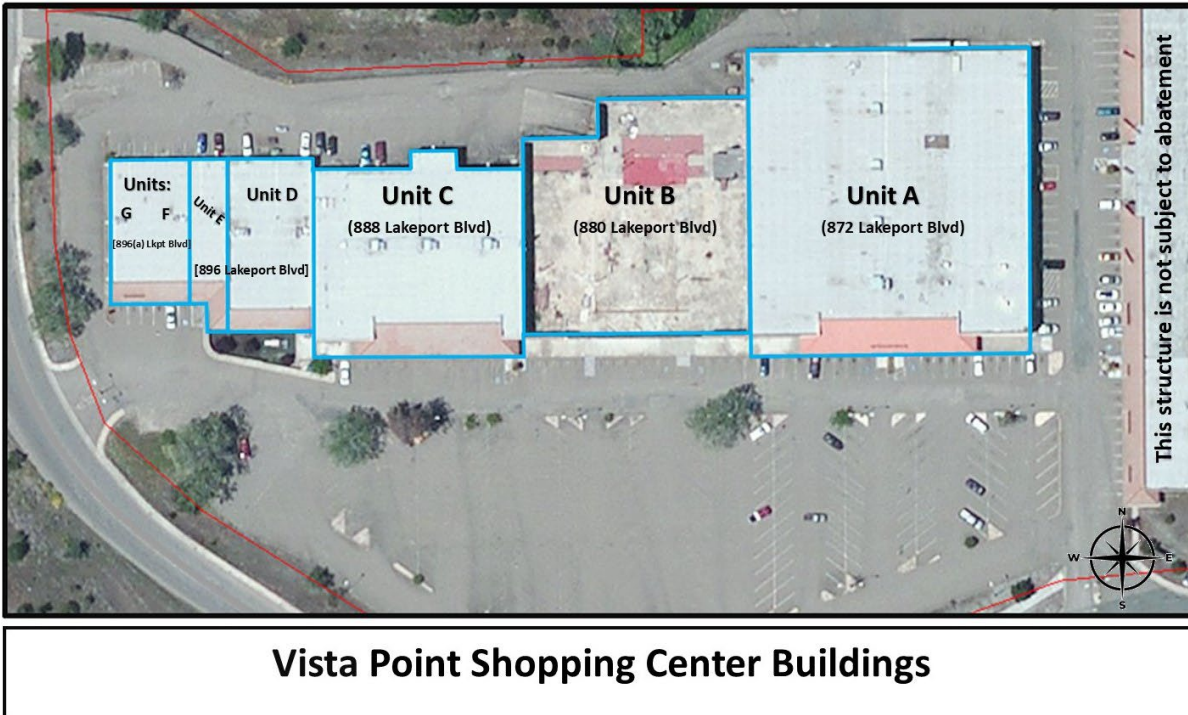
Among the quintet, one building is presently leased and occupied (Units D & E). This building serves as the administrative offices for Lake Family Resource Center and houses the Early Head Start program. Four buildings remain unoccupied (Unit A, Unit B, Unit C & Unit G/F), and most notably, Unit B experienced a roof collapse in 2008, prompting the comprehensive removal of both its roof and facade. Since then, Unit B has been without a roof, as reflected in the image below.

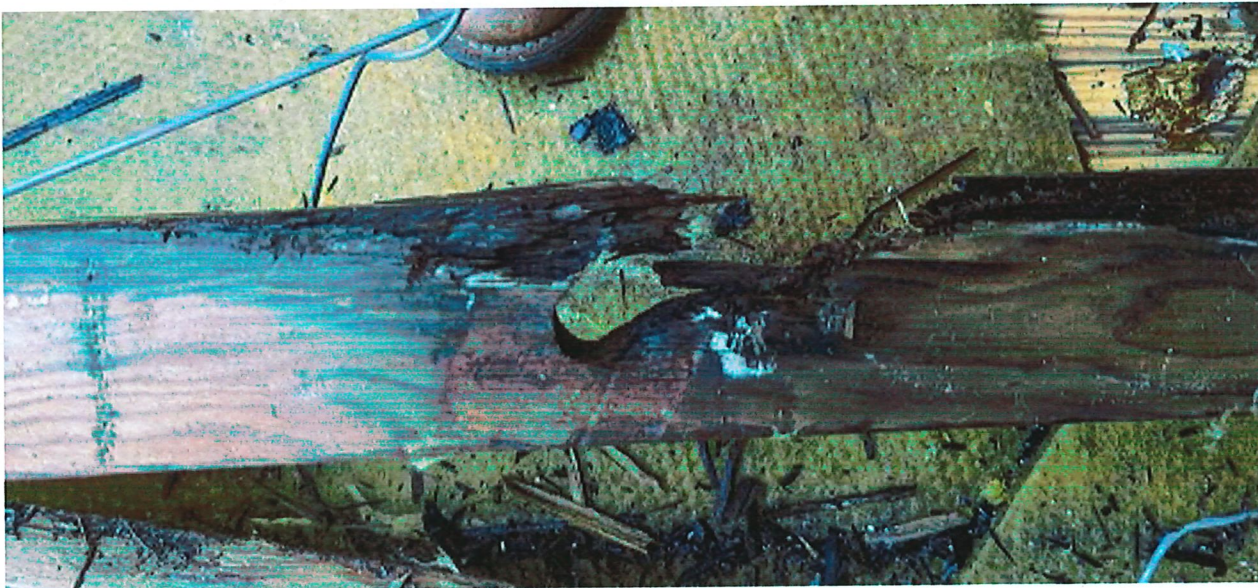
Photo 4 – Deteriorated truss top chord with pin bearing failure, Building A

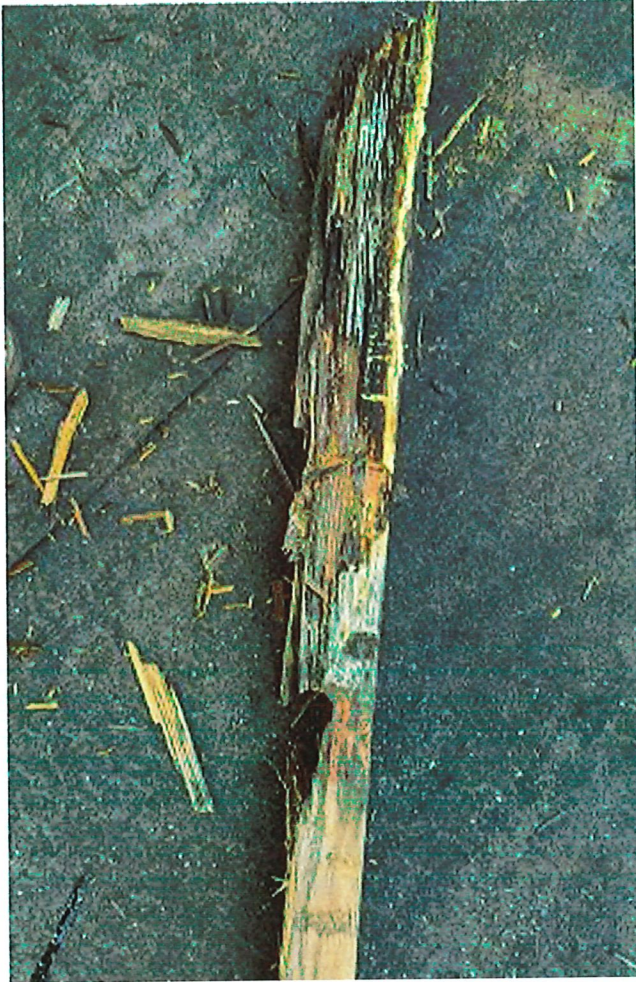
Photo 5 – Deteriorated truss top chord with pin bearing failure, Building A

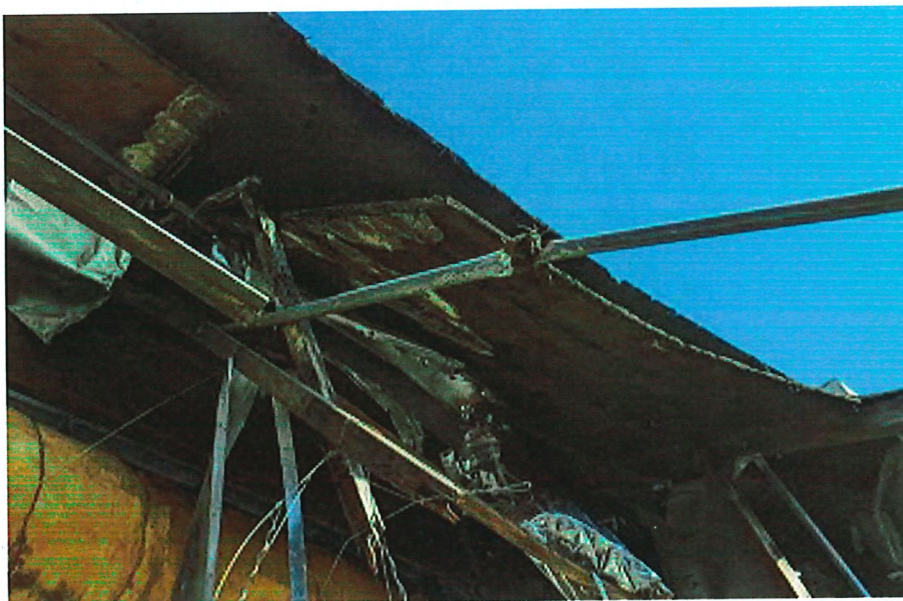
Photo 6 – Deteriorated top chord material visible on pin, Building A

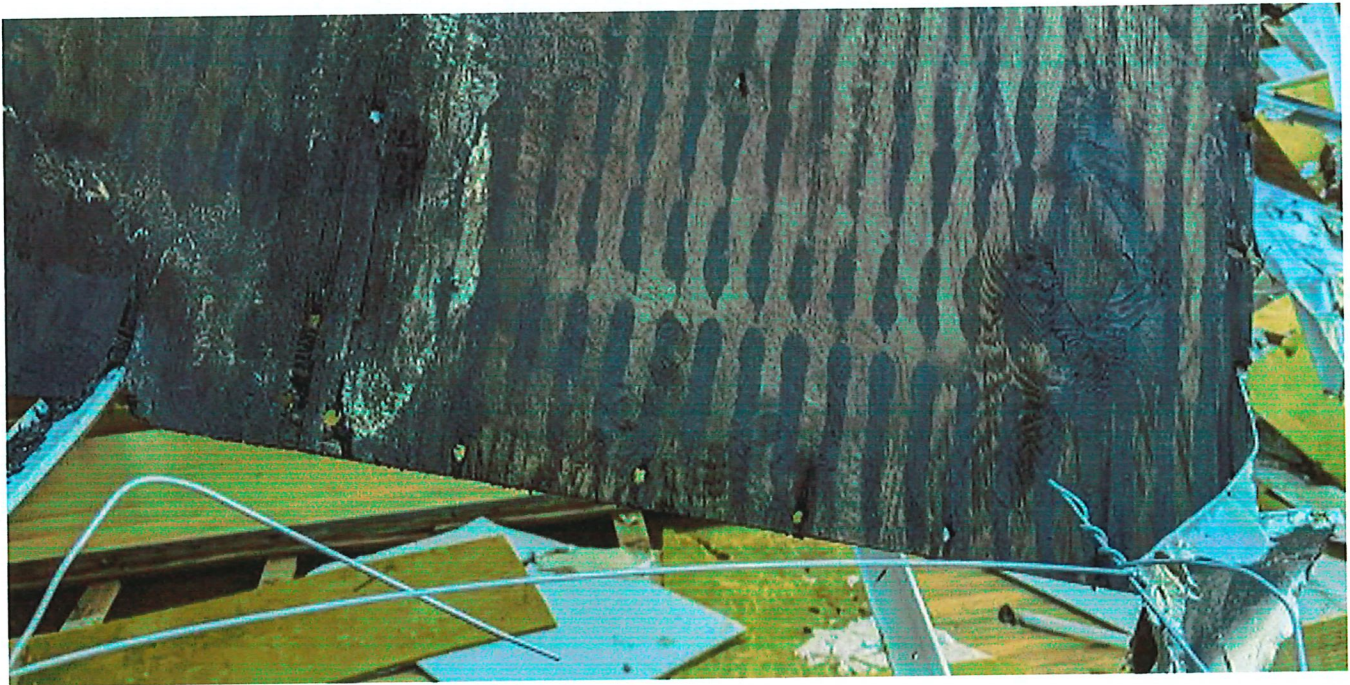
Photo 8 – Plywood/nail connection failure, Building A

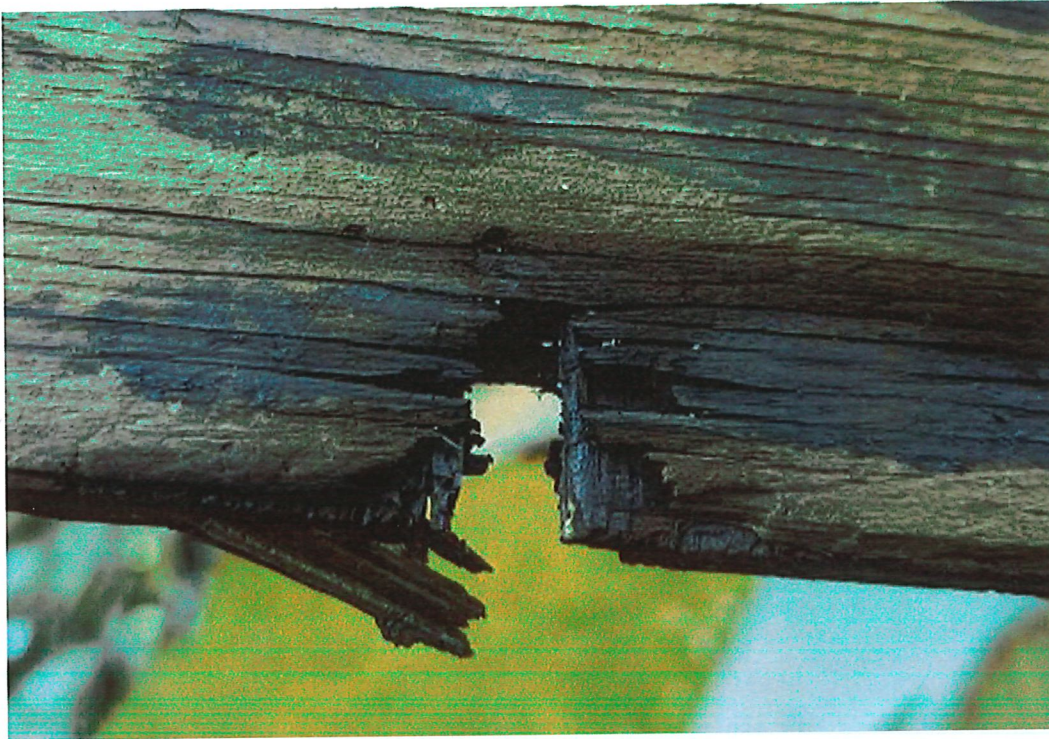
Photo 9 – Plywood nail edge distance failure, Building A

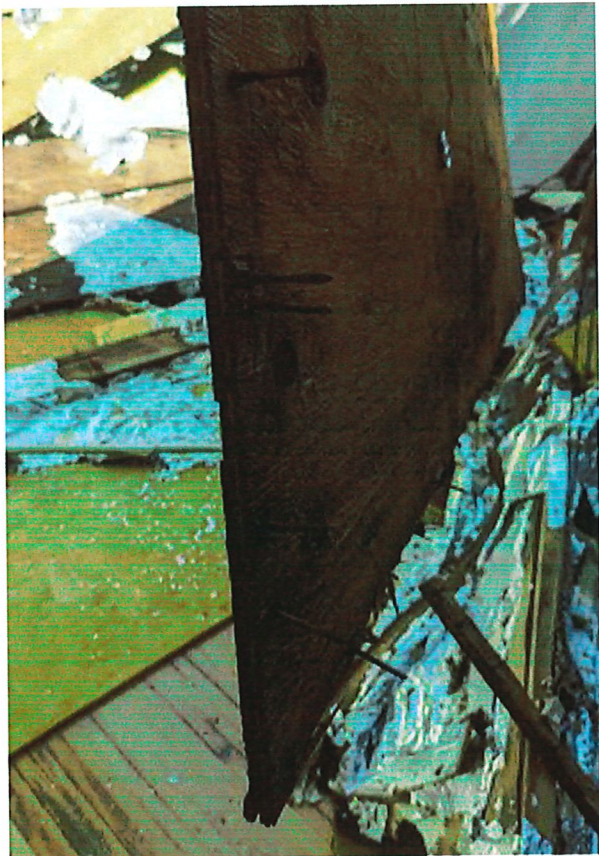
Photo 10 – Corroded nail withdrawal, Building A

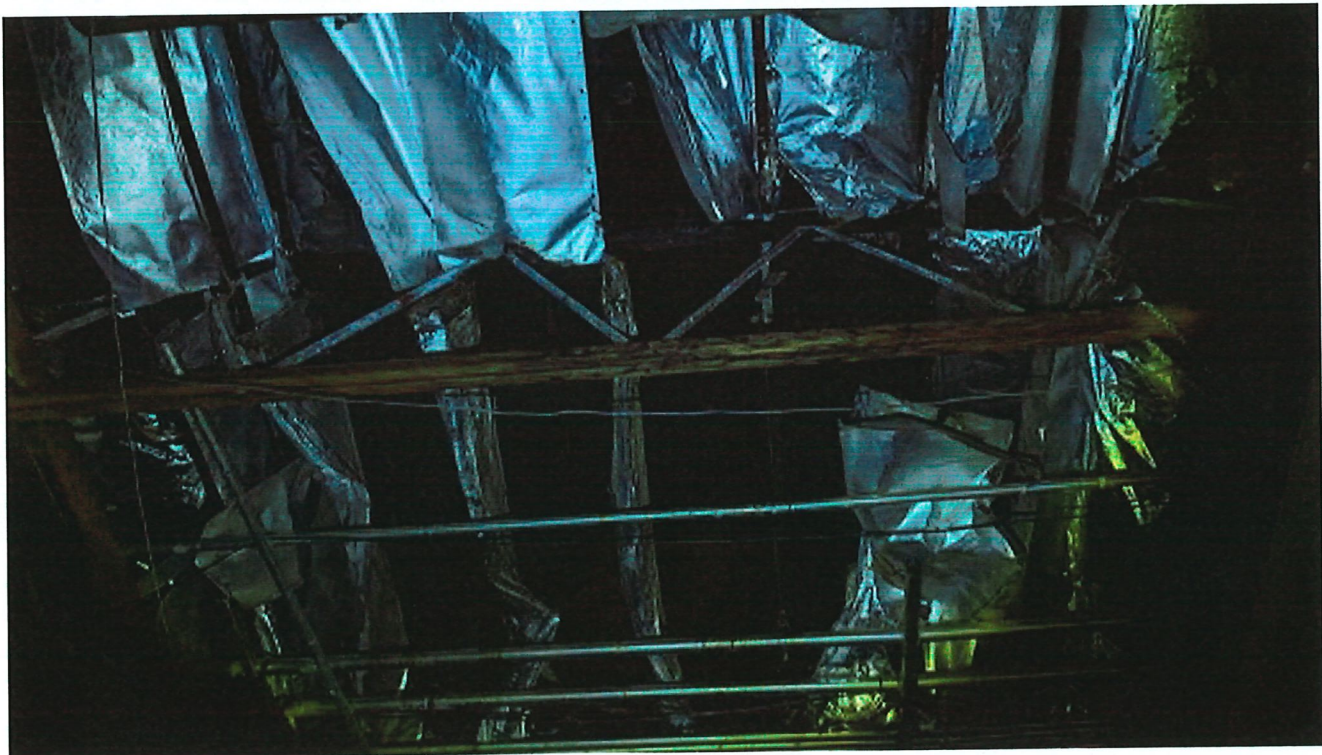
Photo 14 – Saturated framing, Building A

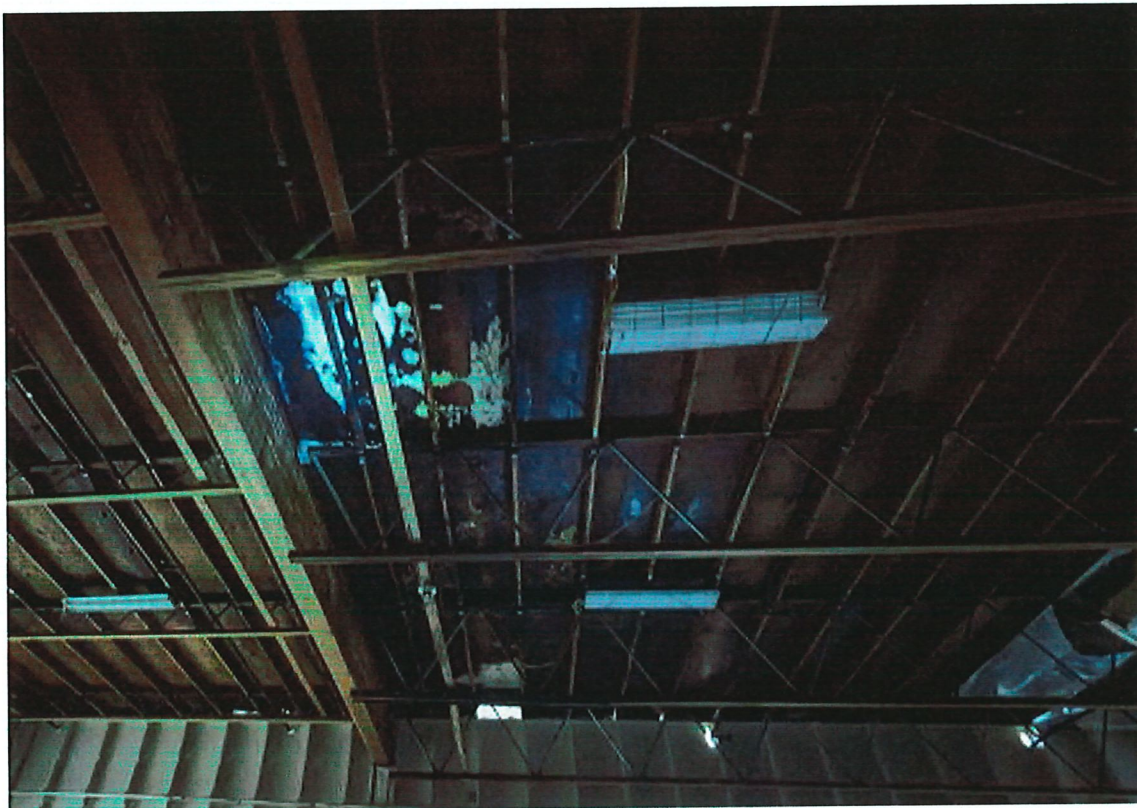
Photo 16 – Framing deterioration, Building A

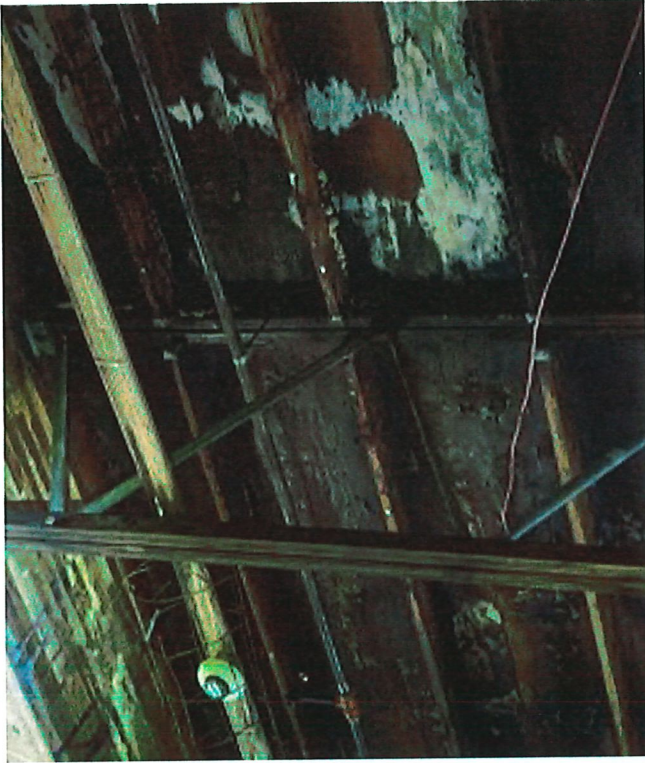
Photo 17 – Framing deterioration, Building A

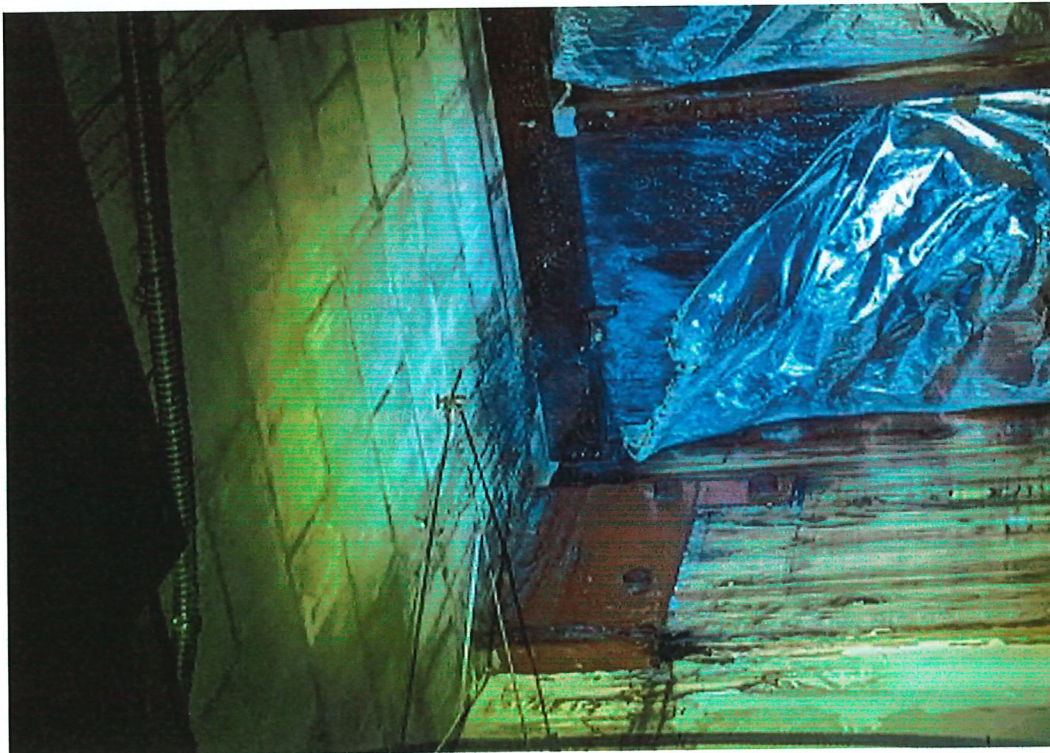
Photo 18 – Glulam beam deterioration, Building A

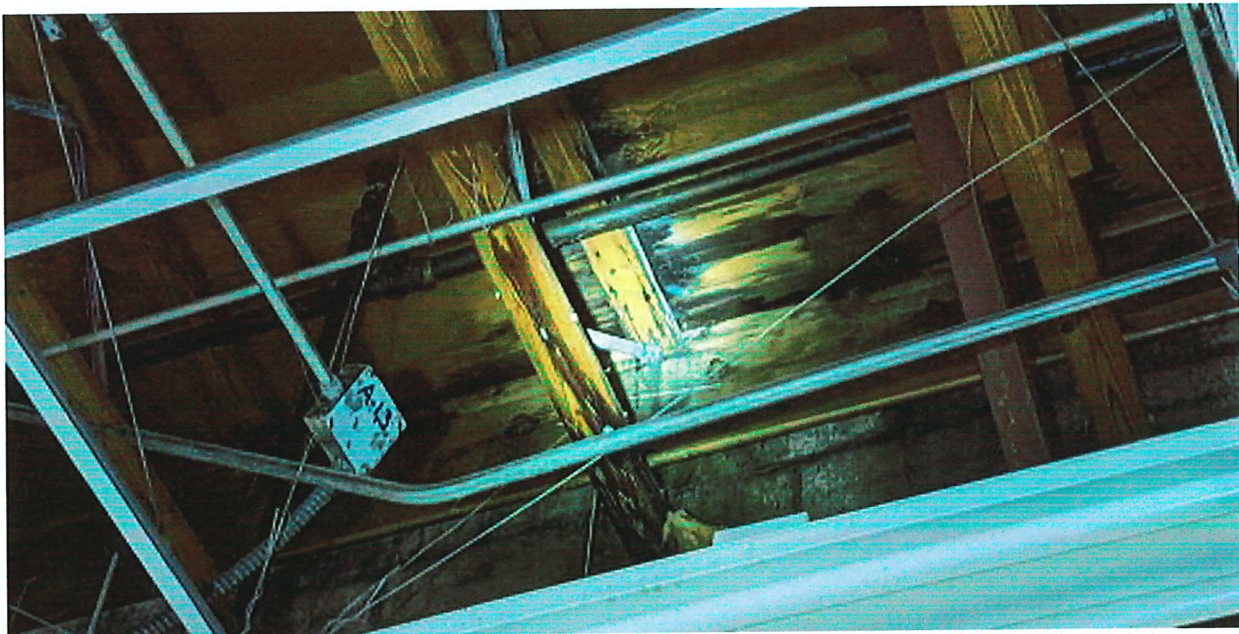
Photo 24 – Framing deterioration, Building C

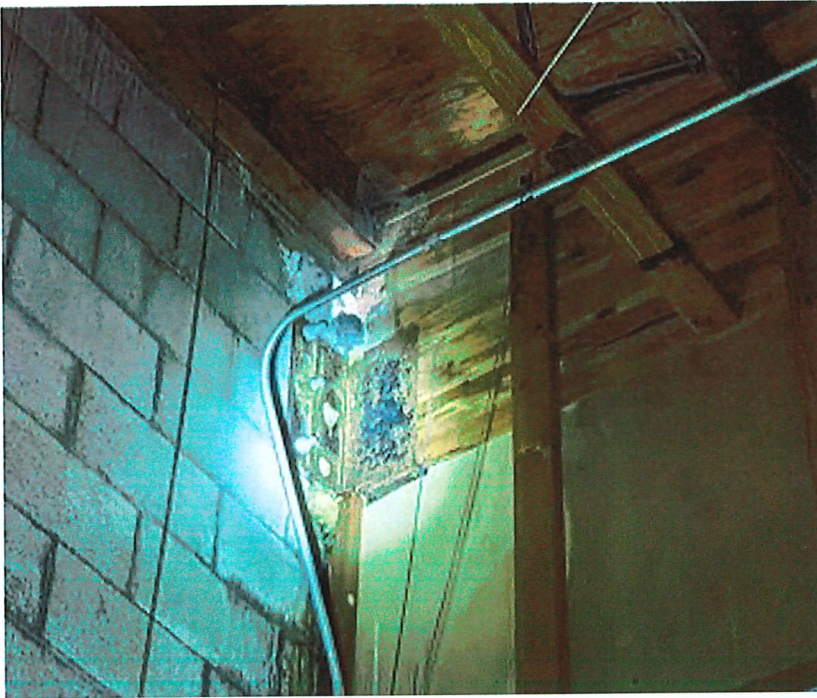
Photo 25 – Visible daylight behind deteriorated glulam beam, Building C

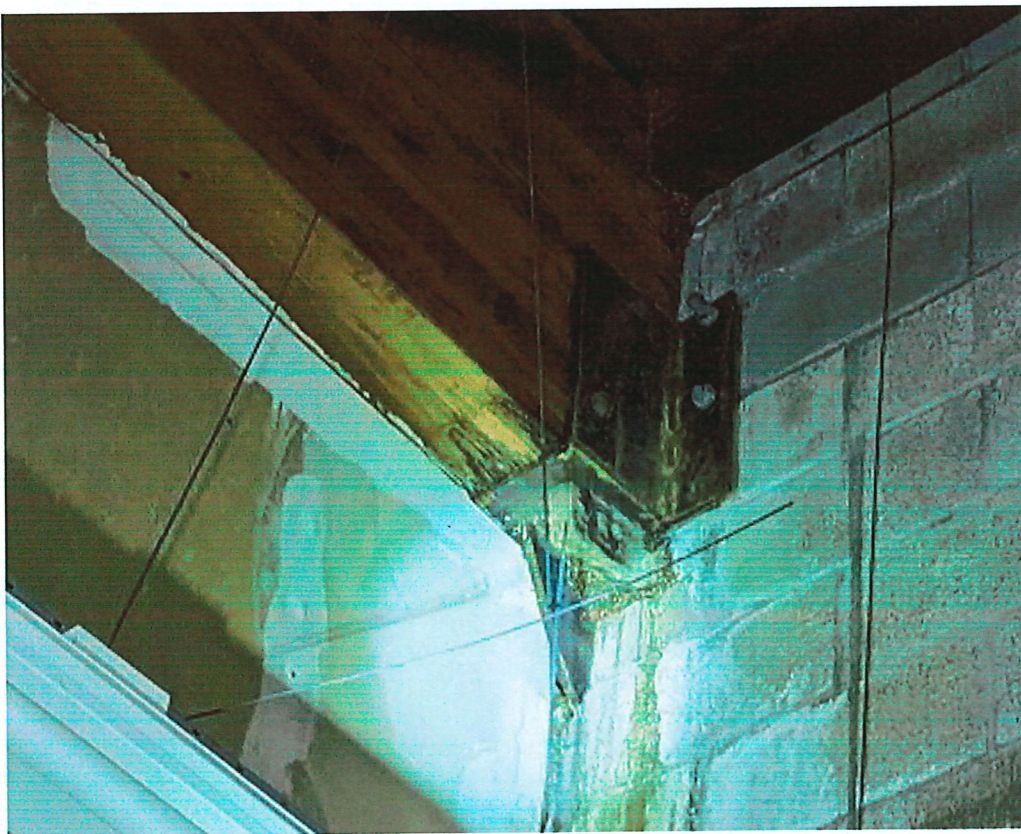
Photo 26 – Glulam beam deterioration at toe, Building C

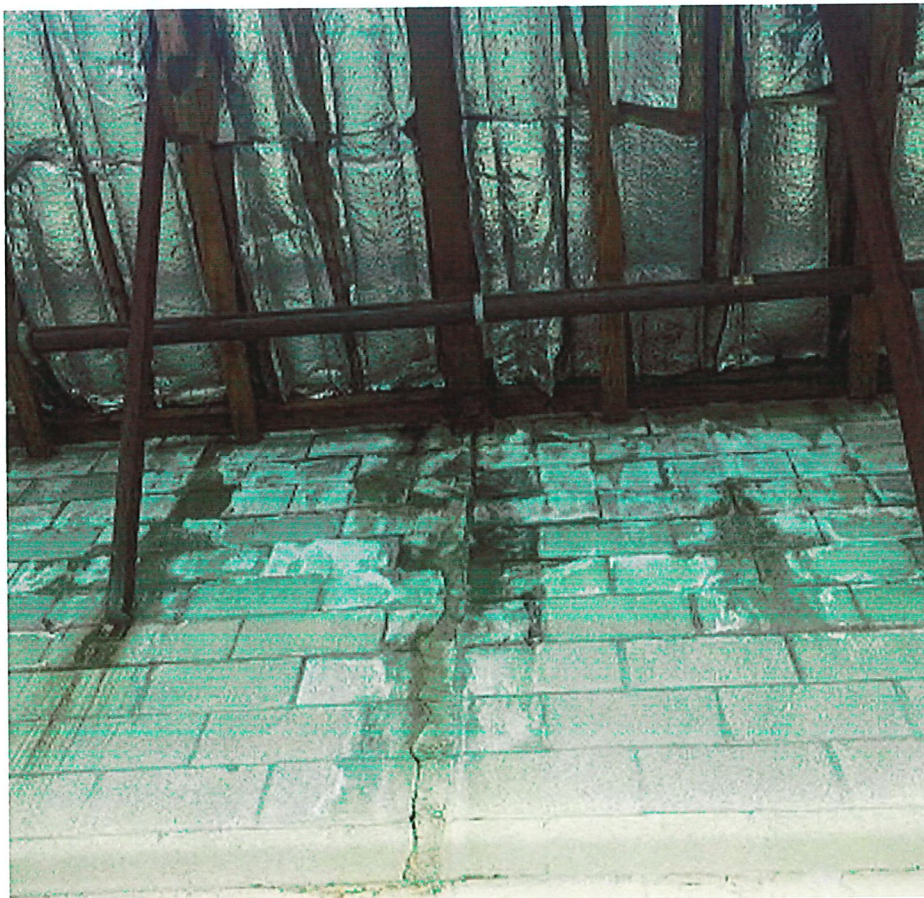
Photo 28 – Wall deterioration, Building C

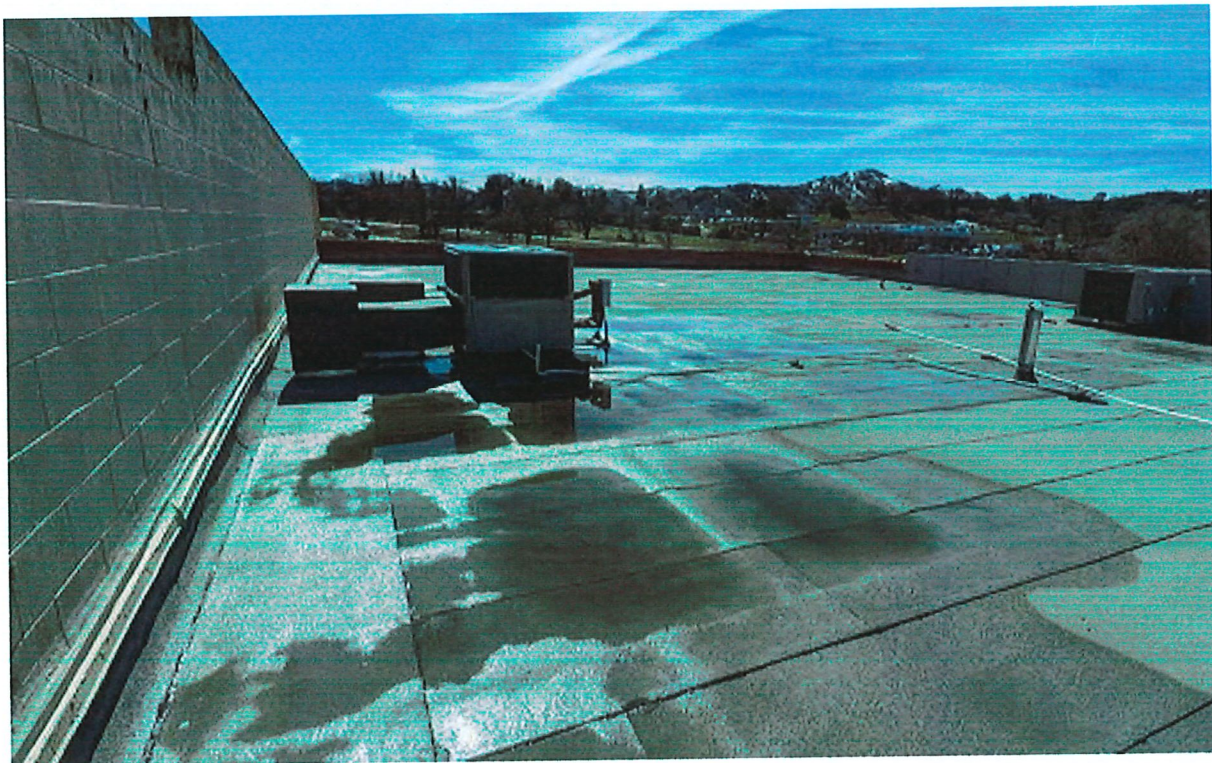
Photo 32 – Ponding at roof, Building D

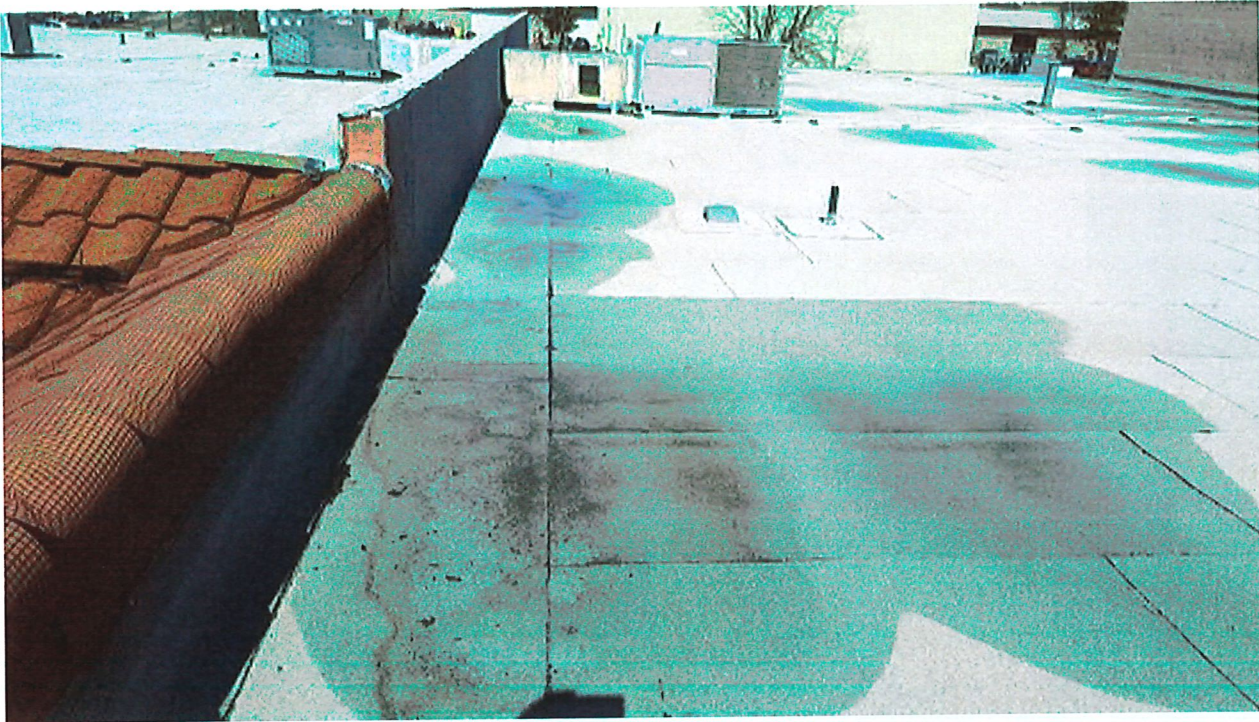
Photo 33 – Ponding at roof, Building D

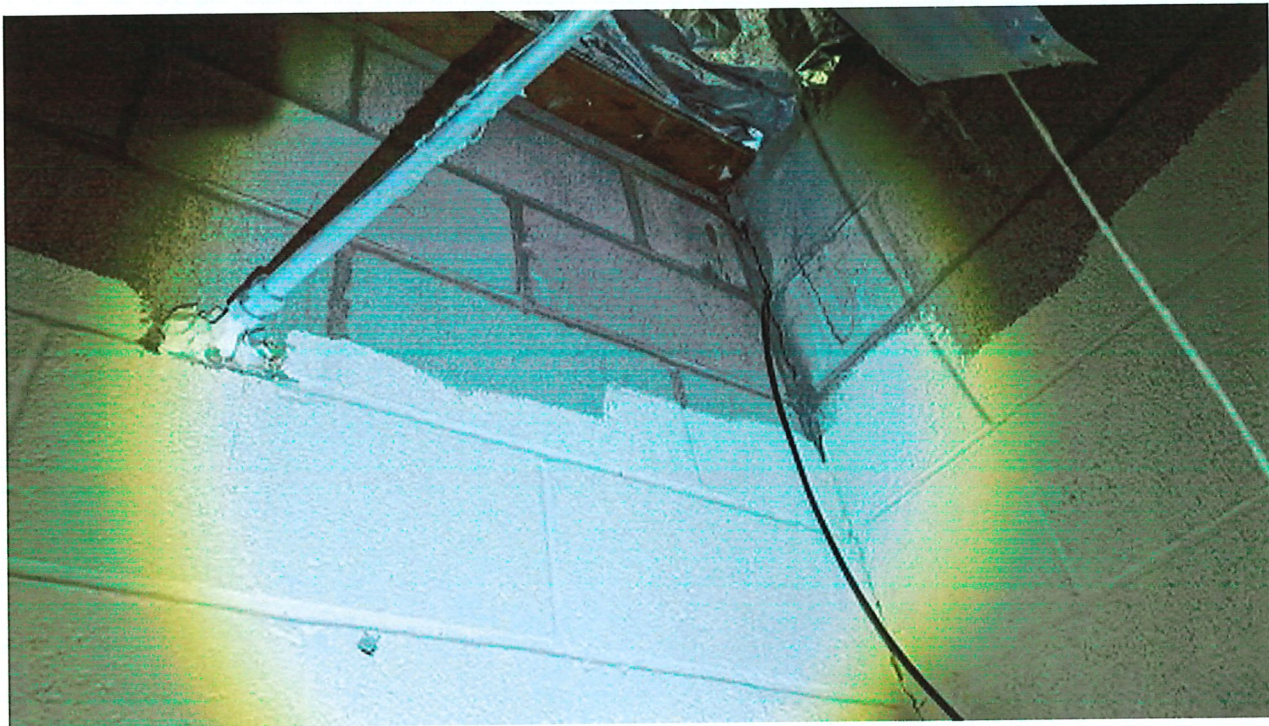
Photo 34 – Water intrusion, Building F/G

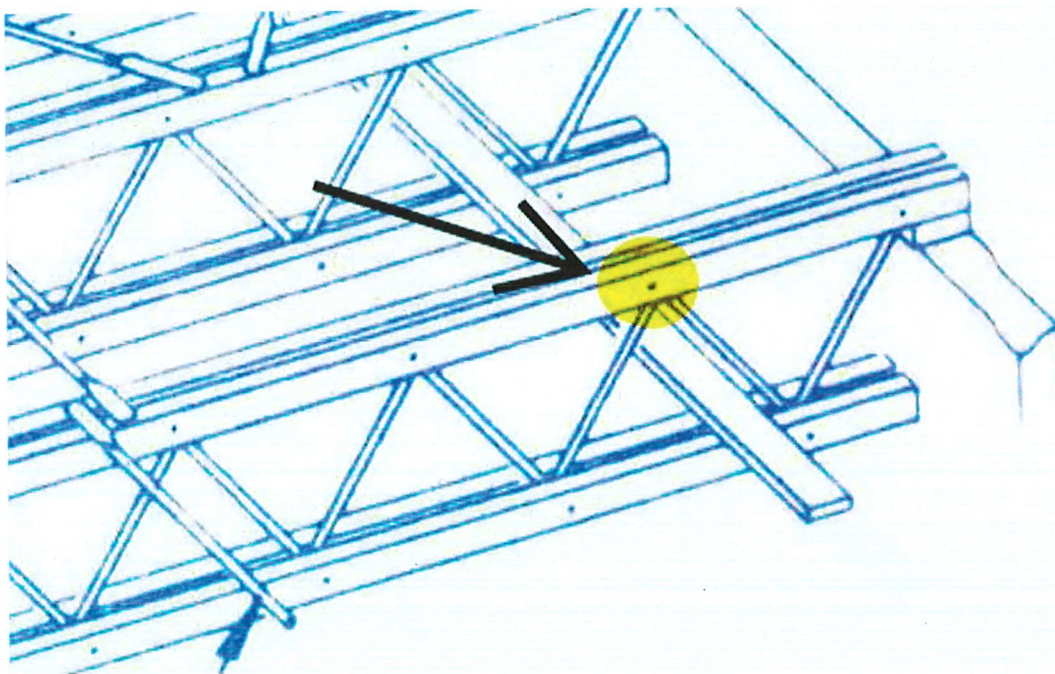
Figure 4 - Enlarged view of suspected truss failure point

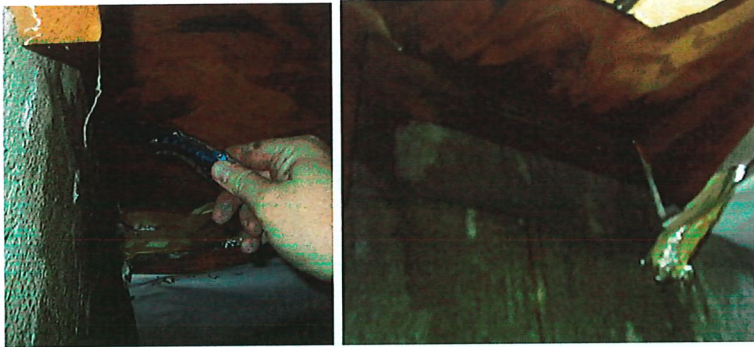
Found small leak and checked wood and found it to still be hard. Leak is probably recent.

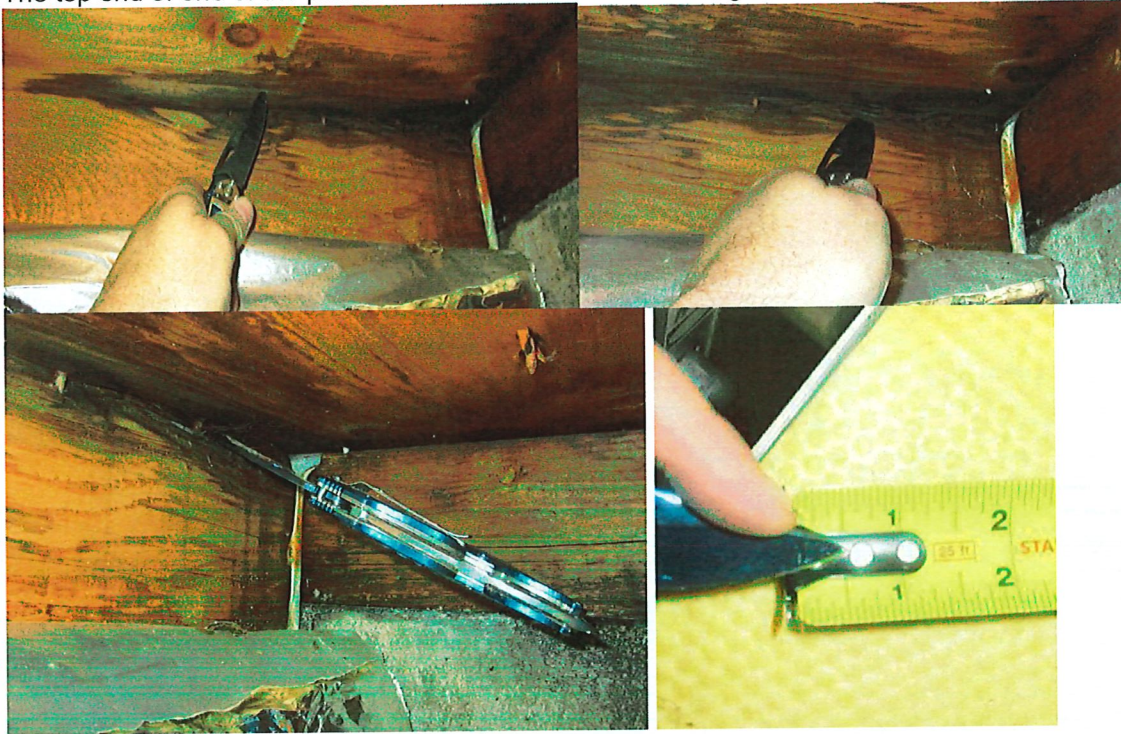
The top end of one of the purlins has some minor water damage. Sheathing is still good.

Owner to sister 2x6 to existing purlin with 16d @ 6" o.c. and clip to plate with A34.

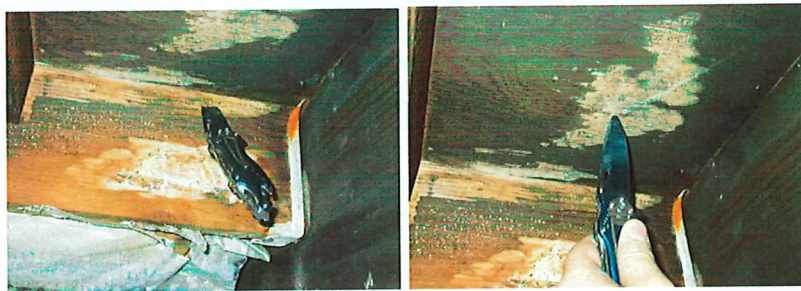
Checked glulam, purlins, and sheathing. All but one purlin found with solid hard wood with no water damage.

Owner to sister 2x6 to existing purlin with 16d @ 6" o.c. and clip to glulam with A34.

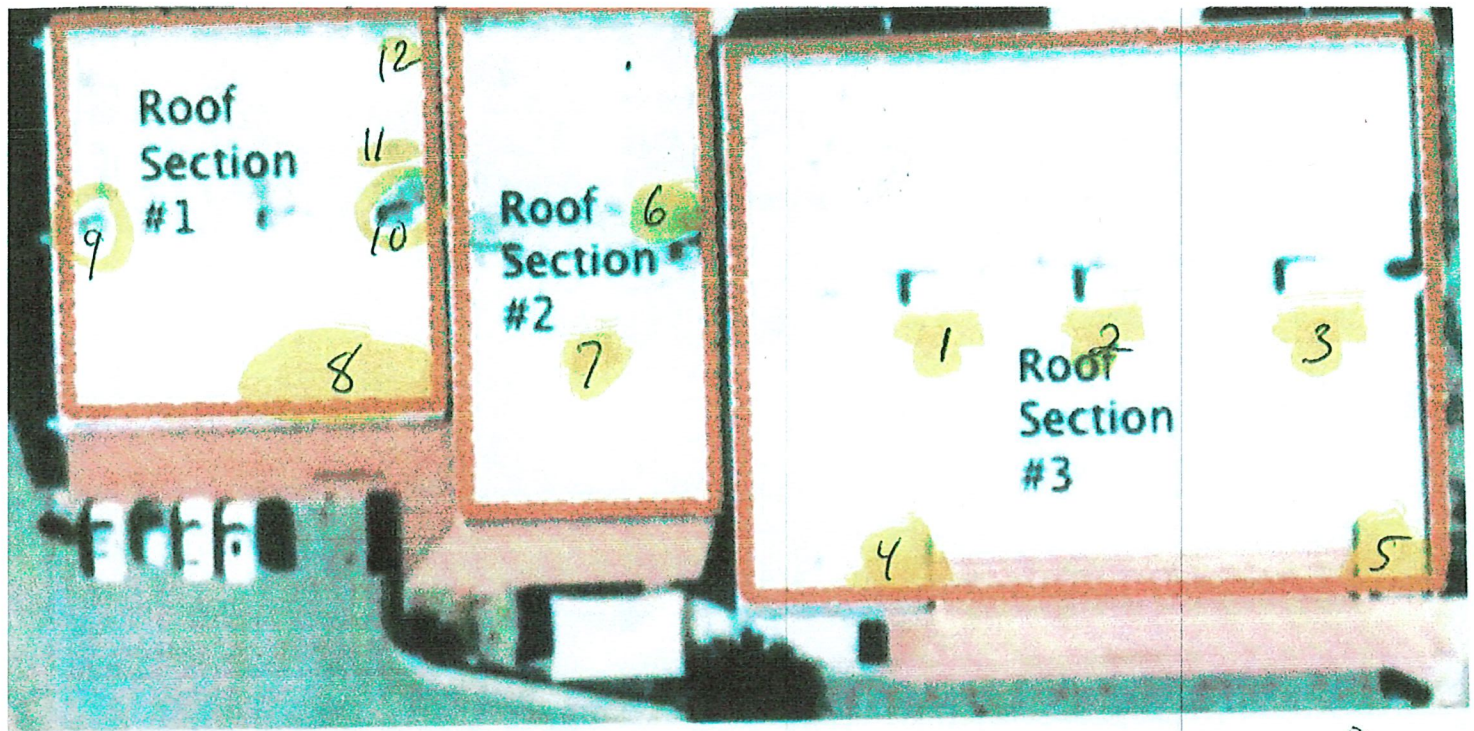
- (1) (2) (3) (4) (5) (6) (7) (8) (9) (10) (11) (12)
- 1 Area 1 Ponding water      Use Mastec Recovery Board  
Base sheet & modified torch.
  - 2 Area 2 Ponding water
  - 3 Area 3 Ponding water
  - 4 Area 4 Parafit Repairs needed      Use modified torch.
  - 5 Area 5 Parafit Repairs needed      Use modified torch.
  - 6 Area 6 Ponding water
  - 7 Area 7 Ponding water
  - 8 Area 8 Roof Buckling lap Repair      3 Course Emulsion
  - 9 Hvac Seal TOP Side DUCT unions & Connection on wall      Foil Face tape & mastec.
  - 10 Hvac seal TOP Side DUCT unions & connections on wall
  - 11 Ponding water
  - 12 seal VENT PIPES,

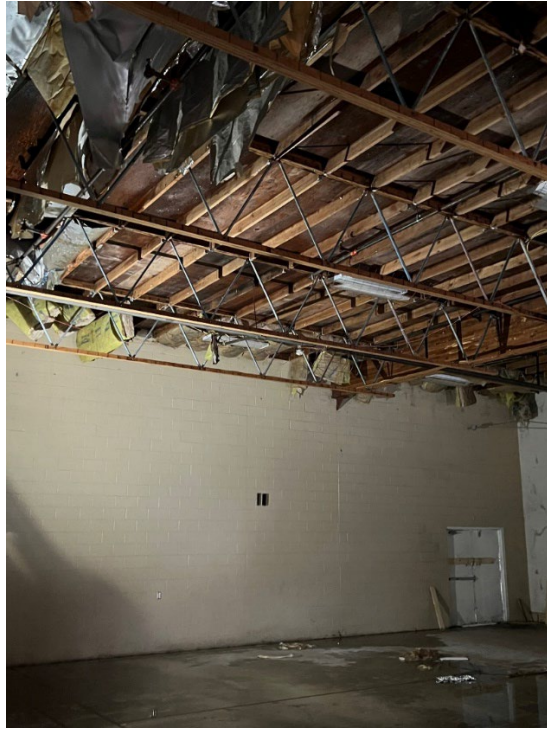
***Unit A - Extensive Water Damage Post-Collapse***

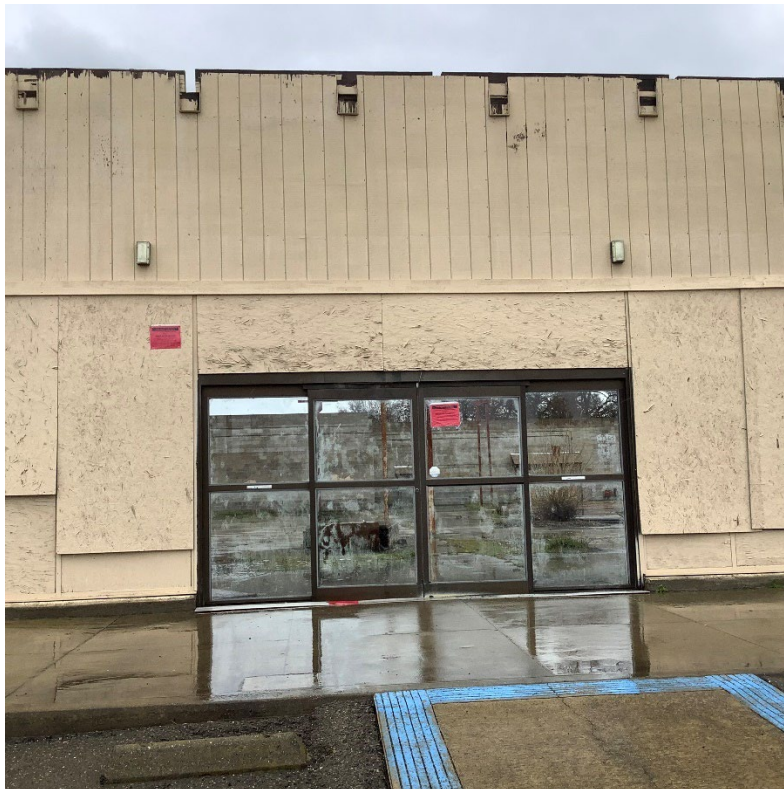
***Unit B – Unsecured plywood with exposed broken glass***

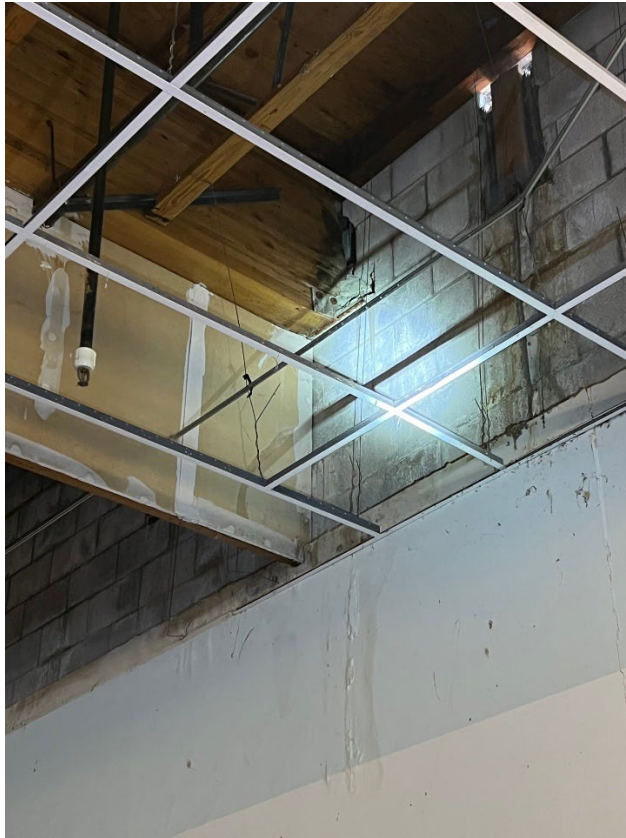
**Unit C – Crack in shared wall with Unit D**

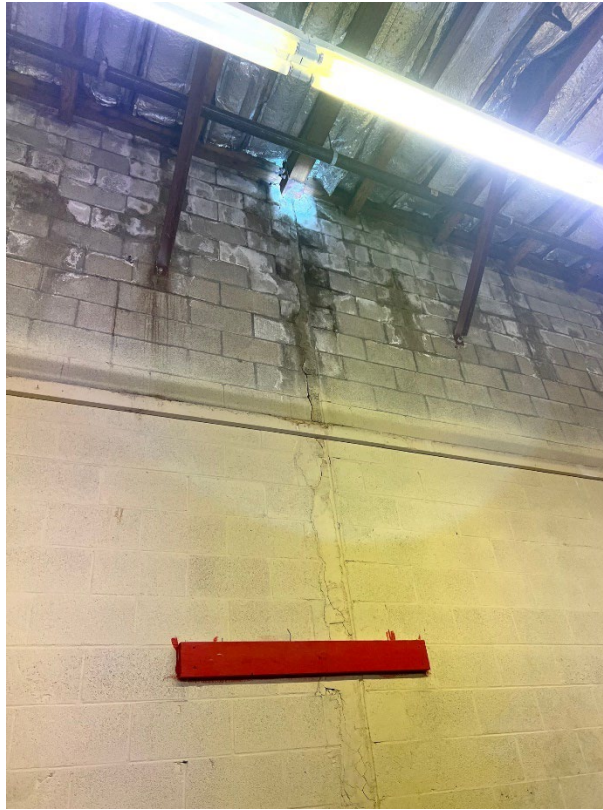
**Unit C – Water intrusion in center of unit**

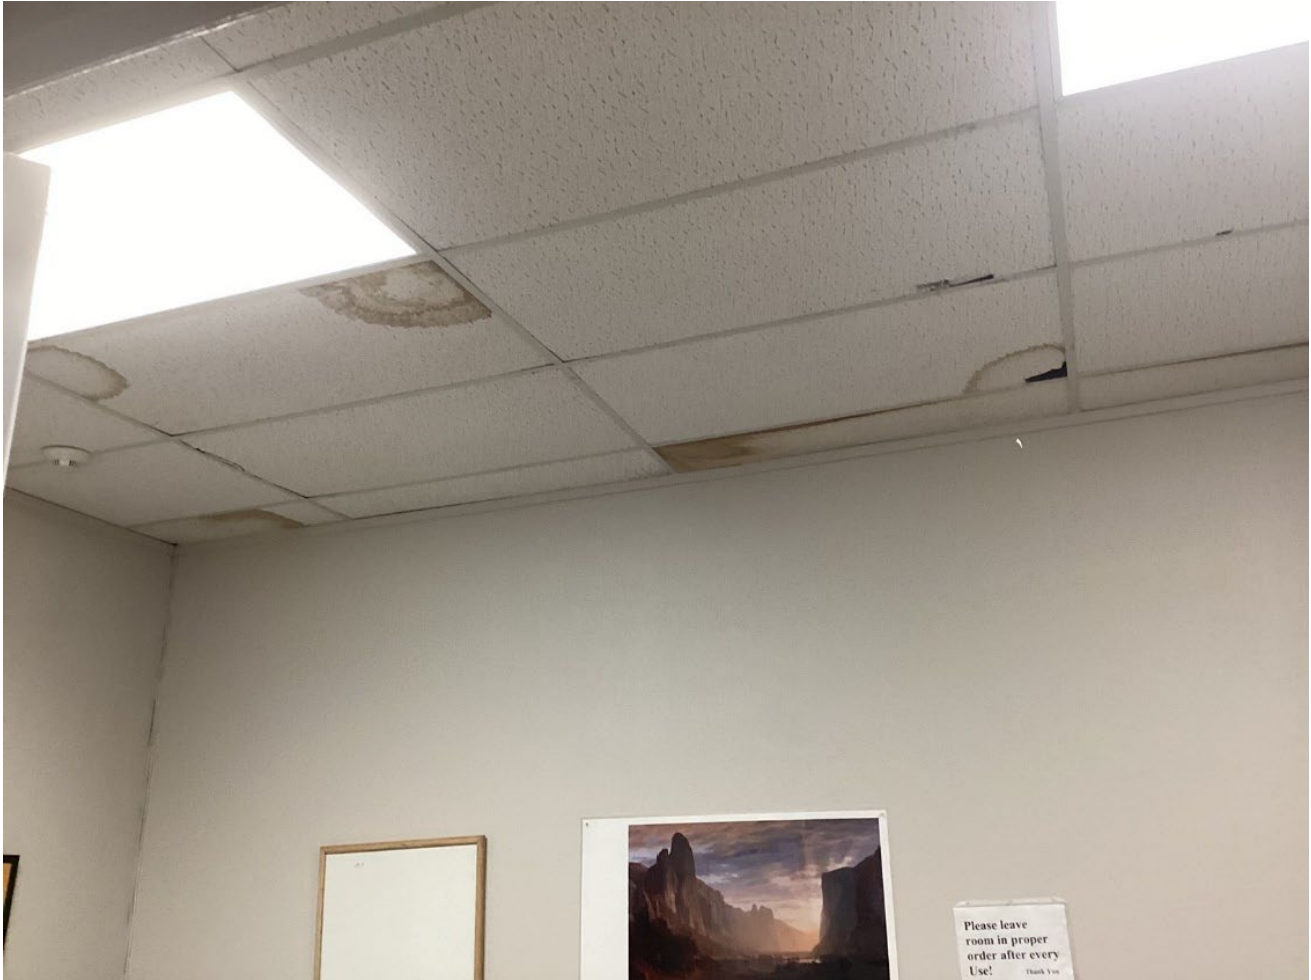
***Unit G – Water running down the walls of the Northwest corner***

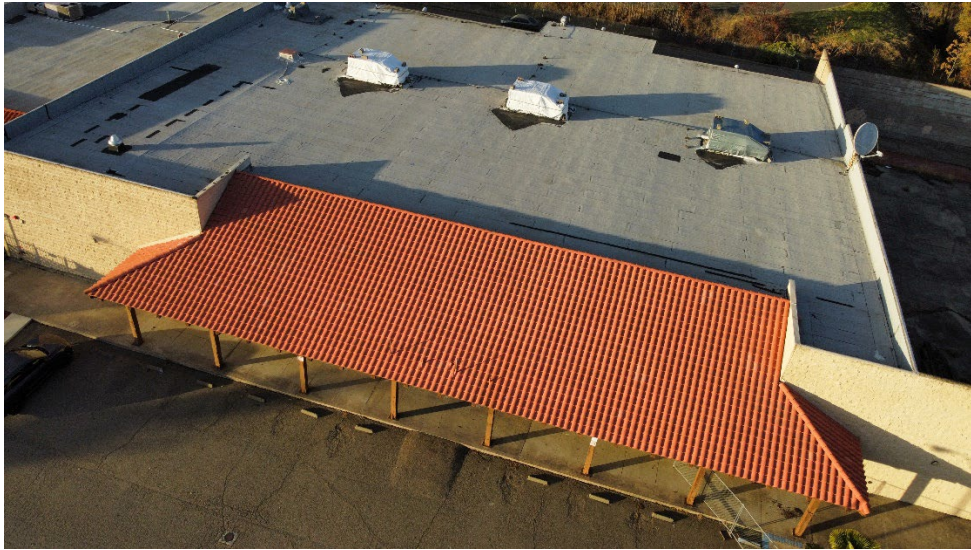
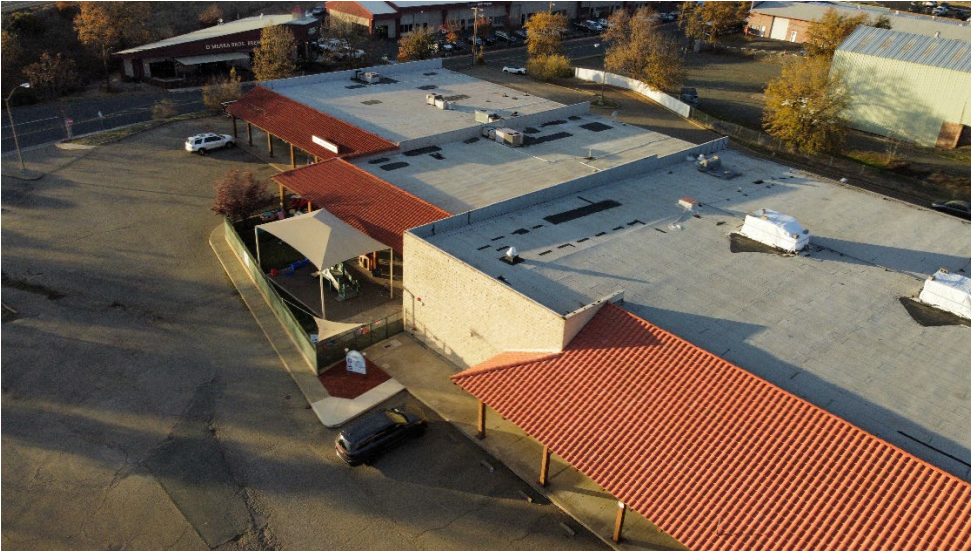
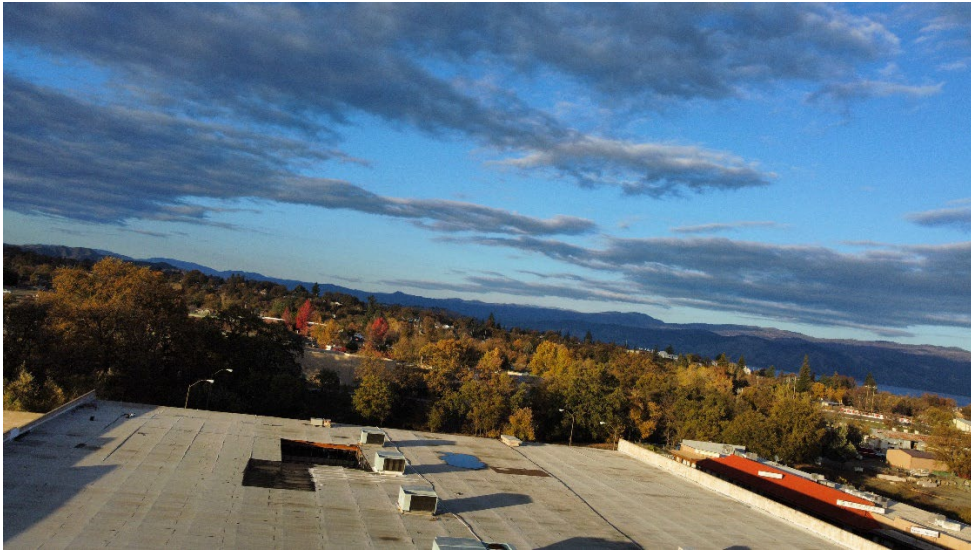
- **October 6, 2023:** Staff identified major roof repairs that were made without required building permits. Donica LLC was made aware of the permit requirement but has not obtained the necessary permits.

**UNPERMITTED ROOF REPAIRS**
