## REGULAR MEETING OF THE LAKEPORT CITY COUNCIL

- VI. **PUBLIC HEARING:**
  - A. Vista Point Shopping Center: Hold a nuisance abatement hearing and adopt a Resolution declaring the primary structure (872-896a Lakeport Blvd) of the Vista Point Shopping Center a public nuisance, order the property owner to abate all identified nuisance conditions within 30 days, and, in the event the nuisances are not timely abated, empowering staff with authority to abate the nuisances, the costs of which may become a special assessment upon the parcel.

Vista Point Shopping Center (Vista Point), situated at 872-896a Lakeport Boulevard, has been under the ownership of Donica LLC since its acquisition in 2007. On July 14, 2022, City staff initiated a Code Enforcement Case (#2022-00046) to address a series of code violations at the property. While items from the initial Code Enforcement case remain outstanding, City staff has presented subsequent code enforcement matters to Donica LLC for resolution. Unfortunately, over the past eighteen months, City staff's persistent efforts to bring Vista Point into compliance have yielded minimal progress in addressing a growing list of violations.

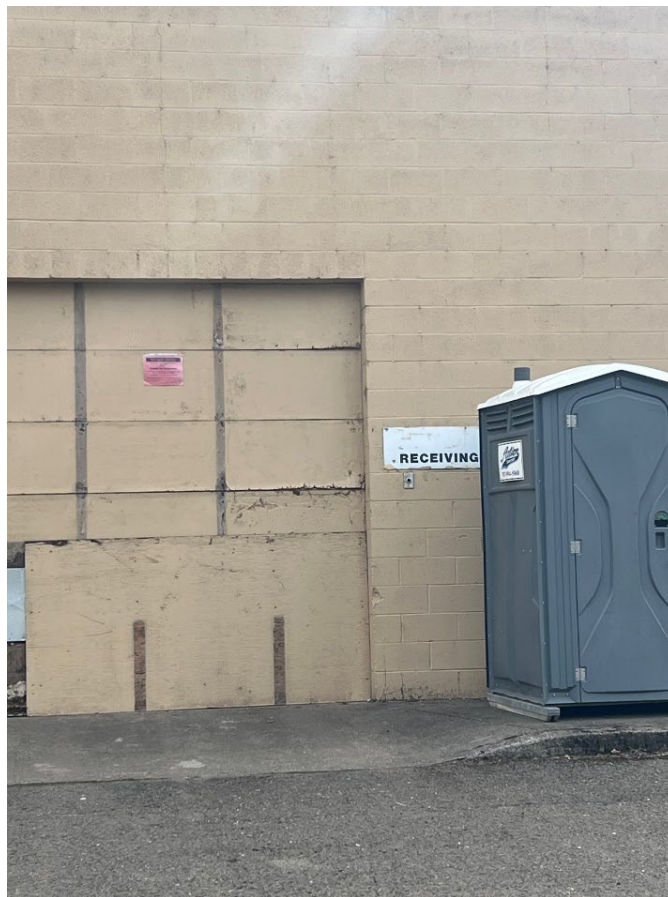
- **November 2, 2023:** Construction was observed inside Unit A without authorization or a building permit. City Staff and Lakeport Police Department intervened, halting all work by Ferranti Construction.

***Unit A – The red tag on the door that the Contractor and workers entered through***
