INTRODUCTION

On December 6, 2018, MAYOTTEgroup Architects conducted a facility assessment of the Mason Library building. The purpose of the visit was to evaluate the conditions and functionality of the building structure, finishes, systems (including mechanical, electrical, plumbing, and I.T.), and site work.

FACILITY ASSESSMENT

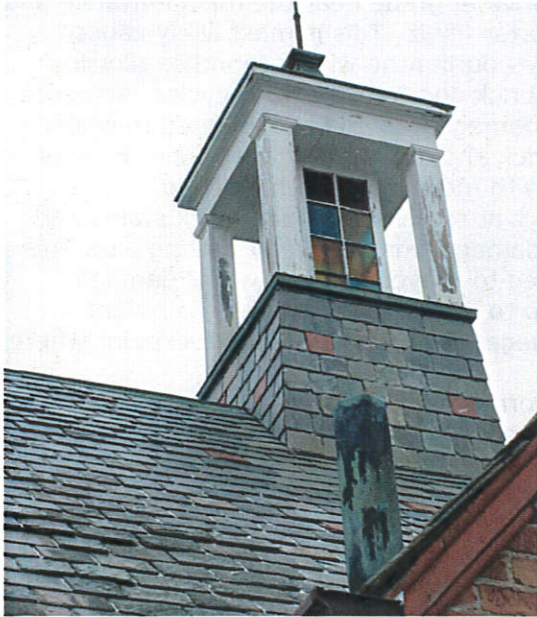
SLATE ROOF

- The slate tiles are weathered and irregular, but overall appear to be in good condition.
- The copper flashing at the wall / roof connections appears to be in good condition.

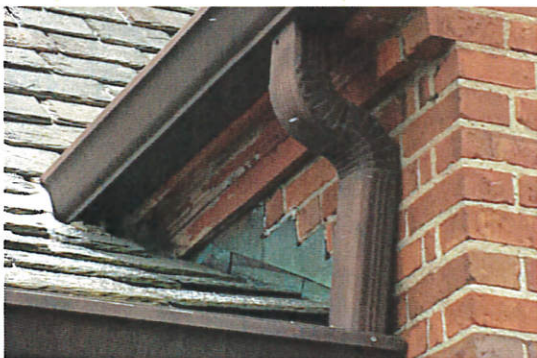
WOOD TRIM

- The wood fascia and rake at the roof edge are in poor condition. There is evidence of the wood rotting, spitting, and paint peeling. In some instances, there are pieces of quarter round or trim missing. It is recommended to remove existing, install new flashing, and provide new, maintenance-free material.
- The wood trim at the cupola and various other locations around the building is in poor condition. There is evidence of rotting and peeling paint. It is recommended to remove and replace the rotted pieces and clean and repaint the remaining wood trim.

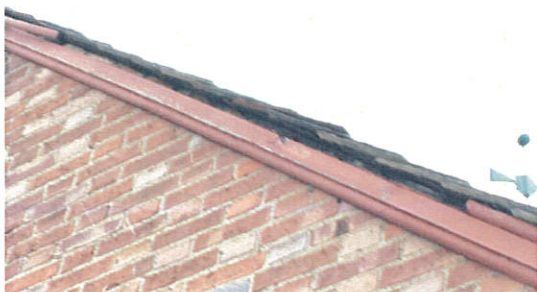
FLASHING

- The flashing at the dormer on the north side near the bookstore is either nonexistent or improperly installed and is causing water damage / staining to the brick, wood trim, and interior. It is recommended to remove existing add new flashing, and reinstall existing finishes.

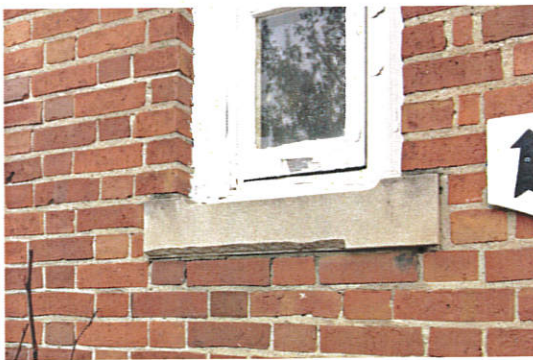
BRICK

- Overall, the Flemish-bond brick and mortar is in generally good condition. There are a few locations where water damage is evident and it is recommended that the damaged mortar joints be cut out and re-tuckpoint with mortar to match existing.

- There is spalling brick at grade near the main entrance and damage to the mortar joints. This is most likely caused by salting entrances during the winter months, allowing moisture into the brick and freeze / thaw cycles. Also, the mortar joints are damaged. It is recommended to replace badly damaged brick and cut out damaged mortar joints and re-tuckpoint with mortar to match existing.

- Inside brick corners at roof valleys have black stains and brick and mortar damage from regularly getting wet. This needs to be avoided to prevent further water damage. It is recommended to install valley baffles to prevent further water damage, clean brick, and re-tuckpoint where needed.

- At the northeast corner of the garage, there are some damaged bricks, probably caused by a collision. It is a non-structural issue.

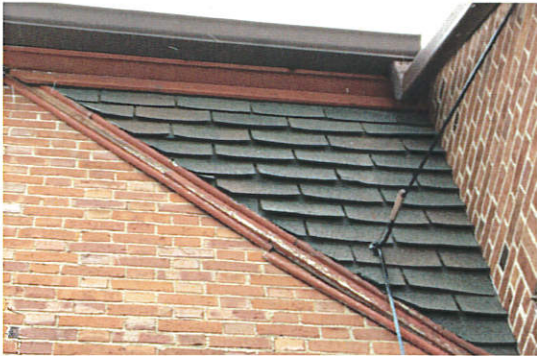
SHINGLES ON SOUTH WALL

- The asphalt shingles on the south wall are not intended to be used on a vertical surface. It is recommended to remove the shingles and replace with wood cedar shakes.

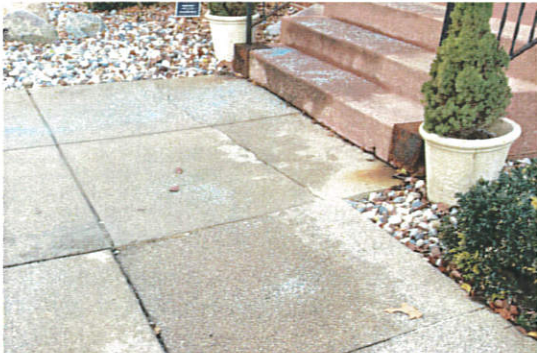
SIDEWALK

- The sidewalk near the main entry door is in poor condition. It has visible cracks and damage from salt and uplift.
- There are instances where the concrete slopes toward the building, which allows water to collect at the base of the building, causing water damage on the exterior and interior face of the foundation wall. It is recommended to lift existing concrete sidewalk to allow water to drain away from the building or to remove and replace concrete to slope away from the building and prevent further damage to the foundation.
- At the exit door in the Children's Area, there is no concrete landing prior to the step down to the sidewalk

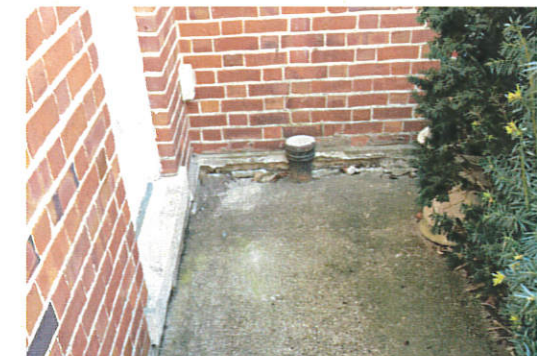
RAMP

- The ramp is in good condition and is compliant with ADA standards. It is recommended to remove existing non-slip finish that is showing signs of wear and replace with a new non-slip finish.
- The ramp leads to a non-ADA compliant door. It is recommended to add an ADA push plate (and additional necessary door hardware changes) on the interior and exterior or to remove and rebuild the landing to provide the appropriate amount of space to allow for accessible access.

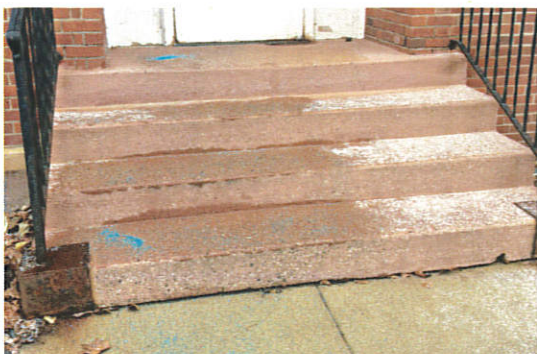
EXTERIOR STAIRS

- The concrete stairs at the main entrance are in fair condition and meet code requirements. There is evidence of salt damage and rust stains at the base of the metal handrails. It is recommended to clean the stairs to remove rust stains.
- The metal handrails are in good condition.

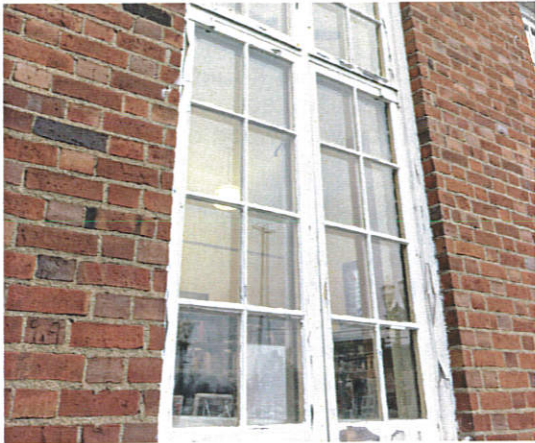
CASEMENT WINDOWS

- The casement windows are in overall poor condition. There is peeling paint and evidence of improper flashing installation that is causing water damage. It is recommended that the windows be removed and replaced with units that replicate the existing.
- The casement windows in the Children's Area appear to have recently been replaced and are in good condition.

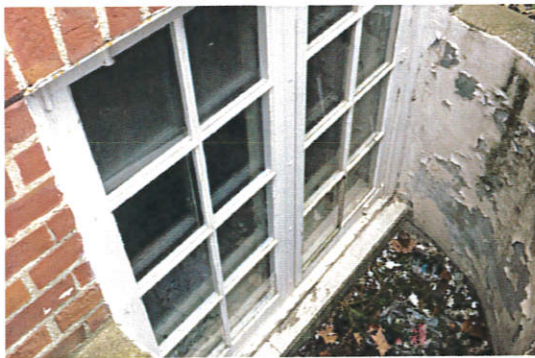
BASEMENT WINDOWS / WINDOW WELLS

- The window wells on the north side near the ramp entrance have been improperly covered. It is recommended to remove and replace with proper window well covers.
- The window wells on the west side in the Activity Room have peeling paint and show evidence of water damage. They also collect trash because of the lack of a well cover. It is recommended to clean, repaint, and install well covers.
- The window well cover on the west side near the mechanical equipment has been damaged. It is recommended to remove and replace with a new cover.
- The basement windows are in poor condition. The paint finish is peeling and there is evidence of water damage on windows as well as the interior due to broken sealant joints, allowing water to penetrate. It is recommended to remove and replace all basement windows.

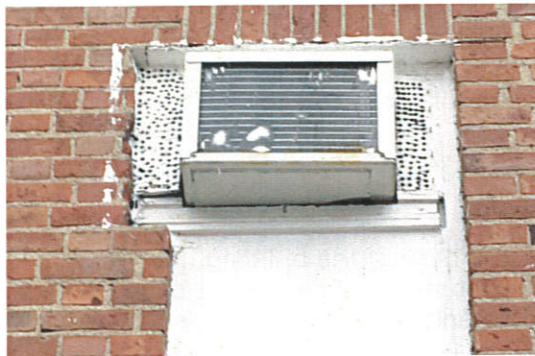
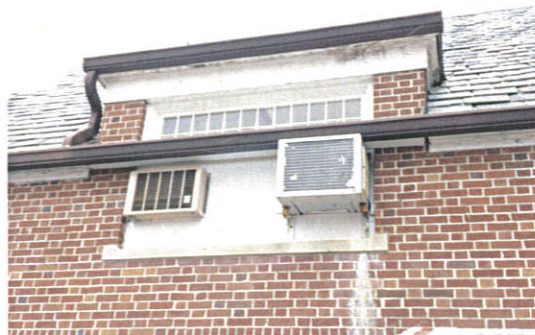
A/C WINDOW UNITS

- The air conditioning window unit in Cheryl's office was improperly installed. The window and the brick on one side of the opening were removed to make room for the window unit and the remaining space was filled in with plywood. Doing this leaves the steel lintel unsupported on one side. It is recommended to remove the A/C unit, reinstall the brick removed and fill the opening.
- The units installed at the dormer in the bookstore were improperly installed, similar to the unit in Cheryl's office. There is evidence of water damage on the interior and it is recommended to remove the units and the surrounding plywood and fill the opening properly with a window similar to the original.
- A/C window units are not ideal for the space. It is recommended to remove all window units and replace with a ground mounted system.

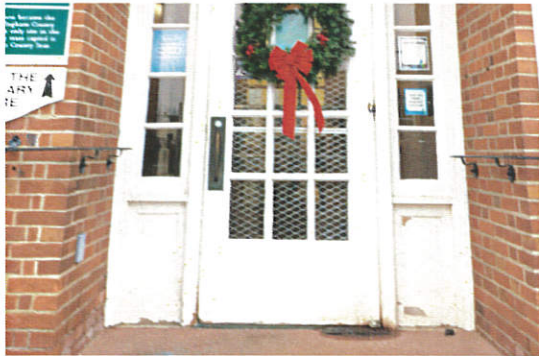
EXTERIOR DOORS

- The door at the main entrance is showing signs of water and salt damage at the base of the door, frame, and side lites due to lack of proper protective measures. It is recommended to remove and replace the door and the side lites.
- The half round window above the main entrance door has peeling paint, but is otherwise in good condition. It is recommended to leave the window in place and clean and repaint.
- The remaining exterior doors have peeling paint and show signs of water / weather damage, but are otherwise in good condition. It is recommended to clean and repaint.
- The garage door has visible signs of water damage at the base due to standing water. It is recommended to remove the door and replace.

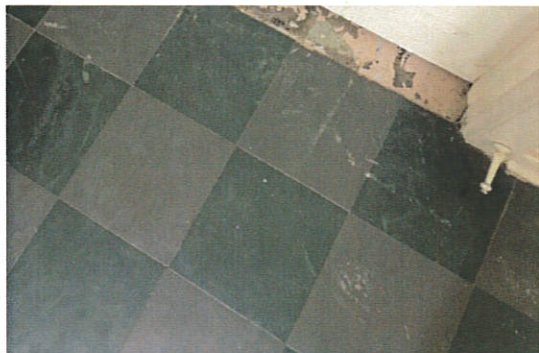
FLOOR FINISHES

- The VCT tile found in various locations throughout the basement and first floor has the potential to contain hazardous materials. It is recommended to have a hazardous materials assessment report conducted on the building in its entirety.

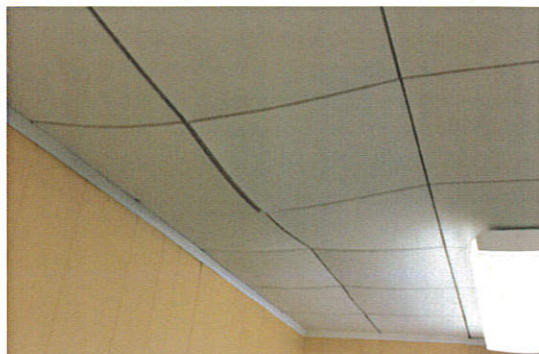
CEILING FINISHES

- The ceiling tiles near the Staff Break Room are sagging. Further investigation is needed to discover the cause. It is recommended to remove the ceiling tiles in its entirety and replace with new grid and acoustic ceiling tiles.
- The ceiling tiles in the second floor Bookstore are also sagging with visual signs of water damage. Further investigation is needed to determine the cause of the water damage. It is recommended to remove the ceiling in its entirety and replace with a drywall finish similar to the sloped ceiling.

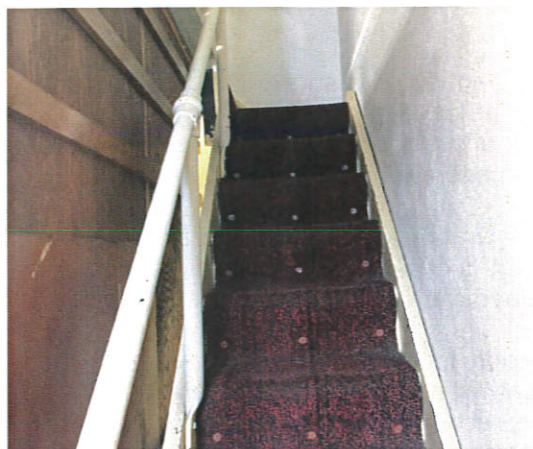
STAIRS

- The stairs leading to Cheryl's Office are too narrow and not compliant with the current code. It is recommended to remove the stairs.
- The stairs near the main entrance are not compliant with the current code. The landing is too narrow and the handrails do not meet the current standard.
- The landing at the base of the stairs in the Children's Area is too small and does not meet current code standards.
- The stairs to the second floor Bookstore are in good condition and meet current code requirements.

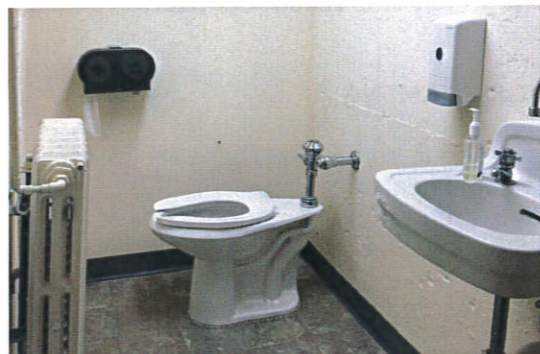
RESTROOMS

- The public restrooms in the basement are inaccessible and are not up to ADA standards. There is no accessible way to get to the restrooms. There is a need to walk up steps and go down a narrow hallway to access the restrooms.
- In both the men's and women's restroom, there are no grab bars.
- The men's restroom is too narrow to provide proper clearances for maneuvering the space.
- It is recommended to renovate the existing restrooms by cleaning and repainting the walls, installing grab bars, provide an accessible route to the restrooms or relocate the restrooms to another location within the building.

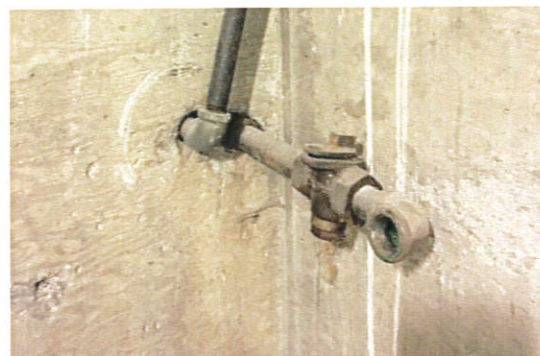
PIPING

- There is abandoned piping throughout the lower level. It is recommended that the piping be removed and the holes in the wall patched.
