## **Playground Assessment Report New Bern, North Carolina**

05-17-18

Kidsville New Bern

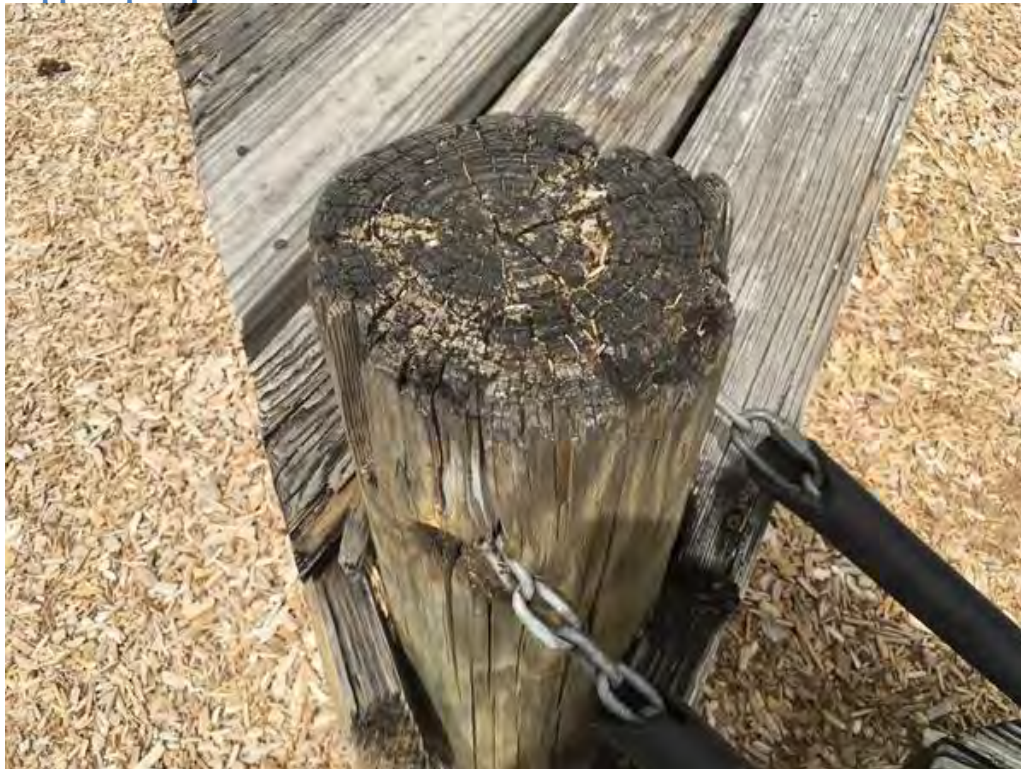
### **Support post picture #1**

Medium= Some visible damage / deterioration / decay observed. Does not appear to be structural at this time.

2. Needs corrective action.

Replace with low maintenance recycled structural plastic where needed.

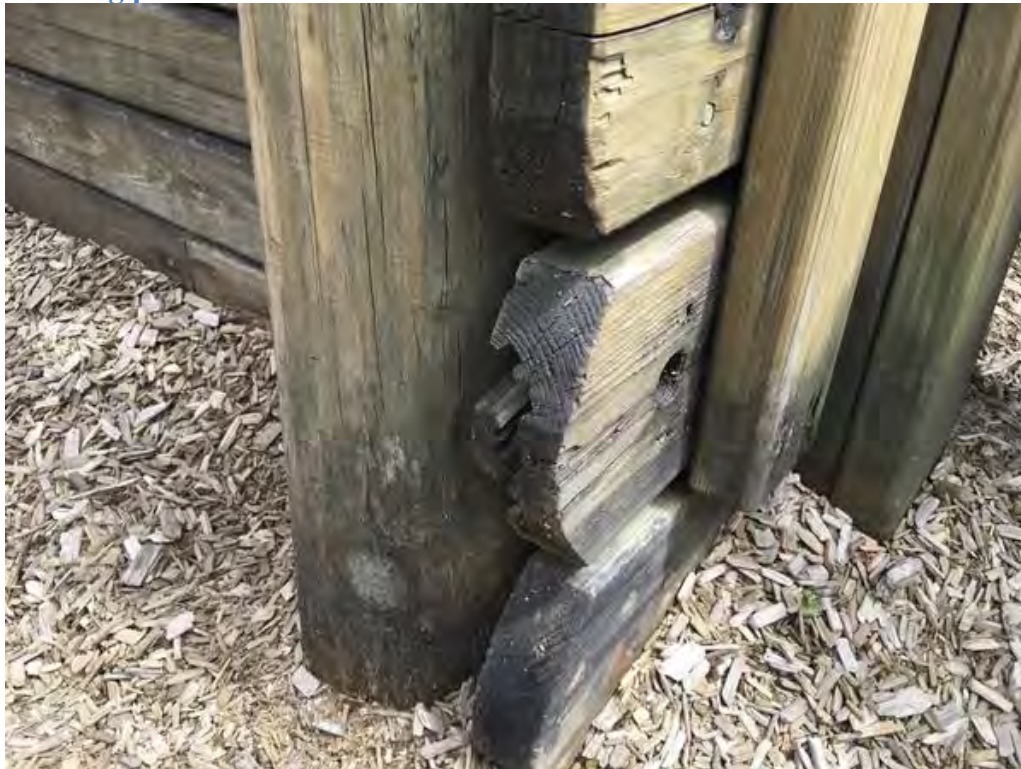
### **Framing picture #1**

Medium= Some visible damage / deterioration / decay observed. Does not appear to be structural at this time.

Although some framing is in good condition, there is much framing that is showing signs of its age. Checking, splitting and cracking is evident throughout the playground.

Replace with low maintenance recycled structural plastic.

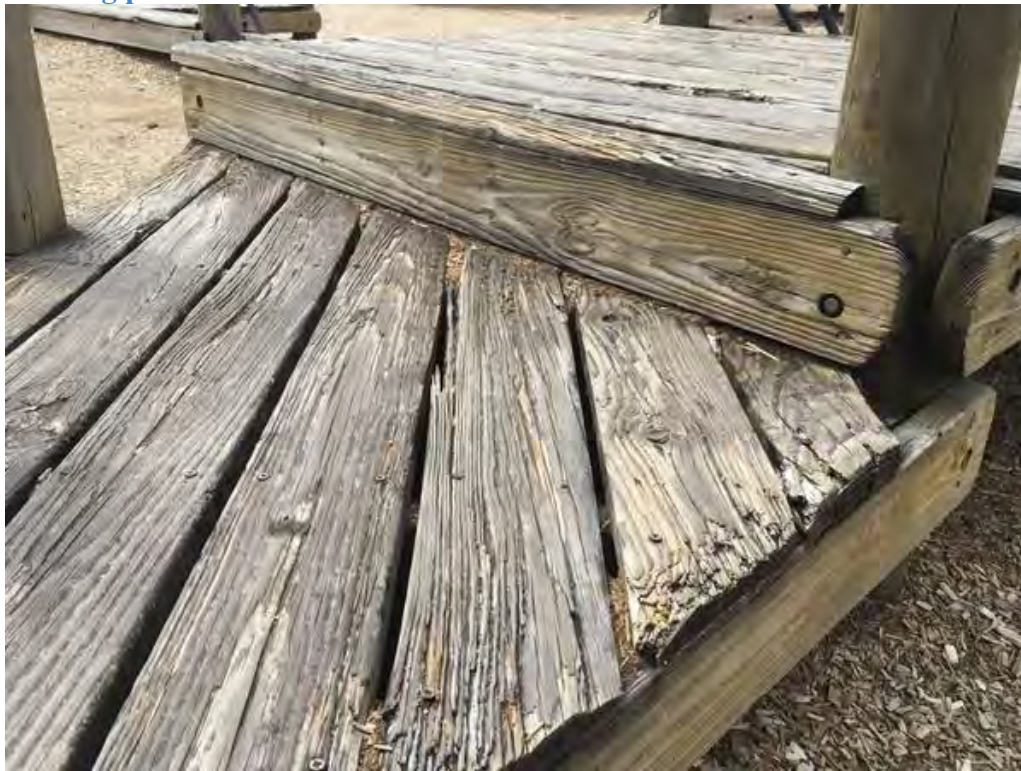
### **Decking picture #1**

Poor= Visible damage / deterioration / decay observed. Structural issues imminent.

The decking on this playground is showing its age. Deterioration, splitting and rot are evident everywhere. A small area of decking has been replaced with a composite decking.

Replace with recycled plastic.

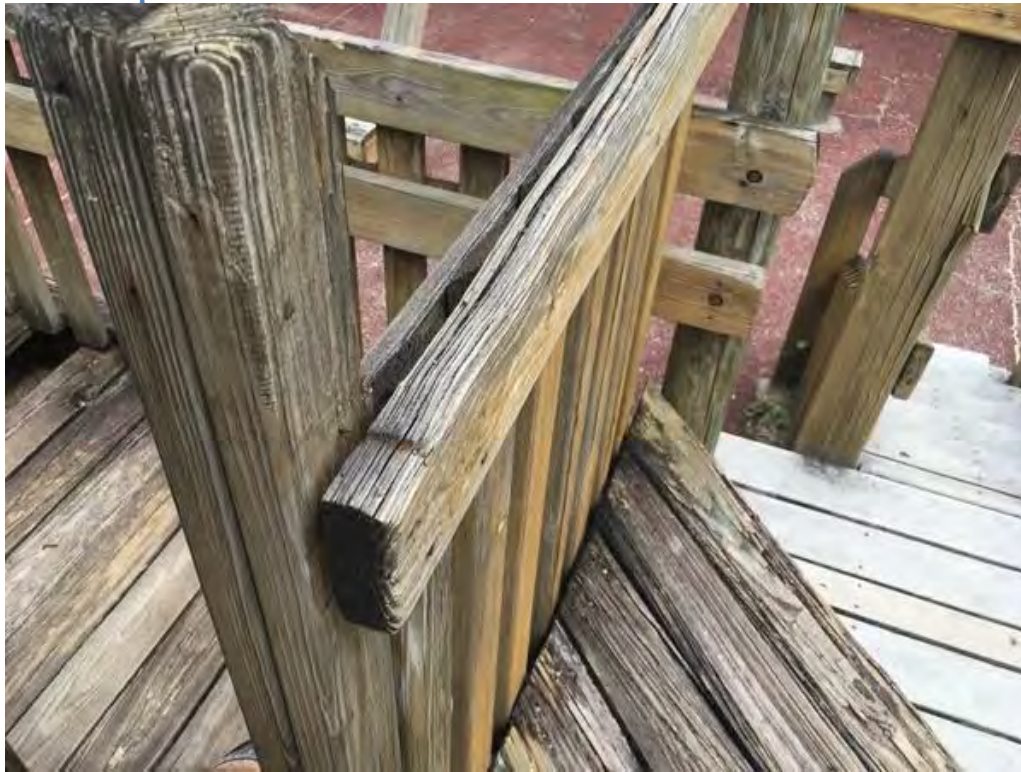
Handrail picture #1

Poor= Visible damage / deterioration / decay observed. Structural issues imminent.

Most of the handrails are splitting, and many have become loose

Replace with composite to reduce the amount of pressure treated lumber on the structure.

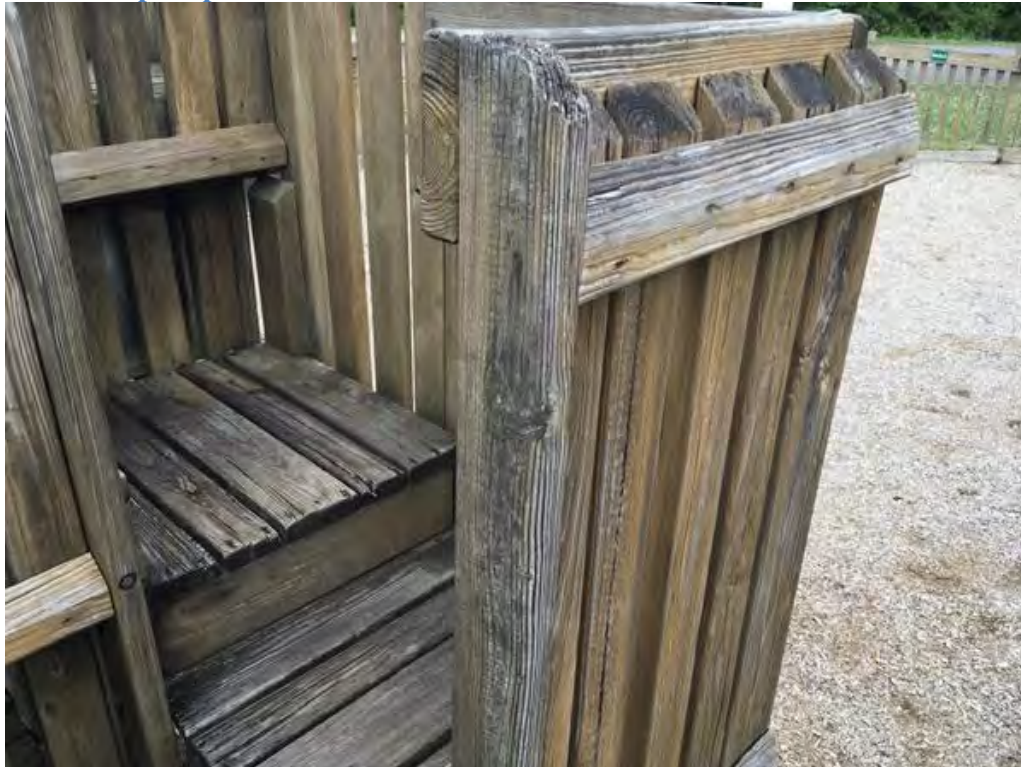
### **Handrail post picture #1**

Poor= Visible damage / deterioration / decay observed. Structural issues imminent.

Handrail posts have become loose and wiggly.

Replace with low maintenance recycled structural plastic.

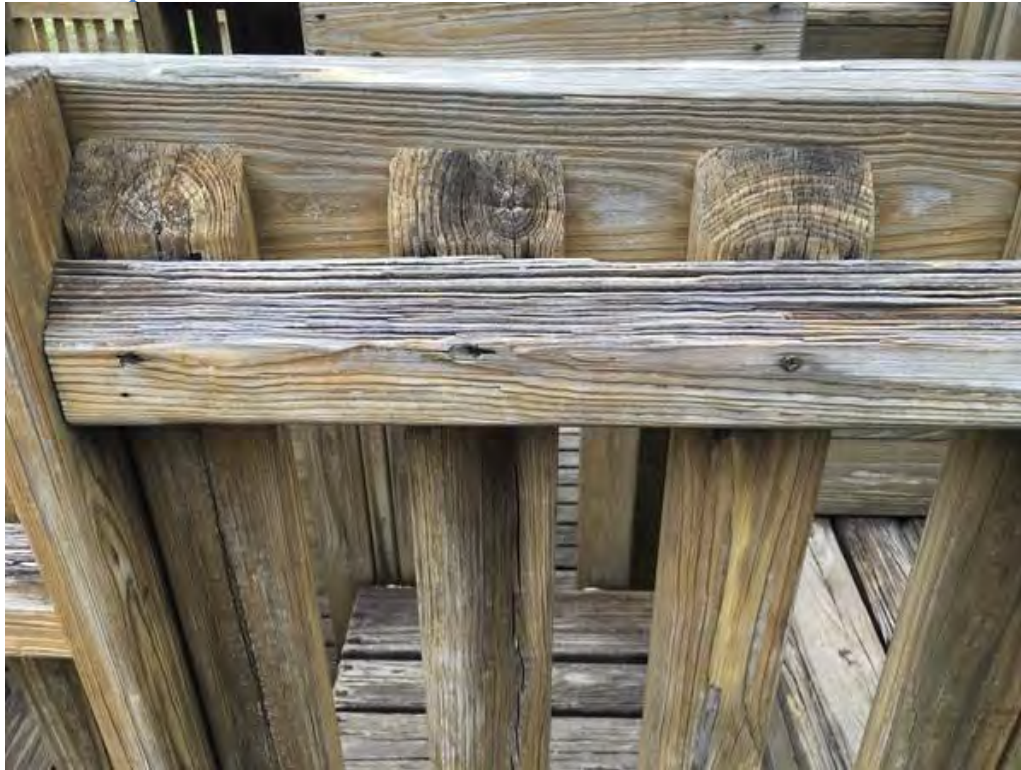
### **Baluster picture #1**

Medium= Some visible damage / deterioration / decay observed. Does not appear to be structural at this time.

Replace with recycled plastic 2x2 balusters to increase visibility.

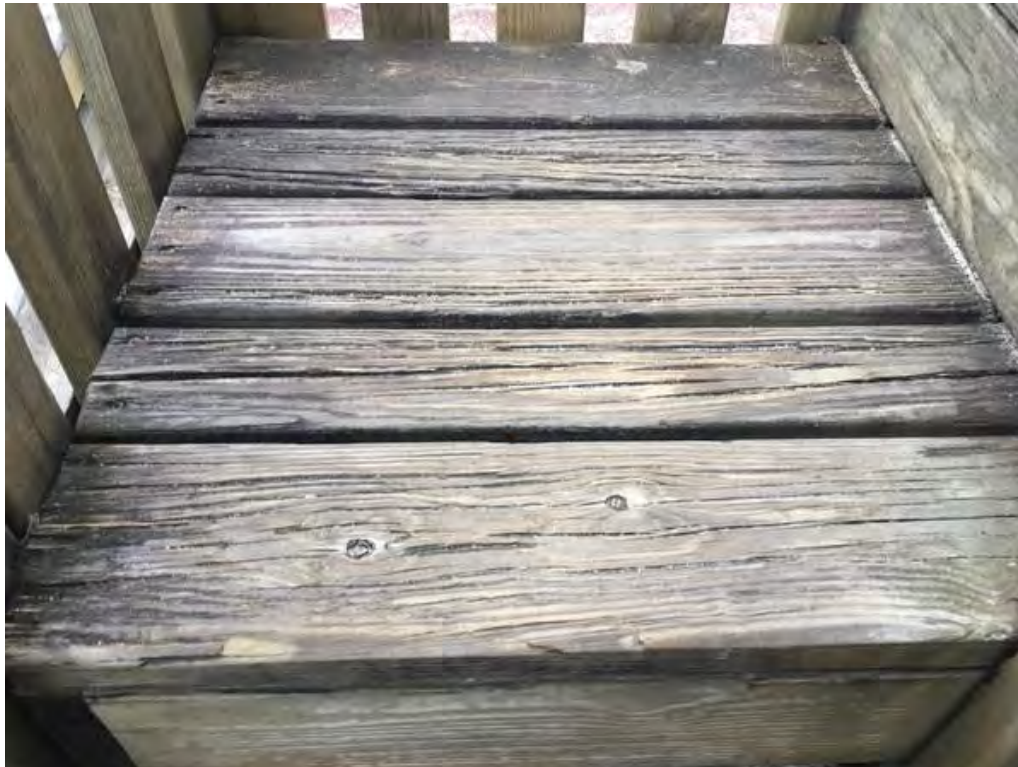
### **Maze cube Picture #1**

Poor= Visible damage / deterioration / decay observed. Structural issues imminent.

The decking on some of the cubes is failing to the point of being unsafe.  
The framing seems a little more intact, but shows signs of splitting

Replace all maze cube decking.

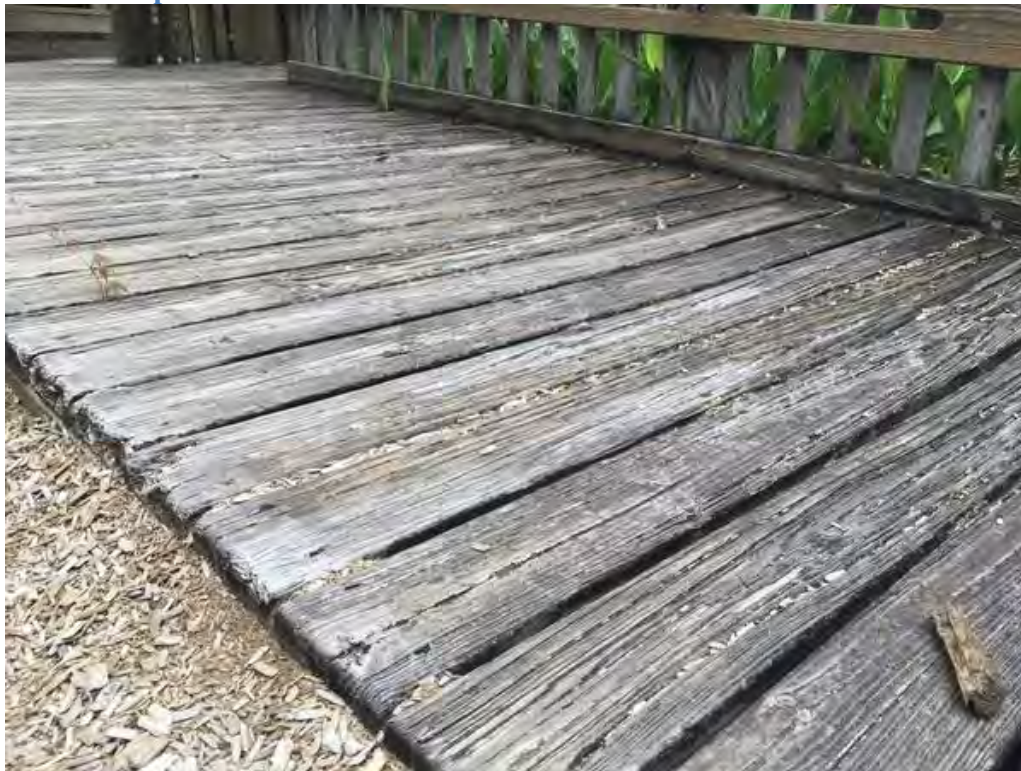
### **Accessible picture #1**

Poor= Visible damage / deterioration / decay observed. Structural issues imminent.

The decking on all of the ramps is deteriorated, rotting, and splitting.

Replace during a rebuild

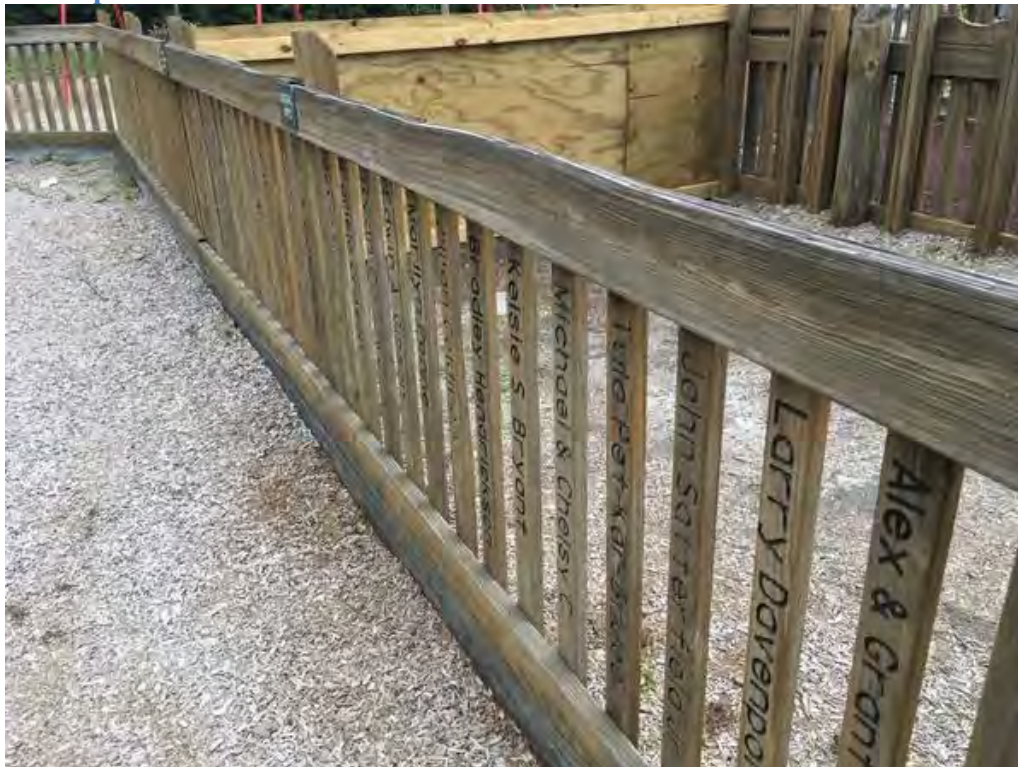
### **Fence picture #1**

Medium= Some visible damage / deterioration / decay observed. Does not appear to be structural at this time.

The fence is in medium condition (minor splintering - missing pickets and wear).

Replace with a new all plastic fence.

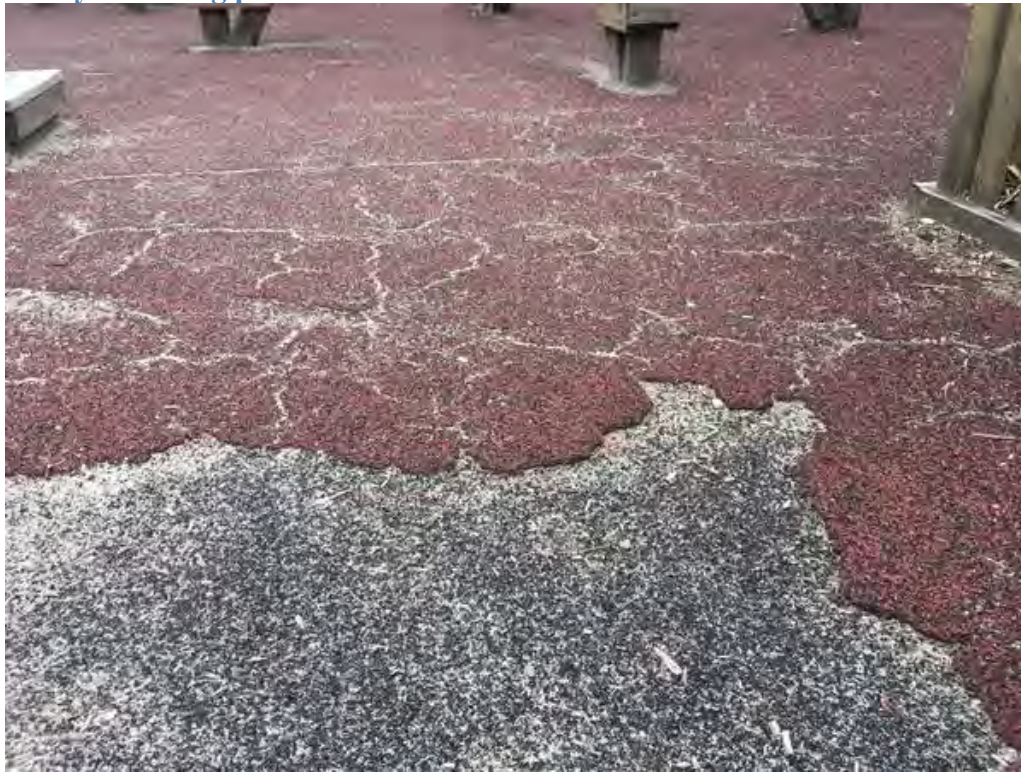
Safety surfacing picture #1

Medium= Some visible damage / deterioration / decay observed. Does not appear to be structural at this time.

4"to 6" Deficient throughout

Safety surfacing is in poor condition several areas need more surfacing added. There is an area in the tot lot which has poured in-place rubber surfacing. This needs to be touched up or replaced as it is showing its age.

Add additional engineered wood fiber to a total depth of 12" throughout. The poured in place rubber in the tot lot needs to be touched up or replaced as its showing its age.

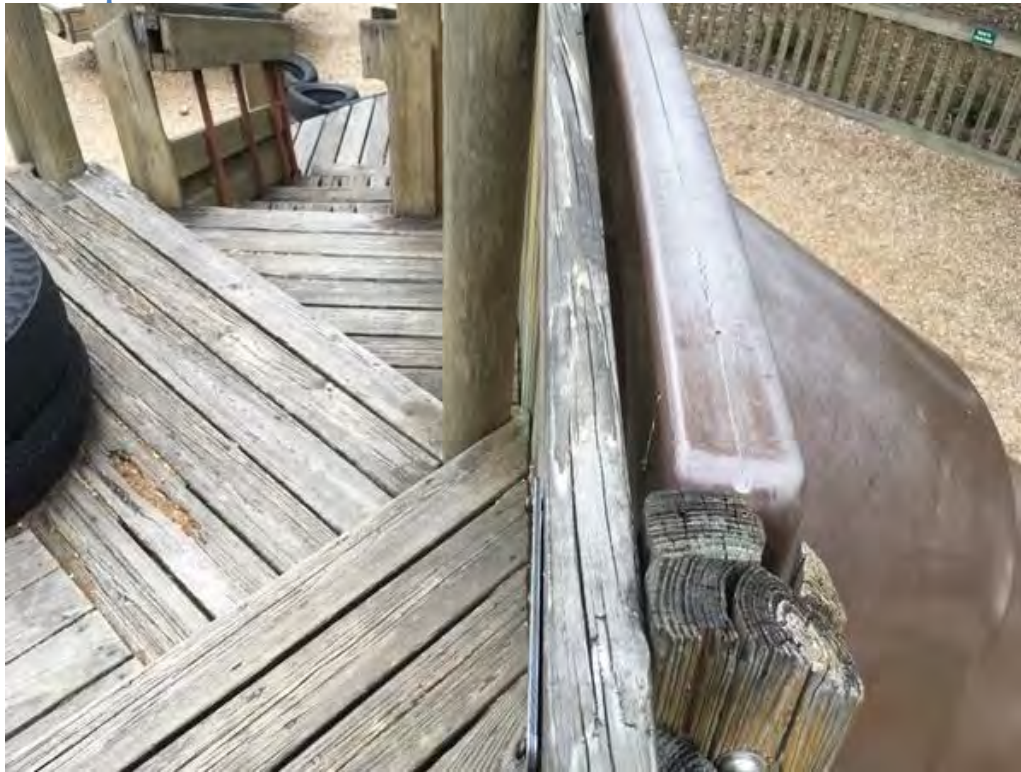
Slide 1 picture #1

Medium= Some visible damage / deterioration / decay observed. Does not appear to be structural at this time.

The framing around the slide is deteriorating. The deck at the entrance has got splintered boards and gaps between the boards. The top of the slide features an unintended platform

Replace with new.

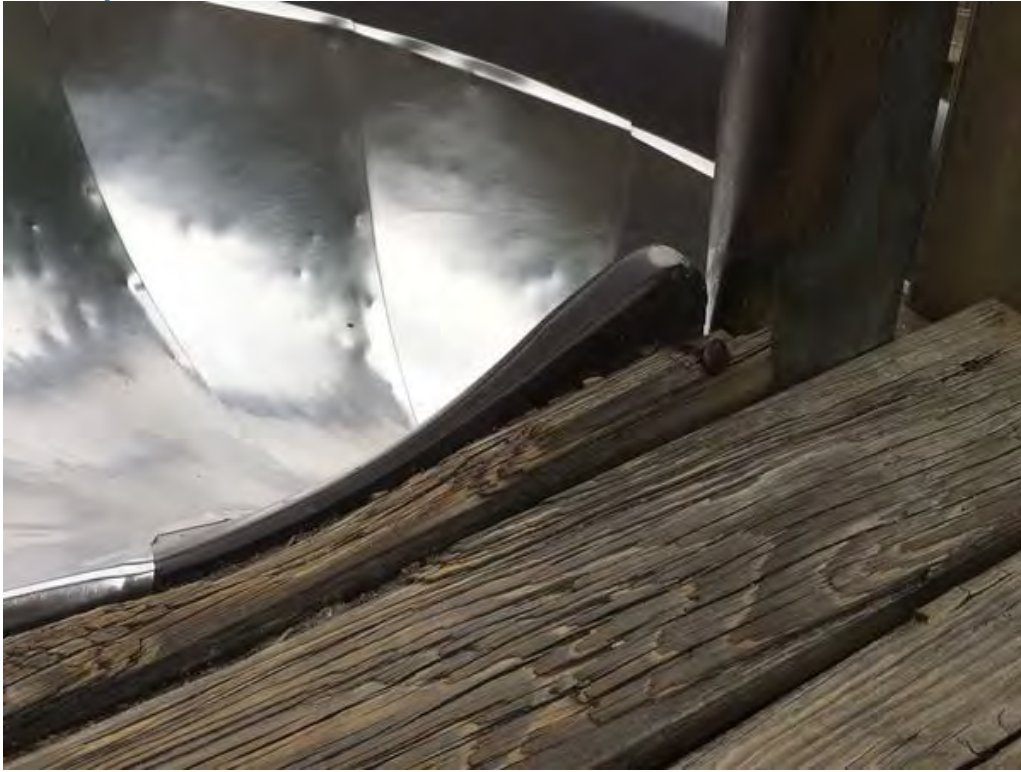
Slide 2 picture #1

Good= No visible damage / deterioration / decay observed.

The framing and decking at the top entrance of the slide are in poor condition, leaving a few hazards, entanglements being the most serious.

Replace with new.

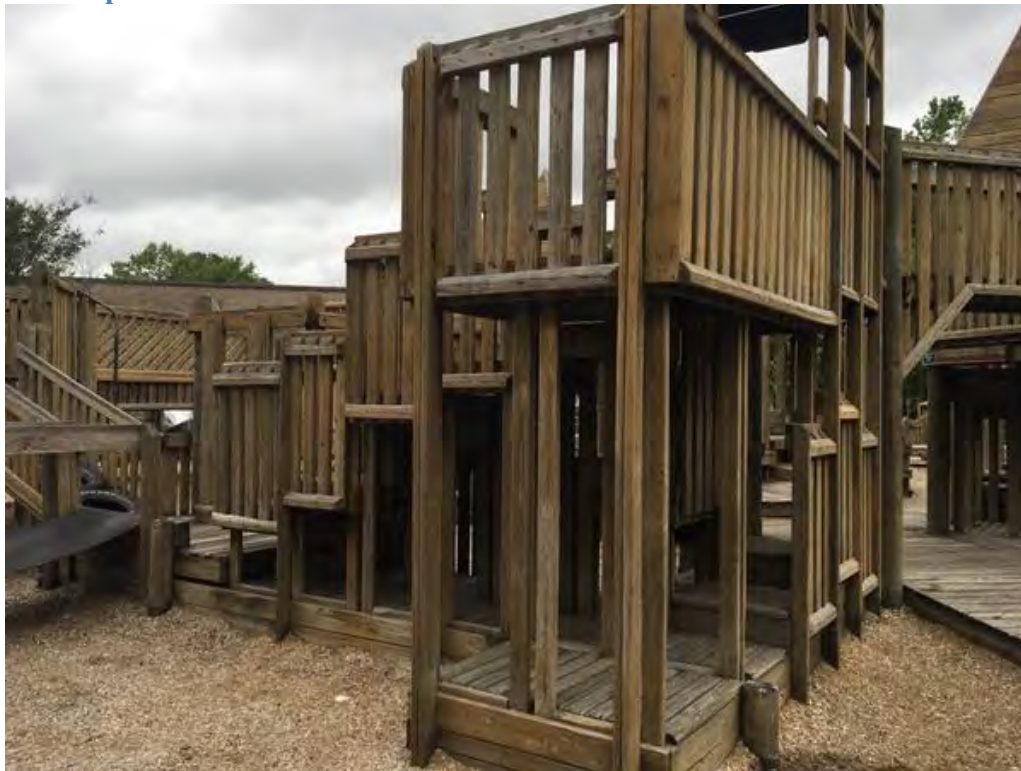
#### **Slide 3 picture #1**

This slide is missing and has been “walled off” with handrail and balusters installed to block off the deck.

Replace with new.

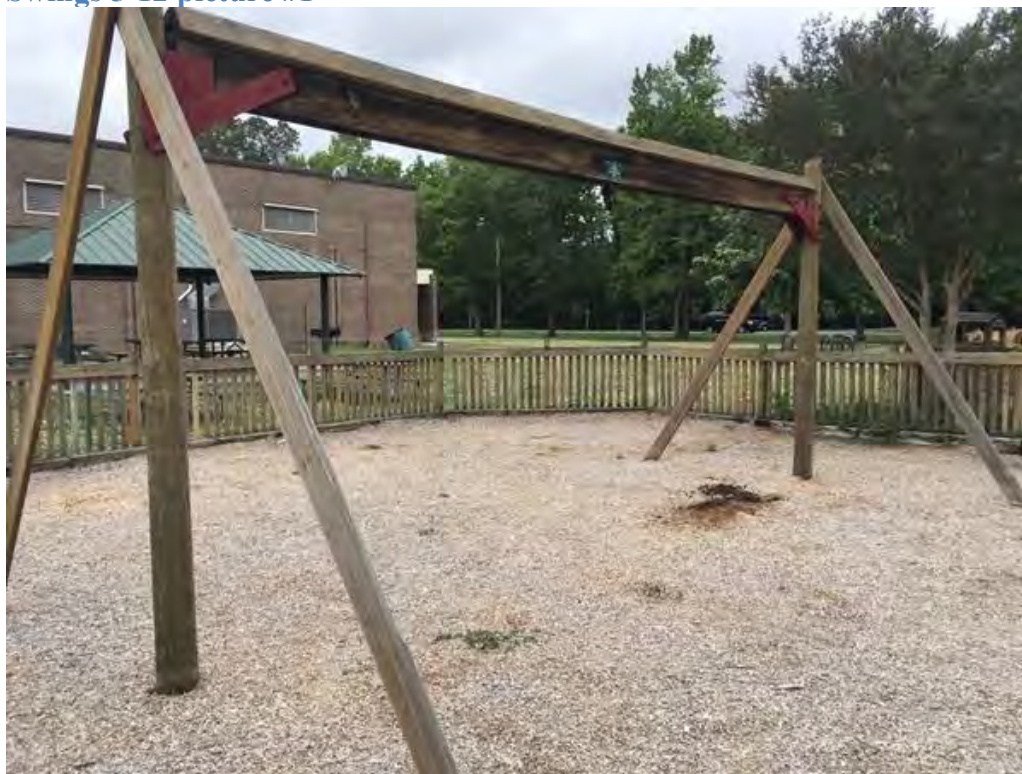
Swings 5-12 picture #1

Medium= Some visible damage / deterioration / decay observed. Does not appear to be structural at this time.

There's only a tire swing, and it is missing. The beam and framework is still in place along with the swivel, but there are no chains or tire at this time

Replace with new manufactured equipment.

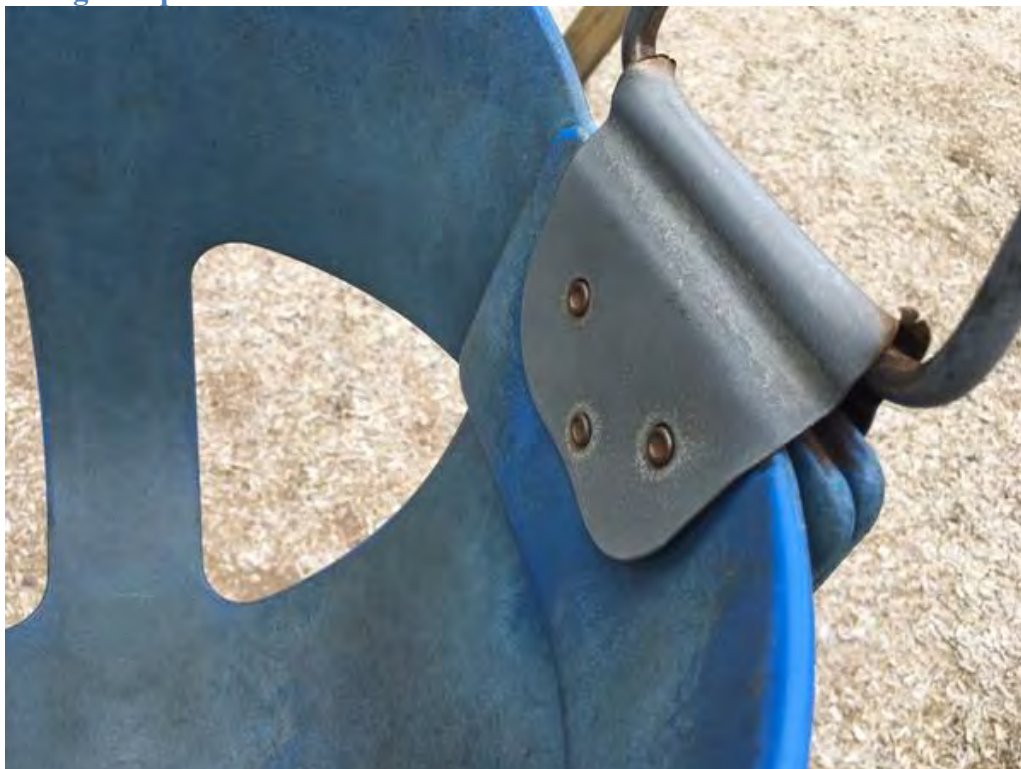
### **Swings 2-5 picture #1**

Good= No visible damage / deterioration / decay observed.

There's one bucket seat missing. The top swings are showing signs of age... Stainless steel is peeling up

Replace with new manufactured equipment.

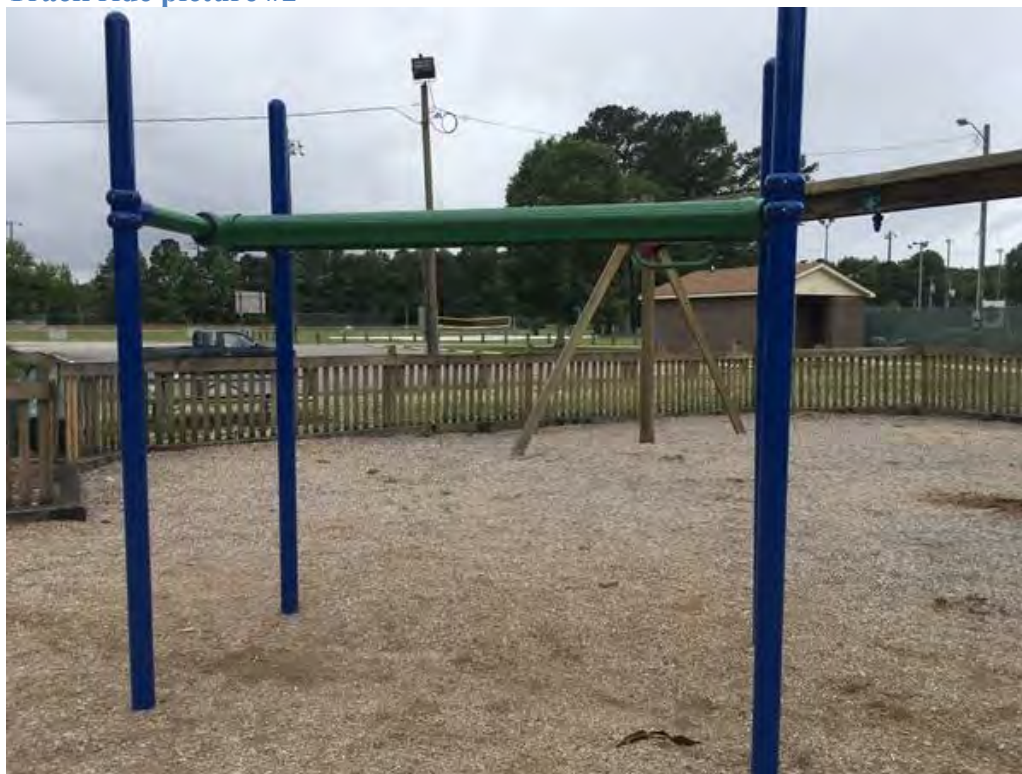
Track ride picture #2

Good= No visible damage / deterioration / decay observed.

This is not the original track ride. This is not a L&A piece of equipment, and has been installed by others. It is a replacement and has been put in the wrong spot and overlaps uses zone with the tire swing causing a safety hazard. The swing beams must be removed, or the track ride must be removed to avoid safety use zones overlapping.

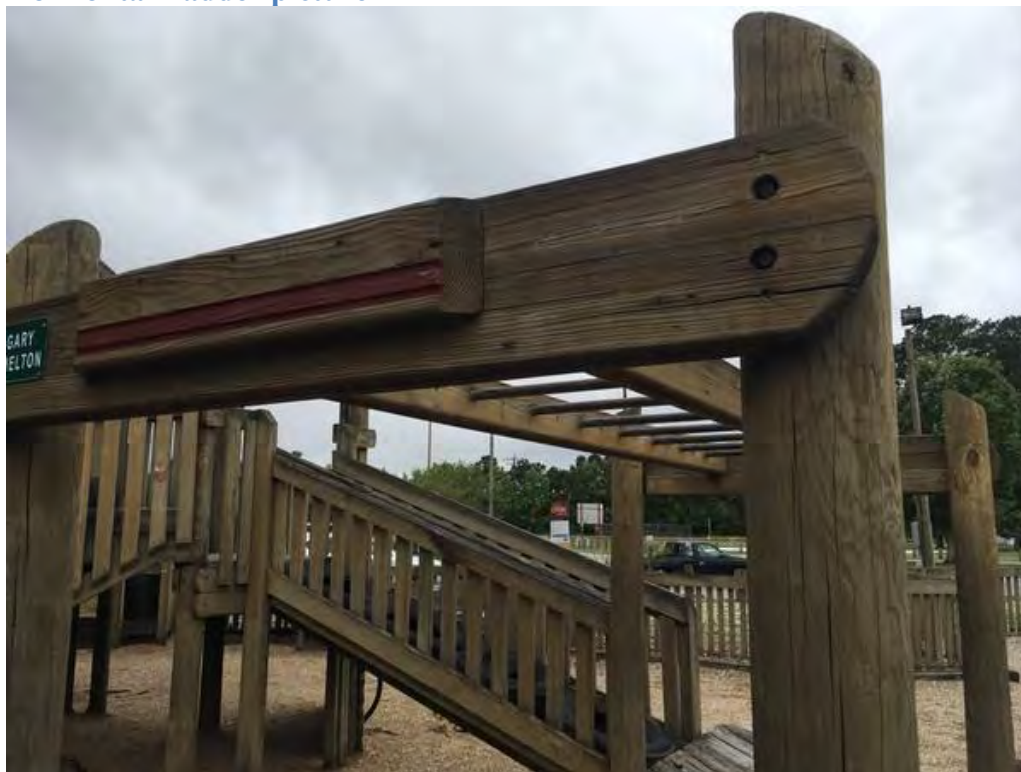
### Horizontal Ladder picture #1

Medium= Some visible damage / deterioration / decay observed. Does not appear to be structural at this time.

Replace with new manufactured equipment.

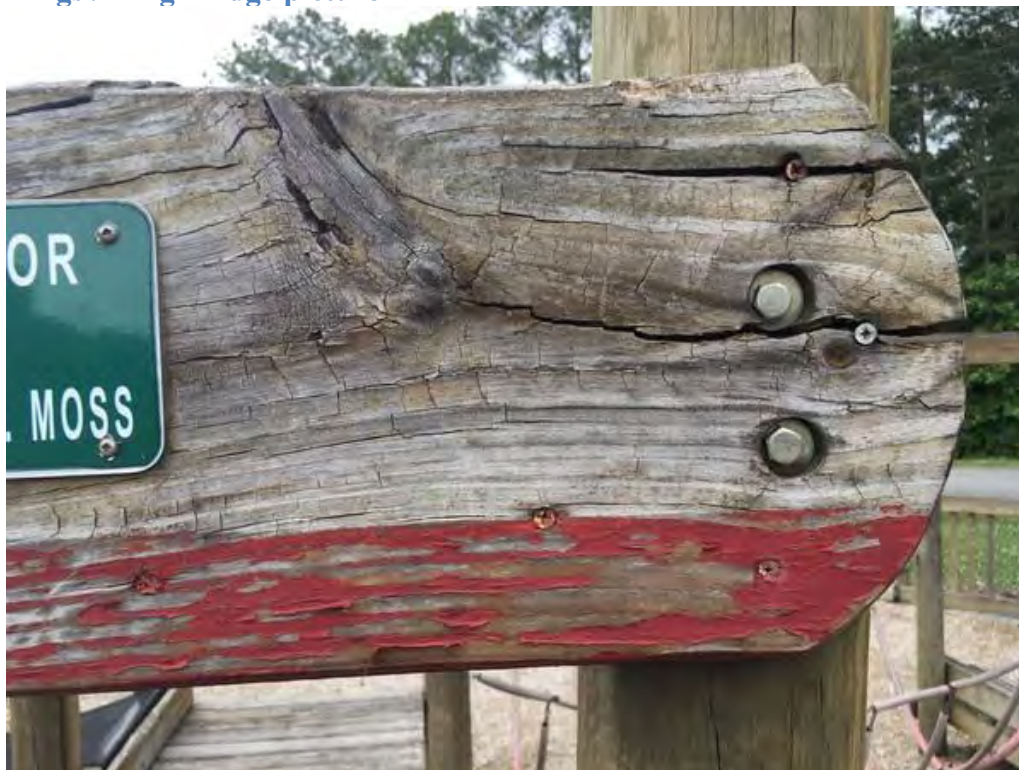
## **Rings / Ring Bridge picture #1**

Medium= Some visible damage / deterioration / decay observed. Does not appear to be structural at this time.

Replace with new manufactured equipment.

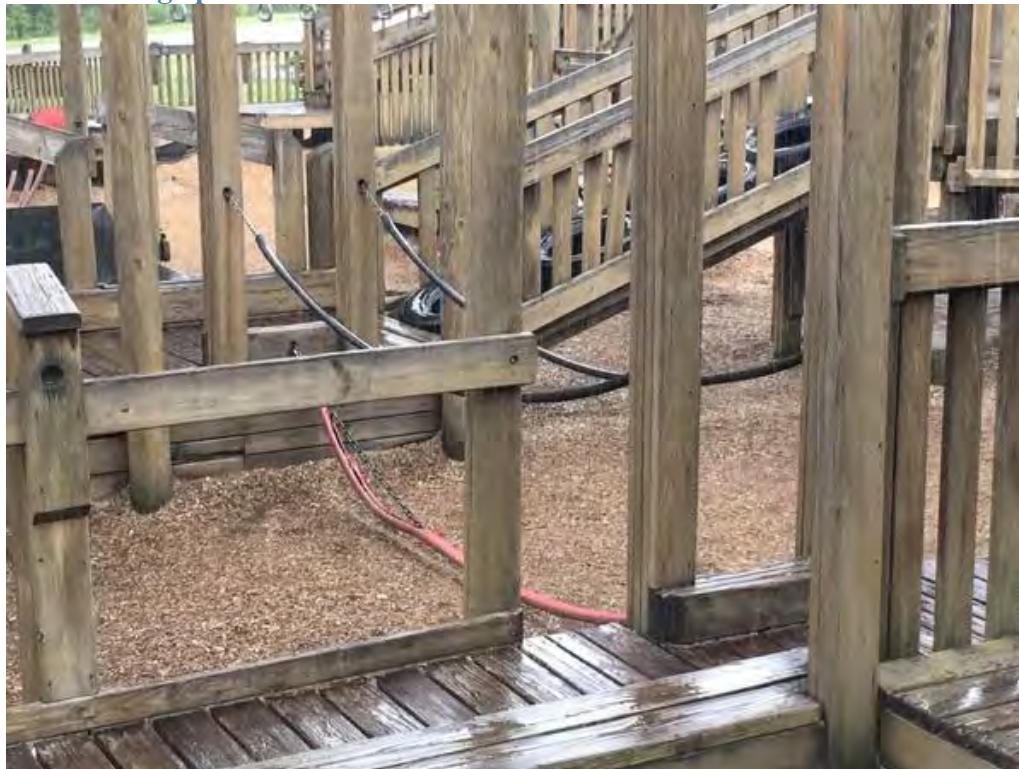
### **Chain bridge picture #1**

Medium= Some visible damage / deterioration / decay observed. Does not appear to be structural at this time.

This item is in fair condition. The framing seems sound, but the chains and hose should be replaced with cable

Replace with newer cable version

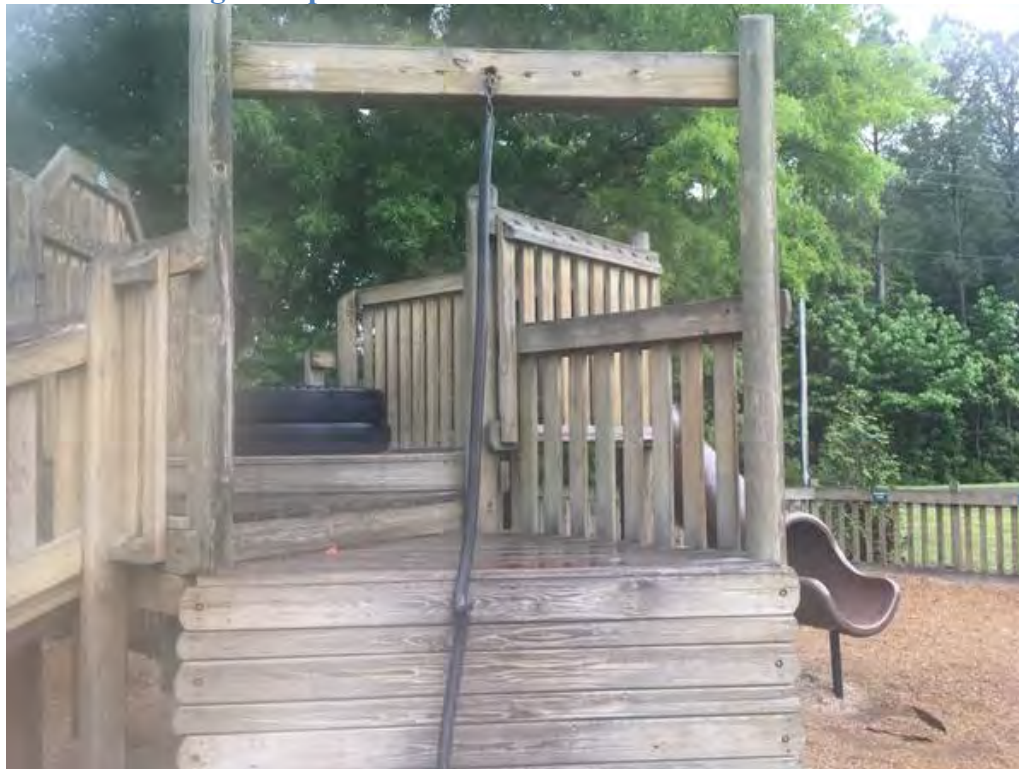
### **Chain Climbing Wall picture #1**

Medium= Some visible damage / deterioration / decay observed. Does not appear to be structural at this time.

This item should be updated to the current ASTM standard and the chain and hose should be replaced with the cable version.

Replace with newer cable version

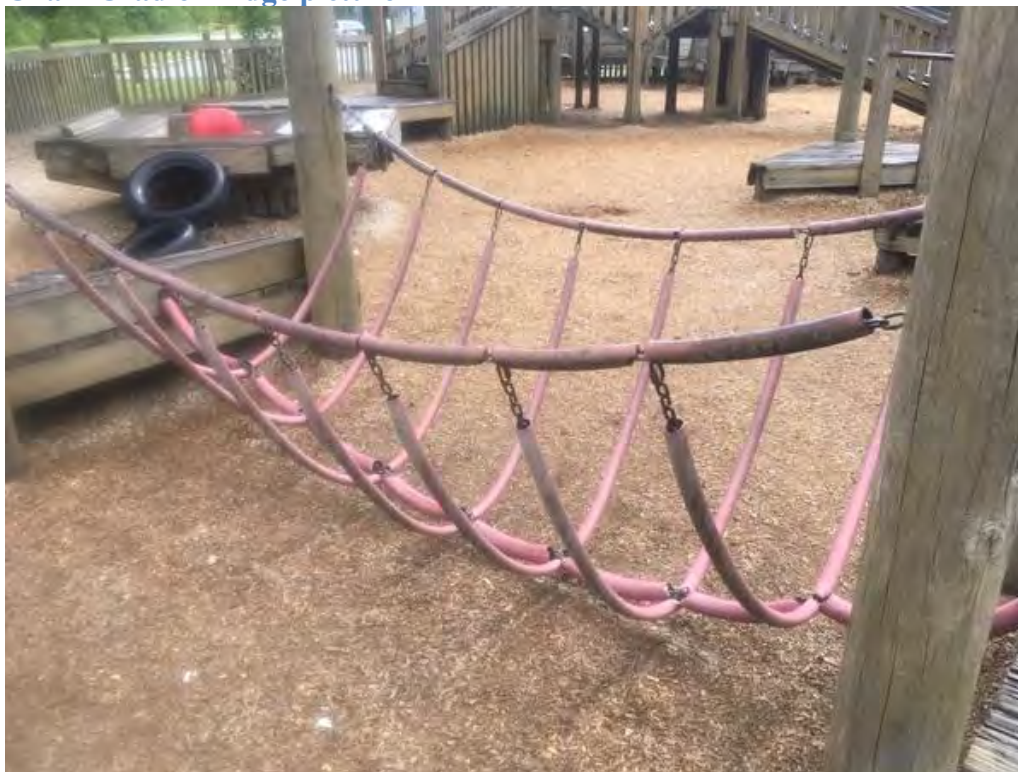
### **Chain Cradle Bridge picture #1**

Poor. The hose is now in sections, and the chain is beginning to rust

Rusty

Medium= Some visible damage / deterioration / decay observed. Does not appear to be structural at this time.

Replace with newer cable version

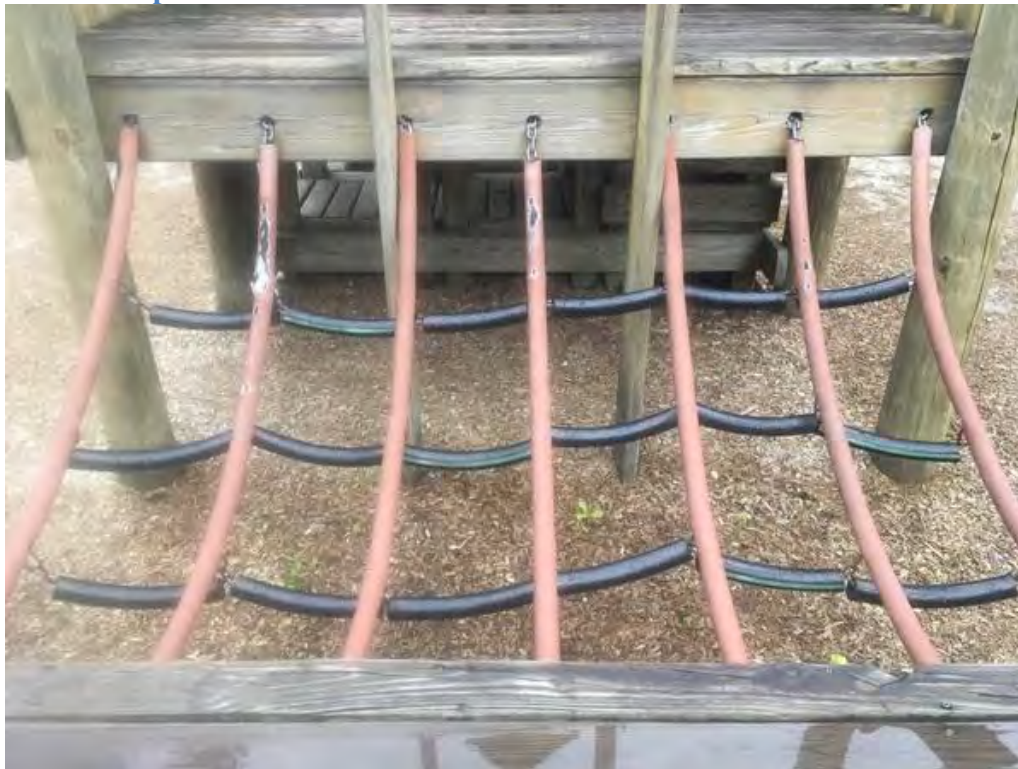
### **Chain Net picture #1**

Poor. The hose is wearing thin and the hose was put in, in sections

Medium= Some visible damage / deterioration / decay observed. Does not appear to be structural at this time.

This item should be replaced as part of renovation or rebuild.

Replace with newer cable version.

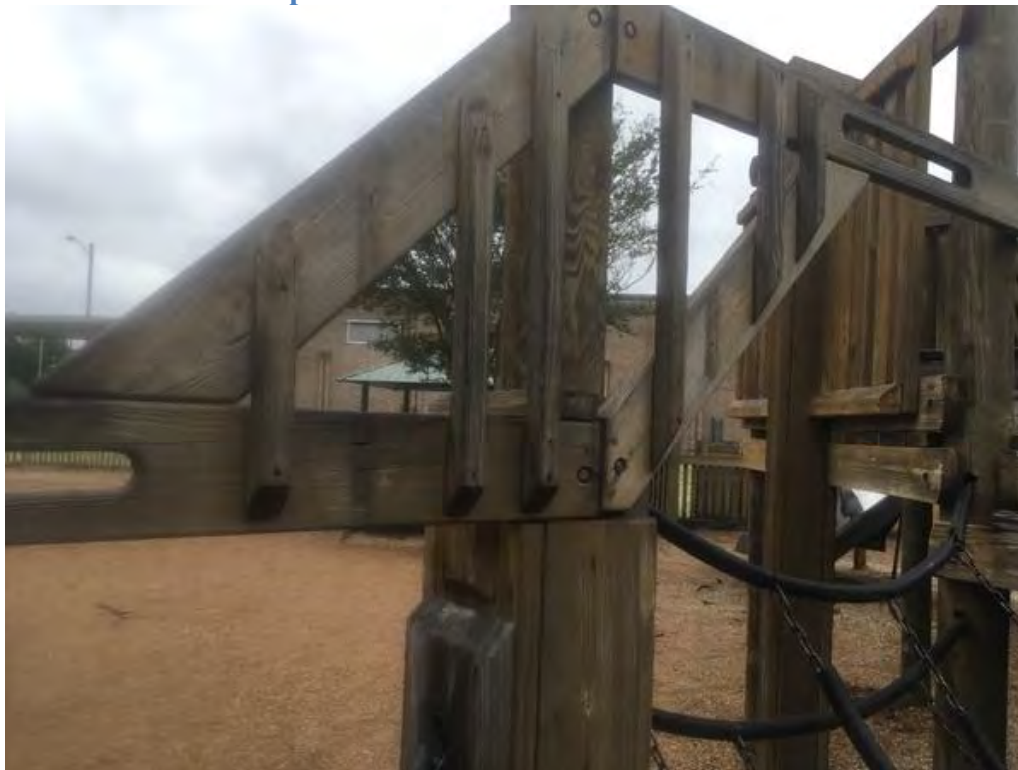
### **Chain Soft Climber picture #1**

Poor. The chain is stretched and rusting. The hose only covers a small portion of the chain.

Rusty

Medium= Some visible damage / deterioration / decay observed. Does not appear to be structural at this time.

This item should be replaced

Replace with newer high to low play element.

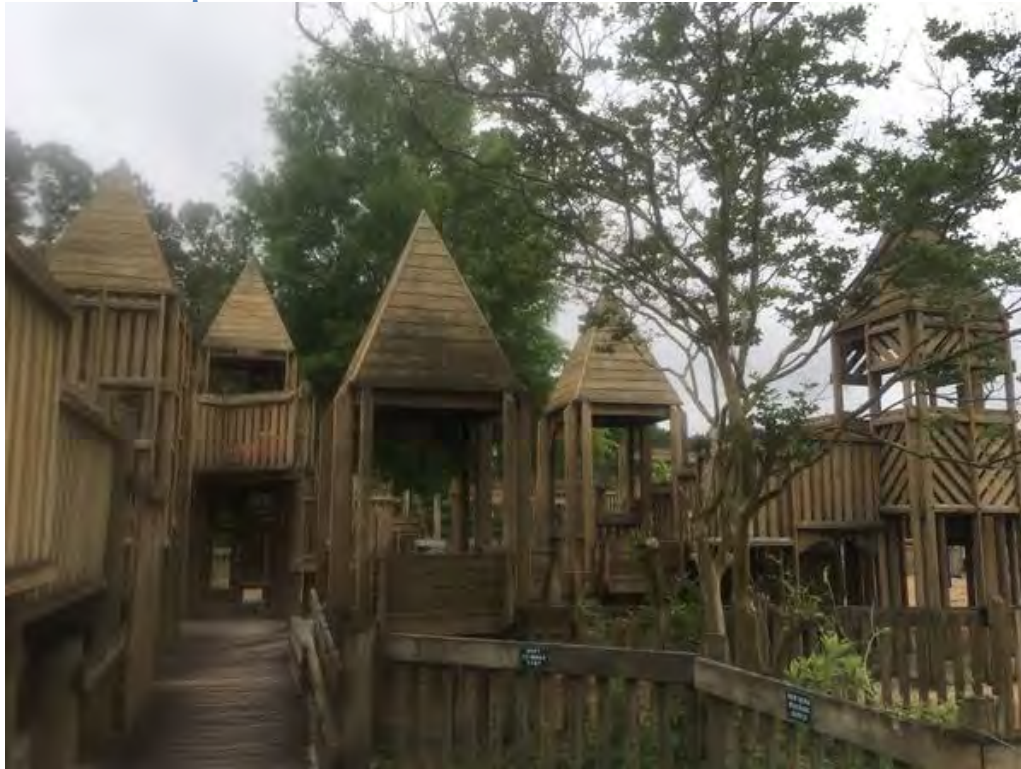
#### **Roofs/towers pictures #1**

Medium= Some visible damage / deterioration / decay observed. Does not appear to be structural at this time.

Staining these roofs would improve their appearance

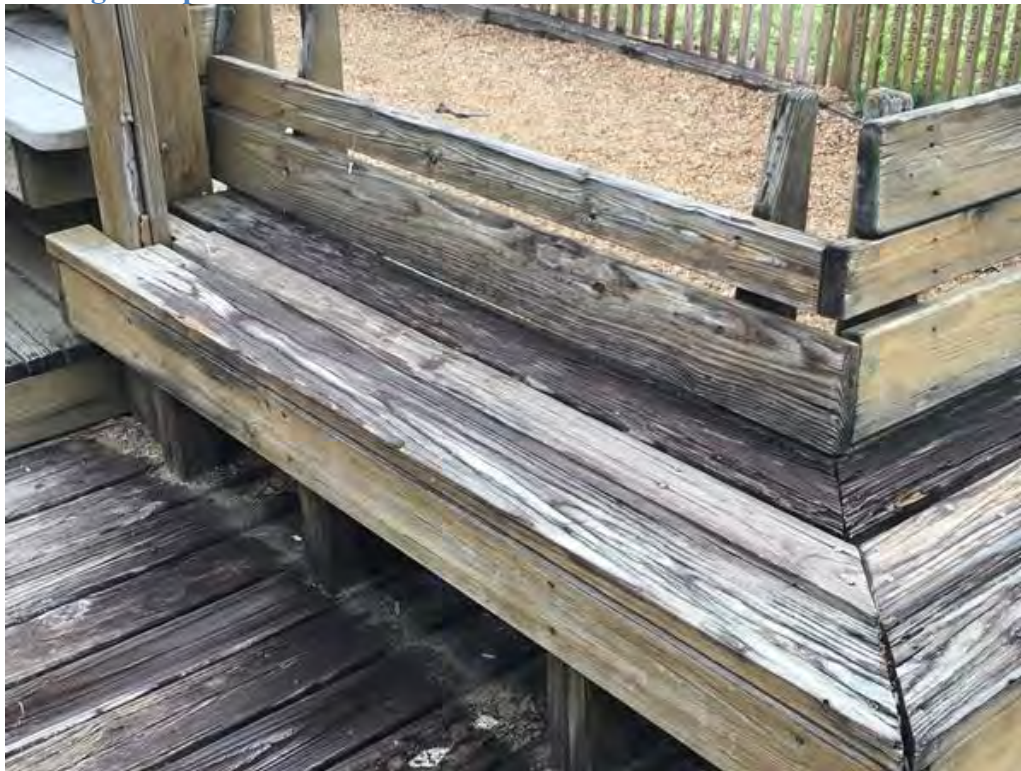
### **Seating area pictures #1**

Poor. There are missing boards for the bench backs and all the decking and seating is splintering

Poor= Visible damage / deterioration / decay observed. Structural issues imminent.

Make any necessary repairs with newer low maintenance materials.

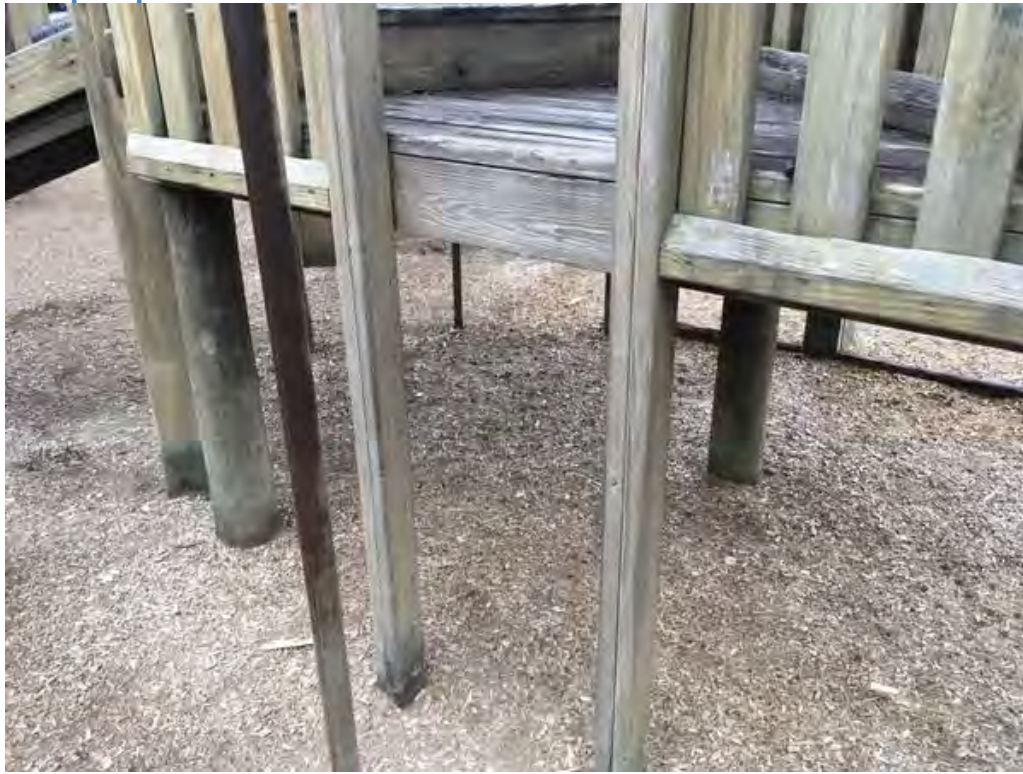
Fire pole picture #1

Good= No visible damage / deterioration / decay observed.

Make any necessary repairs.

Replace with new as part of a major renovation/rebuild
