## **Playground Assessment Report New Bern, North Carolina**

05-17-18

Kidsville New Bern

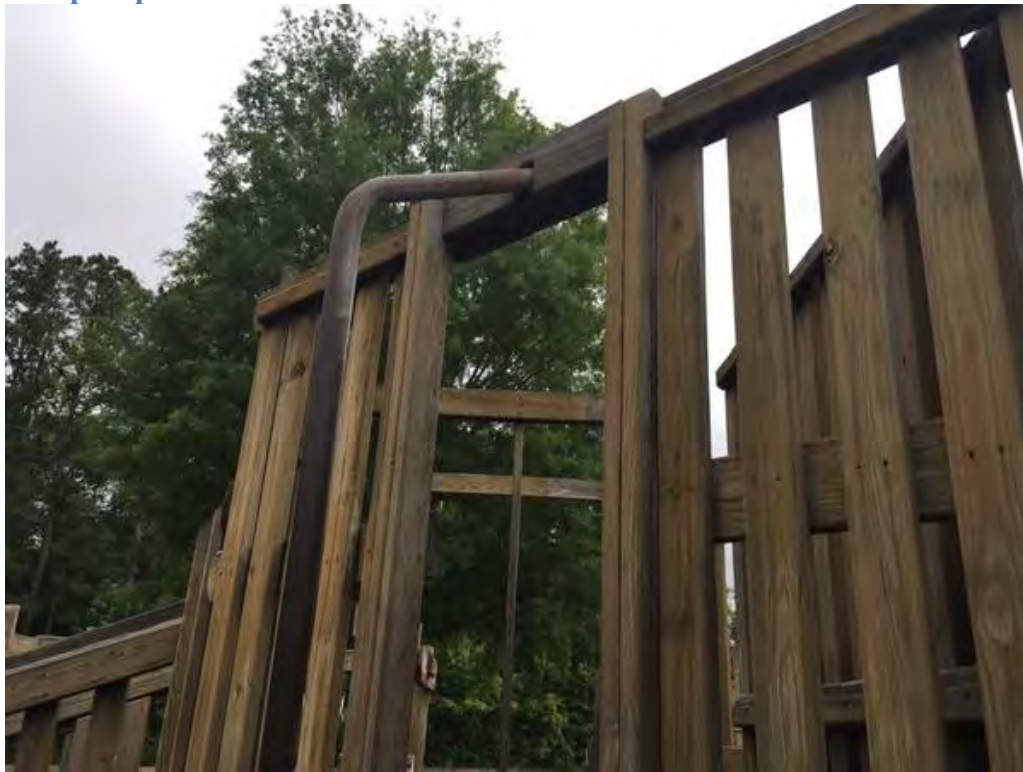
Fire pole picture #2

Good= No visible damage / deterioration / decay observed.

Make any necessary repairs.

Replace with new as part of a major renovation/rebuild

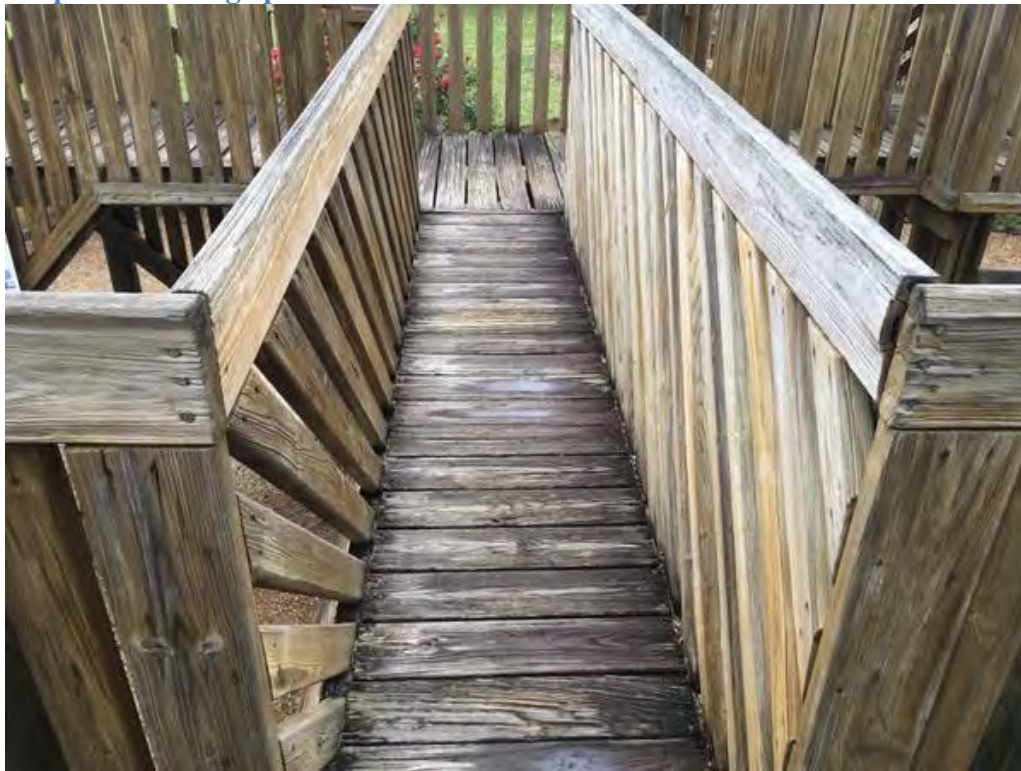
## **Suspension bridge picture #1**

Poor= Visible damage / deterioration / decay observed. Structural issues imminent.

The suspension bridge has been replaced with straight boards without chain. The handrails are loose and not sturdy.

Replace decking as stationary catwalk, and rebuild handrail/balusters.

Replace with new suspension bridge as originally build, utilizing low maintenance materials.

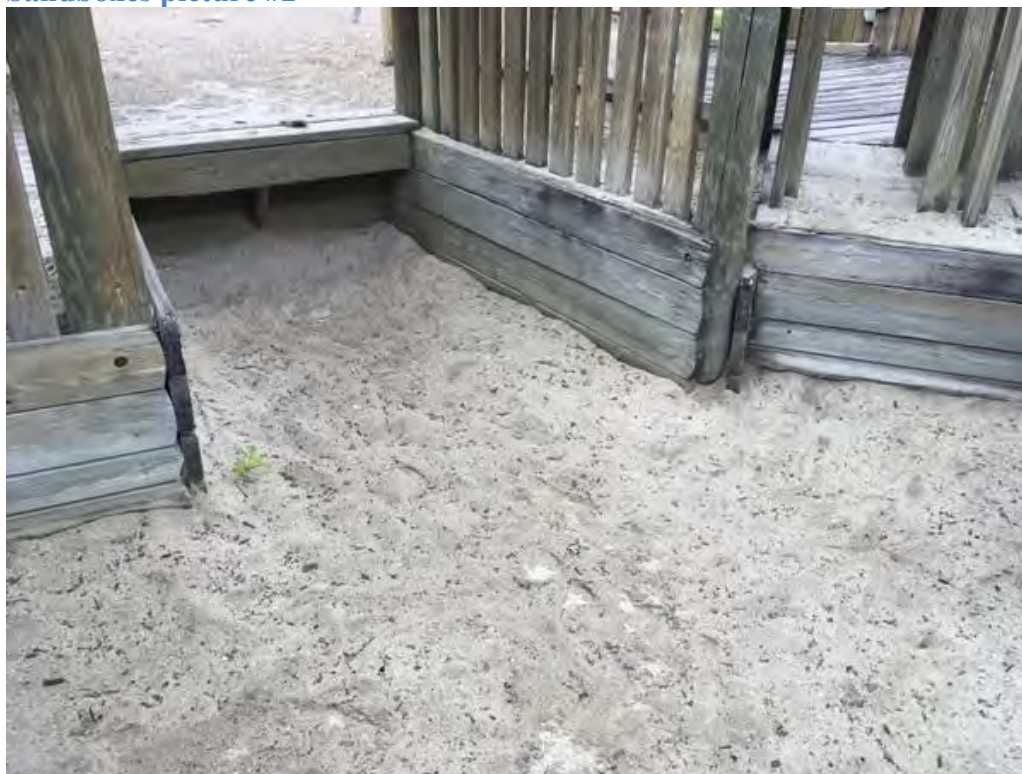
Sandboxes picture #2

Medium= Some visible damage / deterioration / decay observed. Does not appear to be structural at this time.

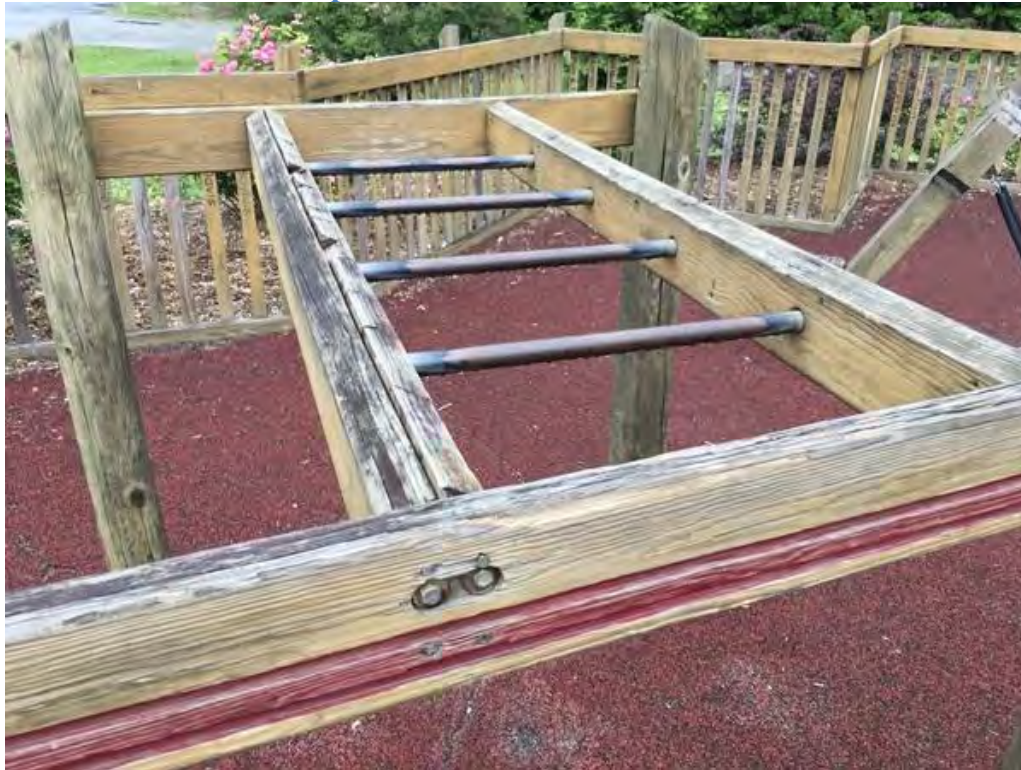
### **Low Accessible Ladder picture #1**

Medium= Some visible damage / deterioration / decay observed. Does not appear to be structural at this time.

This ladder is beginning to splinter, check and crack. The same can be said for the headers that support it

Replace with new manufactured equipment.

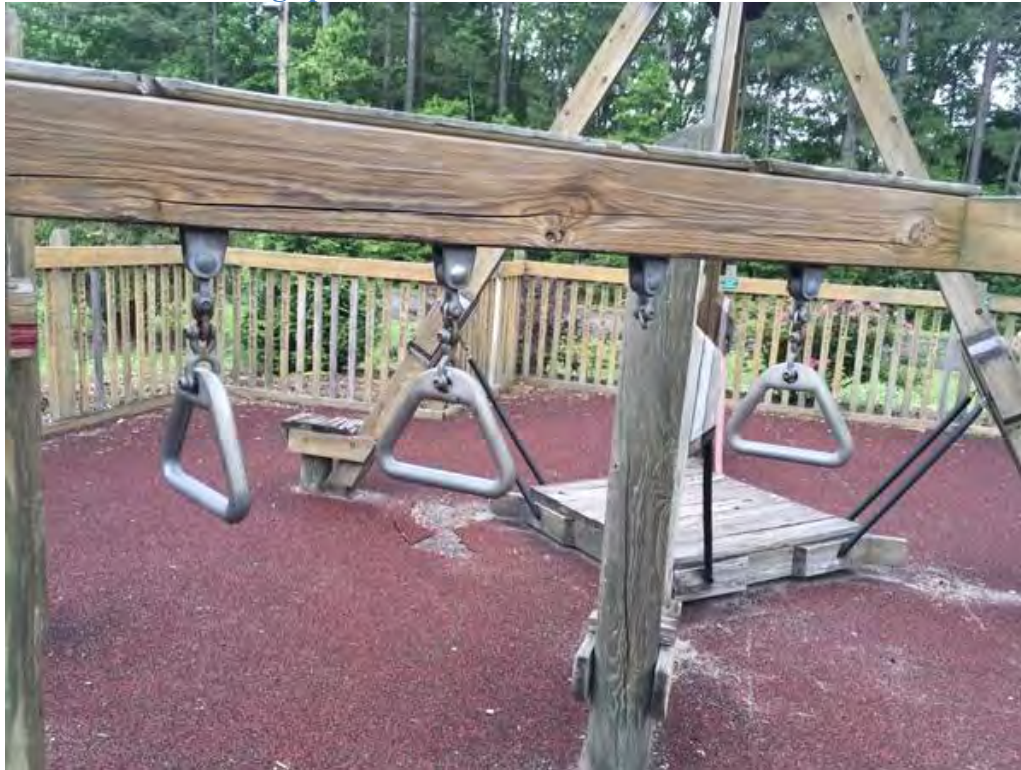
### **Low Accessible Rings picture #1**

Medium= Some visible damage / deterioration / decay observed. Does not appear to be structural at this time.

This item is missing one of the rings. This item has a flat spot built on top of the beam creating a designated playspace/platform. The beam has a number of checks through it.

Replace with new manufactured equipment.

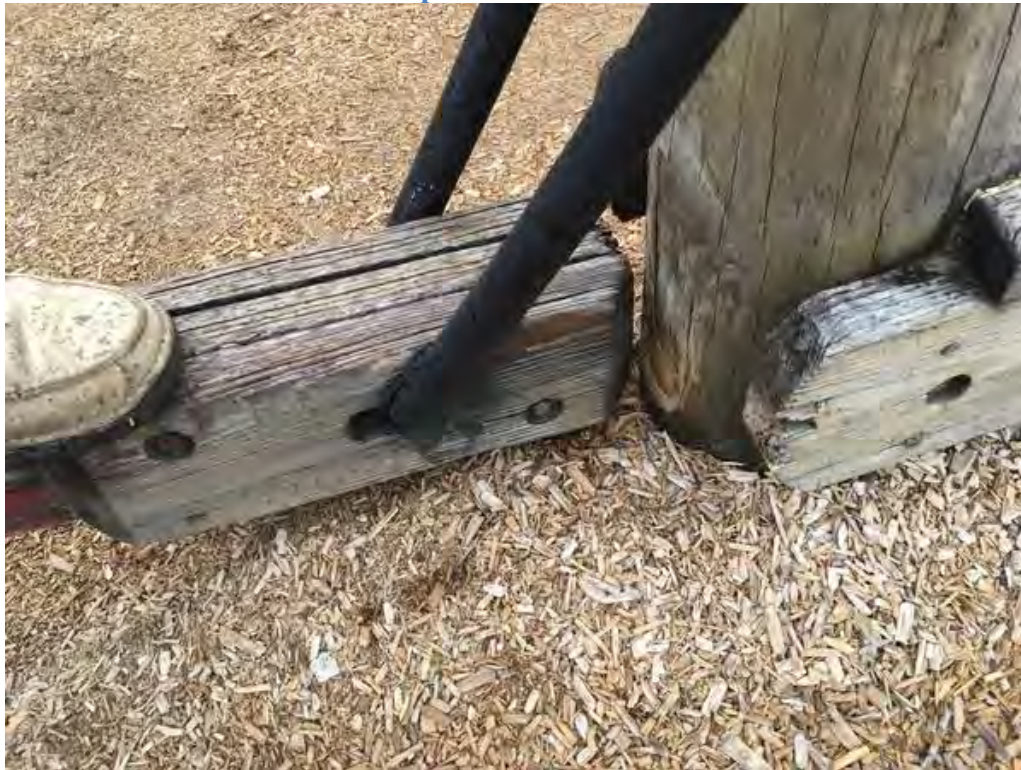
### **Balance Beam on Chains 5-12 picture #1**

Poor= Visible damage / deterioration / decay observed. Structural issues imminent.

There are two balance beams on chains in this area. One is double 2x6 wide, the other is a single 2x6 wide. They are both old and deteriorating, but still functioning. The single has too much action at the end and has become a battering ram. Given their age it is recommended they both be replaced with a modern spring version

These should both be replaced with more modern equipment.

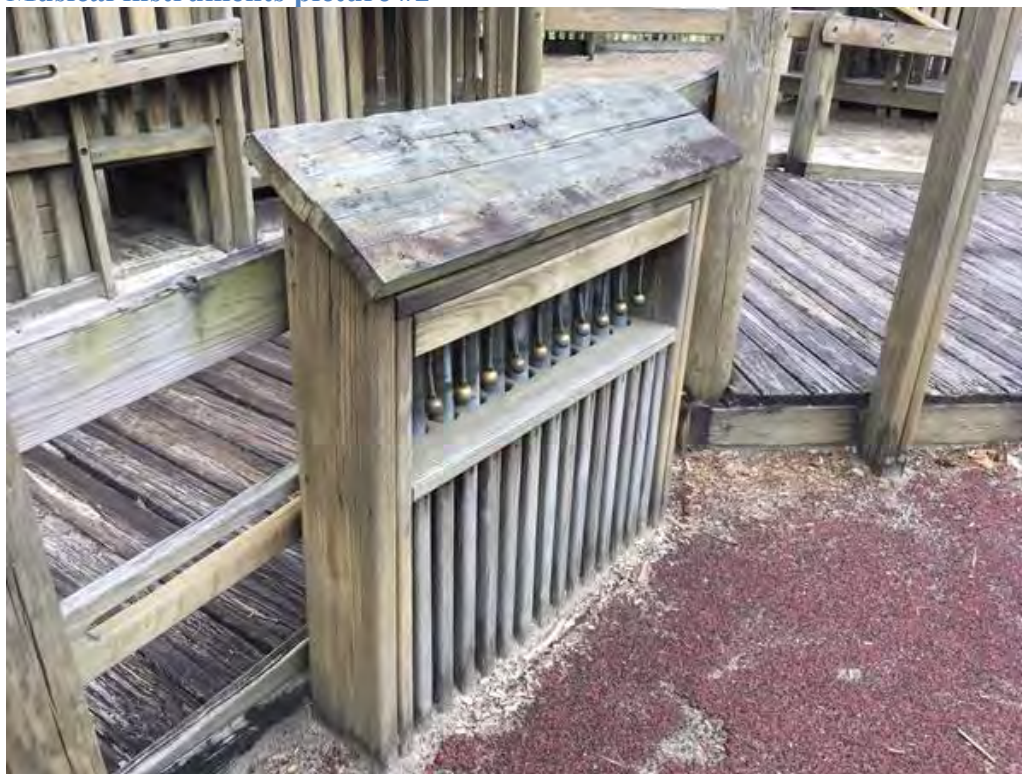
Musical instruments picture #2

Medium= Some visible damage / deterioration / decay observed. Does not appear to be structural at this time.

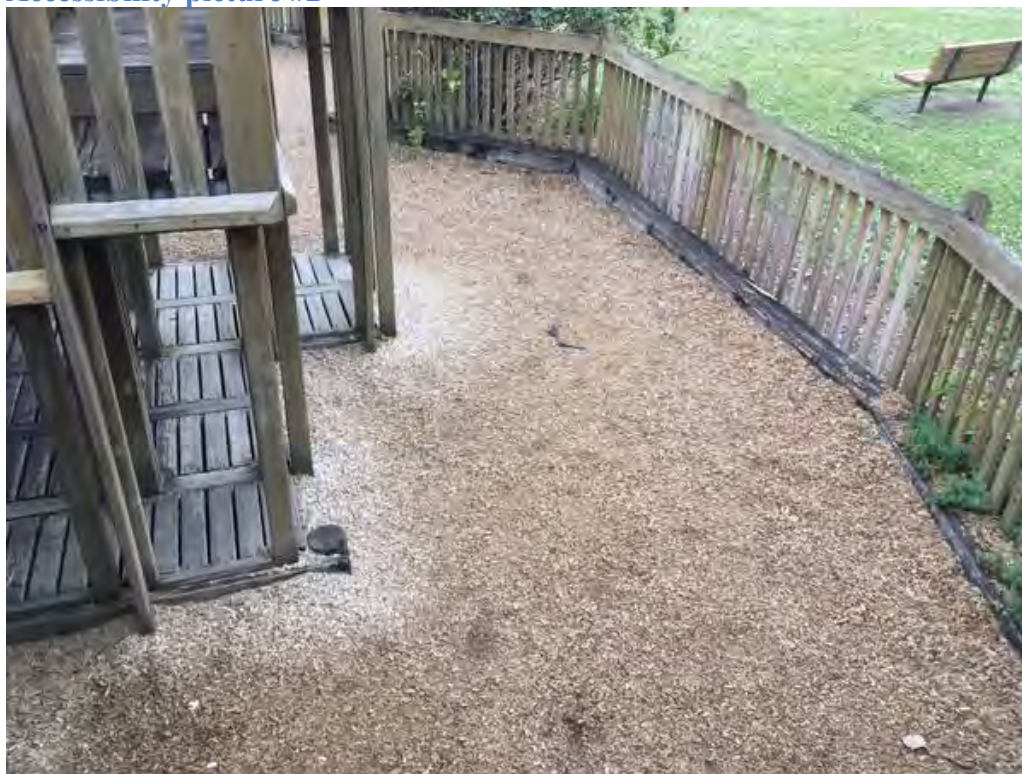
Accessibility picture #2

Good= No visible damage / deterioration / decay observed.

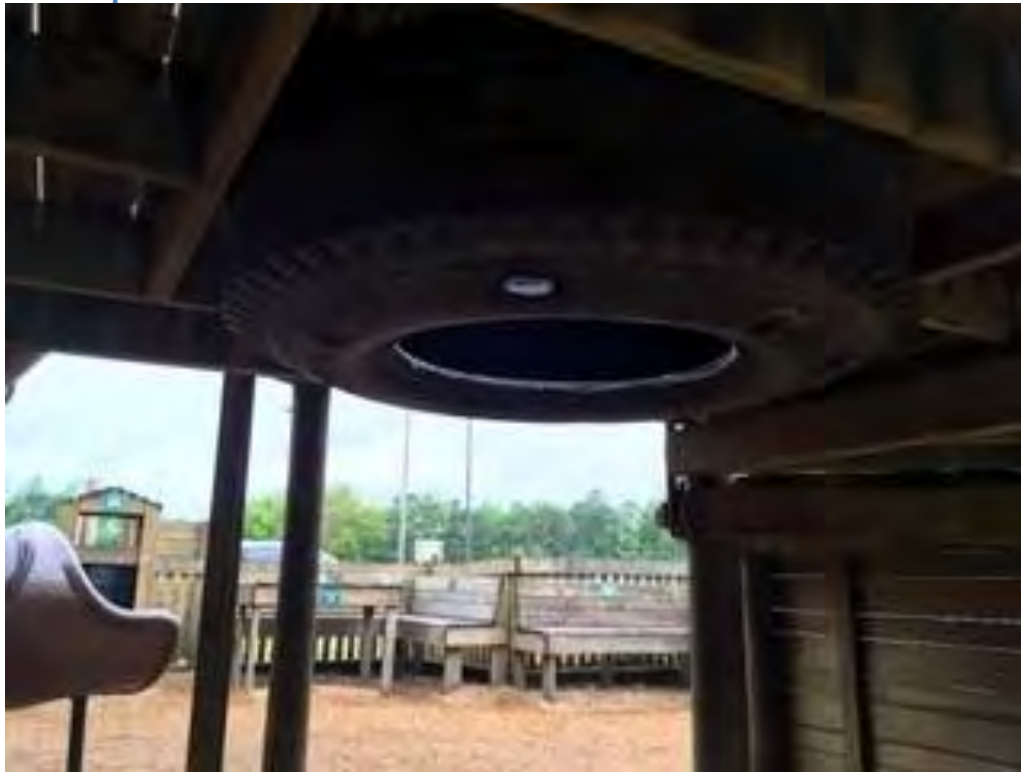
Misc. 1 picture #2

Poor= Visible damage / deterioration / decay observed. Structural issues imminent.

This item is very worn, there is no chain and hose, or tires under the deck. This item should be blocked off/covered to prevent someone falling through it until it is repaired. This is a safety hazard as is.

Replace with cable version – black hole net

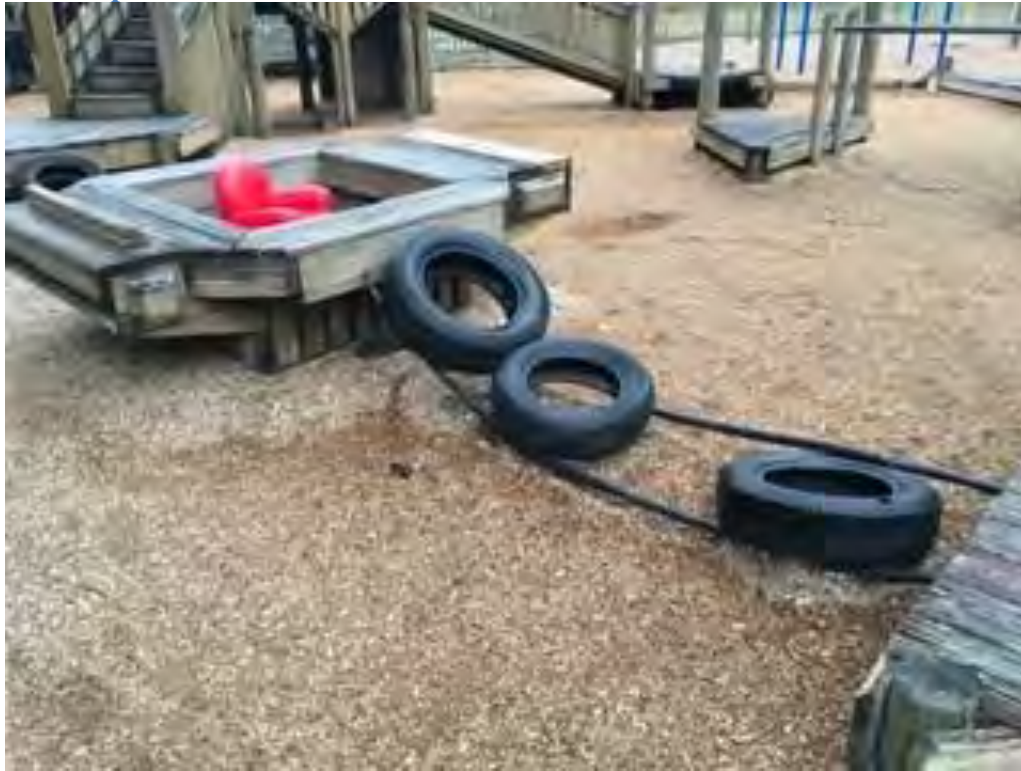
Misc. 2 picture #2

Poor= Visible damage / deterioration / decay observed. Structural issues imminent.

This item is very worn, and the “bouncer” is stuck and leaning to the North. The wood framing inside this item is splintered. The chain and tire connections to the “bouncer/car” are in poor condition as well. Everything is sagging on the ground and tires are missing under the “bouncer”. There is a lot of space used by this item, another item with more play value would be a great improvement.

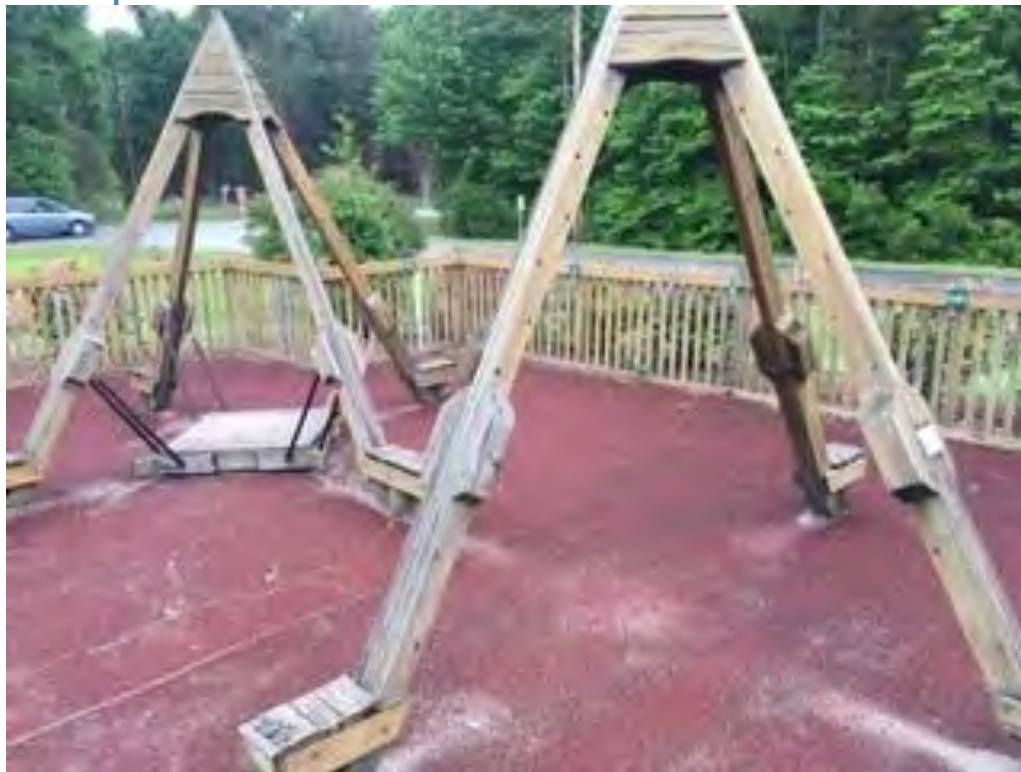
#### **Misc. 3 picture #1**

Poor= Visible damage / deterioration / decay observed. Structural issues imminent.

Although it is not a safety violation, this piece of equipment is very worn and in its current condition has no play value. A redesign of this area would improve play value.

Redesign this area with more accessible components.

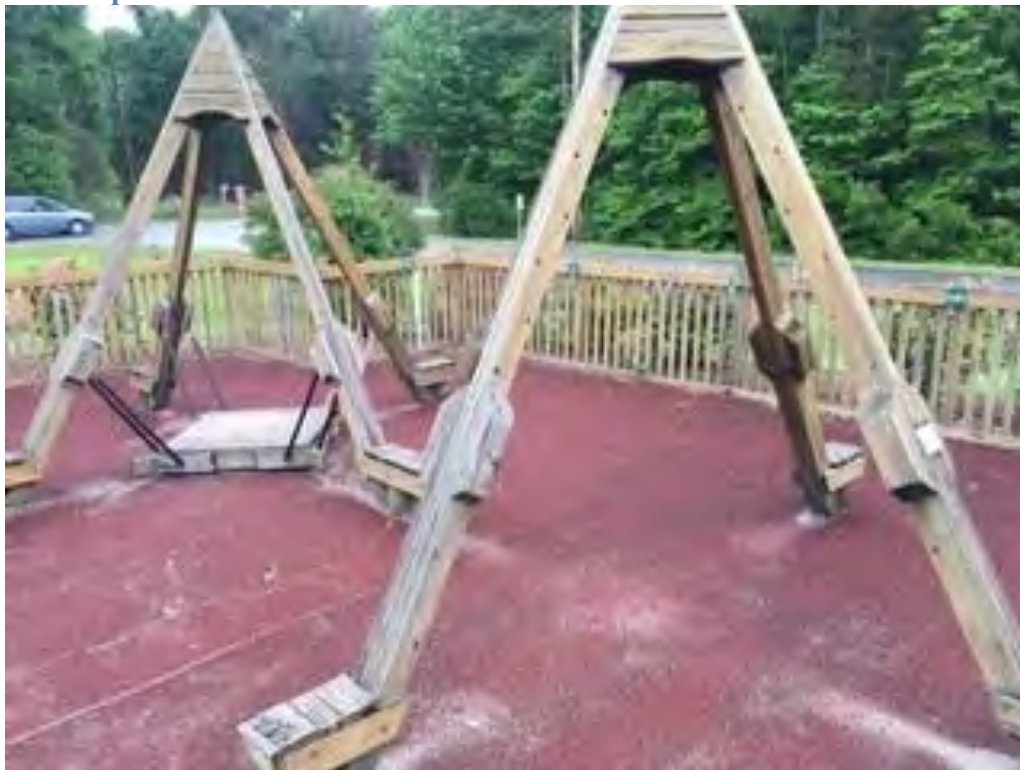
##### **Misc. 4 picture #1**

Poor= Visible damage / deterioration / decay observed. Structural issues imminent.

This item is worn, but still functioning. A redesign of this area would improve play value.

Redesign this area with more accessible components.

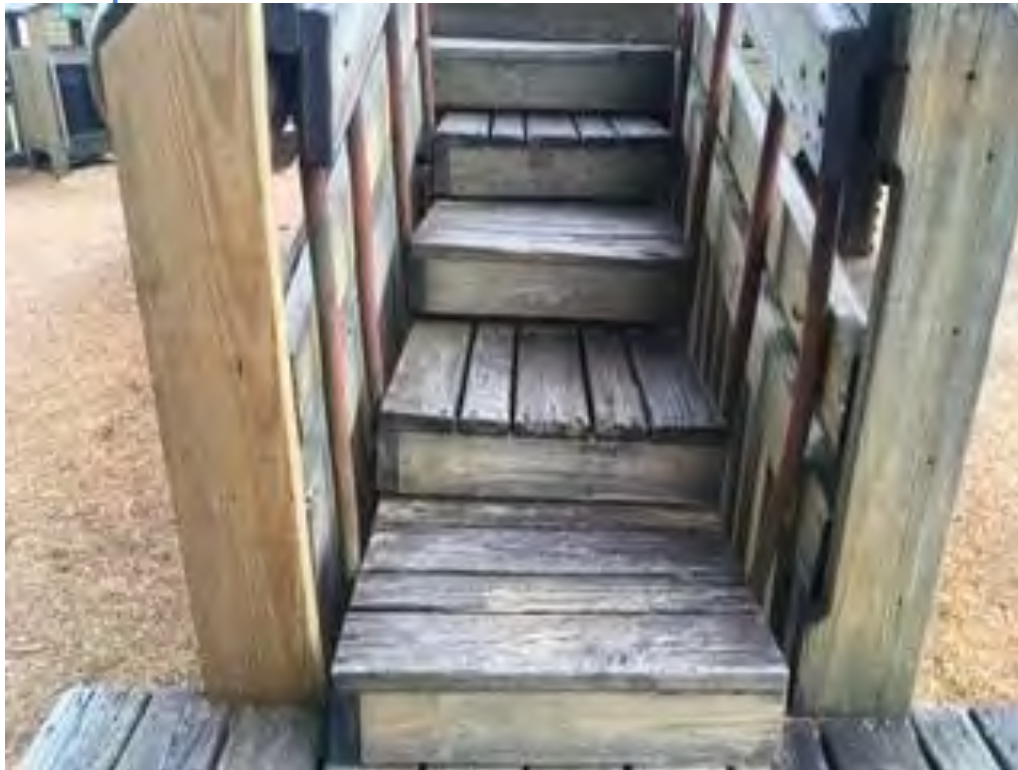
#### **Misc. 4 picture #1**

Poor= Visible damage / deterioration / decay observed. Structural issues imminent.

It is recommended the shaky stairs be removed, and replaced with another high to low piece of equipment with more play value.

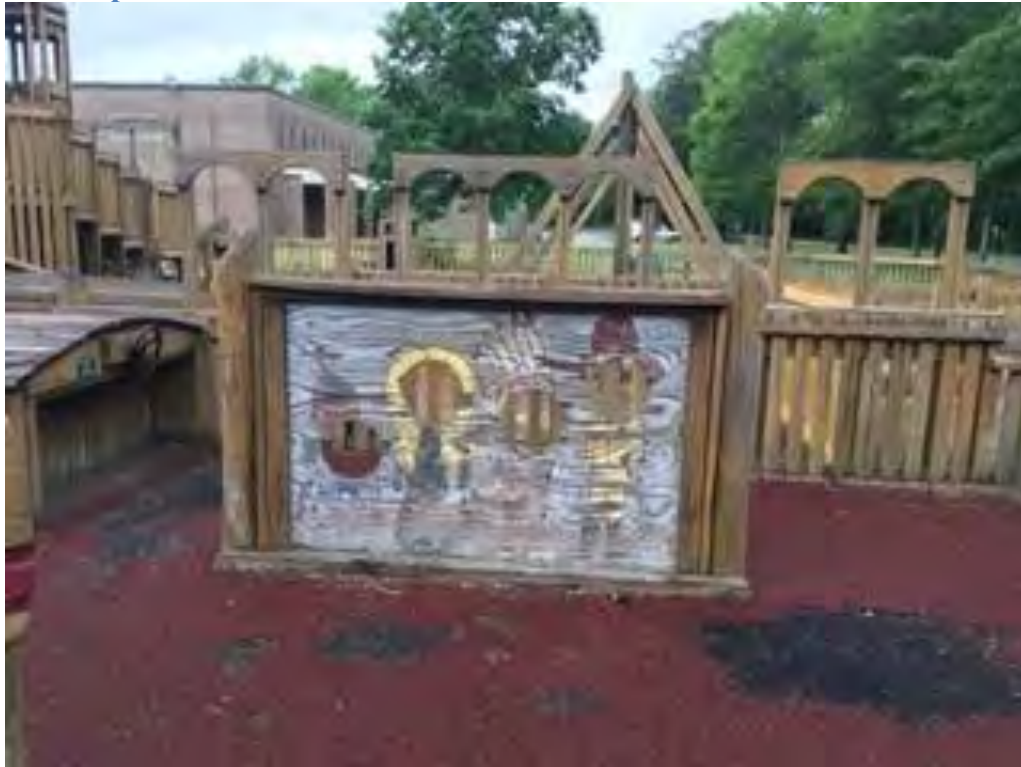
#### **Misc. 6 picture #1**

Poor= Visible damage / deterioration / decay observed.

This item is in poor condition as it was made of plywood

Rebuilding with maintenance-friendly material is recommended.

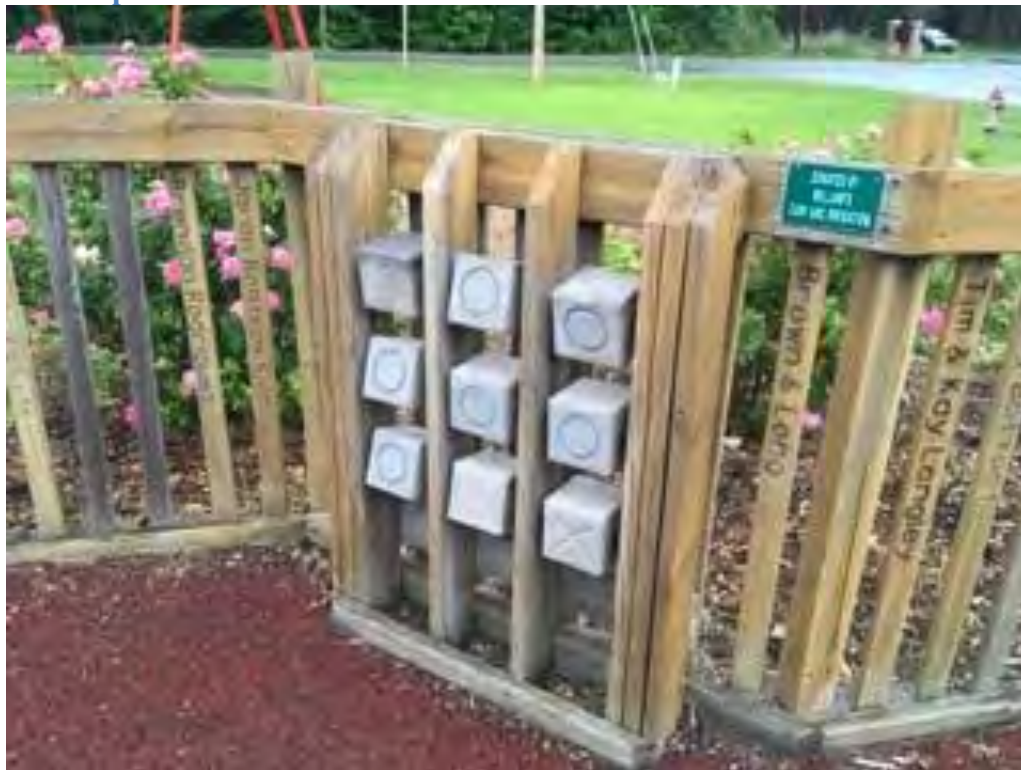
### Misc. 7 picture #1

Poor= Visible damage / deterioration / decay observed. Structural issues imminent.

This item is very worn, and is barely intact. Parts of the framing/top piece are missing

Rebuilding with low-maintenance recycled plastic
