Section04 FireStationNo.1

Background for Shawnee Fire Station No. 1

Assessment Commentary

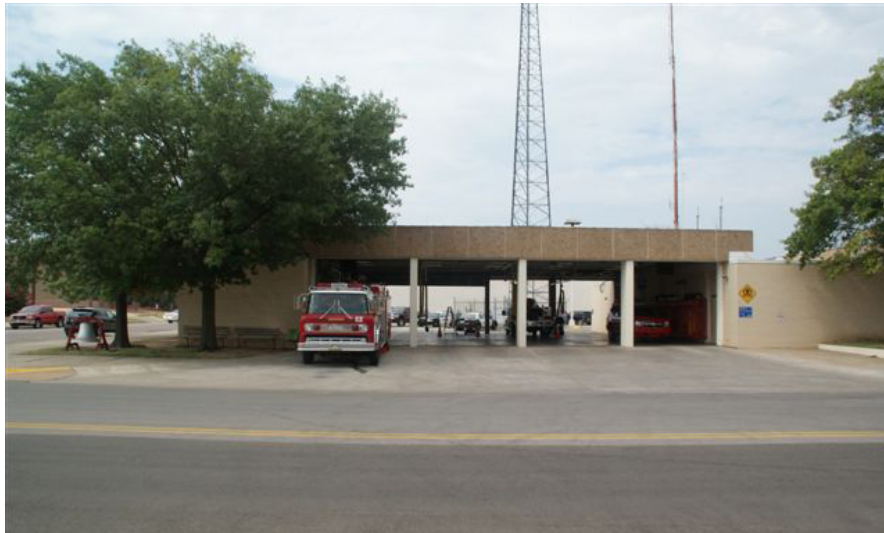
When the station's apparatus doors are closed, there is no readily apparent "public" entrance for "customers" needing to interface with the fire department. "Service" might be as simple as needing directions to as serious as needing medical attention or reporting of a nearby fire or other emergency. Visitors will not normally conclude that the public entrance to the fire station is in the back corner of the City Hall Lobby. This can be especially true under duress or at night.

The concrete apron in front of Station 1 barely accommodates a 75' aerial. To accommodate a 100' aerial device with its longer wheelbase, it will be necessary to create "bump outs" in the curb line on W. 9th out to the edge of the travel lane. See the "illustrative" plan of Station No. 1 at the end of this section to envision the curb bumped out to create a longer apron.

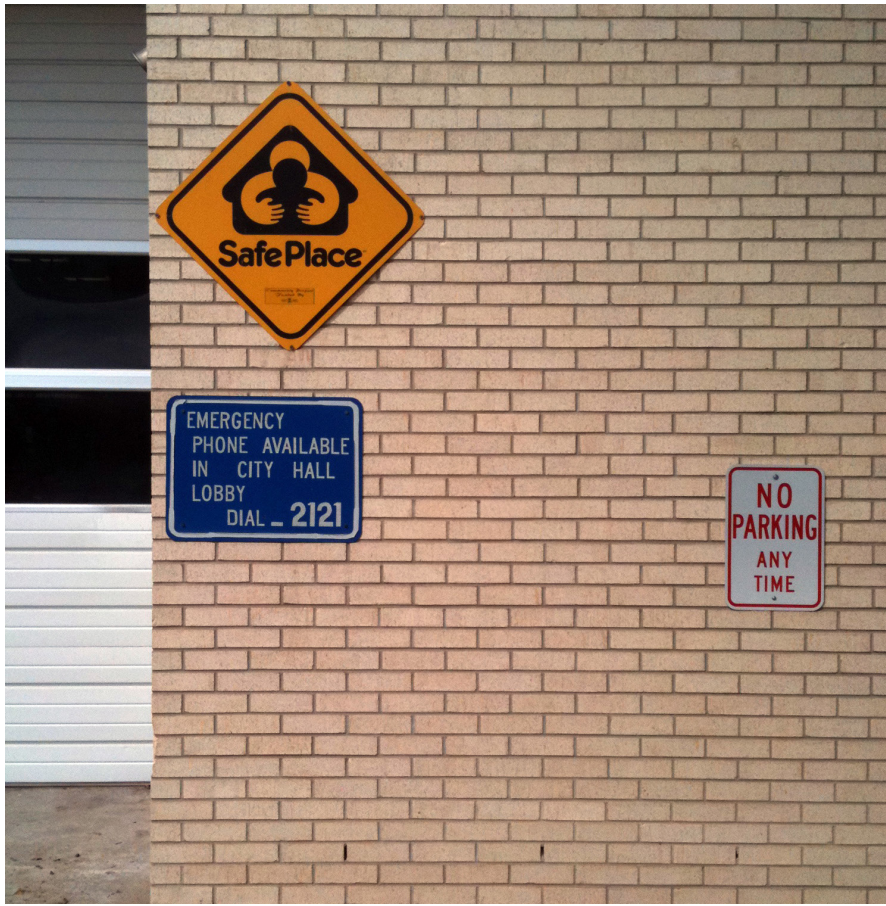
The wall-mounted orange placard to the right of the apparatus bay door proclaims Station No. 1 as a “Safe Place.” “Safe Place” is a national program where people, especially children, in danger of domestic violence or under any other stressful situation can seek immediate, temporary security and shelter. “Safe Place” seekers, instead of gaining immediate entrance to a secure location at the point of the yellow sign, are directed by the blue sign below on how to get in touch with an “emergency call taker.”

This means someone needing immediate shelter and protection cannot find an immediate entry door to a securable vestibule to gain such protection. If the apparatus bay doors are closed, there is no point at which to enter the fire station seeking help. If the City Hall lobby happens to be open, Safe Place seekers could go there to seek help. But if the City Hall Lobby is closed there is no “Safe Place.”

Again the “Safe Place” concept does not function effectively as intended. There needs to be some means to communicate in the evening at the point of the signs directly with the fire station’s “watch desk” or with an officer in charge of the station.

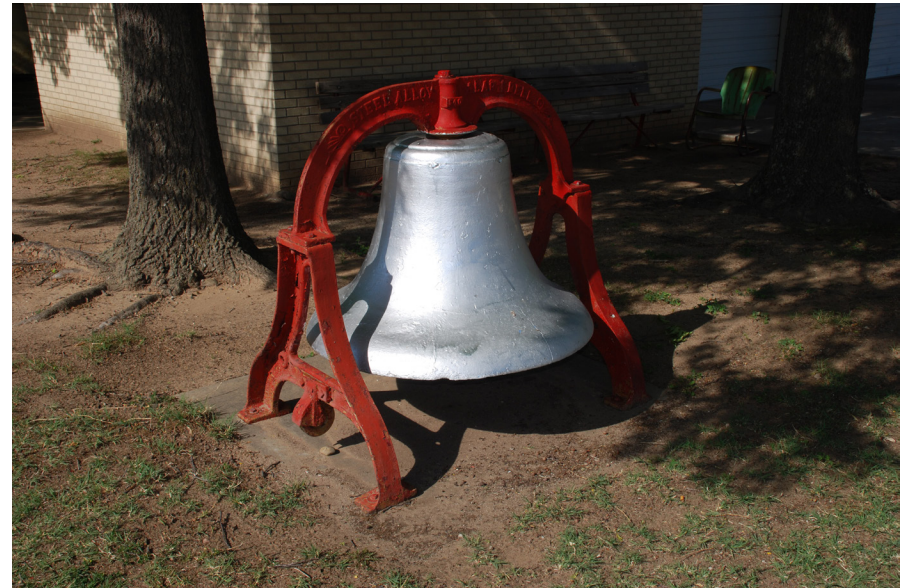
This Shawnee Fire Department bell on the corner was removed from an earlier station. The bell was the alarm system for the city. It was used to alert volunteer or on-call firefighters. While its current location is acceptable, in an ideal situation it would be outside the public entrance (along with a flag pole) to clearly call attention to everyone about where to approach the station for a visit or business. In the near future, it would be advisable to have the bell and frame soda blasted and repainted to enhance the details.

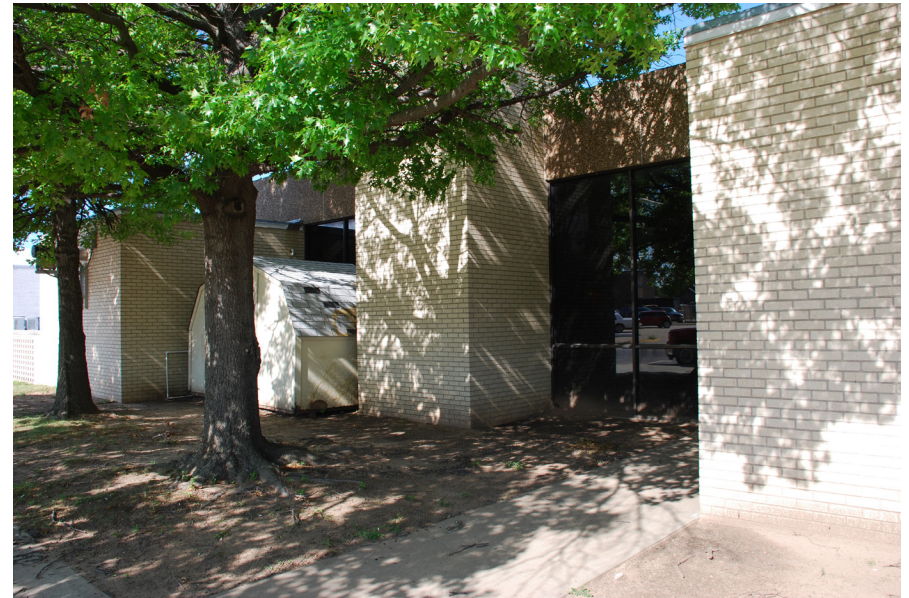
The sidewalk in the foreground leads to the only fire exit door from the apparatus floor. While the sidewalk is already in place, a paved passage all the way to the sidewalk along Beard is not required. Having the sidewalk paved all the way to the public sidewalk at the street makes the fire exit door "read," in the absence of a true entrance door, as the fire station's "public" entrance. (Review the latest IBC for any updates on this.)

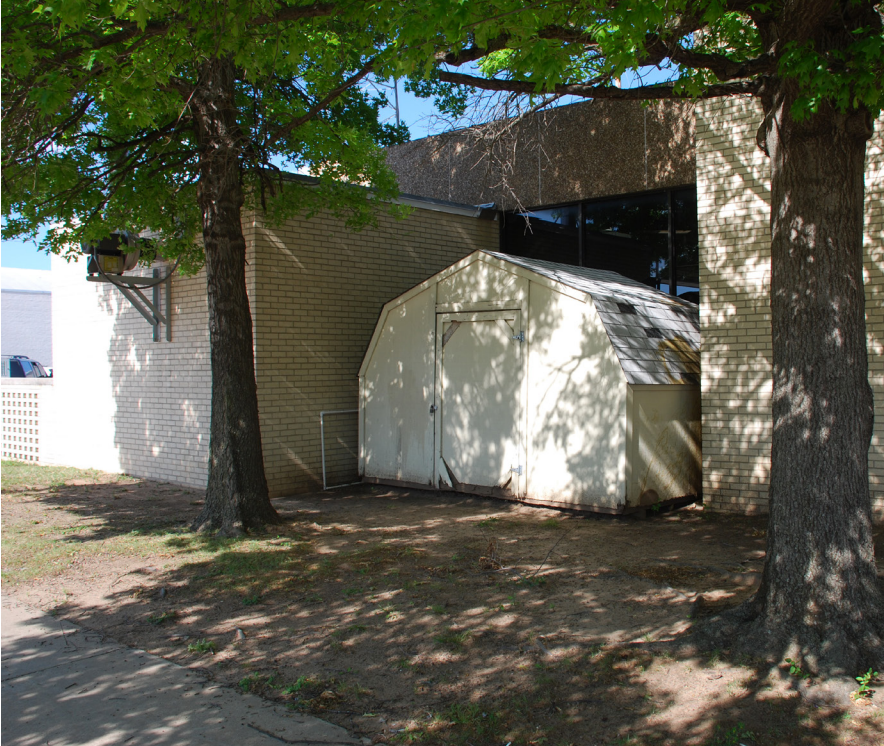
When asked what was in the storage unit, most respondents said “mostly junk.” Perhaps some housekeeping duties are in order to restore the original intent of the west side windows by removing the deteriorated storage shed.

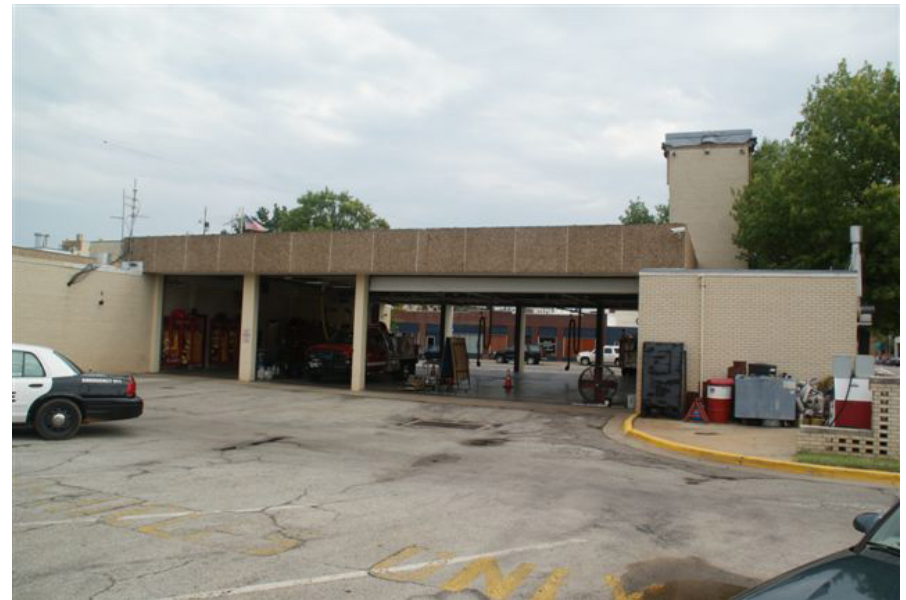
Station 1 may be the only drive-thru station in the nation with a double-wide apparatus door in the rear. The double-wide door was deemed necessary to accommodate the sweep of a long wheel base apparatus, such as a 100' aerial, turning into the station.

In the original plans for the building there was a double-wide door on the left side of the rear. At some point in the history of Station 1, the deep girder spanning the double-wide opening has been removed and replaced with a shallower girder supported by a new column. This was most likely done to increase the opening height. The new column does not match the existing “center” column with respect to width.

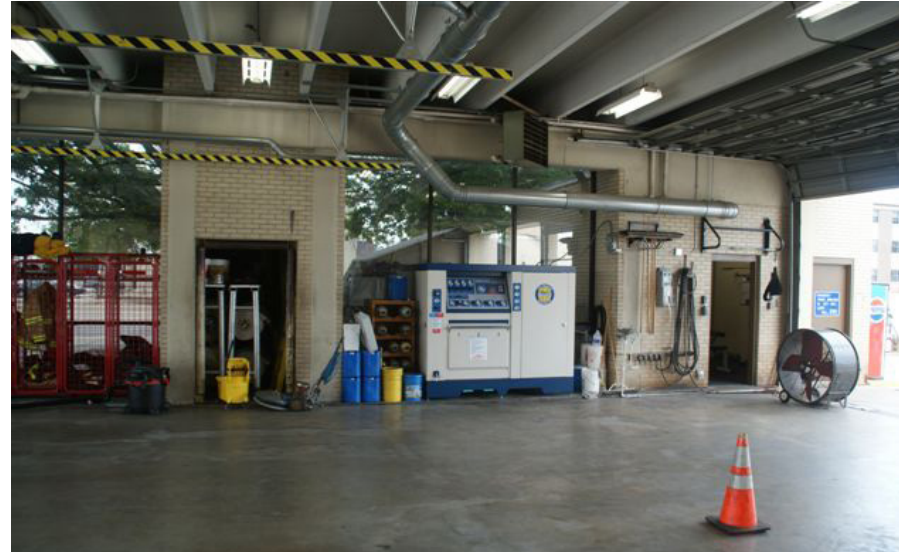
This image above clearly shows Station 1's cluttered apparatus floor. This is due to insufficient apparatus floor support rooms for storage and maintenance issues. Visible are foam concentrate containers, PPE storage lockers, SCBA fill station, SCBA cylinders storage rack, miscellaneous apparatus floor and station maintenance equipment and fitness training equipment stationed outside the fitness training equipment room. The apparatus floor is the dirtiest space in the station. With diesel particulate matter potentially present and outgassing of 71 known carcinogenic agents that can get embedded in PPE fabric during a working fire, no cardio exercise routines should take place on or just off the apparatus floor. Fitness routines require a clean air environment.

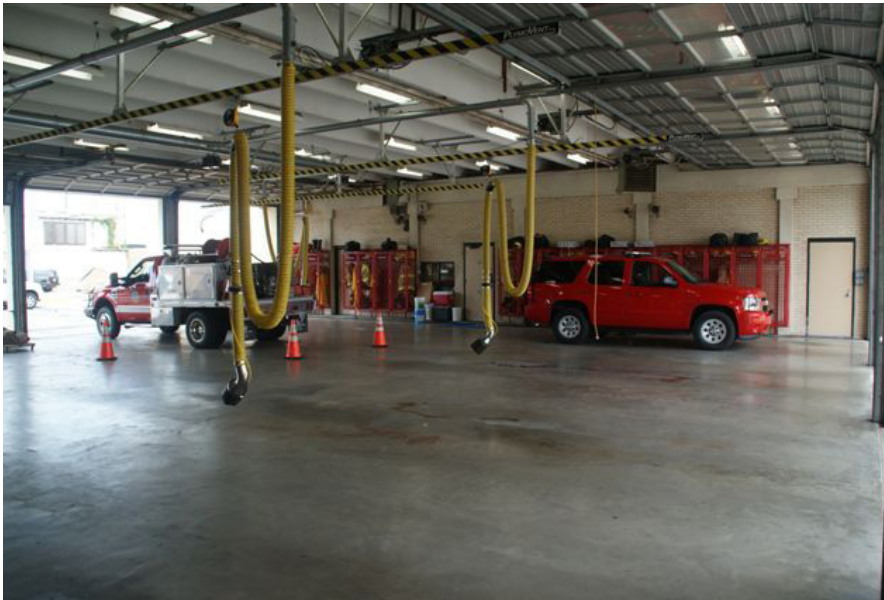
The door on the right far wall leads to the Battalion Chief's (BC) office/sleeping quarters. (It also leads to the sleep area for firefighters.) Positioning the BC's response vehicle next to the office/sleep room where the BC's spend a good deal of their time doing required record keeping means that the BC's vehicle will most likely be the first piece of apparatus out of the station for an alarm and first on the fire ground. (This could be a positive attribute depending on SFD SOG's. In some departments, the BC follows apparatus so as to not get in the way of apparatus positioning, while in other departments the BC leads the response to do the initial size up and then to direct the positioning of apparatus.)

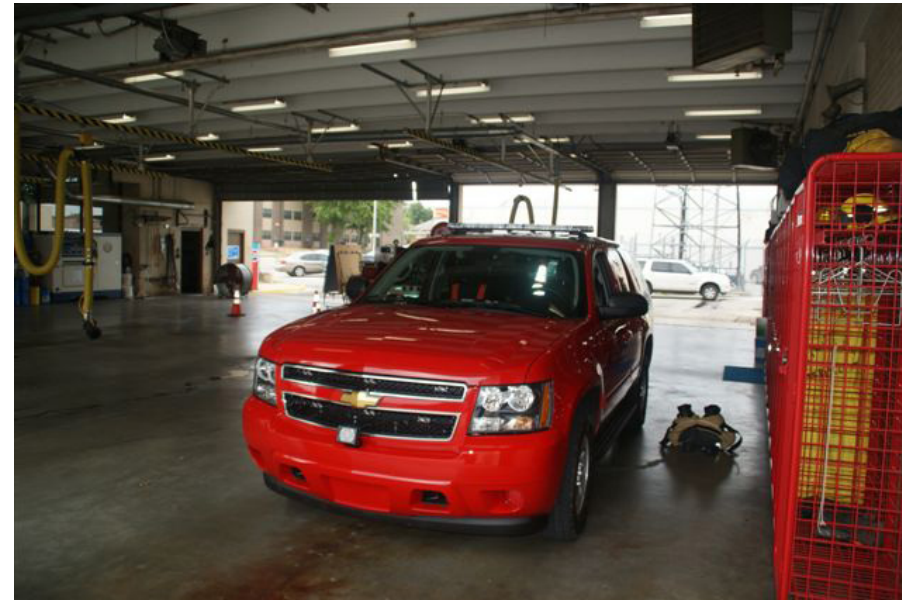
The red "cage" lockers are fine for storage of PPE, but these are too close to the bay door opening allowing direct sunlight on the garment. Sunlight will prematurely weaken the fabric. All PPE for off-duty personnel should be stored in lockers in a room located off the apparatus floor in a space that does not receive direct sunlight. The lockers here should be mounted higher on the wall to facilitate wash-down of the floor without wetting PPE on the bottom. The conduit running under the locker is subject to being wetted.

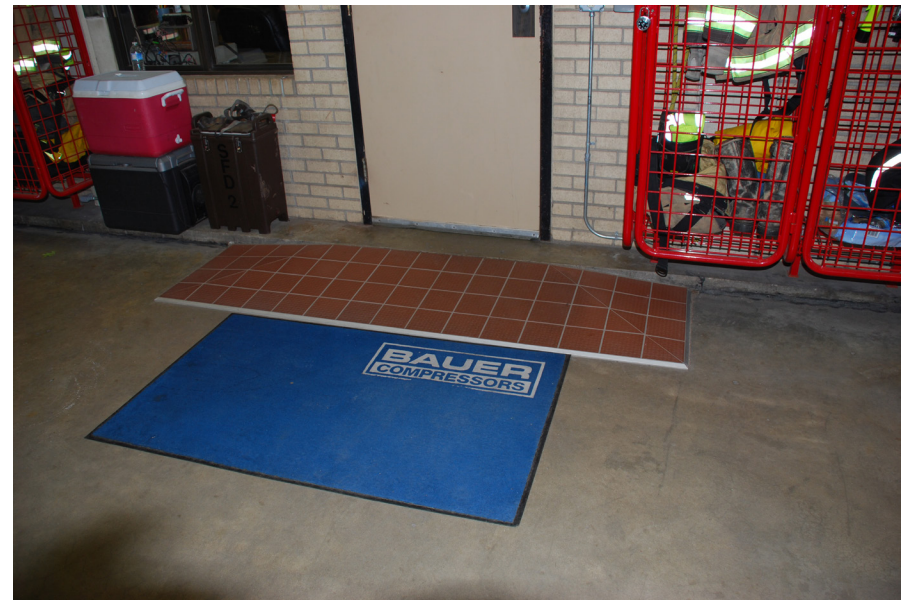
The apparatus floor at Station 1 slopes from the front of the building to a trench drain at the rear along the inside edge of the bay doors. Trying to clear the apparatus floor of water by sloping the floor front to back created a 3" step down at the door leading from the dayroom, a depth not easily perceptible to the human eye under some light conditions. As a result people often stumble walking out of or into the dayroom.

A "fix" for the step down/step up problem has been attempted with a tile patch. The fix helped but a trip edge remained caused by the thickness of the tile and the tile setting bed. This lip could have been prevented by sawing a line in the concrete corresponding to the size of the tile ramp and removing enough concrete to allow the tile ramp to fit flush with the floor.

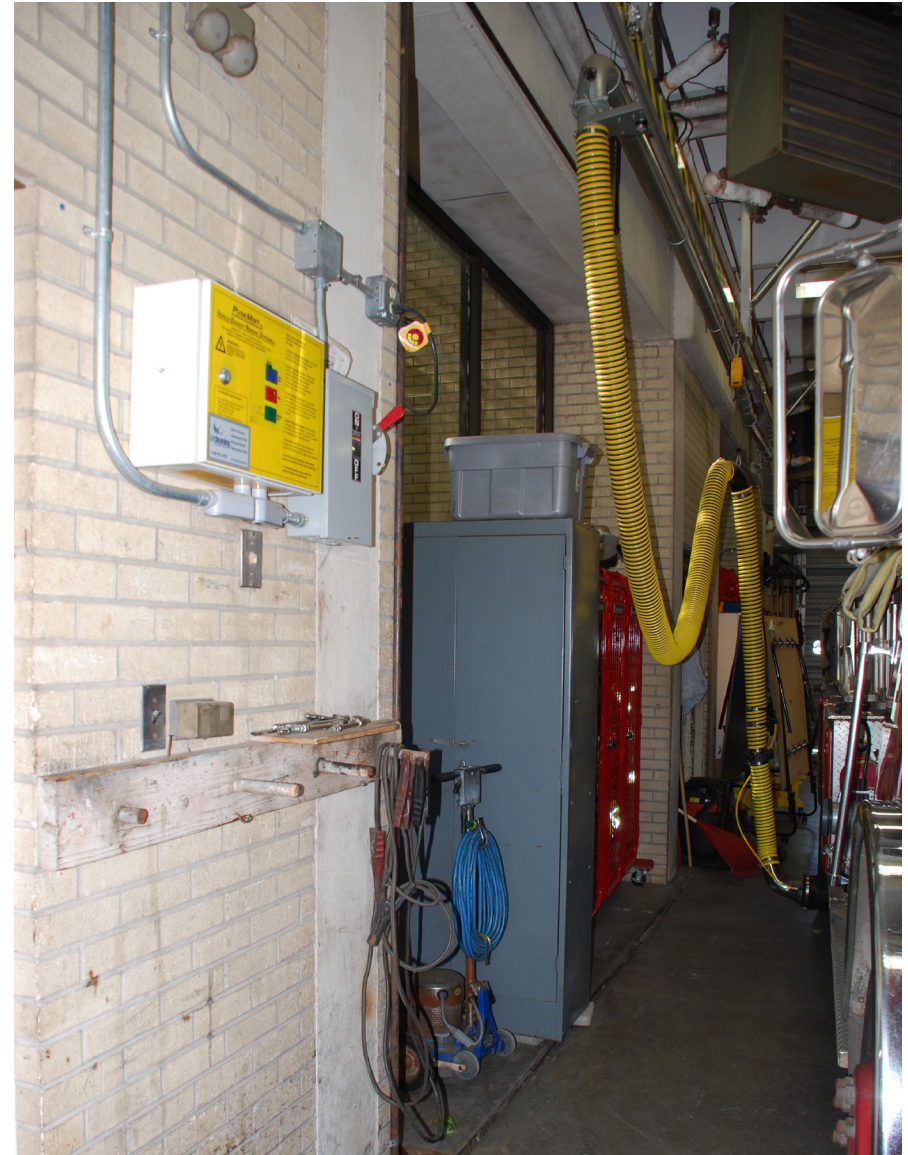
The image above shows the tightness of the space between the fire engine and the items that have been positioned on the apparatus floor. These would normally be located in apparatus support rooms but space is unavailable. The yellow exhaust extraction hose uses an air bellows to clamp to the vehicle exhaust pipe. Air leaks (the small orange line) have been a problem with this system. Magnetic catches are now available.

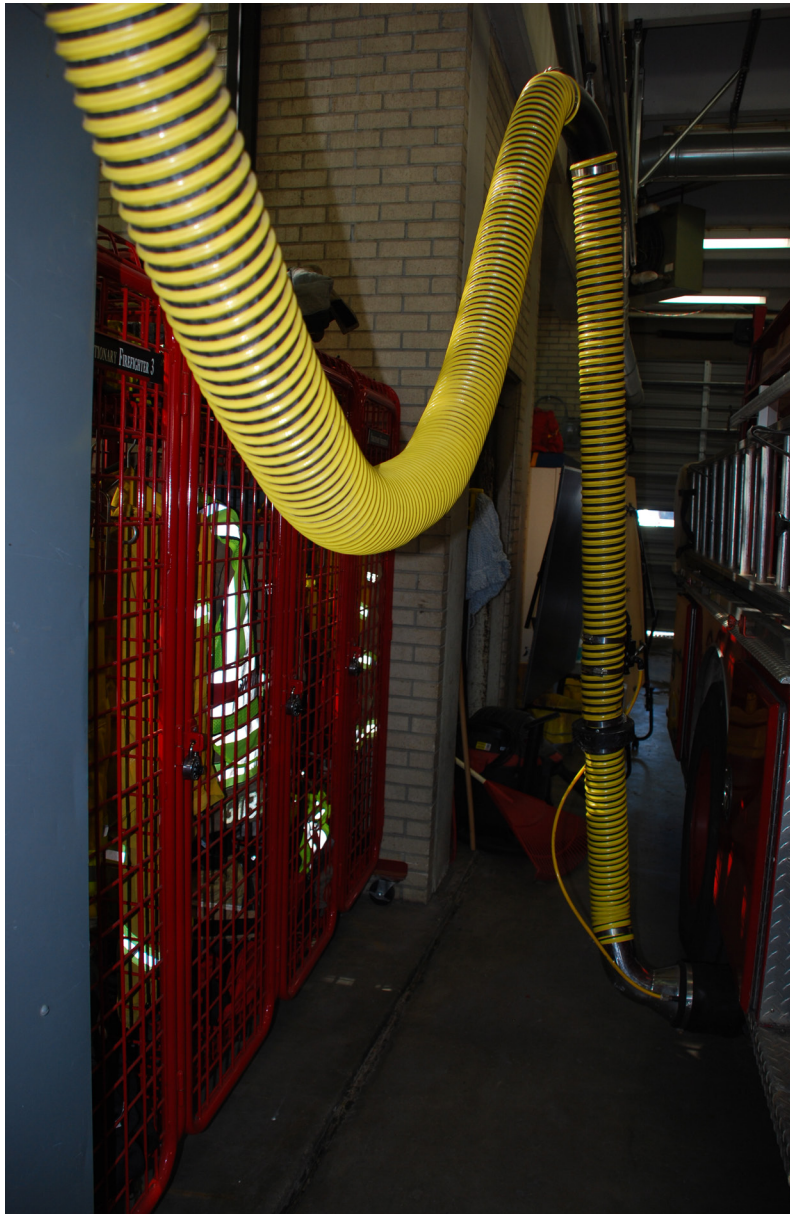
Firefighters should not have to work around exhaust hose to remove their PPE gear from their storage lockers each time they come on duty or go off duty. If the exhaust hose happens not to be hooked up to the apparatus when the apparatus is started in the station, the PPE lockers get fumed!

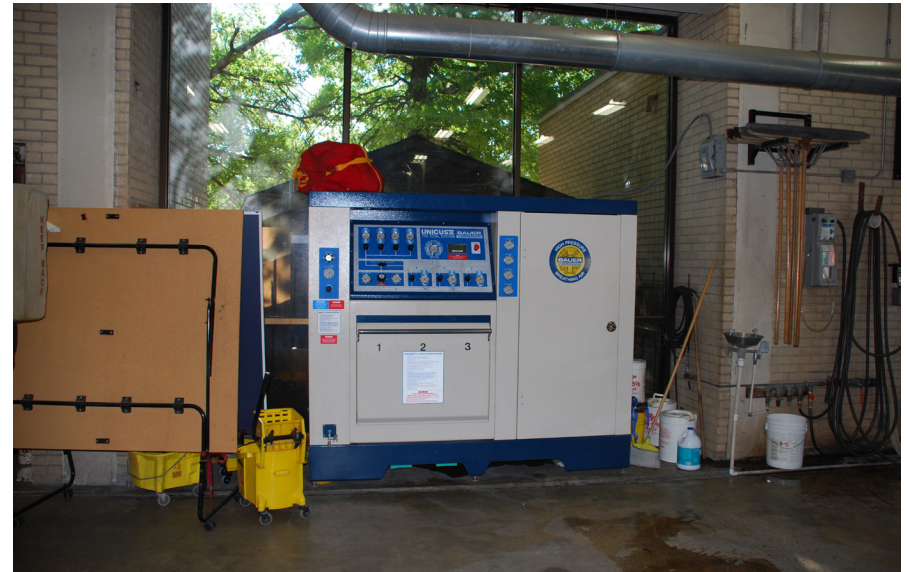
Moving toward the back along the west side of the apparatus floor we find the SCBA cylinder fill station and more clutter in the form of apparatus floor cleaning supplies and equipment. Moving the folding table out of the way reveals a rack for spare SCBA cylinders. These cylinders should be in a "clean" room. Should any debris get in the threads or on a seal, a firefighter's SCBA could be compromised. The view out is marred by the SCBA station.

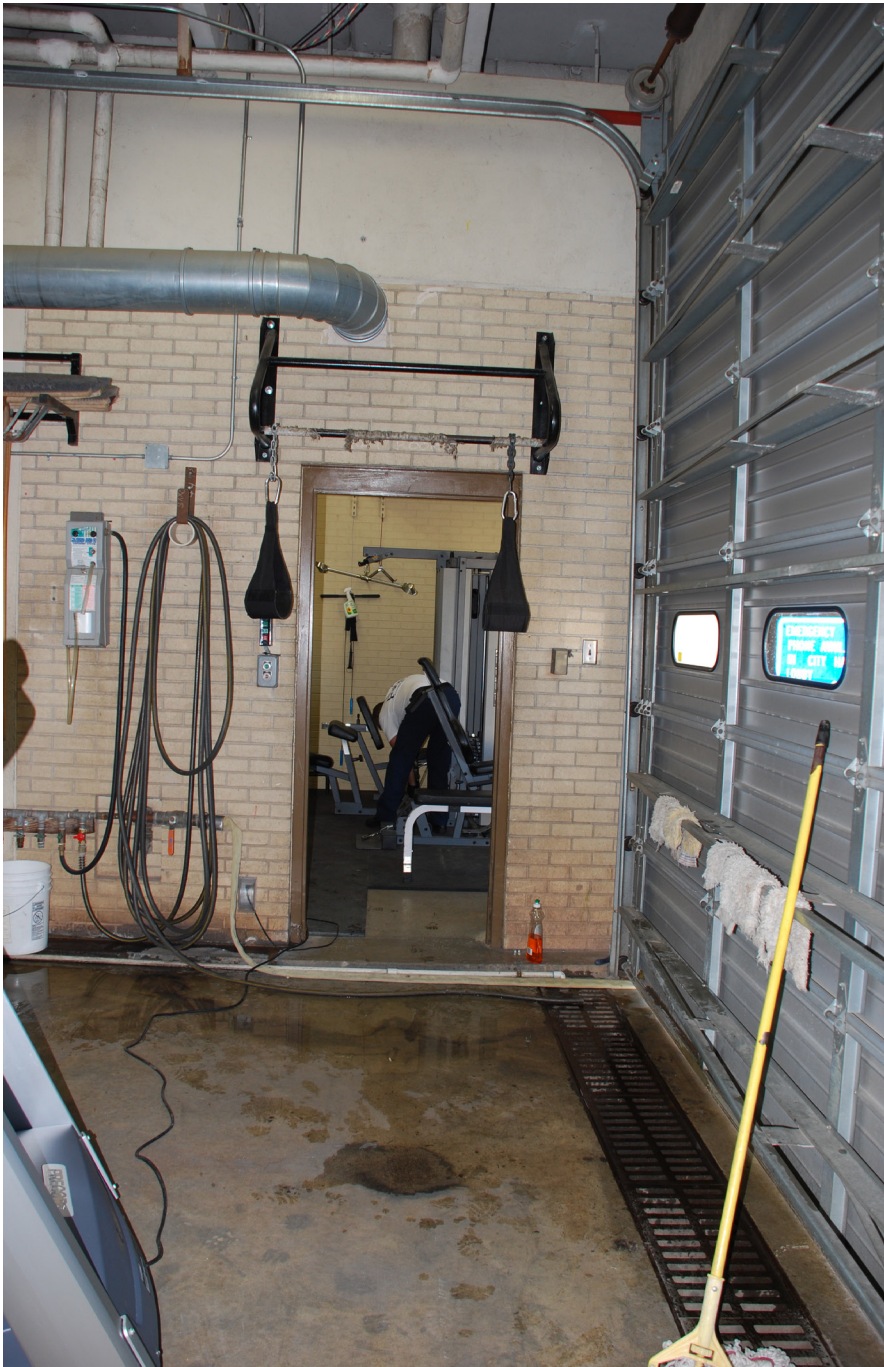
At the back NW corner of the apparatus floor is a room that was originally designated as hose service and storage. It has since been converted to a much needed physical fitness room. Some of the physical fitness training equipment has spilled out into the apparatus floor space. In the lower left hand corner of the image is a treadmill machine. During the site visit these items were observed being used all hours of the day. No endurance-building equipment should be used on the apparatus floor. The apparatus floor is the dirtiest space in the fire station. There is no need to risk breathing in airborne contaminants that might be floating around in the air. The power cord running to the treadmill is a trip hazard. Note the trench drain at the low point of the rearward sloping apparatus floor slab and the barely perceptible step up to the fitness room. Fitness rooms are best located in an observable space near the crew areas. When the bay doors are down, the only emergency exit from the apparatus floor is through the fitness equipment room. Hopefully no equipment will be in the way!

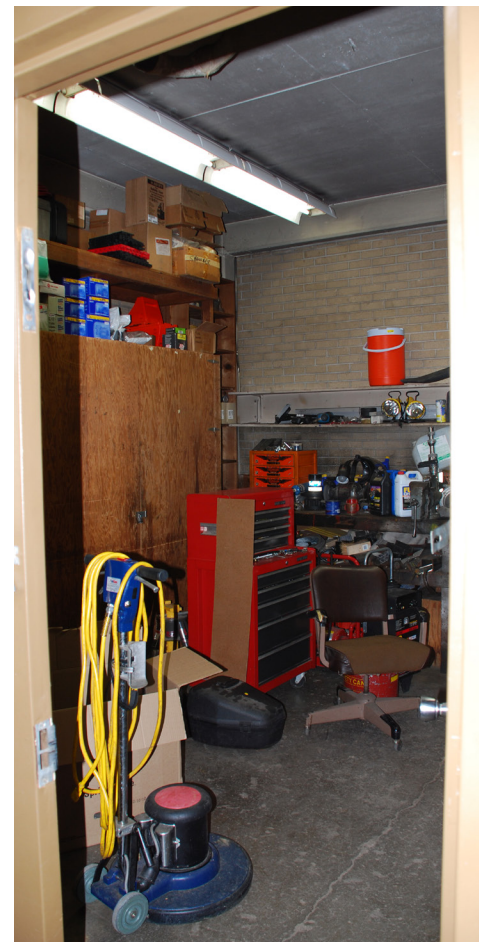
The Vehicle Maintenance space, shown to the immediate left, was originally intended for service and repair of apparatus. It has evolved to also be the service and repair room for both gasoline and electrically powered equipment carried on modern fire apparatus. By default, in the absence of any utility closets off the apparatus floor, the room has become the repository of some of the equipment necessary to clean and maintain the station.

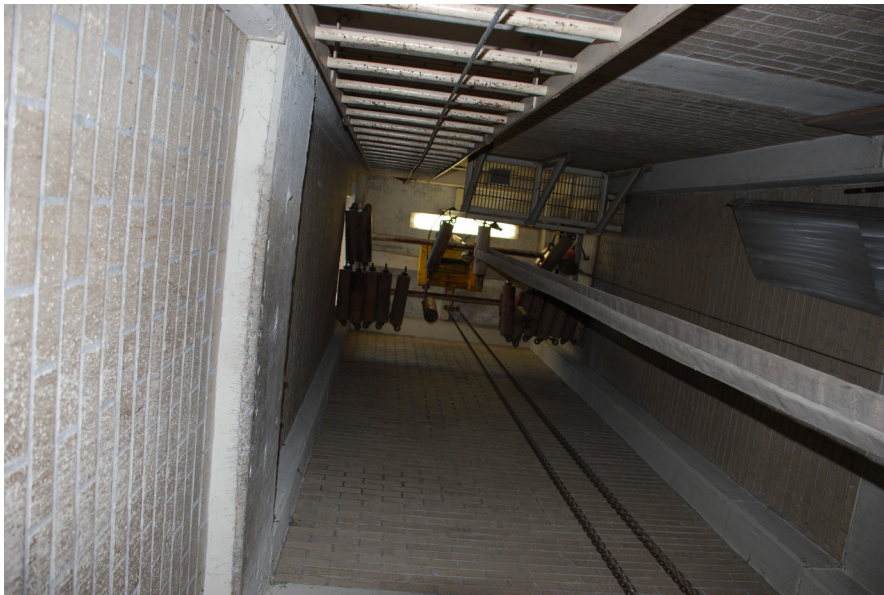
Station 1 has a "25' hose tower that was designed to allow the hanging of 50' sections of hose draped over spindles at the top of the tower. In the photo above can be seen one section of hose. The hose tower is getting little use of late because Shawnee has moved away from "cotton jacketed" attack hose. Cotton jacketed hose had to be dried before being placed back on

the apparatus. Drying the hose prevented the growth of mold on the damp fabric. Fire departments switched to attack hose with a synthetic outer covering that in theory does not have to be cleaned and dried before being reloaded on the apparatus. However, many department using the non-cotton jacketed hose have found they get longer life out of the hose if they at least wash it before putting it back on the apparatus. Doing so, these departments have found that washing the hose removes fire ground debris that was often coarse enough to abrade holes in the hose. Some departments have gone back to washing and drying hose before reloading on the apparatus as a way of keeping the hose beds of the apparatus free of debris and moisture, moisture that often makes its way to the apparatus floor.

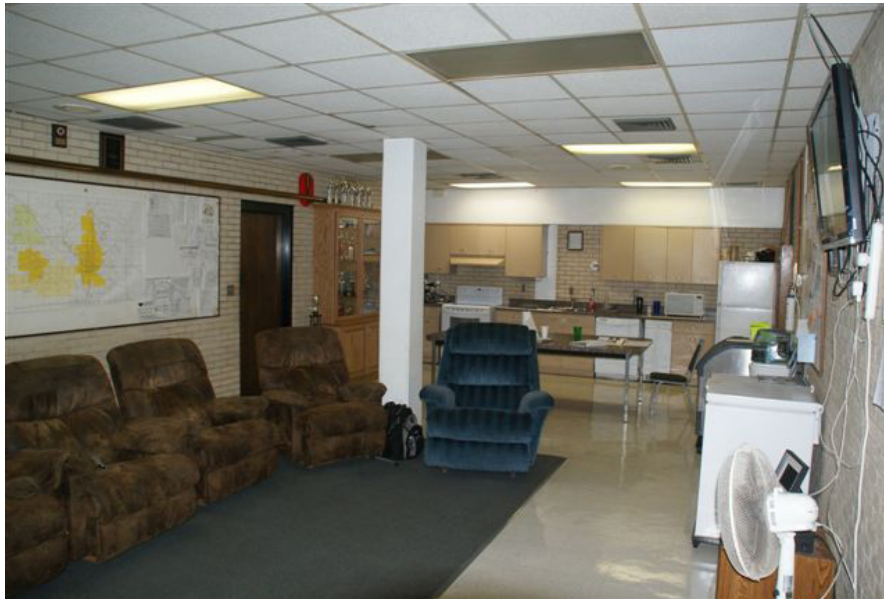
Above is a photograph of the dayroom looking east toward City Hall. Dayrooms are the principal crew space in a fire station. “Dayroom” is actually a misnomer as on average little weekday “daytime” hours are spent in the dayroom save time spent in Company level “classroom” sessions and the preparation and consumption of meals. (In the case of the SFD, the only station with a dedicated classroom is Station No. 3.)

While viewing angles have improved considerable on flat screen televisions, viewing for all would be improved with an orientation that used the long axis of the room. It is imperative that each member be accommodated equally in the dayroom to the greatest extent possible with respect to seating, viewing, etc. The existing dayroom fails to meet this equal accommodation goal when measured against the size of the station crew. The column intrudes into the Dayroom space and hinders options for arranging furniture and other items. Columns also intrude into the dorm and the locker room.

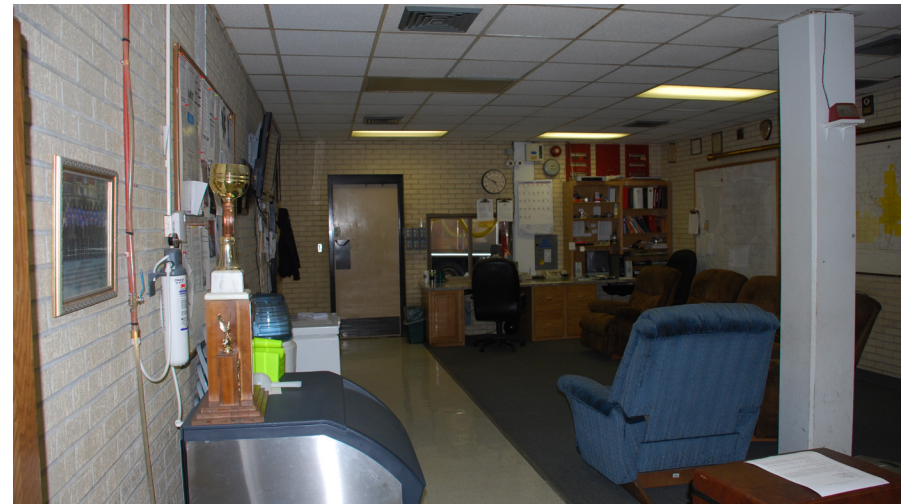
In the photo above looking west toward the apparatus floor, the only existing place for indirect daylight to enter the dayroom is through a small double window, seen just to the right of the door to the apparatus bay. The window looks onto the apparatus floor. Shades are drawn in the window to cut down on the contrast of the dark dayroom and the brighter apparatus floor natural lighting. The shades facilitate the use of a computer and monitor at the “watch” station. There is essentially no way to introduce daylight into this interior room save the installation of skylights or solar tubes.

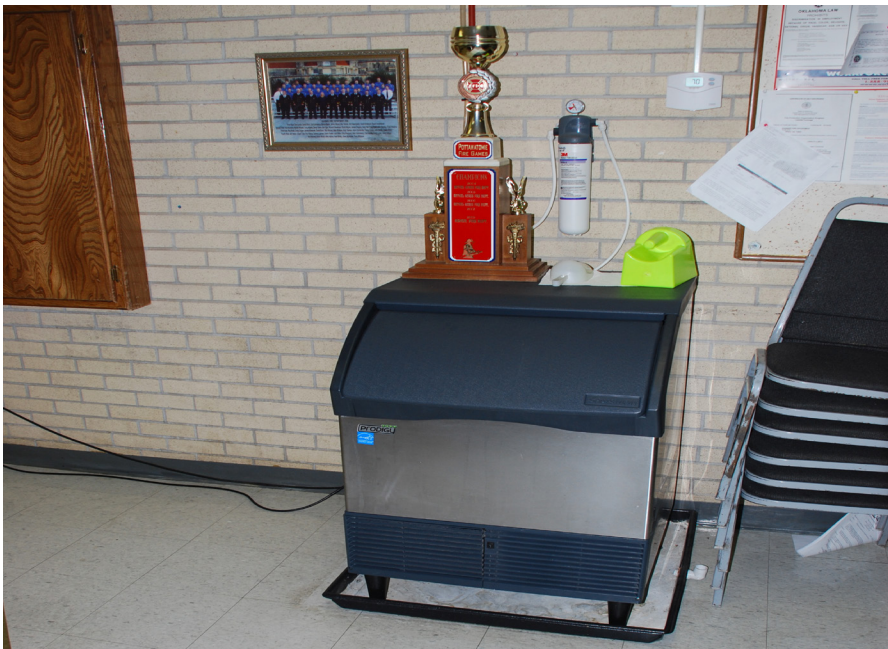
Ice machines were not a typical station item when Station 1 was constructed. Neither was the current level of PPE worn by firefighters in performing their task on the fire ground. The current standard in PPE thermal protection also means that heat is trapped inside the garment raising core body temperatures to dangerous levels in short order. Fire departments have learned that it is absolutely necessary to have adequate amounts of cold fluids on the fire ground to rehydrate fire fighters during rehab. Most fire departments today, at the beginning of each shift, will routinely empty and refill with fresh ice all apparatus mounted coolers. If anything, the ice machine shown here is probably too small for the job of keeping apparatus coolers stocked and supplying the daily needs for ice usage in the dayroom/kitchen routines.

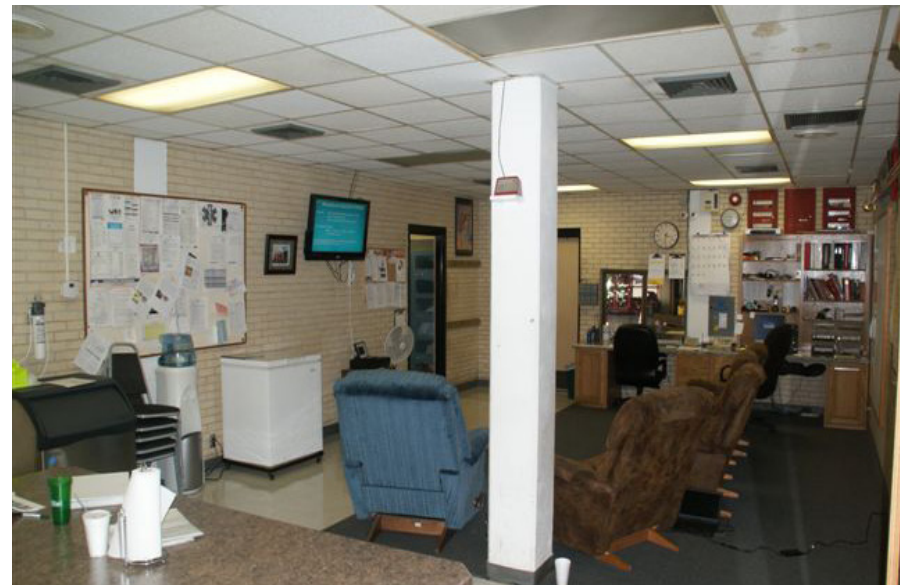
Stackable chairs are best kept in a chair and folding table closet related to the dayroom, or a training/community use room. Station No. 1 has no such room. Ideally, bulletin type boards should be in circulation hallways to avoid the cluttered image that these impart to the dayroom/kitchen area. Many fire departments today are doing away with bulletin boards and replacing them with cloud computer files and calendars that each department member can access at any time. The open door leads into the locker area and dorm.

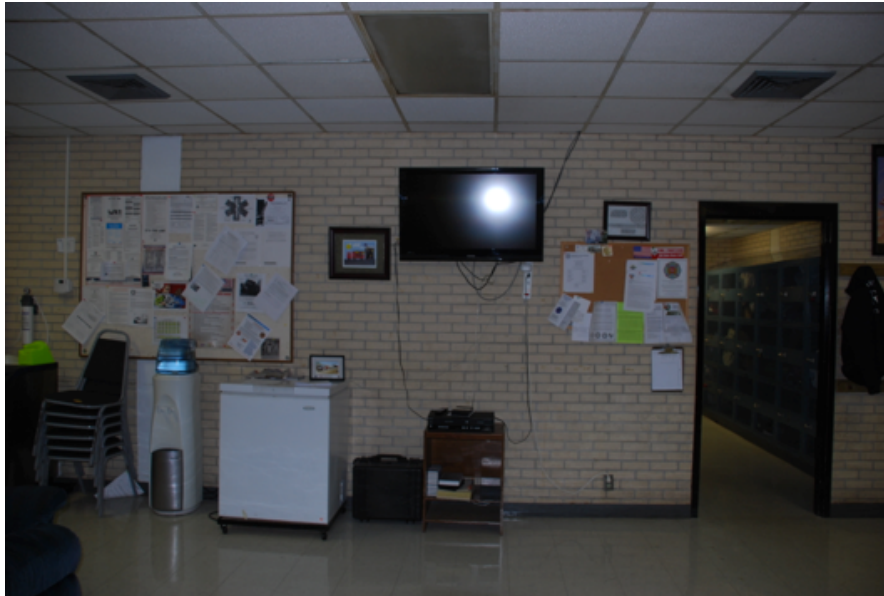
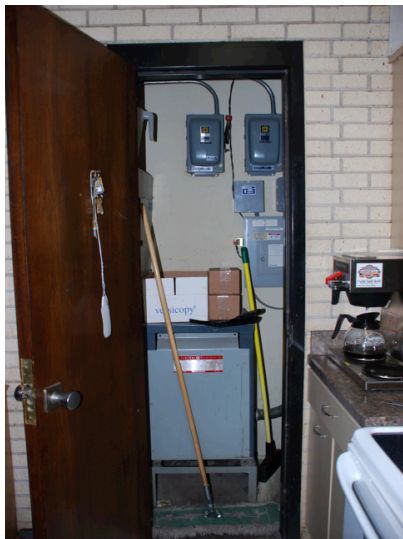
It is not unusual to see an electrical closet being used as a “mop” closet at a fire station but electrical closets should not be so utilized. State of the art fire stations have one or more dedicated janitorial closets for the crew areas and a separate “mop” closet for the apparatus floor. Such closets make a great place to post the OSHA required MSDS sheets for cleaning chemicals used by station personnel in their routine and non-routine daily cleaning. Using the electrical closet as a “mop” storage area, if allowed to get out of hand, could hinder quick access to any electrical shutoff devices such as the ones seen in this image. Electrical “closets” should be accessible from the exterior of the station.

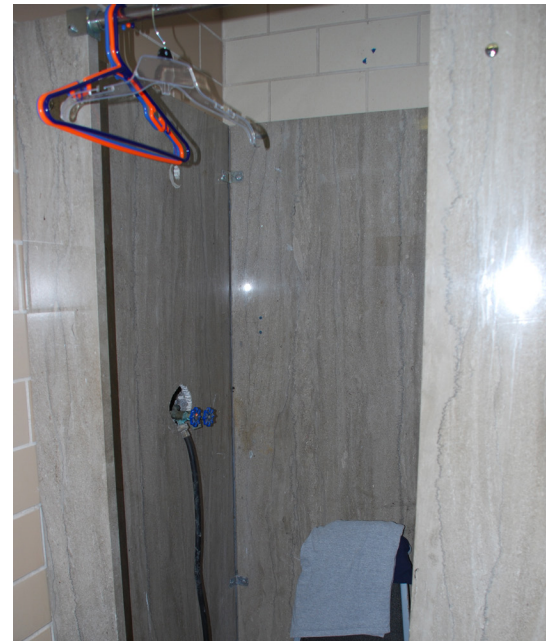
The shower stalls are in reasonably good condition considering their age. This is due primarily to the quality materials used in their installation and finish in the first place.

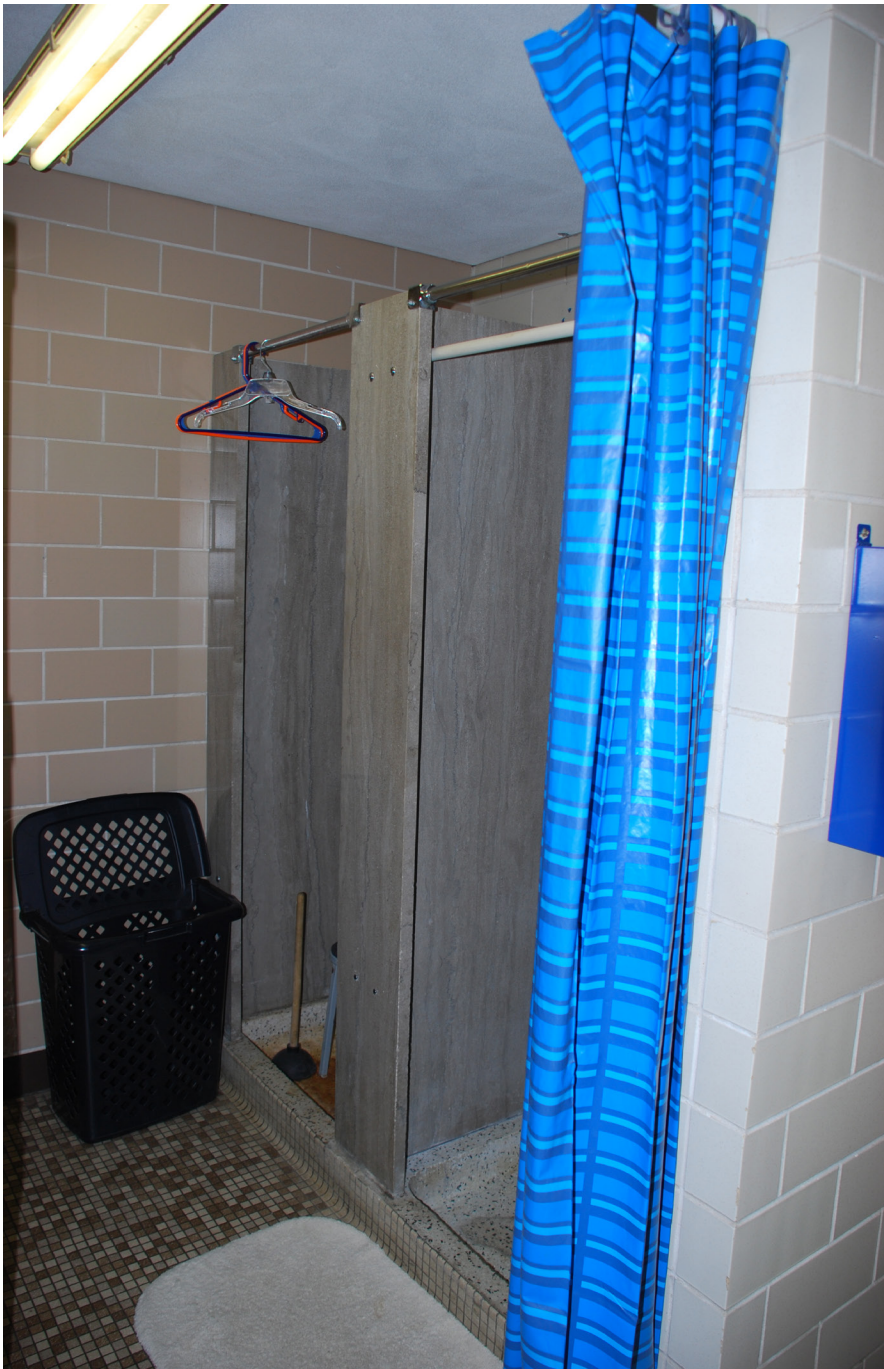
A single shower curtain has been hung in the opening to the shower /washer dryer area. The shower rods for a curtain at each shower stall have been retained and could be used once again if the defunct shower is repaired.

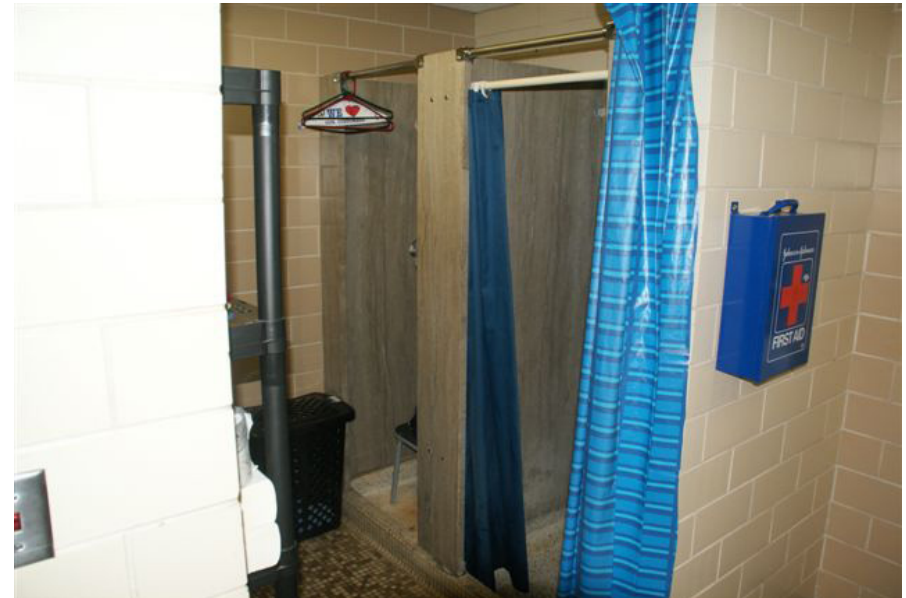
In the one active shower, a second, lower curtain rod has been added to insure the shower curtain hangs low enough so that water running down the inside face of the shower curtain flows into the shower's floor drain and not out on the floor in front of the stall. On reactivation of the disconnected shower, a lower shower rod will need to be added or long custom made shower curtains for both stalls fitted to make use of the original rods.

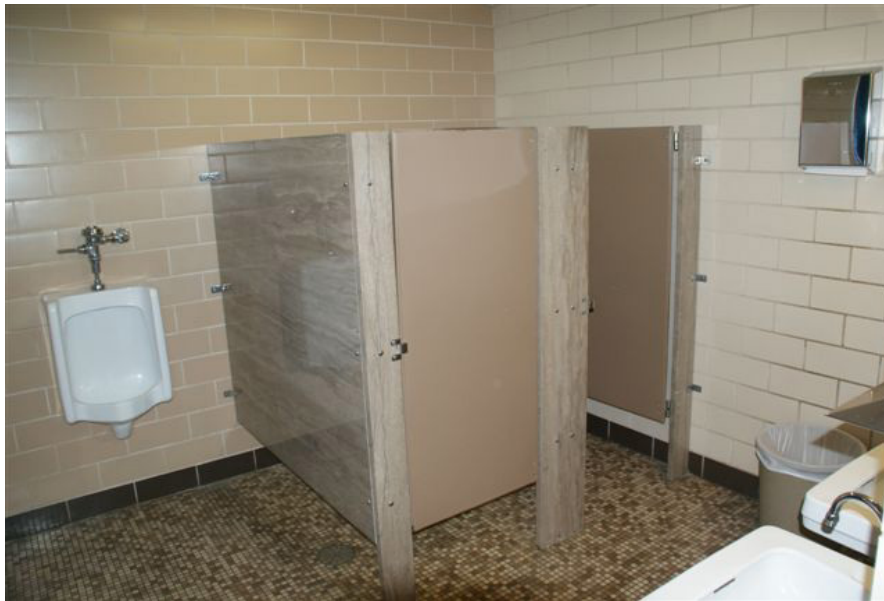
The fixtures, partitions, and wall/floor materials are the originals. This says a lot about using high-end, sturdy equipment for fire station installations. However, one shortcoming evident in this image was the non-provision of integrated trash receptacles. One possibility to consider would be retrofitting the urinals and toilets with automatic flush valves. This gives a consistent flush volume, insures that the devices are flushed and eliminates contact points for the spread of germs. Access to the toilet/shower/laundry areas is through the locker room which is located between the dayroom and the sleeping area.

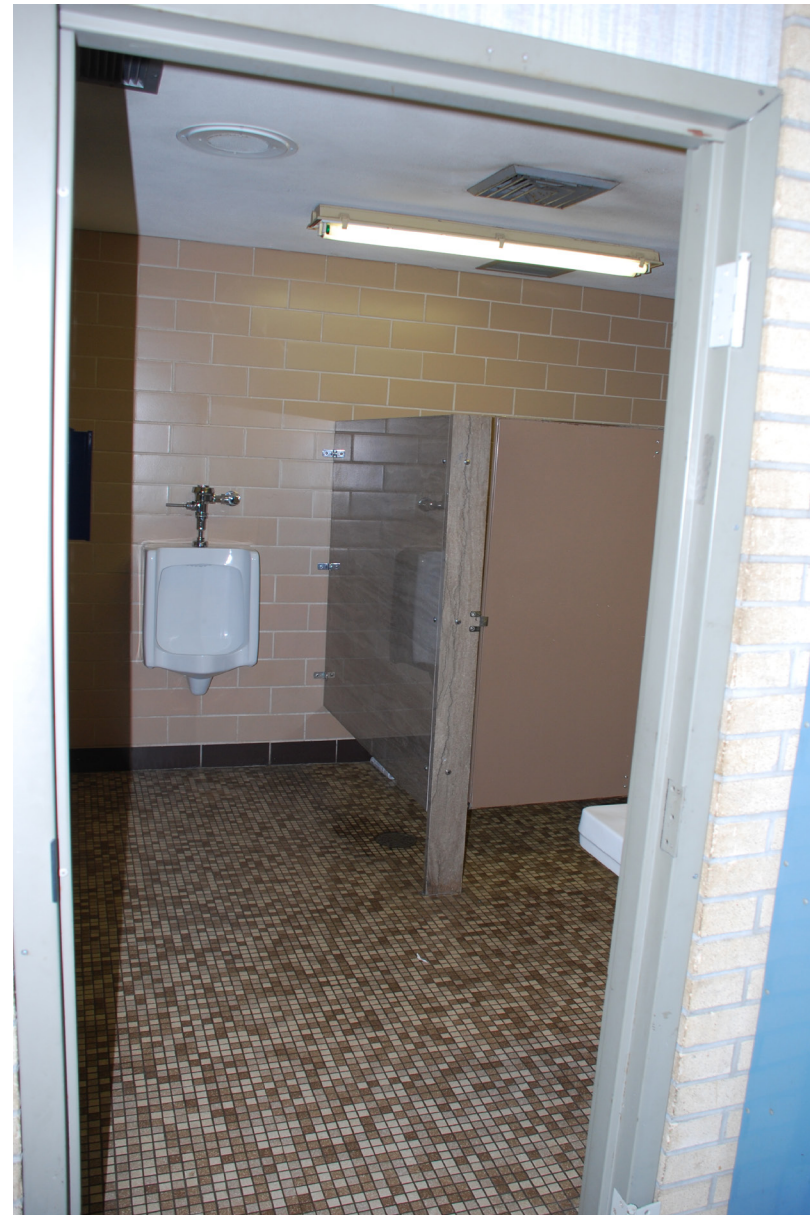
The image above, taken from the locker room, shows that the door separating the two spaces has been removed. The reason for the door removal was not established during the site visit. Any update of the shower/toilet/laundry area should be preceded by a thorough design study of the possibilities.

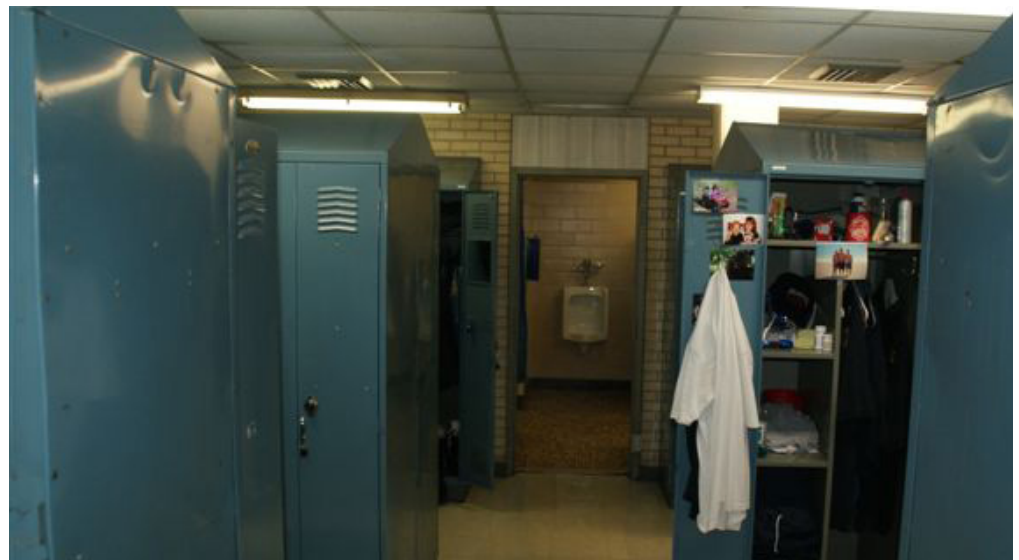
Lockers, while old, are adequate in number. They are inadequate in other ways. They could be larger. Not many changes of clothing can be hung in the lockers. Fire fighters may have to change station duty clothing more than once in a day. Fifteen runs and a working fire or two in a day can take a toll on personal hygiene and a day uniform's condition.
