Section04 FireStationNo.1

Background for Shawnee Fire Station No. 1

Assessment Commentary

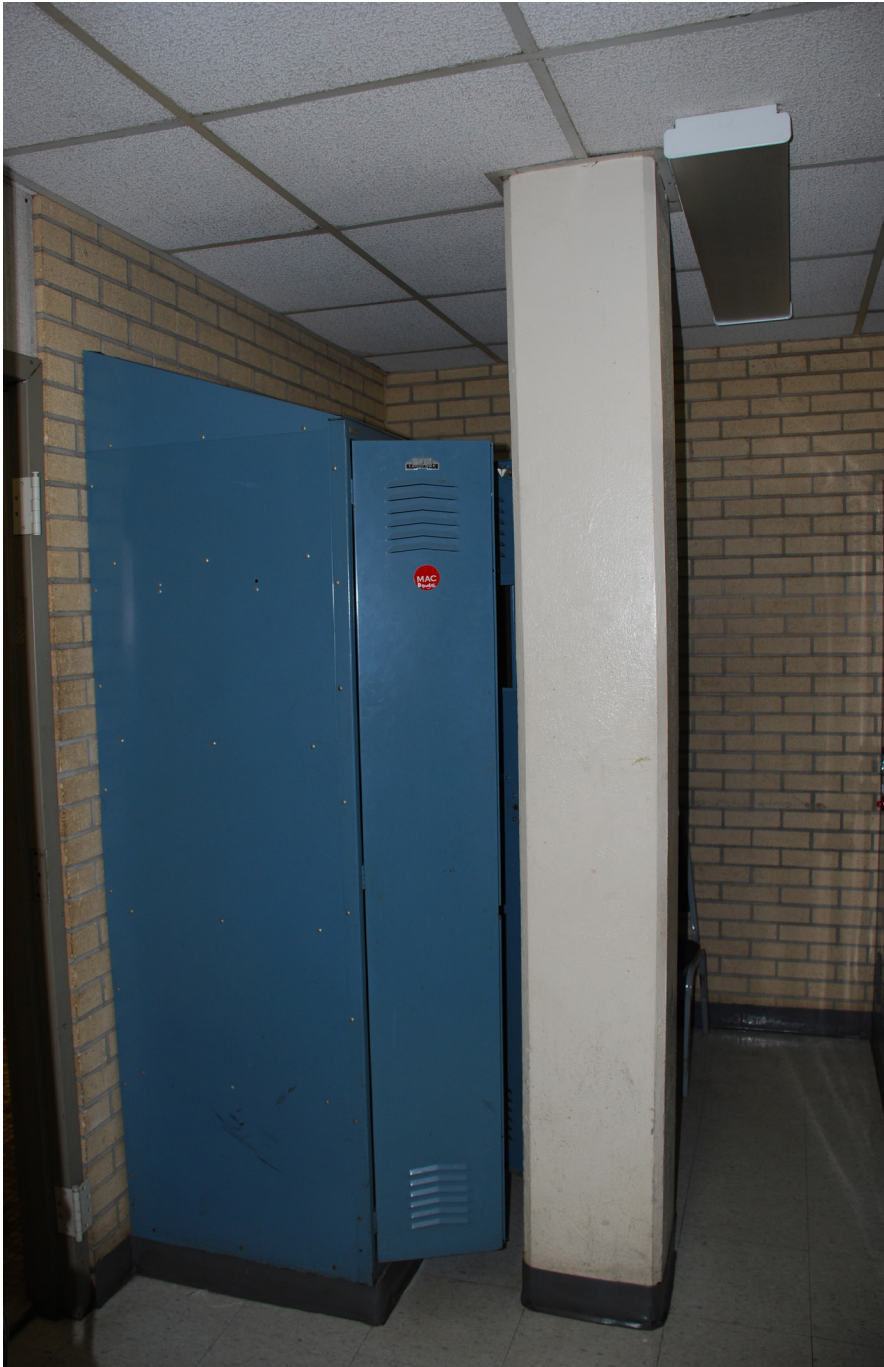
The structural column layout in the locker area interferes with the functional use of the space. The locker with the open door is essentially unusable with the column occupying the “standing space.” The locker is, as a result, unassigned. With the column greatly compromising its use, no one would want to use it. Luckily there are currently more lockers available than personnel assigned to the station. If future staffing levels improve, this will not be a popular locker to be assigned.

The structural column also causes an offset of the lighting fixture from the centerline of the locker bay. The locker room could benefit from the installation of skylights or solar tubes.

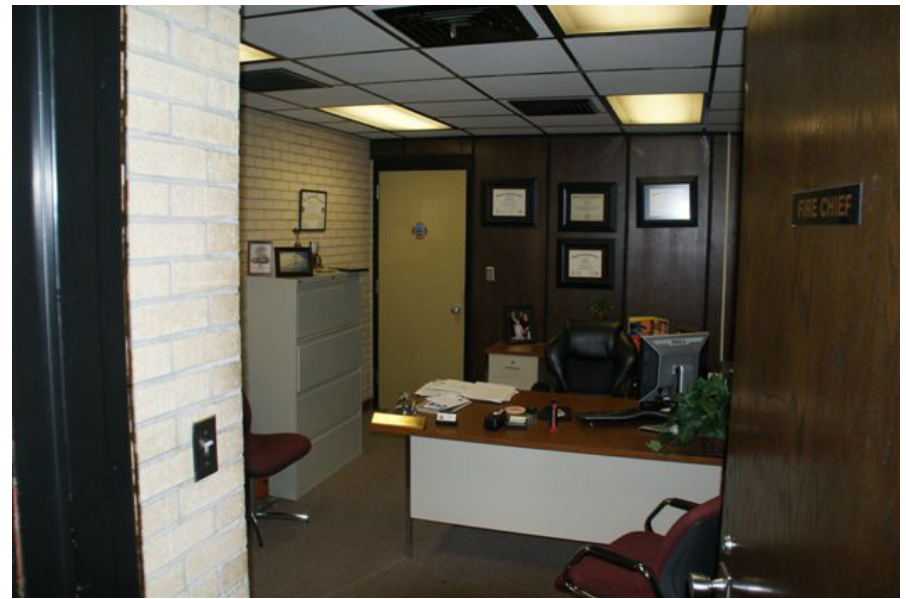
There are no windows in the Fire Chief's office. The dark paneling further adds to the gloominess of the space. Circulation could be improved a bit by moving the desk to the opposite wall. This would allow a more direct egress from behind the desk to the office door. It would also allow seating in front of the desk to be uninterrupted by the circulation flow. The door on the back wall leads to the apparatus floor.

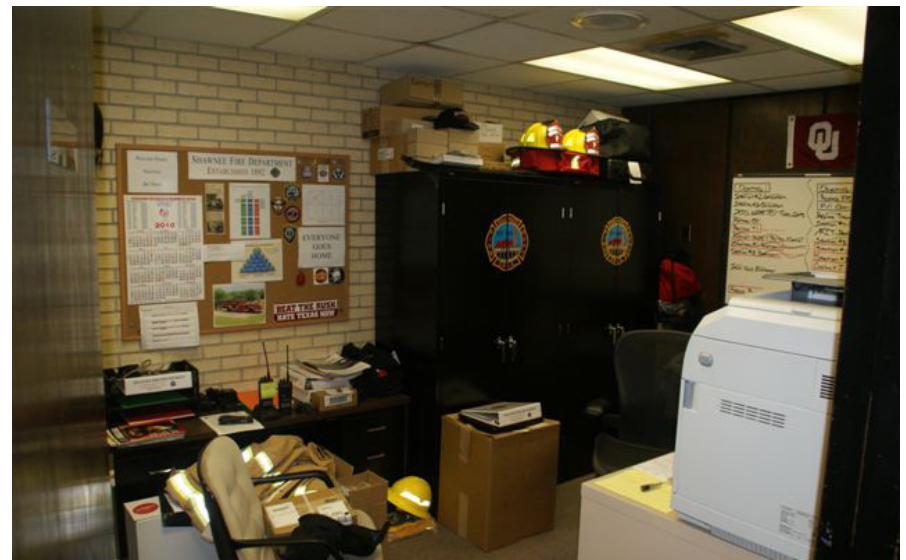
The Deputy Fire Chief's office is also a windowless and gloomy workplace. The brick wall seen in the photograph is not part of an exterior wall. On the other side of the wall is the police department's sally port and other passage spaces used by the police department to securely bring detainees into the police station for integration, booking and/or holding.

The Deputy's Chief's office also serves as the "Quartermaster" for the SFD with most new equipment, station wear and PPE stored here before being issued to new employees or as replacements/upgrades to existing employees. While it is essential that all of the PPE, uniforms, portable two-way radios and small hand tools purchased for use by members of the department be maintained in a secured area until issued, it is not necessary for these items to be stored in the Deputy Chief's office or any other office for that matter. A secured, proper storage area for this gear should be a near-term goal for the department.
