Section06 FireStationNo.3

Background for Shawnee Fire Station 3

Assessment Commentary

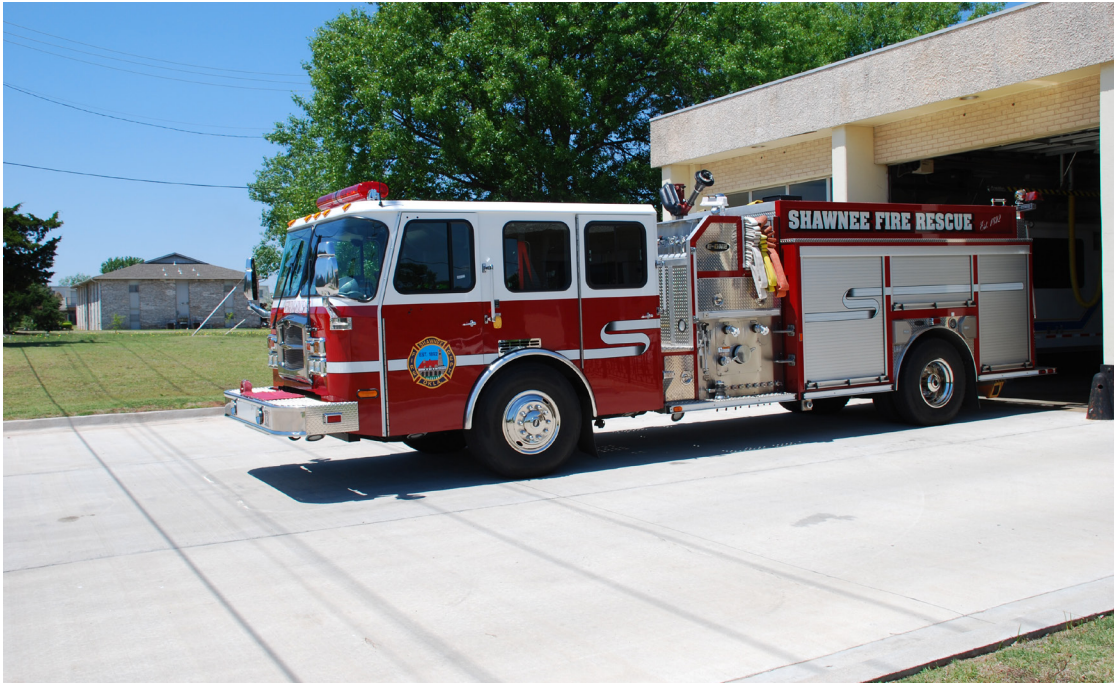
The apron, having been recently replaced, is in excellent condition and adequate for the apparatus currently assigned to the station. The station will most likely not accommodate a rear-mount aerial device of any length because of door height and structure. Even if an aerial can be accommodated, aerial training and daily testing out front is limited because of the overhead power lines at the street ROW. In the images to the left, one can see the shadow line of the overhead power lines falling across the apron.

The station structural columns at the bay doors could be better protected by 2 bollards/column mounted in the apron a foot away from the columns. The column "boots" that are currently used to protect the columns have not been proven sufficient at other stations to prevent column damage from a backing accident. In considering the placement of bollards out from the columns, consideration should also be given to equipping the apparatus with a backup camera.

The construction joint sawed into the concrete, front to back, on the apron at the columns is helpful as a backing aid as it can most likely be seen in the rearview mirrors. It would have been better to have had also sawn two joints at each column with the joints set into the door opening about 6 inches from the columns. Doing so clearly defines the safe backing lane. The placement of "backing aid" joints 4.5 ' on each side of the centerline of the bay insures that they can be clearly seen in the cab mirrors.

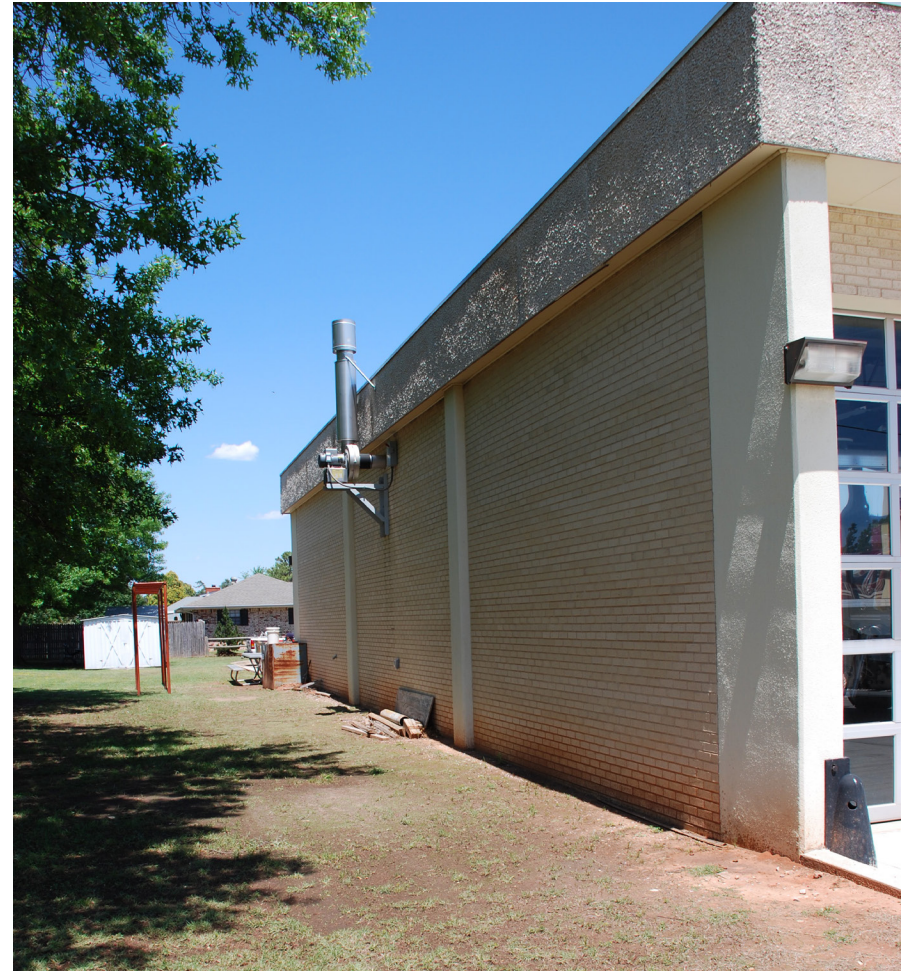
This view affords a close up of the light discussed in a previous caption. If the columns are lighted, it should be by indirect, wall-wash sconce lights.

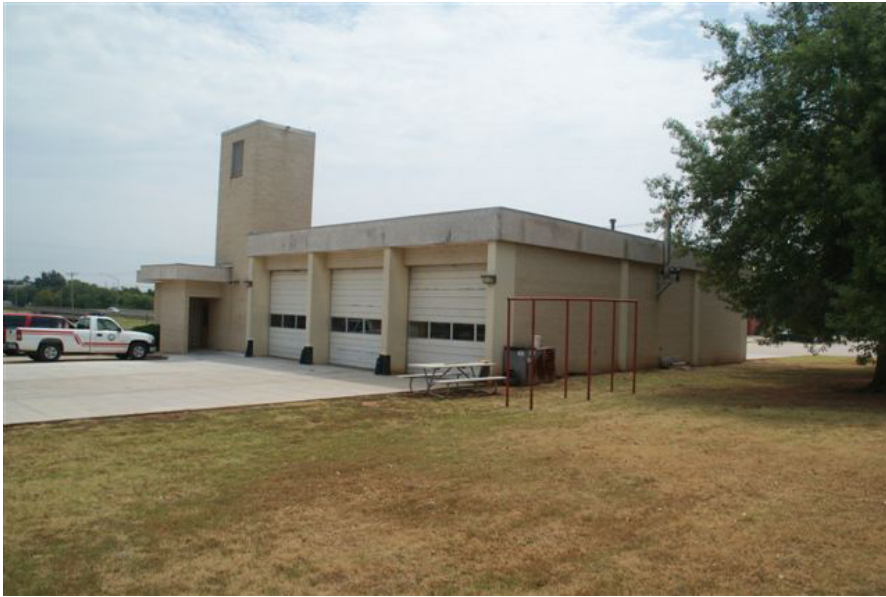
In this view of the rear of Station 3 looking SE, the entry to the station from the rear parking is via a door in the extension next to the hose tower can be seen.. No fire exit doors, required by code, are found leading out of the apparatus floor.

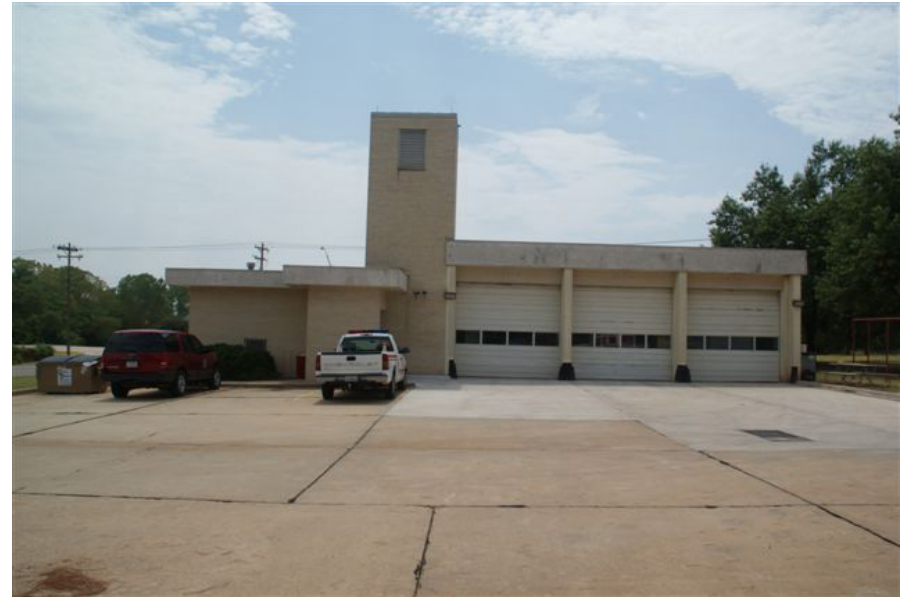
A large concrete apron is provided at the rear to facilitate drive-thru returns to the station. The drive-thru feature does not function as the rear of the apparatus floor is blocked by vehicles, training props and other items.

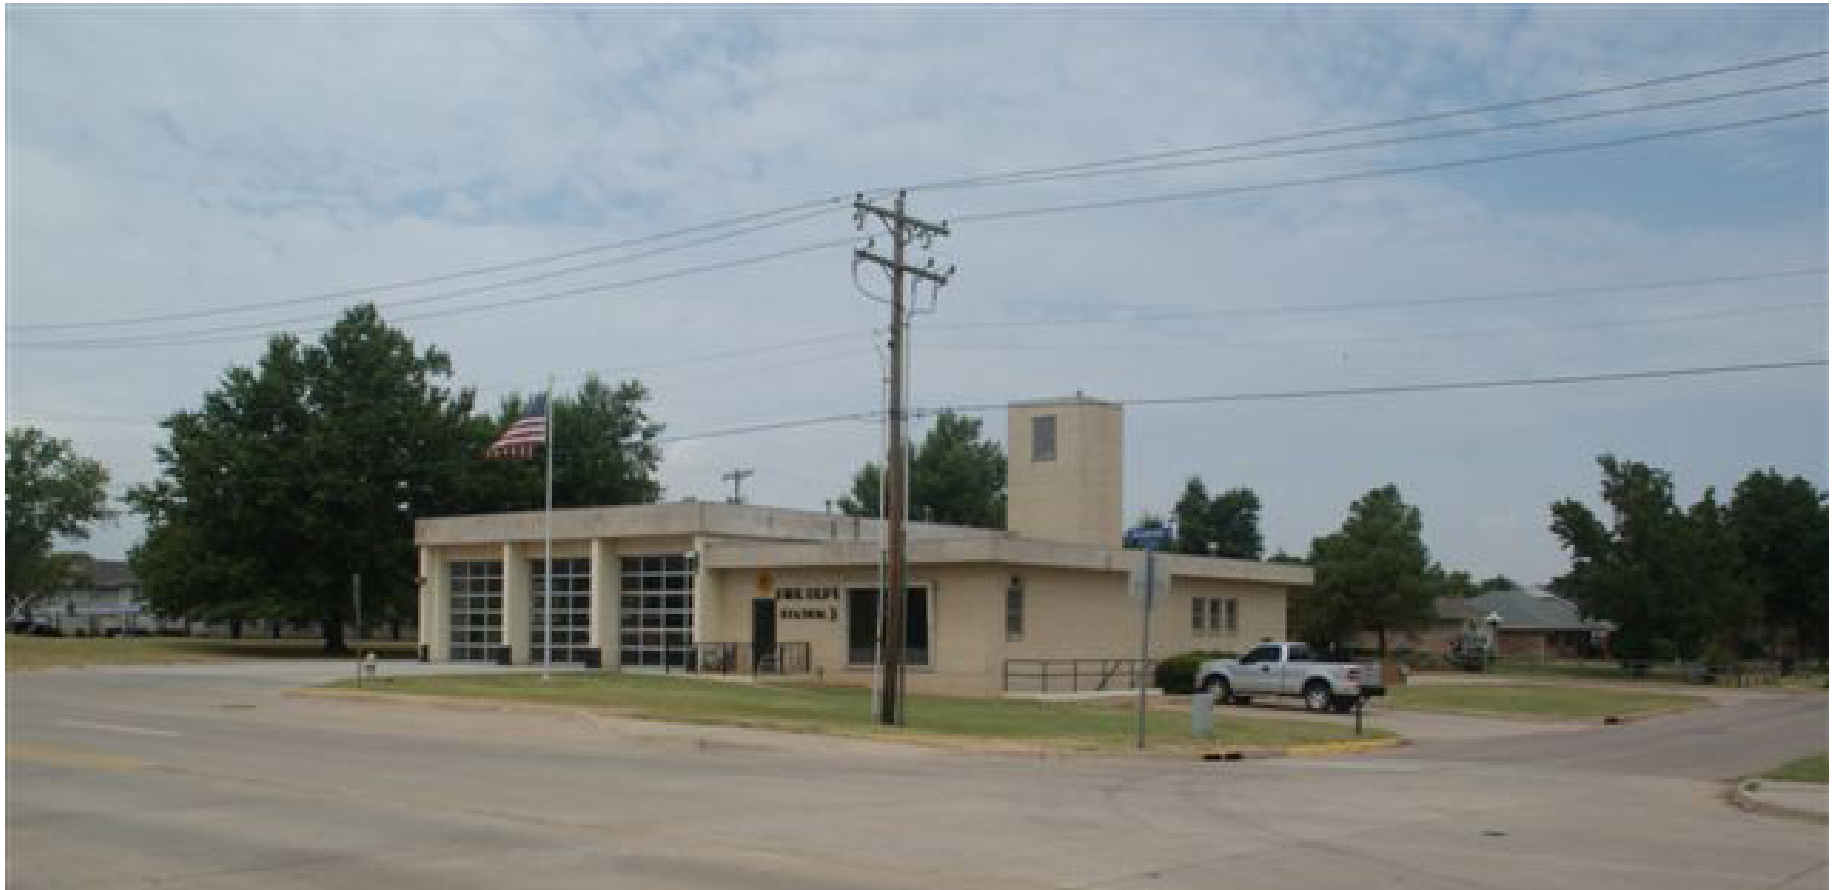
This view of Station 3 from across MacAuthor shows more clearly the overhead power lines that are problematic to any attempt to use the front apron for ladder training. While no ladder apparatus is currently quartered at Station 3 it is within the realm of possibility should the character of the FRA change such that a ladder is required.

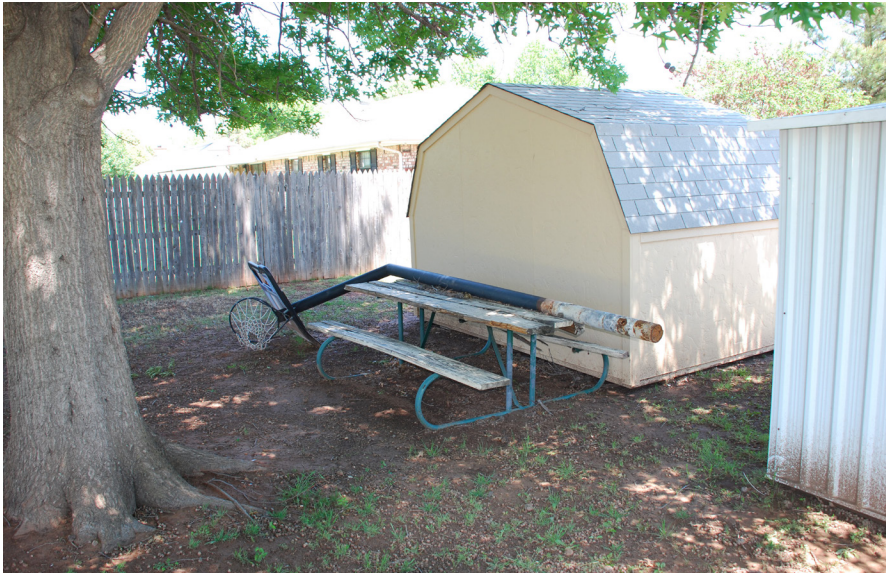
To the left can be seen the view to the backside of the storage sheds. The basketball goal and the picnic table are obviously not being used. They should be disposed of or repaired for use. The goal post could be put back up for exercise opportunities.

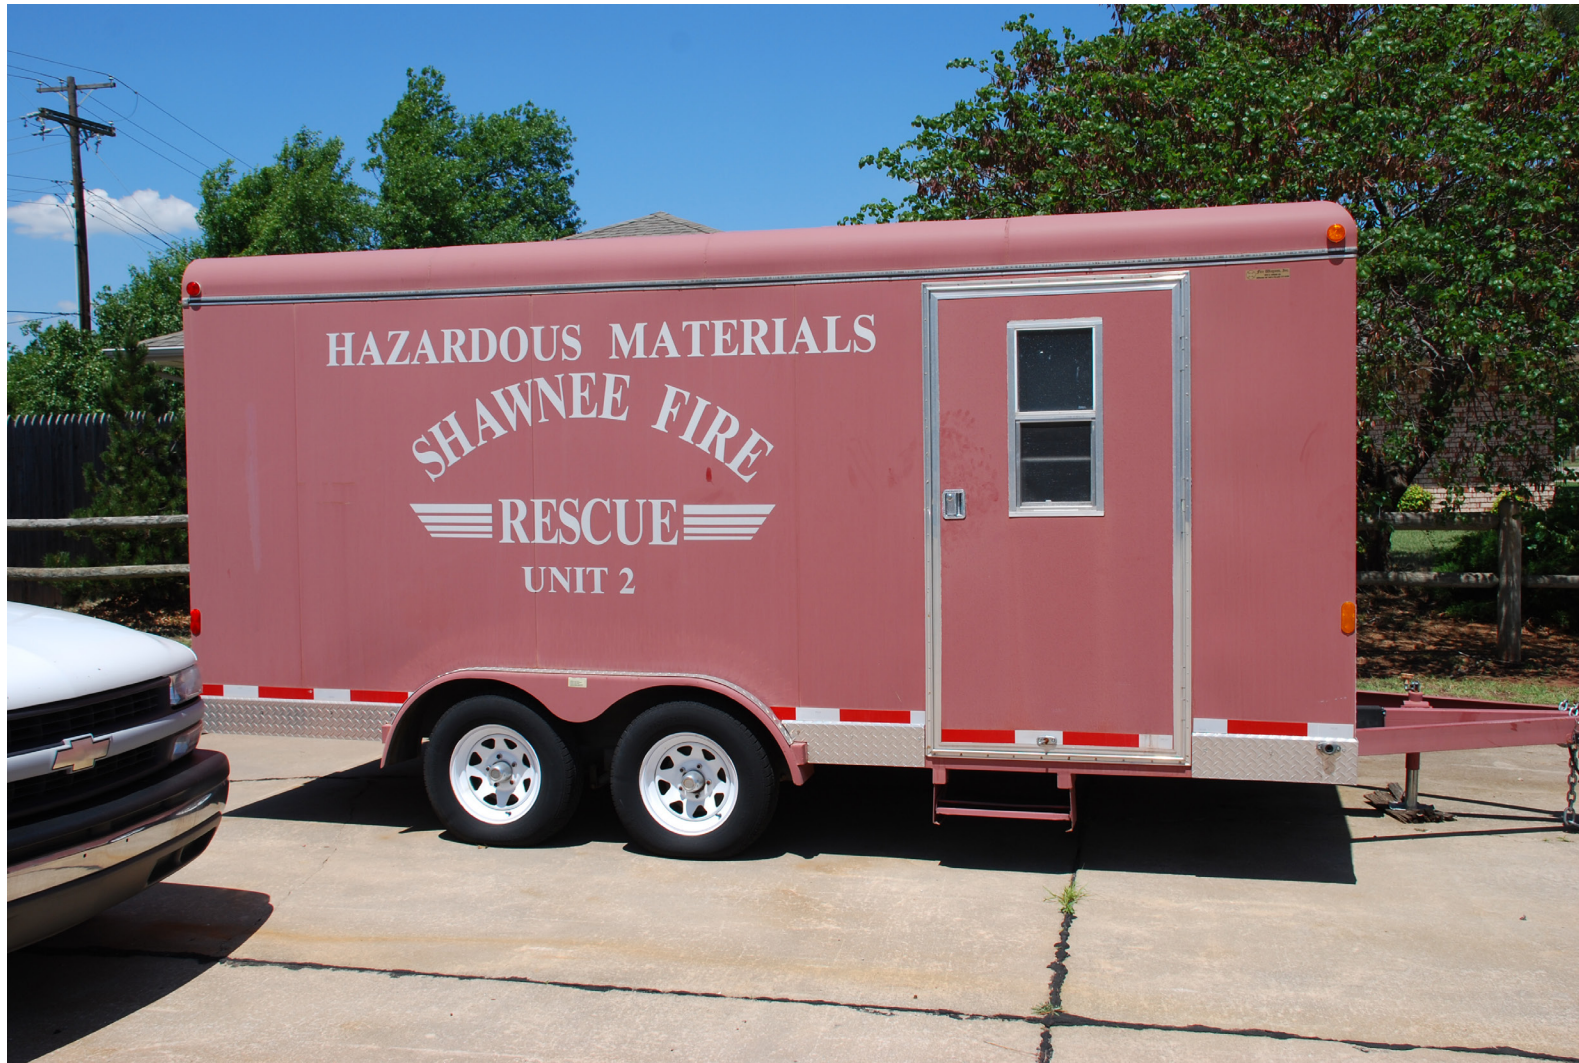
The Department's Hazardous Materials response trailer is parked behind Station 3. Staging this trailer on the back apron affects how the apron can be used by fire apparatus maneuvering or parking. It is an obstacle like the dumpster.

When purchased and placed in service, this trailer was bright red, not dull pink. The fade demonstrates the detrimental effect of storing fire equipment in the sun. The sun and heat have a negative effect on more than just the paint. Equipment stored inside may be sensitive to heat damage, as well. For this reason, the trailer should be staged inside if possible. Ideally it would

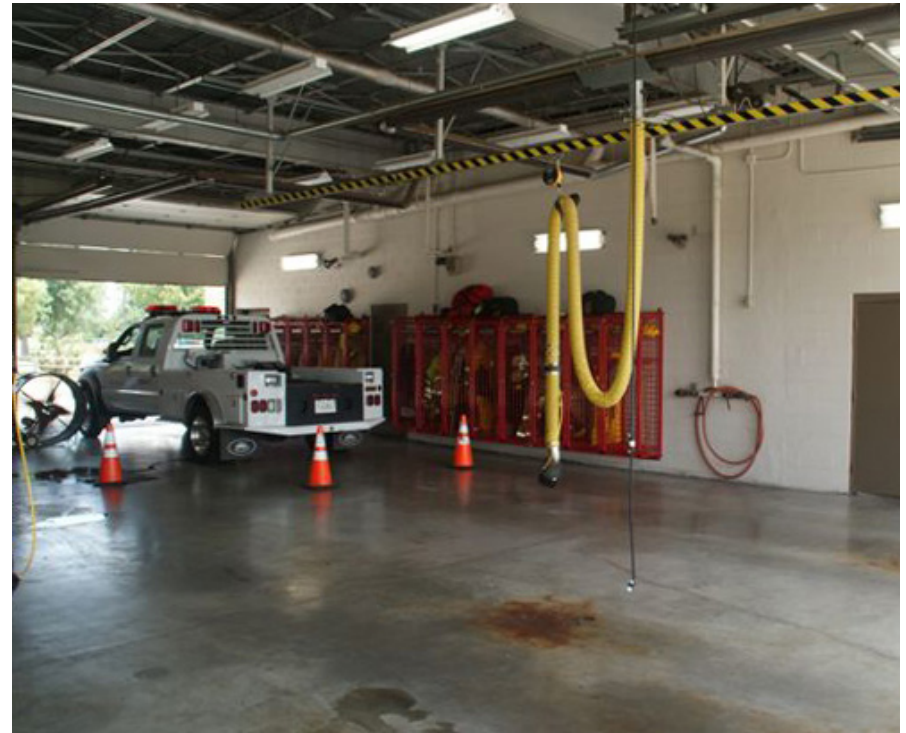
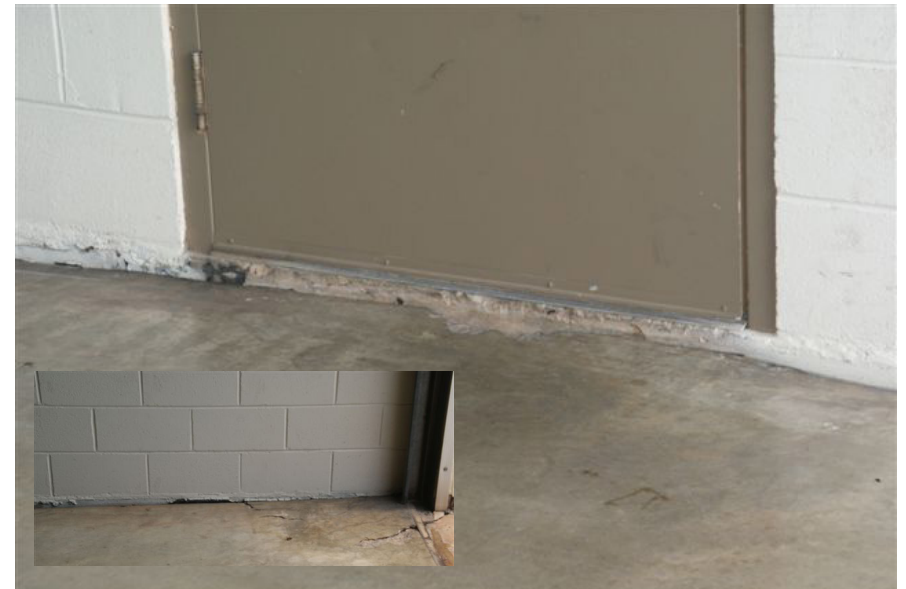
A close up of the door to the right of the lockers is shown in the bottom right hand image. This is the door from the dayroom/kitchen. Take note of how the apparatus floor appears to have settled about 2 inches. This unintended and unperceived step down creates a possible fall hazard for anyone coming from the dayroom. Conversely, the unperceived step up creates a possible trip hazard for anyone moving from the apparatus floor to the dayroom. The settlement, if actual, is most likely caused by soil shrinkage during drought periods over time.

While a raised floor elevation for the crew area is desirable in a station, an intentional difference in elevation is best taken up with a shallow sloped ramp fitted to a short hallway leading from the crew area to the apparatus floor. This solution for the grade differential is not possible at Station 3.

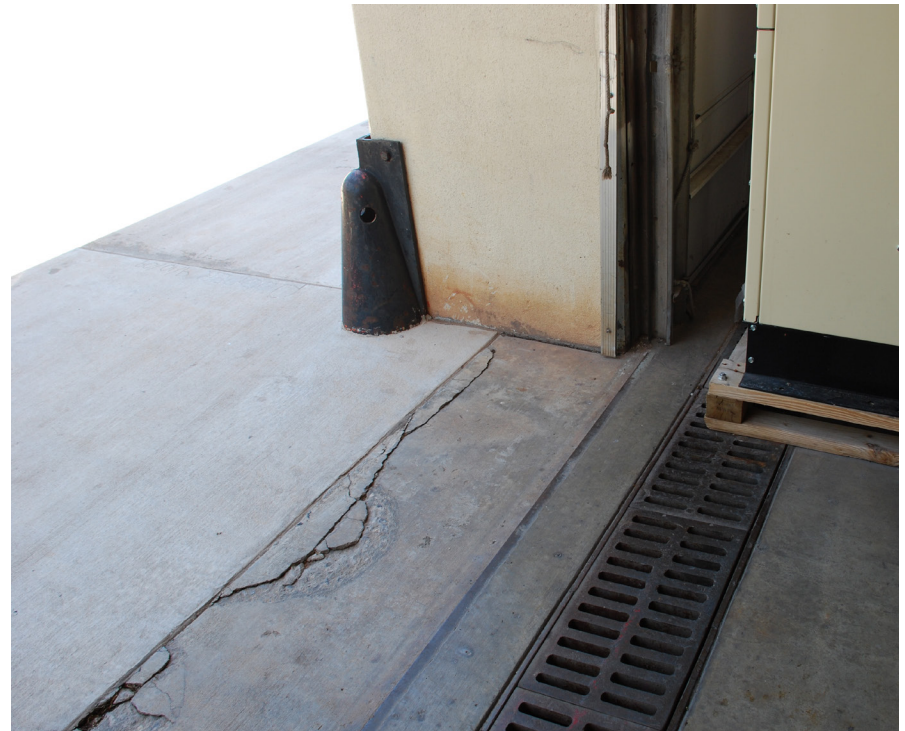
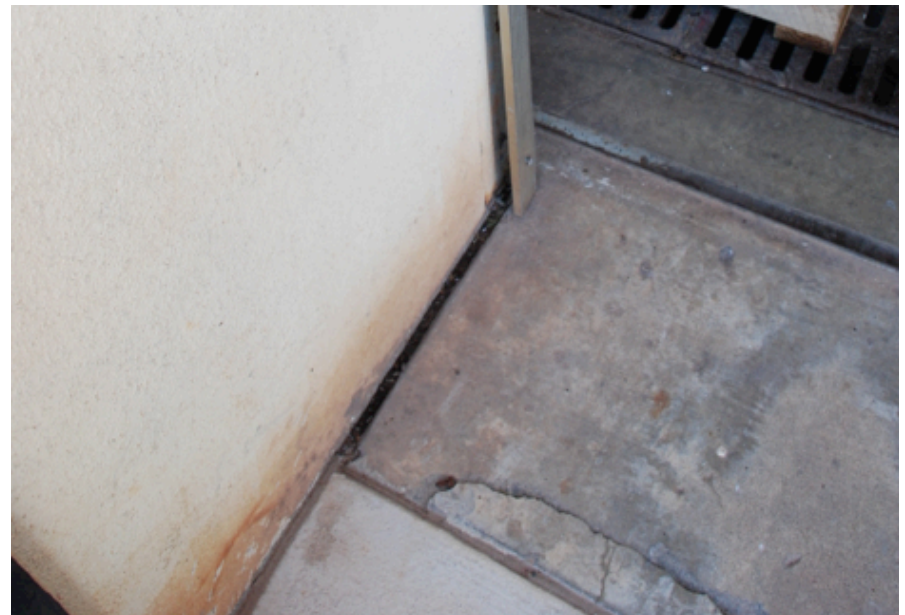
The images to the right show how the floor slab has been properly separated from the outside of the apparatus bay door by a thermal break. The spalling of the concrete on the old grade beam adjacent to the new concrete apron is most likely the result of an inadequate expansion joint thickness between the old and new concrete surfaces.

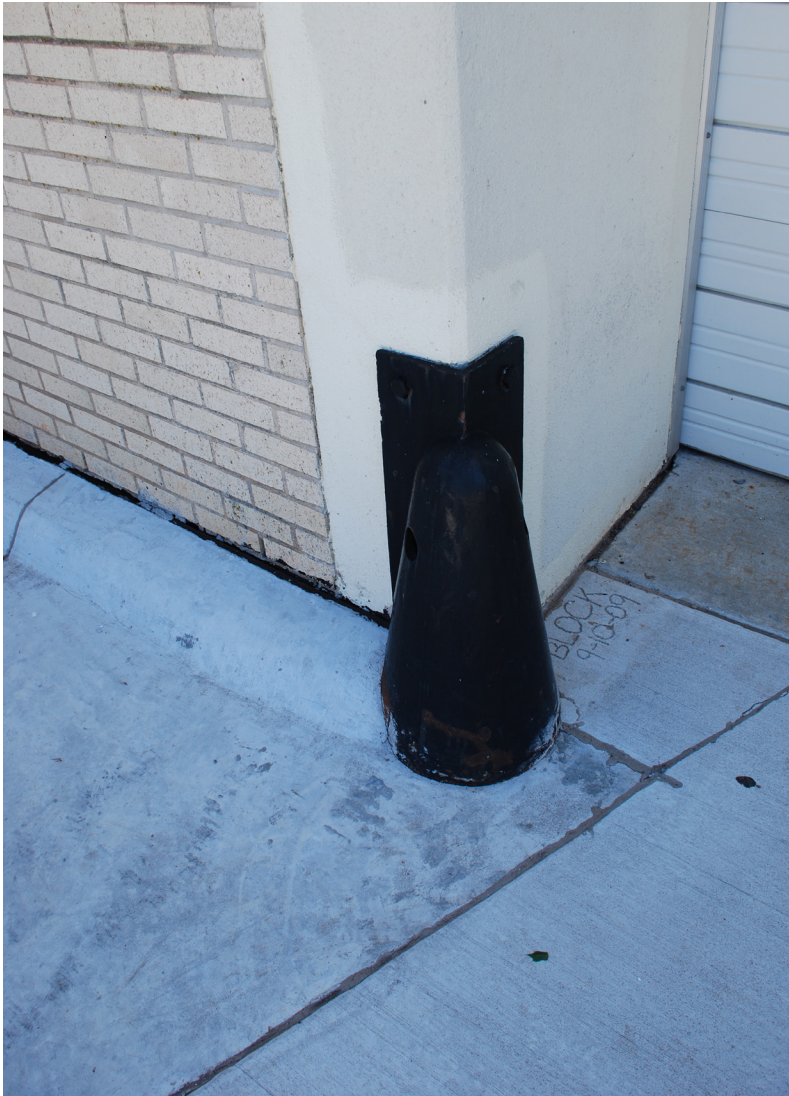
The cast steel “column protectors” at Station 3 do not adequately protect the column from impact. Does the slight difference in paint on the column reveal where a repaint has been accomplished after chip damage of the corner has been repaired? The force of a large impact could damage the structural column.

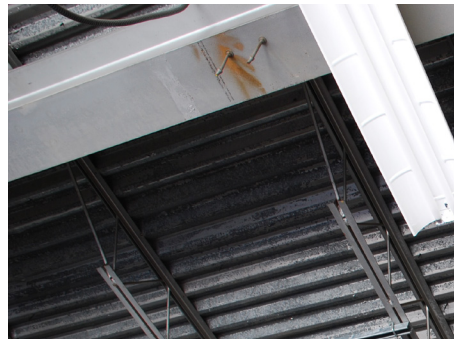
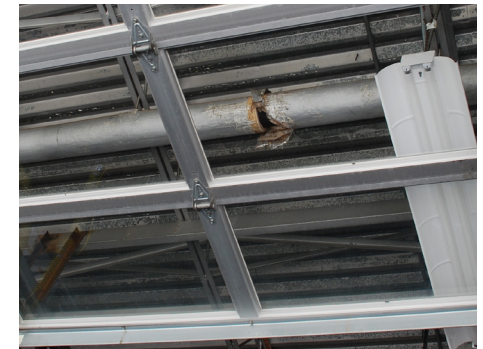
While continuing to look upward, but this time from the inside, two issues are revealed. On the left is evidence of a roof leak revealed by the stain on the steel girder. The second is broken pipe insulation.

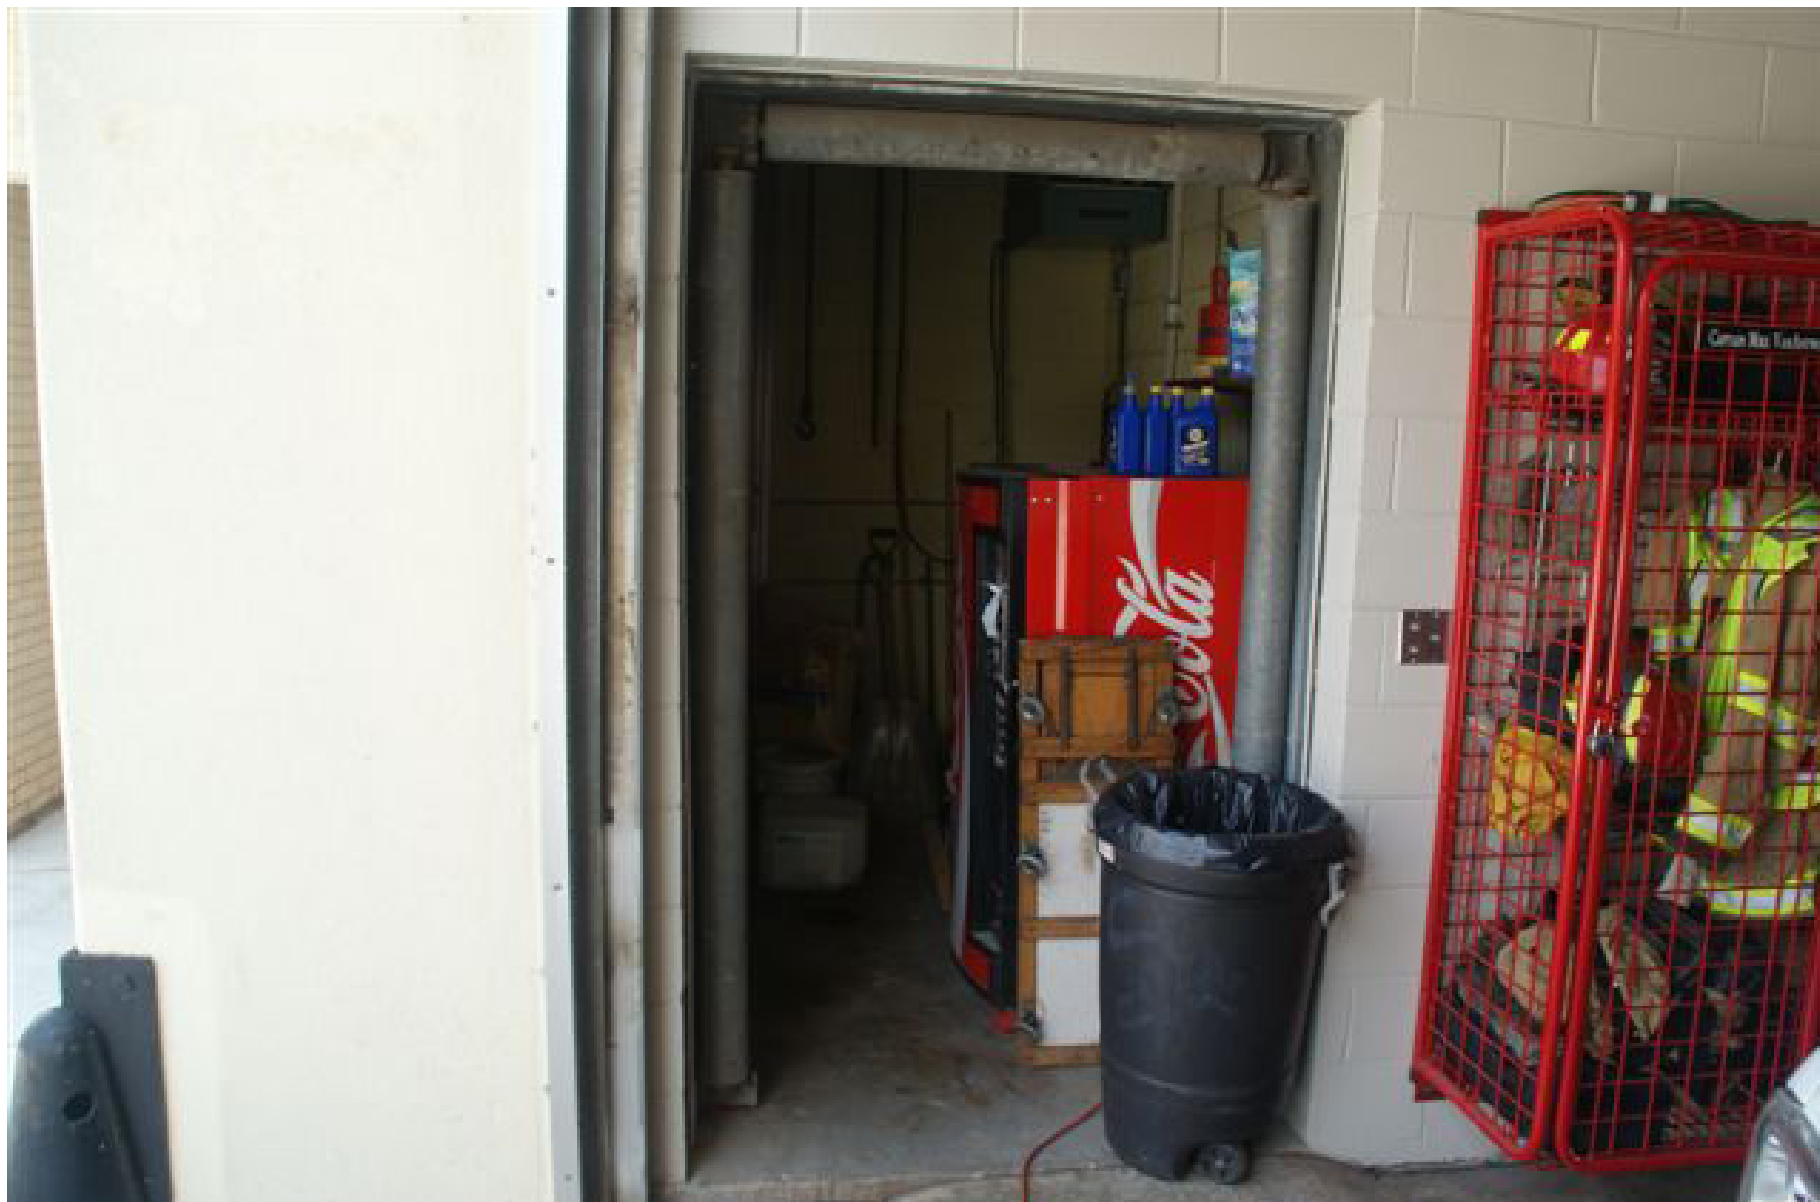
This view shows how the exiting hose drying tower is being used to house a vending machine, apparatus service equipment and other items. While recent LDH technology does not require it to be washed before repacking on the apparatus, many departments today are finding they can get longer

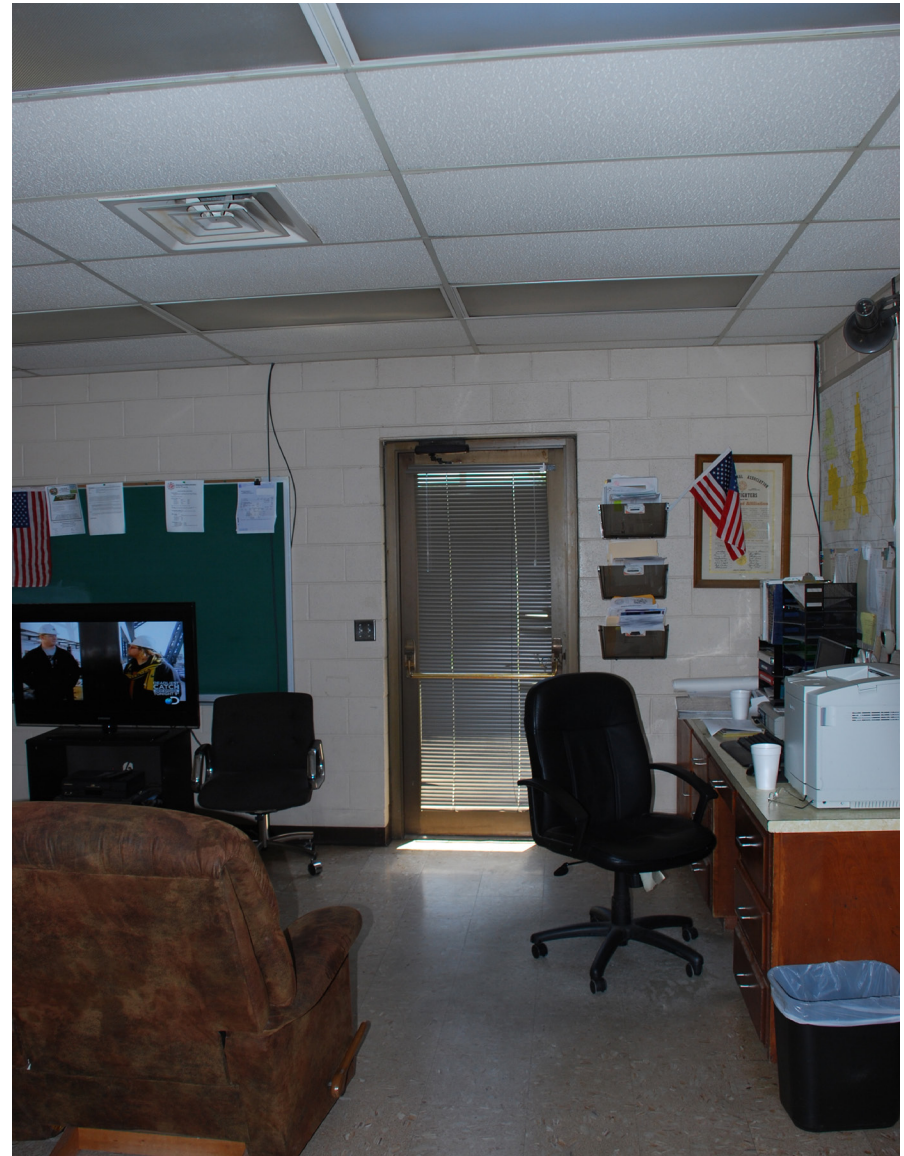
The blinds on Station 3’s front door remain drawn at all times to afford a measure of privacy for the dayroom.

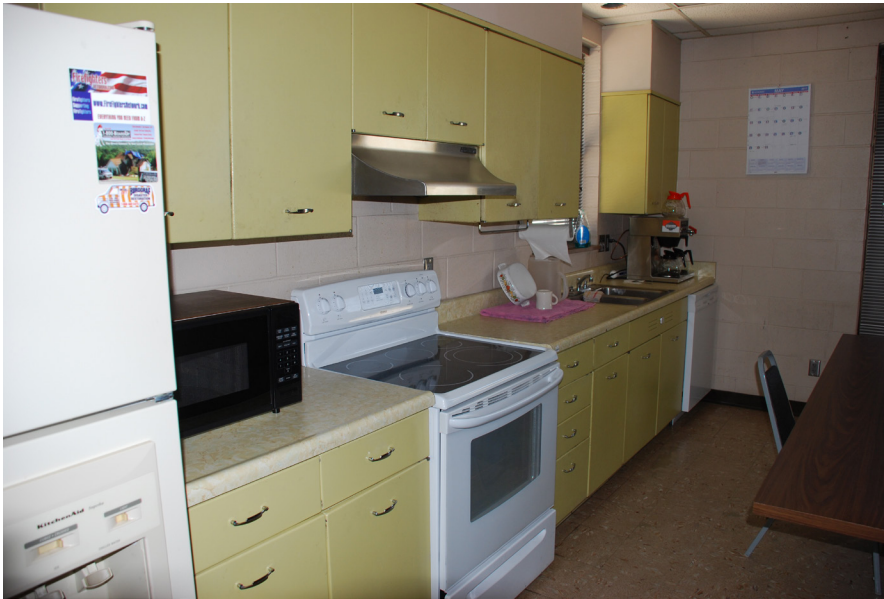
Located at the end of the dayroom opposite the watch desk is the kitchen for Station 3. The kitchen is barely adequate for the size of the duty crew. It would be totally inadequate should Shawnee Fire Department put another company in to service at Station 3 due to increases in call volume.

While there are surely several generation of appliances at Station 3, it is believed that the yellow cabinets are original to the station. There is inadequate counter top space. The hood over the range lacks a required fire suppression system. There is no shut-off “palm switch” button at the door leading to the apparatus floor from the dayroom to shut down the kitchen should an alarm have to be responded to while cooking, nor is there any remote way for the 911 dispatch center to shut down the kitchen.

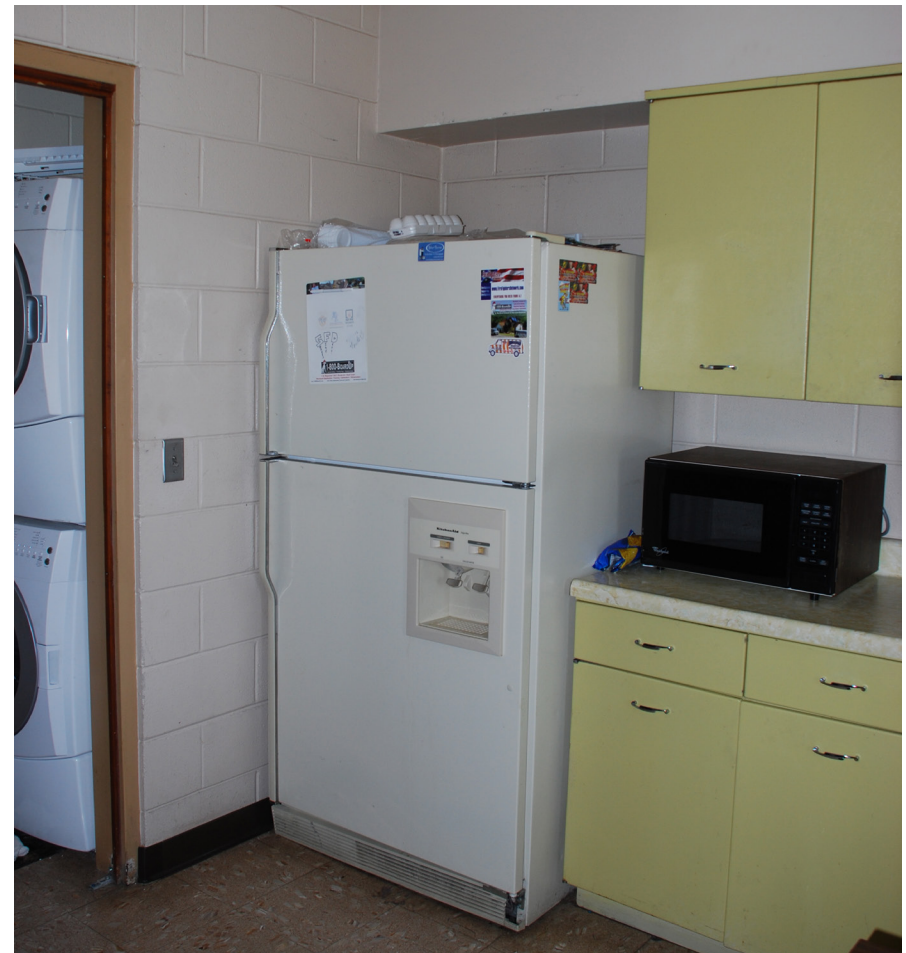
The refrigerator at Station 3 is hinged backward. It is hinged on the right. It should be hinged left so that items can be removed from the refrigerator and placed on the counter without having to work around the open door. The refrigerator capacity is inadequate for 3 “families” of 4 or 5 working at the station.

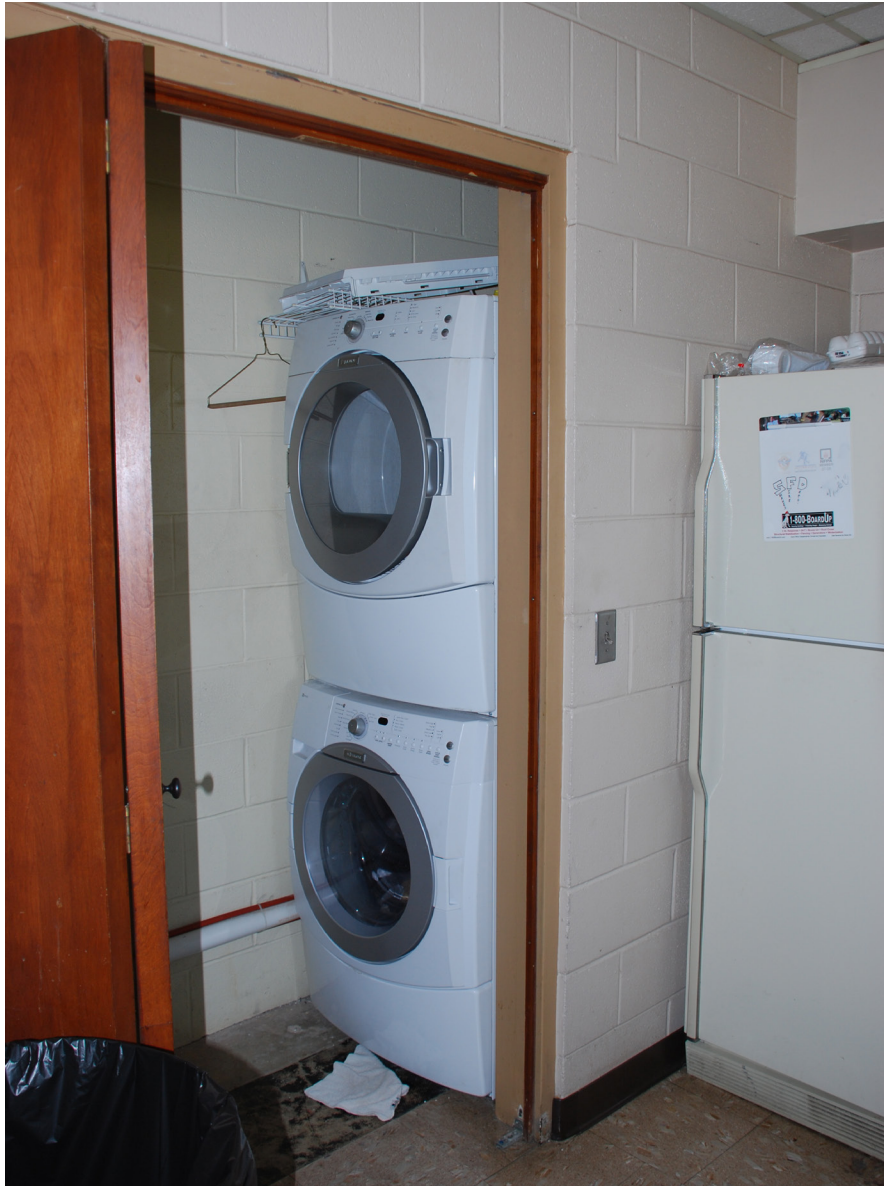
“fair game” to subsequent shifts. What was once a very adequate kitchen pantry has been converted into the station’s domestic laundry. If the building is renovated, the washer and dryer should be moved to a better location nearer the sleeping quarters as it is from that area where most of the soiled laundry is generated. The bifold doors are broken and should be repaired or completely removed.

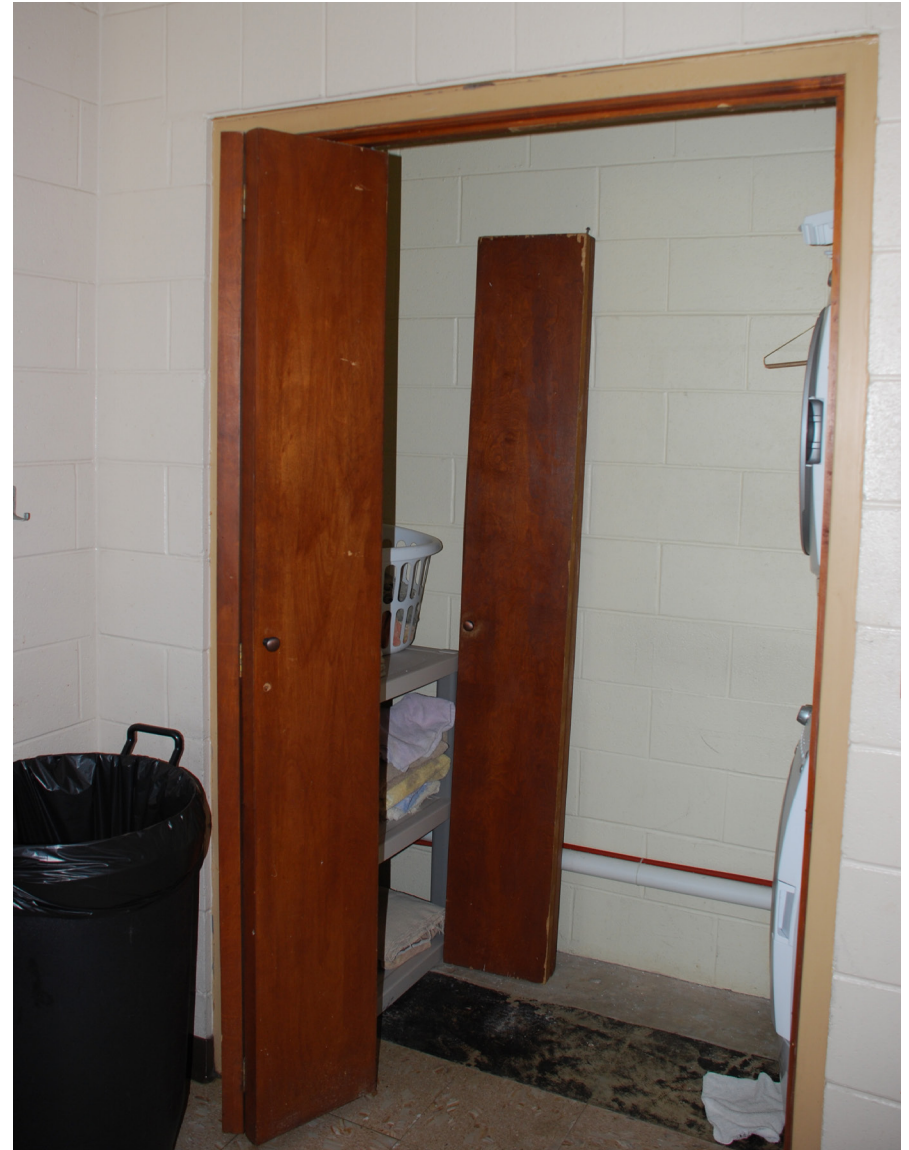
The built in “folding” table for laundry is barely adequate. Note also the unsightly kitchen waste container sitting out in the open kitchen floor space.

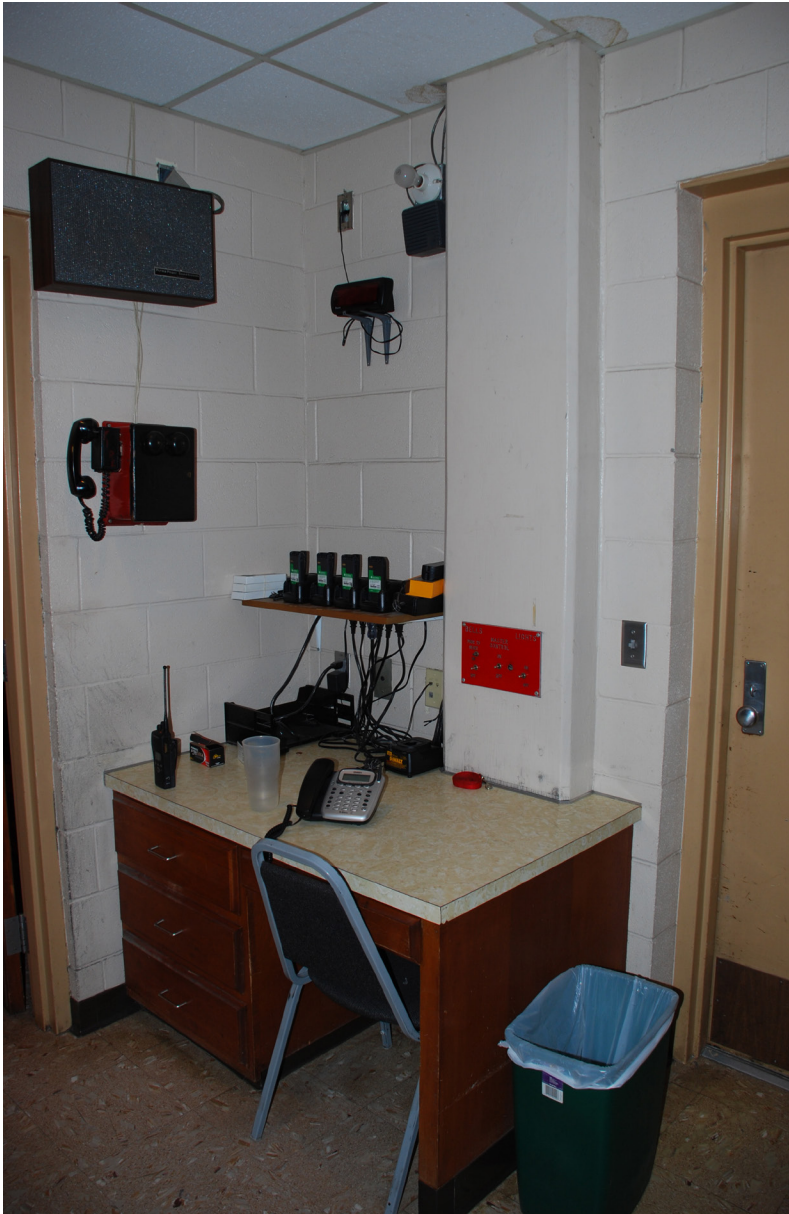
The desk in the SW corner of the dorm is used for communication equipment and radio chargers. The exit door should have a push bar rather than a door knob style latch to make a quick exit smoother for firefighters responding to calls. Note that the trash can is in the path of travel.

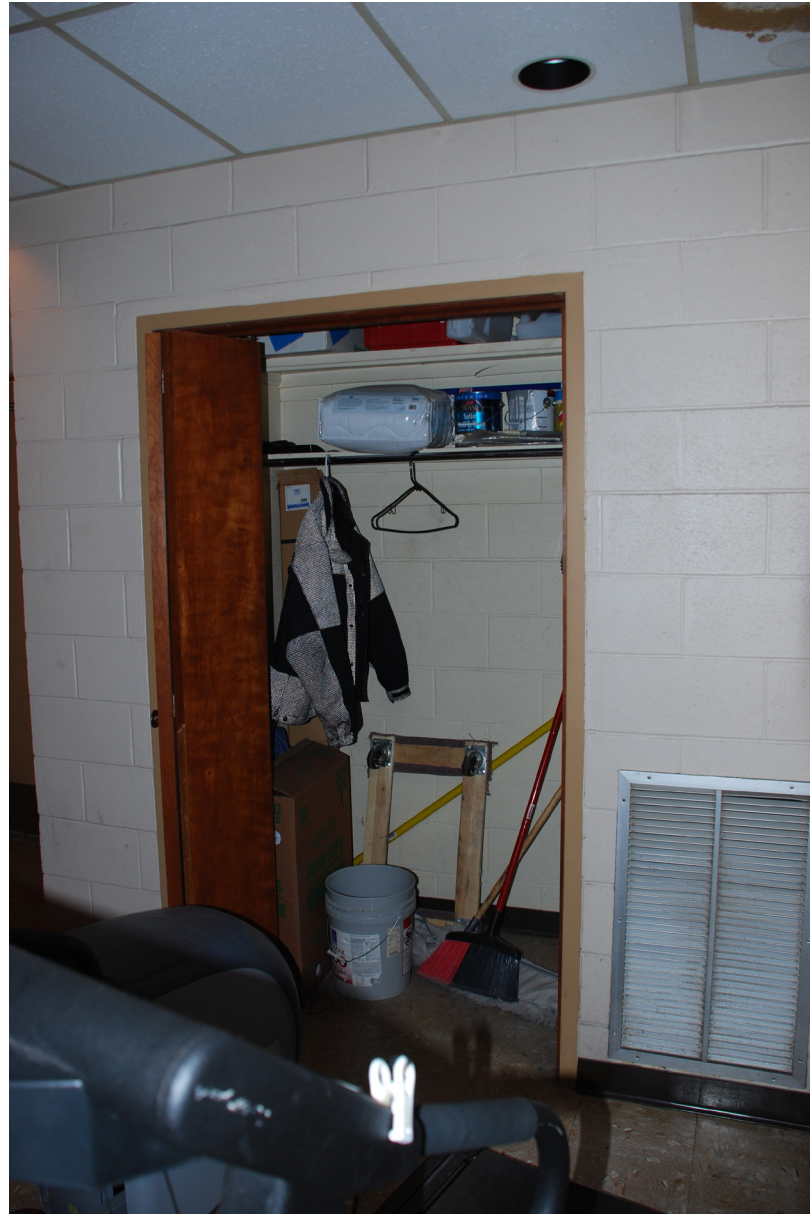
The bedroom linen closet proved inadequate for storage of bed linens for each shift. It has been converted to a janitorial closet and holds miscellaneous supplies. Any remodel should provide appropriate space for bed linens and other storage needs of the occupants.

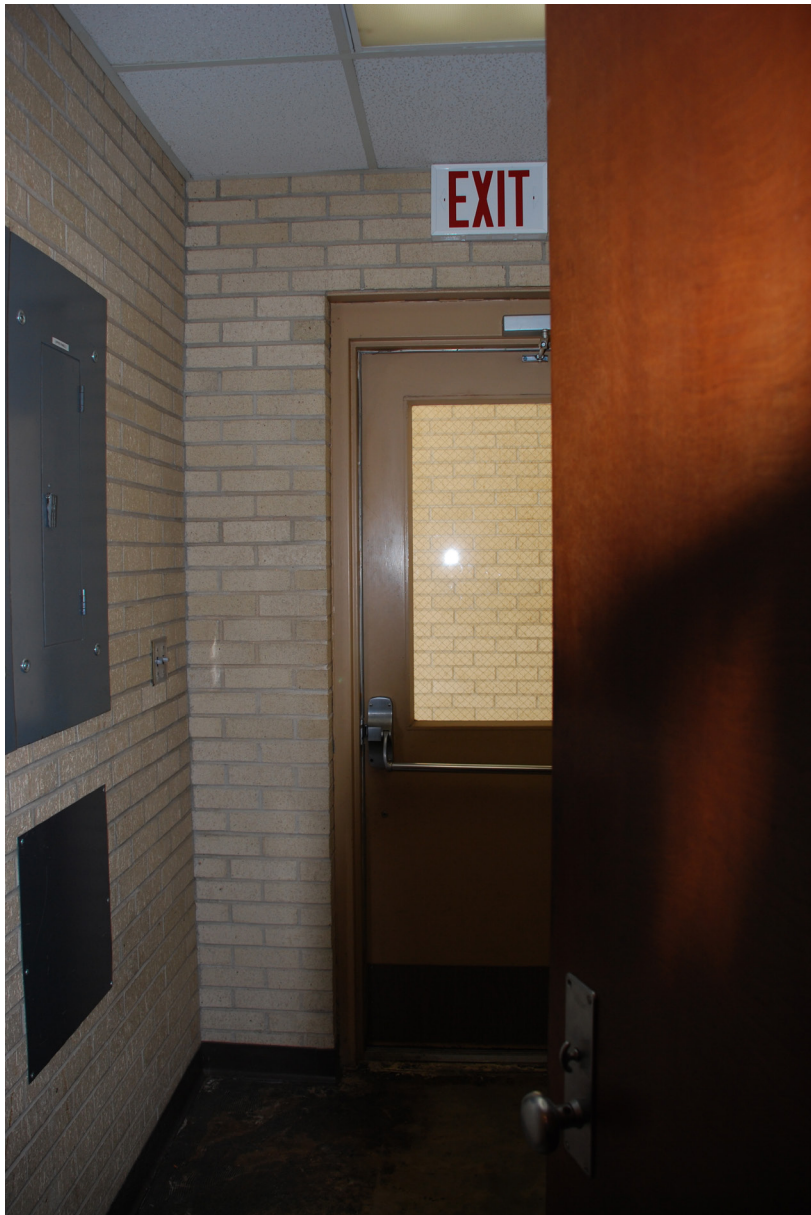
The bedroom door should be an exit door only. As this view shows, it opens to the hall leading to the back door of the station, a public entrance, allowing the public access to the bedroom. Measures should be taken to limit entrance to semi-private areas of the station. The public should not have direct access to the bedroom.
