Section06 FireStationNo.3

Background for Shawnee Fire Station 3

Assessment Commentary

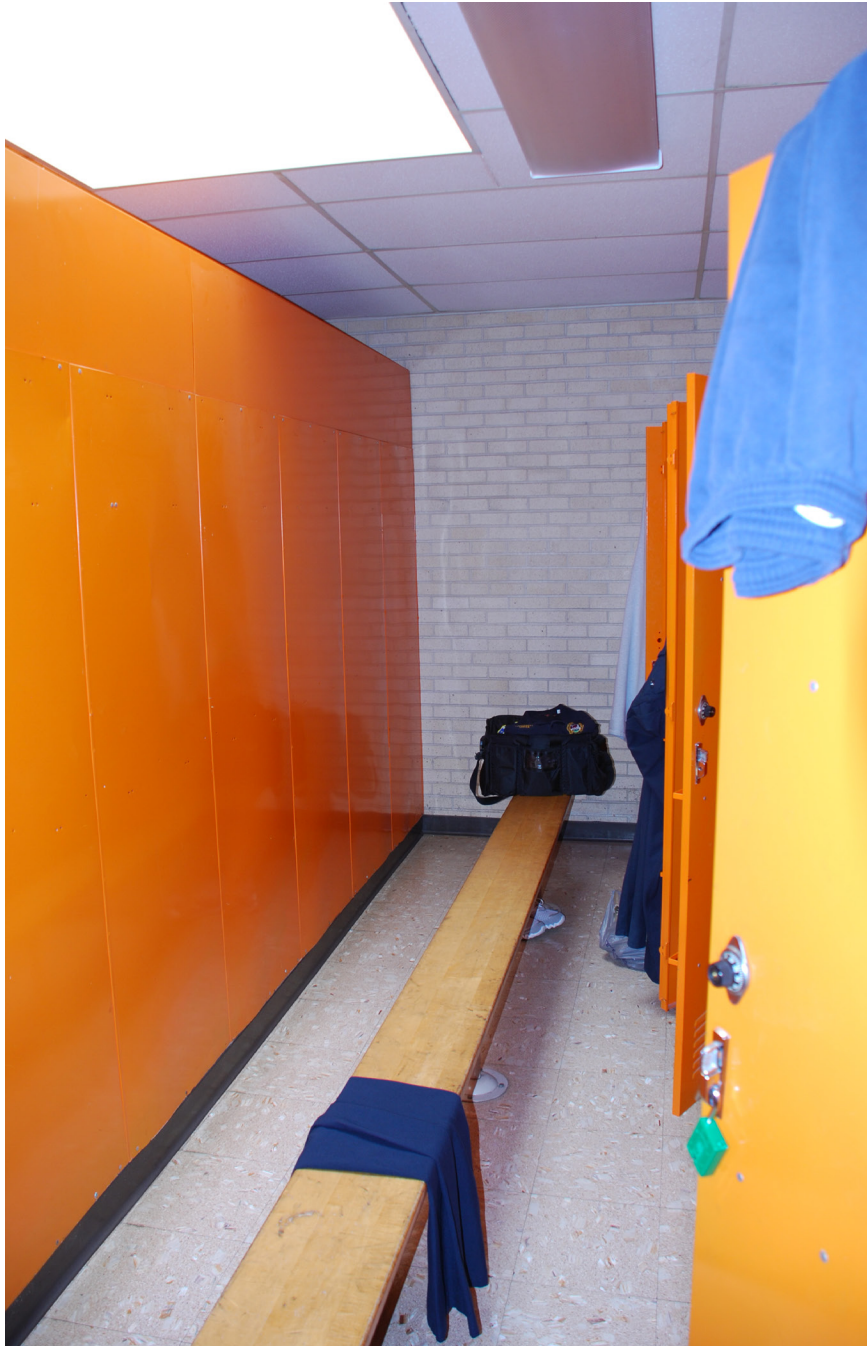
Locker rooms are by nature a private space not in the semi-private or semi-public realm. At Station 3 however, the door to the locker room has been removed, so the room cannot be isolated from the more public spaces in the station.

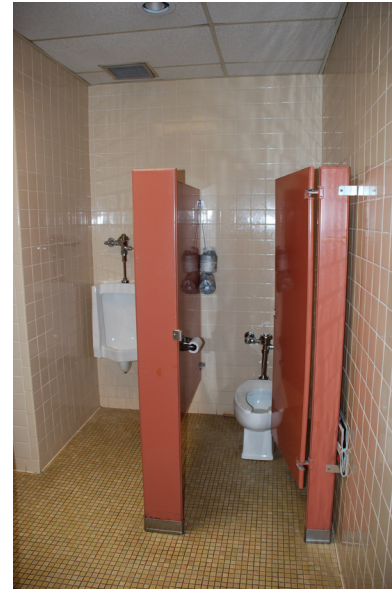
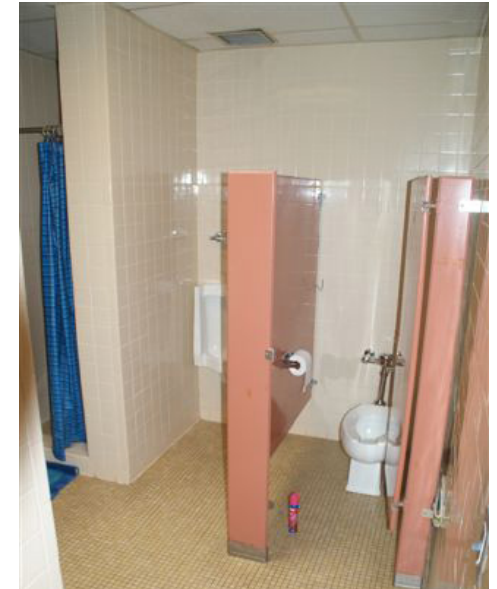
To the left is the view to the shower from the locker room. Above is the view to the single toilet provided at the station. The toilet and urinal lack automatic flush valves. It appears that ventilation is also inadequate. Lighting for the toilet stall and the shower stall is nonexistent. Two roll toilet paper dispensers are in order here.

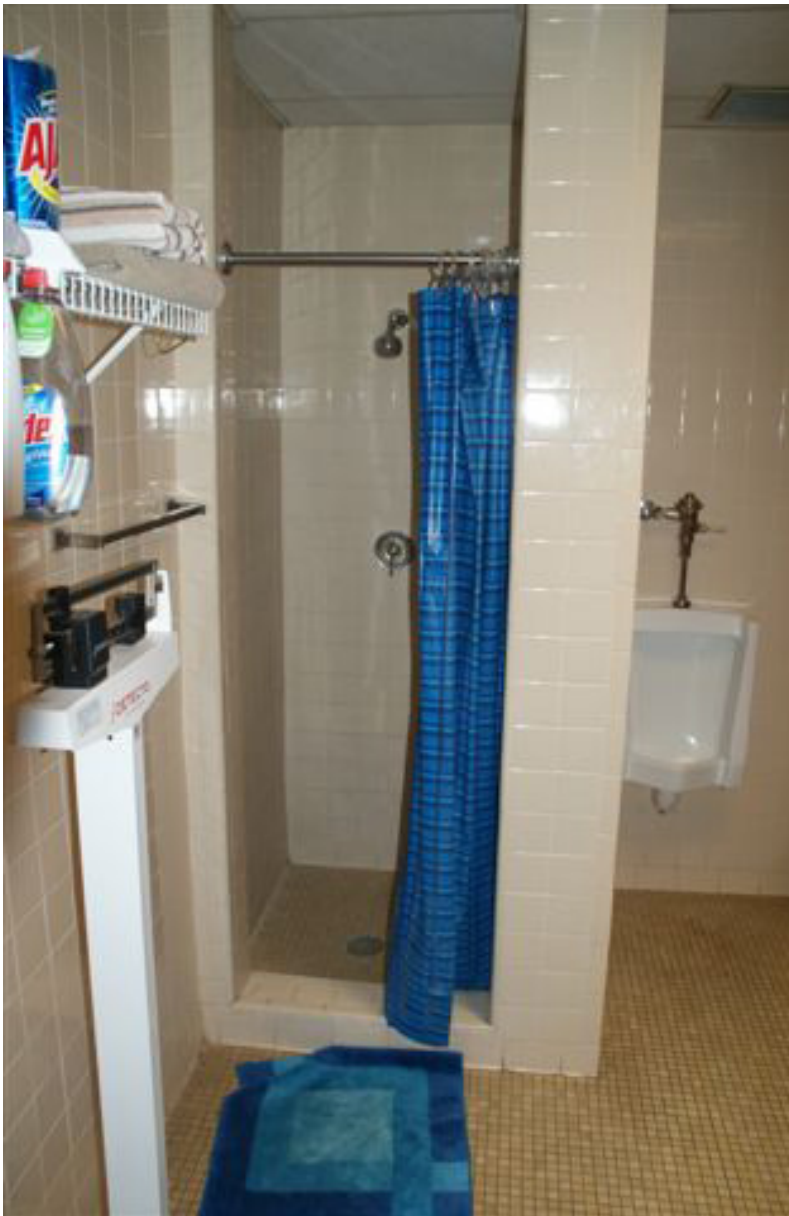
The shower is small by modern standards and lacks a toiletries shelf. Cleaning supplies should have a storage closet or cabinet. MSDS sheets should be on file for all chemicals found in the fire station including all the cleaning materials seen in the photo.

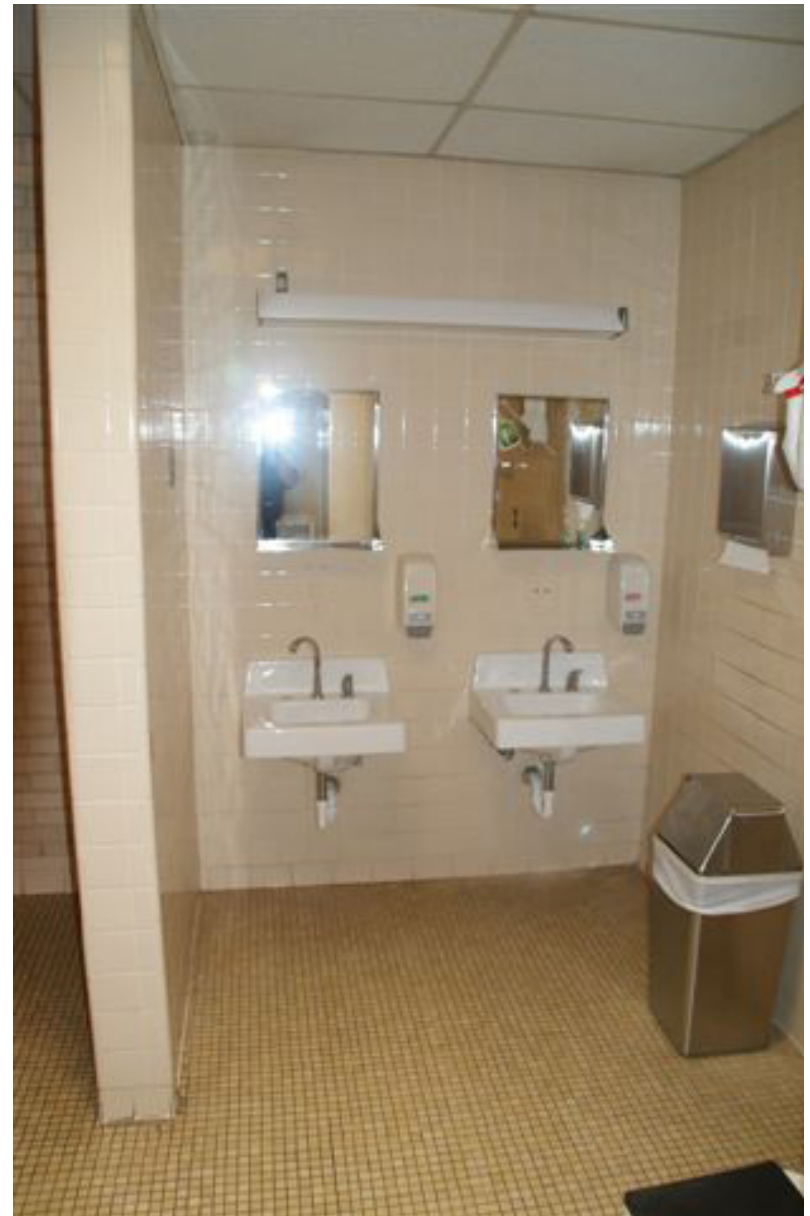
The sinks are barrier free but some modification would be needed for ADA compliance. For example, at least one mirror would need to be lowered.

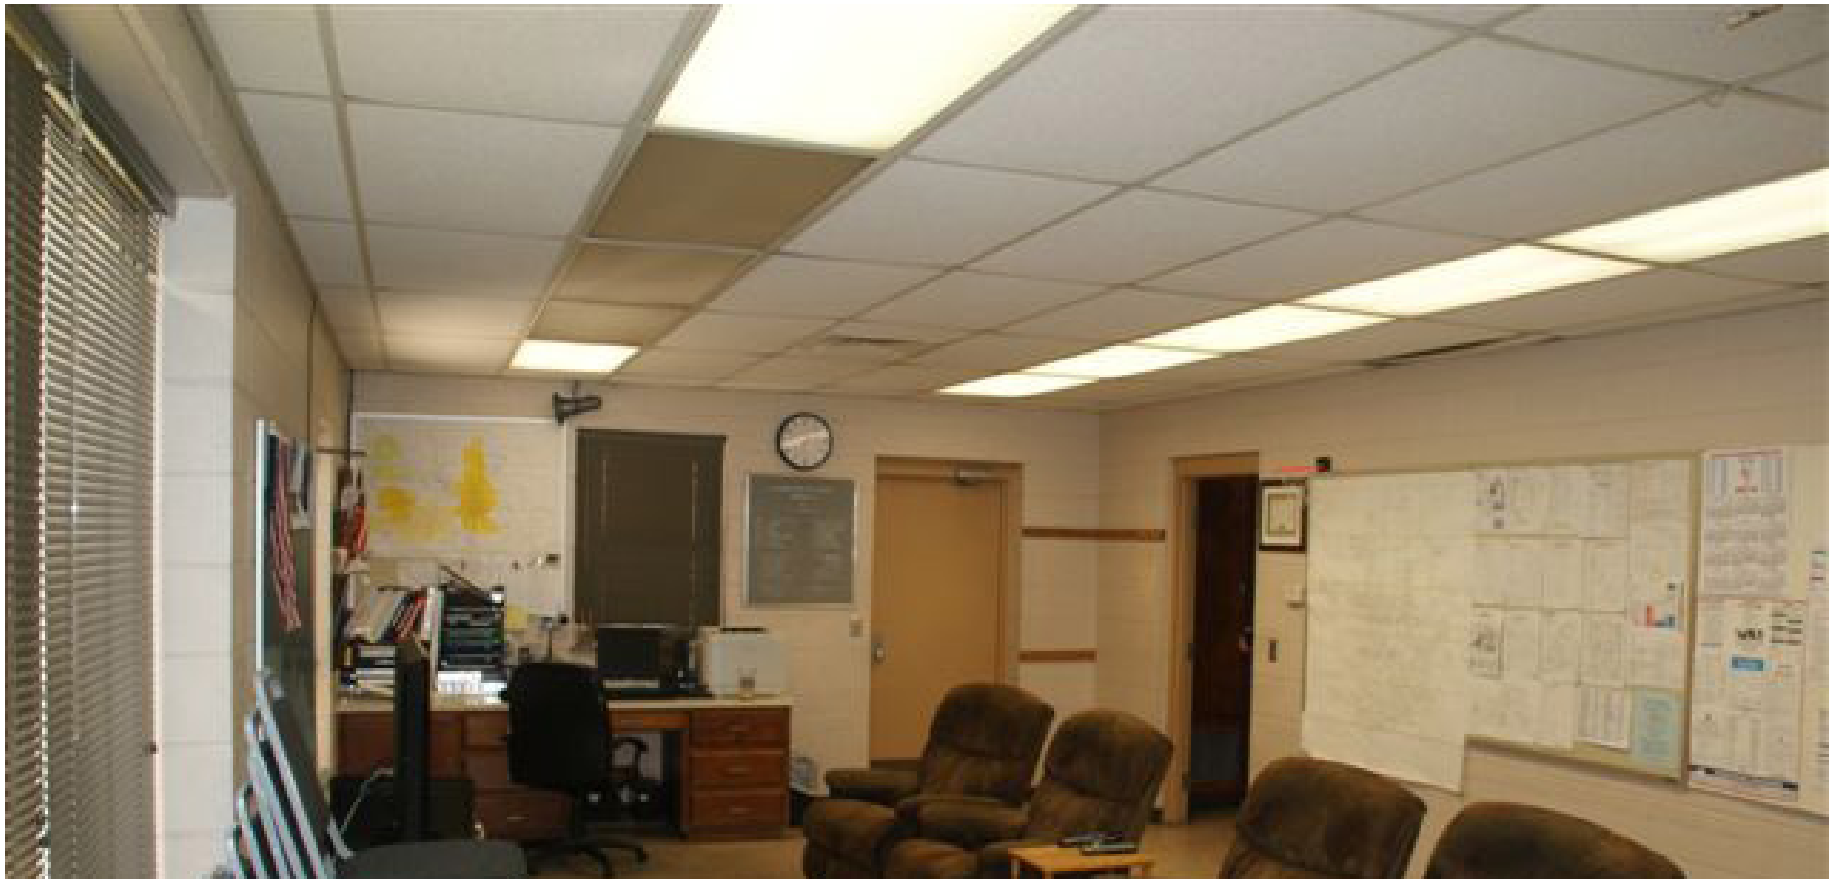
There is a short corridor connecting the dayroom with the sleeping room. Note that the door remains propped open. It no doubt interferes with travel in responding to an alarm. The door swing also makes the lockers behind the door less desirable.
