# Watertown

Main Street - Route 63 – Road Safety Audit

June 13, 2018

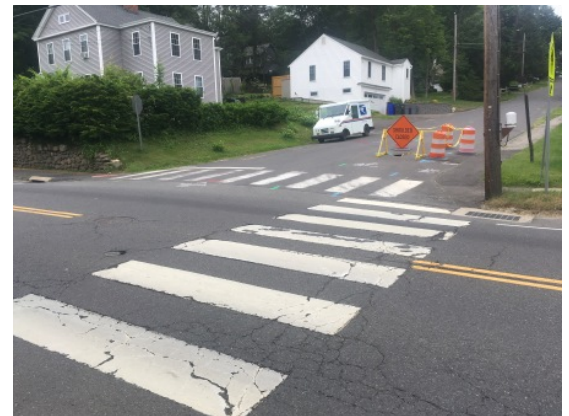
Figure 5. Sight distance impeded by pole and vegetation

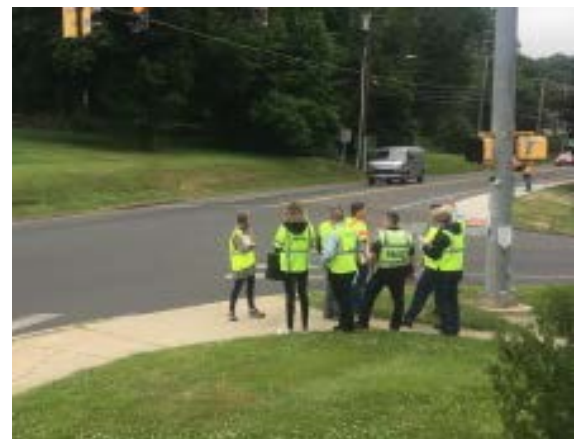
Figure 6. Intersection of Main Street and Cutler Drive/De Forest Street

- There is a sidewalk on the east side with a crosswalk and pedestrian signals. The ramp on the southwest corner is non-compliant (Figure 6). The pushbutton is also difficult to reach, and is non-compliant.
- Significant levels of truck traffic through the intersection were observed.
- There is an exclusive pedestrian phase.
- This signal is tied to the signal at Route 6 and Veterans Hill Road.
- The Town Green is located adjacent to the intersection. Several events occur at the green each year, attracting many pedestrians and much traffic to the area.
- The crosswalk on the south side of the intersection is skewed and potentially could be straightened (Figure 7).

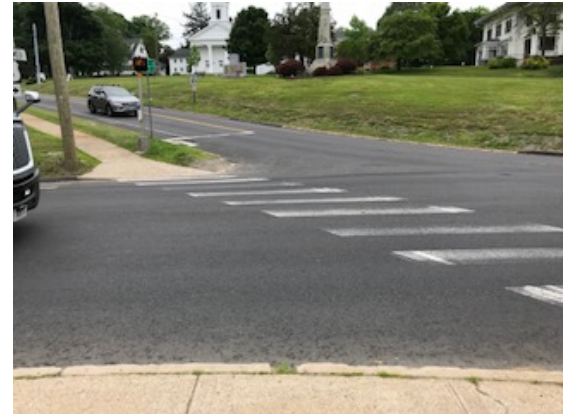
Figure 7. Skewed crosswalk

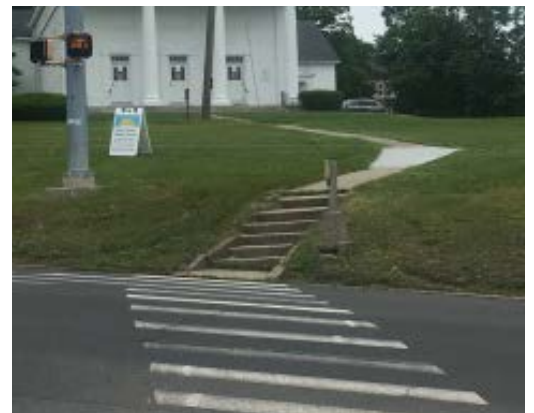
- There are crosswalks from each side of Veterans Hill Road to the opposite side of this T-intersection. The north-side landing meets a set of stairs (Figure 8) that go up-grade to a sidewalk,

Figure 8. Stairs at end of Crosswalk

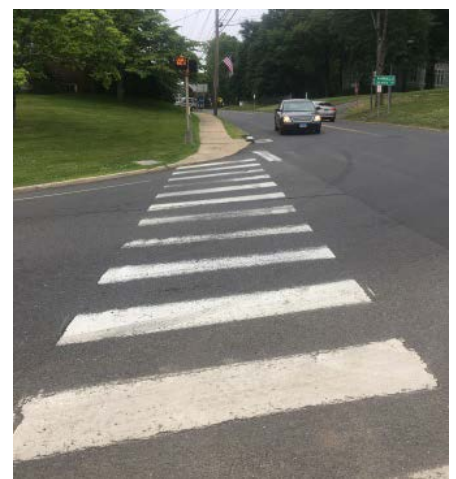
Figure 9. Crosswalk at Veterans Hill Road

which then continues uphill to other walkways. Any attempt to make the sidewalks in this area ADA compliant will require excessive grading and re-orientation of the walks. None of the landings are ADA compatible (Figure 9).

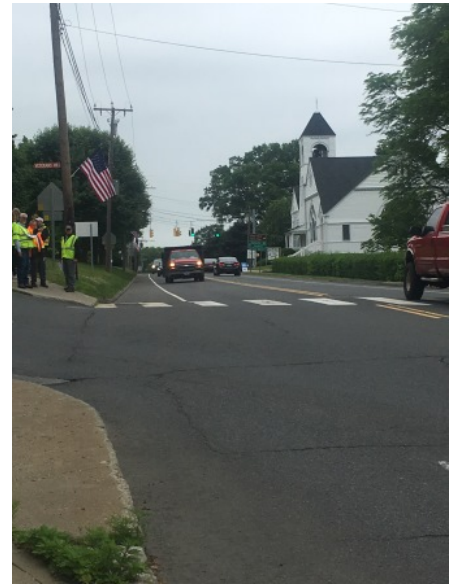
Figure 10. Steep slope approaching Main Street

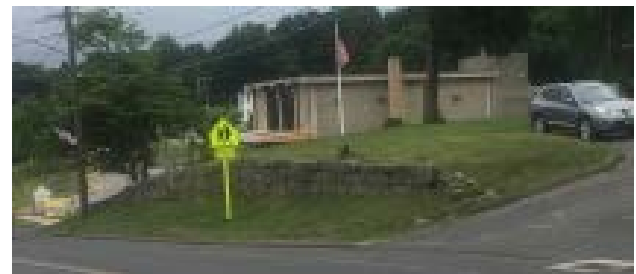
Figure 11. Steep Slope and Stone Wall

- One section of missing sidewalk on the west side is adjacent to a steep slope and stone wall. (Figure 11) Adding sidewalk at this location will be difficult due to the location of the wall and the steep slope.

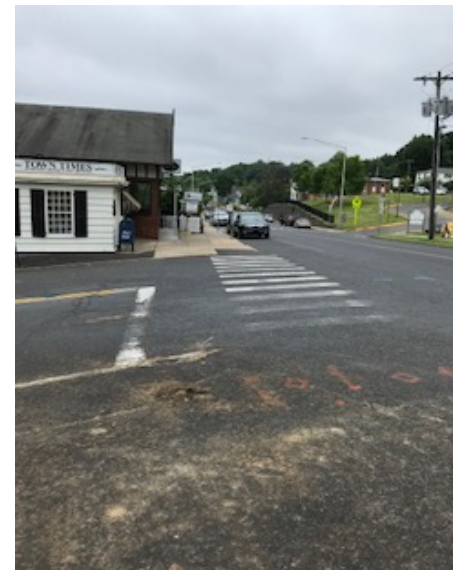
Figure 12. Sight distance at Heminway Park Road

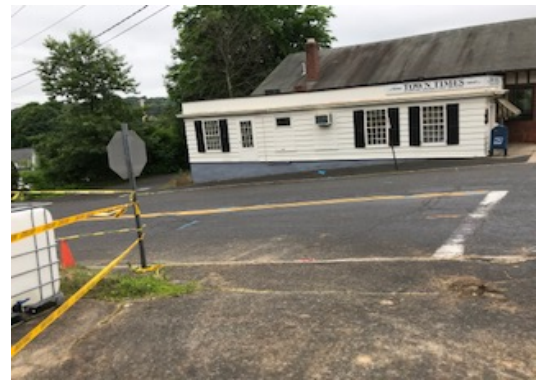
Figure 13. Stop bar and stop sign not aligned

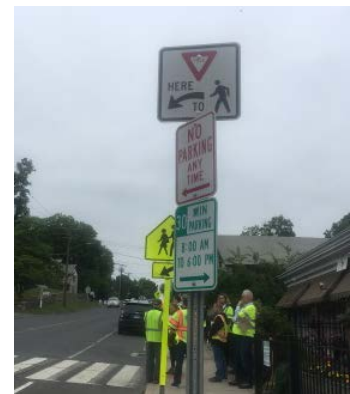
Figure 14. Sign Clutter

- The crossing is properly signed and appears to be ADA compliant. However, parking and other signs add clutter and may cause confusion (Figure 14).
- The parking lot behind the library is used by motorists who are parking for non-library trips.

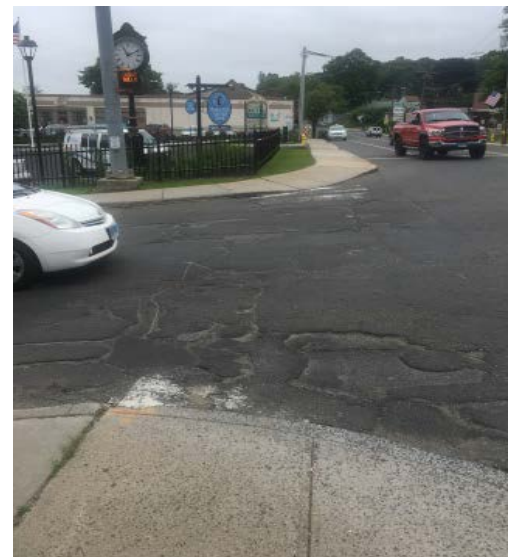
Figure 15. Faded crosswalk, poorly located pedestrian push button

- The intersection is a signalized T-intersection.
- The crosswalk across Echo Lake Road is faded (Figure 15).
- The intersection is very busy due to its proximity to an industrial park and the connection from Echo Lake Road to Route 8.
- Heavy truck traffic is present through this intersection.
- Vehicles were observed wandering out of their lanes.
  - Dotted lines are recommended to better guide drivers through the intersection.
- Echo Lake Road was noted as a major cross connection.
- The pedestrian push buttons and signals are in inconvenient locations far from the ramps (Figure 15)

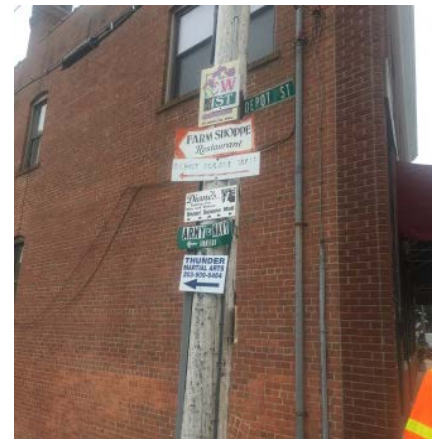
- The intersection is a stop controlled T-intersection.
- Excessive signage clutter was observed. This is mostly private signing, but is a hazard because it competes with regulatory and municipal guide signs. (Figure 16).

Figure 16. Excessive signage

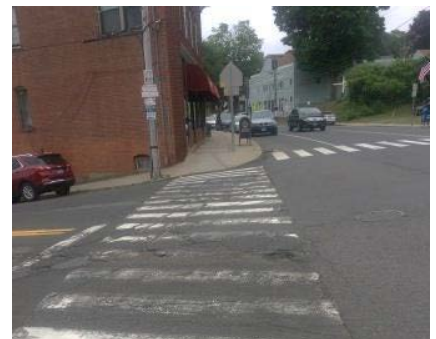
Figure 17. Sight distance at Depot St.

- Sight distance appears to be limited (Figure 17Figure 17). Parking on Main Street further restricts the sight distance.
- There is an existing municipal parking lot on Depot Street. It was observed to be half empty (Figure 18Figure 18). The town would like to add signing to direct people to this facility.
- The crosswalk on the south side of the intersection could be moved to the north side of the intersection to better align with a staircase in front of Rite Aid (Figure 19).
- There is a concrete apron north of the intersection for access to an alleyway. Parking has been allowed in front of it although CT general statutes generally prohibit parking in these locations unless the owner allows it (Figure 20).
- The ramps on the east side of Main Street are not ADA compliant. Because of the grade of Depot Street, it will be difficult to regrade the sidewalk to make them compliant.

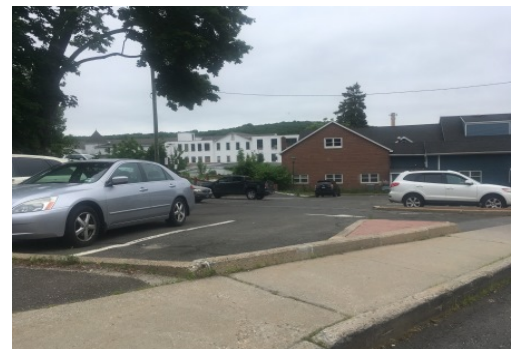
Figure 18. Lightly used parking lot

- There is a parking lot on Depot Street that is lightly used currently.
  - Signage directing drivers to the lot could be added in the short term.
- Between Woodruff Avenue and Pythian Street there are two street trees that need to be replaced.

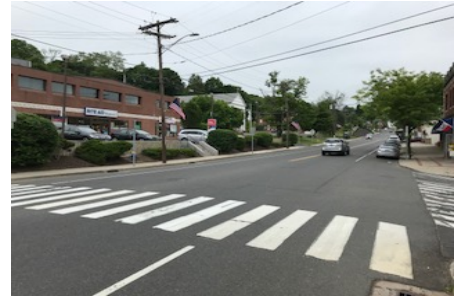
Figure 19. Crosswalks at Depot St.

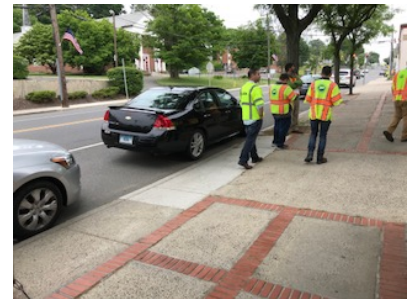
Figure 20. Apron with parking allowed

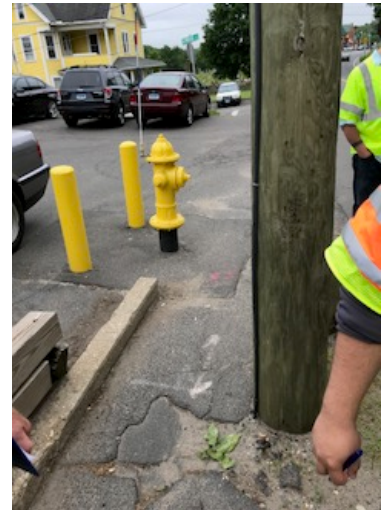
- There is a pinch point in the sidewalk just south of the intersection between a fire hydrant and a utility pole ( Figure 24).
- South of the asphalt drive, the concrete sidewalk continues to French Street.
- On the west side of the street, there is a wide shoulder, with a small curbed (too narrow to be used as a sidewalk) area adjacent to a stone retaining wall. This extends for approximately the length of the school property. There is no sidewalk south of this point to French Street.

Figure 24. Pinch point

- Northbound traffic was noted as being faster and more of a hazard.
- Sidewalk on the east side of the street near French Street could be improved by widening and upgrading sidewalk based on condition and adjusting to eliminate conflicts between sidewalk and utility poles.

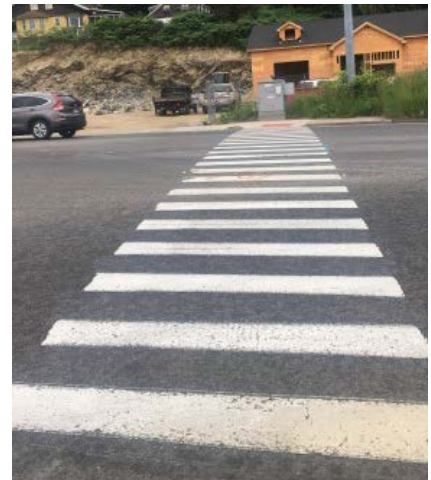
- The intersection is a signalized T-intersection.
- A Starbucks is under construction on the west side of the intersection (Figure 25).
- There is no sidewalk on the west side of the intersection (Figure 26).
  - This is expected to be a high pedestrian traffic area in the future with the construction of Starbucks.
- No right turns on red are allowed for westbound traffic on French Street.
- The intersection is very wide, resulting in a 93-foot long crosswalk across French Street and a 67-foot long crosswalk across Main Street (Figure 25).
- The intersection with Cherry Avenue is very close to the intersection with French Street.
- The acceptance lane on the north side of Main Street is very wide.

Figure 25. Long crosswalk, future Starbucks in background

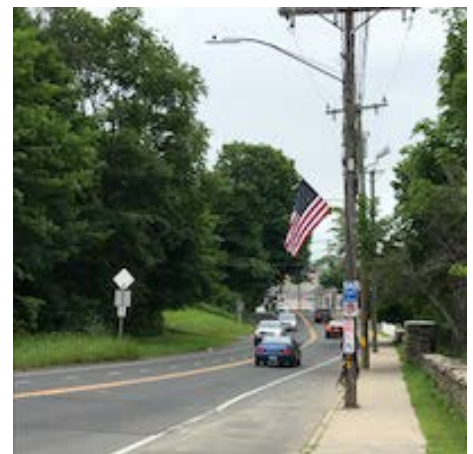
Figure 26. Sidewalk gap on west side, poles in sidewalk on east side

- Several utility poles are currently in the sidewalk (Figure 26).
- Sidewalk condition is degrading in some locations (Figure 27).
- Some of the wide sections of sidewalk could be good locations for grass strips and/or plantings.

3. Upgrade sidewalk ramps to comply with ADA requirements including tactile warning strips (Figure 40).
4. Upgrade the sidewalks based on condition and widen in areas where poles are within the sidewalk area. Use decorative elements in the sidewalk to enhance the pedestrian experience.

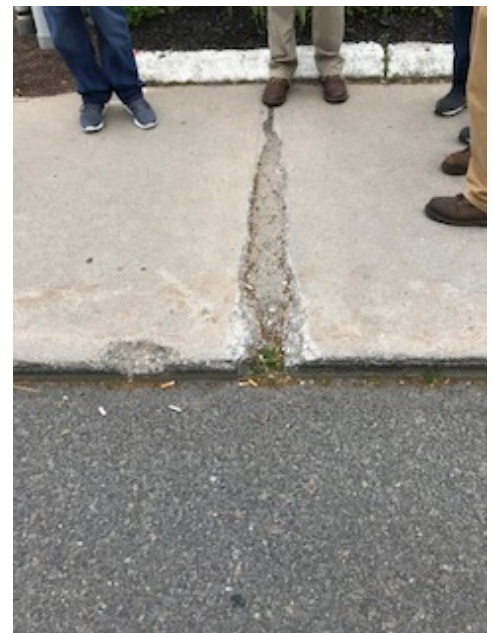
Figure 27. Degrading sidewalk condition
