January 23, 2023 REPLACEMENT OF BRIDGE NO. 04409 WOOLSON STREET OVER STEELE BROOK STATE PROJECT NO. 9153-4409

ADDENDUM NO. 3

Routine Inspection 8/09/2021

Inspection type: Routine Inspection Date: 8/09/2021 Inspected by: Team 1 :Bridge No 04409

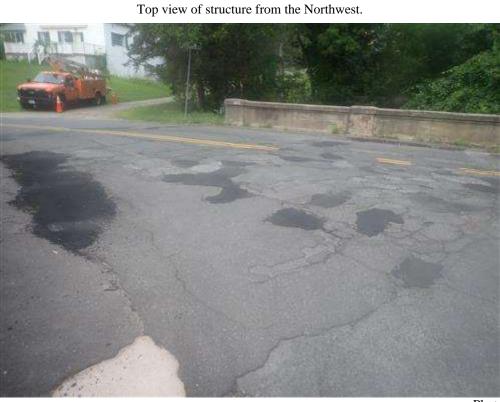
Photo Number: 2 Photo Taken: 08/09/2021
General bituminous concrete wearing surface with numerous patches and cracks.

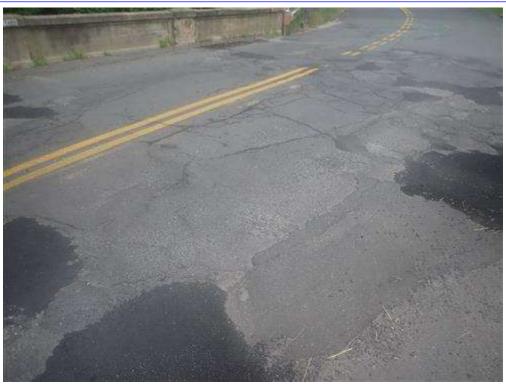
Photo Number: 3 Photo Taken: 08/09/2021
A closer view of the bituminous concrete wearing surface.

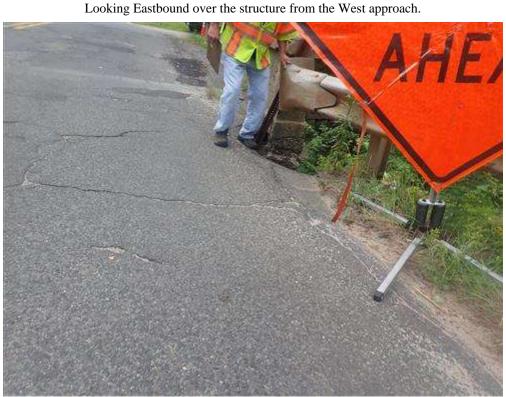
Photo Number: 6 Photo Taken: 08/09/2021 Lead inspector investigating undermining of Bituminous concrete at the Northwest corner of structure.

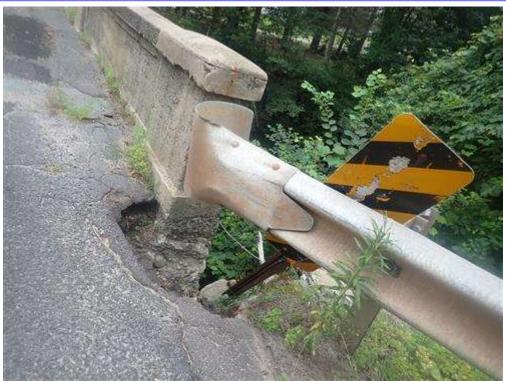
Photo Number: 7 Photo Taken: 08/09/2021 View of the undermining of roadway at the Northwest corner.

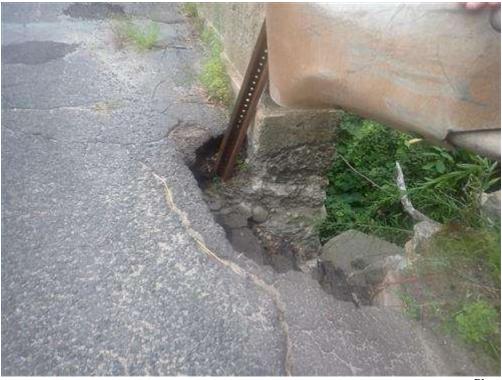
Photo Number: 8 Photo Taken: 08/09/2021
A closer view of the undermining of roadway at the Northwest corner.

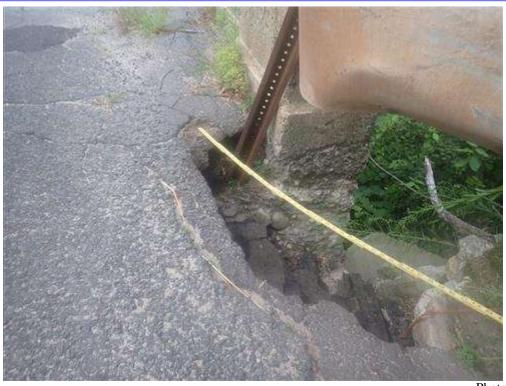
Photo Number: 9 Photo Taken: 08/09/2021
Wooden stick ruler measuring the length of undermining of the bituminous at the Northwest corner

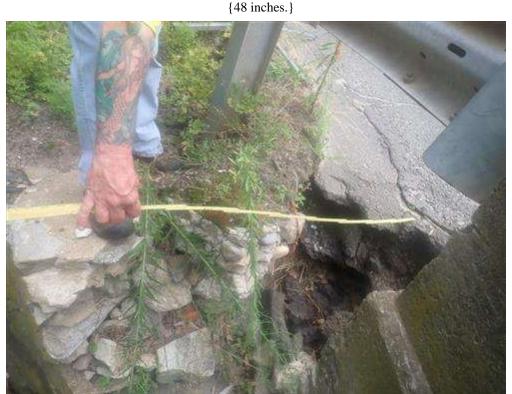
Photo Number: 10 Photo Taken: 08/09/2021

Lead inspector measuring the width of undermining of roadway at the Northwest corner. {15 inches.}

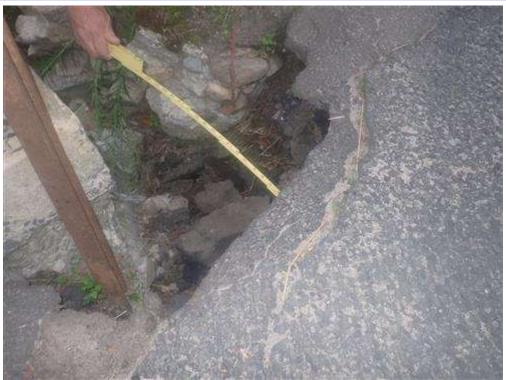
Photo Number: 11 Photo Taken: 08/09/2021 Lead inspector measuring depth of the undermining of roadway at the Northwest corner of structure. {28 inches.}

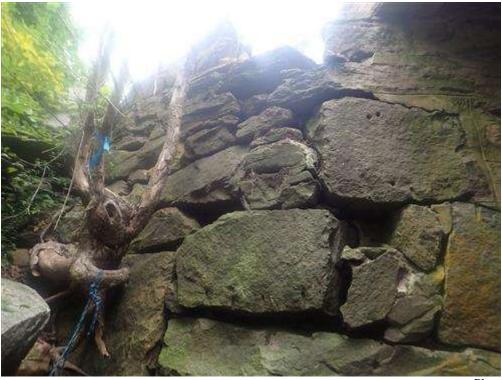
Wingwall 2B has a section of cap missing 48" long x 15" wide x 28" deep, below this area the vertical face has \pm 100 sf of loose and shifting stones.
Piers/Bents - Caps: 5	Concrete pier exhibits: The pier has moderate moss growth and heavy efflorescence with rust stains from previous leakages. There is moderate graffiti on west face of pier.
	Areas of medium to heavy scale up to 26" high along base.
	The base step out portions have up to 36" long x 9" high x up to 7" deep severe scaling and voids up to 10" long x 8" high x 7" deep.
	Pier Nose has heavy scaling up to 36" long x 16" high x 3" deep and up to 60" long x 9" high x up to 9" deep at the step out base.
	Random diaphragms have horizontal cracks with efflorescence and a 10" long x 3" high x 1.5" deep spall in bay 7, span 2.
Piers/Bents - Pile Bent: N	
Piers/Bents - Columns: N	
Piers/Bents - Footings: 6	Pier Scour walls/footings: Footing shows light to medium scale thru-out with pockets of heavy scale.

Photo Number: 14 Photo Taken: 08/09/2021 Loose and missing stones at the top Northeast wing-wall {2-A} adjacent to undermining of roadway at the Northwest corner.

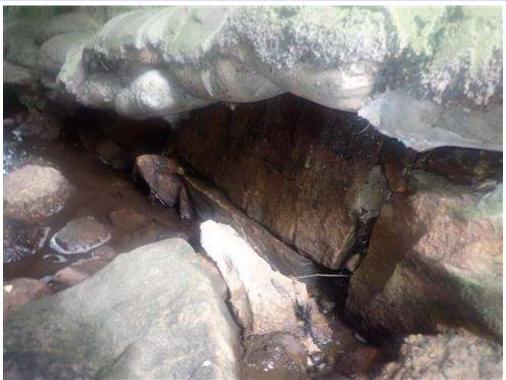
Photo Number: 21 Photo Taken: 08/09/2021

Void at the base of abutment # 1 near the inlet end.

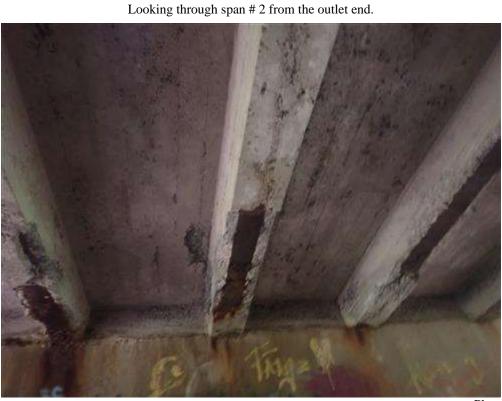
Stringers: N	
Girders: 5	There are 10 {span # 1} and 11 {span # 2} concrete encased I-beams which exhibit: Concrete encasements are missing at numerous locations exposing the bottom flanges and isolated webs of the girders.
	Exposed bottom flanges of the I-beams have laminar rust (negligible section loss) at random locations.
	Concrete encasements have light moss growth, numerous longitudinal cracks, horizontal cracks open up to 1/2" wide, some with efflorescence at random locations.
	Moderate to heavy scaling up to full height and full length (span 2, beam 3 south face) at random locations.
	Hollow areas up to full length x full width (span 1, beam 4 bottom flange).
	There are encasement spalls up to full-length x full width x 2" deep (span 2, beam 8 bottom flange).
Floor Beams: N	
Trusses - General: N	
Trusses - Portals: N	
Trusses - Bracing: N	
Paint: N	
Rust: 4	See Above.
Machinery Movable Span: N

Photo Number: 26 Photo Taken: 08/09/2021 Typical missing concrete at the bottom flange's of beams in span # 2.

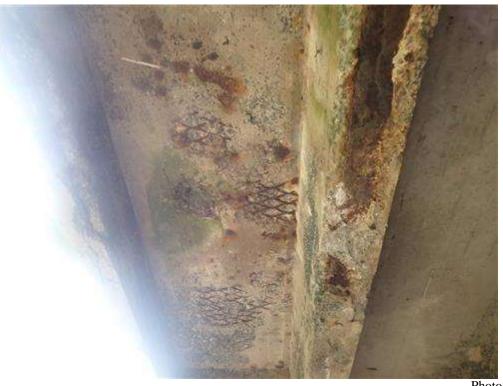
Photo Number: 27 Photo Taken: 08/09/2021 Rust stains and discoloration in the underside of the last bay in span # 2. {Underside of the sidewalk at South side.}

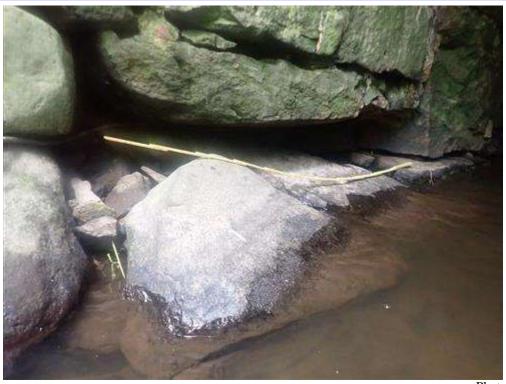
inlet end exposing the base stone, base stones exhibit random voids and shifting stones.
	Abutment # 2 on the north end has an area at the base of displaced stones 6' long x 21" high x up to 44" deep with and adjacent 30 sf area of loose and shifting stones with voids up to 21" deep.
Abutments - Backwall: 6	Concrete end diaphragms exhibit: Moderate to heavy scaling with light efflorescence and random horizontal cracks with and without efflorescence.
	There are edge spalls around the utility in bay 7 of span 1.
Abutments - Footings: 4	See "Abutment-Stem" item above.
Abutments - Settlement: 4	See "Abutments-Wingwalls" item below.
Abutments - Wingwalls: 3	Masonry wingwalls exhibit: Wingwalls have light moss growth and loose/missing joint mortars.
	There are voids in the masonry up to 2' long x 8" high x 28" deep.
	Wingwall 1B is missing stones with voids up to 13" high x 15" wide x 20" deep.
	Wingwalls 1B & 2A has heavy vegetation and vine growth.

Photo Number: 29 Photo Taken: 08/09/2021 Six foot the length of large void at the base of abutment # 2 near the inlet end.

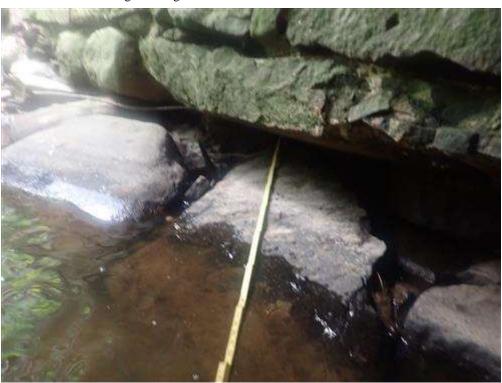
Photo Number: 30 Photo Taken: 08/09/2021 Stick ruler measuring the depth of void near the inlet end of abutment # 2.
