ENGINEER'S REPORT

DRAINAGE DISTRICT NO. 341

WEBSTER COUNTY, IOWA

MAIN DITCH REPAIRS

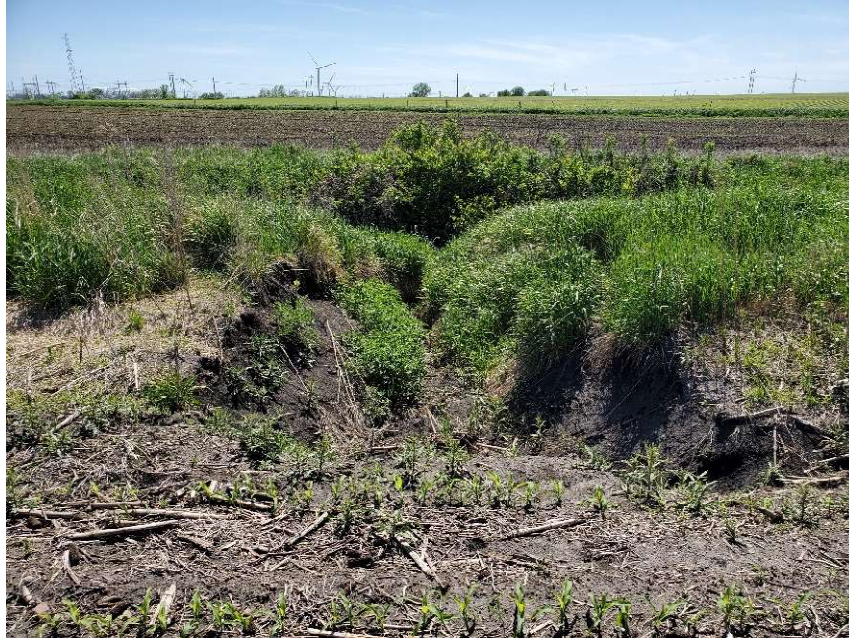
Image 1: Example erosion caused by surface water eroding from above the ditch bank. This failure is commonly referred to as a head cut.

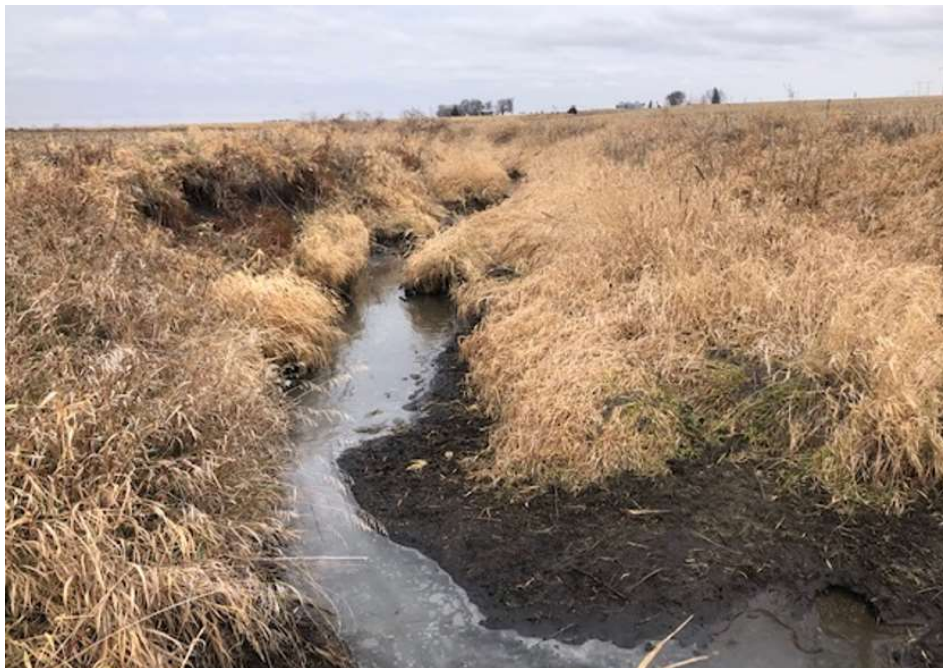
Multiple areas were noted with continuous meandering. Failed side slopes often deposit soil into the side of a ditch then those deposits will divert the water flow around it, into a soft sideslope eroding the opposite bank and depositing silt downstream. Left unattended, these meanders will reduce ditch capacity and could erode out of the ditch right of way.

Image 2: Example of meandering and silt accumulation. The sideslope on the right side of the image has sloughed into the ditch and caused the creek to meander and erode the bank on the left side.

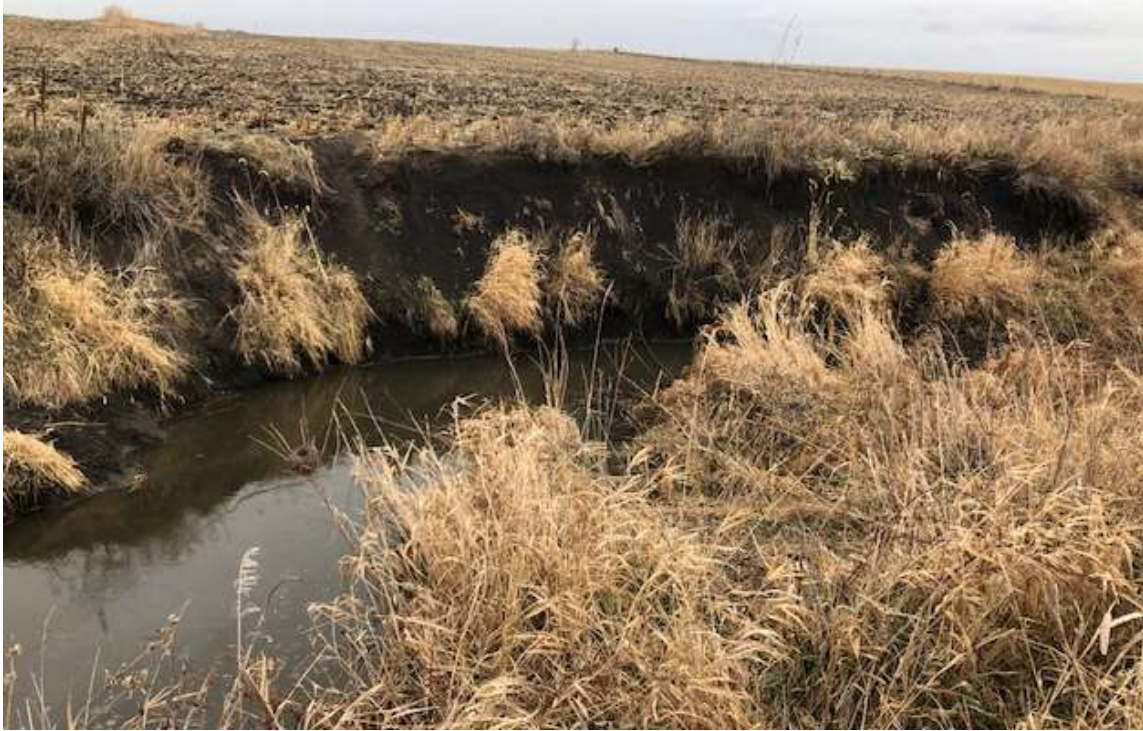
Image 3: Example erosion caused by meandering

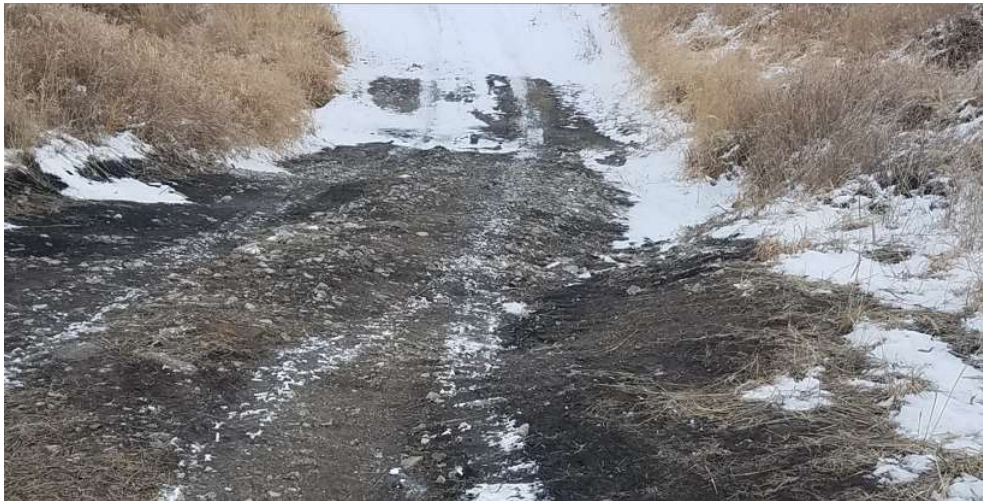
One unique feature on this stretch of ditch is the low water crossing at the north-south $\frac{1}{2}$ quarter section line between the W/1/2 SW1/4 NE1/4 and the E/1/2 SW1/4 NE1/4. It is unclear how it was originally constructed however the existing conditions show a partially rock, soil path. If not properly maintained, this may be another source of erosion during heavy rainstorm events, eventually leading to the downstream portion of the ditch. Maintenance of private farm crossings are typically the responsibility of the individual landowner(s) to maintain, and those maintenance records were not immediately available.

Image 4: Low water crossing of rock and soil

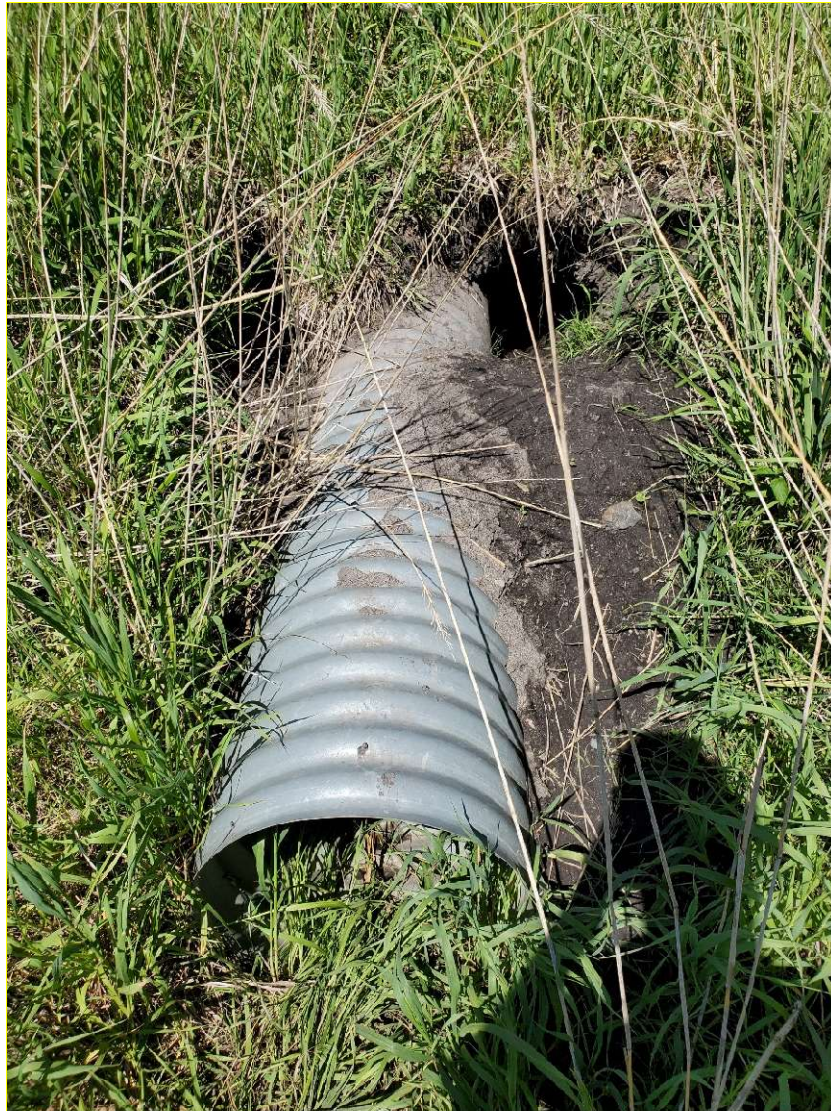
One pipe was noted just upstream of the concerned area that appears to be undersized and is allowing water to wash on either side of the pipe. This should be upsized and have an anti-seep collar placed at the midpoint of the pipe run to prevent water bypassing and opening a cavity on either side as shown in the image below.

Image 5: Pipe with bypass erosion

The proposed repair also consists of replacing all outlet pipes in fair or poor condition with corrugated metal pipe (CMP) and establishing supportive surrounding material. The CMP outlet pipe material is typically durable during Iowa's seasons for both surface drains and sub-surface drains when installed correctly and properly maintained. We recommend installing a minimum of 12" CMP on all outlets regardless of small size to reduce the risk of pipe failure due to differences in manufacturing techniques for smaller sized pipe. We also recommend installing rip rap with engineering fabric beneath the outlet to reduce the chances of future washouts on the side slope around the pipe. Several surface drains and their respective aprons are proposed to be added, after coordination with the adjacent landowner, to better capture surface water flowing towards the ditch from those lands. The upper end of these near the field would be marked with PVC pipe identifiers.
