ENGINEER'S REPORT

DRAINAGE DISTRICT NO. 34

HEADWALL INVESTIGATION

WEBSTER COUNTY, IOWA

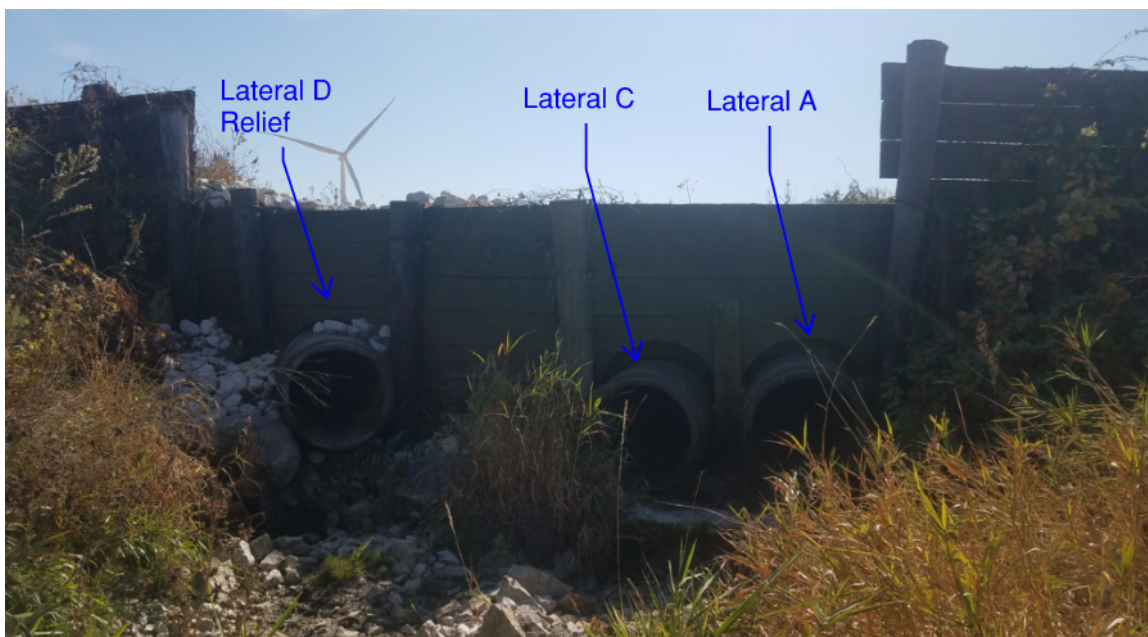
Figure 1: Headwall outlets from a south facing view

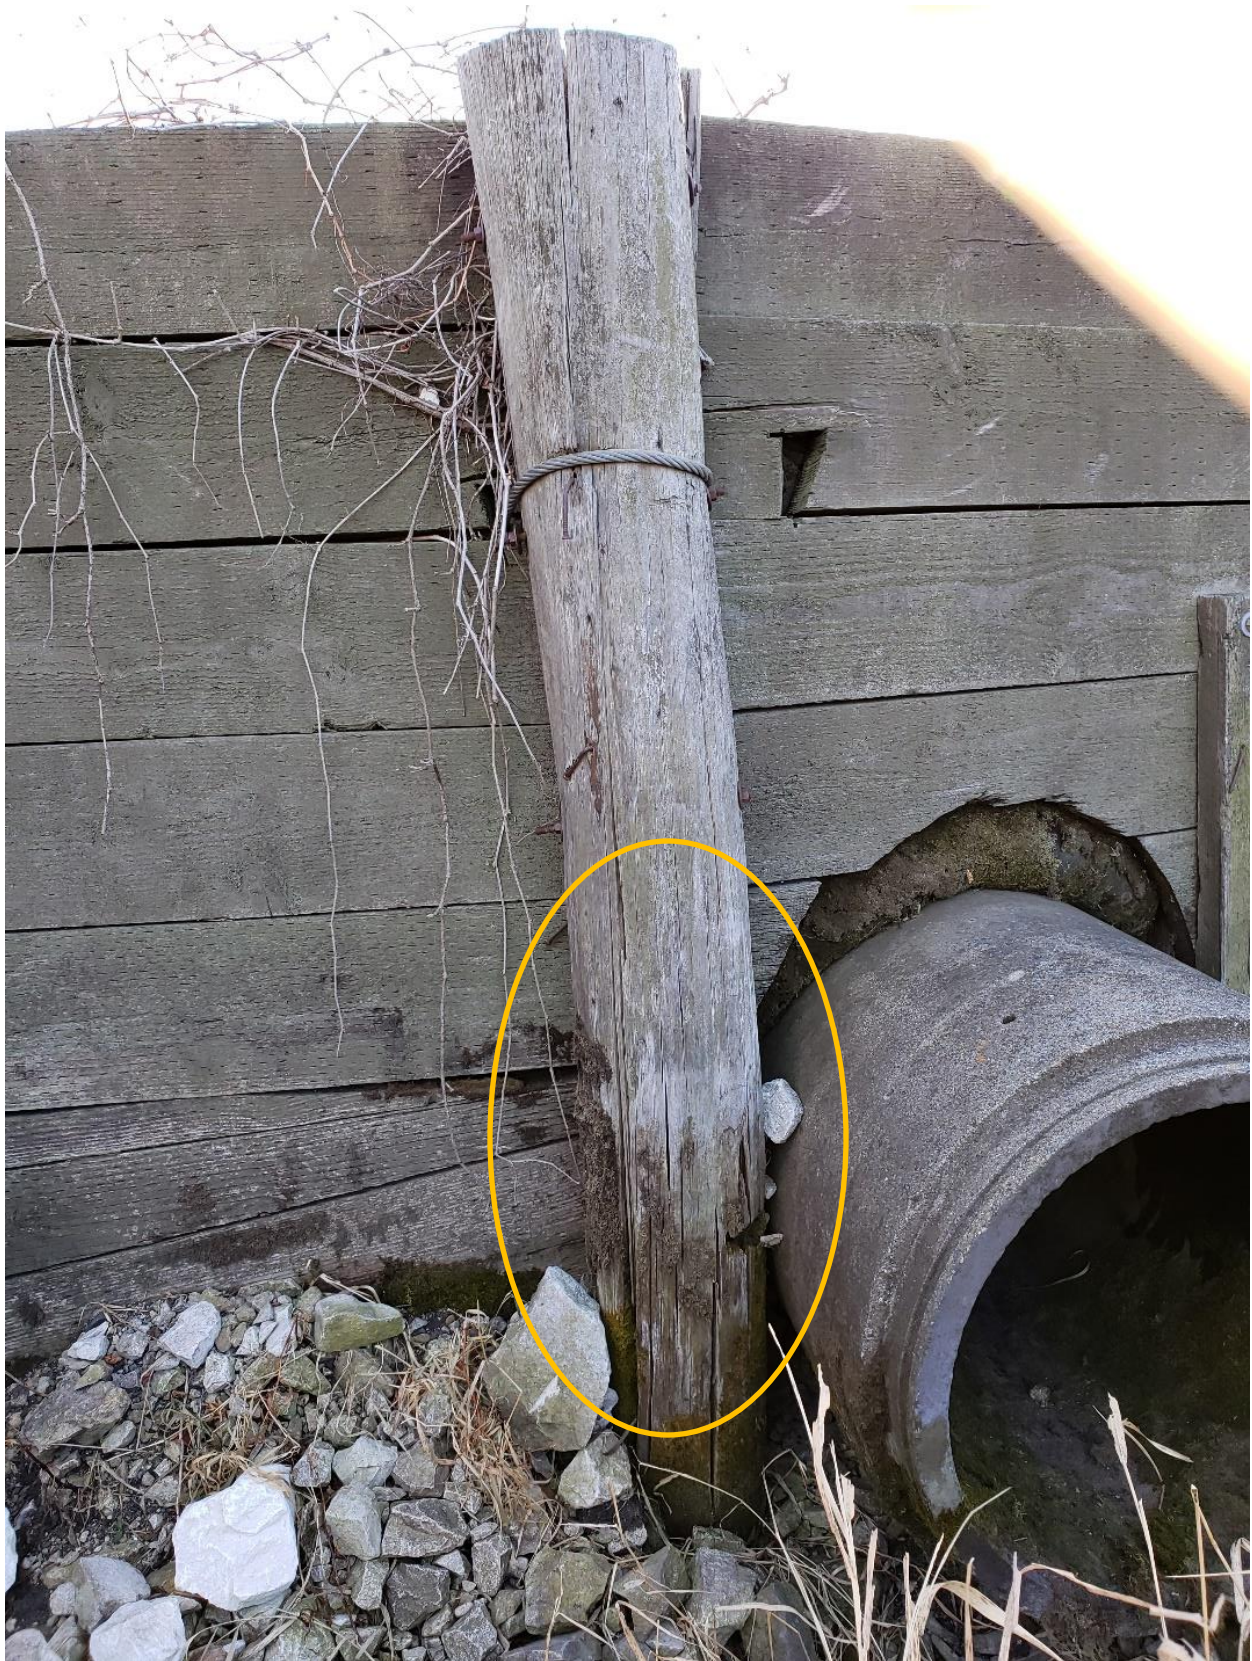
Pilings: The 15 existing 12" circular wood pilings similar to a common power line pole, appear to be serving their intended purpose of providing vertical structural support for the horizontal cross member boards of the headwall with the exception of one piling in particular shown below. The natural deterioration of this pile has led to buckling in that section of the headwall as seen below.

Figure 2: Broken pile allowing buckling next to Lateral C

Repairing the existing headwall and piping would be the most economical option. It is recommended that, for such a repair, the one failing pile next to the Lateral C outlet be removed and replaced with a steel piling installed 10 feet deep. An additional pile would be placed in between the Lateral A and C pipes. It is also recommended that any broken boards attached to that existing pile be replaced. We recommended replacing any of the plastic, CMP, or broken clay pipe sections with tongue and groove RCP of the same or next available size. Construction of any headwall repairs would provide the ideal time to address those repairs and any further pipe conditions identified at that time can be reviewed for future work as needed. To address some of the surface water back pressure and prevent future washouts behind the headwall, we recommend installing two six-inch surface intakes with hickenbottom covers above the parallel Lateral C and Lateral A outlet tiles approximately 20' south of the headwall to serve as primary surface water catchment basins. The surrounding area should be graded toward the weir opening of the headwall with a gradual flow path over the intakes. The existing headwall opening will serve as the secondary overflow for larger rainfall events. New geotextile fabric will be placed where the headwall is exposed to mitigate future soil losses. The estimated project cost to repair the existing headwall is listed in table 1.

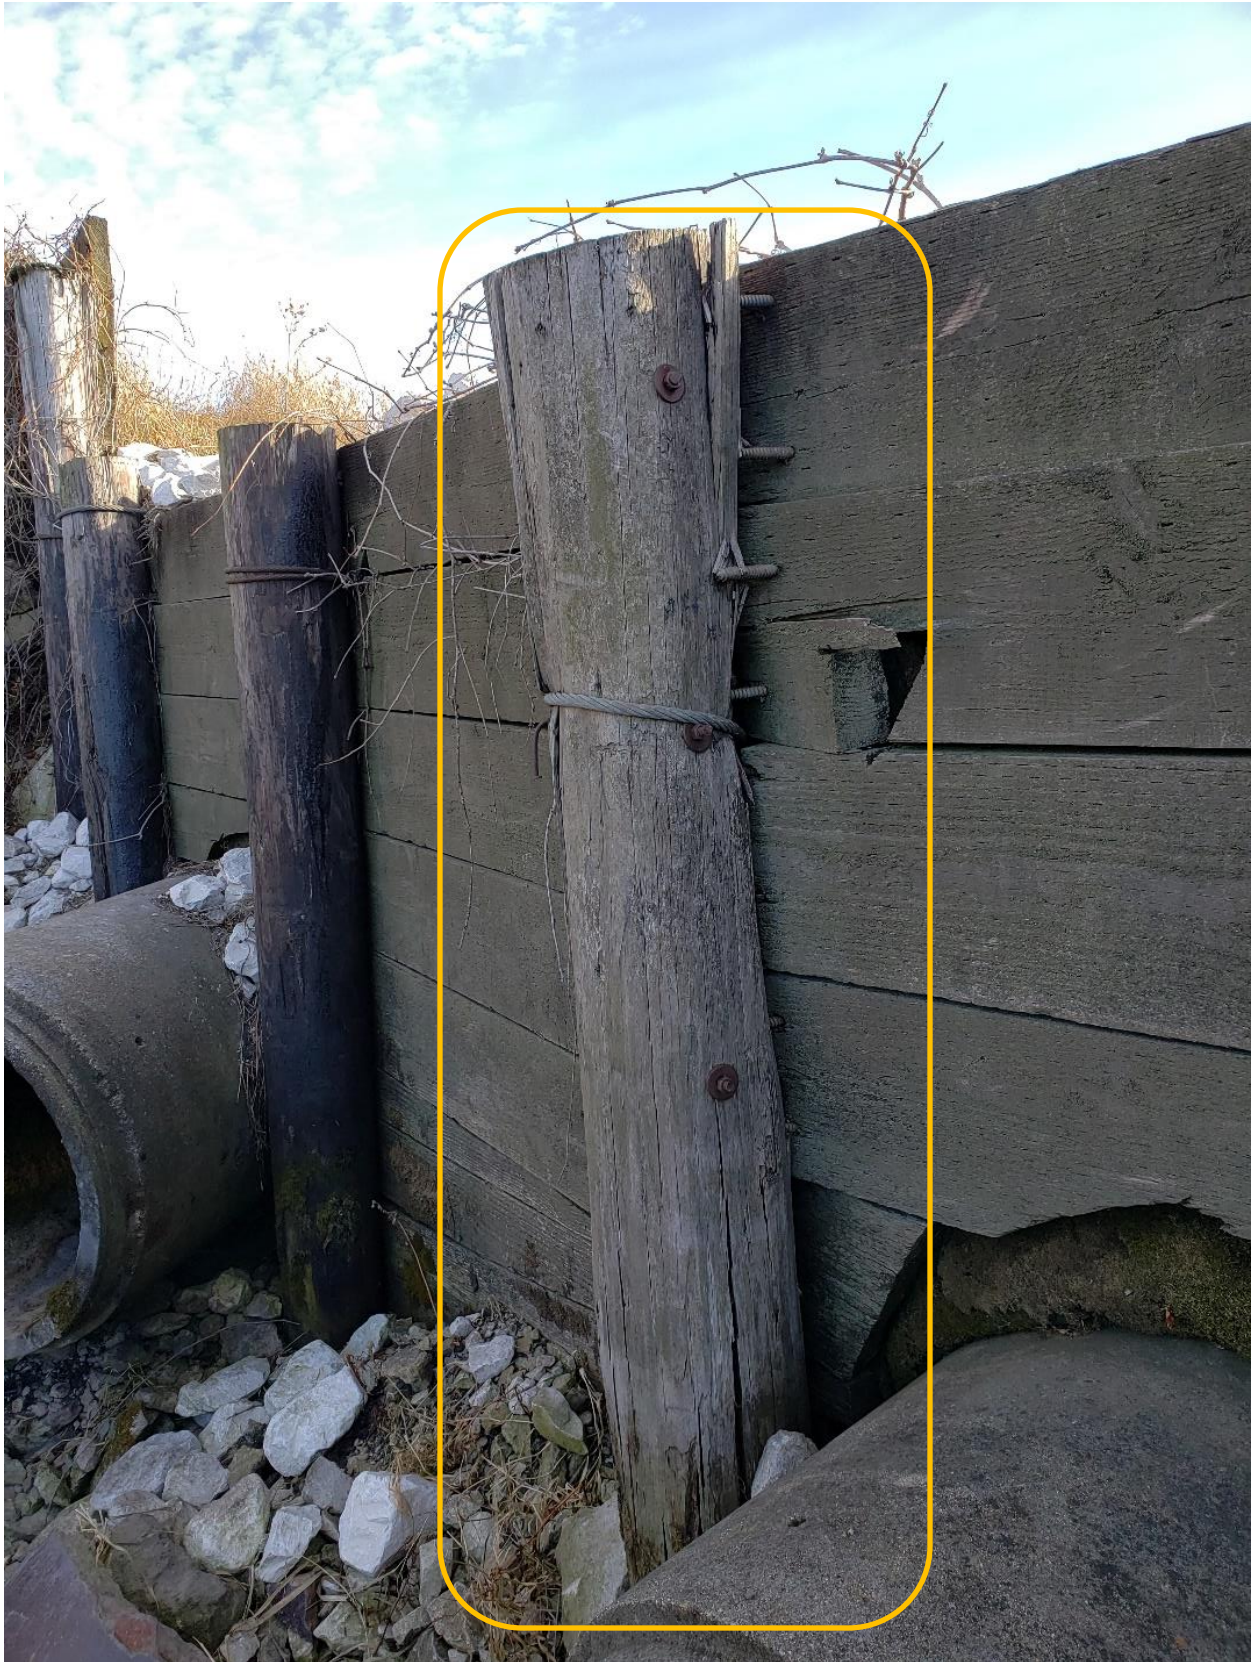
Figure 3: Another view of the broken pile and adjacent broken cross member

Cross Member Boards: The numerous 3"x12" horizontal boards spanning the length and height of headwall also are noted as serving their intended purpose with slight natural deterioration. As was shown above in Figure 2, buckling around the failing pile has altered an adjacent board.

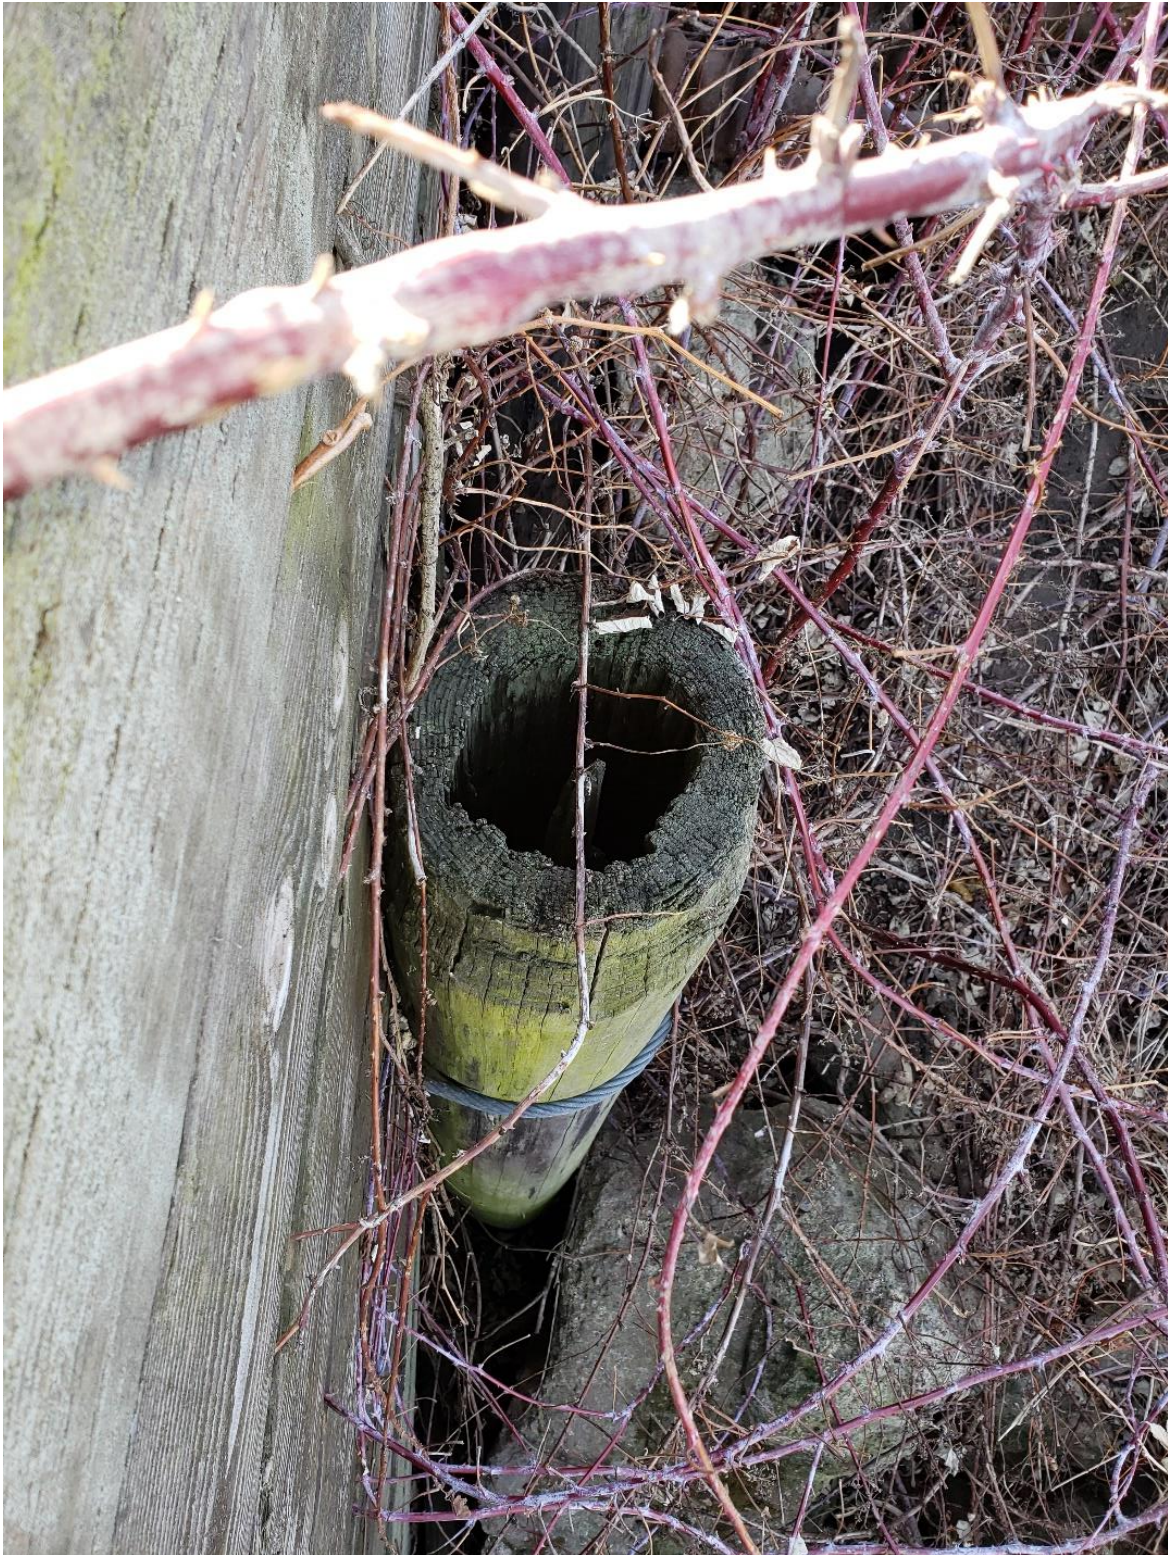
Some of the other piles are showing signs of natural deterioration as seen in Figure 4 however they are not displaying buckling of the cross members behind them.

Figure 4: Another pile experiencing deterioration on the top, center.

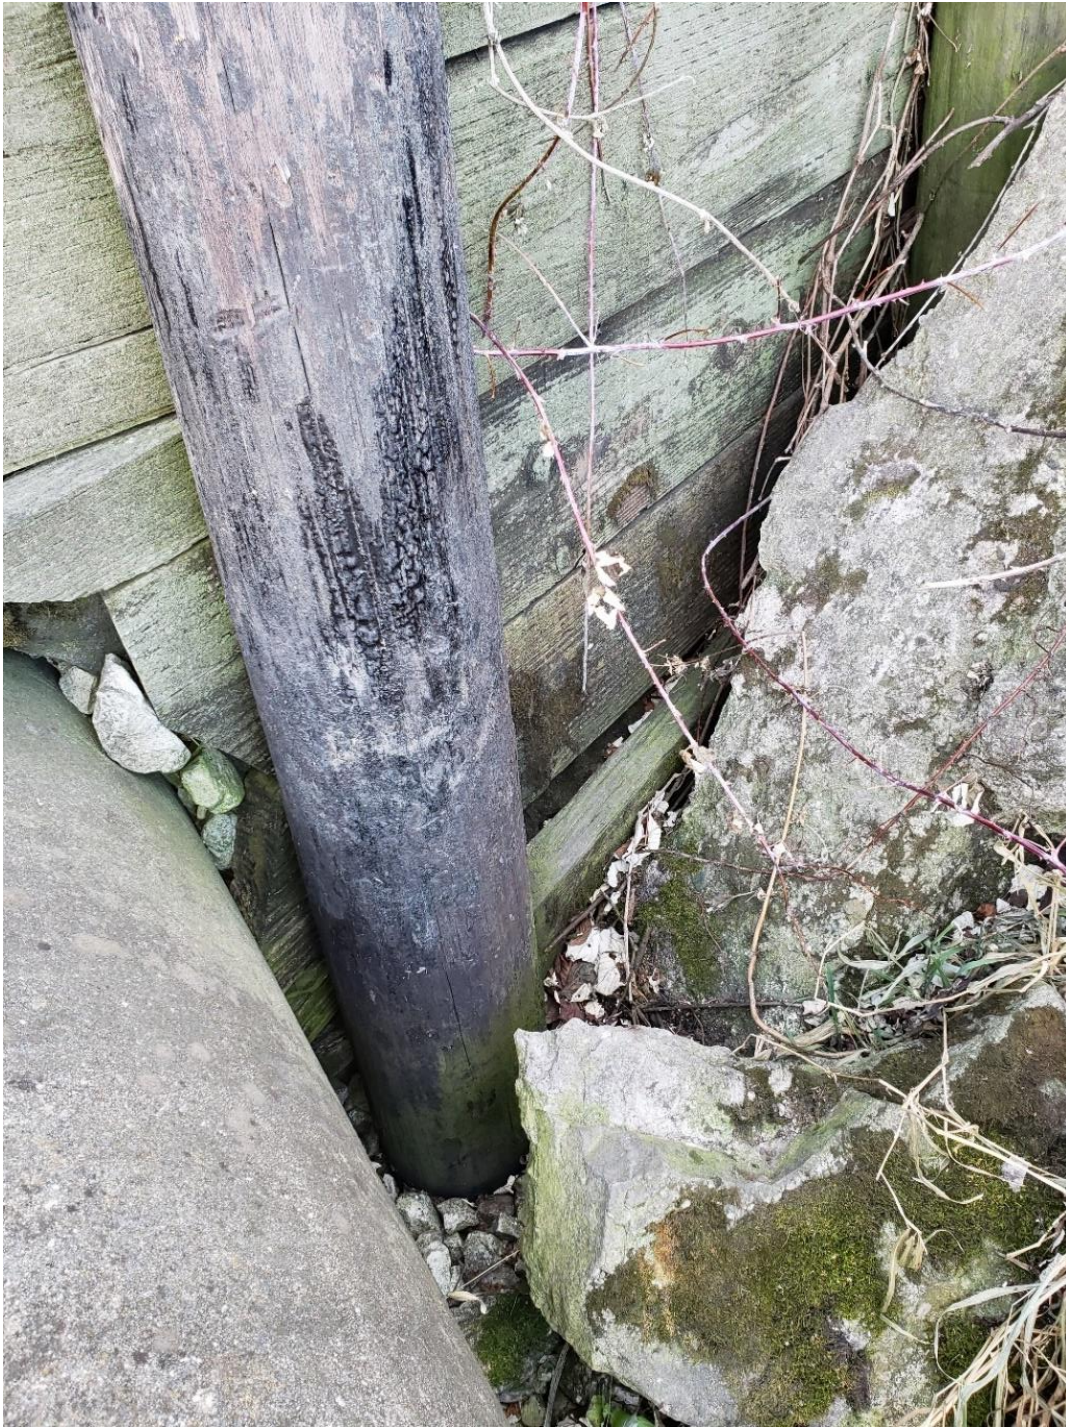
Figure 5: Base board failing.

Figure 5 also shows one base board that has bowed outward however that section of headwall is also being supported by the old concrete debris.

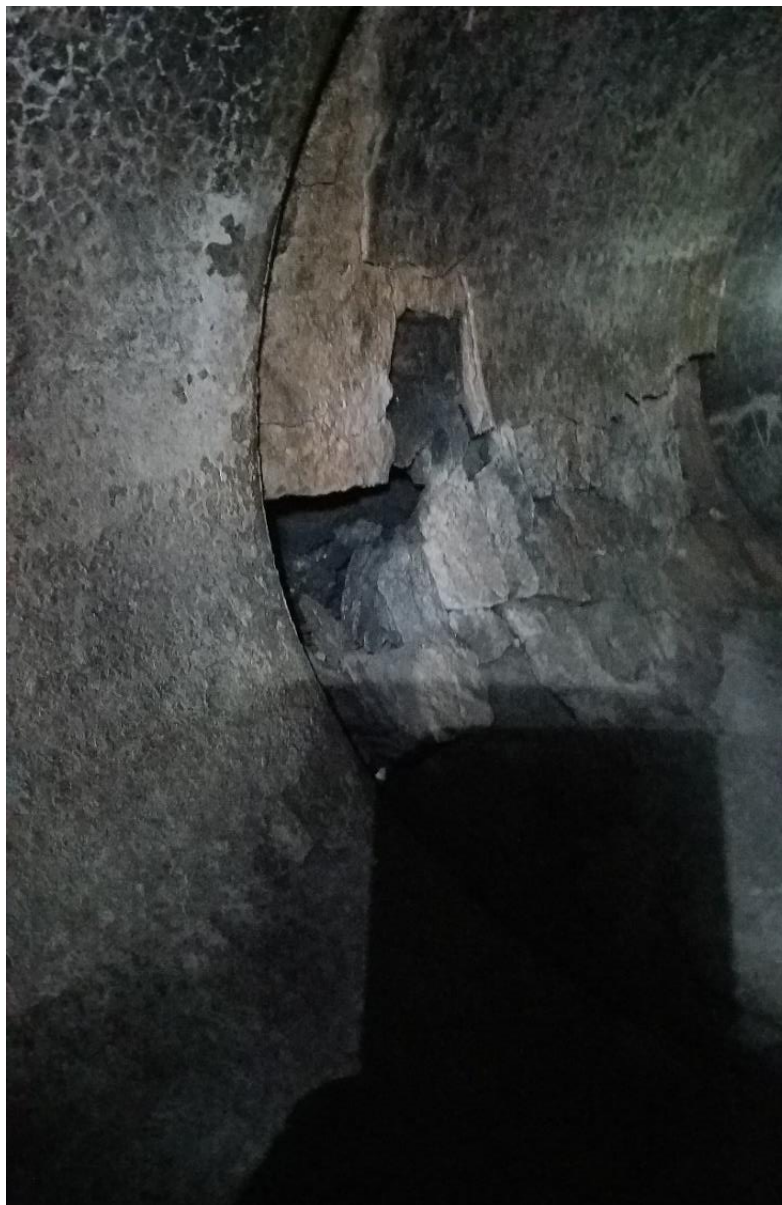
Lateral A, the westernmost of the pipes in the headwall, exhibits longitudinal cracking and broken clay pipe past the initial 23 feet of RCP. This can be categorized as suitable for imminent failure.

Figure 6: Lateral A broken 30" clay pipe segments.

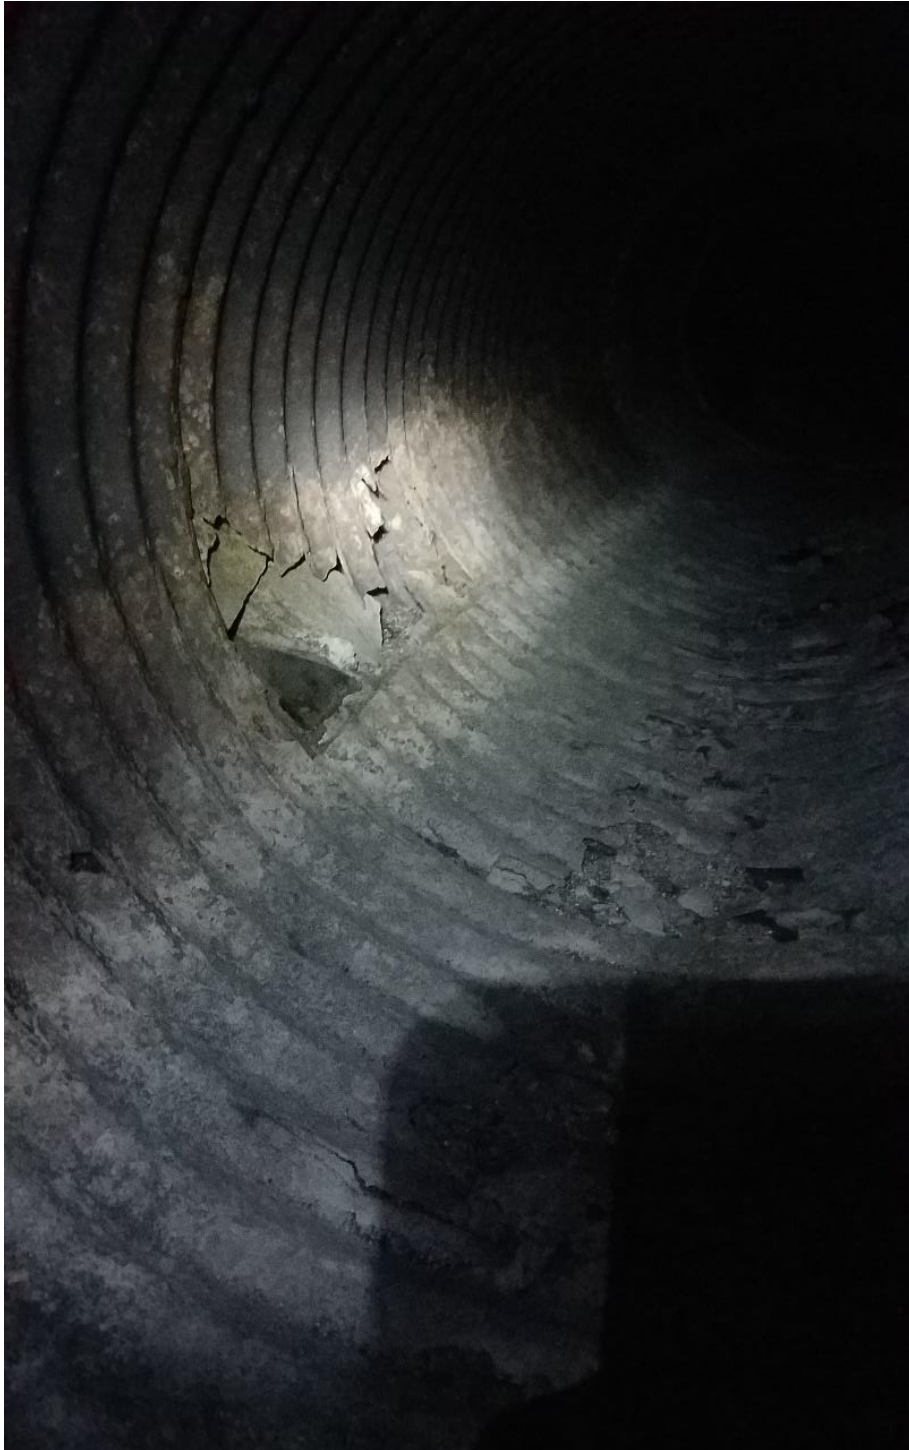
At 50' Lateral A transitions to corrugated metal pipe (CMP) for 17' which is rotted and deteriorating.

Figure 7: Lateral A deteriorating 30" CMP.

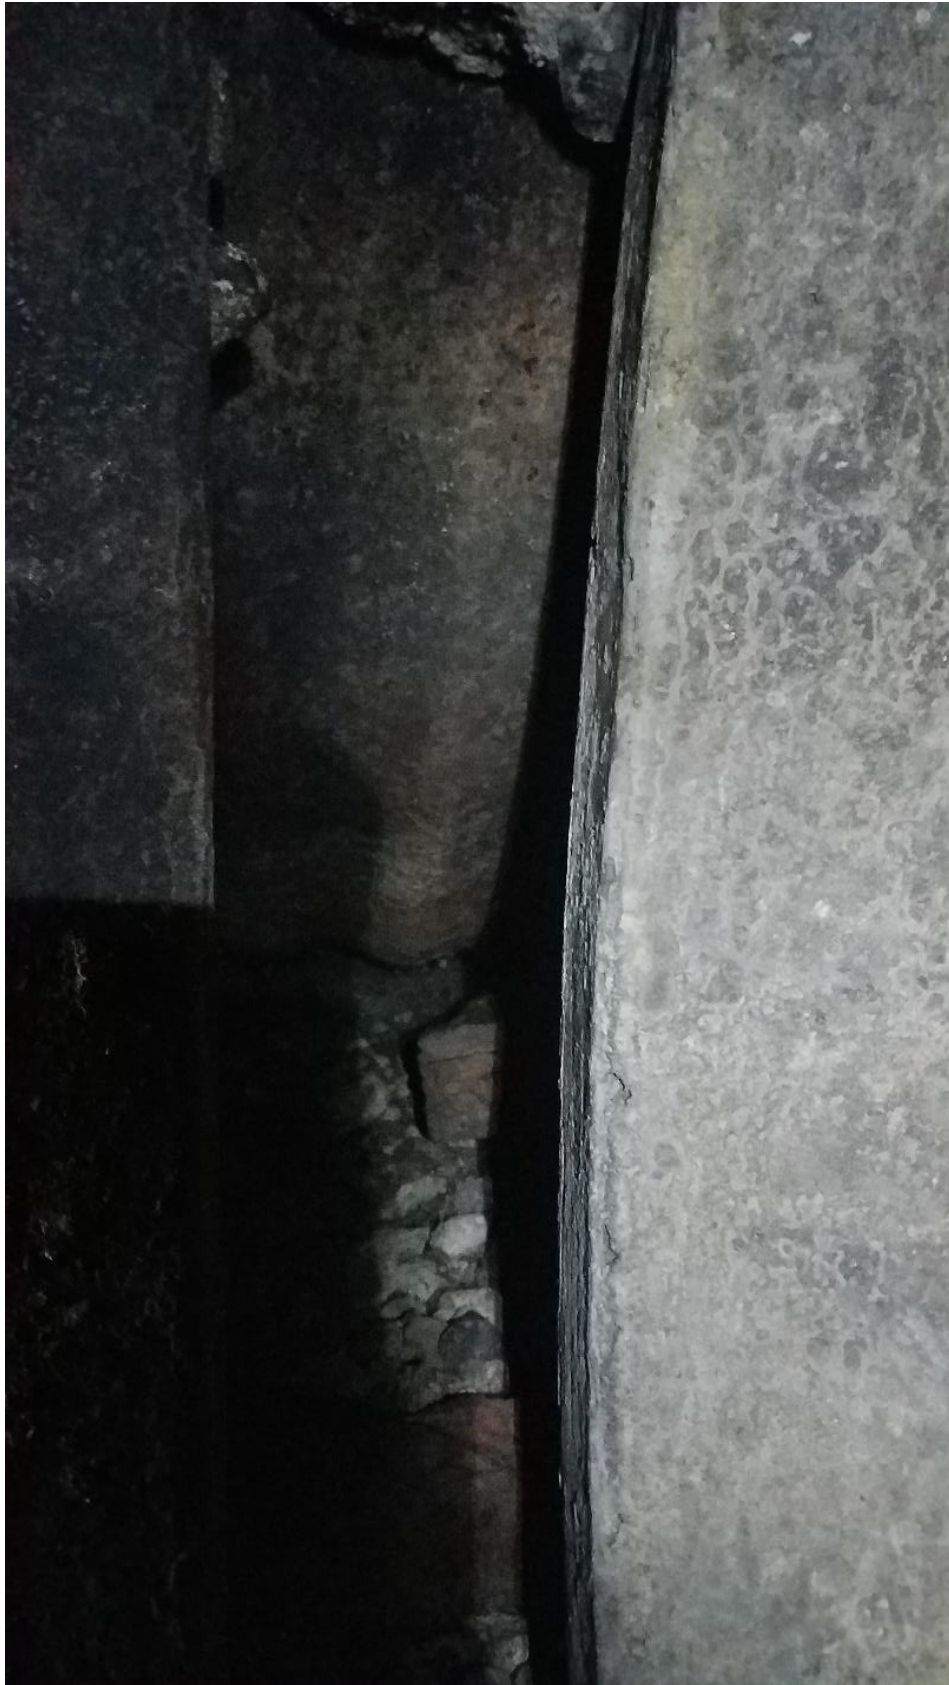
Clay pipe beyond that was found in good condition. Several separated joints were noted throughout these stretches of varying materials and one separated joint showed the physical relation between this Lateral A outlet and Lateral C with the pipes almost touching without fill material between the two.

Figure 8: View of Lateral C from Lateral A separated joint.

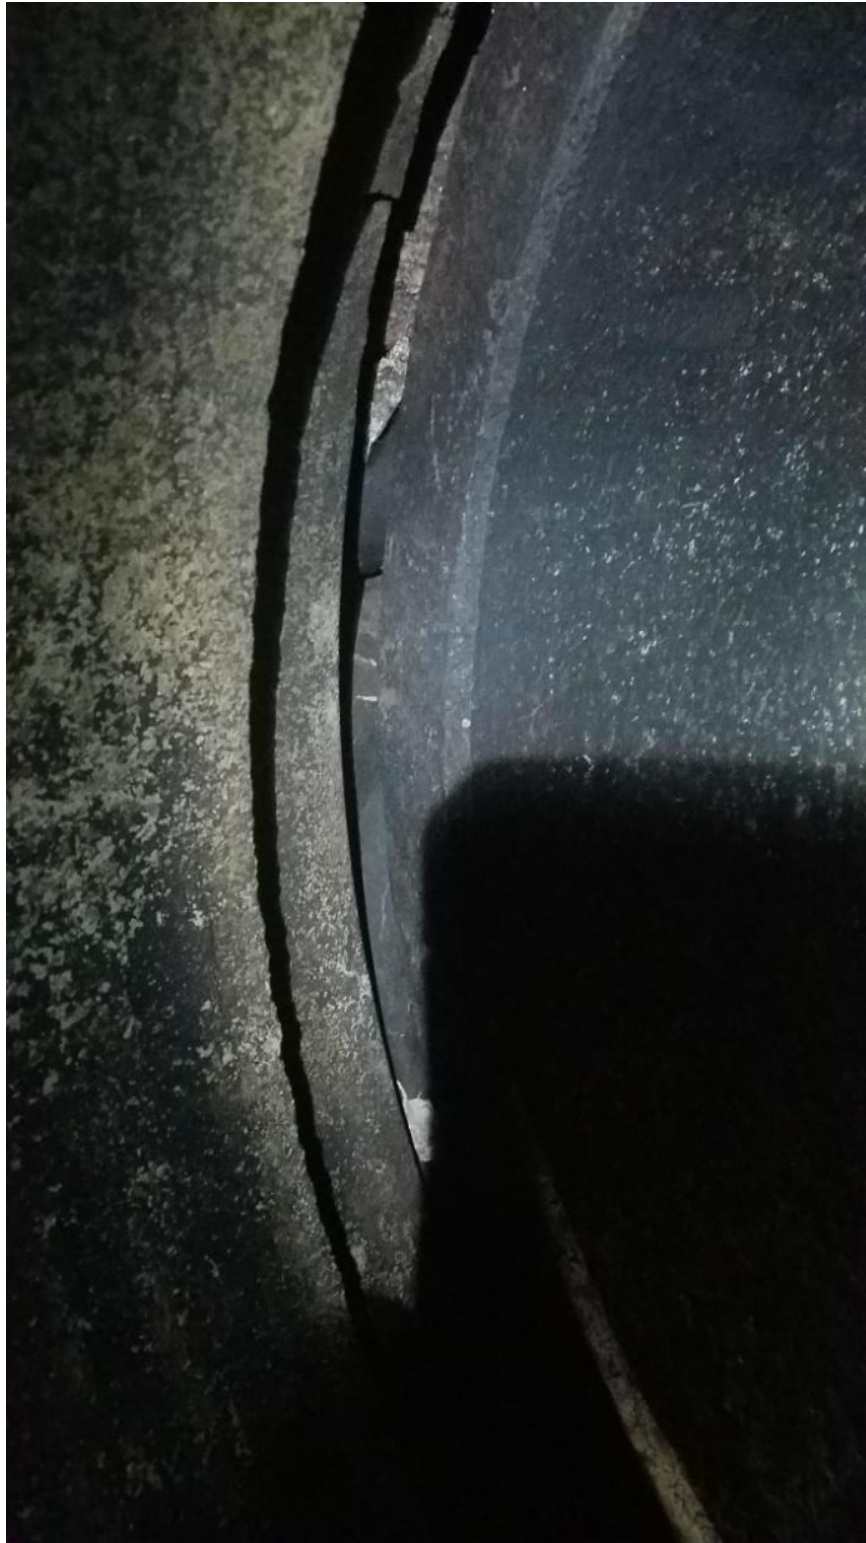
Lateral C, the middle pipe outletting in the headwall, has a poor connection at the joint between RCP and VCP at 21'. It then switches to CMP in good condition for approximately 15' then back to clay pipe in good condition past that.

Figure 9: Lateral C offset joint.

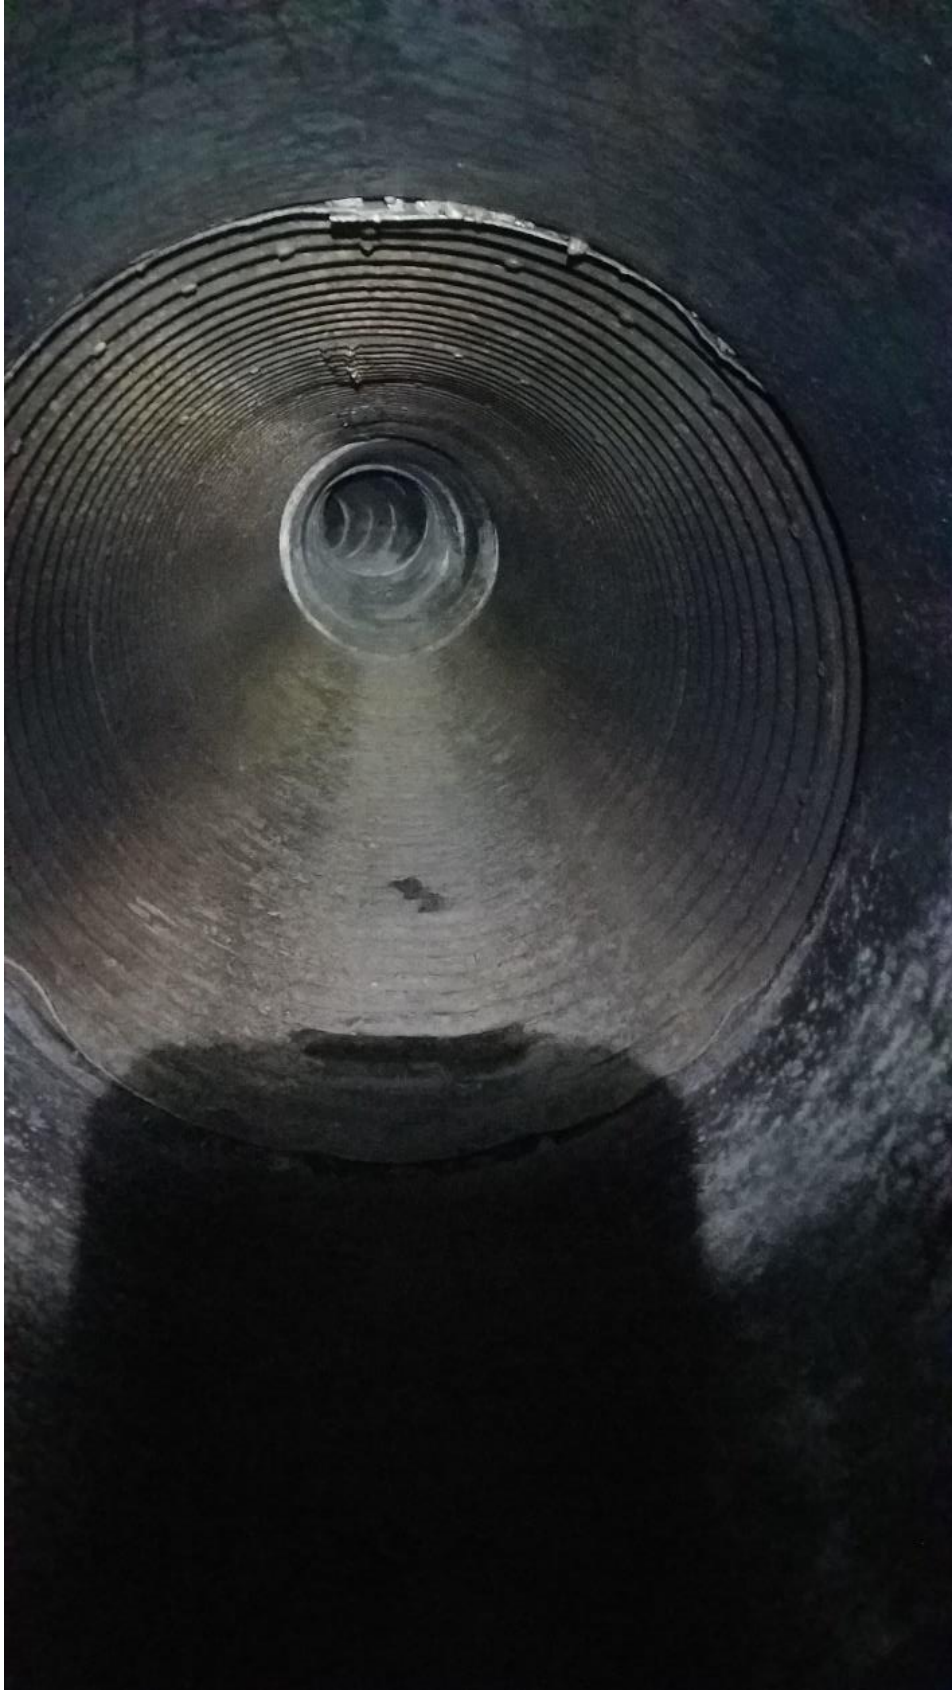
Figure 10: Lateral C CMP in good condition.

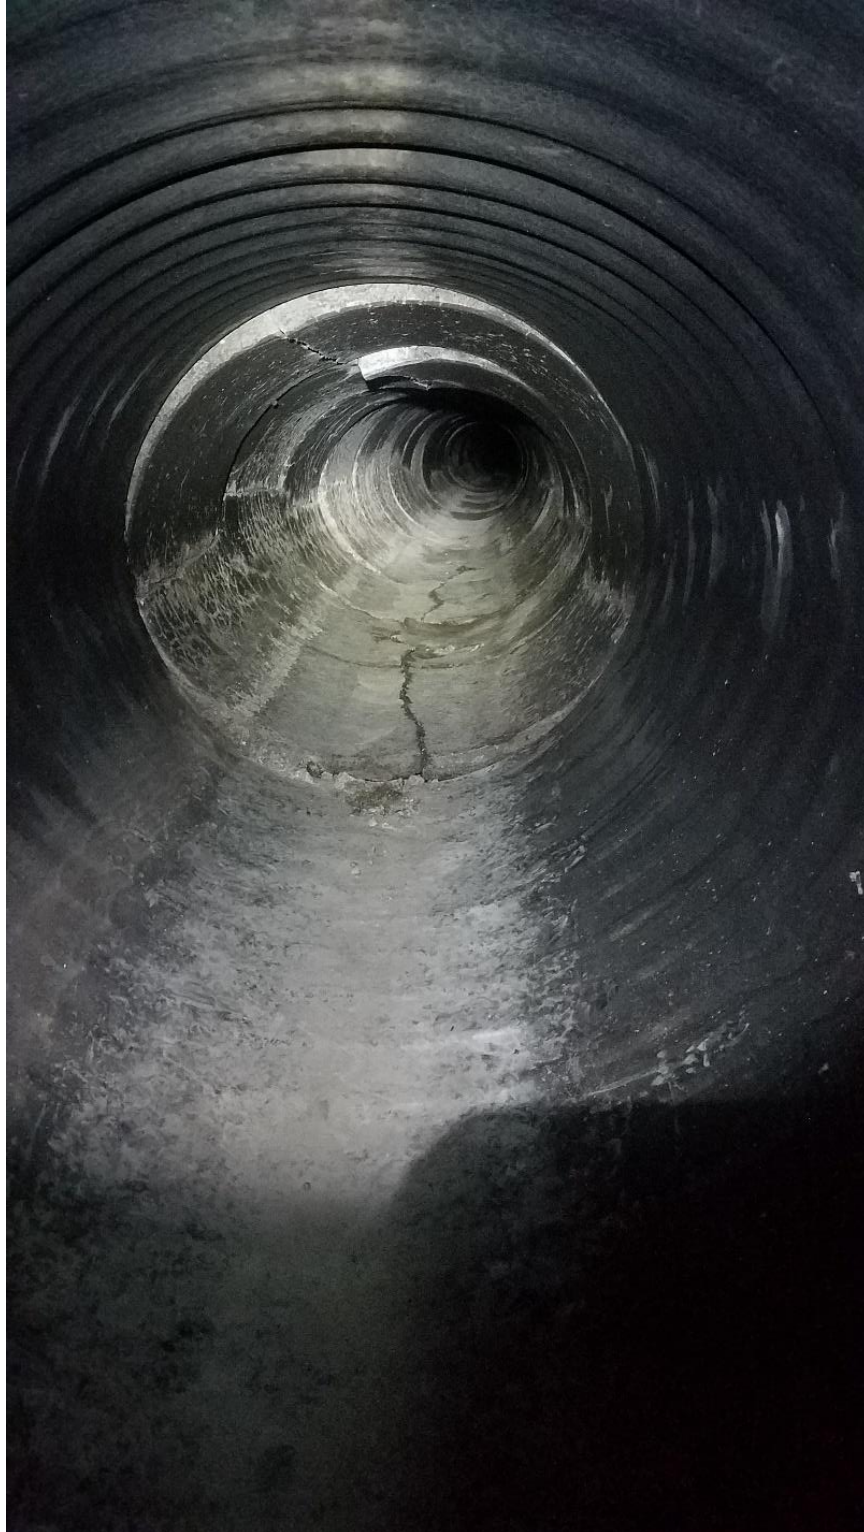
Lateral D Relief, the eastern most pipe outletting in headwall, had 37 feet of good RCP followed by a spot repair of plastic pipe for approximately 6 feet followed by cracked and broken clay pipe for the next 15 feet. Most notably that clay pipe is categorized as suitable for imminent failure needing immediate repairs.

Figure 11: Lateral D Relief view from plastic pipe to cracked and broken clay pipe.

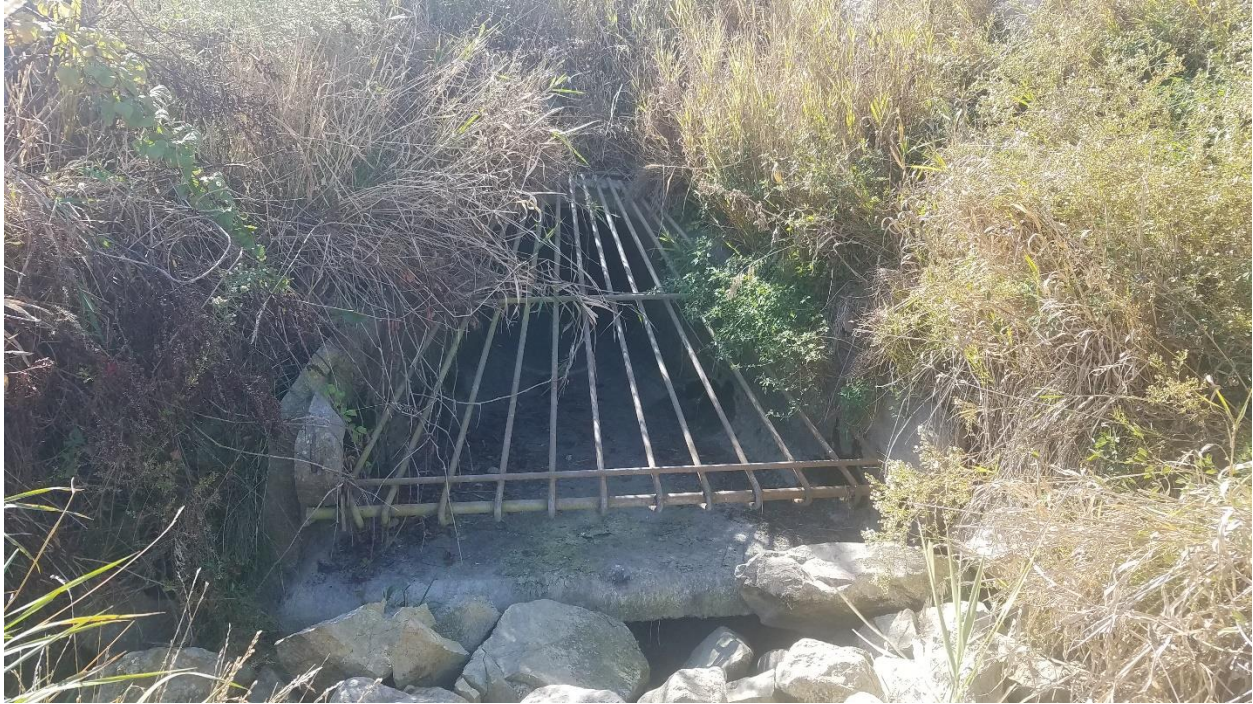
Lateral A Relief installed in 2010 shown below, is located just west of the headwall. It was not investigated upstream due to the animal guard however a pipe this new would theoretical still be functioning near its intended capacity.

Figure 12: Lateral A Relief west of the headwall.
