Town of Altavista

Town Council Work Session Agenda

Tuesday, October 27, 2015

SITE RE-CHARACTERIZATION REPORT

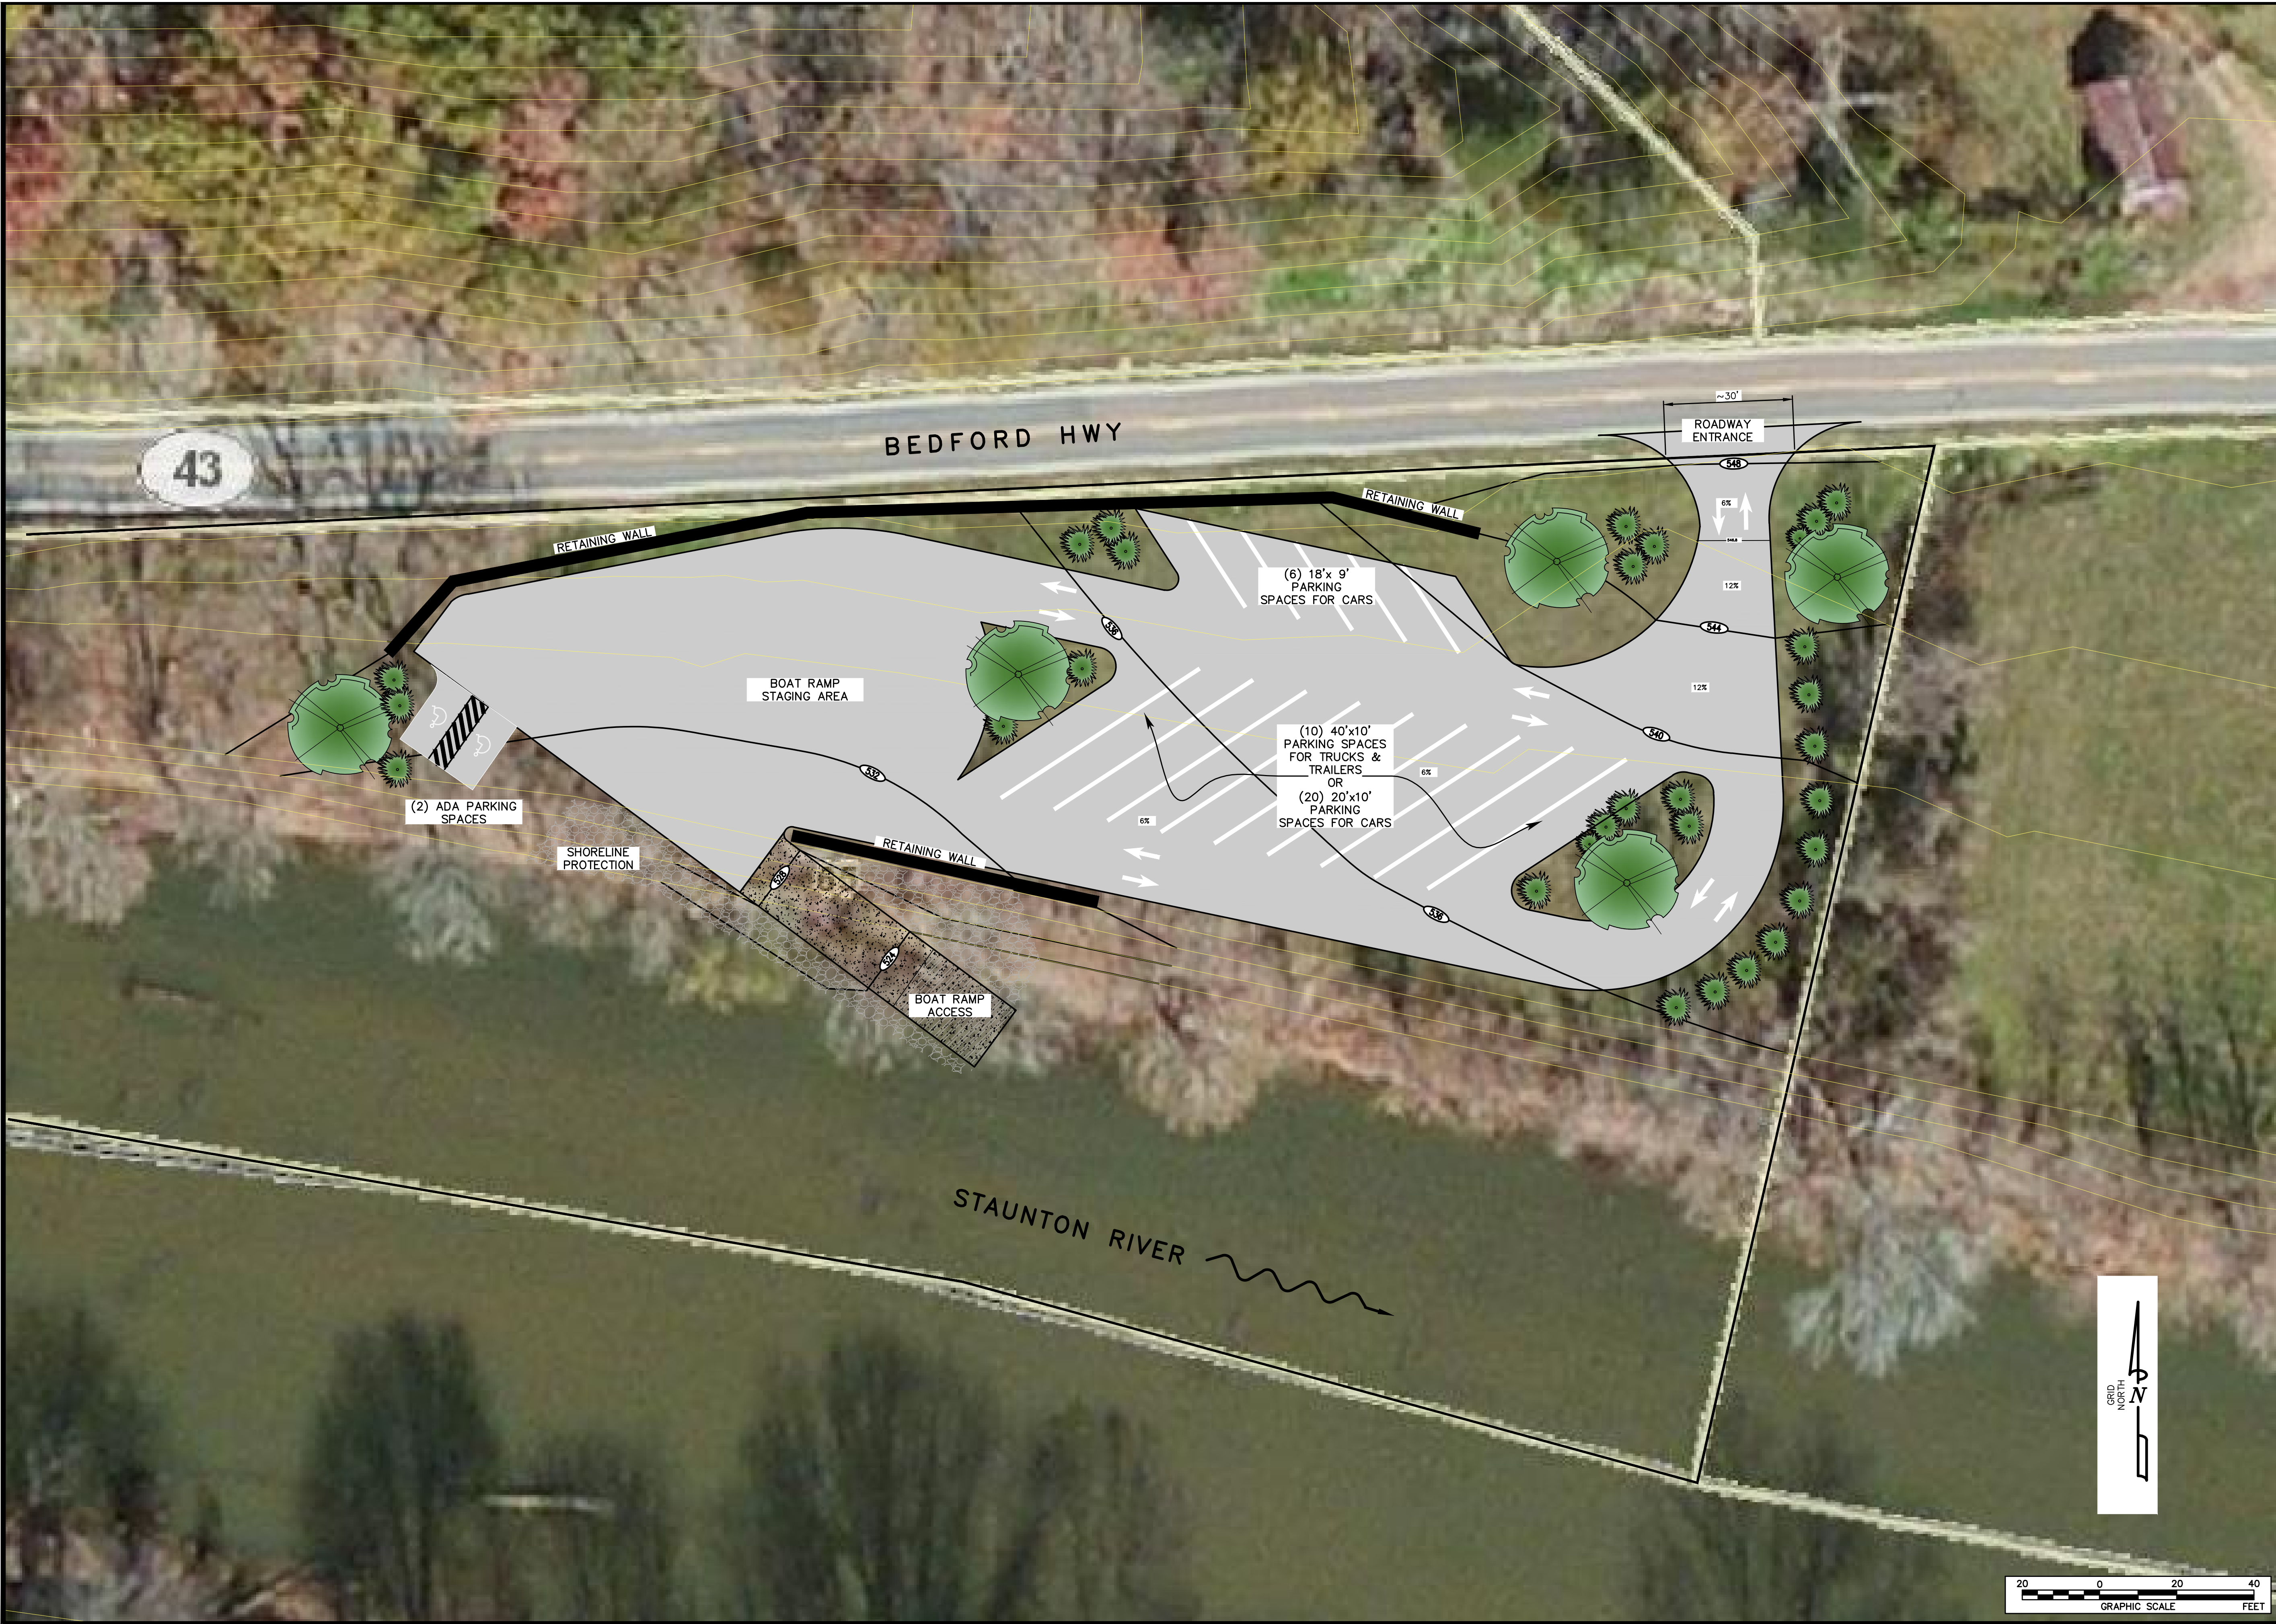
STAUNTON RIVER BOATRAMP

Staunton Boat Landing - Option 1

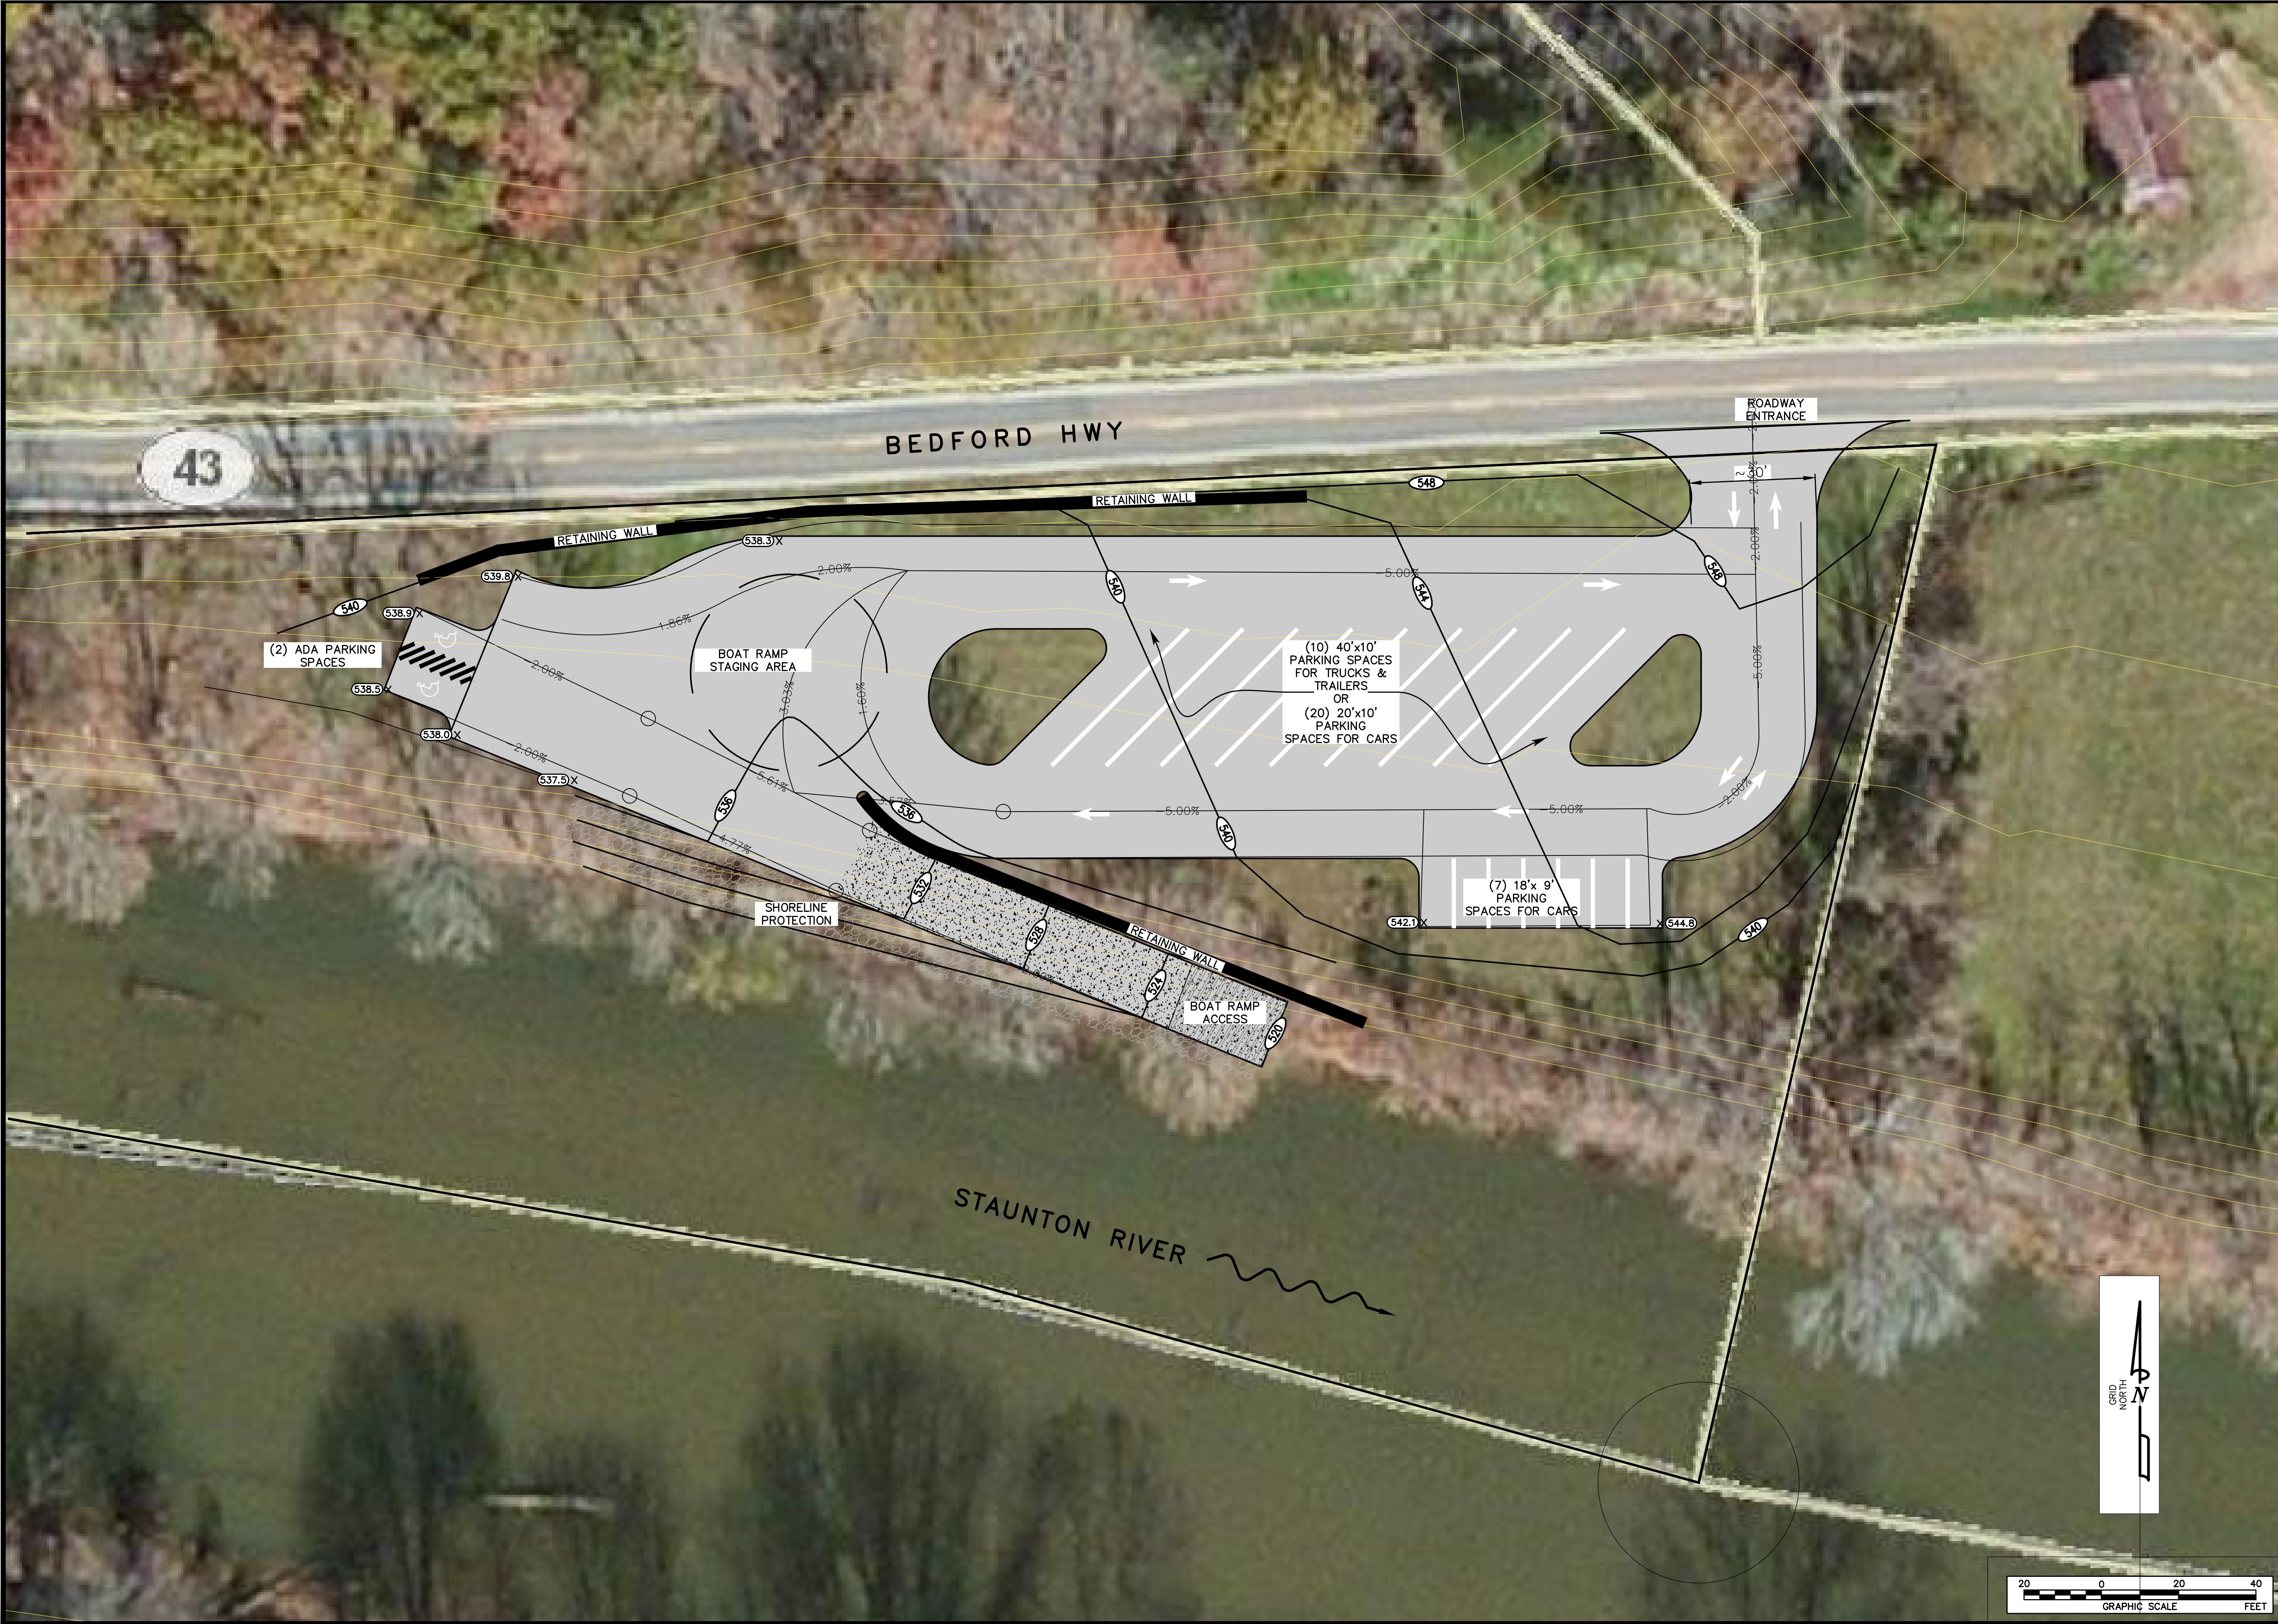
STAUNTON RIVER BOATRAMP

Staunton Boat Landing - Option 2

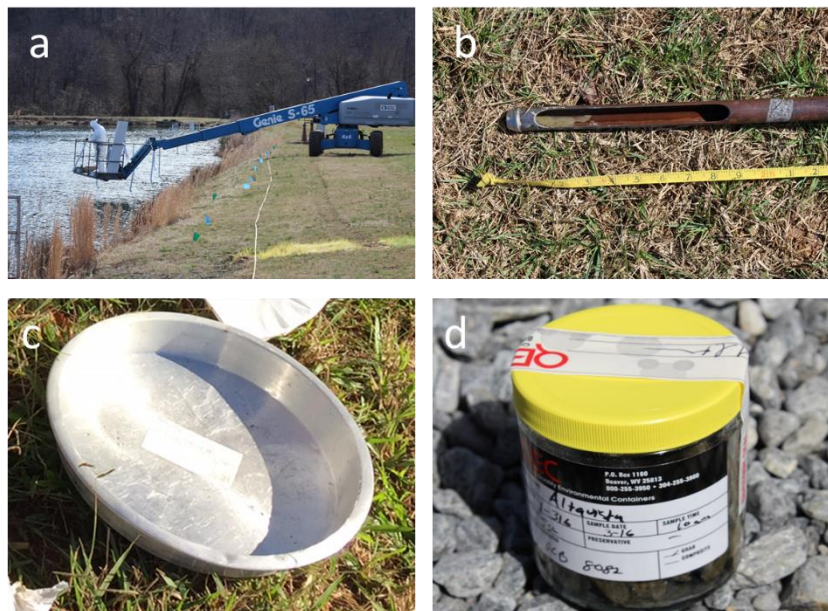
Figure 1. (a) Example of taking samples 10 and 20 feet from the shore on 3/16/15. (b) Sampler used for the pond re-characterization in 2015. (c) 14 inch metal pan used to homogenize each sample. (d) Sample jar with custody seal applied.

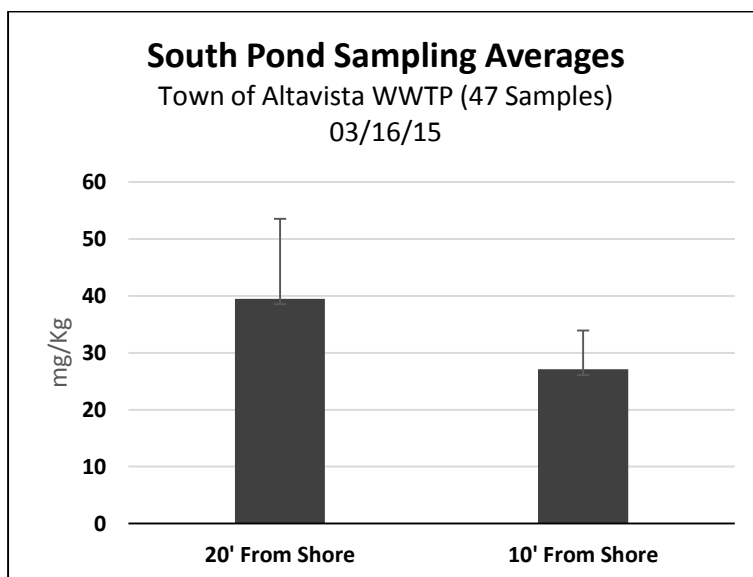
Figure 2. Averages of sample values from 10' and 20' off the shoreline on the south side of the pond. Forty seven total samples were taken and averaged. The bars indicate standard error.

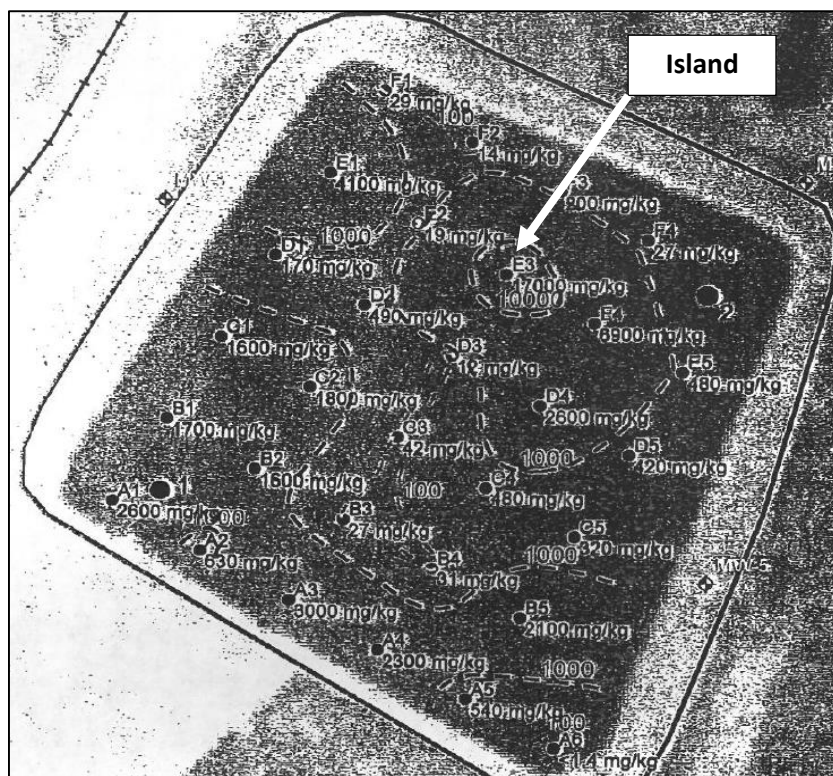
Figure 3. Sample analysis results from the 2003 Voluntary Remediation Report.

Aroclor 1242 was detected in all samples. As shown in **Figure 3**, PCBs are distributed throughout the pond. As stated in the 2003 report, the observed distribution of PCBs suggests that PCBs were dissolved in wastewater, and associated with fine sediments discharged to the pond. Evaporation, flocculation, and currents caused by winds served to distribute the PCBs throughout the footprint.

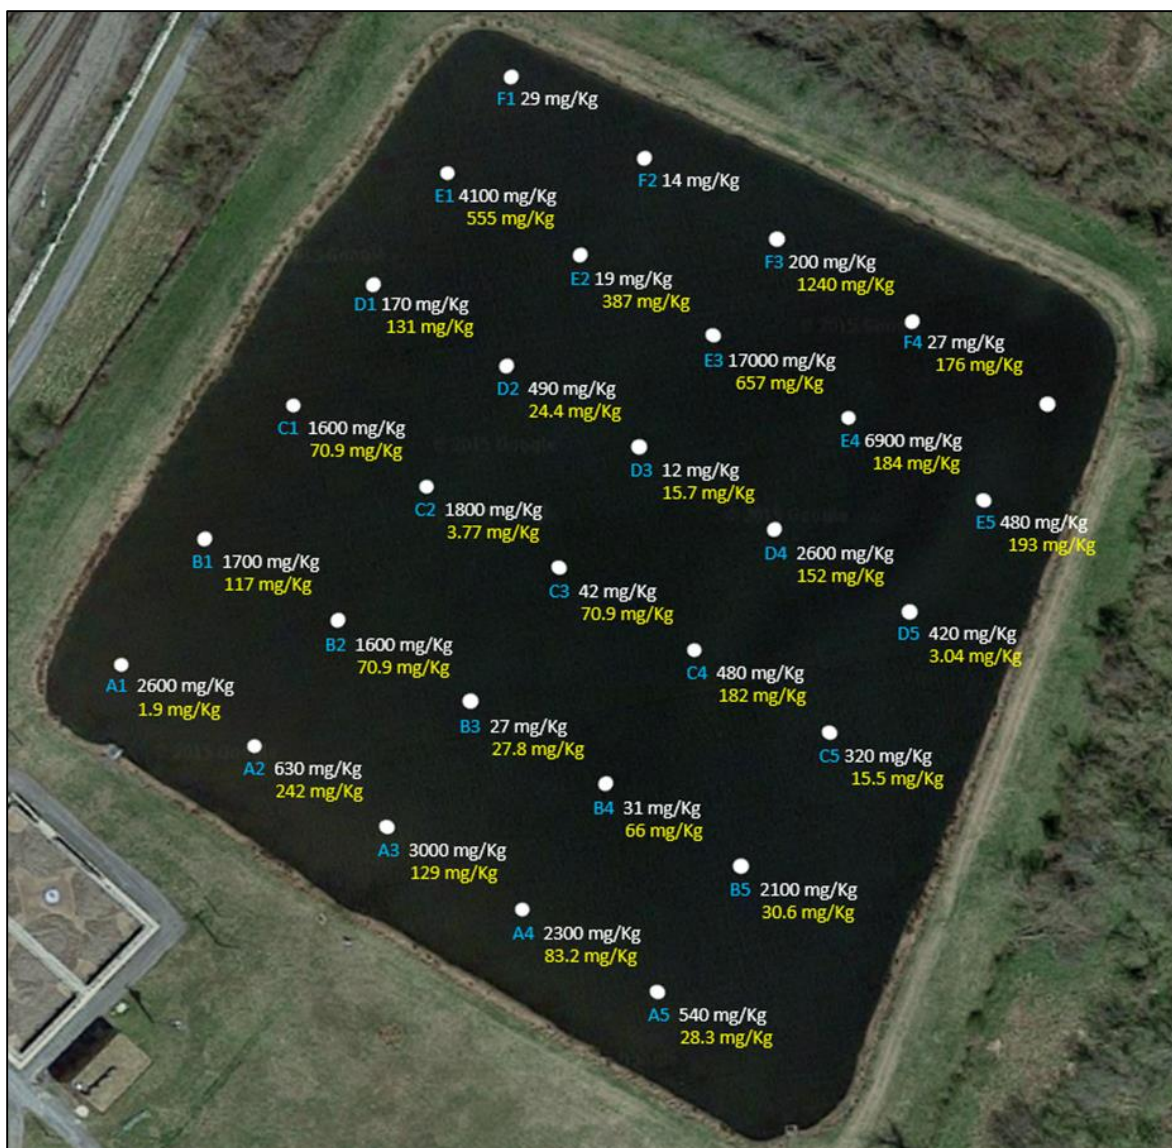
Figure 4. 2015 pond re-characterization results. Blue indicates the sample position. White represents data from the 2003 VRR. Yellow indicates results from the 2015 sampling.

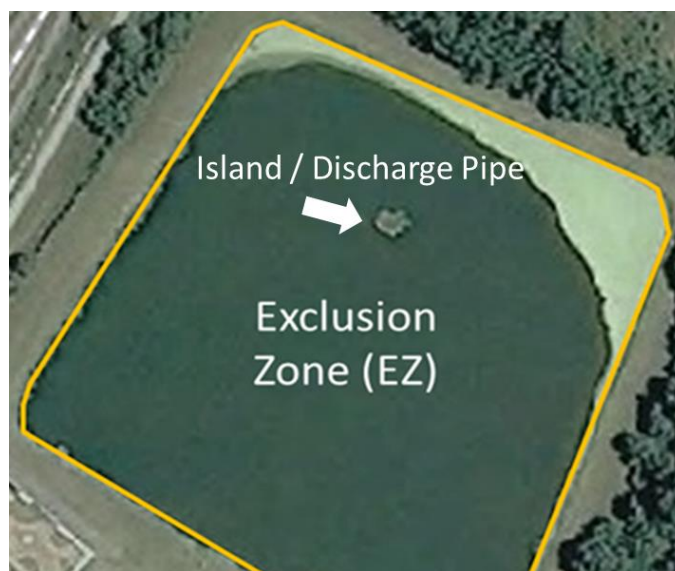
Figure 5. Location of discharge pipe / island and demonstration of sediment accumulation in the northeast area.

A couple of discrepancies were noted. F3 and F4 values were much higher compared to values recorded in 2003. This may be explained by the apparent transport and accumulation of sediment in the northeast corner (**Figure 5**). Prevailing weather and wind patterns would be

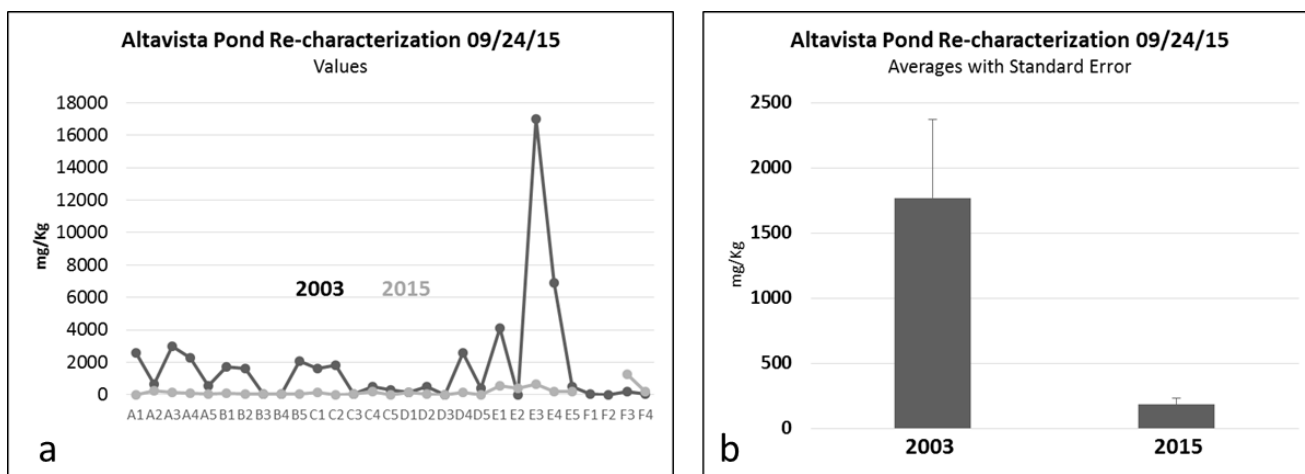
Figure 6. (a) Individual values of the 2003 and 2015 samplings. The black line represents 2003 sample points and the gray line represents 2015 results. (b) Averages of the two sampling events. The bars represent standard error.

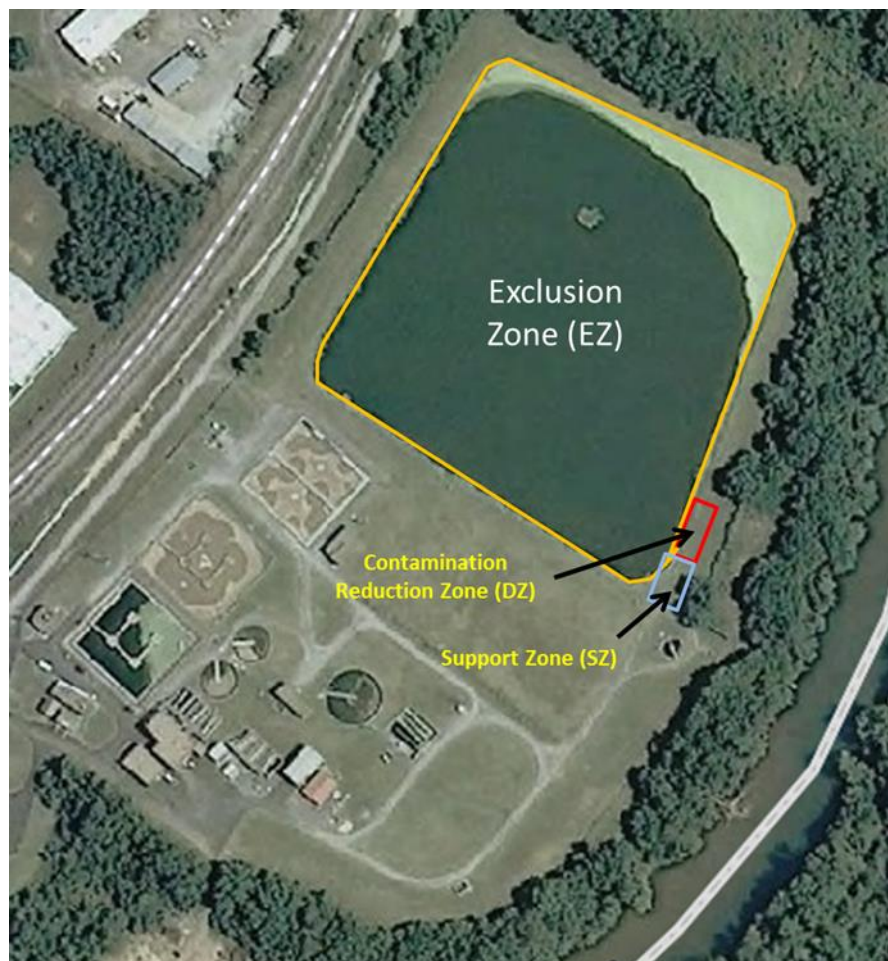
APPENDIX A - SITE MAP TO DELINEATE ZONES

Figure 1 – Site zones are intended to control the potential spread of contamination and to assure that only authorized individuals are permitted into potentially hazardous areas. A three-zone approach will be utilized. It shall include an Exclusion Zone (EZ), Contamination Reduction Zone (CRZ), and a Support Zone (SZ).

Site zones are intended to control the potential spread of contamination and to assure that only authorized individuals are permitted into potentially hazardous areas. A three-zone approach will be utilized. It shall include an Exclusion Zone (EZ), Contamination Reduction Zone (CRZ), and a Support Zone (SZ). Specific zones shall be established on the work site when operations begin for each task requiring such delineation. A map depicting the zones is located in Appendix A and will be available at the site. This research is being conducted under the requirements of 29 CFR 1910.120, and any personnel working in an area where

Exclusion Zone – The exclusion zone is primarily located in the pond itself. However, all activities which may involve exposure to site contaminants, hazardous materials and/or conditions should be considered an exclusion zone. The TOA may establish more than one EZ where different levels of protection may be employed or different hazards exist. The size of the EZ shall be determined by TOA allowing adequate space for the activity to be completed.
