APPENDIX IID1
WETLANDS EVALUATION

City of Edinburg Landfill Expansion Project Wetlands Evaluation

NEI Project No. 9323

July 2015

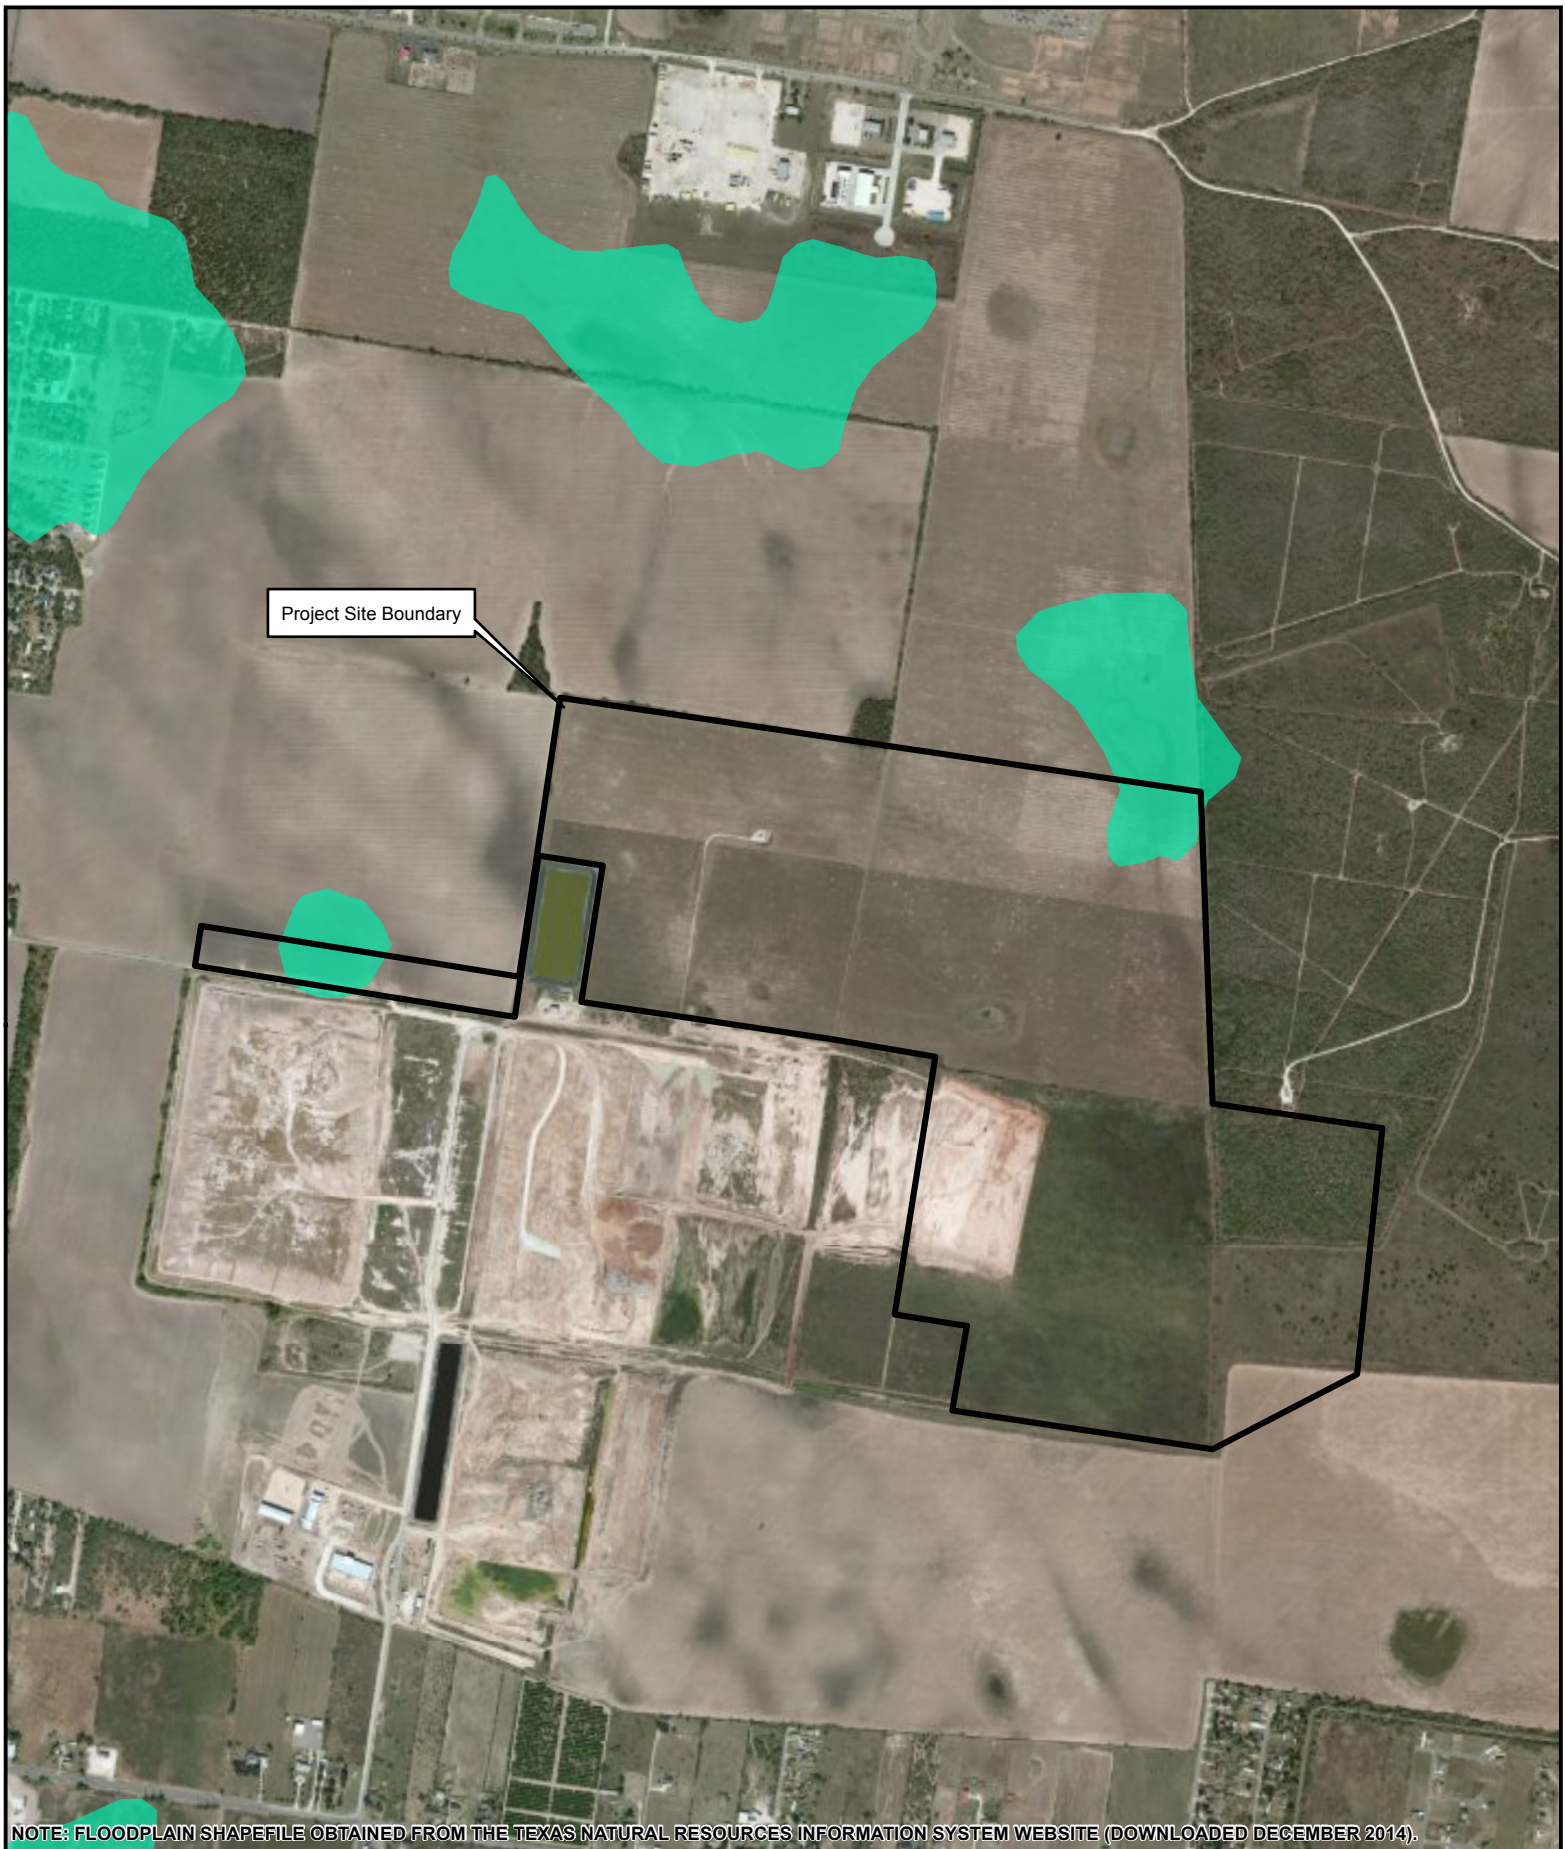
EXHIBIT 3
FEMA FLOODPLAIN MAP

According to recent FEMA floodplain maps, the project site contains two areas that are located within the 1% Annual Chance Flood Zone (Zone A) (see Exhibit 3). Zone A is defined as special flood hazard areas that are subject to inundation by the 1% annual chance flood. The 1% annual chance flood (100-year flood), which is also known as the base flood, is the flood that has a 1% chance of being equaled or exceeded in any given year. One of the mapped floodplain areas is situated along the northeast property line. The second floodplain area is located along the site’s northwest boundary. Both of the floodplain areas (depicted on Exhibit 3) are located in plowed and/or fallow agricultural fields.

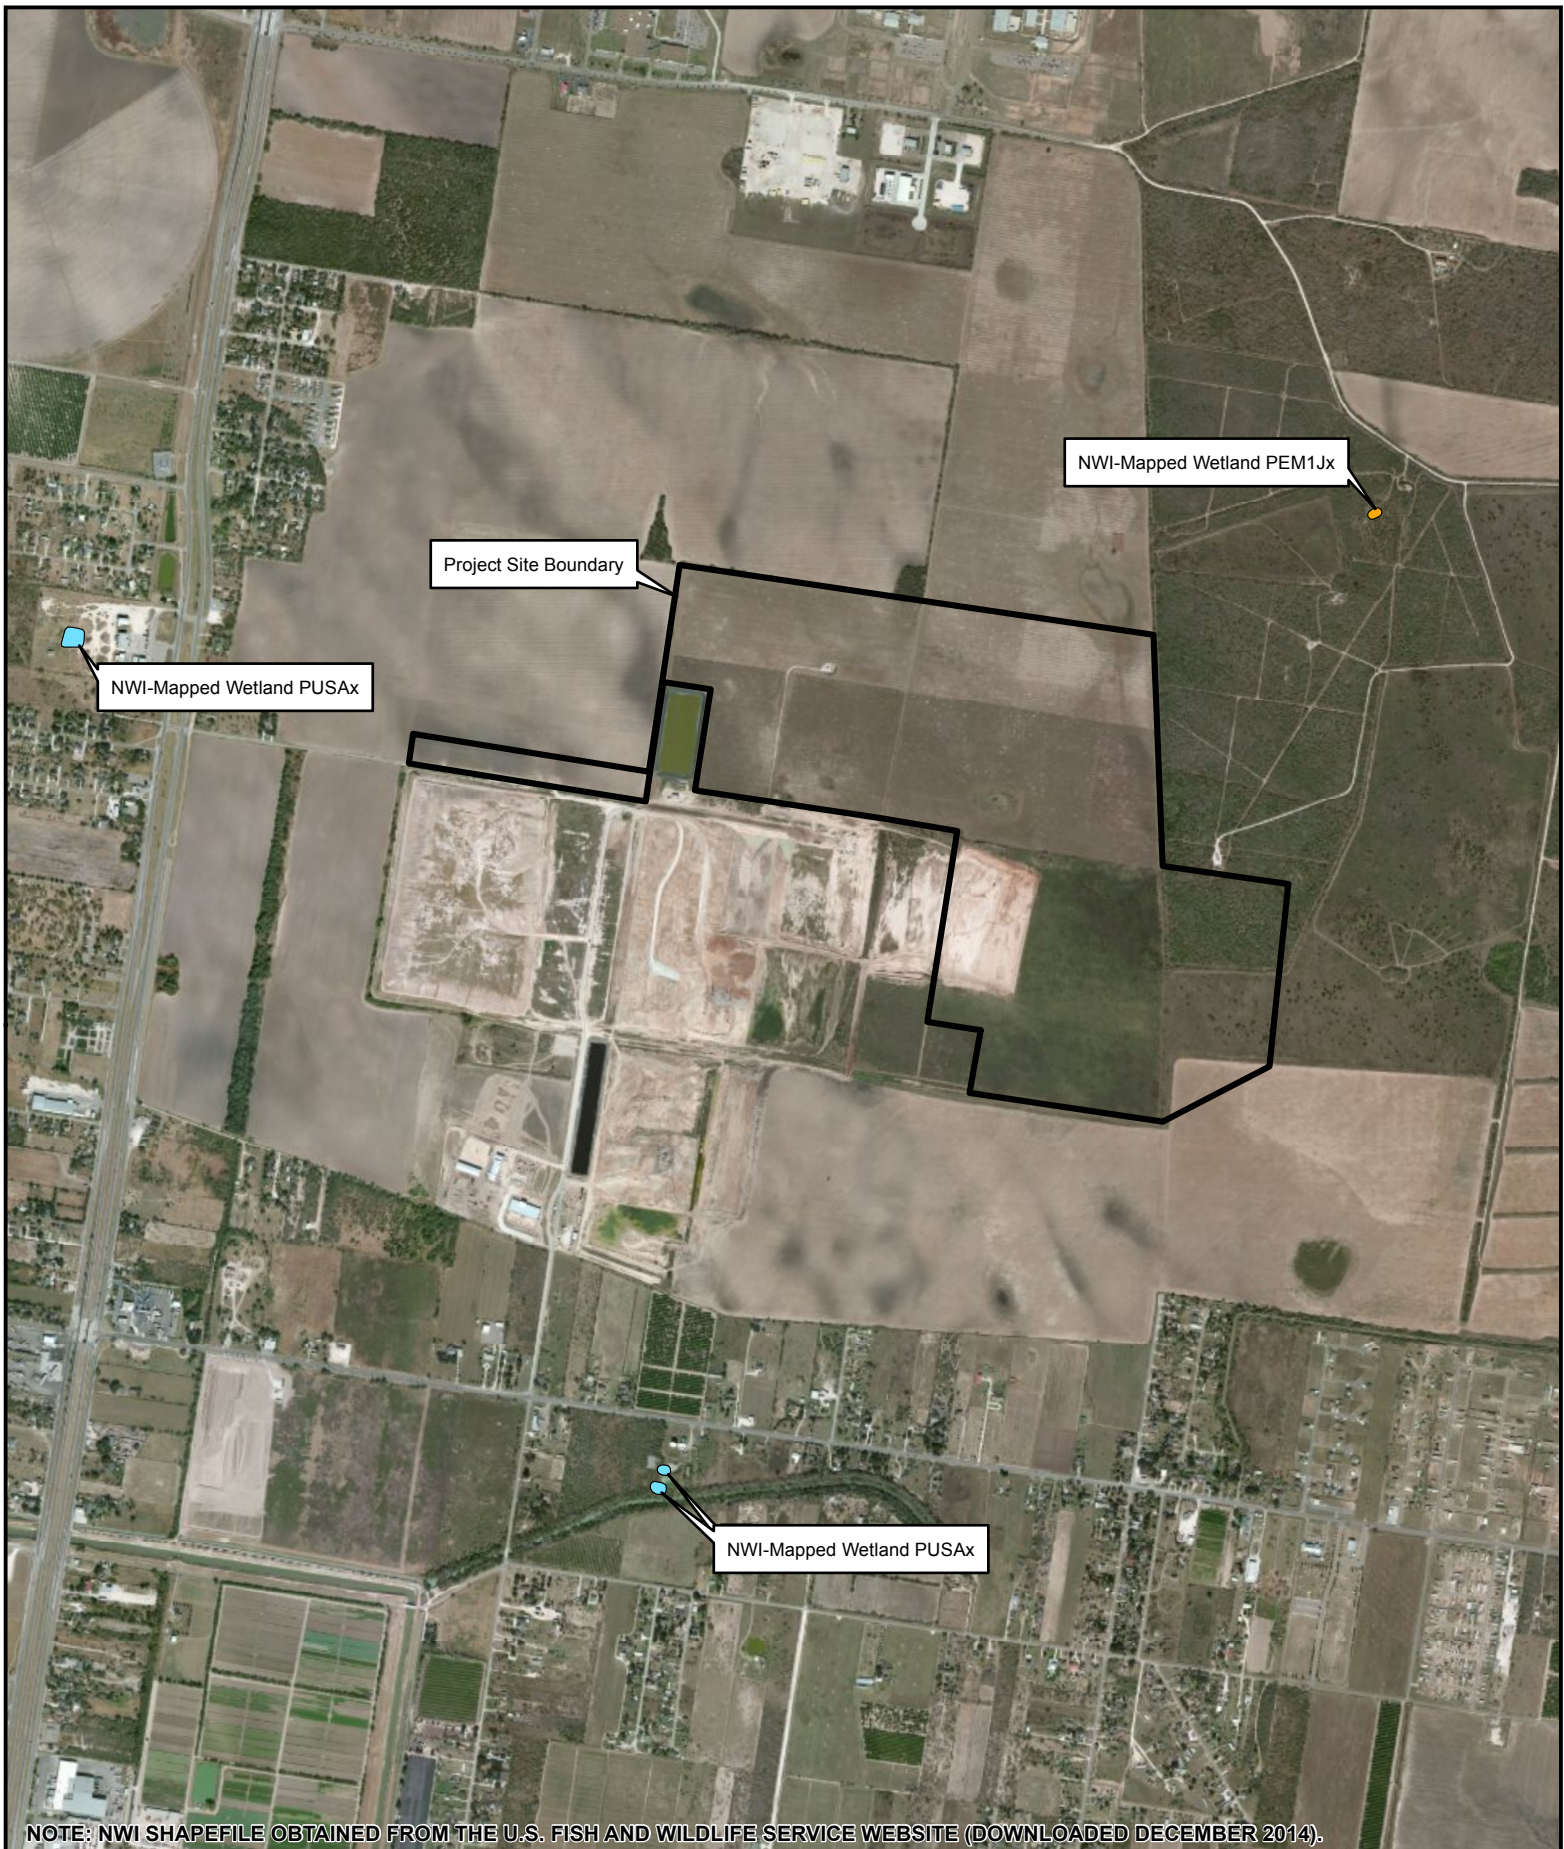
EXHIBITS 5A AND 5B
NATIONAL WETLANDS INVENTORY (NWI) MAPS
(2014 AND 1989)

NOTE: NWI SHAPEFILE OBTAINED FROM THE U.S. FISH AND WILDLIFE SERVICE WEBSITE (DOWNLOADED DECEMBER 2014).

NWI maps, which are developed and maintained by the U.S. Fish and Wildlife Service, provide geospatially referenced information on the status, extent, characteristics, and functions of wetland, riparian, deep water, and related aquatic habitats in priority areas. It should be noted that NWI maps are not intended to determine whether wetlands are jurisdictional under the USACE; only that a wetland may occur in a particular area.

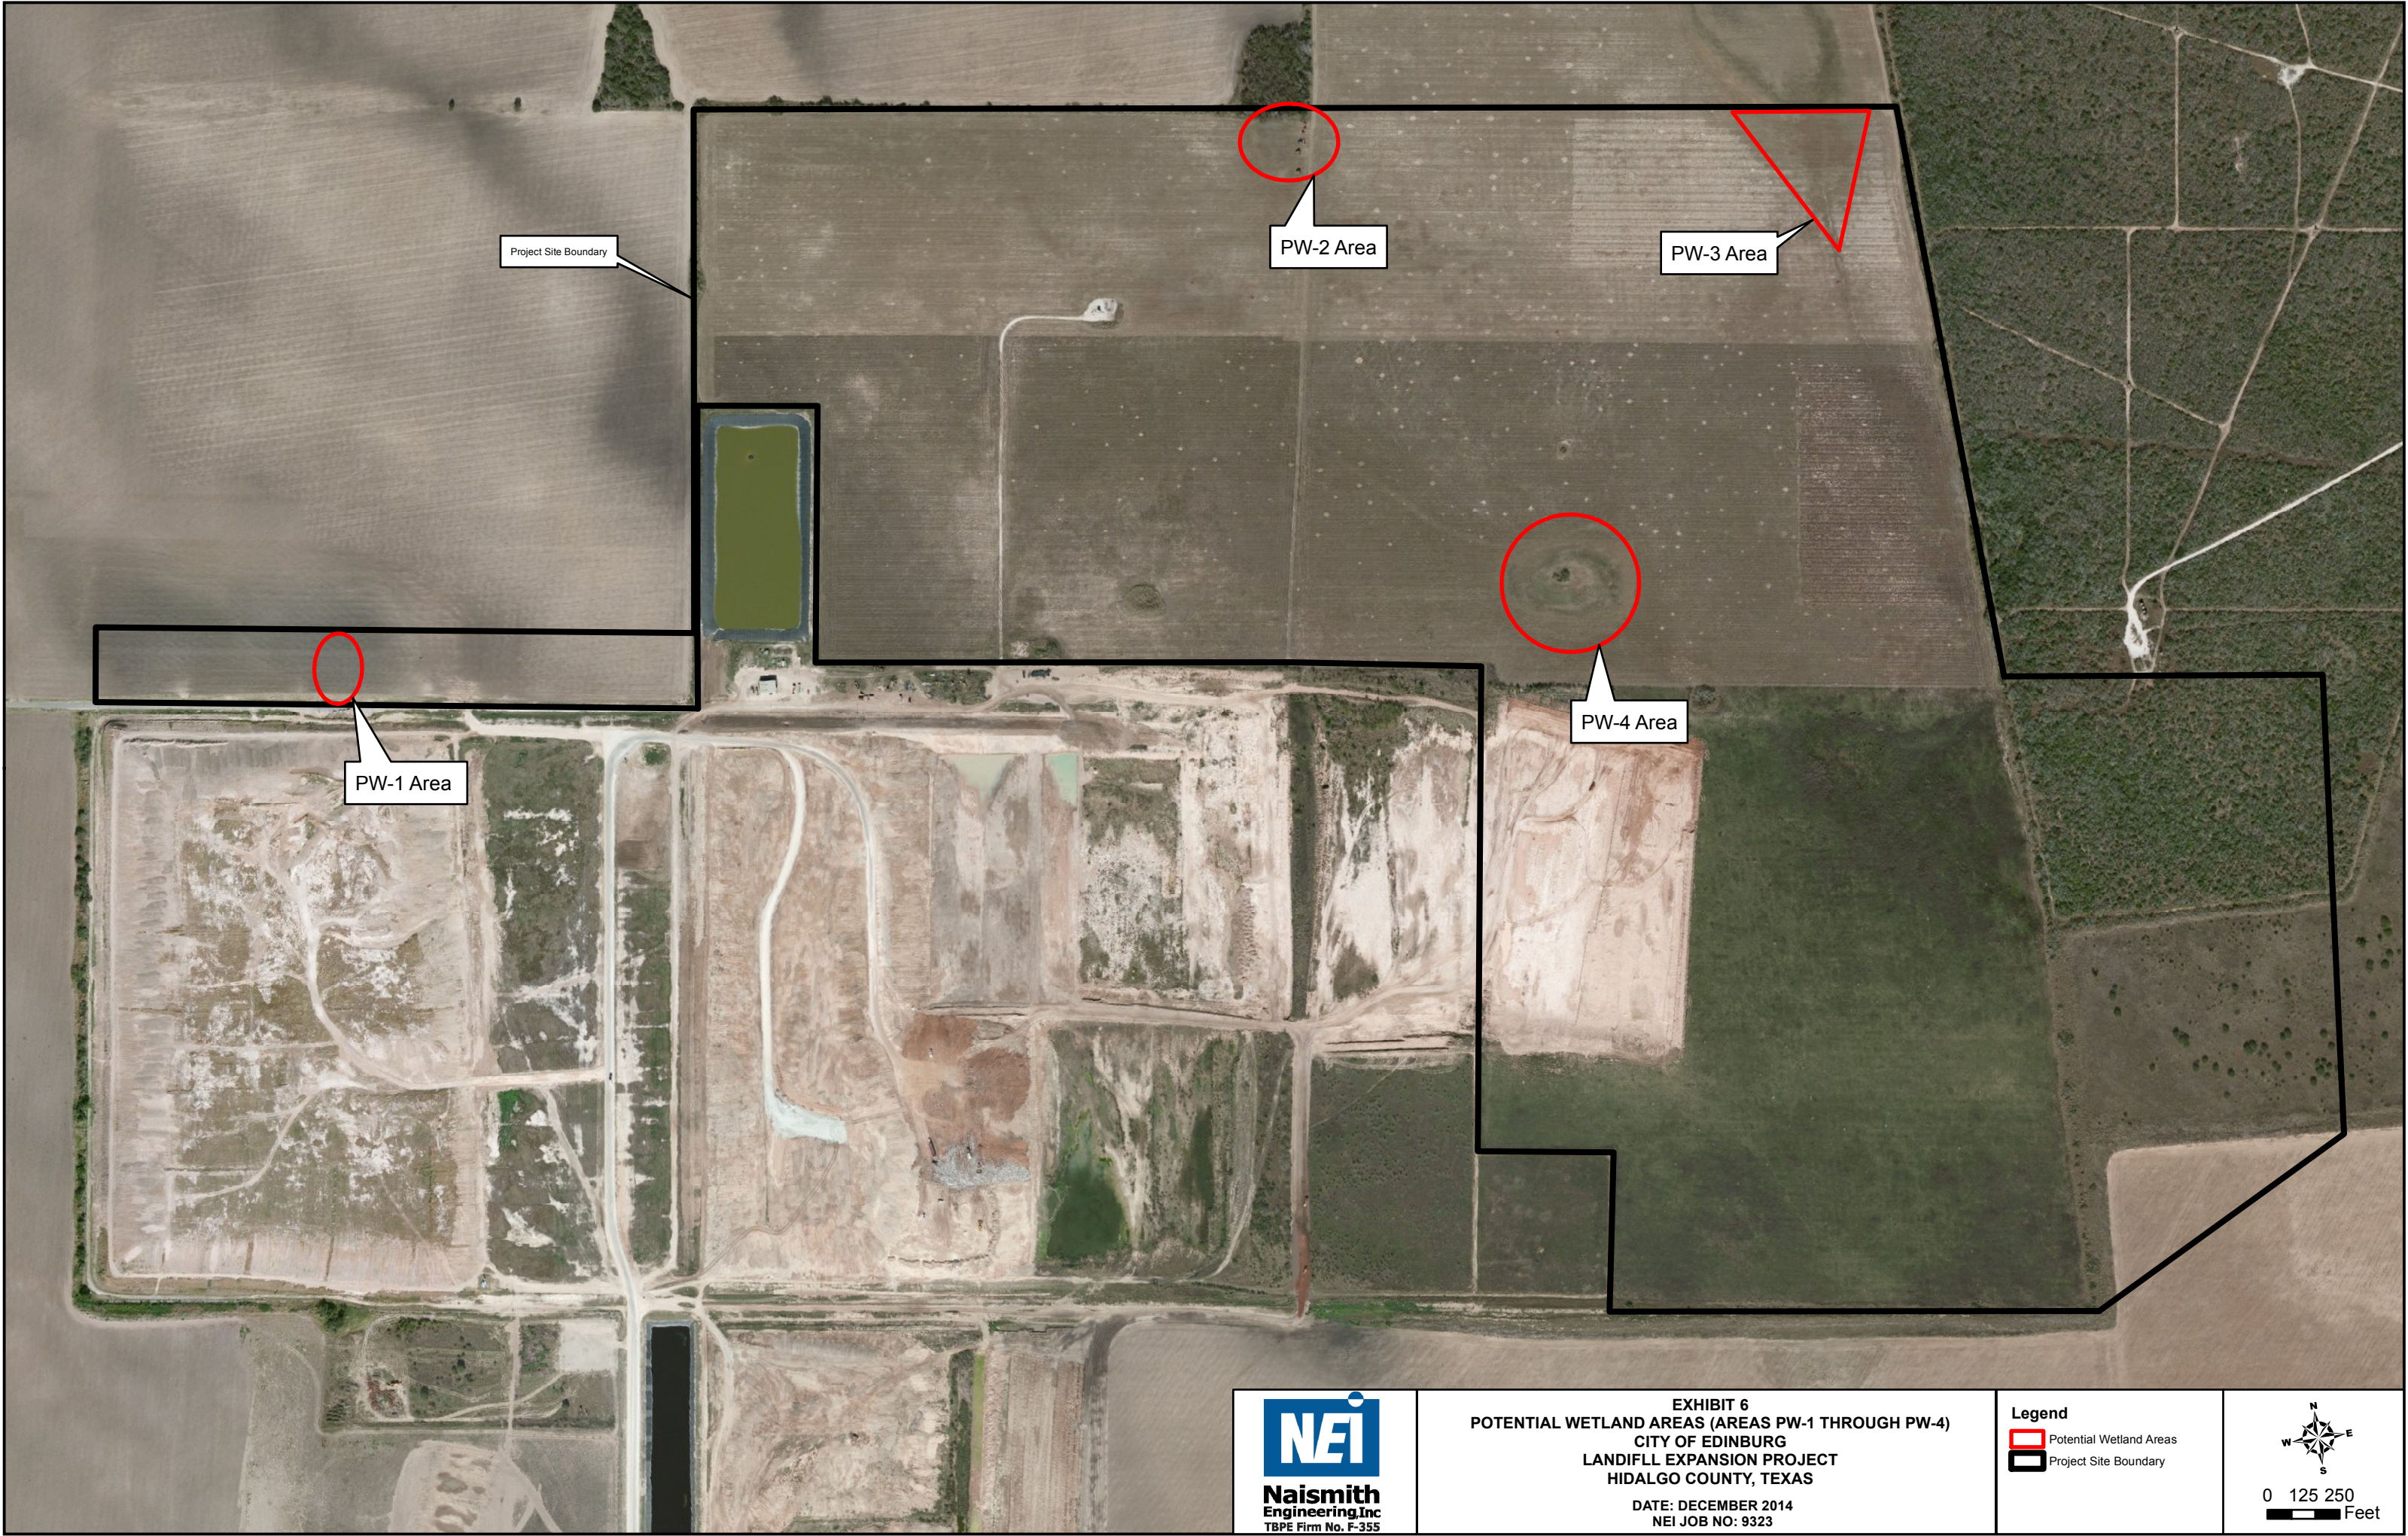
POTENTIAL WETLAND AREAS SITE MAP

The proposed landfill expansion area was evaluated for potential wetlands. Based on information obtained during the desktop review, four (4) areas were identified as being potential wetland sites. These potential wetland areas (PW-1, PW-2, PW-3, and PW-4) were surveyed in the field. PW-1, PW-2, and PW-3 failed to meet the three wetland criteria (hydrology, vegetation, and hydric soils) and therefore do not qualify as wetlands.

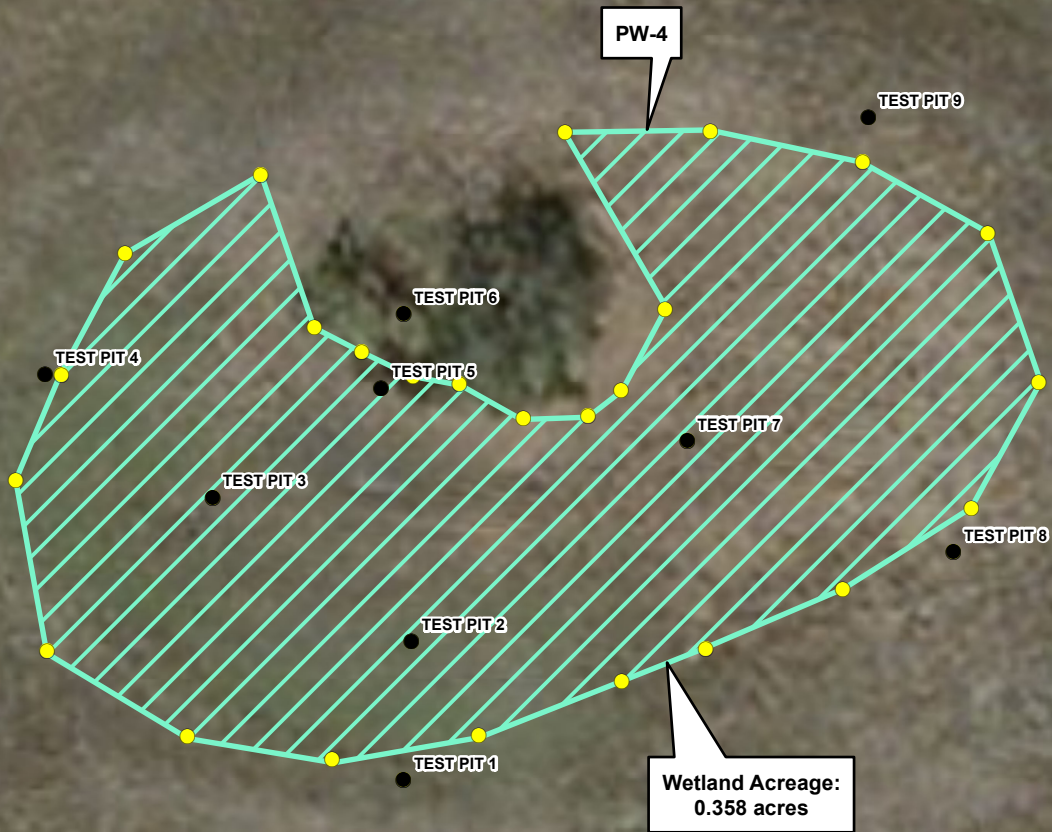
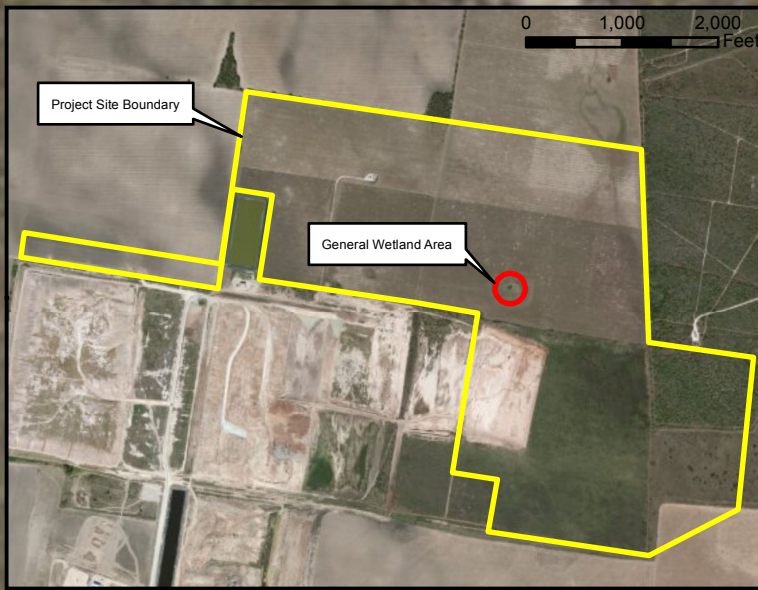
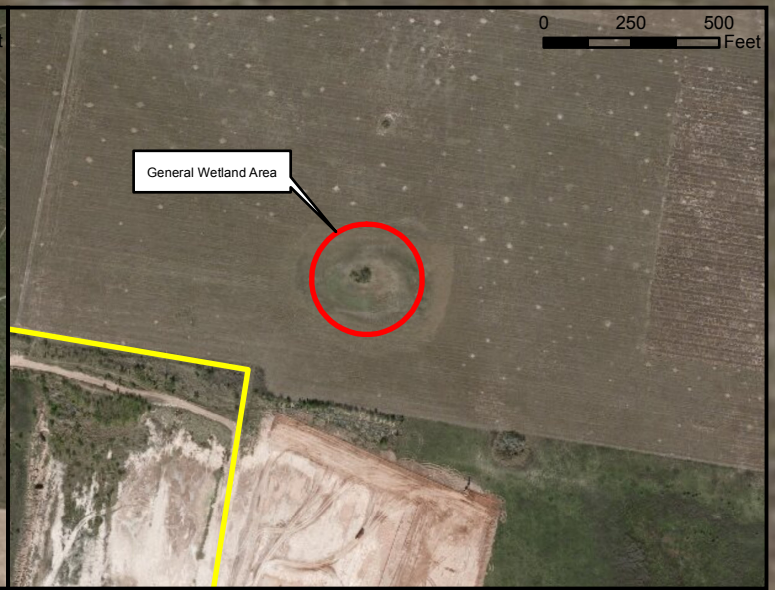
WETLAND DELINEATION MAP FOR AREA PW-4

A wetland delineation was subsequently performed on PW-4 February 6, 2015 amid what could be considered “normal” climatic/hydrologic conditions at the site. The site received approximately 0.4 inches of rainfall the week prior to the site visit. The site had been plowed or disked since the November 2014 evaluation and the plant community had changed dramatically despite normal climatic conditions. The recent plowing affected both the vegetation and soils, which qualifies the area as being “disturbed” with atypical conditions. A summary of the wetland determination and delineation field results is included below.

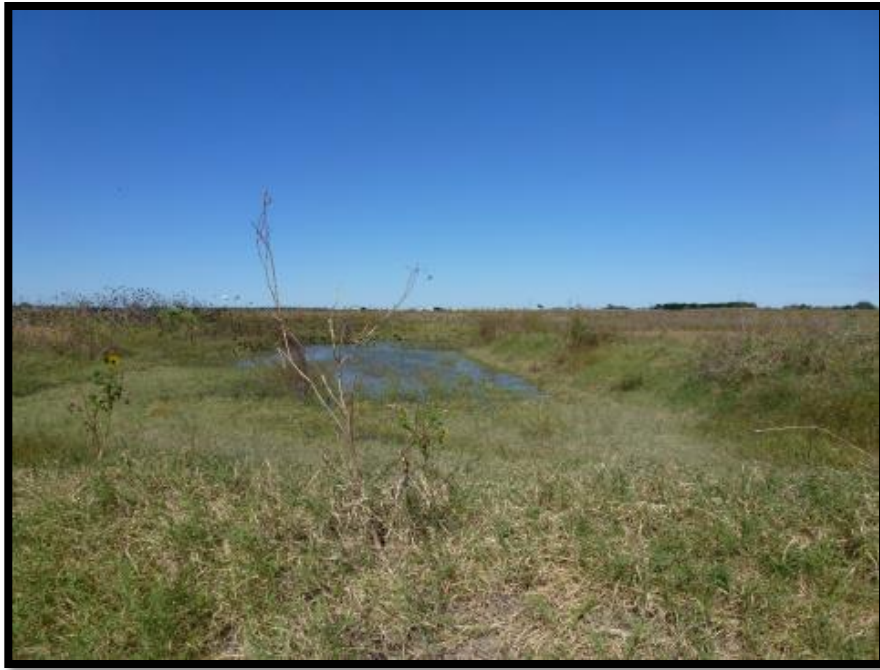
Photo 1 – Area PW-1 facing north. This excavated pond contained standing water during the site visit (it had rained just prior to the site inspection) but no wetland vegetation was observed.

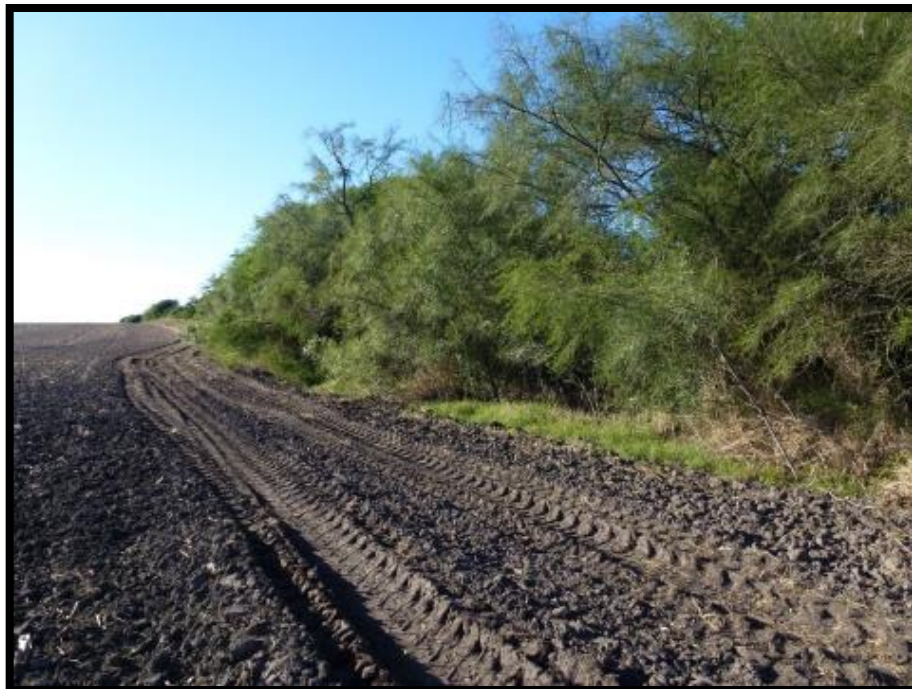
Photo 2 – This photo depicts Area PW-2 (the dirt plowed field) while facing west and looking down the project's northern boundary. The woodlands to the right are located immediately adjacent to Area PW-2 but are just north of the project's boundary line.

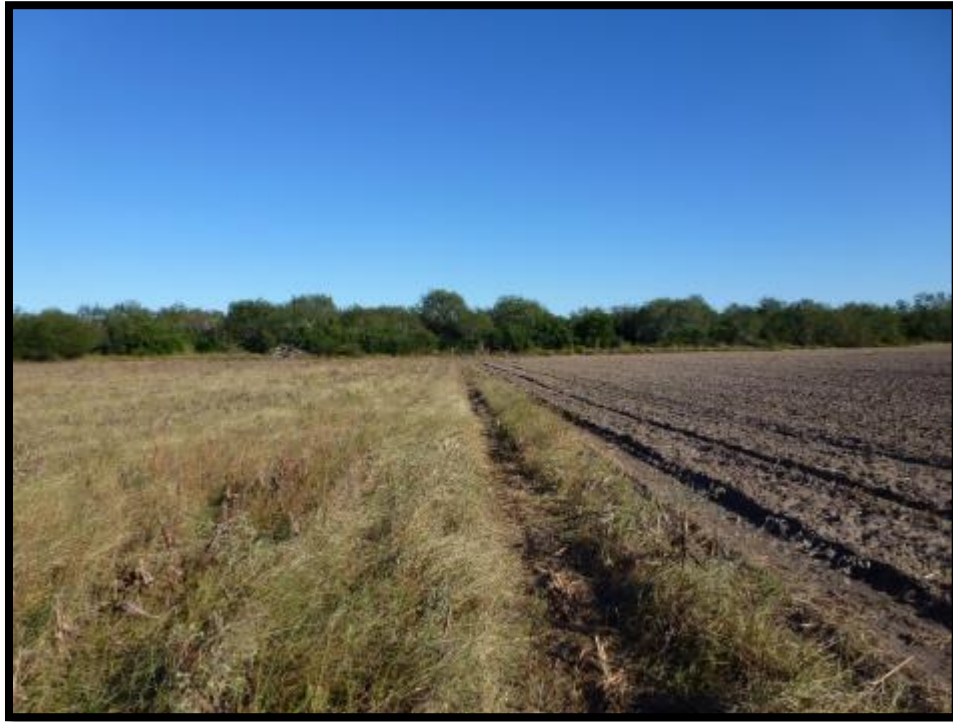
Photo 3 – Area PW-3 facing east and looking down the northern project boundary line.

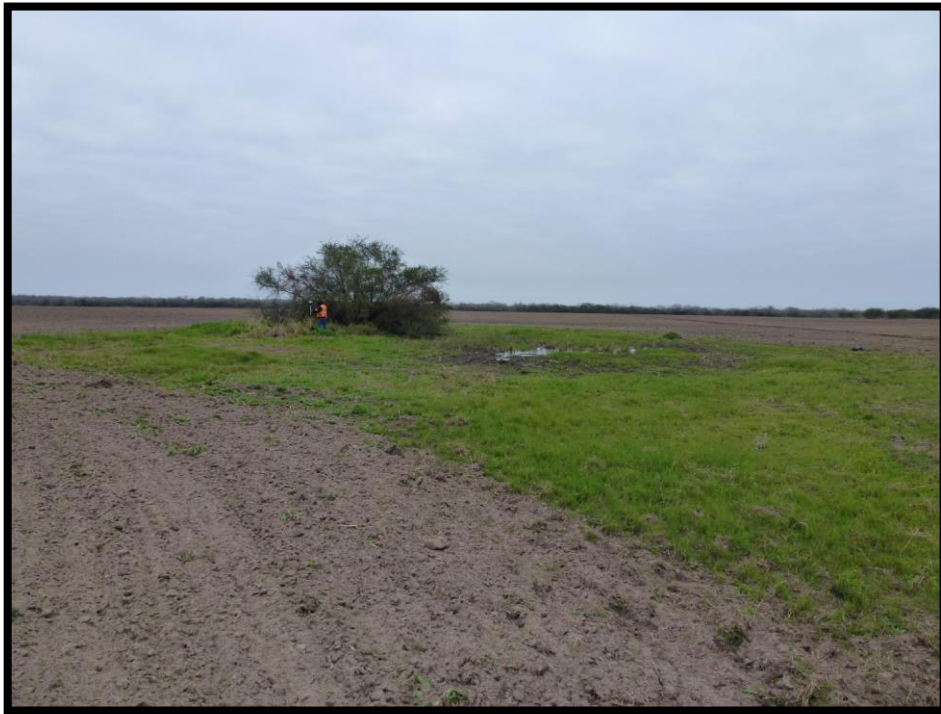
Photo 4 – Area PW-4 facing northeast. This area did qualify as a wetland.

PW-4 is not located within the FEMA-mapped floodplain. It is located in an agricultural field that has been cultivated for at least 20 years (see Appendix 1 – Photo 4). An initial field visit was conducted November 17, 2014, and conditions reflected that the area had been previously plowed or disked. During this initial site evaluation, PW-4 was dominated by wetland plants (*Cyperus* spp. and *Sagittaria latifolia*), contained surface soils which appeared to be hydric, and were saturated (see Appendix 2). Based upon this initial site evaluation, PW-4 was preliminarily determined to be a wetland and scheduled for a formal delineation.

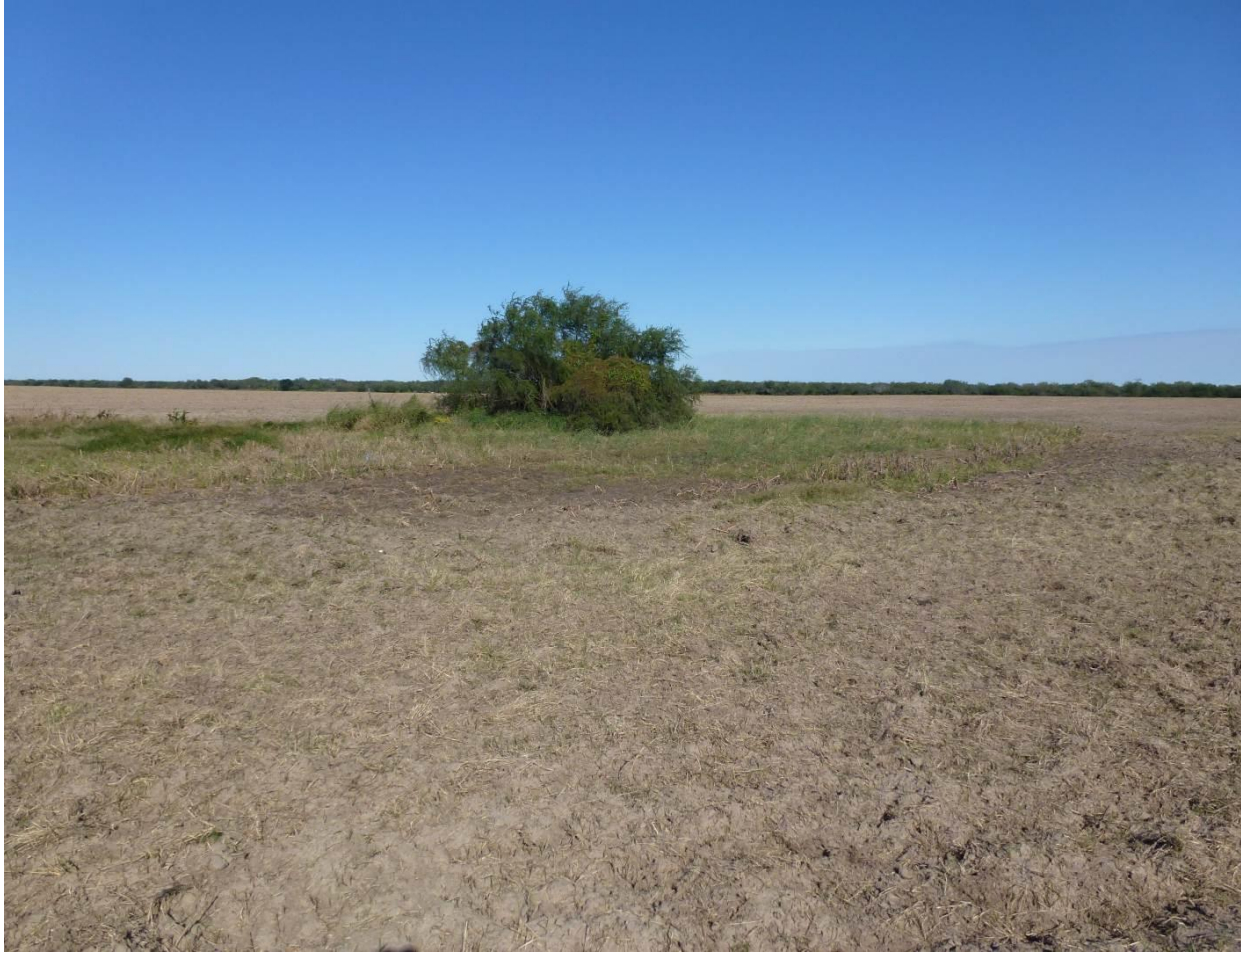
Photo 1 – This photo was taken while facing northeast and looking across the wetland feature. This potential wetland (Area PW-4) is a very shallow depression that is located within a cultivated field.

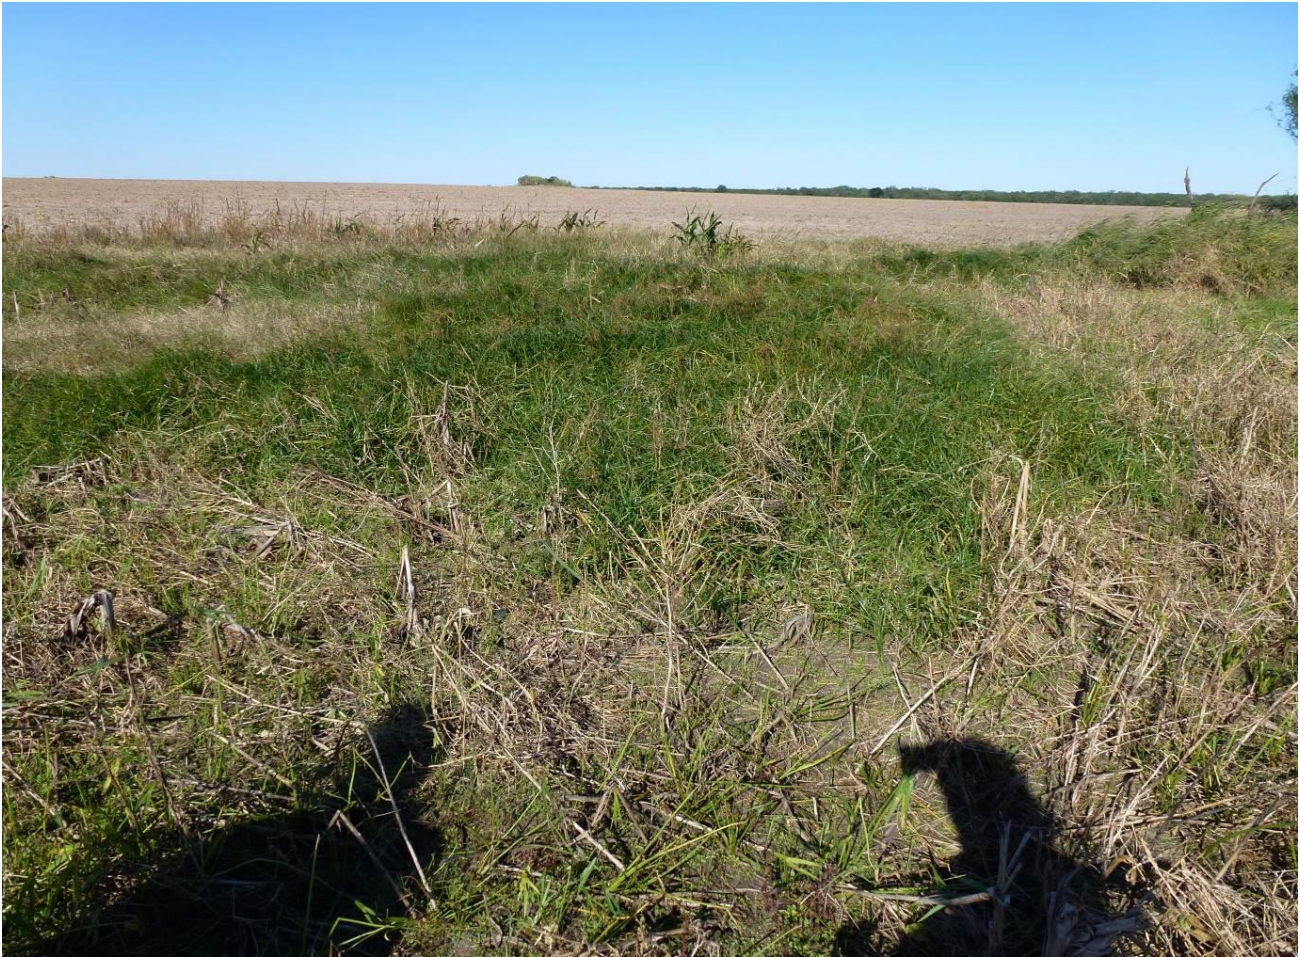
Photo 2 – This photo, which was taken facing north, illustrates the mixture of wetland and upland vegetation occurring in Area PW-4. The dominant wetland plants include flatsedge and broad leaf arrowhead. This area also contained barnyard grass and guineagrass.

Vegetation noted during the November 2014 preliminary site visit (see photos, Appendix 2) was different than the wetland delineation site visit which was performed in February 2015 (see photos, Appendix 3). The area had been disked or plowed in the three months between site visits, and all soils and vegetation (except for the single huisache tree) had been disturbed. Due to the recent ground disturbance, the plant community consisted primarily of pioneer wetland species (small forbs) and did not constitute a majority of the ground cover because most of the area was unvegetated. During the November 2014 preliminary site visit, dominant plant species included *Cyperus* spp. and *Sagittaria latifolia*. Dominant plant species during the February 2015 delineation included golden-fruited dock (*Rumex chrysocarpus*), southern marsh yellowcress (*Rorippa teres*), and false daisy (*Eclipta prostrata*). Dominant hydrophytic vegetation was present at wetland test pits (see Appendix 3). Table 1 shows a comparison of the vegetation present and percent ground cover composition during the November 2014 and February 2015 site visits to PW-4.

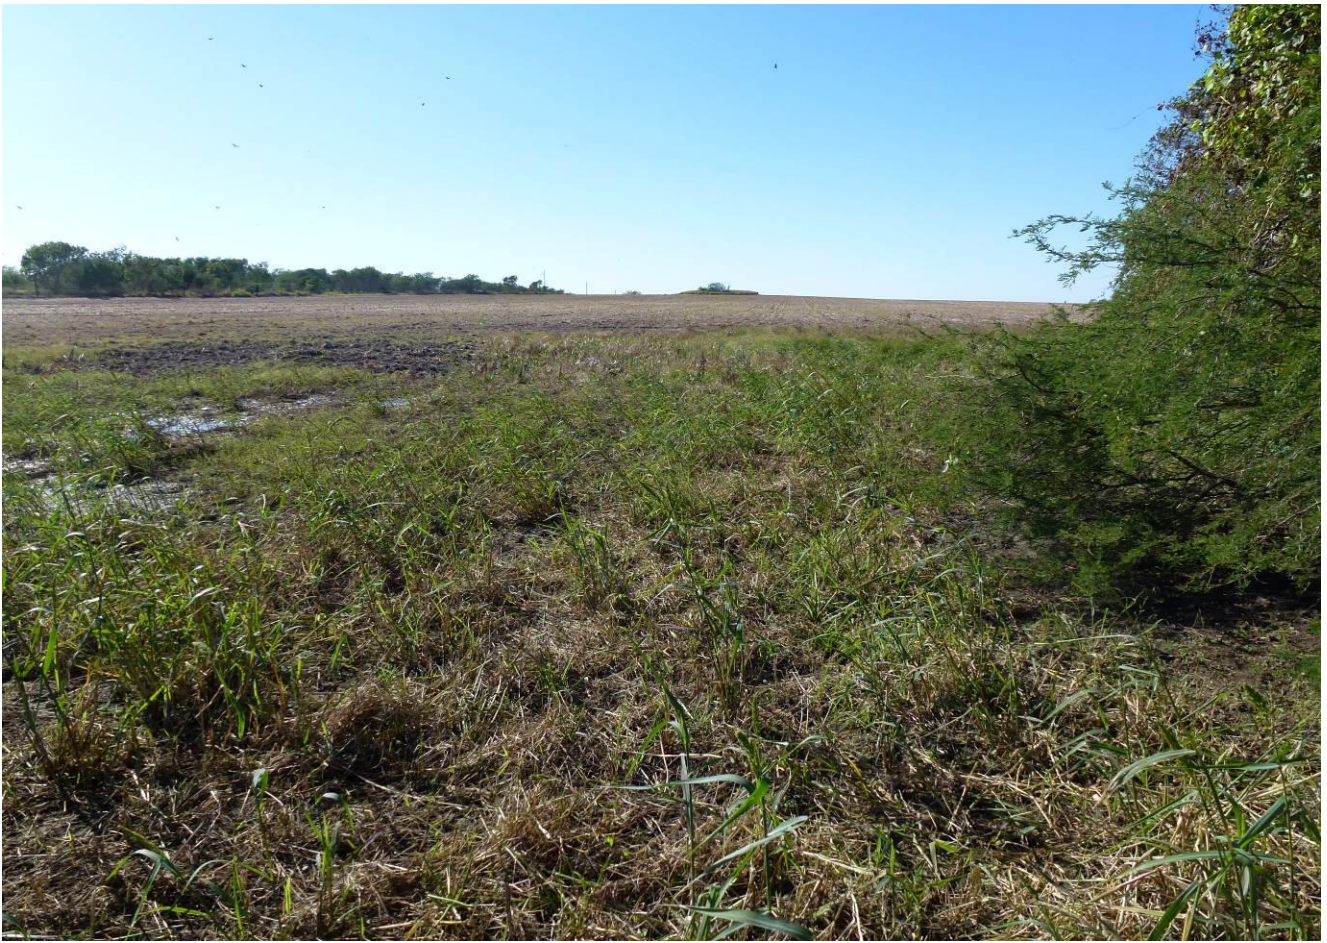
Photo 3 – This photo was taken within Area PW-4 while facing west. Upland vegetation, such as huisache and red center morning glory can be seen to the right. This photo also depicts areas of shallow standing water that occurred primarily within tractor ruts.

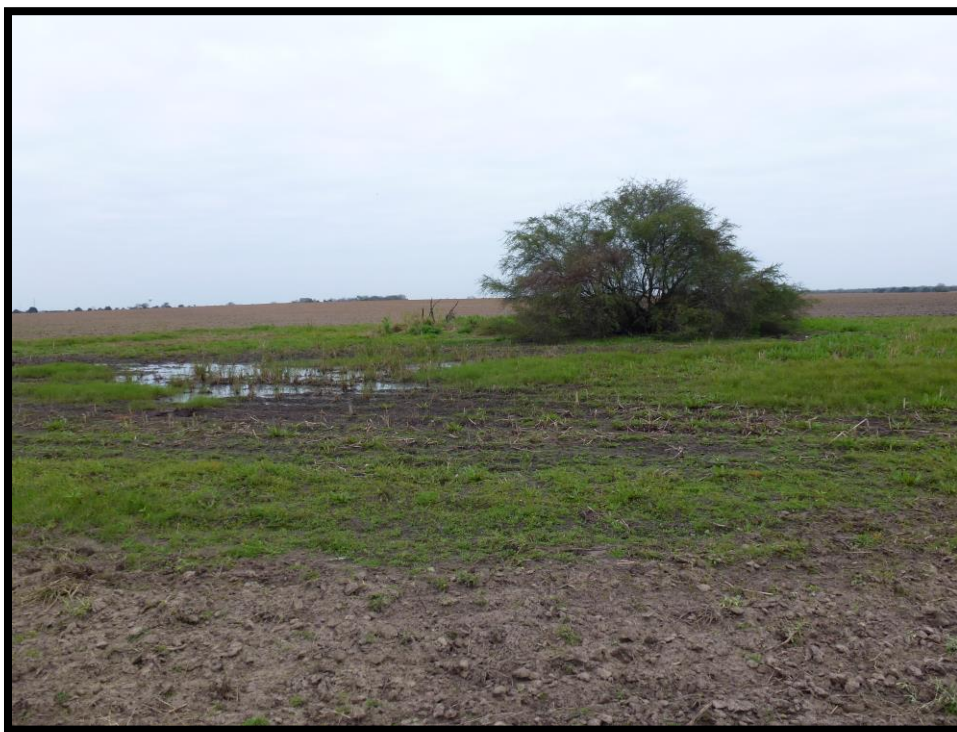
Photo 1 – Area PW-4 facing northwest.

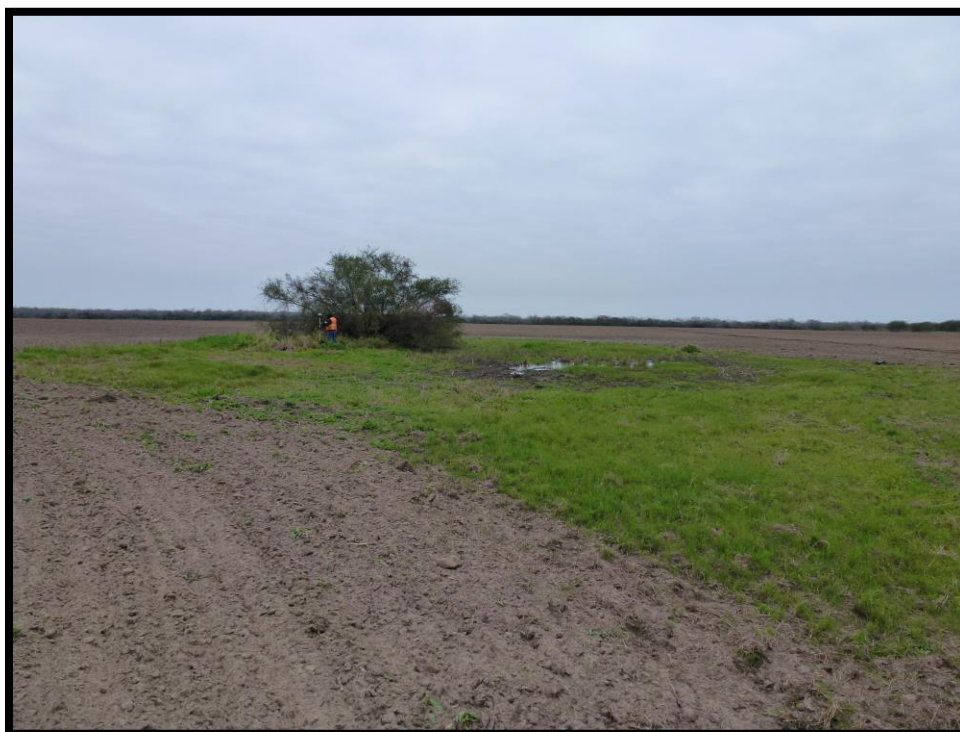
Photo 2 – Area PW-4 facing northeast.
