City Manager's Report: January 21, 2019

INTRODUCTION

On December 6, 2018, MAYOTTEgroup Architects conducted a facility assessment of the Mason Library building. The purpose of the visit was to evaluate the conditions and functionality of the building structure, finishes, systems (including mechanical, electrical, plumbing, and I.T.), and site work.

FACILITY ASSESSMENT

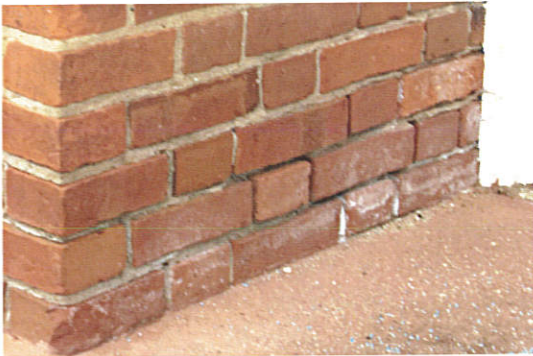
BRICK

- Overall, the Flemish-bond brick and mortar is in generally good condition. There are a few locations where water damage is evident and it is recommended that the damaged mortar joints be cut out and re-tuckpoint with mortar to match existing.

- There is spalling brick at grade near the main entrance and damage to the mortar joints. This is most likely caused by salting entrances during the winter months, allowing moisture into the brick and freeze / thaw cycles. Also, the mortar joints are damaged. It is recommended to replace badly damaged brick and cut out damaged mortar joints and re-tuckpoint with mortar to match existing.

- Inside brick corners at roof valleys have black stains and brick and mortar damage from regularly getting wet. This needs to be avoided to prevent further water damage. It is recommended to install valley baffles to prevent further water damage, clean brick, and re-tuckpoint where needed.

- At the northeast corner of the garage, there are some damaged bricks, probably caused by a collision. It is a non-structural issue.

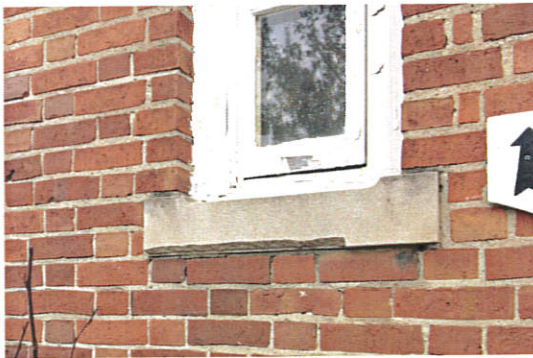
LIMESTONE SILL

- The limestone sills below window openings are weathered and have black stains. A few throughout the exterior are damaged / chipped. It is recommended to clean the stains and repair the damaged parts with an epoxy material to match existing.

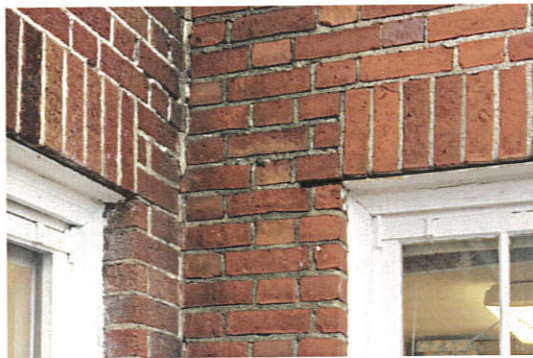
STEEL LINTELS ABOVE OPENINGS

- The steel lintels are rusting because of water damage / exposure and therefore have swelled, causing lifting brick. This caused mortar joints to spall off at the bearing points. To slow down the rusting, it is recommended to clean the steel lintels and repaint or to replace the steel lintel in its entirety and replace with hot dipped galvanized steel lintels of the same size with stainless steel drip through wall flashing then reinstall brick and install weep holes.

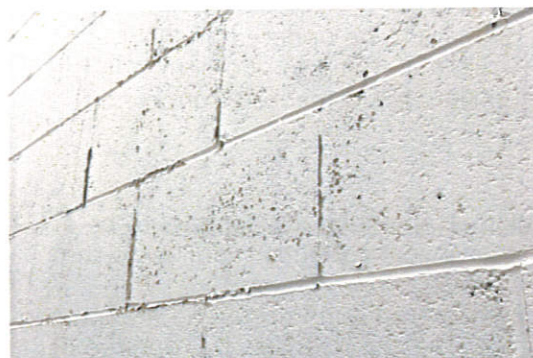
CONCRETE MASONRY UNITS

- The CMU wall on the south is in good condition. There are some hairline cracks, but no structural issues. It is recommended to clean off the dirt and flaking paint and repaint.
