## Greenwood Cemetery Excavation and Investigation

Kimberly Byrnes and Madison Long

Dr. Charles Ewen, Principal Investigator,  
Department of Anthropology

## East Carolina University

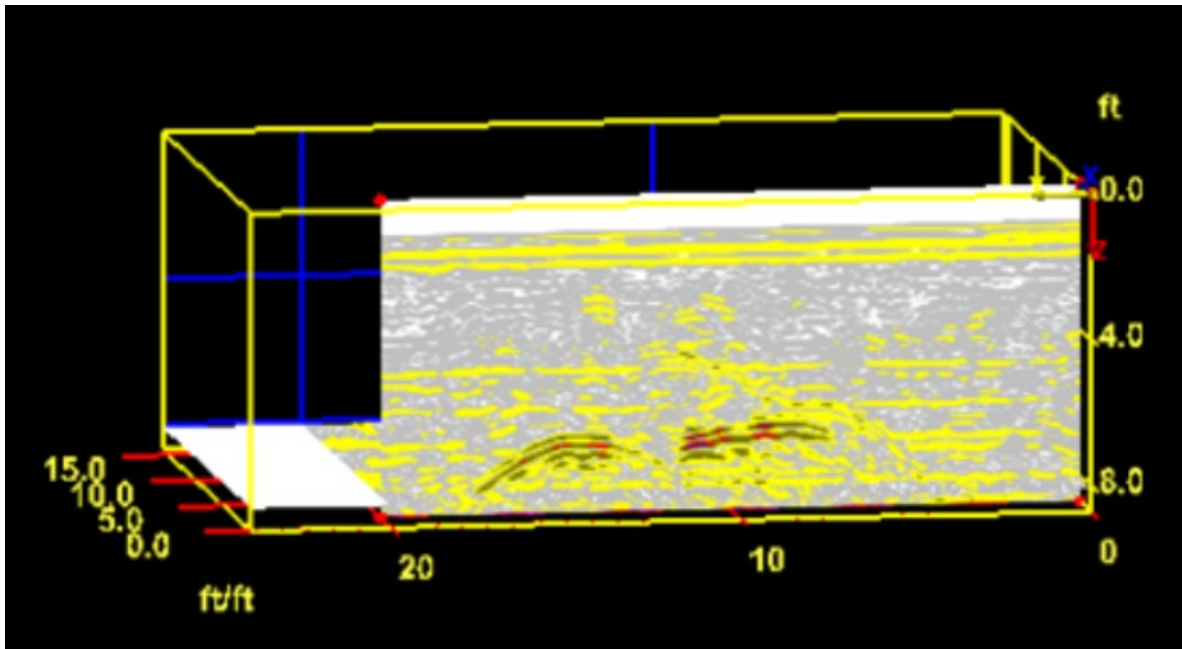
Figure 3 - GPR results showing consistent planar reflection at a depth of approximately 4ft

Stage one of the project involved the use of ground-penetrating radar (GPR) to survey the area of interest for any anomalies that could indicate the presence of burials. The GPR survey was conducted by Dr. Charles Ewen and ECU graduate student Matt Harrup using a TerraSIRch SIR System-3000. The survey took place in a 16ft. by 10ft. grid divided into 2ft. transects. The scans revealed the presence of many reflections, both parabolic and planar in shape. Notably, a consistent planar reflection, indicating a change in stratigraphy was observed at a depth of approximately 4ft. (Figure 3), with slightly stronger and more parabolic reflections, indicative of buried anomalies at a depth of just over 5ft (Figure 4). The presence of the anomalies indicated the need for excavation.

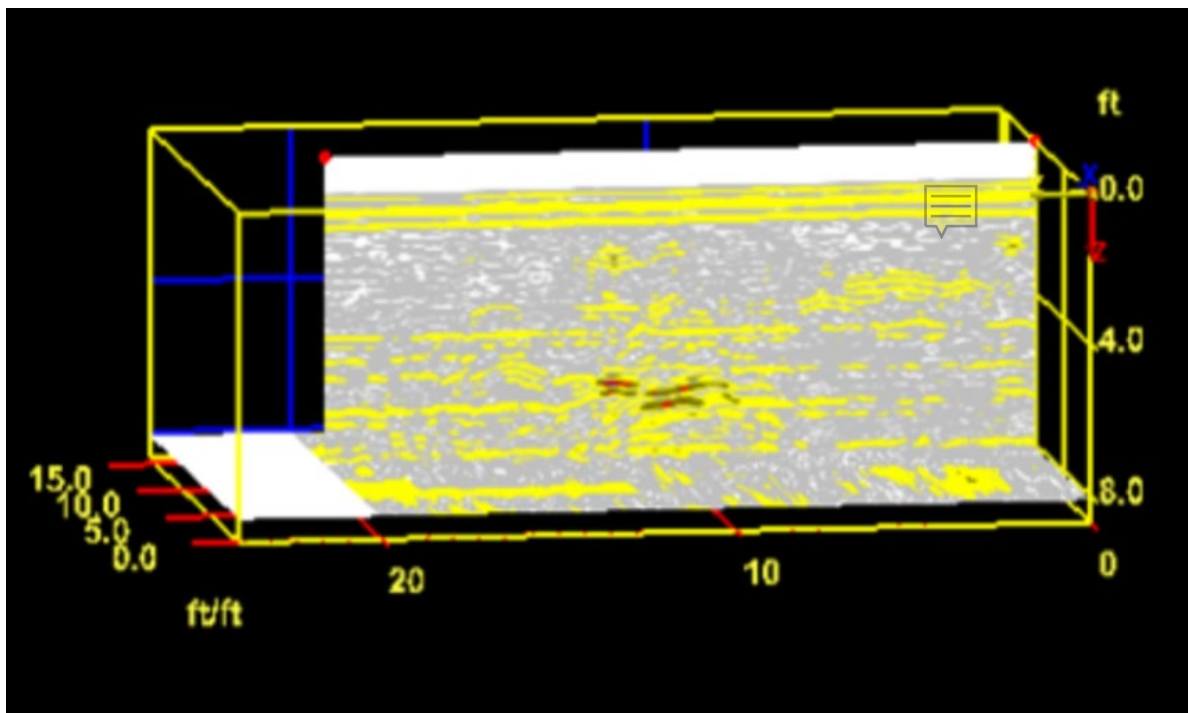
Figure 4 - GPR results showing stronger, more parabolic reflection at a depth of approximately 5ft.

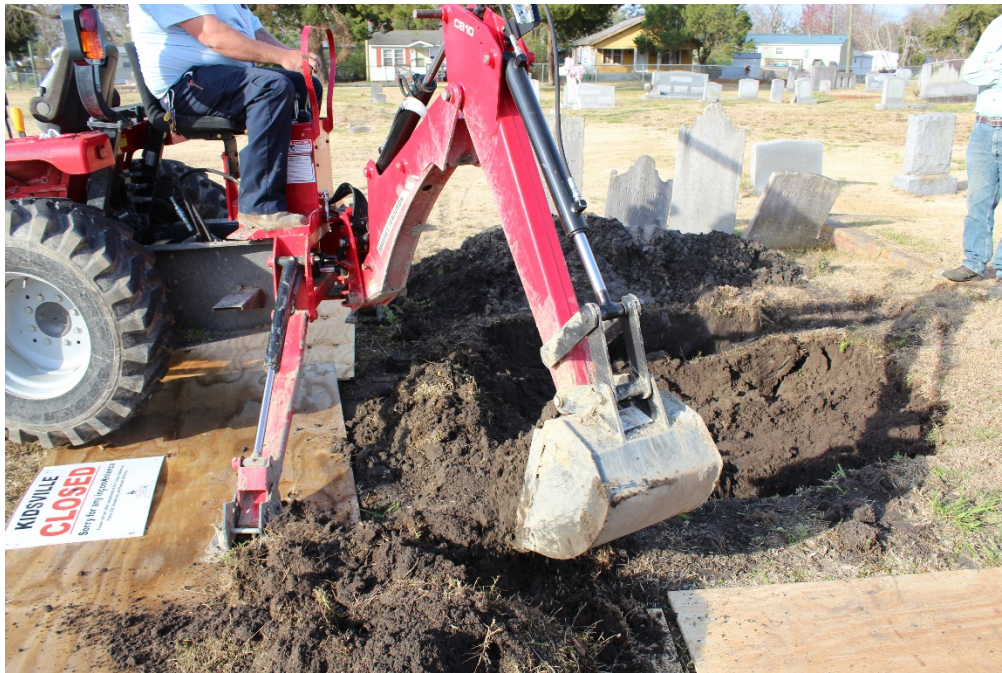
*Figure 6m- Backhoe Excavation – Facing West*

Based on past GPR research, it was determined that there were no anomalies in the ground until at least four feet below surface level. To expedite the excavation, a backhoe was used to carefully remove these top few feet of fill soil (Figure 6). The headstones were removed

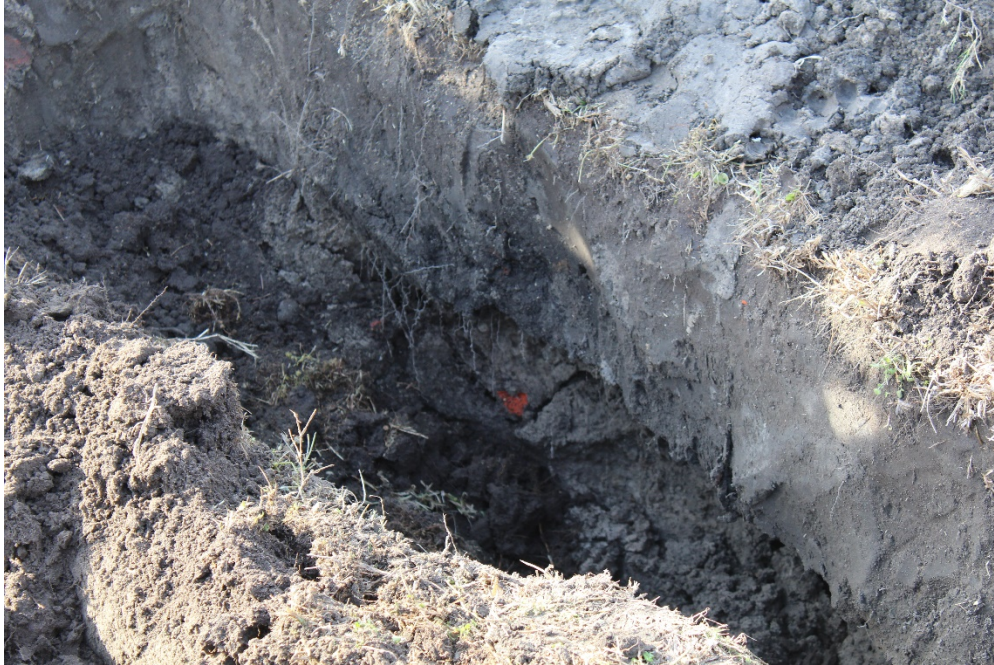
*Figure 8 = Backhoe Excavation Close-up – Facing Southwest*

from the plot to facilitate the excavation. These stones were photographed and set to the side (Figure 7). A backhoe was used to excavate the first three to four feet of soil, until the brick walls of an unexpected burial vault were exposed around the perimeter of the burial plot (Figure 8).

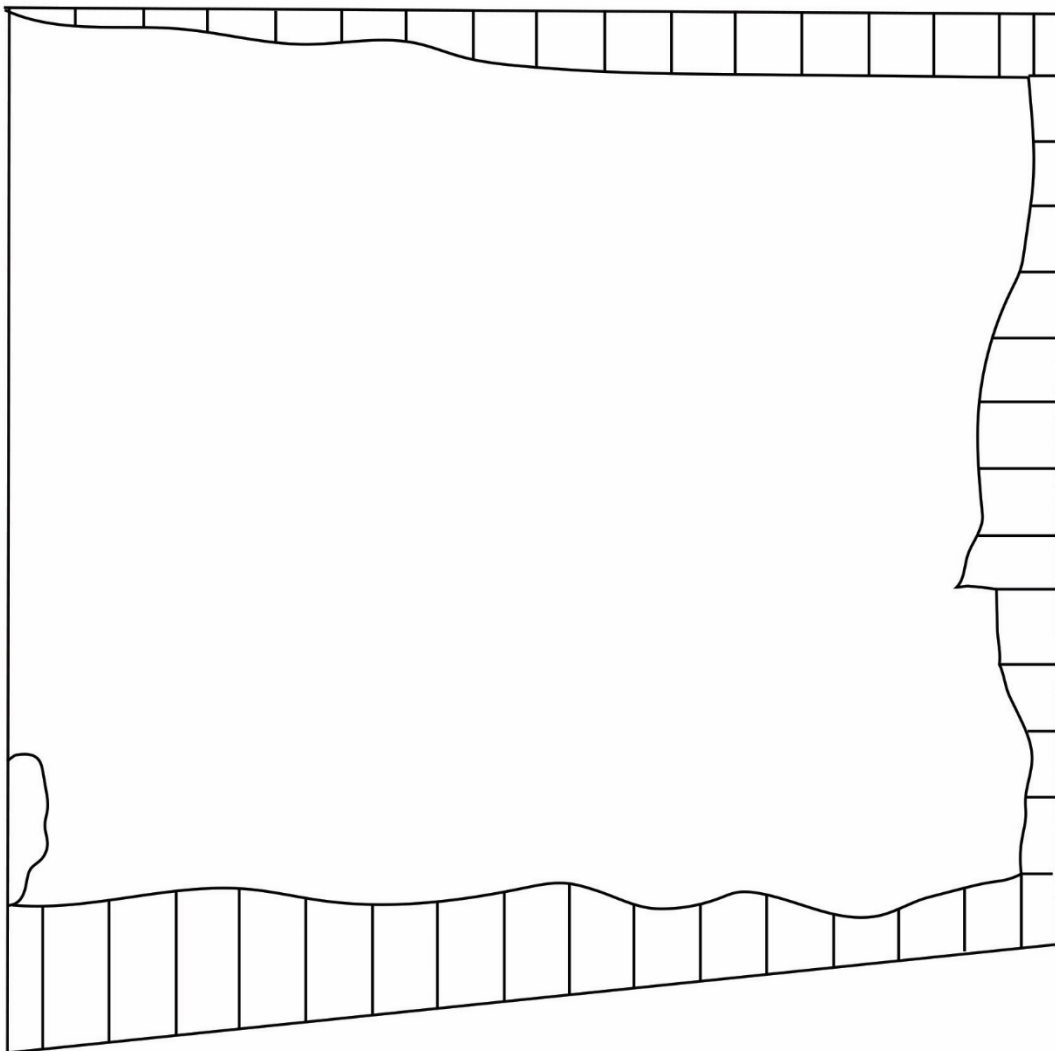
Figure 9 - Plan View Map of Exposed Brick Vault

Brick Vault

After the brick burial vault wall was uncovered, shovels were used to level out the excavation surface and hand trowels were used to carefully expose more of the brick. Soil was screened using  $\frac{1}{4}$  inch mesh to ensure the recovery of artifacts and human remains in the soil. Three brick walls were exposed on the north, south, and east sides of the burial plot (Figure 9). The excavation extended to the west wall as well, but that side was not completely excavated as it was directly beneath the headstones which were left in place. After the burial vault was mapped, the north half of the excavated area was sectioned off to be excavated further. Excavation was conducted using shovels and hand trowels, and arbitrary levels were established every half of a foot to maintain vertical control over the excavation. All artifacts were placed in 2mil plastic curation bags, and each bag was labeled according to level.

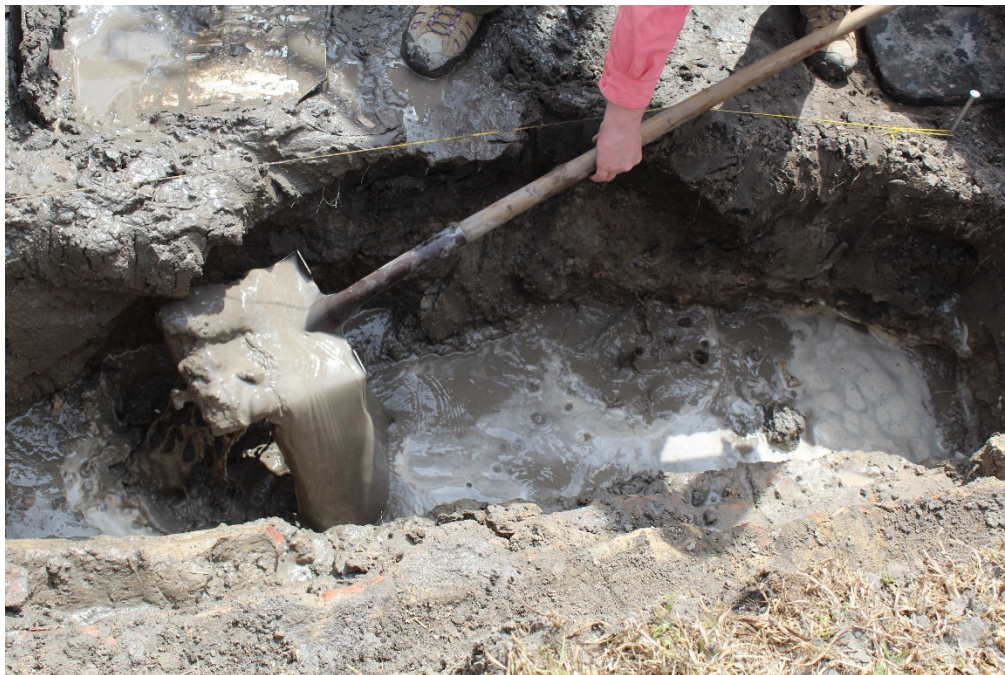
*Figure 10 - Water Filled Feature – Facing South*

The water table was reached approximately 4.4 feet below ground surface and excavation of the northern half of the burial vault continued with shovels into the water and mud until a brick fall was identified approximately five feet below ground surface (Figure 10). At this time the southern half of the burial vault was excavated down to the same level as the northern half with the backhoe in order to expose more of the brick fall. Once this was accomplished, a sump pump provided by city officials of New Bern was used to pump water out of the unit for excavation to continue (Figure 11).

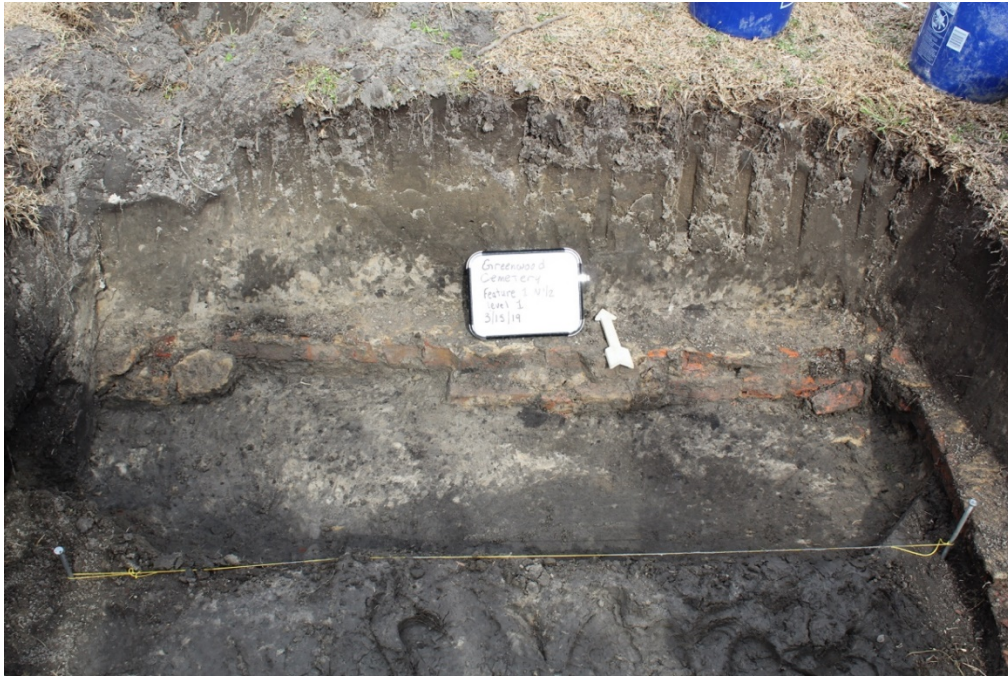
Level 1 extended from 1.9ft. down to 2.4ft. below the ground surface. The soil was wet, and shifted from a dark gray brown at the top to a light gray at the bottom (Figure 12).

*Figure 12 - Feature 1 North Half Level 1 Base – Facing North*

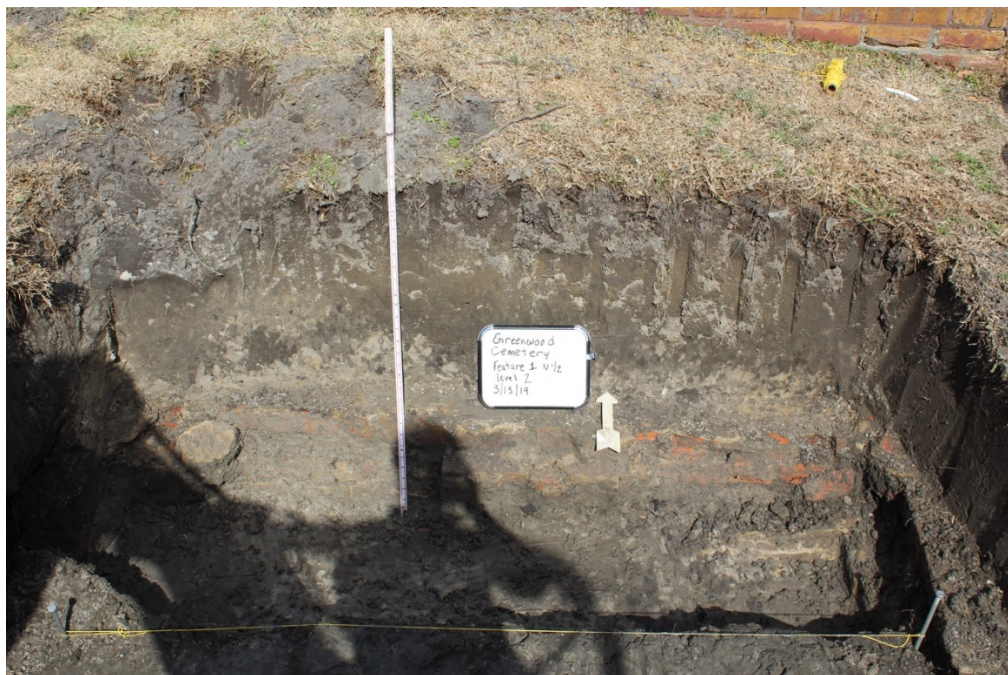
Level 2 extended from 2.4ft. to 3.9ft. from the ground surface, and was 0.5ft. to 1.0ft. below the surface of the exposed brick wall (Figure 13). The soil was thick and muddy. Artifacts recovered from level 2 were similar to those recovered from level 1.

*Figure 13 - Feature 1 Level 2 Base – Facing North*

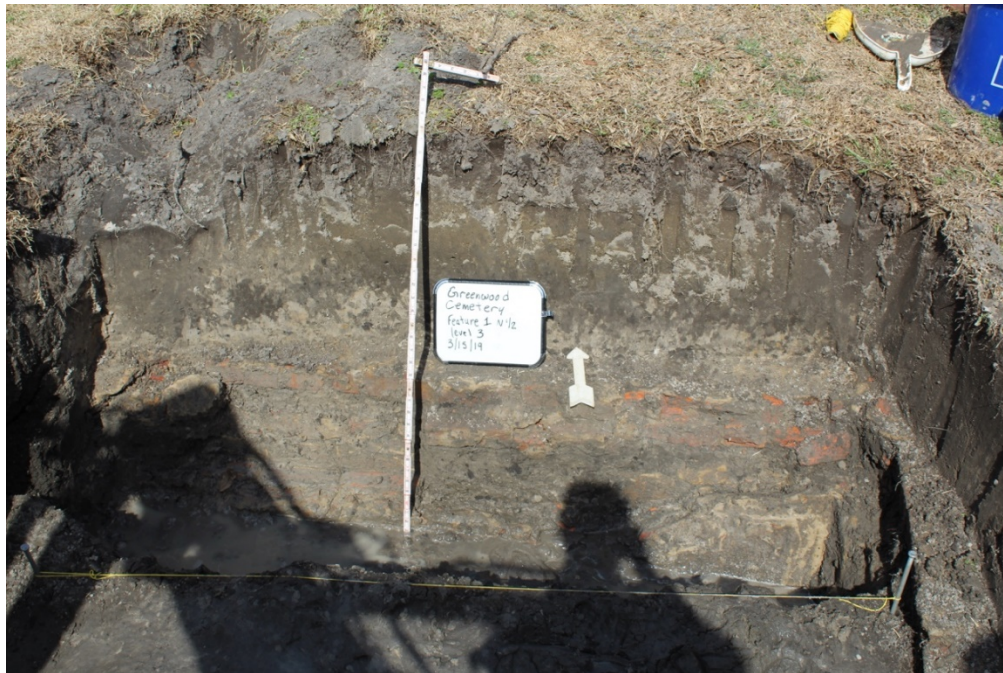
Level 3 extended from 3.9ft. to 4.4ft. below the ground surface, and 1.0ft. to 1.5ft. below the surface of the brick wall (Figure 14). The water table was reached within this level, and shell fragments were the only material recovered from the fill.

*Figure 14 - Feature 1 Level 3 Base – Facing North*

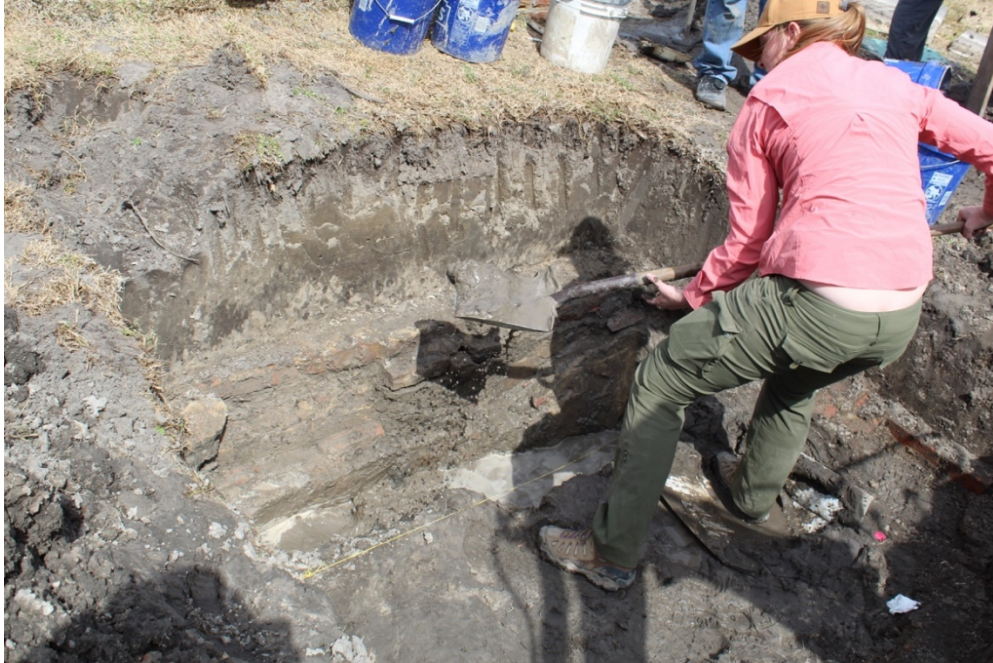
Level 4 began at 4.4ft. below the ground surface and extended down into the water table and ended at 5.1ft (Figure 15). Brick and mortar fragments were recovered and identified as brick fall. No other artifacts were recovered from Level 4.

*Figure 15 - Feature 1 Level 4 Excavation – Facing Northeast*

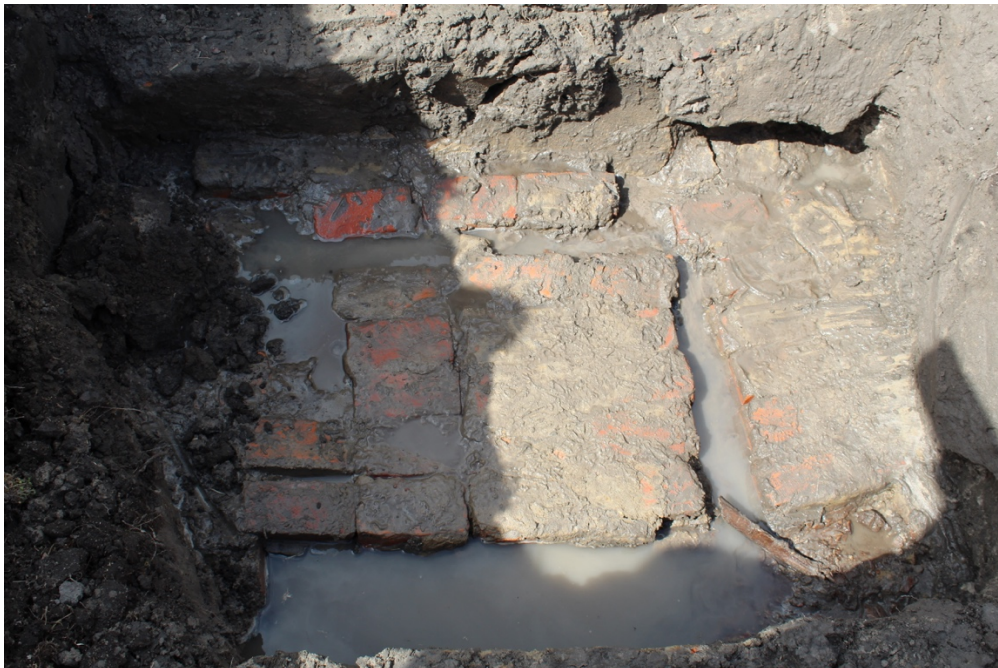
Level 5 was excavated with the backhoe until a flat level of brick was reached at 5.7ft., and deemed a brick floor (Figure 16). At this point, bone fragments were reached.

*Figure 16 - Brick Floor – Facing North*

Commingled human skeletal remains were recovered from within channels existing throughout the brick floor in a crisscross pattern. Human remains recovered included many small

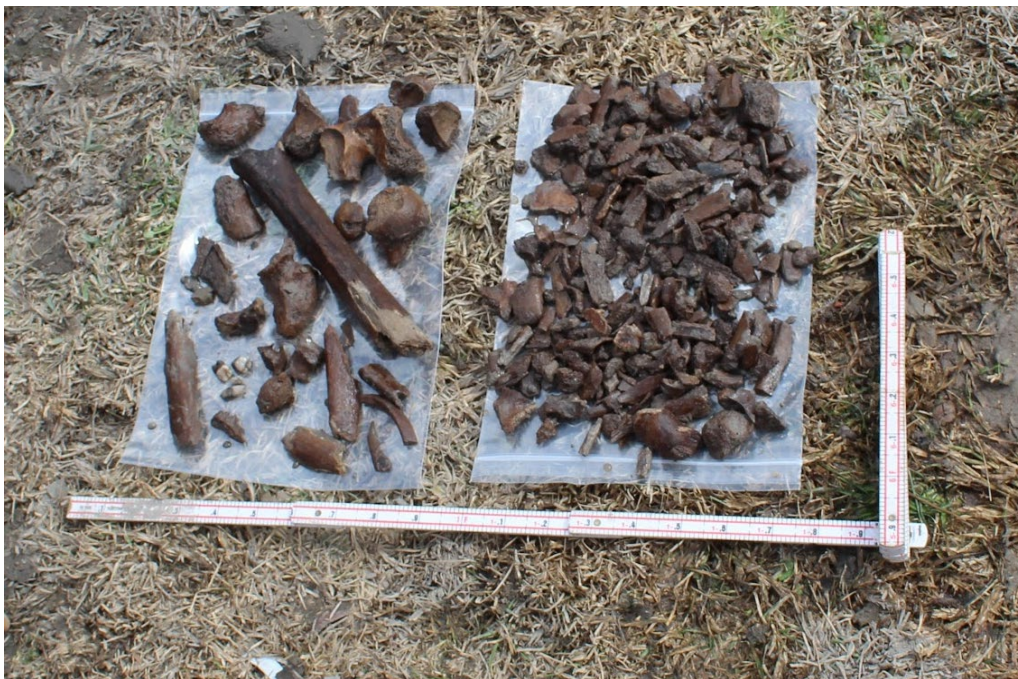
fragments and a few larger pieces of long bones and an os coxae (pelvis), including a femur shaft and ilium (portion of pelvis) respectively (Figure 17). Of the smaller fragments, identifiable elements include ribs and acetabula (hip joint on pelvis). Additionally, at least four teeth were recovered, some of which were noted to be molars, all with relatively good preservation levels. Overall, however, the preservation level of the skeletal remains was poor and fragmentary. Based on the identification of brick fall, it is also likely that the skeletal remains were crushed by brick, adding to the poor levels of preservation. In addition to the human skeletal remains, wood fragments (possible coffin remain) and one leather fragment were also recovered from level 5.

*Figure 17 - Recovered Human Remains*

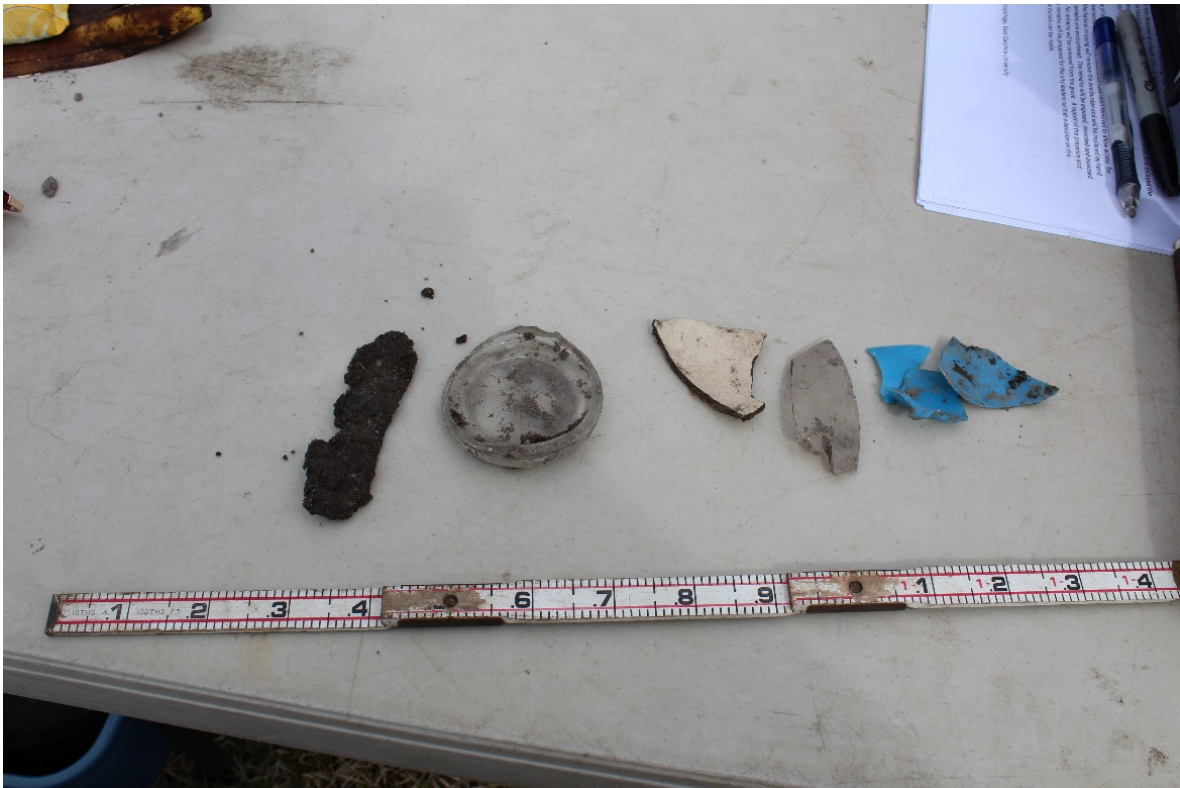
*Figure 18 - Recovered Artifacts*

the brick collapsed it caused a depression in the ground which was then filled in. This fill dirt contained the sparse collection of artifacts excavated. The artifacts consisted of nails or other pieces of unidentifiable metal, ceramic dishes, glass from jars and a fragment of a small blue urn, and shoe leather (Figures 18, 19, and 20).

The nails and shoe leather might be associated with burials, being nails from the coffin and shoe leather from the deceased. However, many of the individuals moved from Cedar Grove cemetery had been buried there in the mid 1800s or earlier, and leather typically degrades within 50 years (Reference 2019). Reducing exposure to light will help preserve leather and keeping it moist will reduce cracking. The leather excavated was moist, but reduced cracking does not mean increased preservation. The best situation for preservation is an environment with little to no oxygen (Dirksen 1997). This was not the case for the shoe leather identified in the top level excavated, therefore making it unlikely to be associated with these burials which are 200-150 years old. The nails recovered could be from coffins but, again, they were found in the upper mixed fill level. Perhaps they were from coffins, but as no coffin wood was excavated in the top level with the nails, there is little evidence directly associating the nails with coffins.

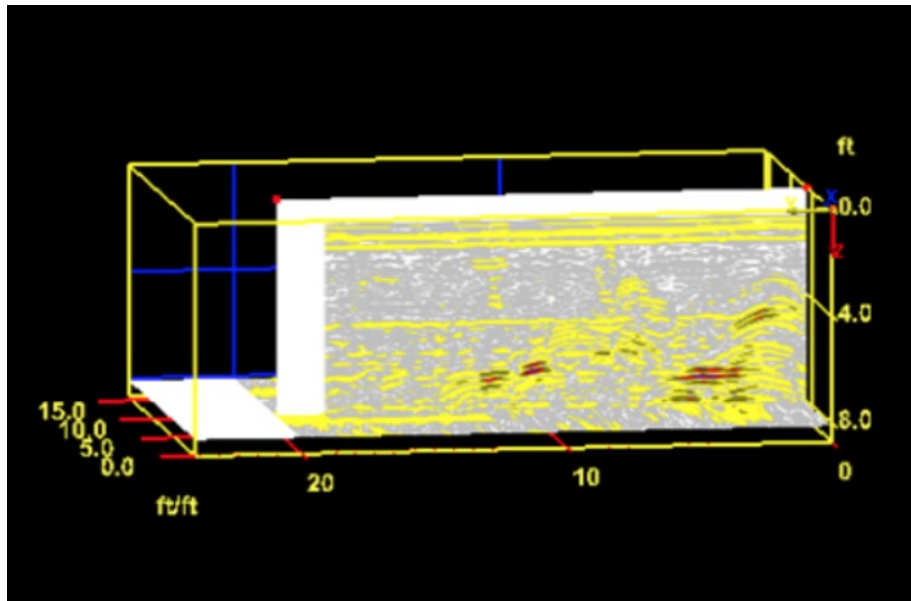
According to the results of the phase I survey and phase II excavation that has taken place at the Greenwood Cemetery site, further archaeological investigation is not recommended. The GPR results show reflections at depths below 5.7ft, the level at which excavation ceased (Figure 23). However, it is likely that these reflections are indicative of the floor of the vault and water, as the water table was reached by a depth of 4.4ft. (level 3 of excavation).

*Figure 23 - GPR results showing additional reflections below 5.7ft.*

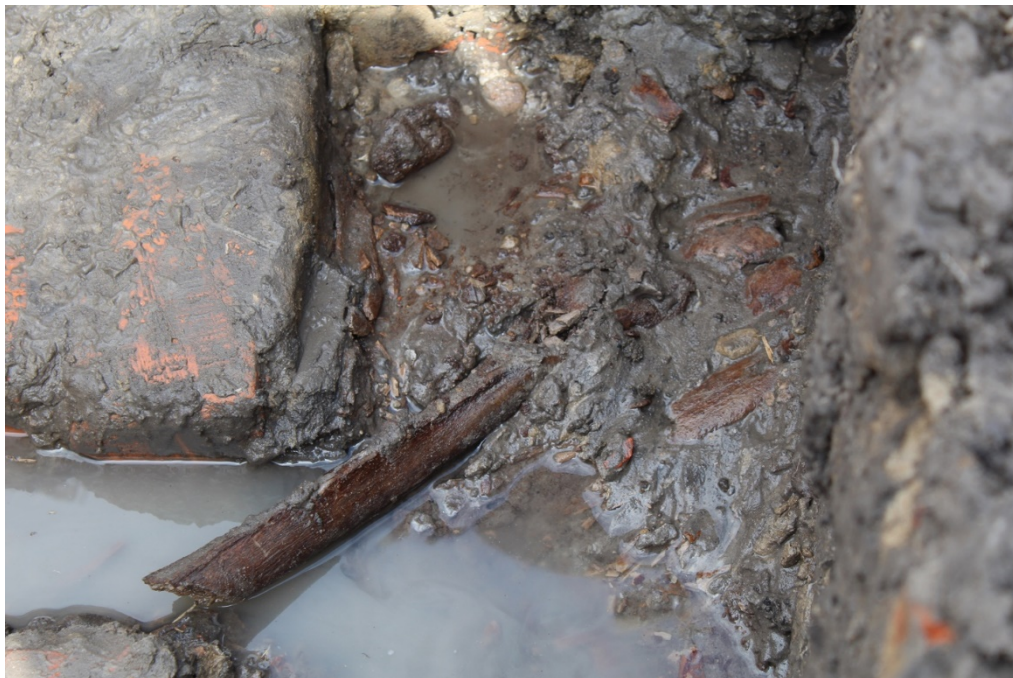
Valuable information about the nature and preservation of the burial site was gained through phase I survey and phase II excavation that would allow for recognition and interpretation of the site through historical signage or other means that do not require further excavation and analysis of the site, artifacts, and skeletal remains. However, further excavation is possible and could provide more information regarding the reinternment process and the lived experiences of the individuals buried within the brick lined shaft at Greenwood Cemetery. More extensive inventory and osteological analysis of the human skeletal remains from the site could provide a minimum number of individuals (MNI), as well as additional demographic information. At least one os coxa (pelvis) was preserved enough that it would be possible for sexually dimorphic features (i.e. greater sciatic notch) to be assessed for sex estimation (Buikstra & Ubelaker 1994). While there is a possibility for DNA analysis, it is likely that significant exposure to water has decreased the likelihood of successful DNA extraction (Figure 24) (Götherström et al. 2002). Overall, the fragmented and commingled nature of the remains would

make further demographic information difficult to obtain through osteological methods. Additionally, the preservation levels and commingling of the remains render it extremely challenging, if not impossible, to determine which bones are from the same skeleton, and to whom those remains may belong.

*Figure 24 - Bones on the vault floor Floor - Southeast*

All the remains recorded during the excavation were bagged and carefully replaced on the floor of the vault before backfilling the vault. Should further analysis be desired, the backfill would be removed and the bagged and any loose bones would be recovered and the vault fully exposed and recorded. Additional historical research should be undertaken in any event to better understand the transferal event and perhaps determine who responsible for the construction of the brick vault.
