Former Asphalt Plant

510 South Glenburnie Road

New Bern, Craven County, NC

Terracon Project No. 72187050

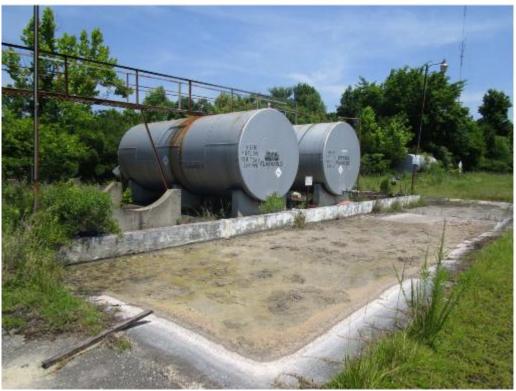
Photo 3

A view of two ASTs within a concrete containment structure near the northwest property line.

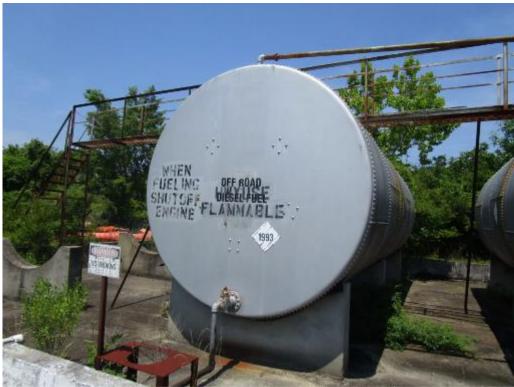
Photo 4 A view of one of the two ASTs near the northwest property line.

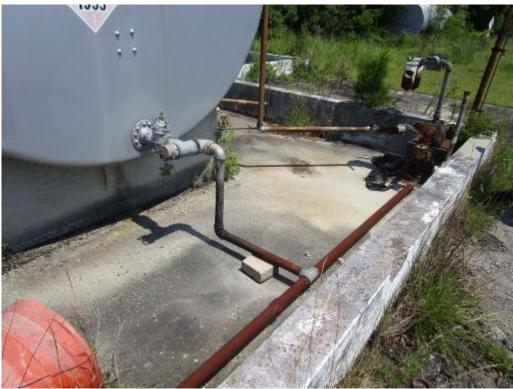
Photo 5

A view of one of the two ASTs and the fuel lines connected to it, all of which is confined within a concrete secondary containment structure near the northwest property line.

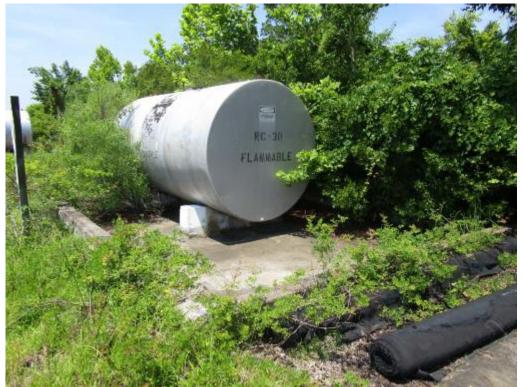
Photo 6

A view of a standalone AST and vegetation growing around it within a concrete secondary containment structure near the northwest property line.

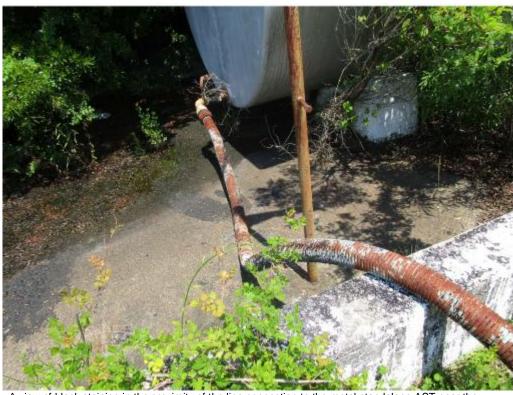
Photo 7

Staining was observed within the concrete secondary containment structures where the metal ASTs and aboveground lines were located. No staining was observed outside of the containment areas,

A view of black staining in the proximity of the line connection to the metal standalone AST near the northwest property line. The staining was within a secondary concrete containment structure.

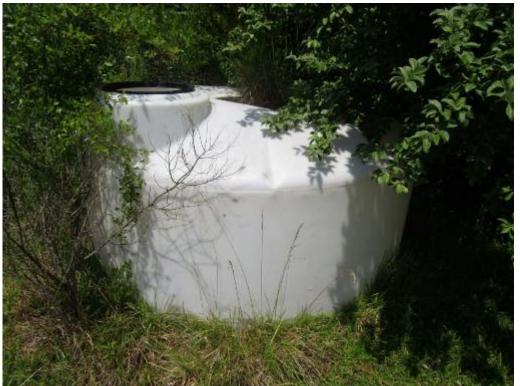
There was also a large plastic unmarked AST in a grass covered area of the site near the northwest property line. There was no staining or residue observed adjacent to this AST.

A view of an unmarked AST surrounded by vegetation near the northwest property line.

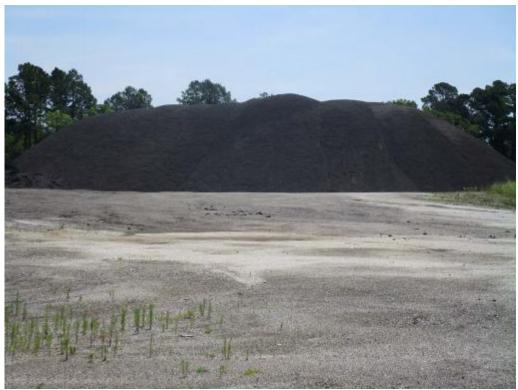
Photo 9

A view of a large RAP mound near the northeast property line.

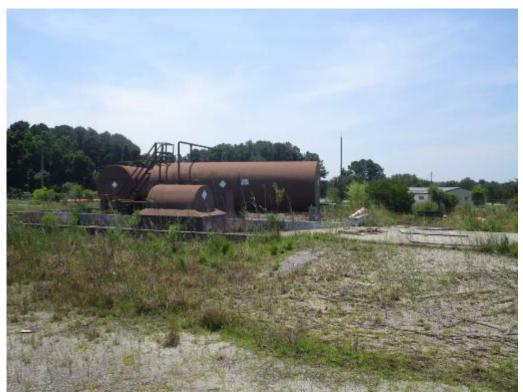
Photo 10 A view of two large ASTs near the central portion of the site confined within a concrete containment structure.

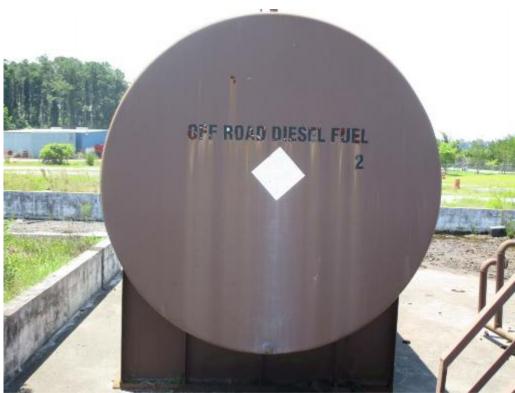
A view of one of the two ASTs near the central portion of the site labeled "off road diesel fuel.".

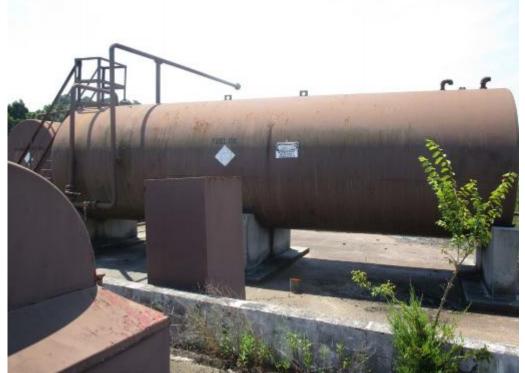
Photo 12 A view of one of the two ASTs near the central portion of the site labelled "fuel oil."

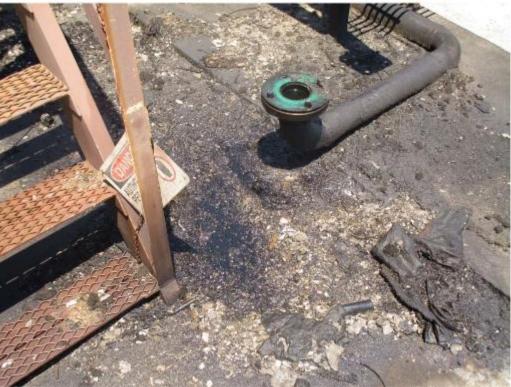
Photo 13

A view of a fuel line attached to one of the Off-Road Diesel ASTs near the central portion of the site with black Staining and residue around it. The staining and residue was not evident outside of the concrete containment structure.

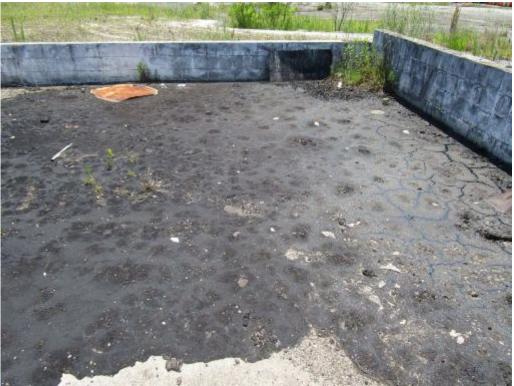
Photo 14 A view of black staining and residue within the concrete containment structure that confined the ASTs labeled Off-Road Diesel near the central portion of the site.

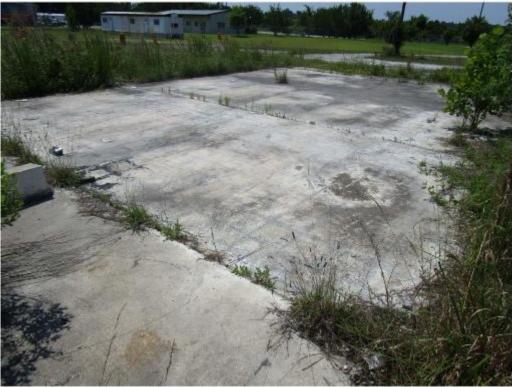
Photo 15

A view of concrete pads near the central portion of the site that is reported to be a former truck wash down area.

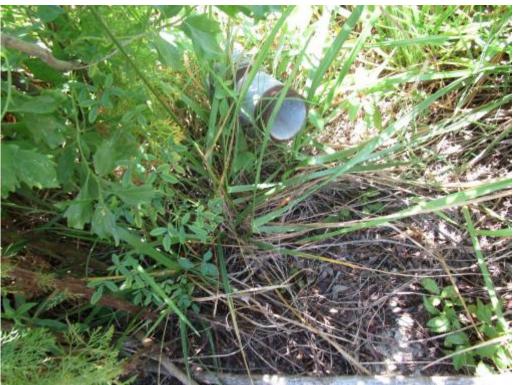
Photo 16

A view of a metal pipe coming out the ground next to the concrete pads that are near the central portion of the site. The pipe is indicative of a water supply well.

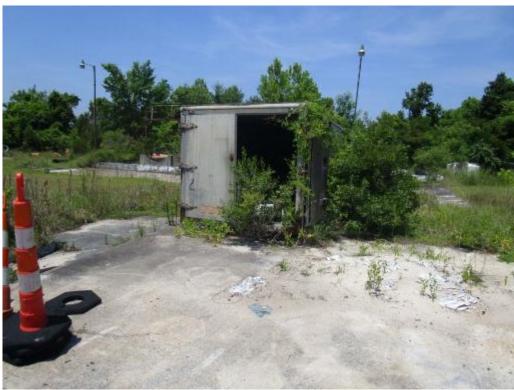
One of the trailers had several unlabeled five gallon buckets with lids stored inside; however, there was no staining or spills.

A view, facing northwest, of a storage trailer near the central portion of the site.

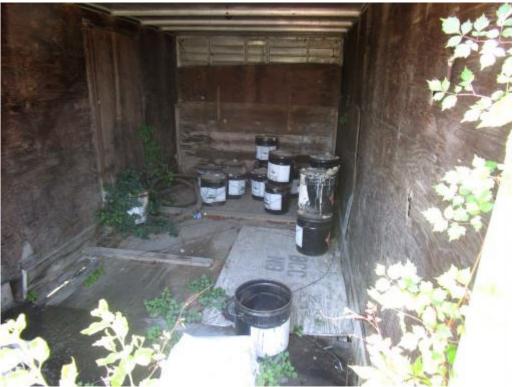
Several 5-gallon buckets with lids were observed inside a trailer in the central portion of the site. There was no staining or residue observed adjacent to the buckets

18 A view inside the storage trailer near the central portion of the site which had 5-gallon buckets inside.

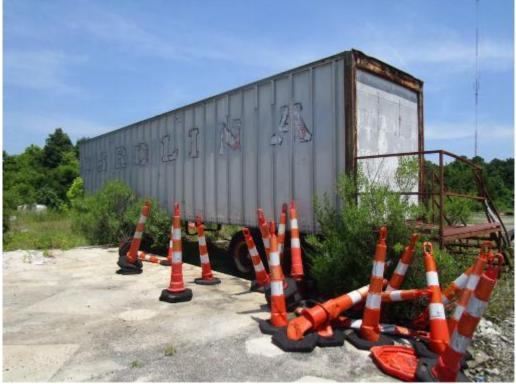
Photo 19

A view of one of the storage trailers with several safety cones in front of it near the central portion of the site looking north.

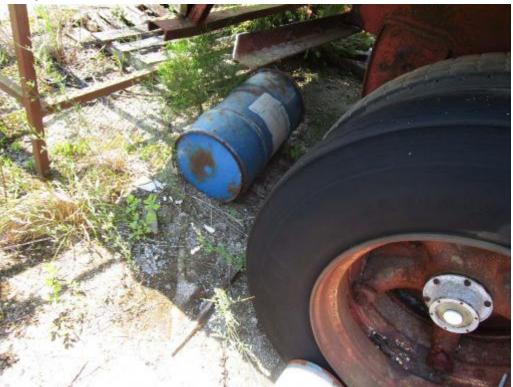
A 55-gallon metal drum was observed to be tipped over underneath a storage trailer in the central portion of the site. The labels on the drum were illegible. The drum was sealed by a lid. No staining or residue was observed adjacent to the drum.

A view of a tipped over 55-gallon metal drum underneath one of the trailers near the central portion of the site.

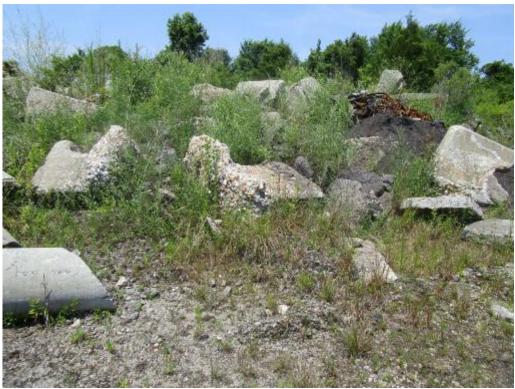
A view of multiple concrete chunks stockpiled near the northwest/northeast corner of the property.

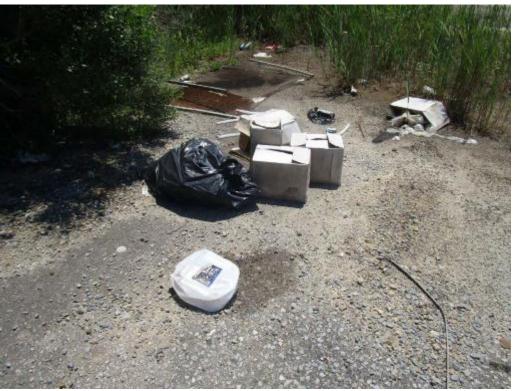
Windblown trash consisting of paper wrappers and cups and plastic bottles were observed scattered across the site. A cluster of waste including card board boxes, a plastic trash bag, metal scraps, etc. was observed near the northeast and southeast corners of the property. Several stockpiles of road signs and traffic cones were also observed on the site.

Photo 21 A view of discarded trash (i.e. carboard boxes, a trash bag, plastic bottles, etc.) near the northeast/southeast corner of the site.

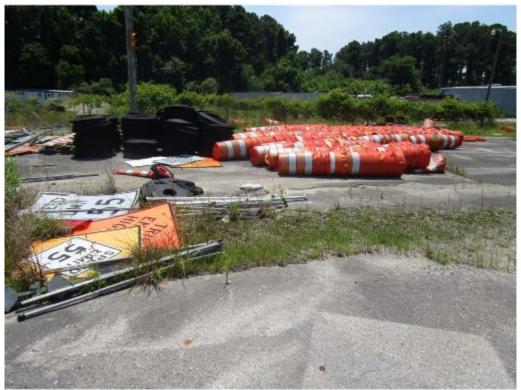
Photo 22

Street signs and traffic cones viewed near the southeast property line.

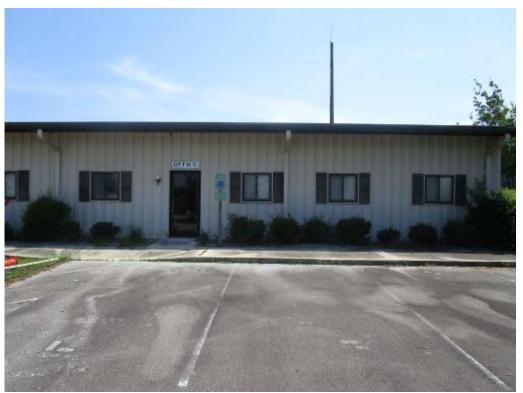
Photo 23 A view of the front side of the former administrative office building located near the southeast/southwest corner of the site along South Glenburnie Road.

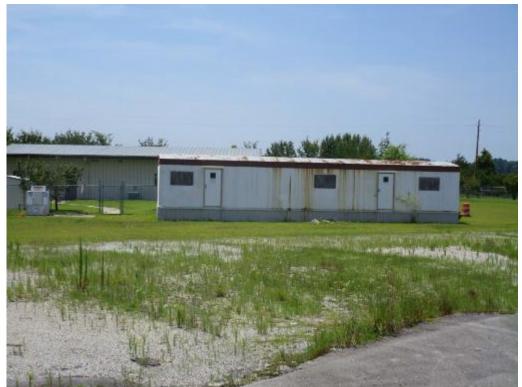
Photo 25 A view of a trailer and icebox located just behind the former administrative building near the southeast/southwest corner of the property.

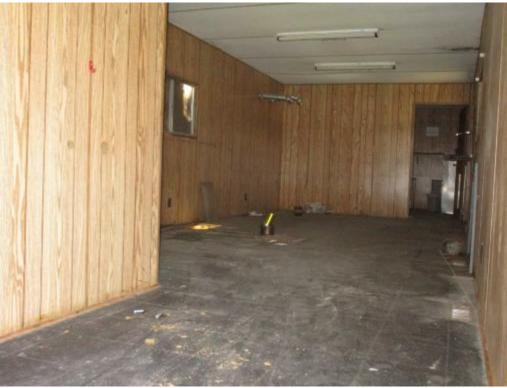
A view inside the trailer that is located just behind the former administrative building which is near the southeast/southwest corner of the property.

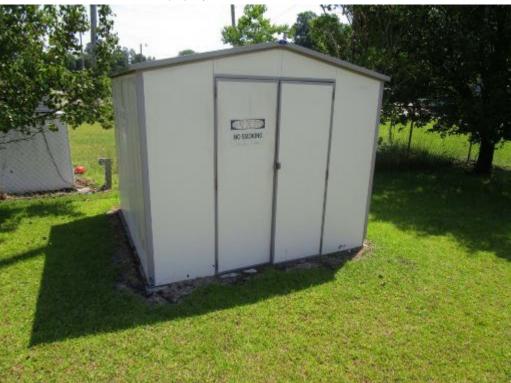
Photo 27 A view of a shed that is located just behind the former administrative building near the southeast/southwest corner of the property..

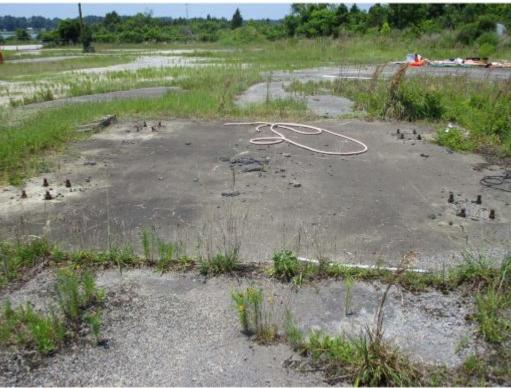
Photo 28

A view of a concrete pad near the central portion of the site that has building bearings at each corner. It is reported that a NCDOT asphalt testing lab once occupied this concrete pad.

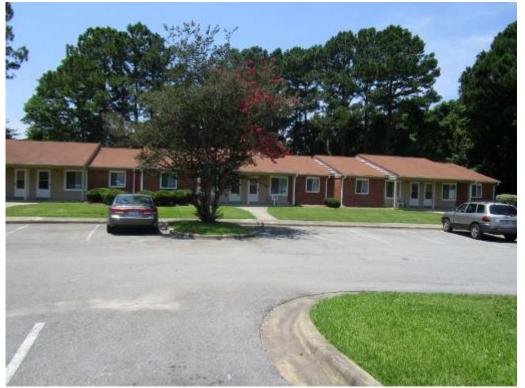
Photo 29

A view of residential structures which are a part of the Wind Hill Apartments community adjoining the site to the northeast.

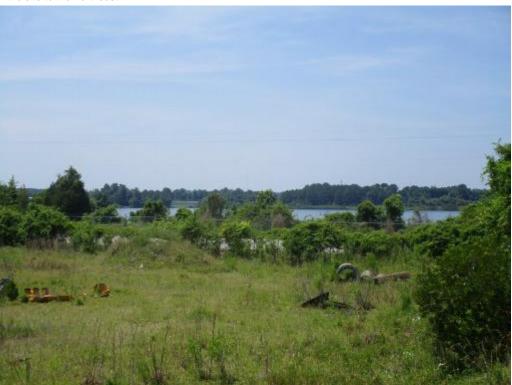
Photo 31 A view of the borrow pit filled with water that adjoins the site to the southwest.

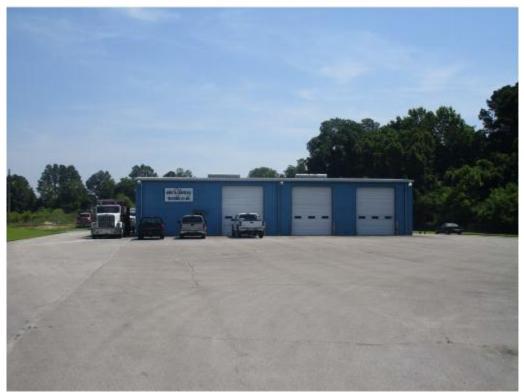
Photo 32

2 A view of Geo A Yancey Trucking Company that occupies the property that adjoins the site to the southeast.
