## Technical Memo

**To:** Max DeJarnatt, City of Olympia  
**From:** Whitney Holm, SCJ Alliance  
Sam Dunn, SCJ Alliance  
**Date:** February 4th, 2022  
**Project:** City of Olympia Parking Lot Accessibility Assessment  
**Subject:** Accessibility Report

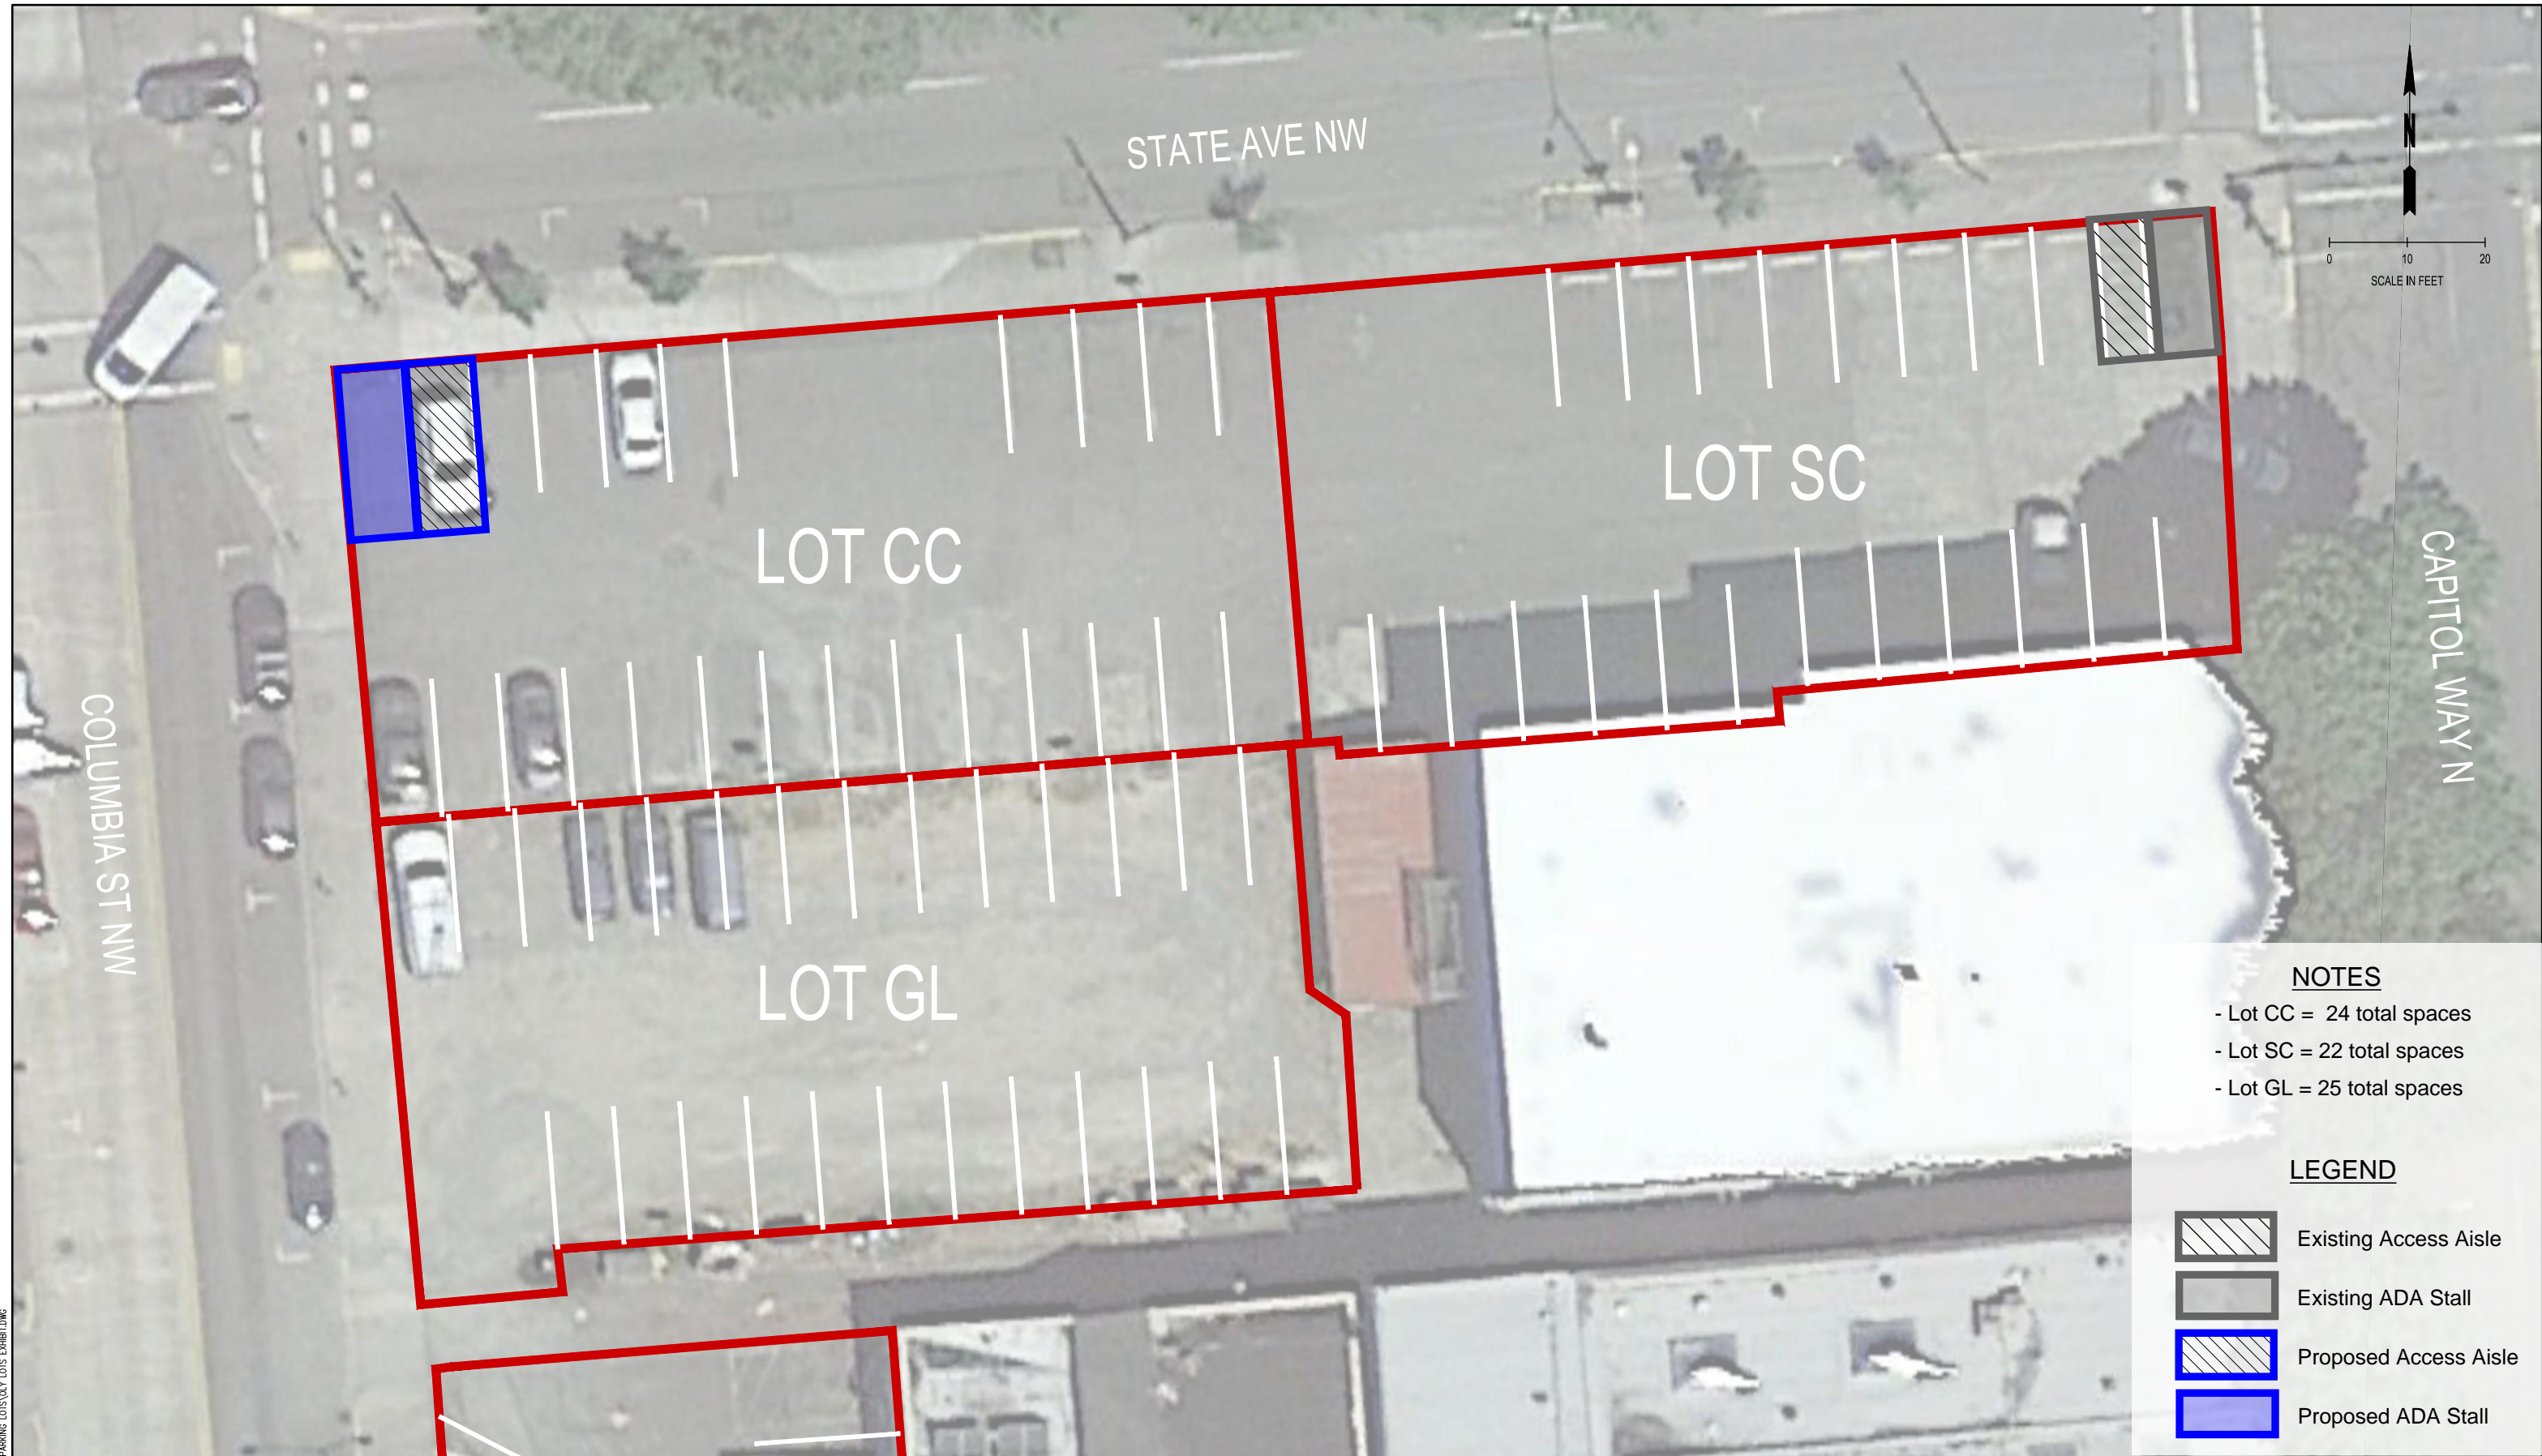
EXHIBIT No.	EX-01
SHEET No.	1 OF 7

Parking Lot CC is an asphalt lot located at the southeast corner of State Ave NW and Columbia St NW and has 24 perpendicular parking stalls. This lot does not have any designated ADA parking stalls and is missing wheel stops in all of the parking spaces. The paint lines for each parking space are visible and serviceable. Lot CC serves the City Center on the north side of State Ave.

Parking Lot SC is an asphalt lot located at the southwest corner of State Ave NW and Capitol Way N. Lot CC has 22 perpendicular stalls including one ADA stall and access aisle. In this lot there are 8 wheel stops all of which are located along the northern edge next to the sidewalk. Lot SC has many faded paint lines scattered throughout the lot making it difficult to determine exactly where the current parking stalls are. The painted ADA symbol and access aisle markings are faded as well. At 54" wide, the access aisle next to the ADA stall does not meet the 60" minimum width requirement per section 502.3.1 of the ADA Standards. The ADA stall is also missing a wheel stop.

Parking Lot GL is a gravel lot located on Columbia St NW between State Ave NW and 4<sup>th</sup> Ave. There are no parking stall lines but there is room for 25 perpendicular parking spaces. 20 of those spaces have wheel stops, most of which have experienced some degree of movement over time and are not in their original locations. Many of the wheel stops have settled into the ground and are in unknown condition. There is not a designated ADA parking stall in this lot.

Olympia ADA Parking Assessment  
 CC, SC & GL PARKING LOTS

**Recommendations:** Per Table 208.2 of the ADA Standards manual, a lot with <25 parking spaces requires one ADA accessible stall with an adjoining access aisle for passenger loading and unloading to be installed in the lot. Per section 208.2.4, the current ADA stall is required to be van accessible with a minimum width of 132" as detailed in section 502.2. Per section 502.3.1, access aisles require a minimum width of 60". An ideal location for an ADA van stall and access aisle would be in the northwest corner of the lot (see Exhibit EX-01). This would provide the shortest accessible route to the nearby city center. The existing parking spaces in the northwest corner currently meet ADA dimensional, slope and surface requirements. To become ADA compliant the two parking spaces would require repainting to delineate the ADA stall and aisle. This would not affect the adjacent parking spaces since a 132" wide van stall and 60" wide access aisle could fit within the existing footprint of the two 100" parking spaces. Appropriate signage and symbols would need to be installed per sections 502.6 and 703.7.2 of the ADA Standards. Wheel stops should also be added to all parking spaces within the lot to prevent vehicles from encroaching on pedestrian routes or adjacent lots.

Recommendations: To meet ADA requirements the existing 100" wide ADA stall would need to be widened to 132" minimum to accommodate van parking. The access aisle would need to be widened to a minimum of 60" as well. This would affect the adjacent parking spaces next to the ADA stall and require them to be moved over roughly 50". This would place the last parking space at the west end of the row in the opening parking lot entrance. Thus, that last parking space would need to be removed, bringing the lot's total parking spaces to 20. The existing ADA sign should be centered on the newly painted ADA stall. The City should repaint all parking stall lines and symbols in the lot to improve visibility and functionality.

Recommendations: Since Lot GL has an uneven gravel surface that is not compliant with ADA requirements, Lot GL's parking spaces will be combined with Lot 4A's for a total number of 40 spaces between the two lots. Per Table 208.2 of the ADA Standards, any lot with <50 parking spaces requires two ADA accessible stalls and section 208.2.4 requires one of those stalls to be van accessible. Both of these ADA stalls will be located in Lot 4A. If Lot GL were to ever be resurfaced with asphalt, then an ADA compliant van stall and access aisle would be required, preferably in the northwest corner closest to the lot entrance and sidewalk. New wheel stops should be purchased for each parking stall.

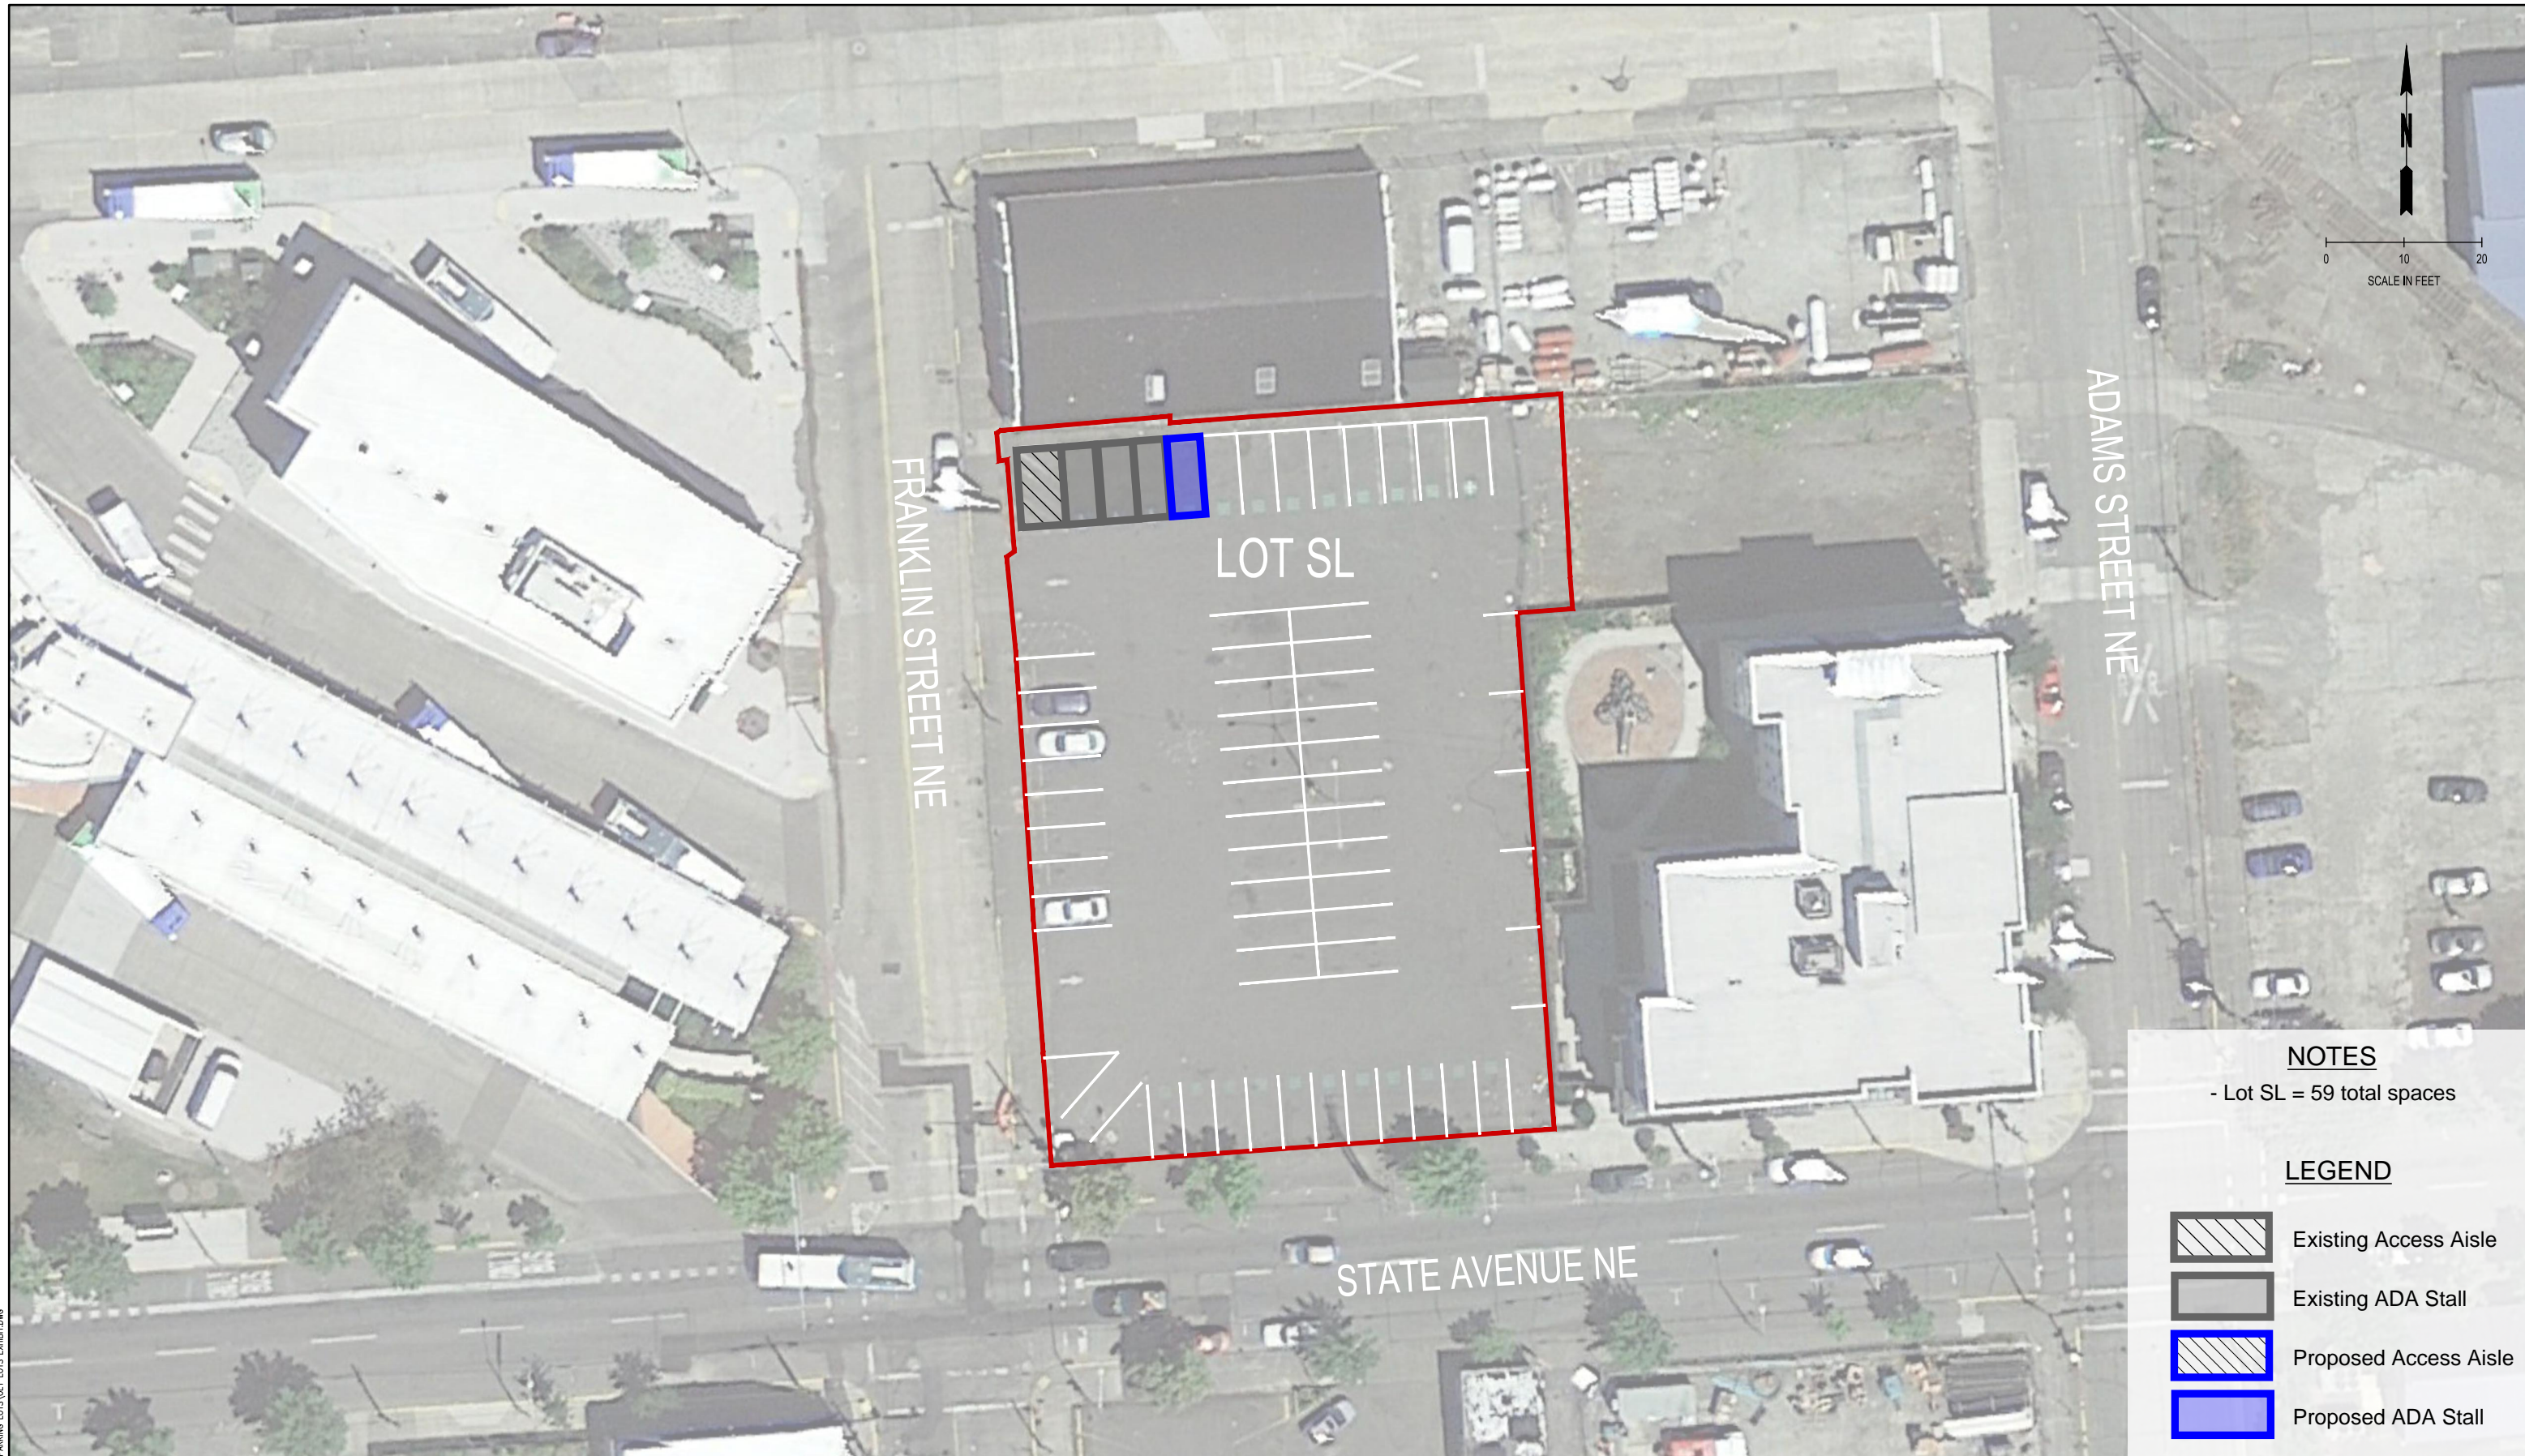
EXHIBIT No.  
**EX-05**  
 SHEET No.  
**5 OF 7**

Parking Lot SL is an asphalt parking located in the northeast corner of the State Ave NE and Franklin St NE intersection and serves as a city parking lot for the Greyhound and Intercity Transit bus station across the street. Lot SL has 56 perpendicular and parallel parking stalls including 3 ADA stalls but only one access aisle. One of the ADA parking signs is shorter than the required 60". The access aisle borders the existing sidewalk along Franklin St and has a rough, cracked asphalt surface. The aisle is also 4" higher than the sidewalk next to it and could be a potential hazard to people unloading in the aisle. The painted stall lines and ADA symbols in the lot are faded.

Olympia ADA Parking Assessment  
 SL PARKING LOT

Recommendations: Since there is currently only one existing access aisle, an additional aisle needs to be added between two of the existing ADA stalls per section 502.3 of the ADA standards. The remaining ADA stall would need to be widened to accommodate a van. This can be achieved by using some of the area of the existing access aisle which is currently oversized at 12' wide. The existing aisle should be resurfaced to provide a smooth surface and adjusted in elevation or have a barrier installed to mitigate the current height difference at the edge of the aisle next to the sidewalk. The single low ADA sign needs to be adjusted to a minimum height of 60" per section 502.6 of the ADA Standards. The parking stall lines and ADA symbols throughout the parking lot should be repainted.

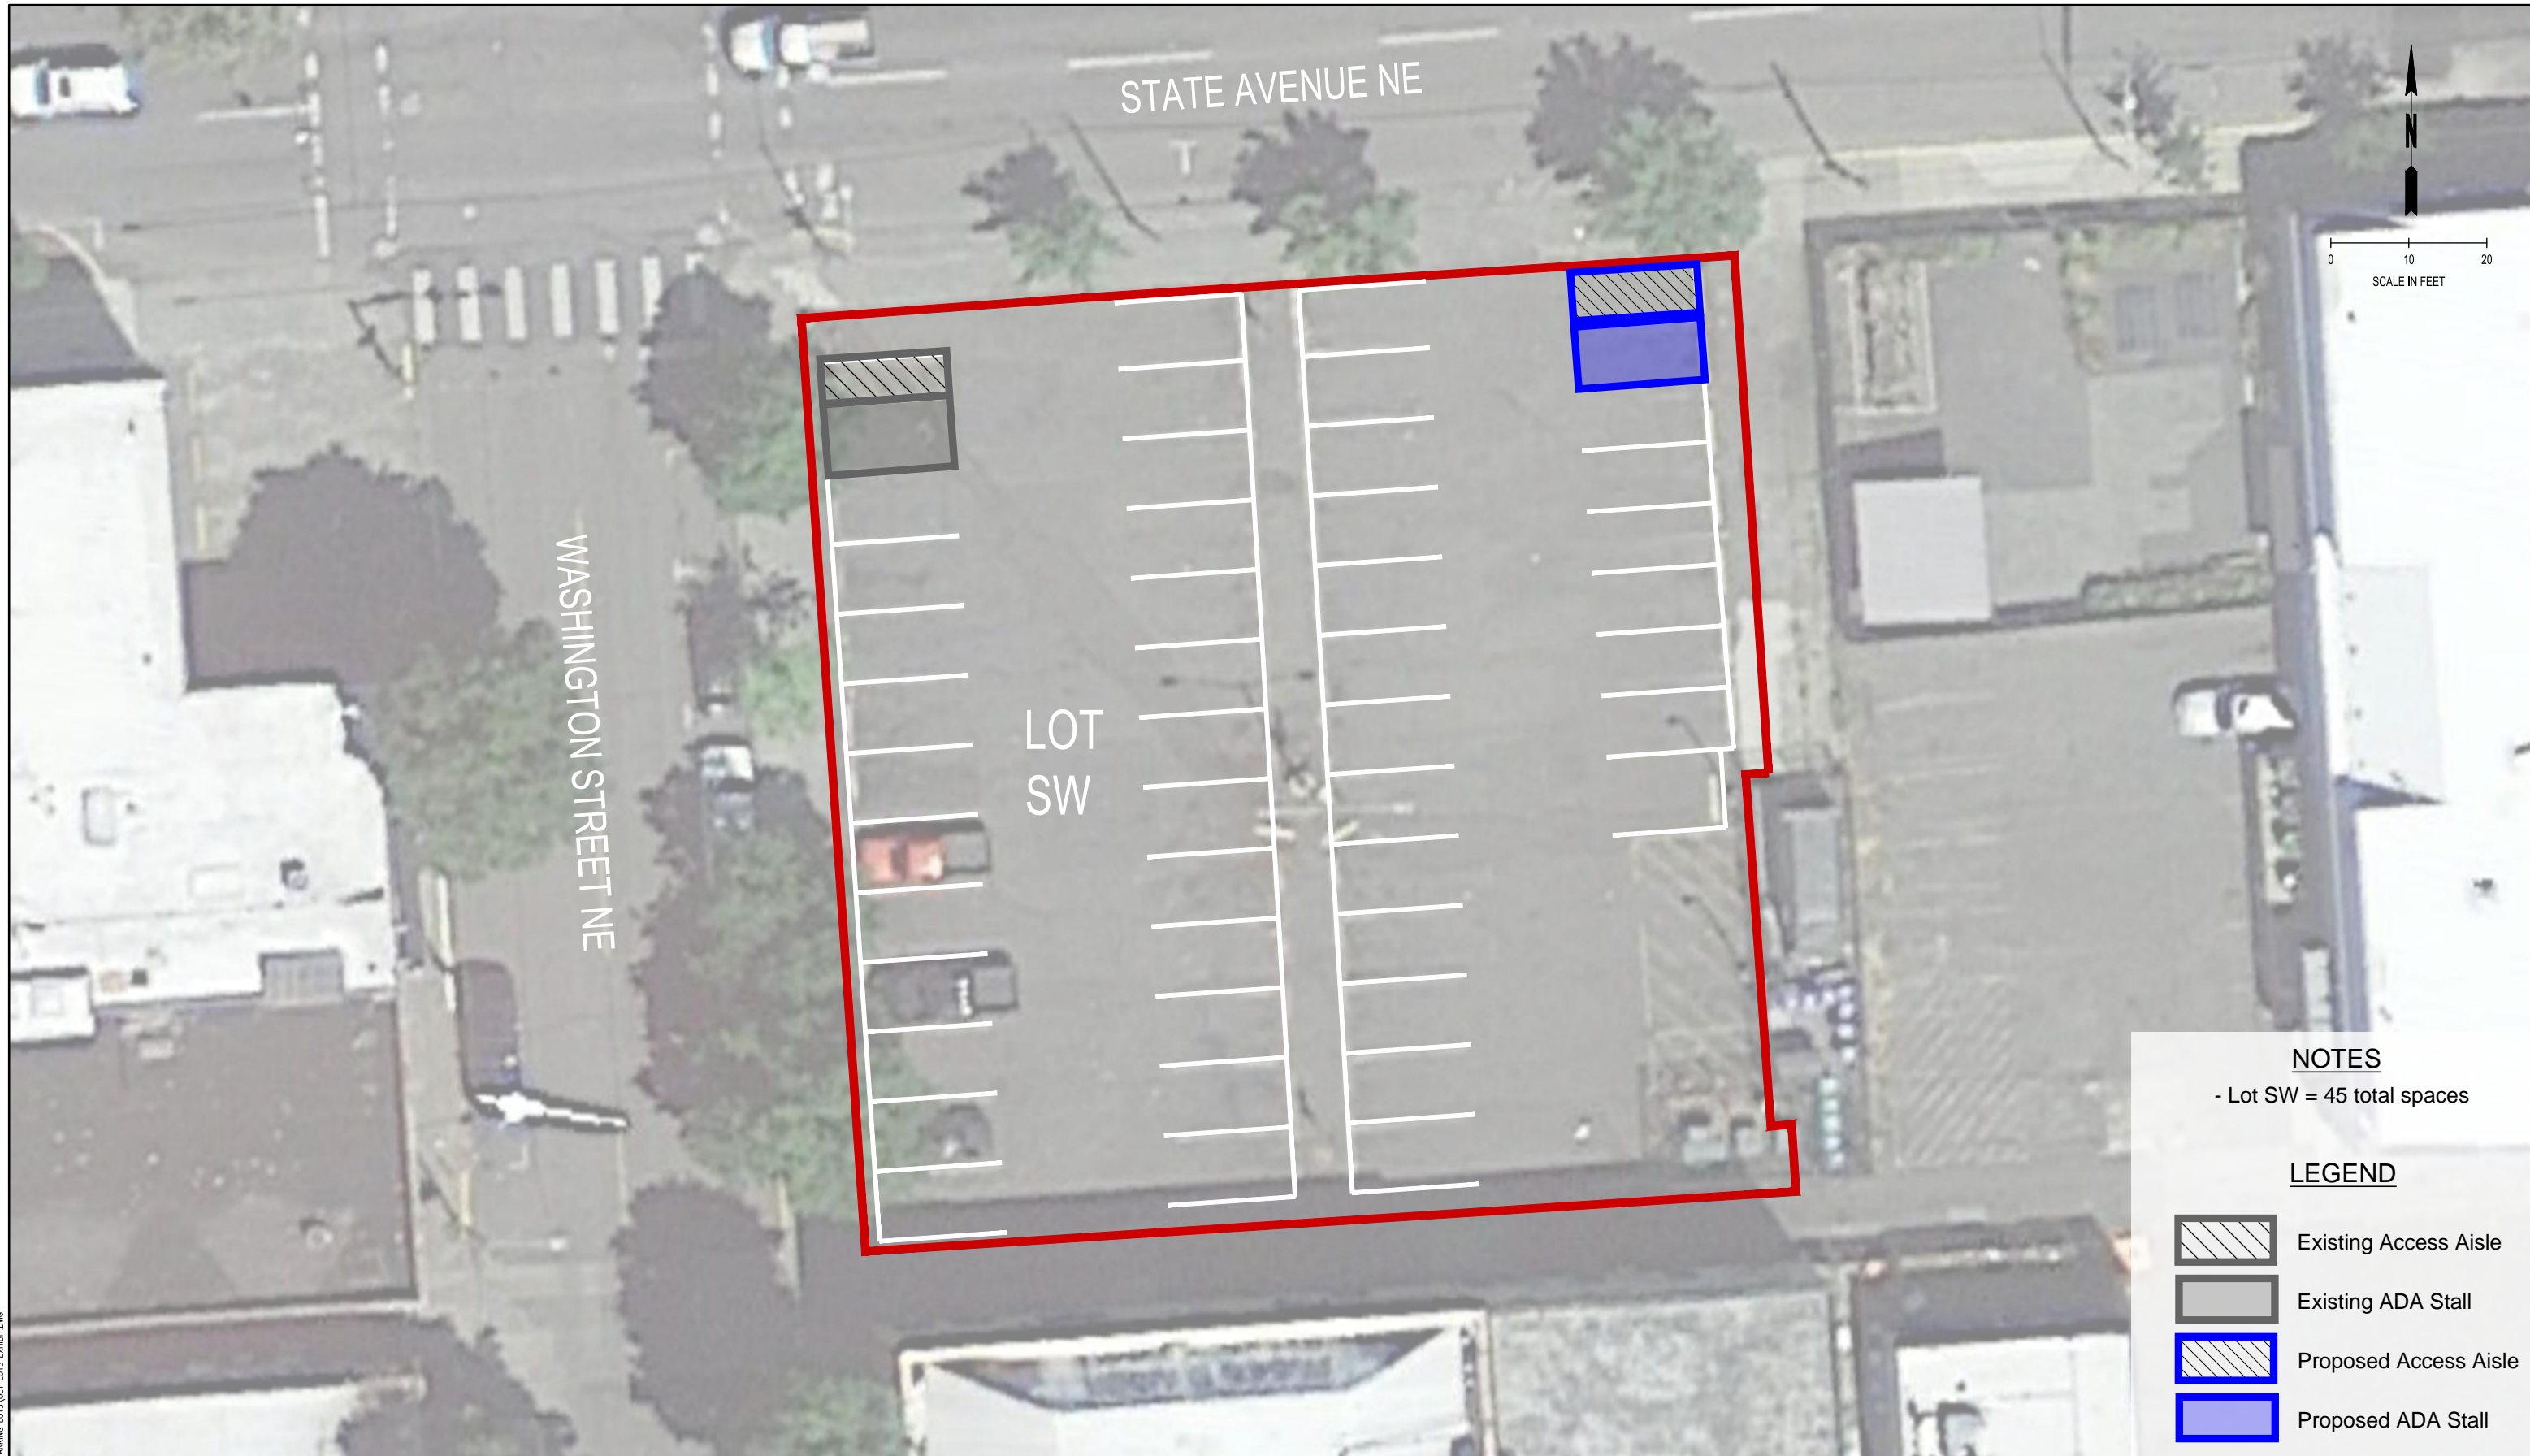
Parking Lot SW is an asphalt parking lot located in the southeast corner of the State Ave NE and Washington St NE intersection. Lot SW has 45 perpendicular parking spaces including 1 ADA stall and access aisle. The lot is divided into two halves with each half containing two rows of parking stalls with a buffer strip down the middle containing an illumination pole. Each half has its own entrance from State Ave at the north end of the lot. The existing ADA stall and aisle are located in the western half of the lot and they currently block half of the entrance from the road making it difficult to enter and exit the lot. The existing ADA signage is below 60" in height. Most of the parking stall paint lines and the existing ADA accessibility symbol are faded and hard to see.

- Lot SW = 45 total spaces

Recommendations: An additional ADA stall and aisle should be added to make Lot SW compliant with ADA standards. An ideal location would be in the eastern half which would place an ADA stall in each half of the lot. One of the two ADA stalls should be sized to accommodate van parking. The existing ADA stall and access aisle have enough room to be resized to accommodate a van. The western lot entrance on State Ave should be moved east so as to not encroach on the existing ADA access aisle per section 502.7 of the ADA Standards. The existing ADA signage needs to be raised to a minimum of 60" above the finished surface. The parking stall paint lines and ADA symbols in the lot should be repainted.

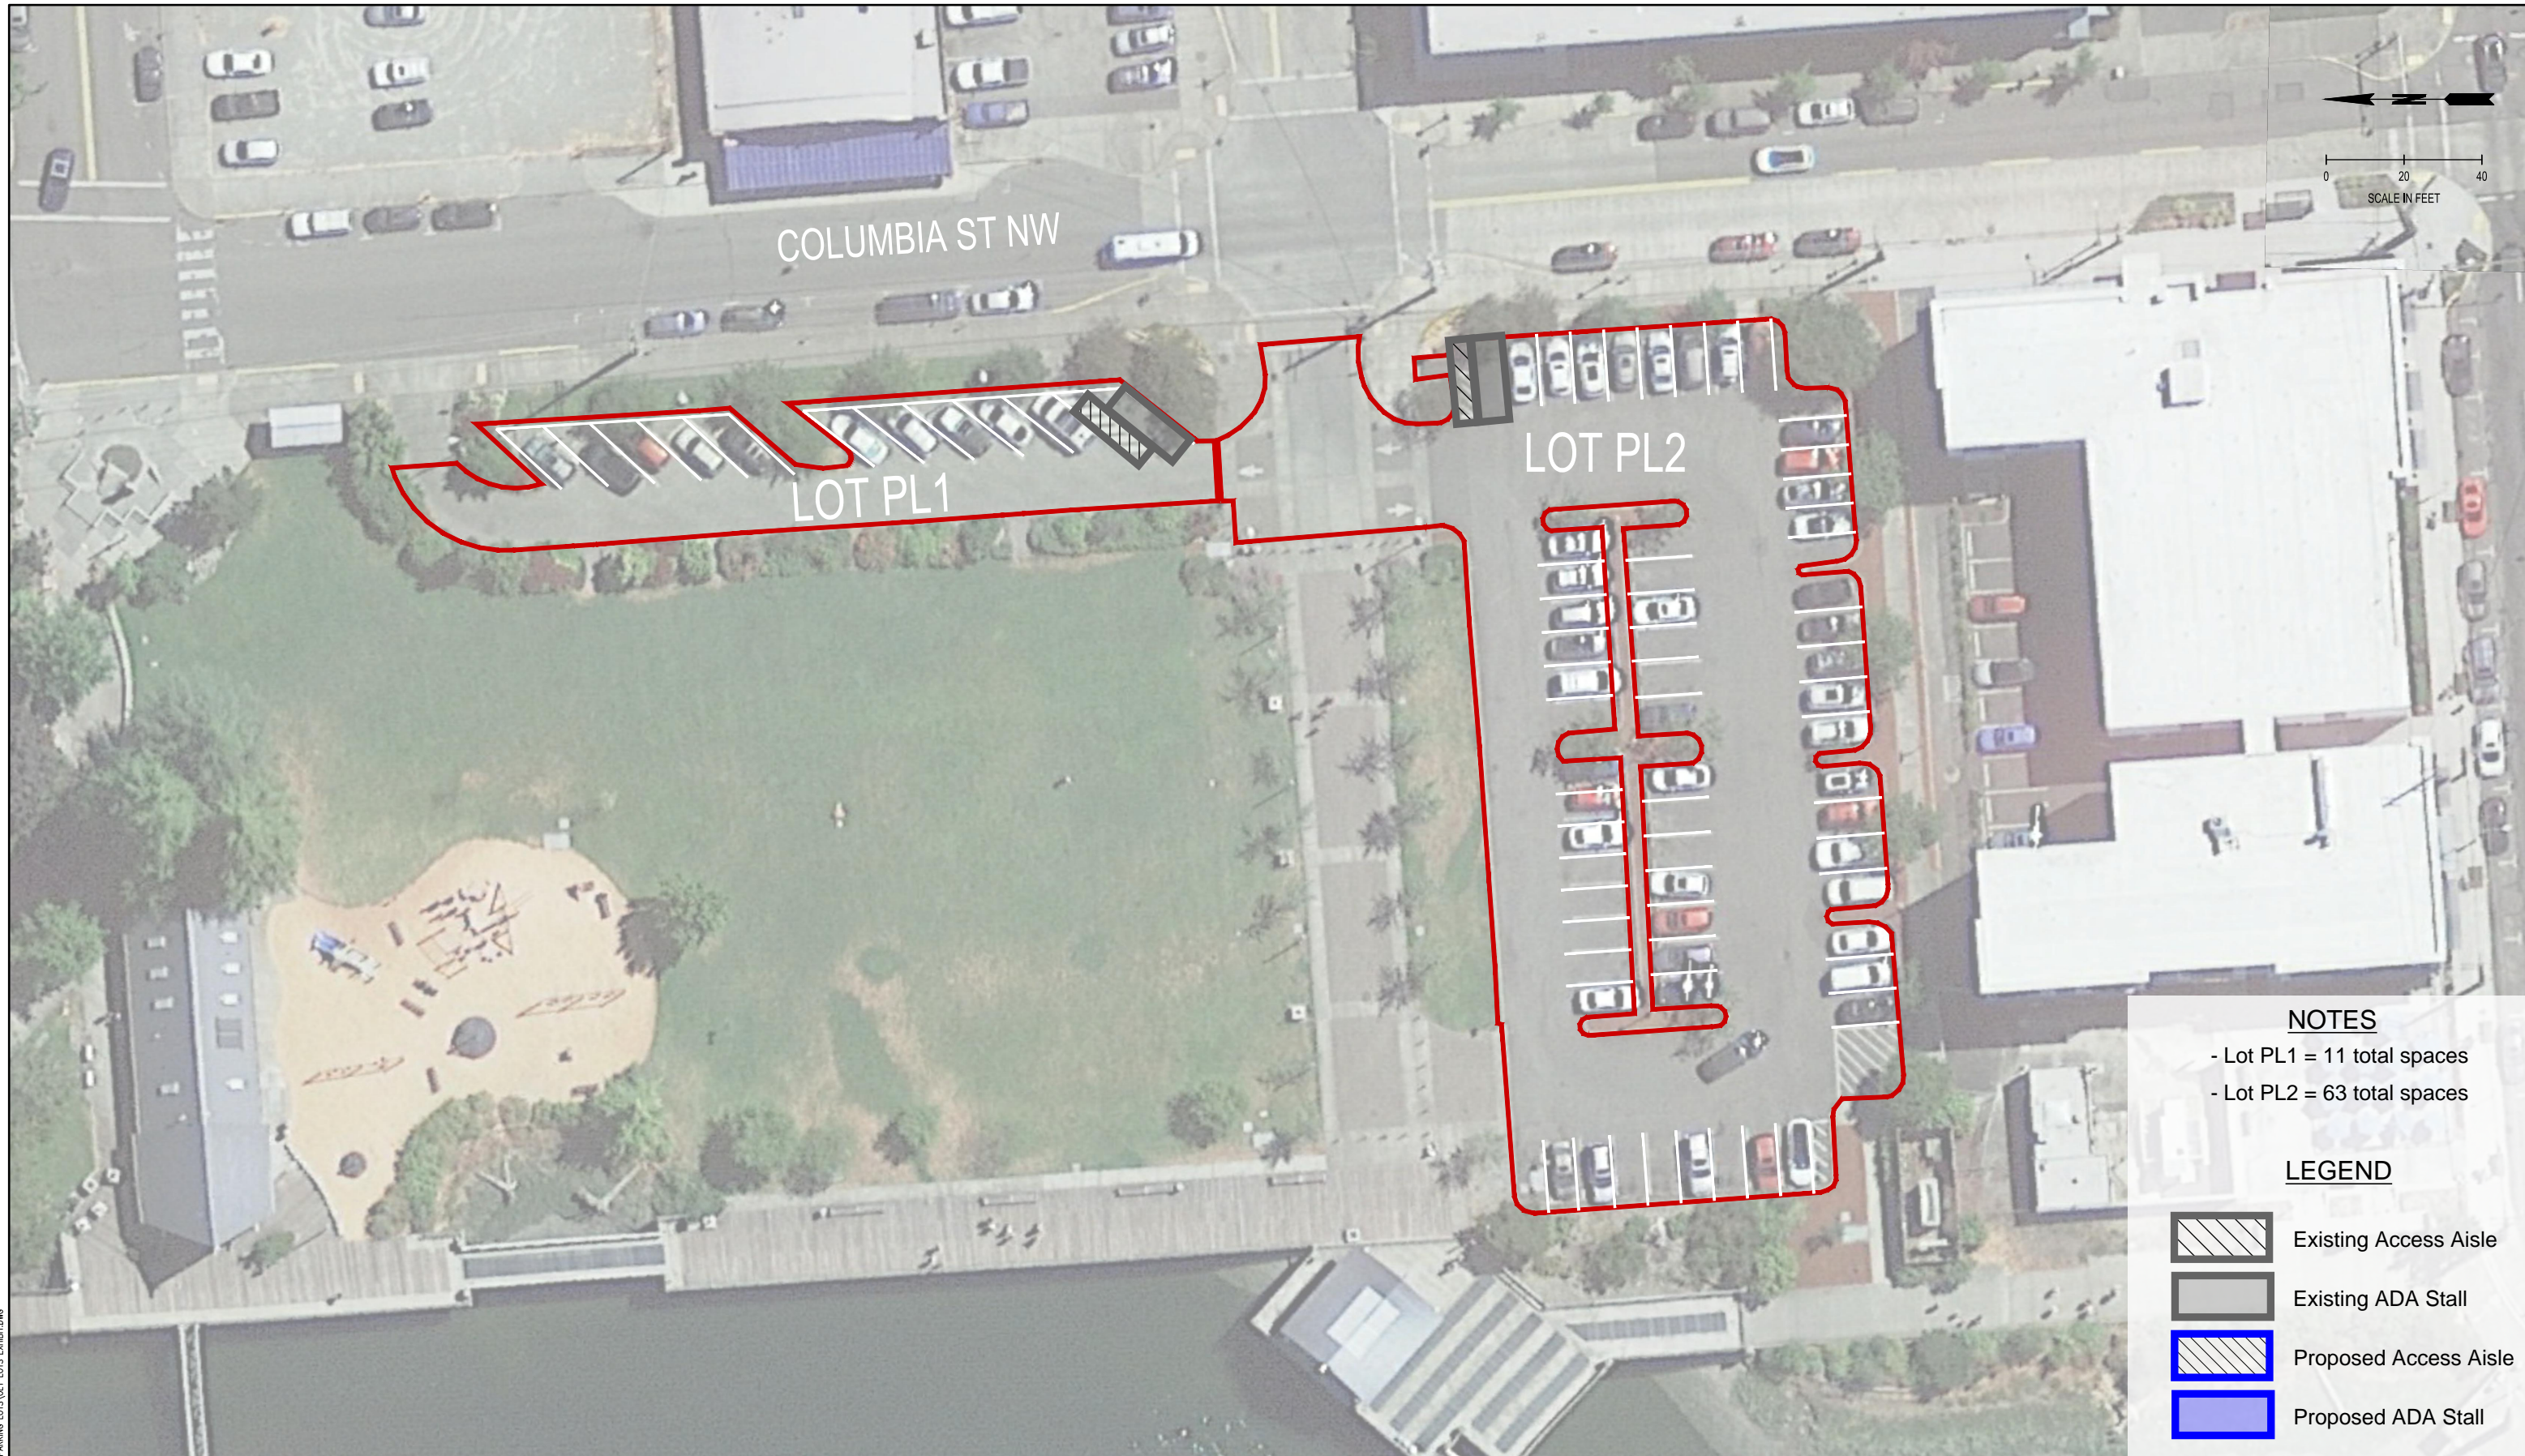
EXHIBIT No.:  
**EX-07**  
 SHEET No.:  
**7 OF 7**

Parking Lot PL1 is the smaller of the two parking lots located at Percival Landing next to Columbia St NW. Lot PL1 has 11 angled parking stalls with wheel stops including 1 ADA stall and access aisle. The existing access aisle is on the driver side of the existing ADA stall.

Parking Lot PL2 is the larger of the two Percival Landing parking lots and it borders Columbia St NW. Lot PL2 has 63 perpendicular parking stalls including 1 designated motorcycle stall, 1 ADA stall and 1 access aisle. The existing access aisle is only 52" wide. Each parking space has a wheel stop in serviceable condition and visible stall lines.

Olympia ADA Parking Assessment  
 PERCIVAL LANDING LOTS

Recommendations: Since Lot PL1 is exclusively angled parking, per section 502.3.4 of the ADA standards, the access aisle should be moved to the passenger side of the existing ADA stall. This would require that the ADA stall and access aisle switch locations. During that relocation the ADA stall should be widened to accommodate van parking.

Recommendations: An additional 2 ADA stalls and a shared access aisle should be added to the parking lot to meet current ADA standards. These could be located in the northwest corner of the parking lot closest to Percival Landing and the existing ramps located in that corner. Either one of the new ADA stalls or the existing ADA stall should be widened to accommodate van parking. The existing access aisle should be widened to meet the 60" minimum width required in the ADA Standards.
