Pine County Aquatic Vegetation Management Plan DRAFT: Pokegama, Cross, Sand and Sturgeon Lakes

Prepared for:
Pine County Planning and Zoning

Prepared by:
Tom Langer
Jeff Strom

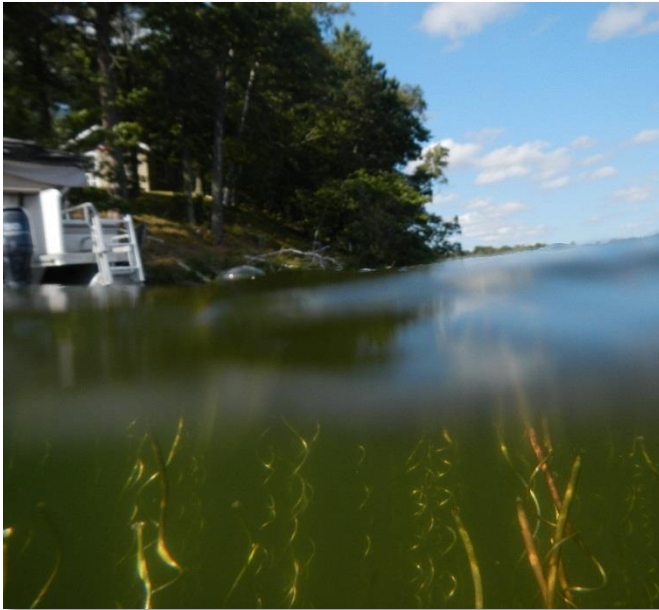
Figure 1-1. Pine County overview and lakes included in this plan.

Pine County is in east-central Minnesota along the Minnesota-Wisconsin boarder (Figure 1-1). There are five major river watersheds (also referred to as HUC8 watersheds) that have a portion of their boundary in Pine County: Lower St. Croix River, Snake River, Kettle River, Upper St. Croix River, and the Nemadji River. Most of Pine County is situated in the

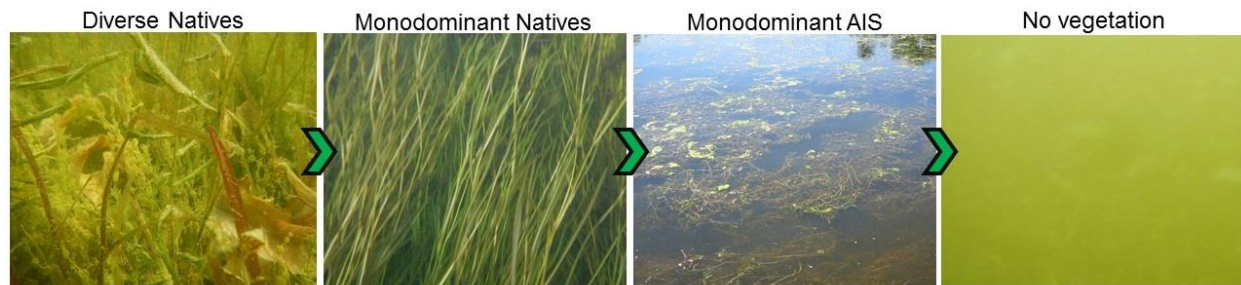
Figure 2-1. Continuum of a healthy submerged aquatic vegetation community and associated ecosystem services.

little to no SAV, while shallow lakes often persist at one end of this continuum or the other with little in between (Figure 2.1). Most SAV-dominated lakes tend to have clear or bluish water, high water clarity, diverse plant growth and little to no noticeable algae. In contrast, algal-dominated lakes tend to have green water, poor water clarity, and support SAV and fish that are adapted to tolerate disturbance and degraded water quality conditions.

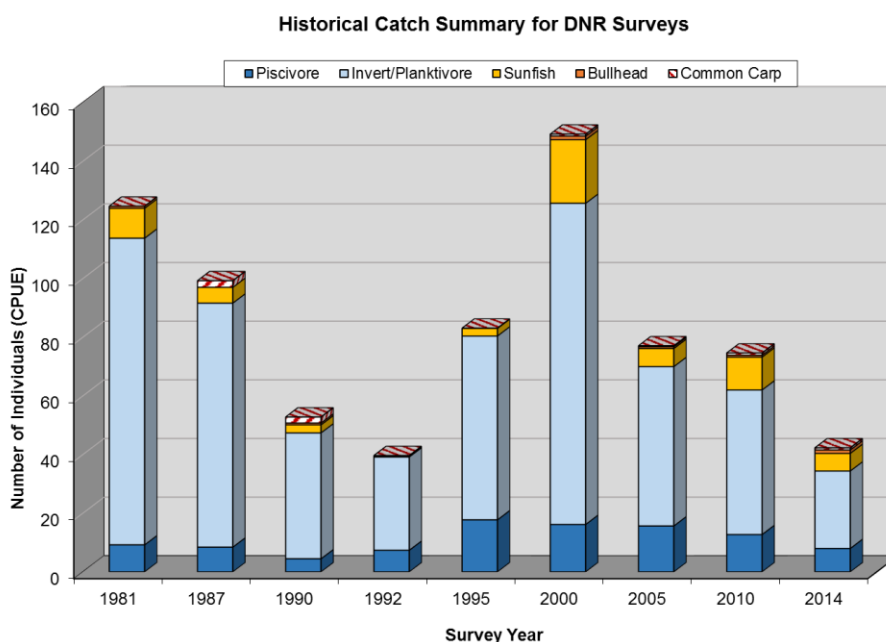
Figure 4-3. Pokegama Lake fisheries summary.

Pokegama receives moderate fishing pressure and is actively stocked for walleye by the MnDNR. The most recent fisheries assessment was conducted in 2014 by the MnDNR and demonstrated a decrease in overall fish numbers across species from recent surveys with the largest group of fish caught existing in the invertivore species (excluding sunfish species) grouping. Piscivorous fish, including the walleye and northern pike were below historic catch rates while bluegill, crappie and freshwater drum were species that achieved normal status for either catch rate or average length during the survey. Long-term records demonstrate a cyclical trend where abundances of all fish increase and decrease over a decade, therefore, fish populations may be expected to increase by the next fish survey event (Figure 4-3).

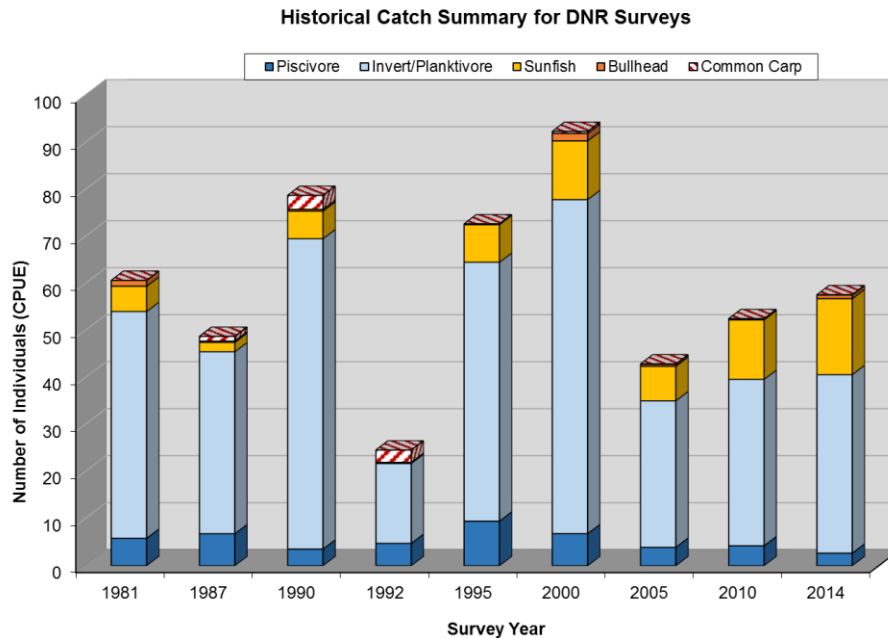
Figure 5-3. Cross Lake fisheries summary.

Sunfish species comprised a high percentage of the fish catch which may pose concerns for natural weevil control of Eurasian Watermilfoil within the lake. Declining catch rates of top predator (walleye) may also be a potential concern. Fish management activities should continue to follow MnDNR fishing regulations and practice selective fishing or catch release fishing, to maintain a balanced fishery.

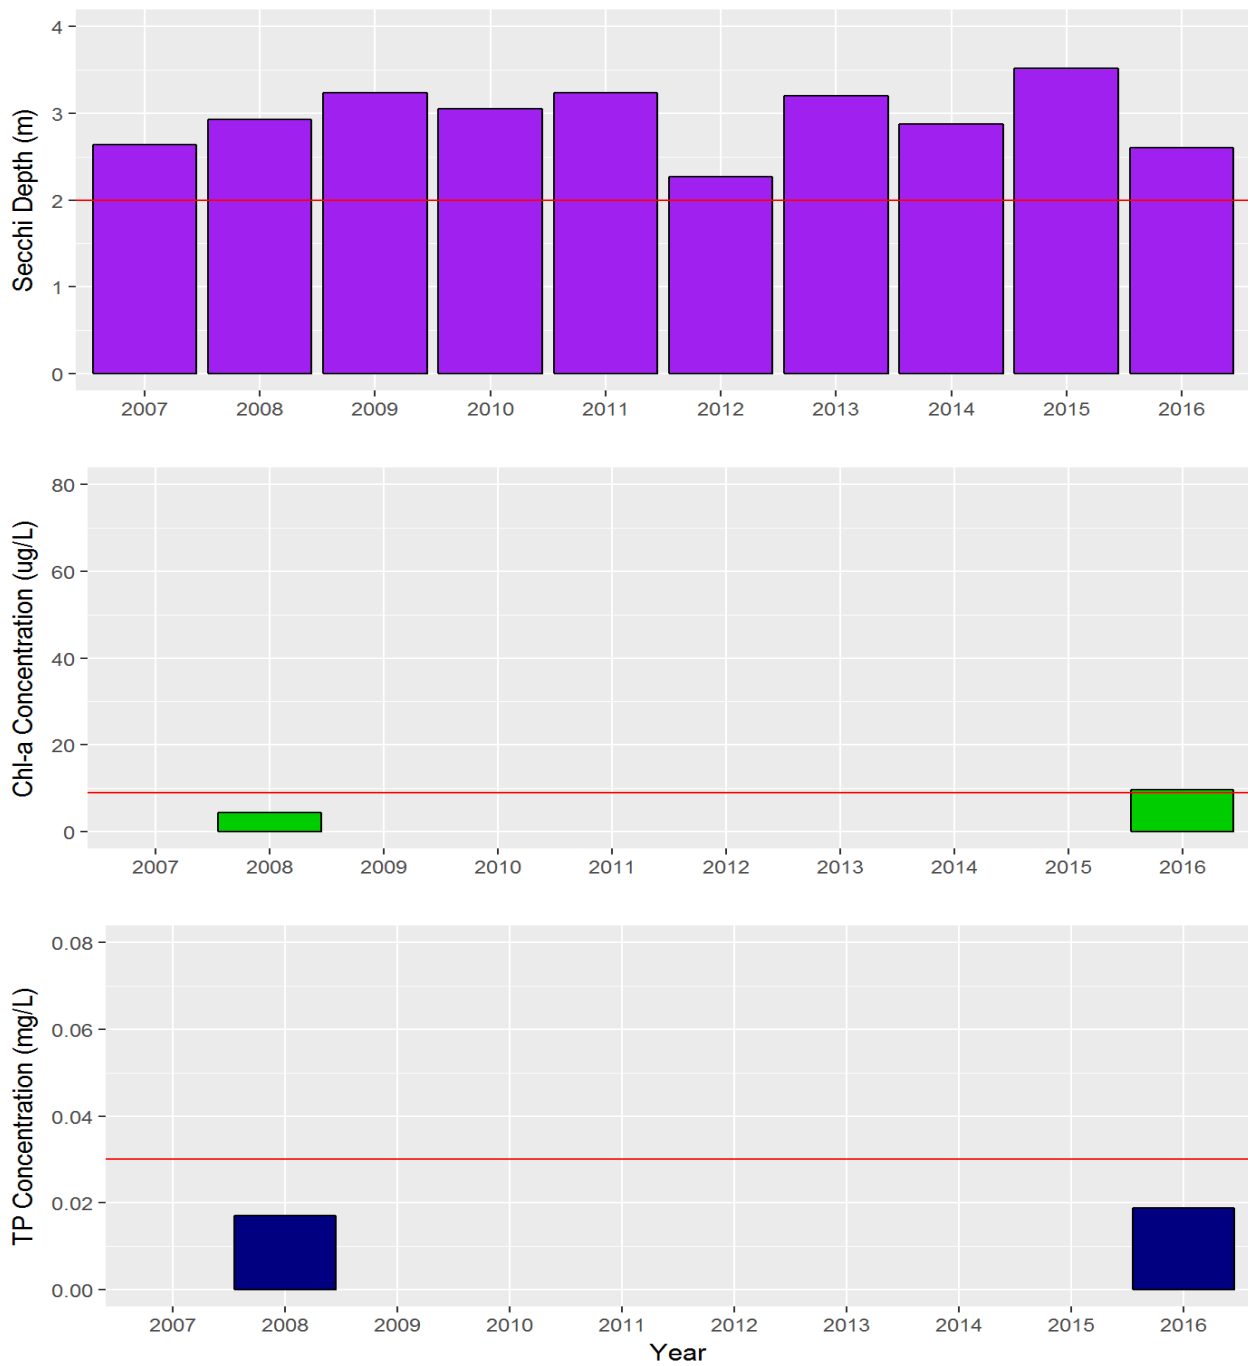
Figure 6-1. Sand Lake average annual Secchi depth, chlorophyll-a and total phosphorus concentrations.

[Watershed page](#)). As described above, Sand Lake is currently meeting state water quality standards for all three parameters and therefore is not impaired. Strategies to protect water quality in Sand Lake and its watershed will be developed as part of the MPCA's Watershed Restoration and Protection Strategy (WRAPS) report for the Kettle River. This report will be done at the same time as the watershed-wide TMDL study and therefore also has a target completion date of 2019.

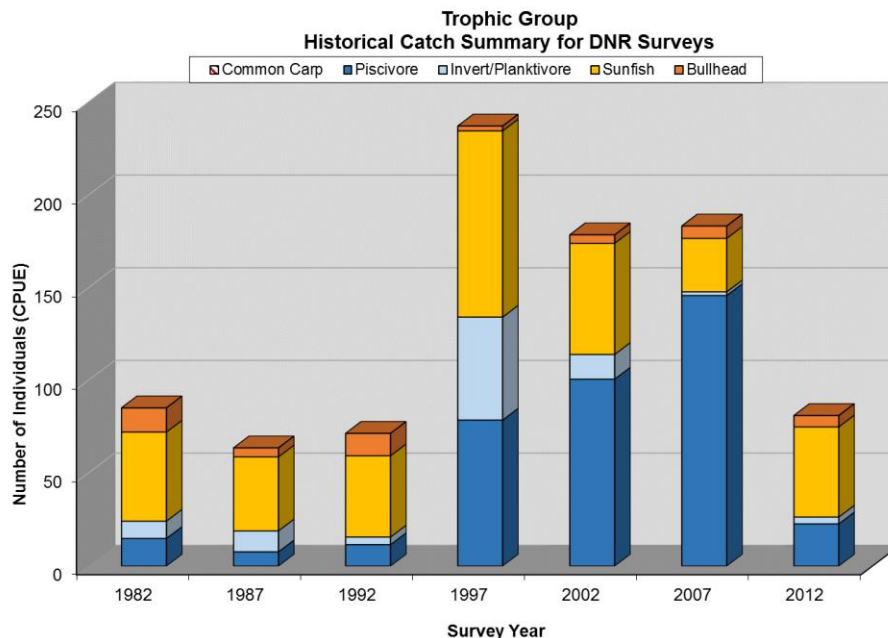
Figure 6-3. Sand Lake fisheries summary.

In the most recent survey, Bluegill comprised 47% of the catch and limited large piscivorous fish species (i.e. Northern Pike) were observed. The large proportion of bluegill likely has the potential to limit significant weevil control of EWM within the lake. Weevil control will not eradicate EWM but has the potential to reduce nuisance level growth of EWM in systems where their abundance is high. It is noted by the MnDNR that catch rates of Bluegill are around average for lakes with similar characteristics, however, it is unclear if this is most appropriate condition for the lake. It is unclear whether an imbalanced fishery currently exists within Sand Lake and efforts to practice selective harvesting or catch and release may prove beneficial at protecting large piscivorous fish species.

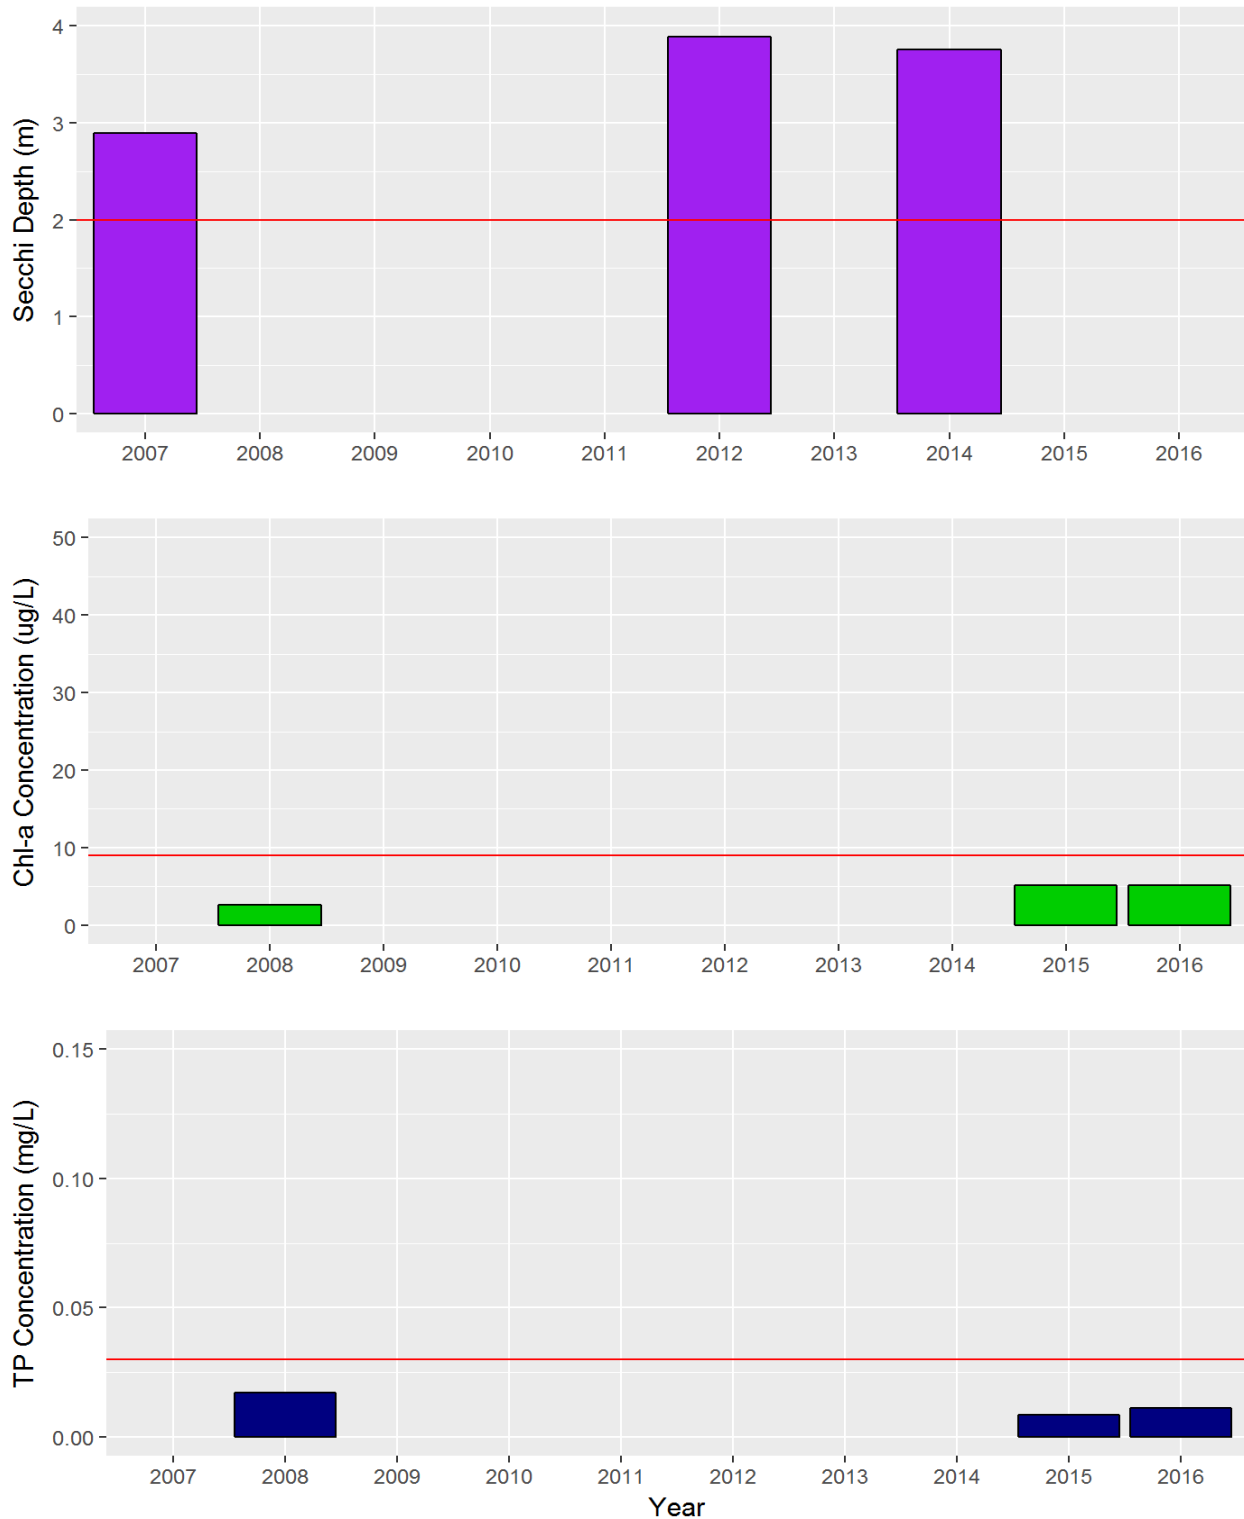
Figure 7-1. Sturgeon Lake average annual Secchi depth, chlorophyll-a and total phosphorus concentrations.

The MPCA is currently completing the Kettle River Watershed Monitoring and Assessment Report which will identify lakes and streams within the watershed that are currently meeting state water standards, and those that are considered impaired (not meeting standards). Waterbodies that are considered impaired will be included in the Kettle River Watershed TMDL study which has a target completion date of 2019 ([link to MPCA's Kettle River Watershed page](#)). As described above, Sturgeon Lake is currently meeting state water quality standards for all three parameters and therefore is not impaired. Strategies to protect water quality in Sturgeon Lake and its watershed will be developed as part of the MPCA's Watershed Restoration and Protection Strategy (WRAPS) report for the Kettle River. This report will be done at the same time as the watershed-wide TMDL study and therefore also has a target completion date of 2019.

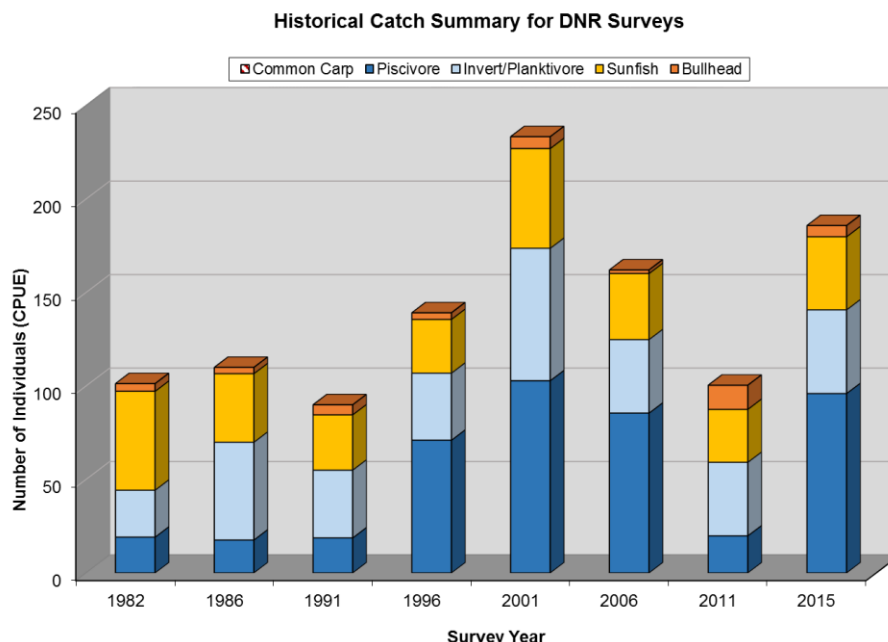
Figure 7-3. Sand Lake fisheries summary.

Sturgeon Lake has a variety of targeted game fish species and is actively stocked for walleye on an annual basis by the MnDNR. Recent fish surveys have demonstrated considerable variability in the catch rate of all fish with the most recent survey having a relatively high catch rate compared to historic records (Figure 7-3). The MnDNR has instilled a slot limit regulations on northern pike within the lake since 1997 with a change to the regulation in 2008 to an effort increase the size and number of the species within the lake. It appears that the size structure of the population has declined since the regulation change, possibly suggesting an imbalance in the fishery.
