# NONPOINT SOURCE SUCCESS STORY

### Heminway Pond Dam Removal and Steele Brook Restoration

EPA 841-F-22-001JJ  
December 2022

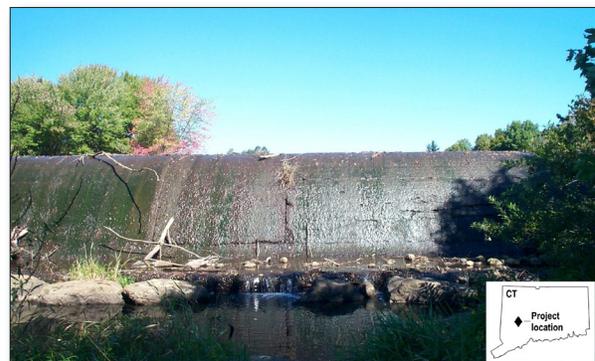
Figure 1. The Heminway Pond Dam blocked the upstream passage of aquatic life.

Heminway Pond was created in the early to mid-1800s when a dam was built across a section of Steele Brook just upstream of Echo Lake Road near the center of Watertown. The original purpose of Heminway Pond Dam was to provide water to a local thread and string mill. The mill no longer exists, and the dam fell into disrepair (Figure 1).

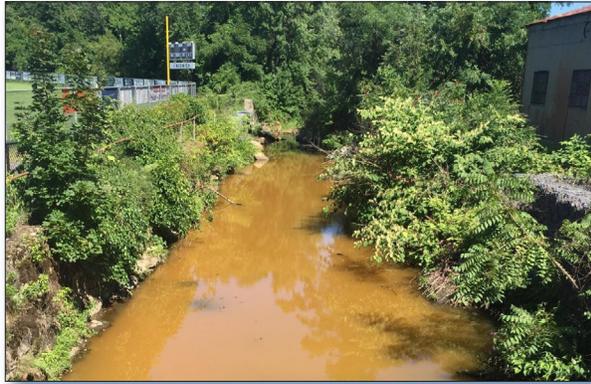
Figure 2. Looking upstream at dam site, before removal.

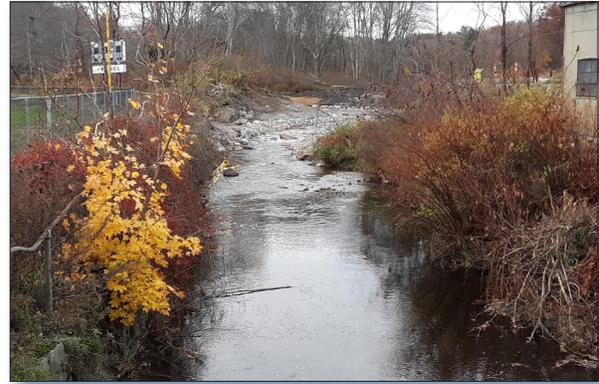
Figure 3. Looking upstream at the dam site, after removal.

Fortunately, it was determined that the sediments in the impoundment behind the dam had relatively low contaminant levels and could be reused on site with some protective layering or capping. Construction activities commenced in July 2018, and most of the major work was completed by early November 2018 (Figure 3). The Heminway Pond Dam removal and Steele Brook channel restoration process was documented through a video: [Removal of Heminway Pond Dam & Restoration of Steele Brook](#).

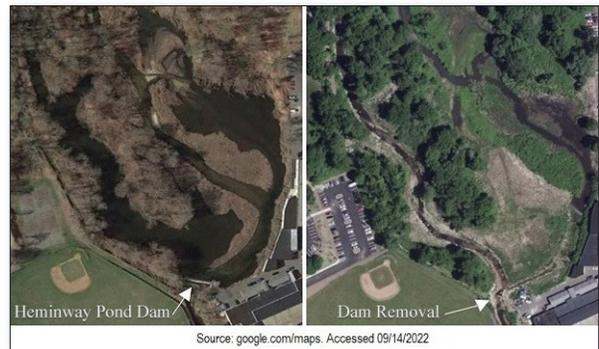
Figure 4. Aerial imagery shows the Heminway Pond Dam location, before (left) and after (right) removal.

This 15-year-long project ended in 2018 with the successful removal of Heminway Dam and the restoration of Steele Brook channel and its natural habitats (Figure 4). The water quality assessments in Connecticut's 2022 Integrated Water Quality Report to Congress indicate that aquatic life use support is still impaired in this section of Steele Brook due to iron. The reasons for this are not entirely clear, and further study is required. However, flows through this stretch of Steele Brook remain lower than anticipated after the dam removal, which may be a contributing factor in the current assessment.

The project helped restore the waterway's ecology. With the dam removal and brook reconnection, approximately 0.2 miles of Steele Brook is now once again naturally free-flowing. Aquatic habitat was restored, and passage was reestablished for riverine fish and other aquatic species to travel up and down this section of the river. The stream bottom habitat was restored by adding boulders and cobbles, and the streambanks were stabilized. New floodplain and
