Country Meadows Estates Phase 1

Staff Report Supplement

TRAFFIC IMPACT ASSESSMENT (TIA)

COUNTRY MEADOW ESTATES I TRAFFIC IMPACT ANALYSIS

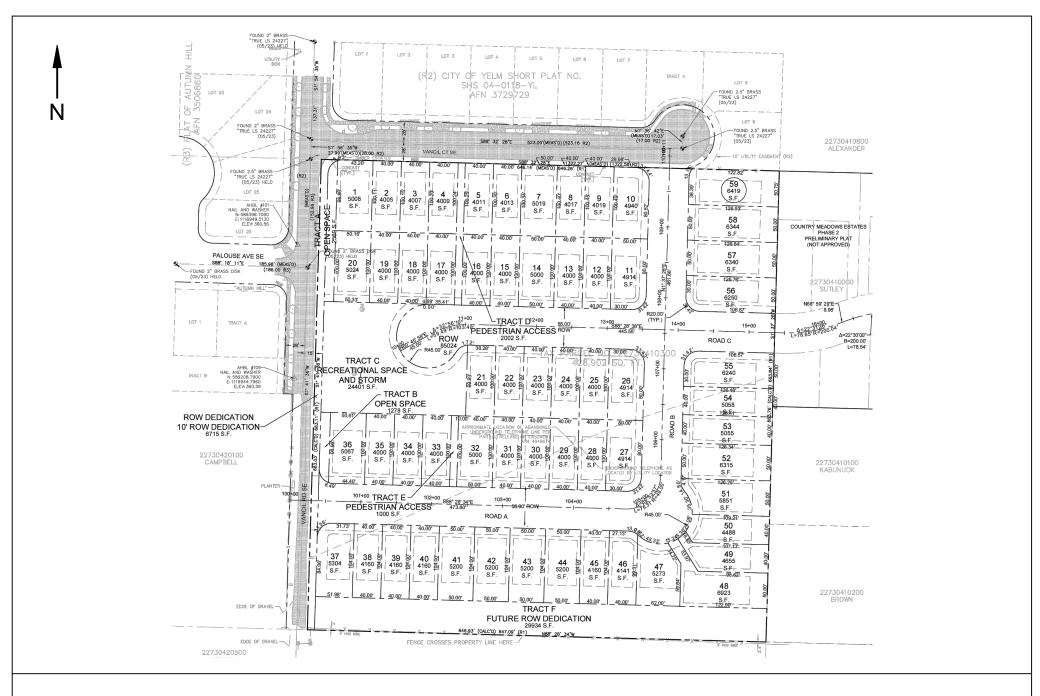
SITE PLAN FIGURE 2

Country Meadow Estates I proposes for the construction of a residential development consisting of 59 single-family homes located within unincorporated Thurston County. The subject site is bordered to the west by Vancil Road SE situated 10.0-acres within undeveloped tax parcel #: 22730410300. Site ingress/egress is proposed via one new access point extending east from Vancil Road SE. Connectivity to the north development is also proposed via Vancil Court SE. Moreover, a future easterly connection is provided (to tie into Country Meadow Estates II). A vicinity map is provided below with Phase I shown in red and phase II shown in blue. Figure 2 on the following page displays the conceptual site plan.

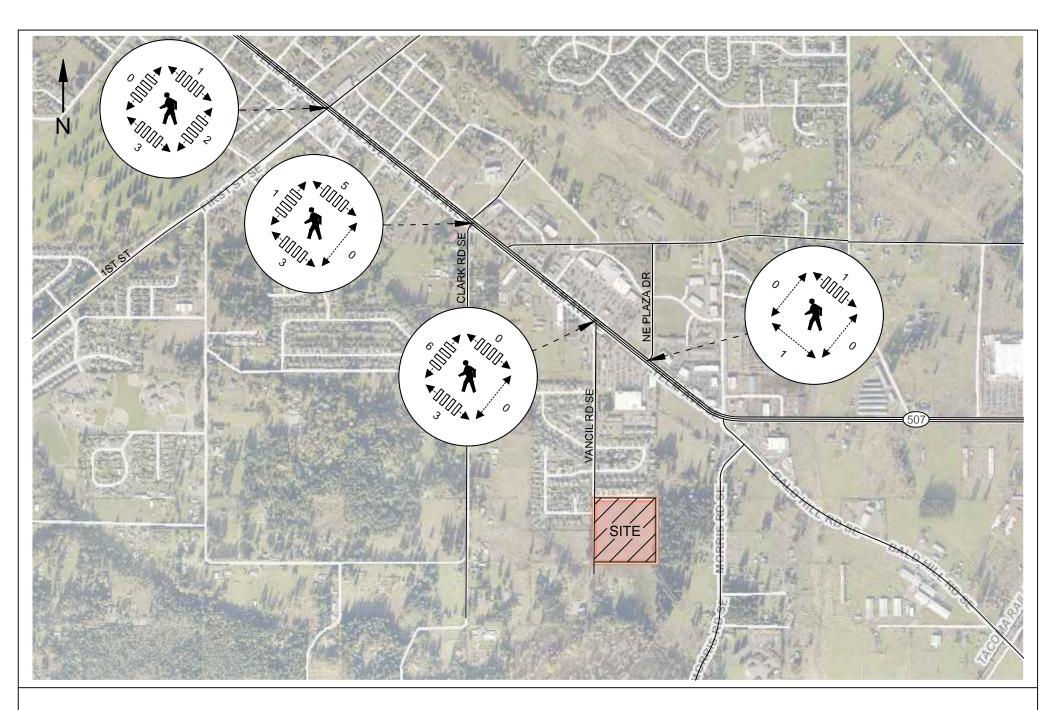
EXISTING PM PEAK HOUR PEDESTRIAN VOLUMES FIGURE 4

Pedestrian and bicycle activity were monitored at each intersection studied for this project during routine PM peak hour field counts. Figures 4 and 5 display the existing non-motorist activity observed at each study intersection.

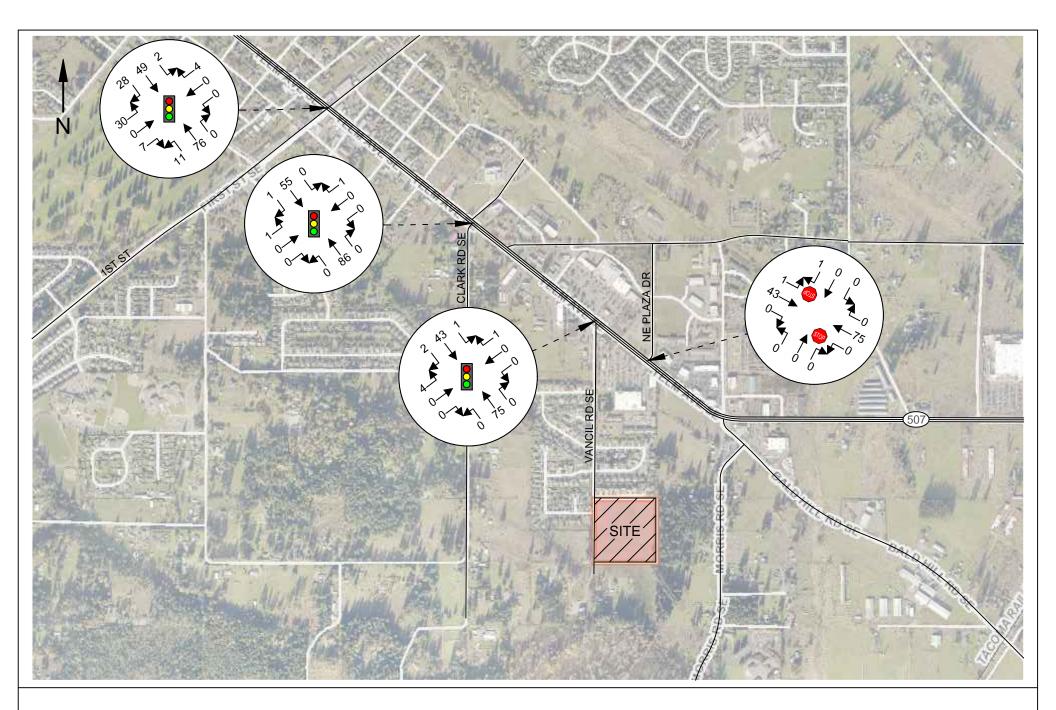
PM PEAK HOUR PIPELINE VOLUMES FIGURE 7

A 3-year horizon of 2026 was used for future traffic delay analysis. Forecast 2026 background traffic volumes were derived by applying a one percent compound annual growth rate to the existing volumes shown in Figure 3. This growth rate was developed from WSDOT volumes along SR 507 just south of 1st Street which are shown to be consistent from 2016 (ADT – 18,000) to 2019 (ADT – 18,000) (pre-COVID conditions). Moreover, also taken into consideration are in-process developments within the city which includes: The Hutch⁷, Durant Street Plat, Alpine Estates, Tahoma Boulevard Apartments, El Rey Burro, The Summit at Thompson Creek, Samantha Ridge, Habitat for Humanity, Liberty Grove, and 407 E Yelm Coffee. PM peak hour pipeline volumes are shown in Figure 7.

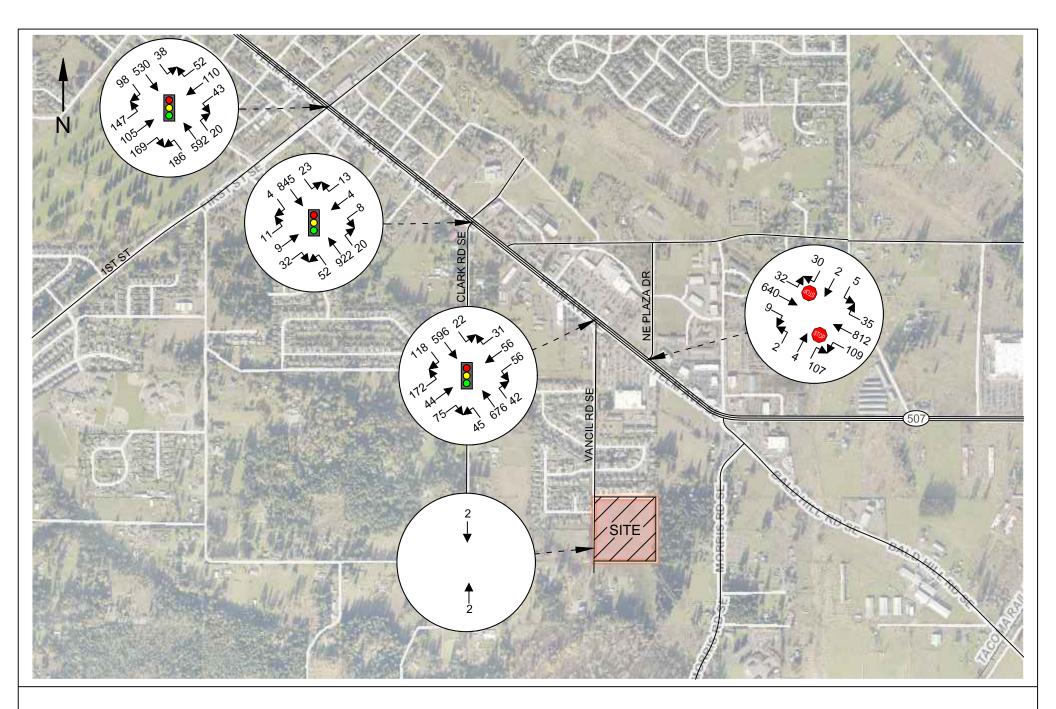
FORECAST 2026 PM PEAK HOUR VOLUMES WITHOUT PROJECT FIGURE 8

Level of service analyses were made of the future PM peak hour volumes without (background) and with project related trips added to the key roadways and intersections. This analysis once again involved the use of the *Synchro 12 analysis* program. Delays for the study/access intersections under future conditions are shown below in Table 6.

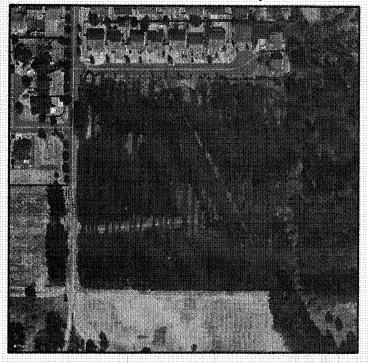
Photo 6: 1st Site Visit - GPS-tracked survey route

The initial site visit was conducted on June 17, 2021. The parcel contains a single-family residence. Visibility was excellent. The site has numerous active mole mounds, but no gopher mounds were observed.

No Mazama Pocket Gopher mounds were observed on the parcel.

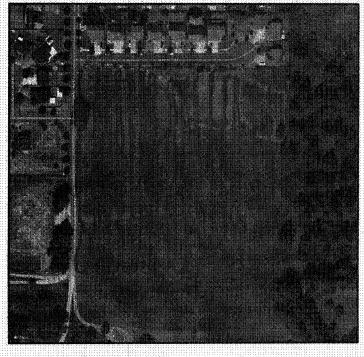
Photo 7: 2nd Site Visit - GPS-tracked survey route

The second site visit was conducted on July 19, 2021, again following the County's protocol. As with the initial survey, numerous mole mounds were detected, but no gopher mounds were observed.

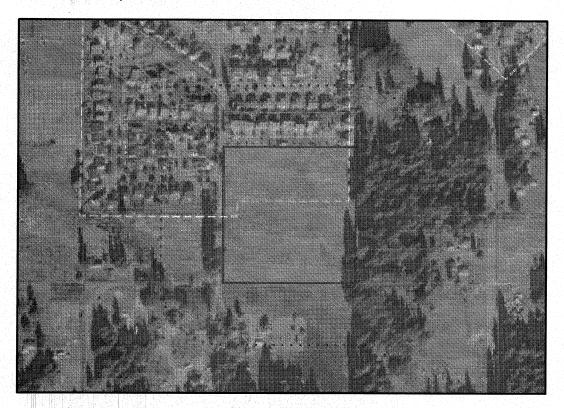
Photo 5: PHS Report Area

A search of the Washington Department of Fish and Wildlife's (WDFW) Priority Habitats and Species (PHS) database did not indicate an occurrence of the Mazama Pocket Gopher within 300 feet of the property. A printout of PHS report for this area is included as an attachment.

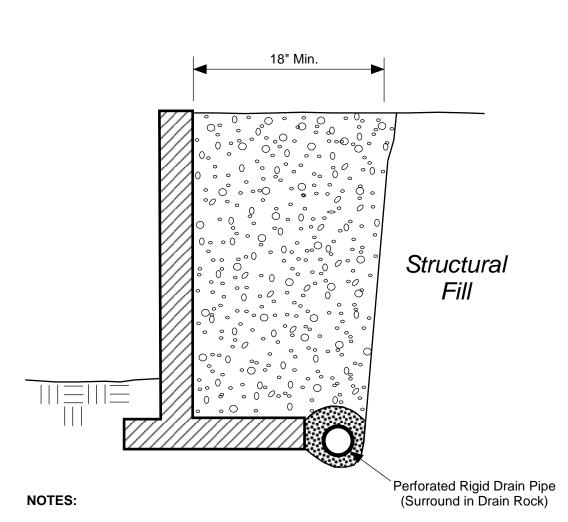
- Free-draining Backfill should consist of soil having less than 5 percent fines.
 Percent passing No. 4 sieve should be 25 to 75 percent.
- Sheet Drain may be feasible in lieu of Free-draining Backfill, per ESNW recommendations.
- Drain Pipe should consist of perforated, rigid PVC Pipe surrounded with 1-inch Drain Rock.

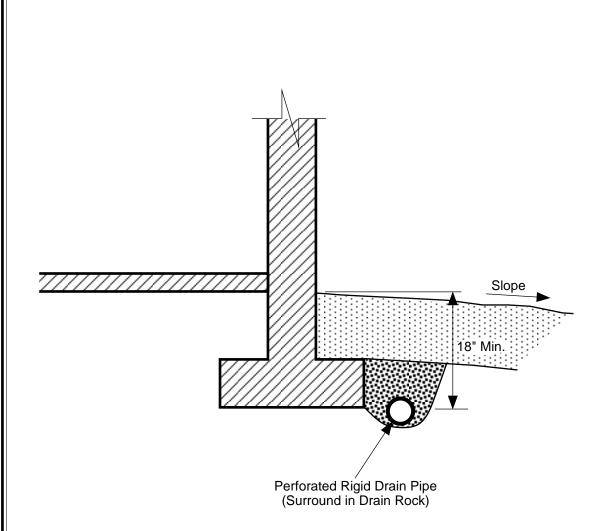
- Do NOT tie roof downspouts to Footing Drain.
- Surface Seal to consist of 12" of less permeable, suitable soil. Slope away from building.

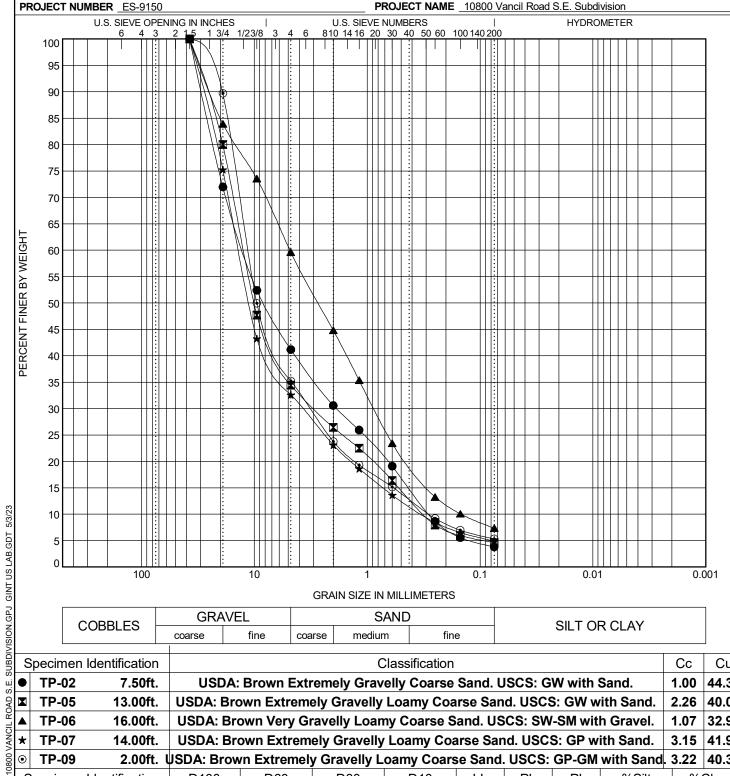
GRAIN SIZE DISTRIBUTION

H							
L	Specimen I	dentification	Classification				
	● TP-02	7.50ft.	USDA: Brown Extremely Gravelly Coarse Sand. USCS: GW with Sand.	1.00	44.36		
Ī	▼ TP-05	13.00ft.	USDA: Brown Extremely Gravelly Loamy Coarse Sand. USCS: GW with Sand.	2.26	40.04		
ſ	▲ TP-06	16.00ft.	USDA: Brown Very Gravelly Loamy Coarse Sand. USCS: SW-SM with Gravel.	1.07	32.95		
Ī	★ TP-07	14.00ft.	USDA: Brown Extremely Gravelly Loamy Coarse Sand. USCS: GP with Sand.	3.15	41.95		
	⊙ TP-09	2.00ft. l	SDA: Brown Extremely Gravelly Loamy Coarse Sand. USCS: GP-GM with Sand	3.22	40.31		
, _

50 1	Specimen Identification			D100	D60	D30	D10	LL	PL	PI	%Silt	%Clay
-S-91	• TP-	02 7	'.5ft.	37.5 12.425 1.868 0.28			3.8					
DA E	▼ TP-	05 13	.0ft.	37.5	12.362	2.94	0.309				4.7	
E US	▲ TP-	06 16	.0ft.	37.5	4.834	0.87	0.147				7	.4
N SIZ	★ TP-	07 14	.0ft.	37.5	13.65	3.741	0.325				4	.9
3RAI	TP-	09 2	.0ft.	37.5	11.317	3.196	0.281				5	.3

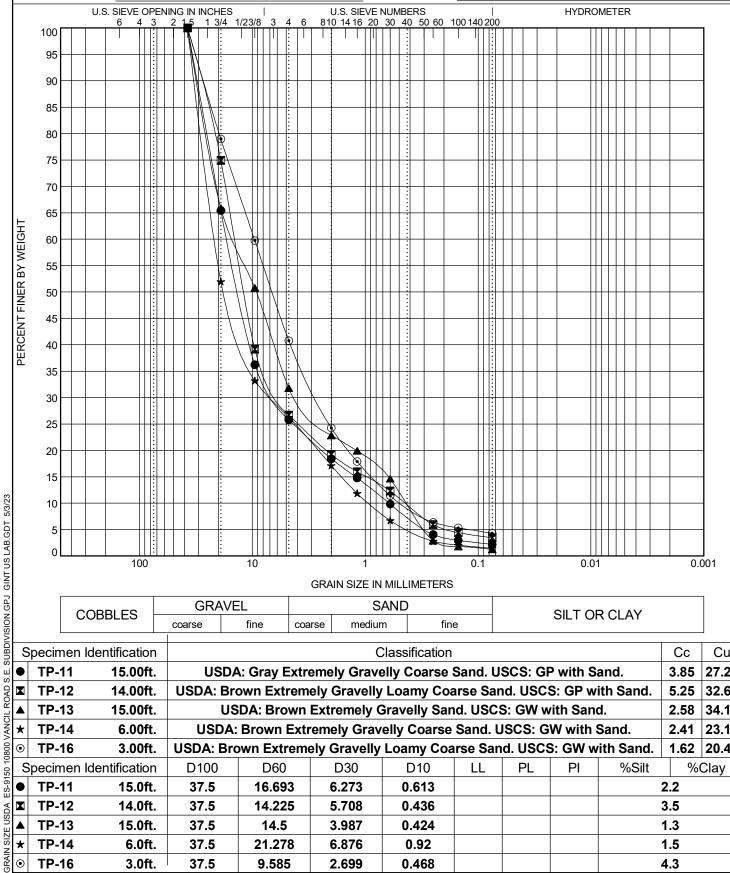
۱ د													
	S	pecimen Id	entification		Classification							Сс	Cu
֓֞֜֜֞֜֞֜֞֜֓֓֞֜֜֞֜֓֡֓֜֜֞֜֞֜֓֓֡֡֡֡֡֡֡	•	TP-11	15.00ft.	USDA	USDA: Gray Extremely Gravelly Coarse Sand. USCS: GP with Sand.						3.85	27.25	
	X	TP-12	14.00ft.	USDA: Bro	JSDA: Brown Extremely Gravelly Loamy Coarse Sand. USCS: GP with Sand.					5.25	32.63		
	A	TP-13	15.00ft.	US	USDA: Brown Extremely Gravelly Sand. USCS: GW with Sand.					2.58	34.17

*	TP-14	6.00ft.	USDA:	USDA: Brown Extremely Gravelly Coarse Sand. USCS: GW with Sand.					2.41	23.12		
	•	TP-16	3.00ft.	USDA: Bro	wn Extrem	ely Gravelly	Loamy Coa	arse Sar	d. USCS	S: GW w	ith Sand.	1.62	20.48
3	S	pecimen Id	entification	D100	D60	D30	D10	LL	PL	PI	%Silt	%	Clay
5	•	TP-11	15.0ft.	37.5	16.693	6.273	0.613					2.2	
5	lacksquare	TP-12	14.0ft.	37.5	14.225	5.708	0.436					3.5	
3	A	TP-13	15.0ft.	37.5	14.5	3.987	0.424					1.3	
202	*	TP-14	6.0ft.	37.5	21.278	6.876	0.92					1.5	
3	•	TP-16	3.0ft.	37.5	9.585	2.699	0.468					4.3
