Yuba County Self-Evaluation and Transition Plan for the Public Right-of-Way

County of Yuba

Department of Public Works

April, 2018

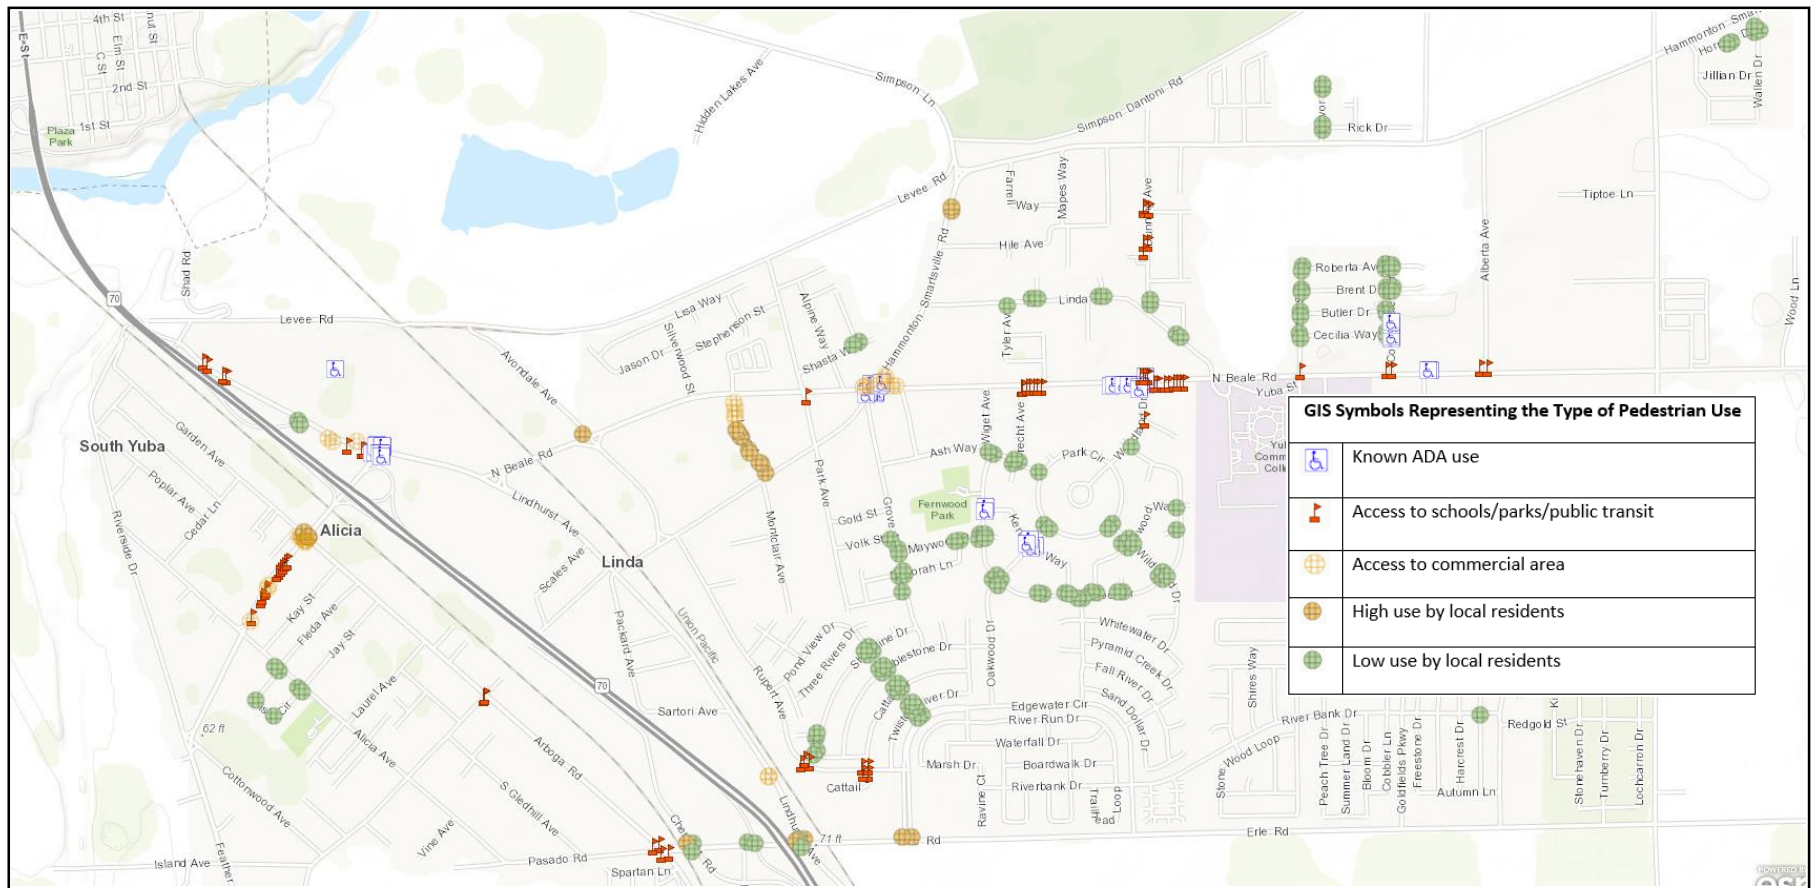
Figure 2a: Data Collection Map

Each symbol on the maps designates a facility that was evaluated in the field. The symbols represent the type of pedestrian use for each facility as determined by the evaluator. The description for each symbol can be found in the legend for the map.

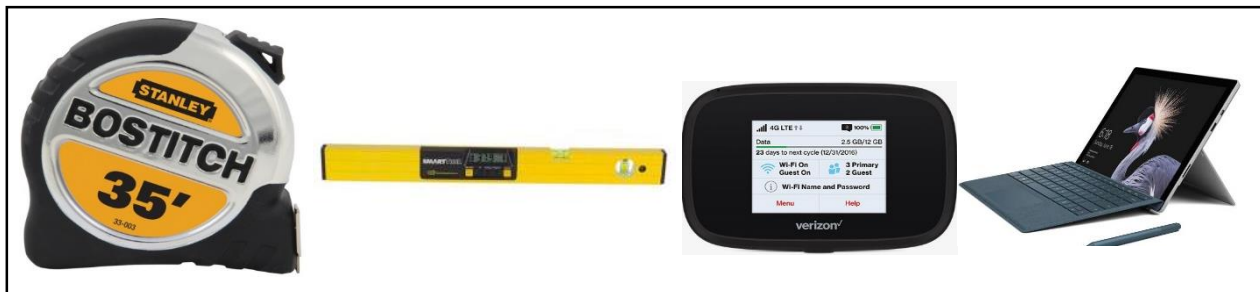
Figure 3: ADA Self-Evaluation tools from:

A Stanley Bostitch 35-foot measuring tape and a M-D Building Products SMARTTOOL were the materials used to take measurements at each facility. Two Microsoft Surface Pro tablets were leased to the Yuba County Department of Public Works for the Self-Evaluation program. Also, two Verizon Mifi devices were used to enable Wi-Fi access in the field. These tools are shown below in Figure 3.

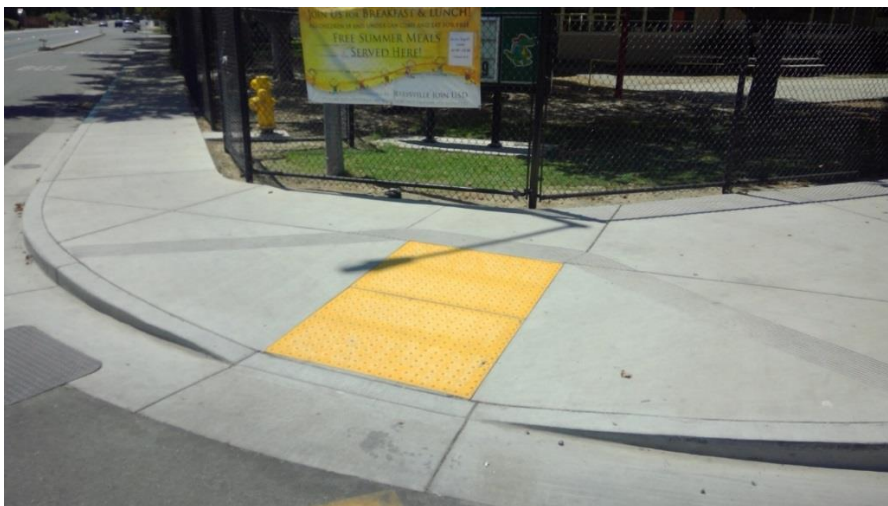
Figure 4: Example of curb ramp compliant with ADA standards (Data entry #38)

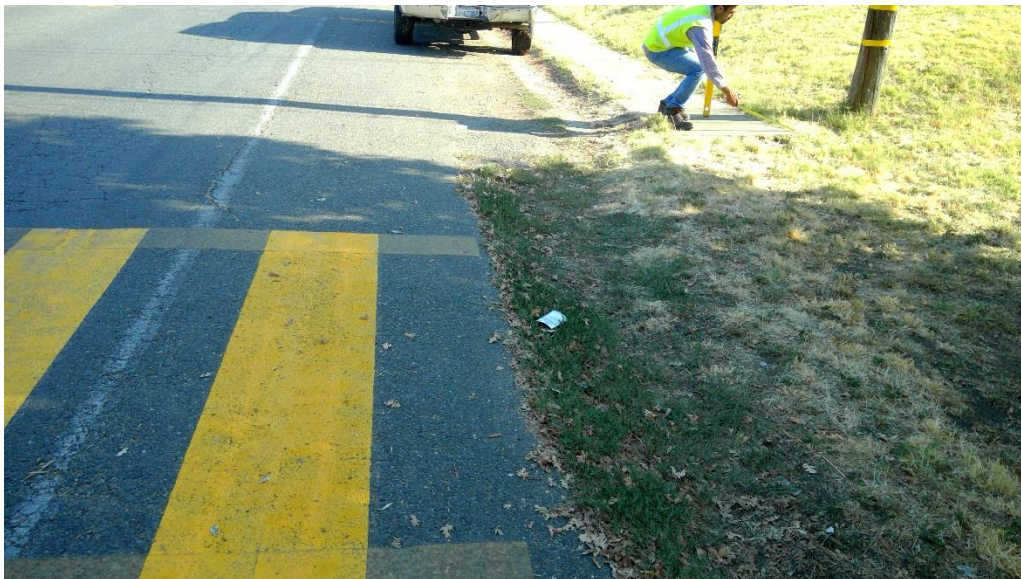
A physical barrier can be seen in Figure 6. This facility features a crosswalk, but there is no transition from the crosswalk to the sidewalk. The sidewalk can be seen in the figure, but a curb ramp should be constructed to allow handicapped pedestrians to access the sidewalk.

Figure 6: Example of a barrier (Data entry #455)

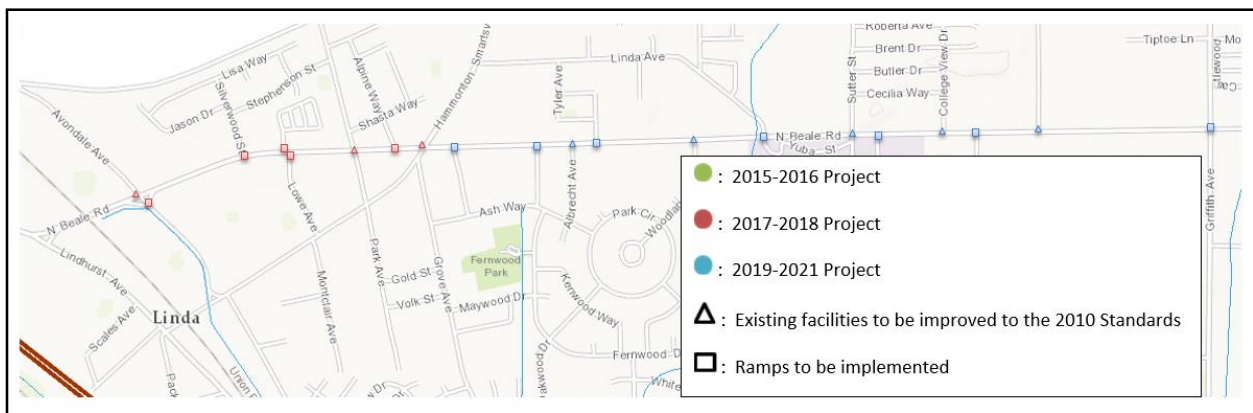
Figure 7a: Proposed and completed ADA Projects

The Priority 1 category represents the approximate number of ADA facilities that are scheduled to be completed before 2021 (See Figure 7 below for locations of scheduled projects). The YCDPW evaluated 59 facilities that did not meet 2010 Standards criteria, but will be improved under the scheduled Priority 1 work. These 59 facilities include four Priority 2 barriers, one Priority 3 barrier, two Priority 5 barriers, nineteen Priority 7 ramps, twenty-two Priority 8 ramps, five Priority 9 ramps, five Priority 10 ramps and one Priority 11 ramp. At least 50 more new facilities will be introduced as a result of completing all Priority 1 work. The new facilities include pedestrian crossings, pedestrian signal lights, bus stops, ADA compliant curb ramps, sidewalks and ADA accessible parking lots and driveways.

Each symbol on the maps represents an “ADA Project”. An ADA Project can be defined as the construction or improvement of one more ADA facilities. Each symbol depicts an ADA Project that has already been completed, or is proposed, as a result of capital improvement projects. Many of the ADA Projects located at intersections represent 2-8 facilities. The locations where ramps have been, or will be, implemented will result in the removal of existing barriers. These ADA Projects do not even exhibit the vast number of driveways that will be improved.

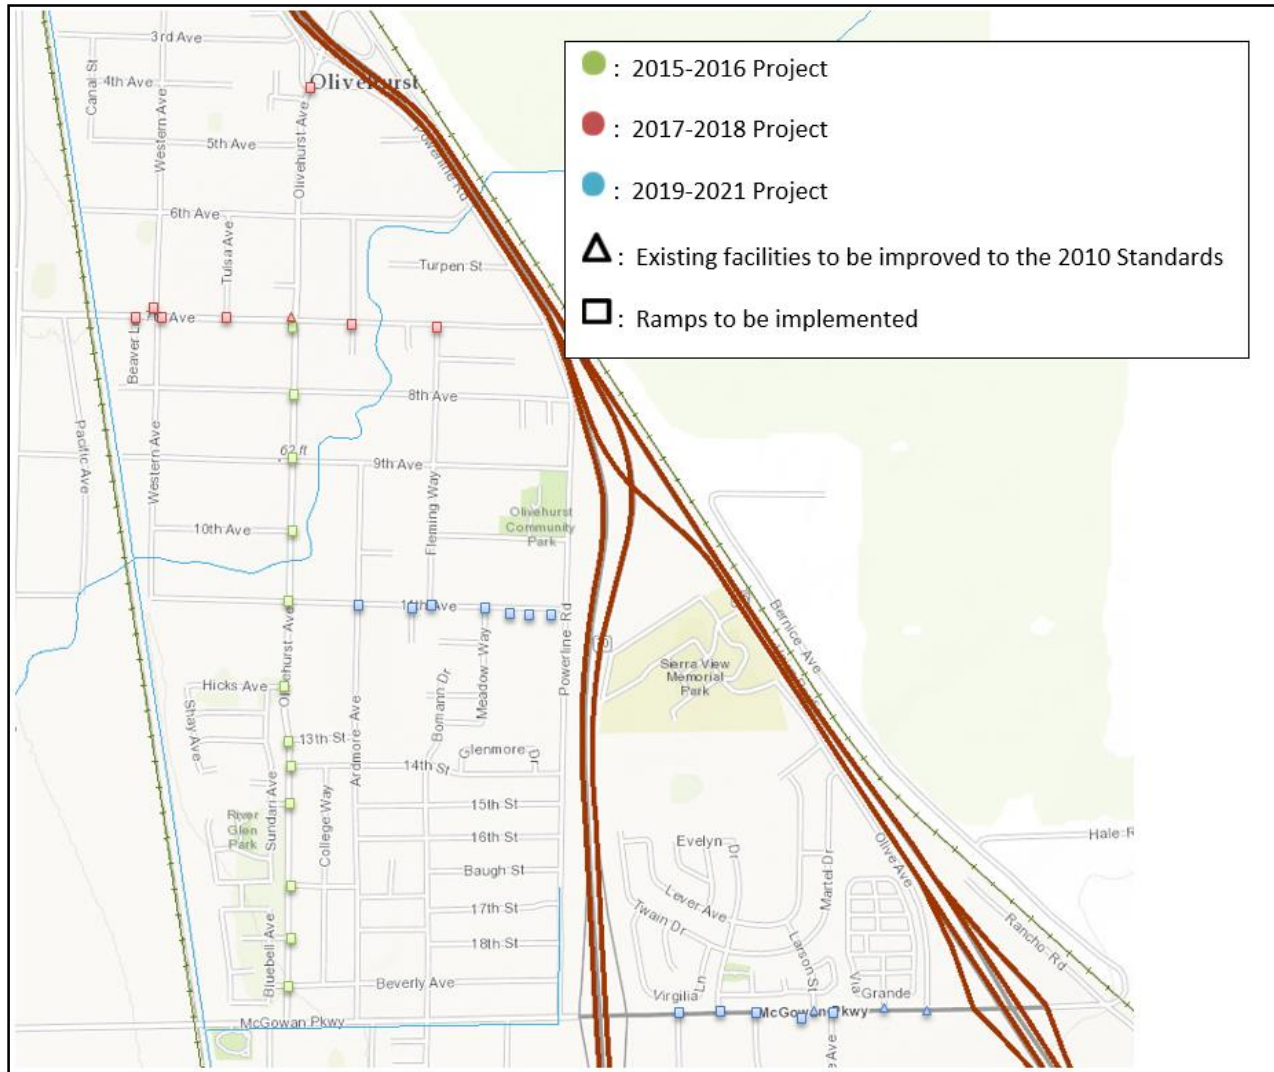
Figure 7b: Proposed and completed ADA Projects

Olivehurst Ave received a complete streets improvement from McGowan Parkway to 7th Avenue in 2016. Sidewalks were introduced, as well as a curb, gutter, and bike lanes. This stretch of roadway had utilities that were moved underground to increase safety and reduce the chance of damage to utilities. The ADA improvements as a result of this project can be seen in Figure 7b.
