Yuba County Self-Evaluation and Transition Plan for the Public Right-of-Way

County of Yuba

Department of Public Works

April, 2019

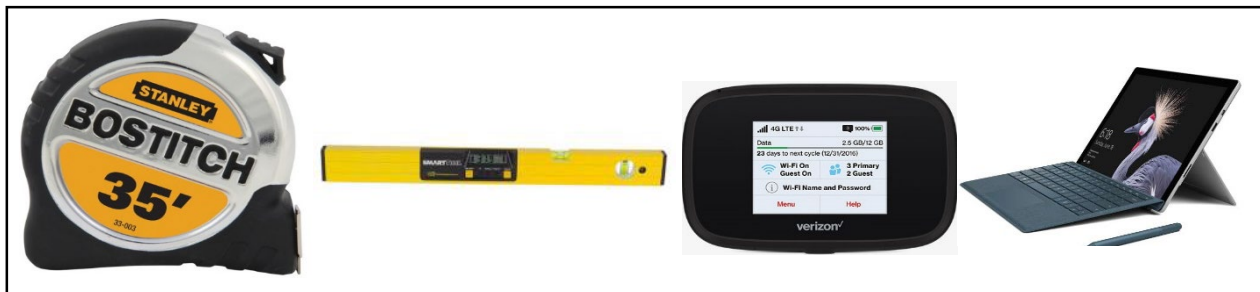
Figure 3: ADA Self-Evaluation tools from:

A Stanley Bostitch 35-foot measuring tape and a M-D Building Products SMARTTOOL were the materials used to take measurements at each facility. Two Microsoft Surface Pro tablets were leased to the Yuba County Department of Public Works for the Self-Evaluation program. Also, two Verizon Mifi devices were used to enable Wi-Fi access in the field. These tools are shown below in Figure 3.

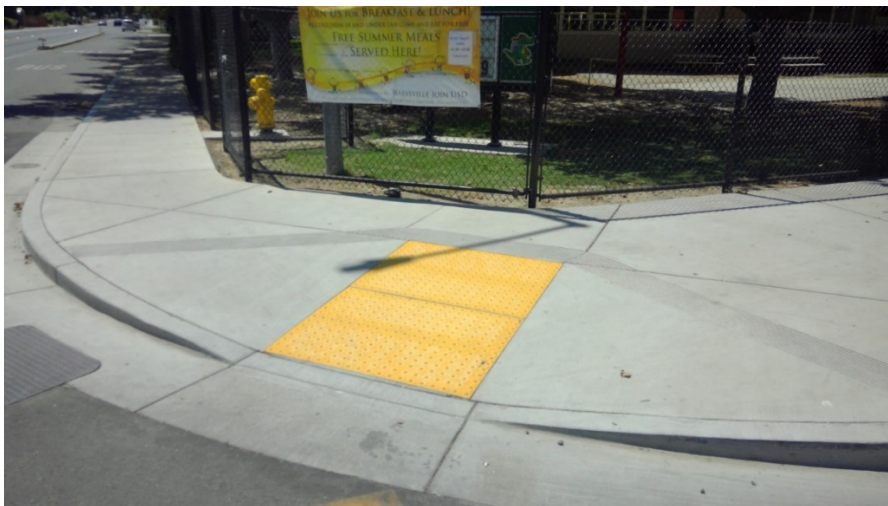
Figure 4: Example of curb ramp compliant with ADA standards (Data entry #38)

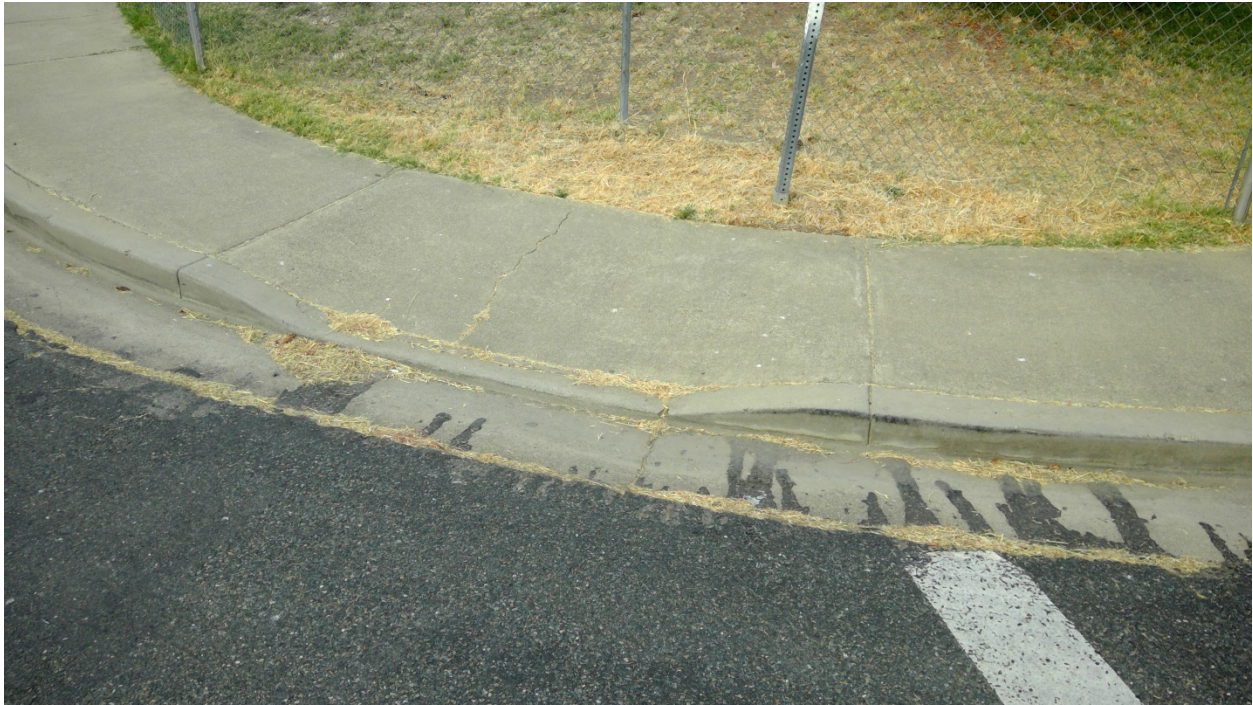
The ramp in Figure 5 did not meet the 2010 standards for a variety of reasons. While it met the standards for ramp cross slope and ramp width, the curb ramp had slope values above the allowable design for the ramp slope, right and left flare slope, and the gutter slope. There is also no top landing attached to this curb ramp, but that is not always a necessary requirement.

Figure 5: Example of ADA non-compliant curb ramp (Data entry #181)
