APPENDIX R
WELL SITES EVALUATION

Technical Memorandum

Re: Evaluation of Potential Well Sites for the Chadwick Ranch Estates

Evaluation of Potential Well Sites for the Chadwick Ranch Estates

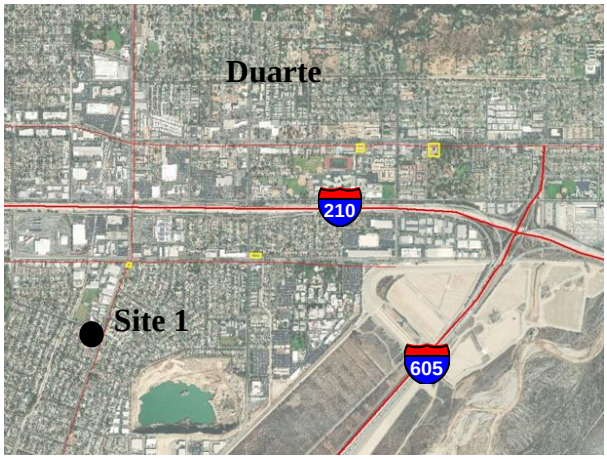
Site 1 is a vacant, undeveloped parcel located at the intersection of Mountain Avenue and Euclid Avenue (see Figure 5). The parcel is privately-owned by New Hope Church of God in Christ in Duarte. The site contains adequate space for drilling rig and equipment. There are some trees on the site that might need to be removed.

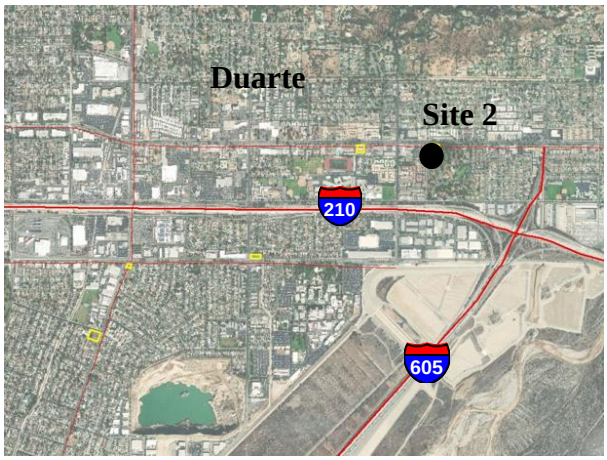
Site 2 consists of a mostly vacant, undeveloped parcel owned by Westminster Gardens. Westminster Gardens is a senior living retirement community. The site is located within a residential neighborhood near the intersection of Santo Domingo Avenue and Huntington Drive (see Figure 6). The site contains adequate space for drilling rig and equipment. There are boulders and trees on site as well as unlevel land, so site maintenance will likely be necessary. A review of aerial imagery suggests this site is periodically used as a parking lot for the senior community. At the time of the site visit, there were no cars and gates were closed and locked.

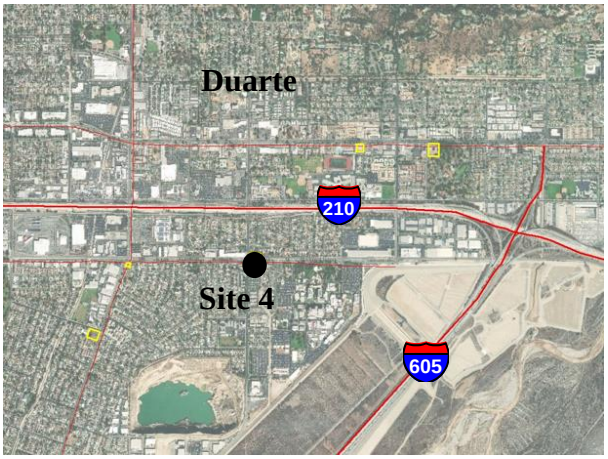
Site 4 is a parking lot adjacent to the train tracks at the intersection of Buena Vista Street and East Duarte Road (see Figure 8). It is privately-owned by Dura Properties, LLC. The site

contains adequate space for drilling rig and equipment. Minor site maintenance might be necessary to remove trees and to redirect a power line trending through the site.

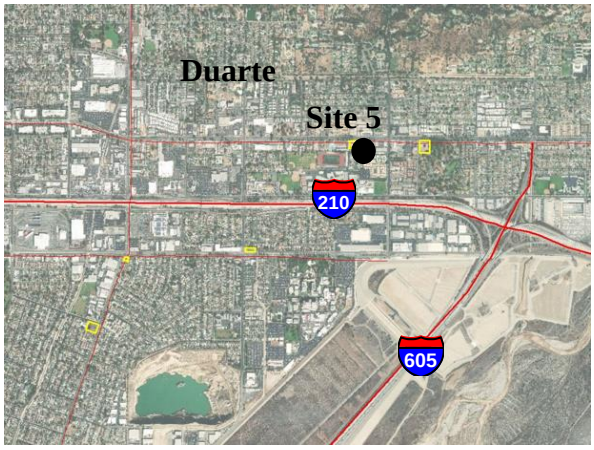
Site 5 is a vacant, undeveloped parcel located off of Huntington Drive and Pops Road (see Figure 9). The parcel is owned by the City of Duarte. The site contains adequate space for drilling rig and equipment. The southern portion of the site has a berm and the western portion of the site dips down. Currently the site contains plants and trees with irrigation lines and hoses along the perimeter, so minor site preparation may be necessary to grade the site and remove any plants as deemed necessary.
