Pavement Photo Inspection Report

Town of China Grove

2023 Pavement Photo Inspection Report

KCA Project Number: 005-202318.00

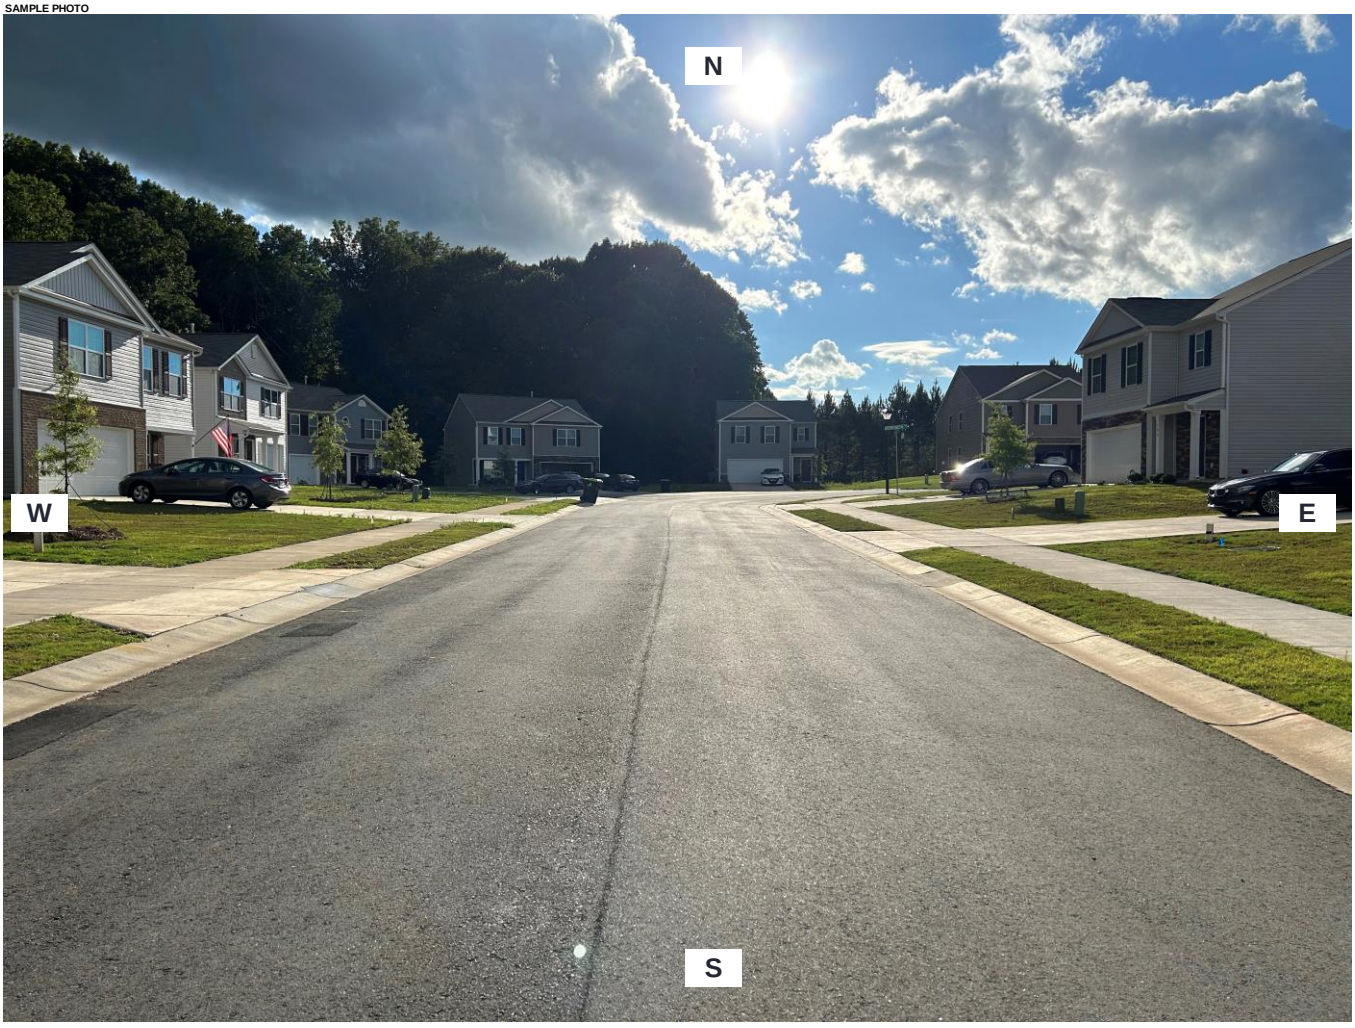
SAMPLE PHOTO

#	DISTRESS	SV	QUANT	UNITS
11	PATCH/UT CUT	L	15	SQFT

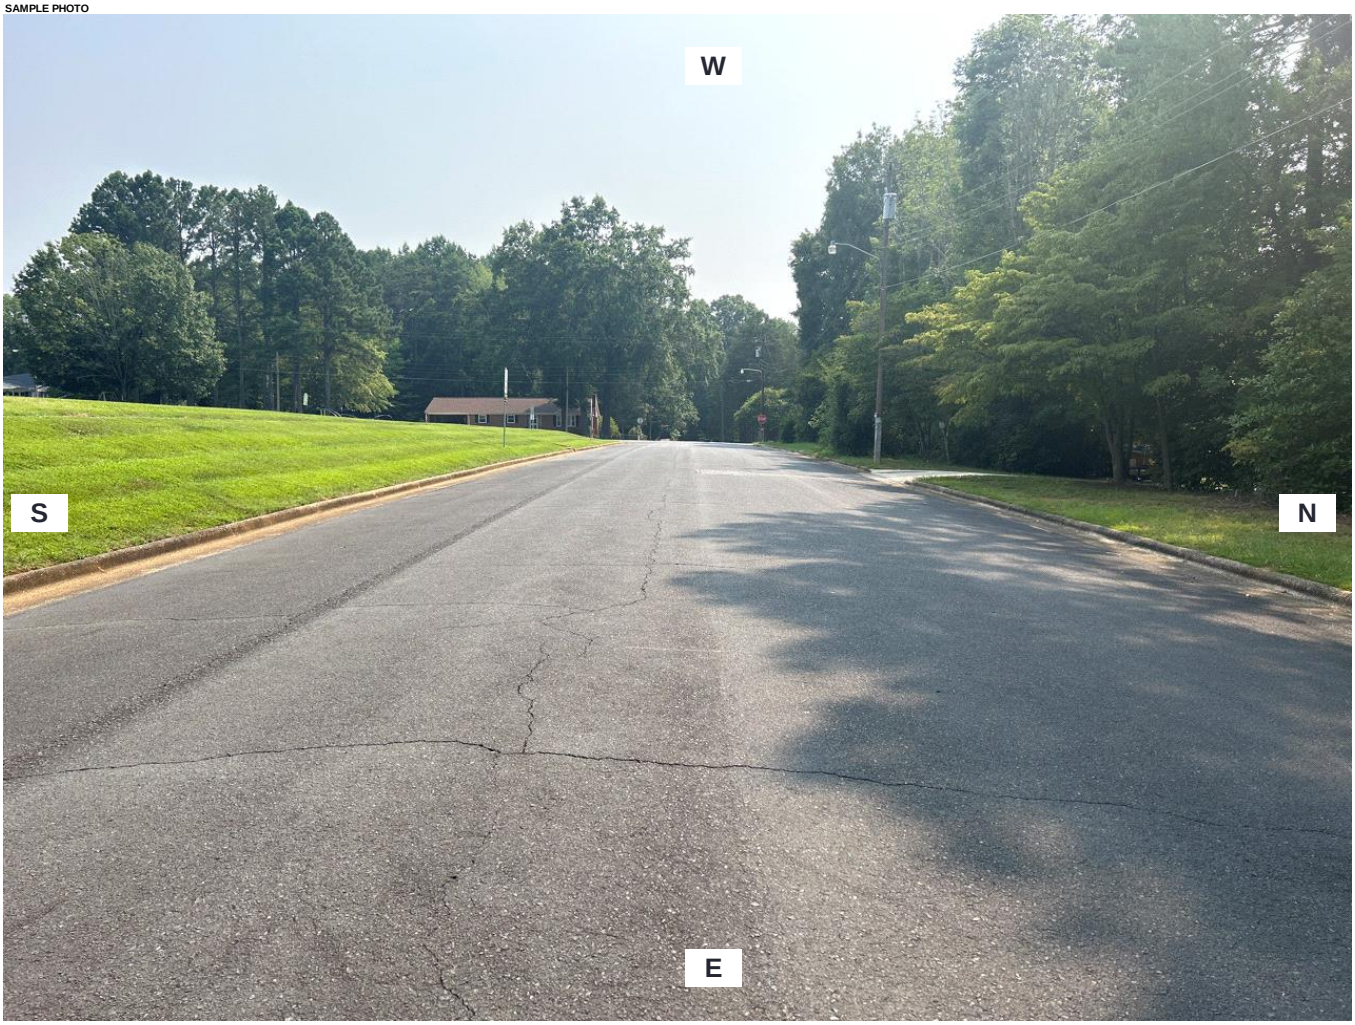
SAMPLE PHOTO

#	DISTRESS	SV	QUANT	UNITS
9	LANE SH DROP	L	100	FT
10	L & T CR	L	191	FT
20	WEATHERING	L	1,800	SQFT

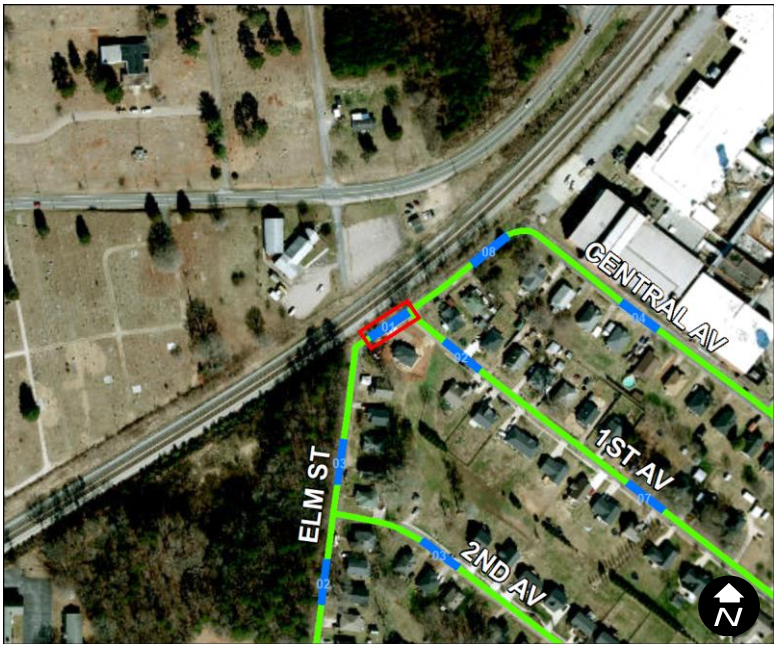
SAMPLE PHOTO

#	DISTRESS	SV	QUANT	UNITS
10	L & T CR	L	65	FT
20	WEATHERING	L	2,000	SQFT

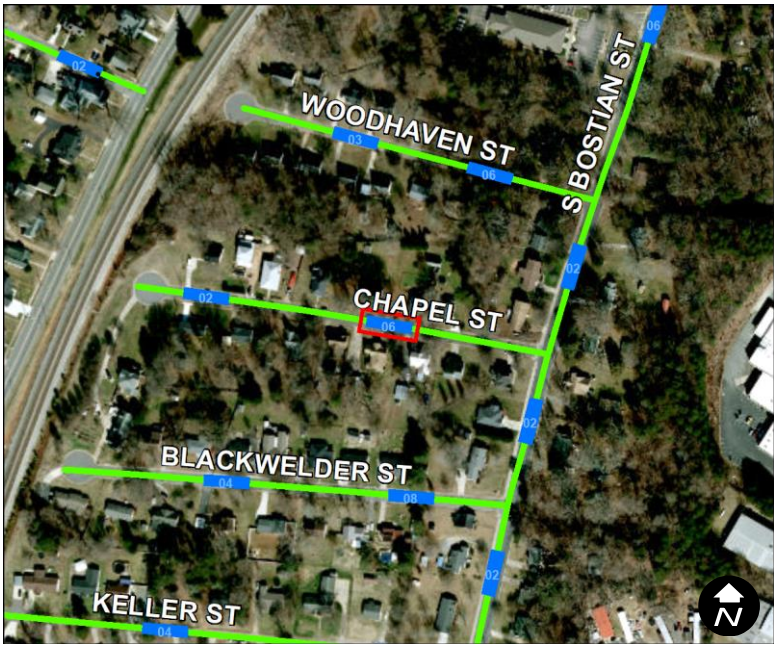
SAMPLE PHOTO

#	DISTRESS	SV	QUANT	UNITS
1	ALLIGATOR CR	M	590	SQFT
3	BLOCK CR	M	287	SQFT
4	BUMPS/SAGS	M	9	FT
6	DEPRESSION	M	161	SQFT
10	L & T CR	L	159	FT
11	PATCH/UT CUT	M	238	SQFT

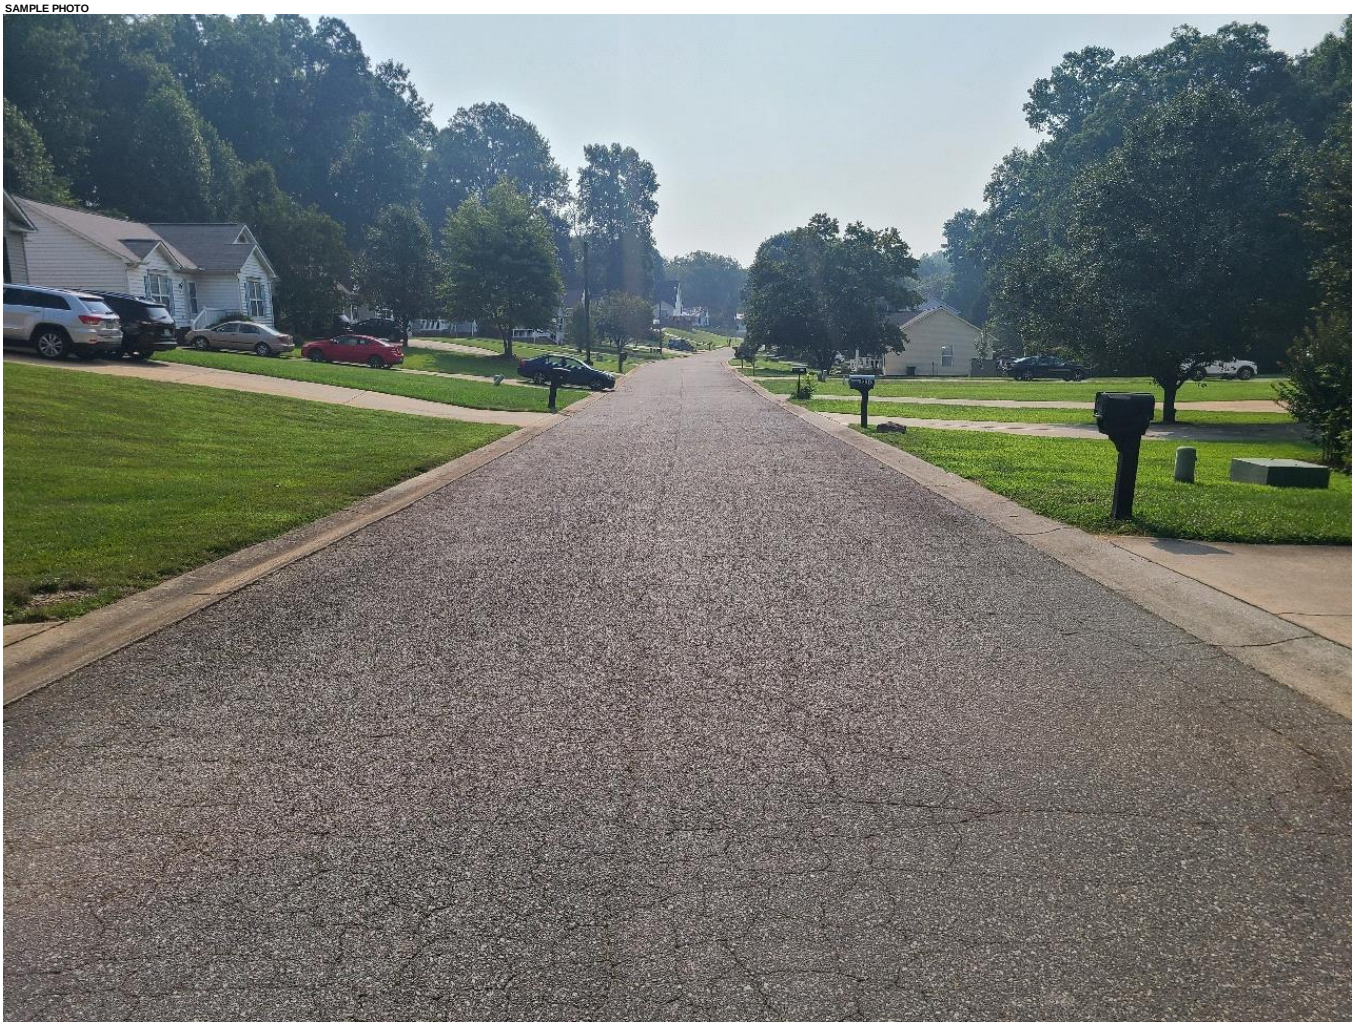
SAMPLE PHOTO

#	DISTRESS	SV	QUANT	UNITS
1	ALLIGATOR CR	M	400	SQFT
3	BLOCK CR	M	1,800	SQFT
20	WEATHERING	L	2,200	SQFT

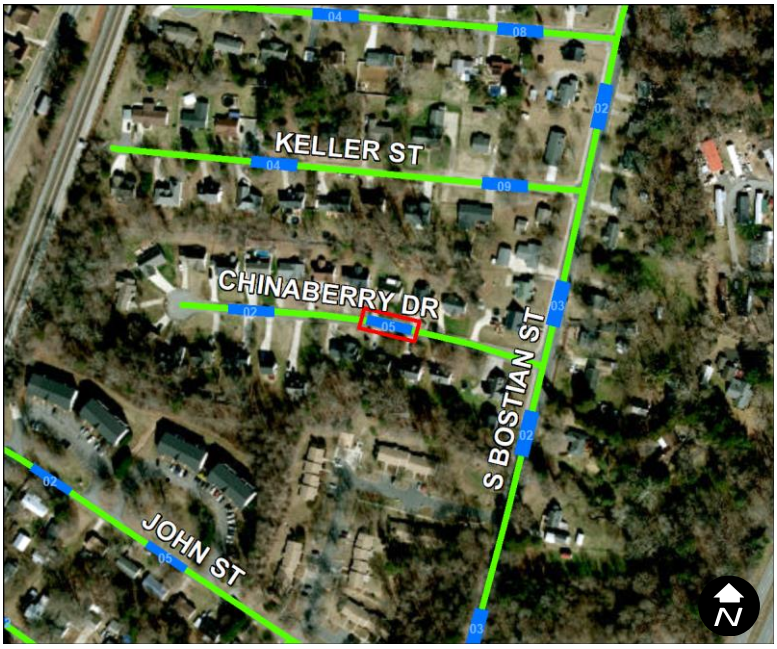
SAMPLE PHOTO

#	DISTRESS	SV	QUANT	UNITS
1	ALLIGATOR CR	L	400	SQFT
3	BLOCK CR	L	1,202	SQFT
20	WEATHERING	M	2,200	SQFT

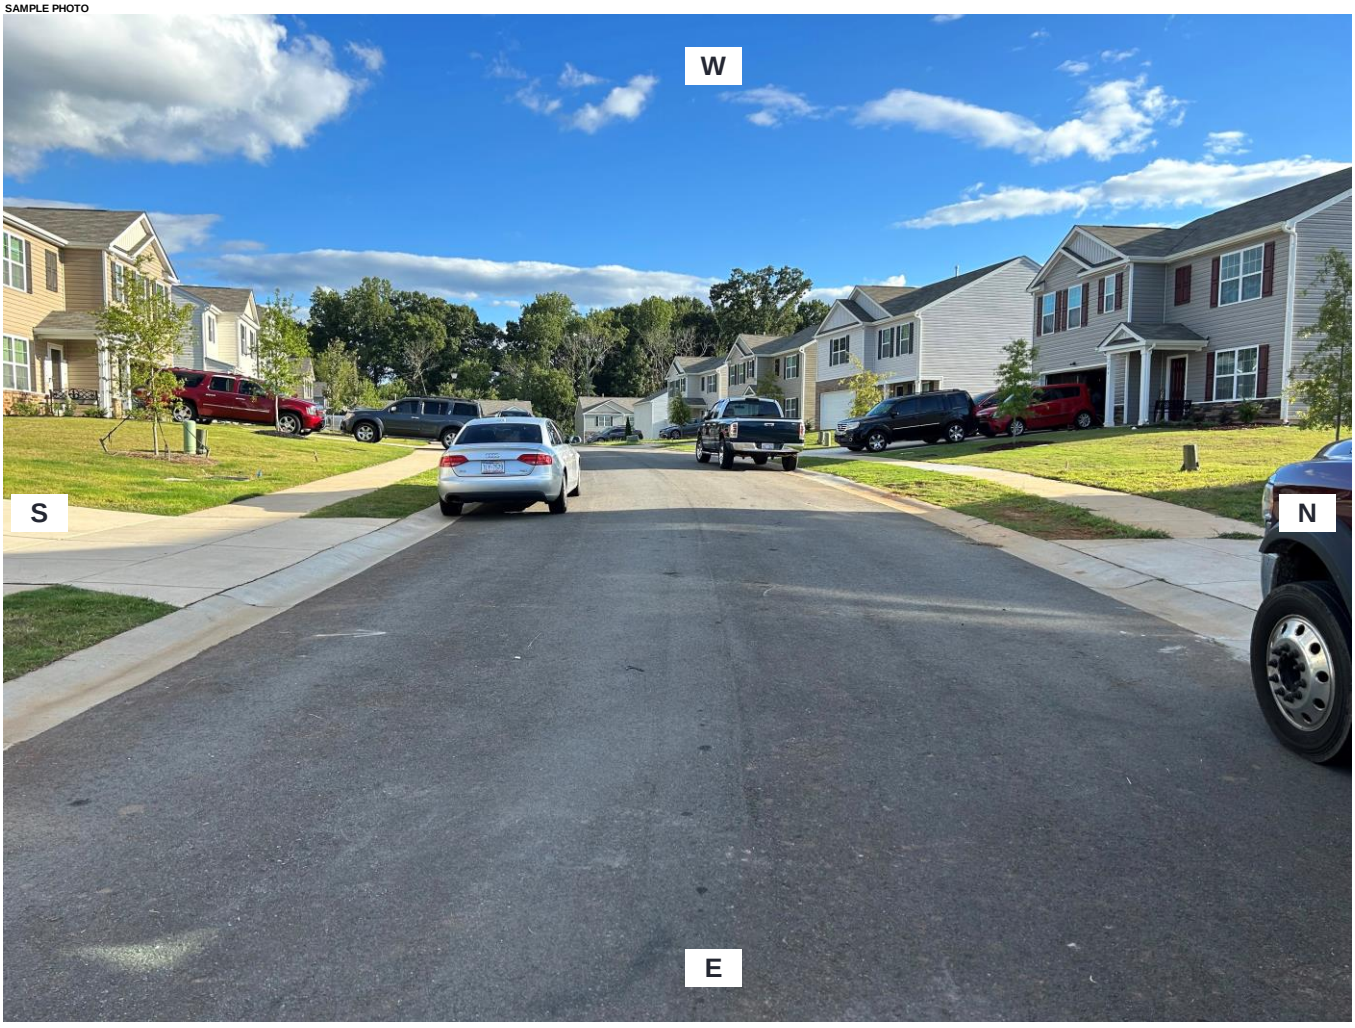
SAMPLE PHOTO

#	DISTRESS	SV	QUANT	UNITS
2	BLEEDING	L	19	SQFT
19	RAVELING	L	15	SQFT

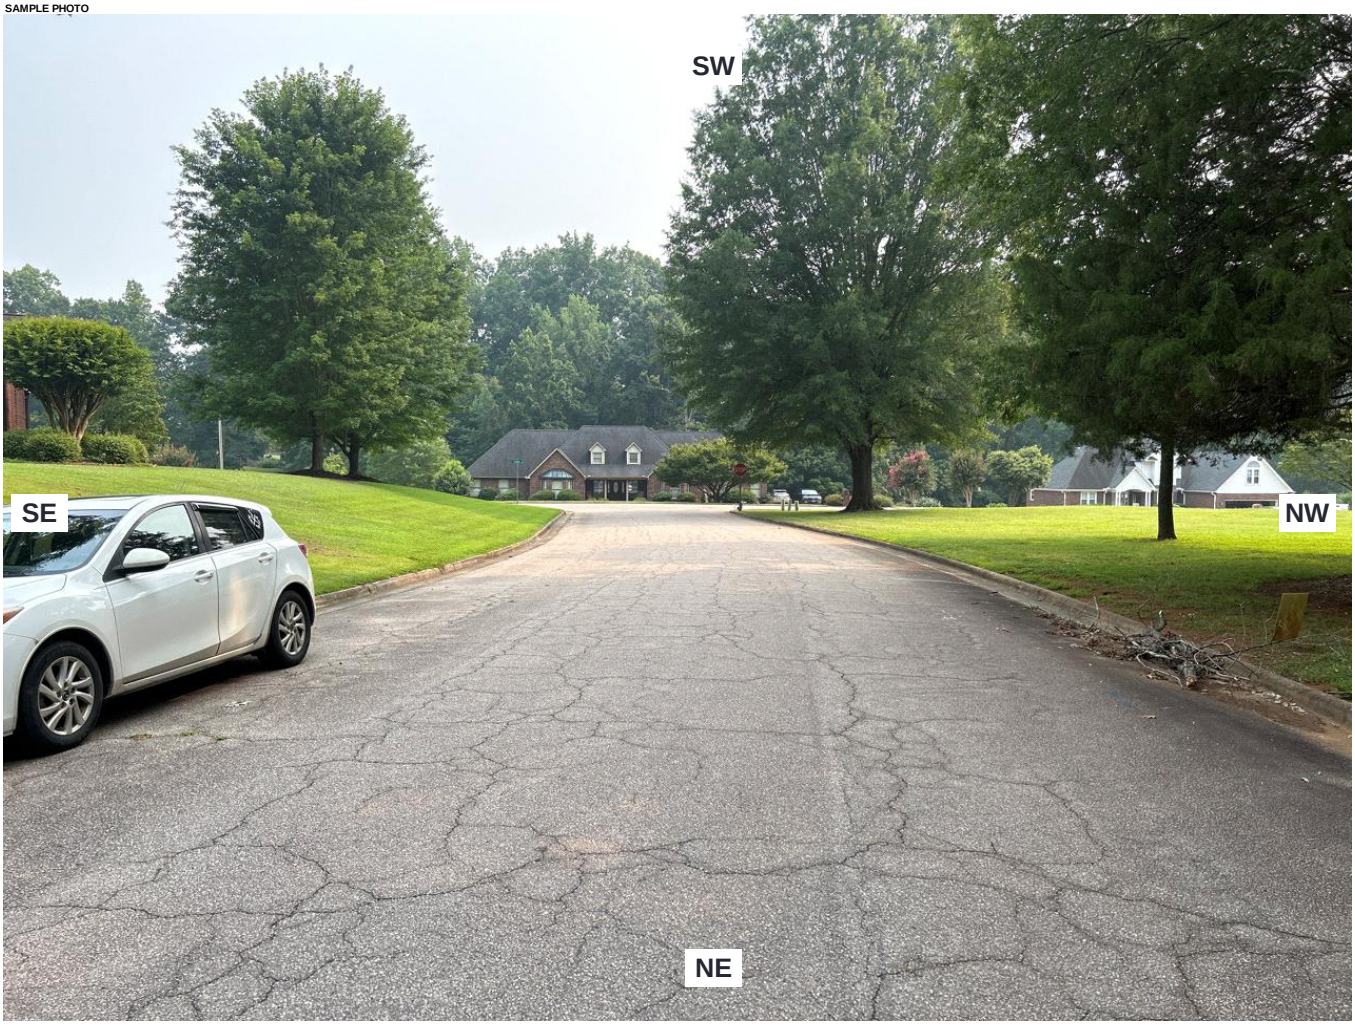
SAMPLE PHOTO

#	DISTRESS	SV	QUANT	UNITS
3	BLOCK CR	M	2,553	SQFT
10	L & T CR	L	91	FT
20	WEATHERING	M	2,900	SQFT

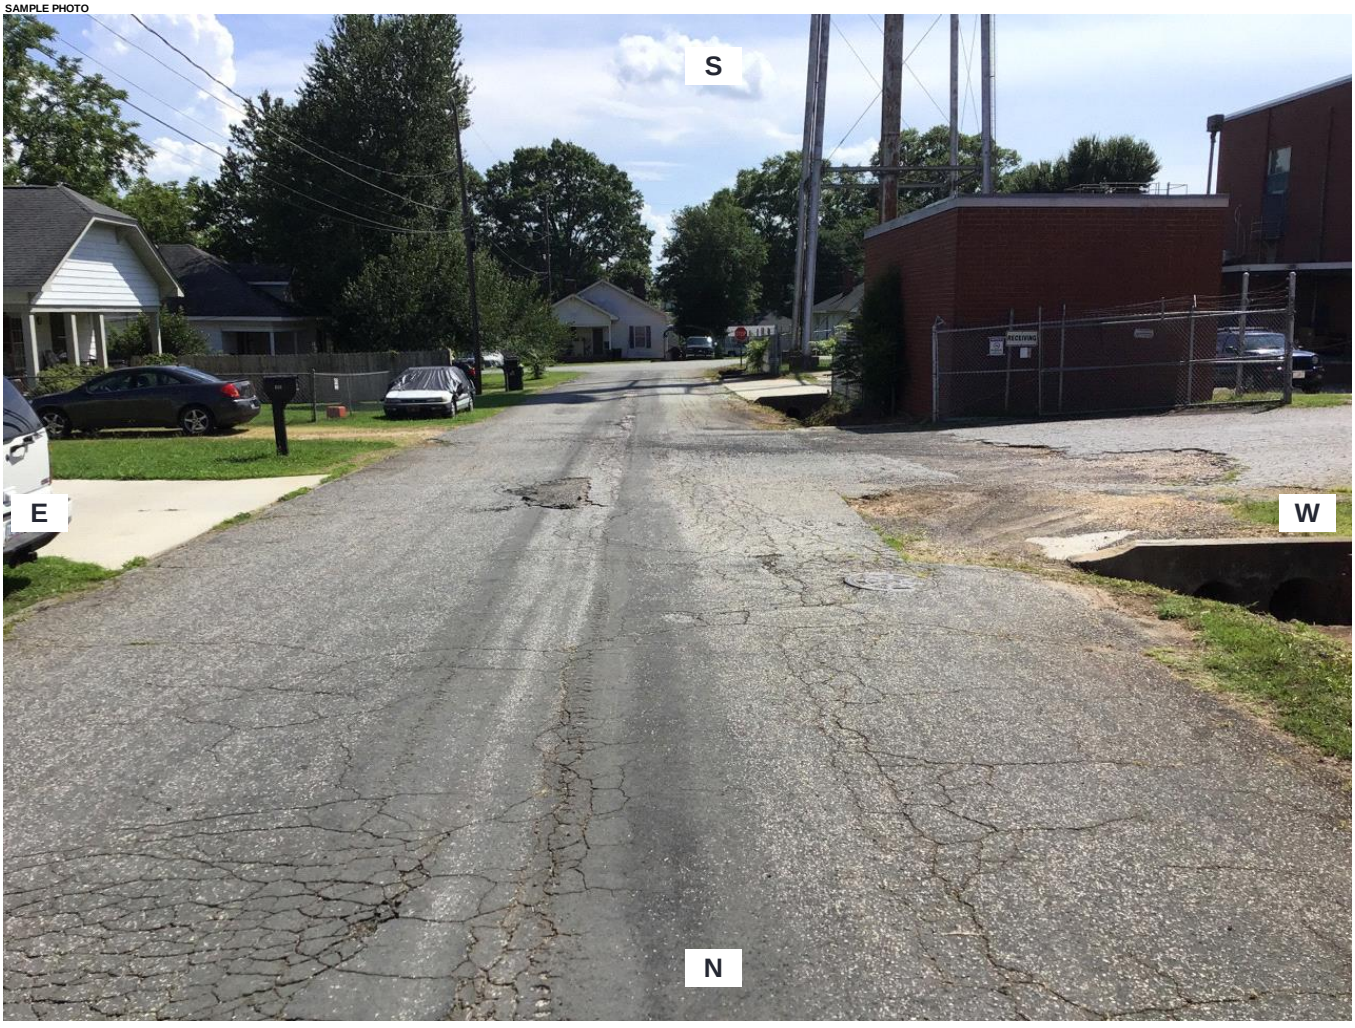
SAMPLE PHOTO

#	DISTRESS	SV	QUANT	UNITS
1	ALLIGATOR CR	H	931	SQFT
3	BLOCK CR	M	328	SQFT
4	BUMPS/SAGS	M	15	FT
15	RUTTING	H	372	SQFT
19	RAVELING	H	135	SQFT
20	WEATHERING	H	2,400	SQFT

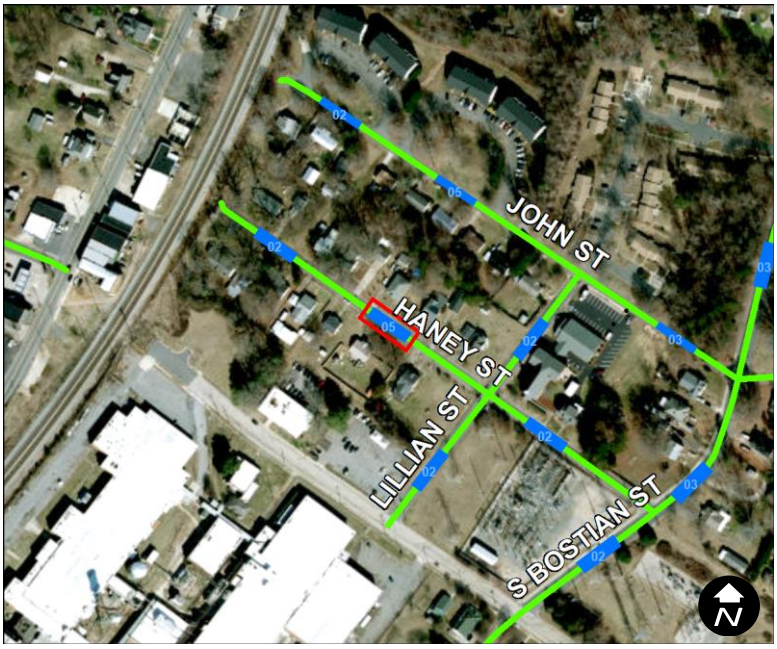
SAMPLE PHOTO

#	DISTRESS	SV	QUANT	UNITS
1	ALLIGATOR CR	L	132	SQFT
3	BLOCK CR	L	2,300	SQFT
11	PATCH/UT CUT	H	40	SQFT
15	RUTTING	H	52	SQFT

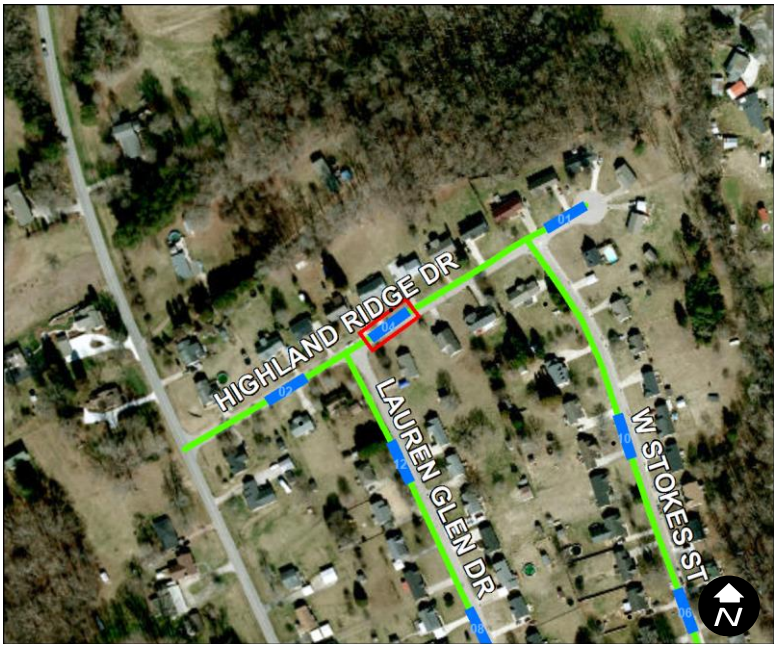
SAMPLE PHOTO

#	DISTRESS	SV	QUANT	UNITS
1	ALLIGATOR CR	M	306	SQFT
7	EDGE CR	L	51	FT
10	L & T CR	L	44	FT
20	WEATHERING	L	2,300	SQFT

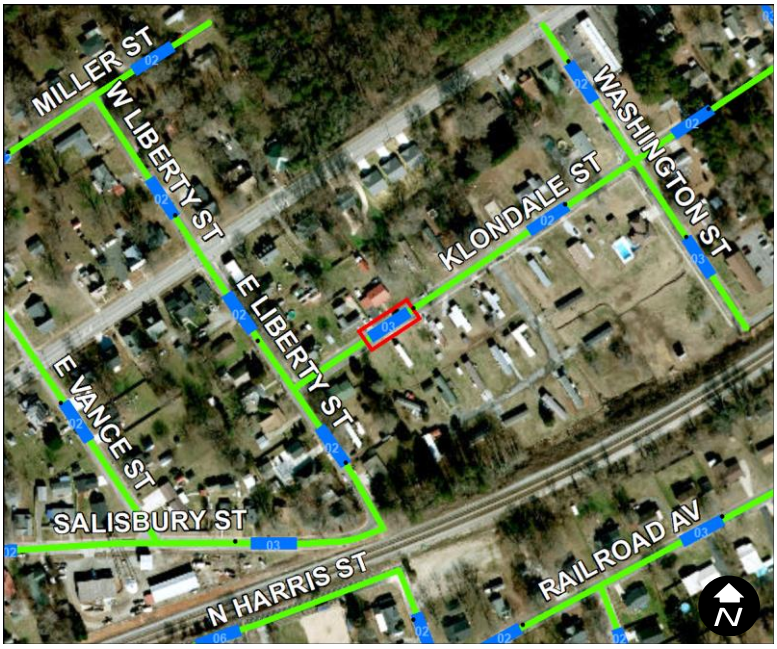
SAMPLE PHOTO

#	DISTRESS	SV	QUANT	UNITS
1	ALLIGATOR CR	M	415	SQFT
3	BLOCK CR	M	34	SQFT
10	L & T CR	L	325	FT
20	WEATHERING	L	2,600	SQFT

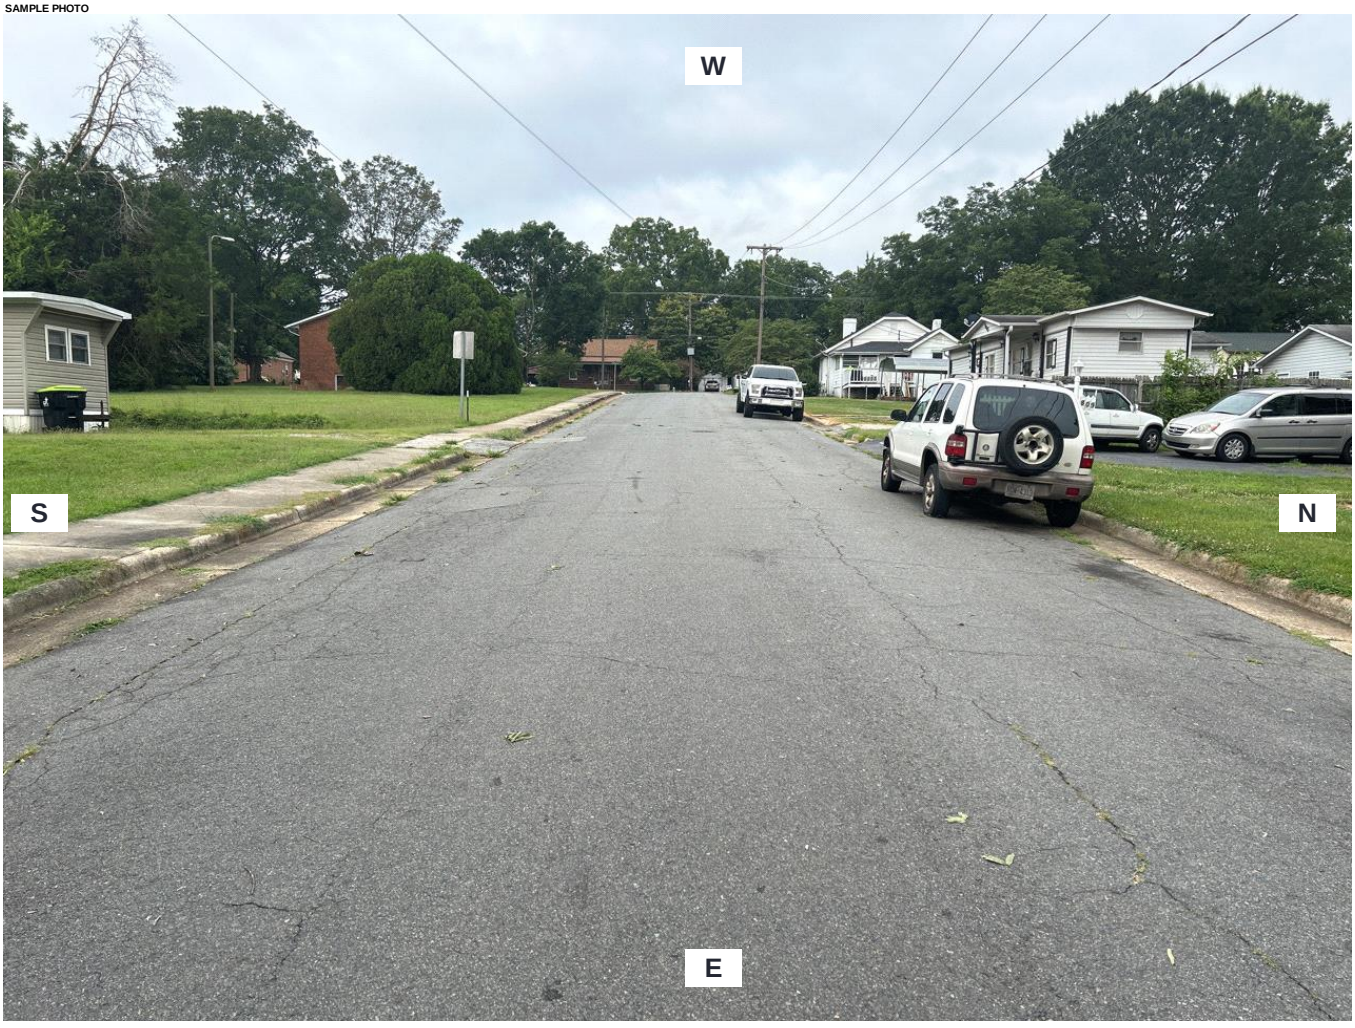
SAMPLE AREA (SQ FT)	SUNIQUEID	BRANCH TO	SECTION PAVEMENT CONDITION INDEX	SECTION STRUCTURAL CONDITION INDEX
2,600	4a92578a8c9c4d588e3e6d01df71529e	WASHINGTON ST	SECT PCI 51.1	SECT SCI 66.3

SAMPLE PAVEMENT CONDITION INDEX	SAMPLE STRUCTURAL CONDITION INDEX
SAMP PCI 51	SAMP SCI 66

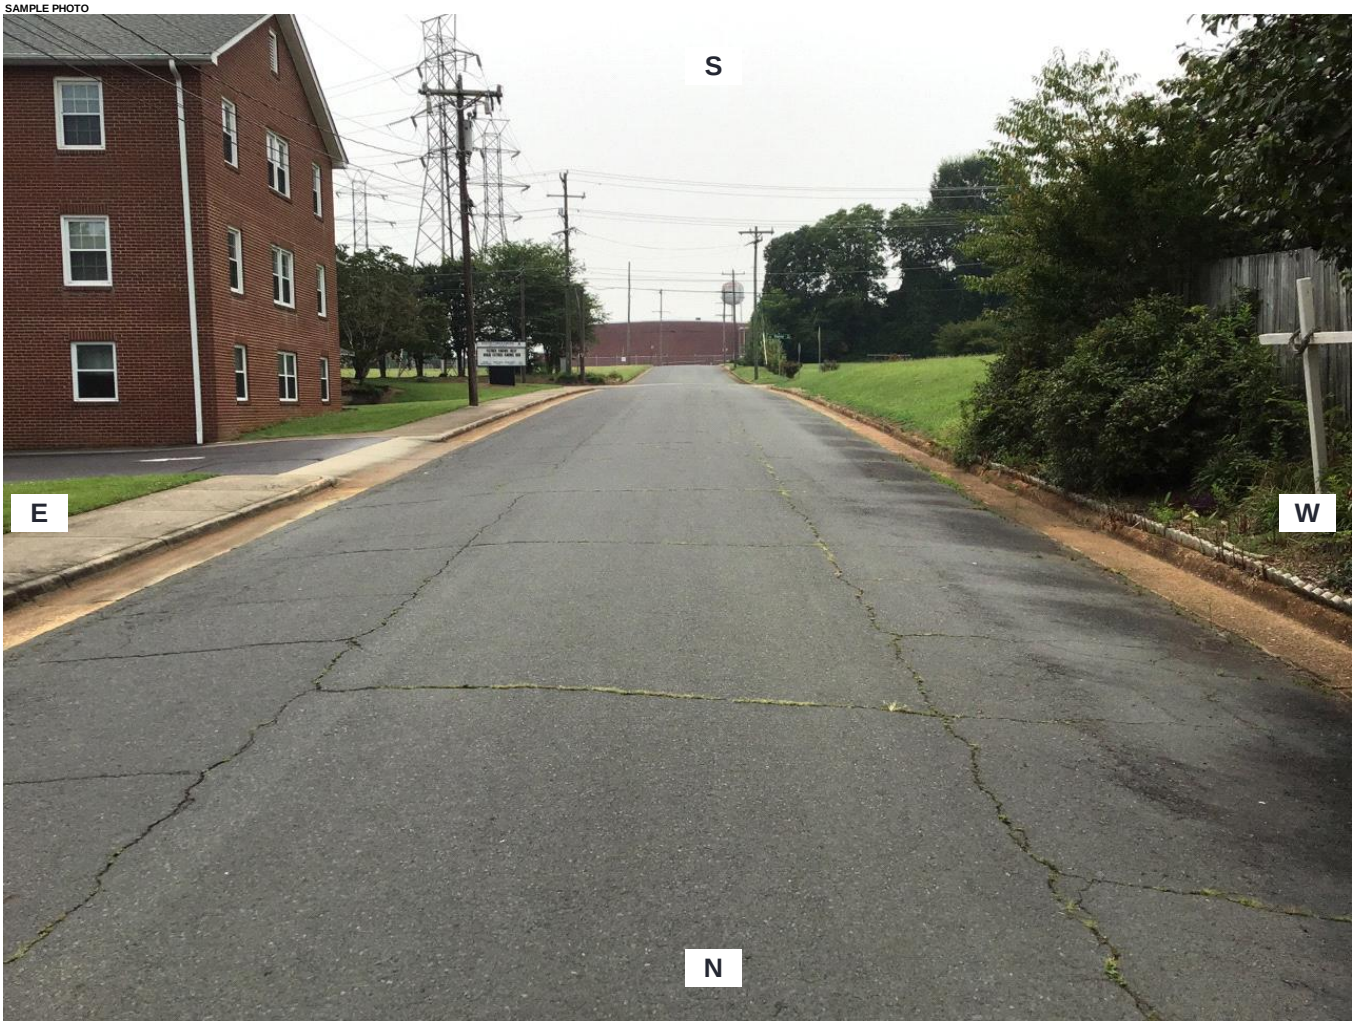
SAMPLE PHOTO

#	DISTRESS	SV	QUANT	UNITS
1	ALLIGATOR CR	L	312	SQFT
3	BLOCK CR	M	2,200	SQFT
3	BLOCK CR	M	2,200	SQFT
7	EDGE CR	M	51	FT

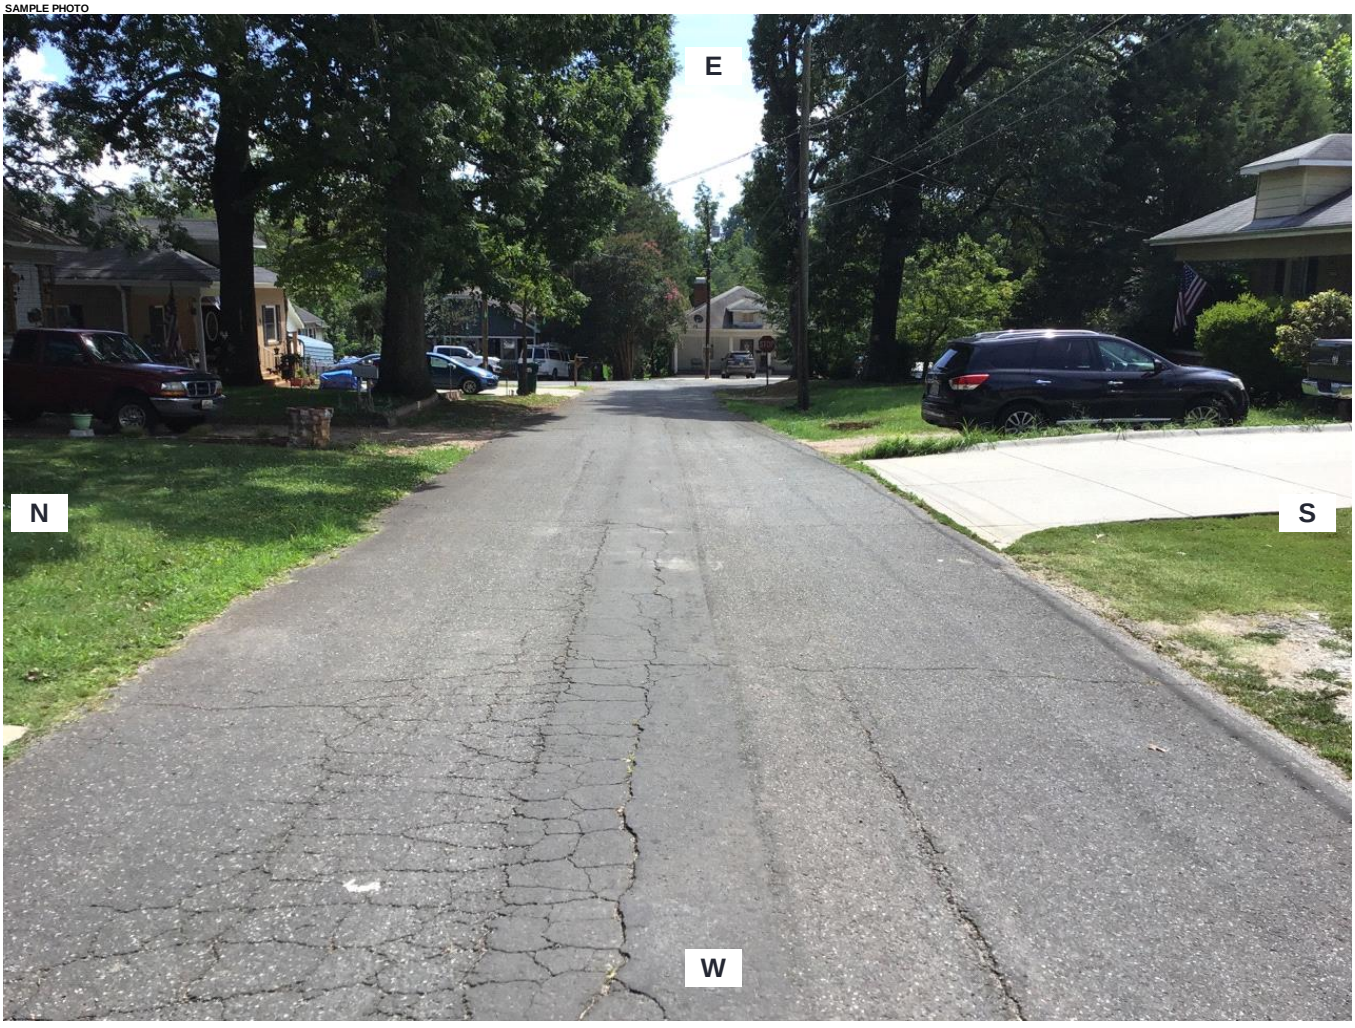
SAMPLE PHOTO

#	DISTRESS	SV	QUANT	UNITS
1	ALLIGATOR CR	H	58	SQFT
3	BLOCK CR	L	107	SQFT
4	BUMPS/SAGS	M	50	FT
7	EDGE CR	M	53	FT
10	L & T CR	L	83	FT
15	RUTTING	H	260	SQFT

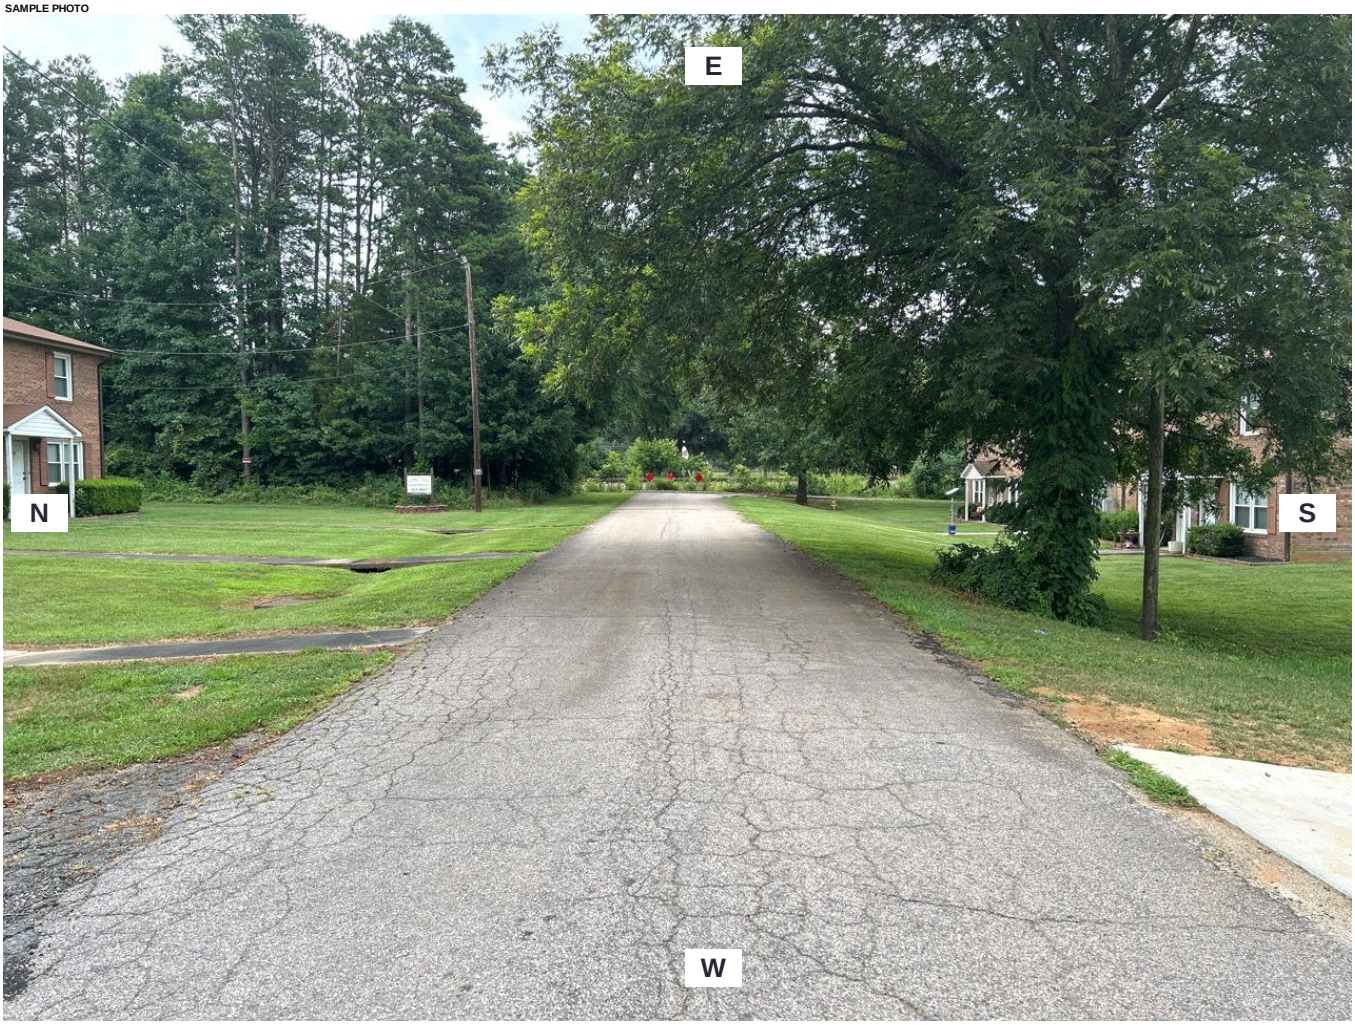
SAMPLE PHOTO

#	DISTRESS	SV	QUANT	UNITS
1	ALLIGATOR CR	H	80	SQFT
3	BLOCK CR	M	165	SQFT
7	EDGE CR	M	24	FT
10	L & T CR	M	162	FT
15	RUTTING	L	138	SQFT
20	WEATHERING	M	1,700	SQFT

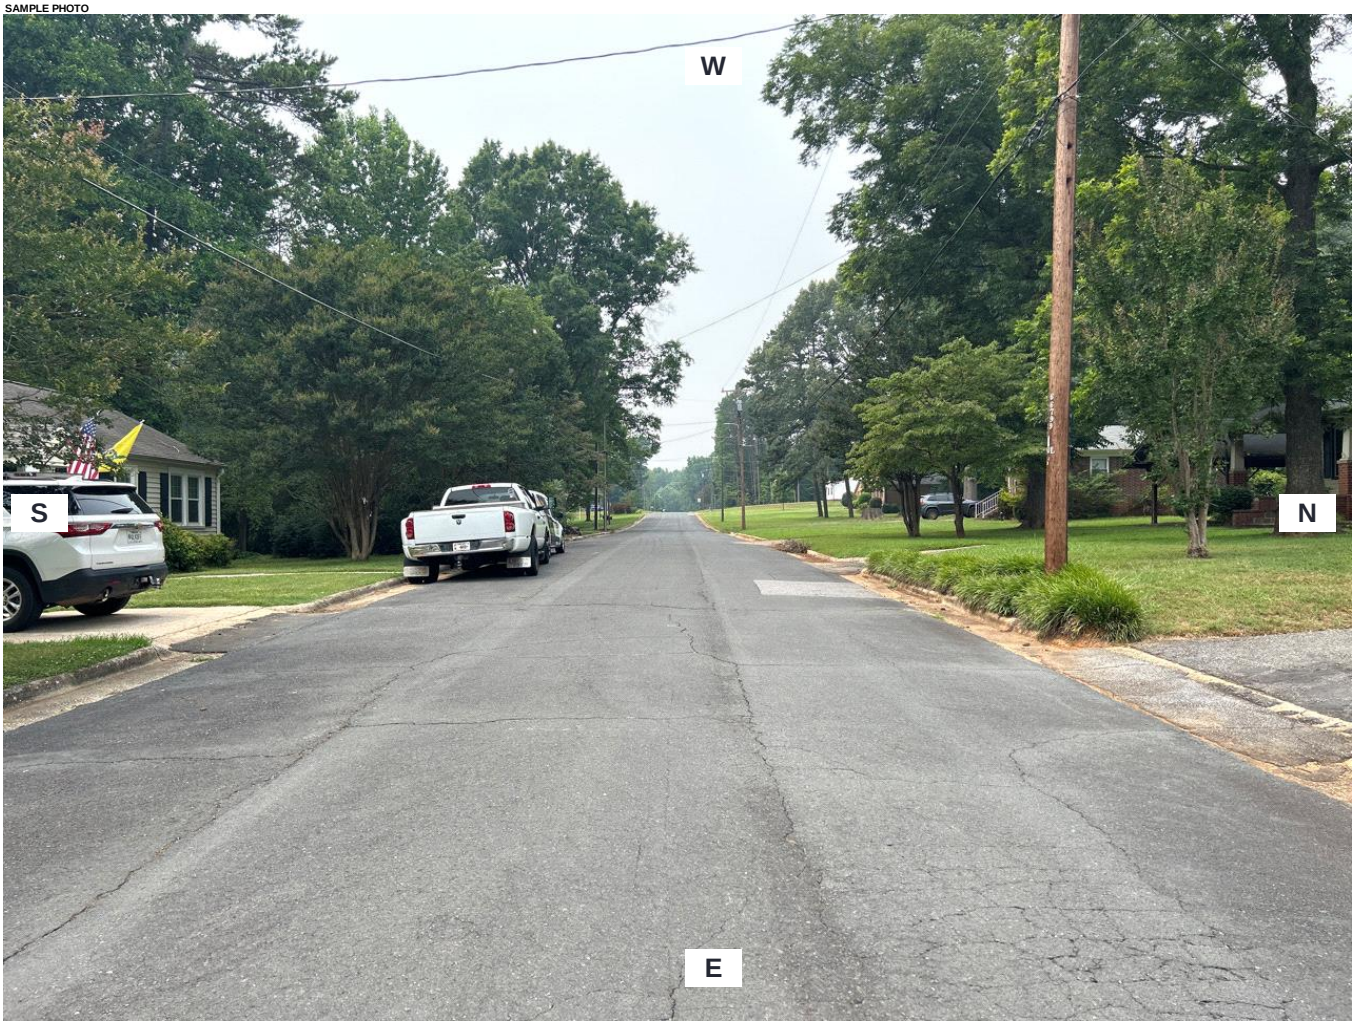
SAMPLE PHOTO

#	DISTRESS	SV	QUANT	UNITS
1	ALLIGATOR CR	M	36	SQFT
3	BLOCK CR	M	2,000	SQFT
9	LANE SH DROP	M	200	FT
11	PATCH/UT CUT	L	70	SQFT
20	WEATHERING	L	2,600	SQFT

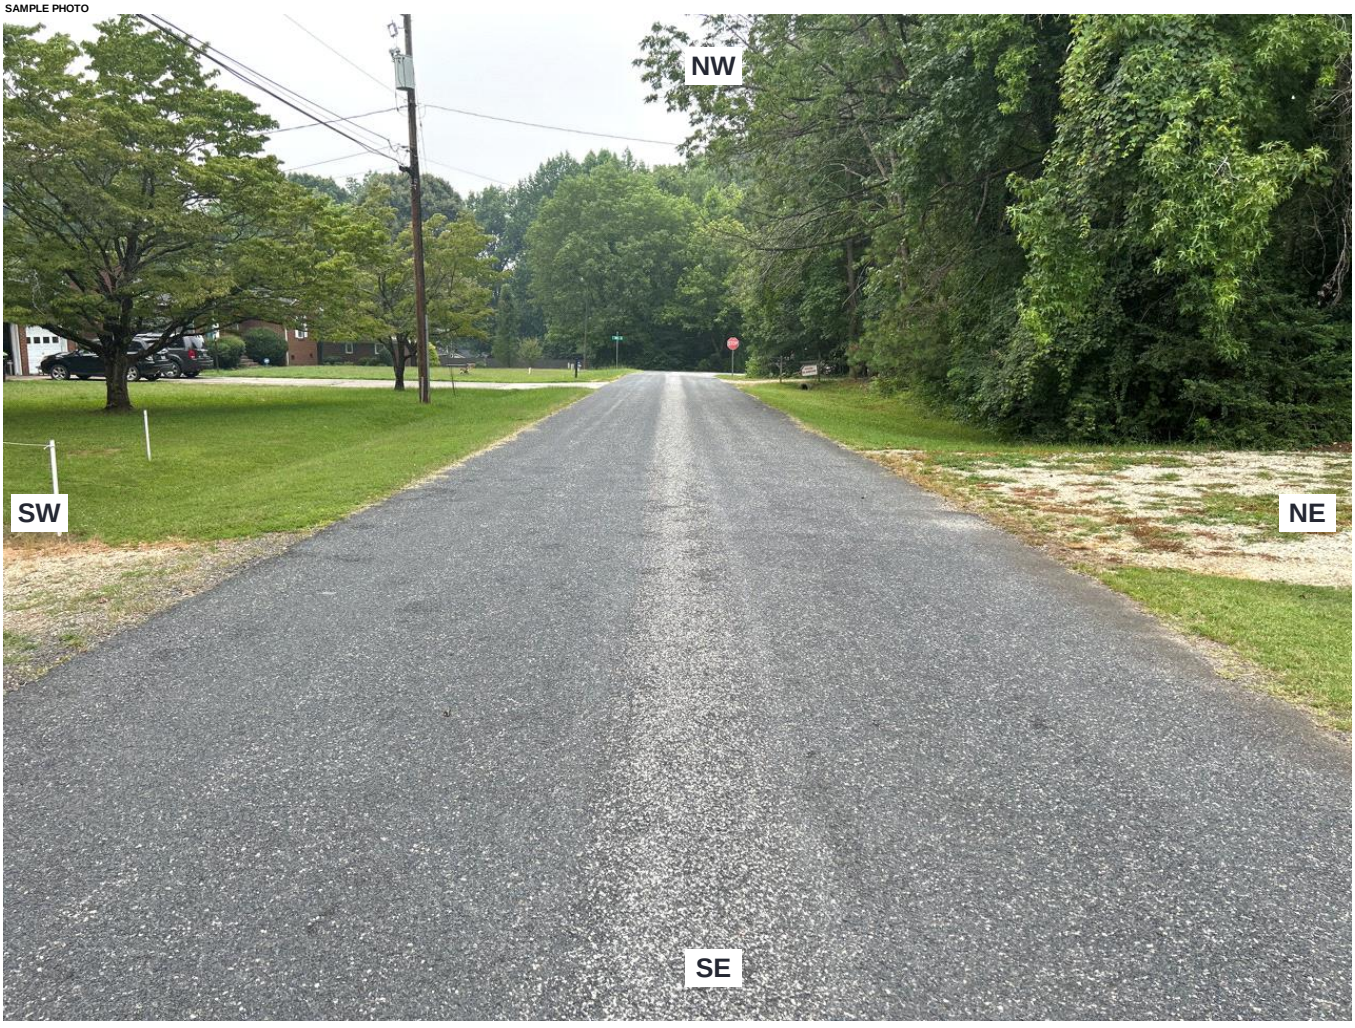
SAMPLE PHOTO

#	DISTRESS	SV	QUANT	UNITS
7	EDGE CR	L	36	FT
10	L & T CR	L	7	FT
20	WEATHERING	M	1,900	SQFT

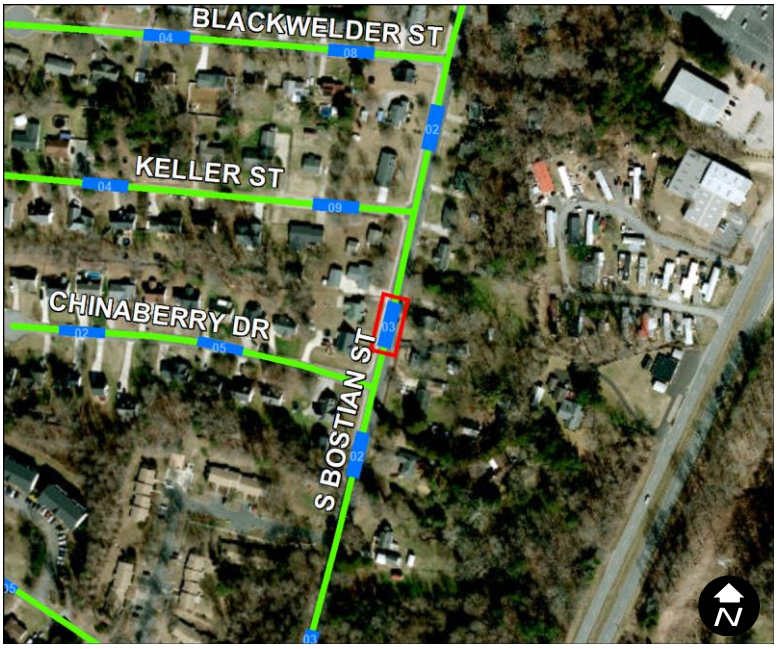
SAMPLE PHOTO

#	DISTRESS	SV	QUANT	UNITS
1	ALLIGATOR CR	M	300	SQFT
2	BLEEDING	H	156	SQFT
2	BLEEDING	L	70	SQFT
3	BLOCK CR	M	2,007	SQFT
11	PATCH/UT CUT	M	8	SQFT
19	RAVELING	H	5	SQFT
19	RAVELING	M	20	SQFT

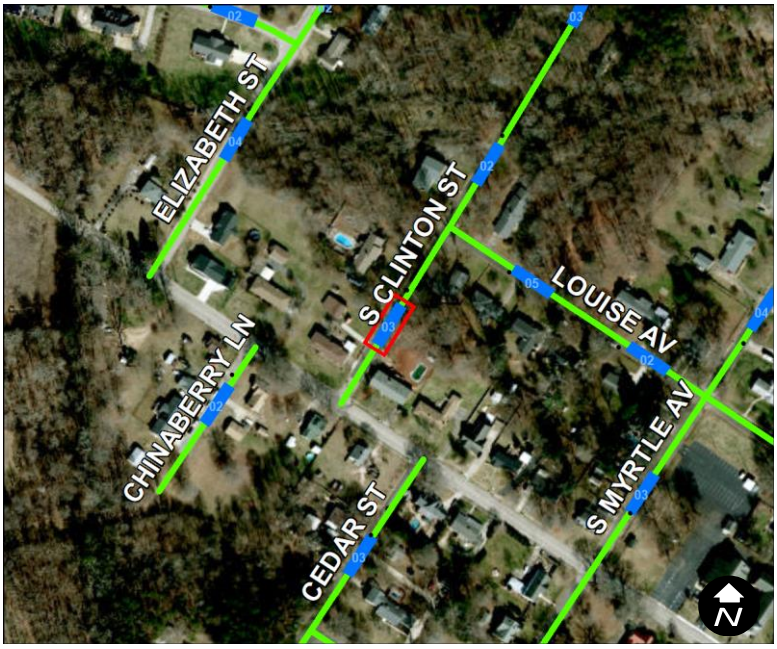
SAMPLE PHOTO

#	DISTRESS	SV	QUANT	UNITS
1	ALLIGATOR CR	L	80	SQFT
6	DEPRESSION	L	10	SQFT
10	L & T CR	L	275	FT
11	PATCH/UT CUT	L	77	SQFT
11	PATCH/UT CUT	M	16	SQFT
13	POTHOLE	L	10	COUNT
20	WEATHERING	L	2,600	SQFT

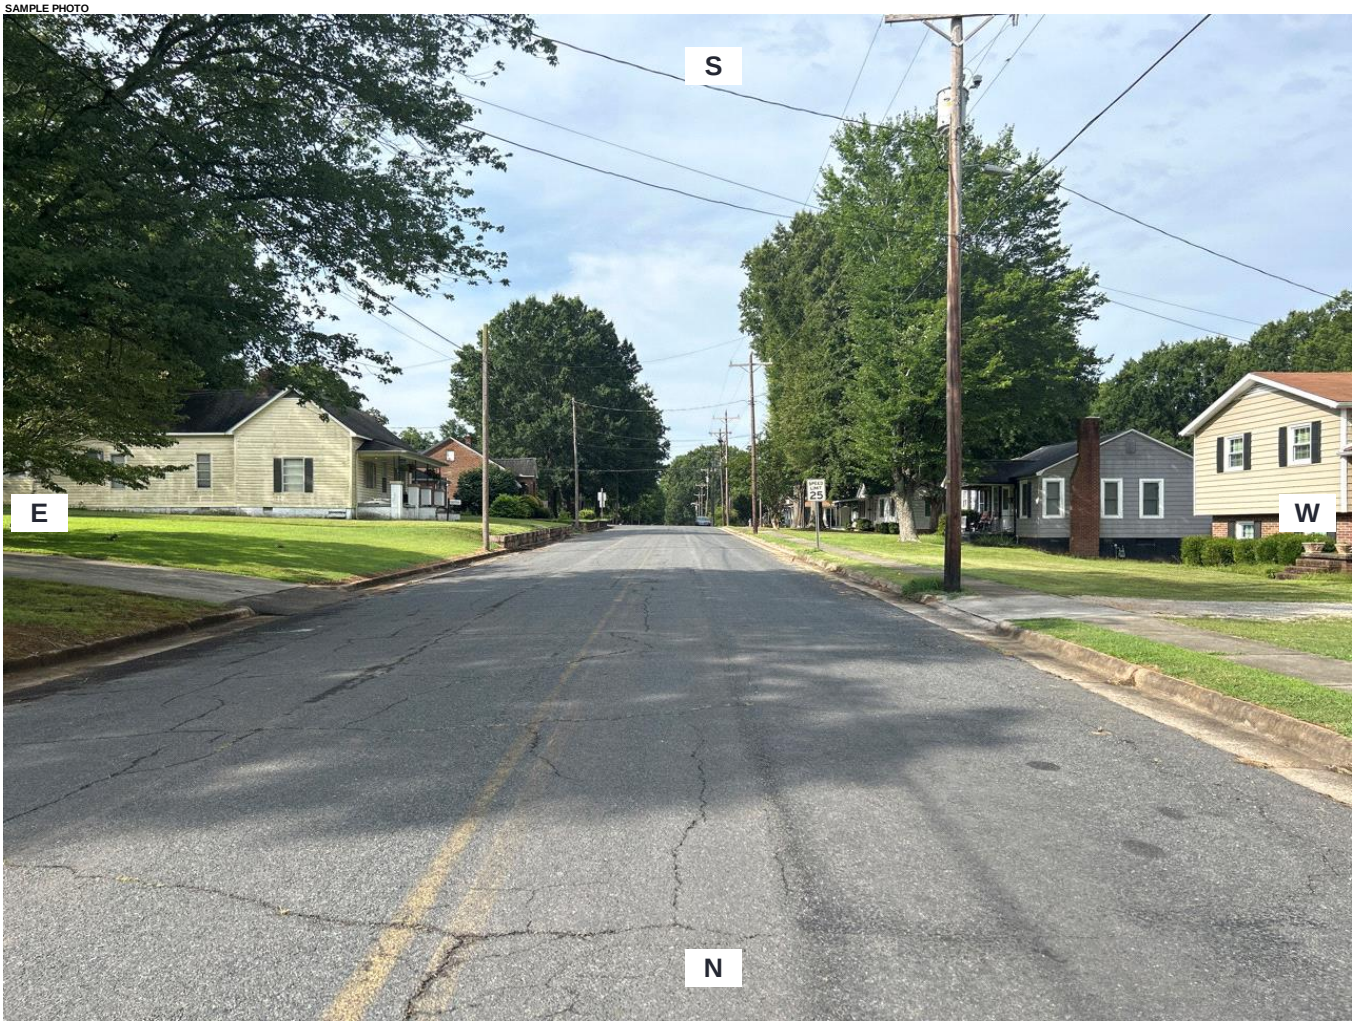
SAMPLE PHOTO

#	DISTRESS	SV	QUANT	UNITS
3	BLOCK CR	L	1,056	SQFT
10	L & T CR	L	78	FT
19	RAVELING	L	6	SQFT
20	WEATHERING	L	3,400	SQFT
