Pavement Photo Inspection Report

Town of China Grove

2023 Pavement Photo Inspection Report

KCA Project Number: 005-202318.00

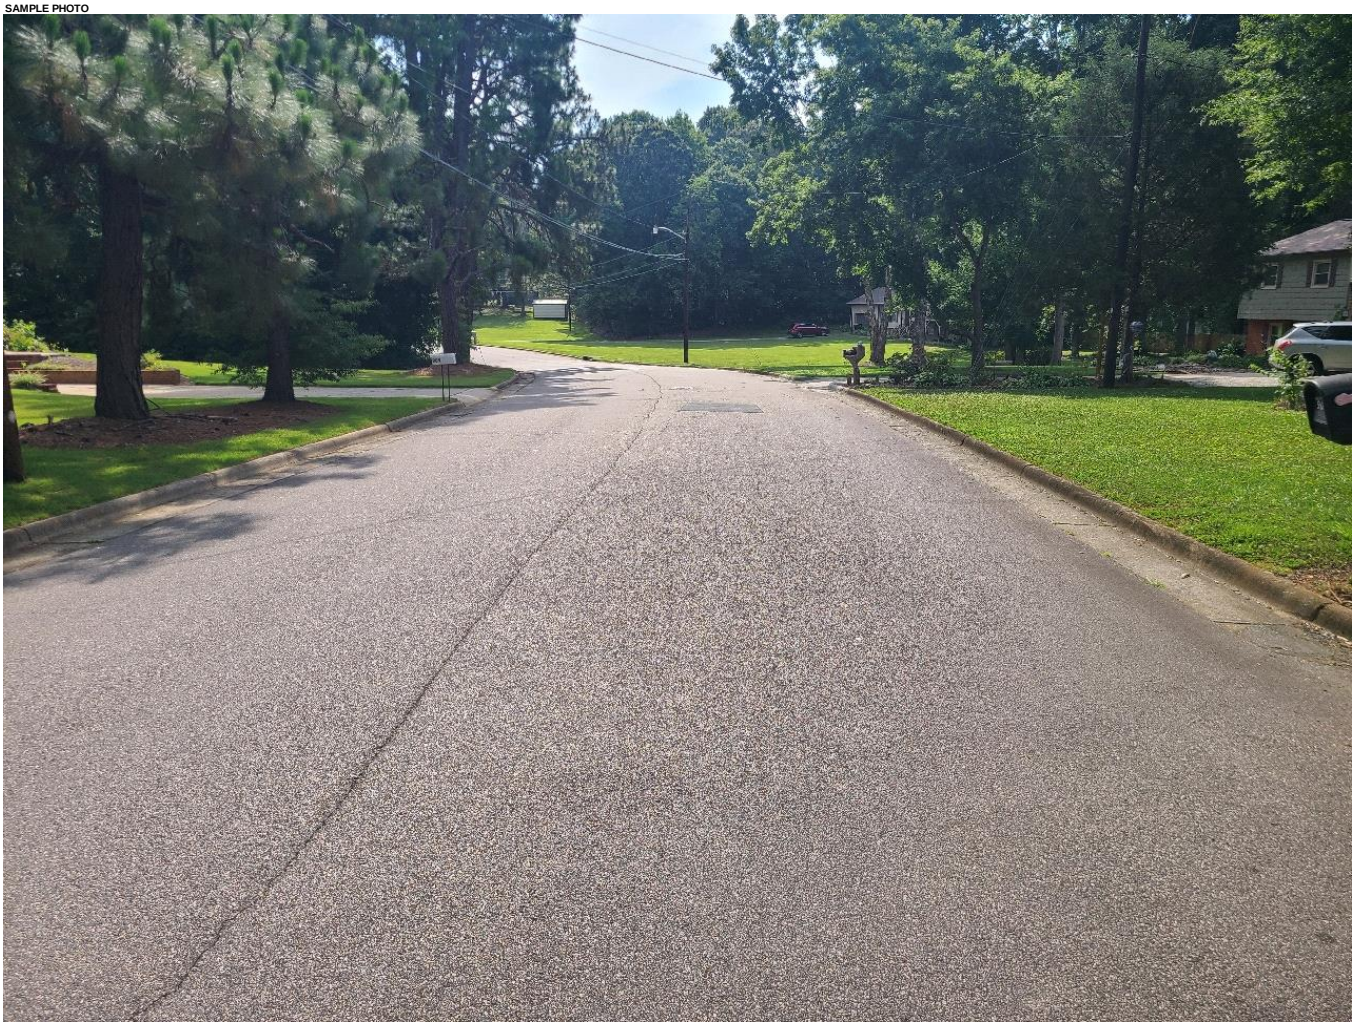
SAMPLE PHOTO

#	DISTRESS	SV	QUANT	UNITS
1	ALLIGATOR CR	L	27	SQFT
3	BLOCK CR	L	50	SQFT
10	L & T CR	L	281	FT
11	PATCH/UT CUT	L	24	SQFT

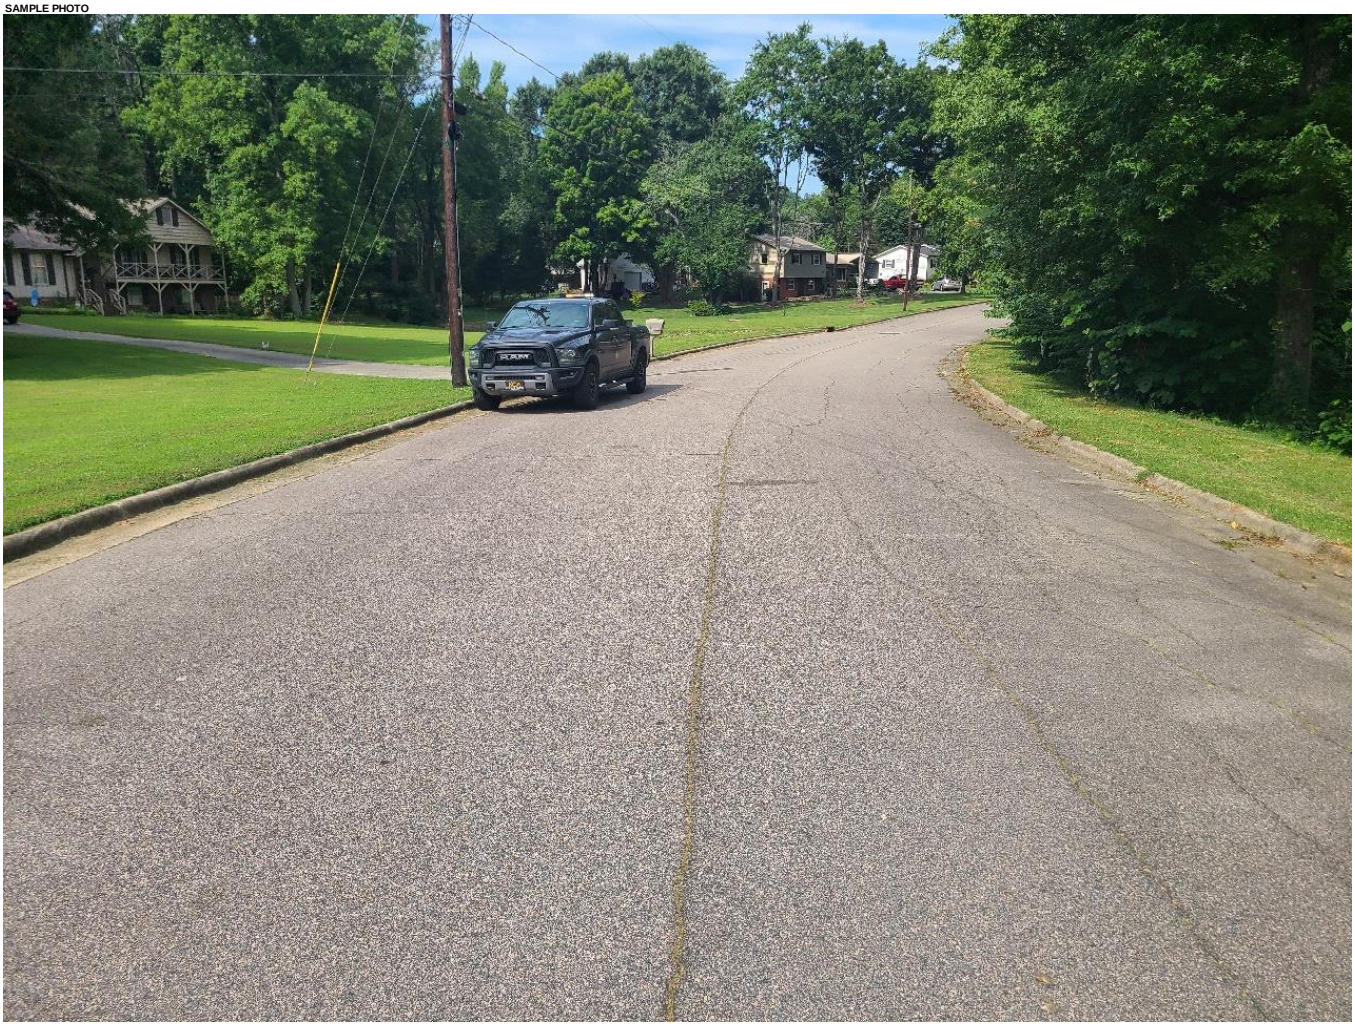
SAMPLE PHOTO

#	DISTRESS	SV	QUANT	UNITS
1	ALLIGATOR CR	L	9	SQFT
3	BLOCK CR	L	127	SQFT
3	BLOCK CR	M	27	SQFT
10	L & T CR	L	199	FT
20	WEATHERING	L	2,800	SQFT

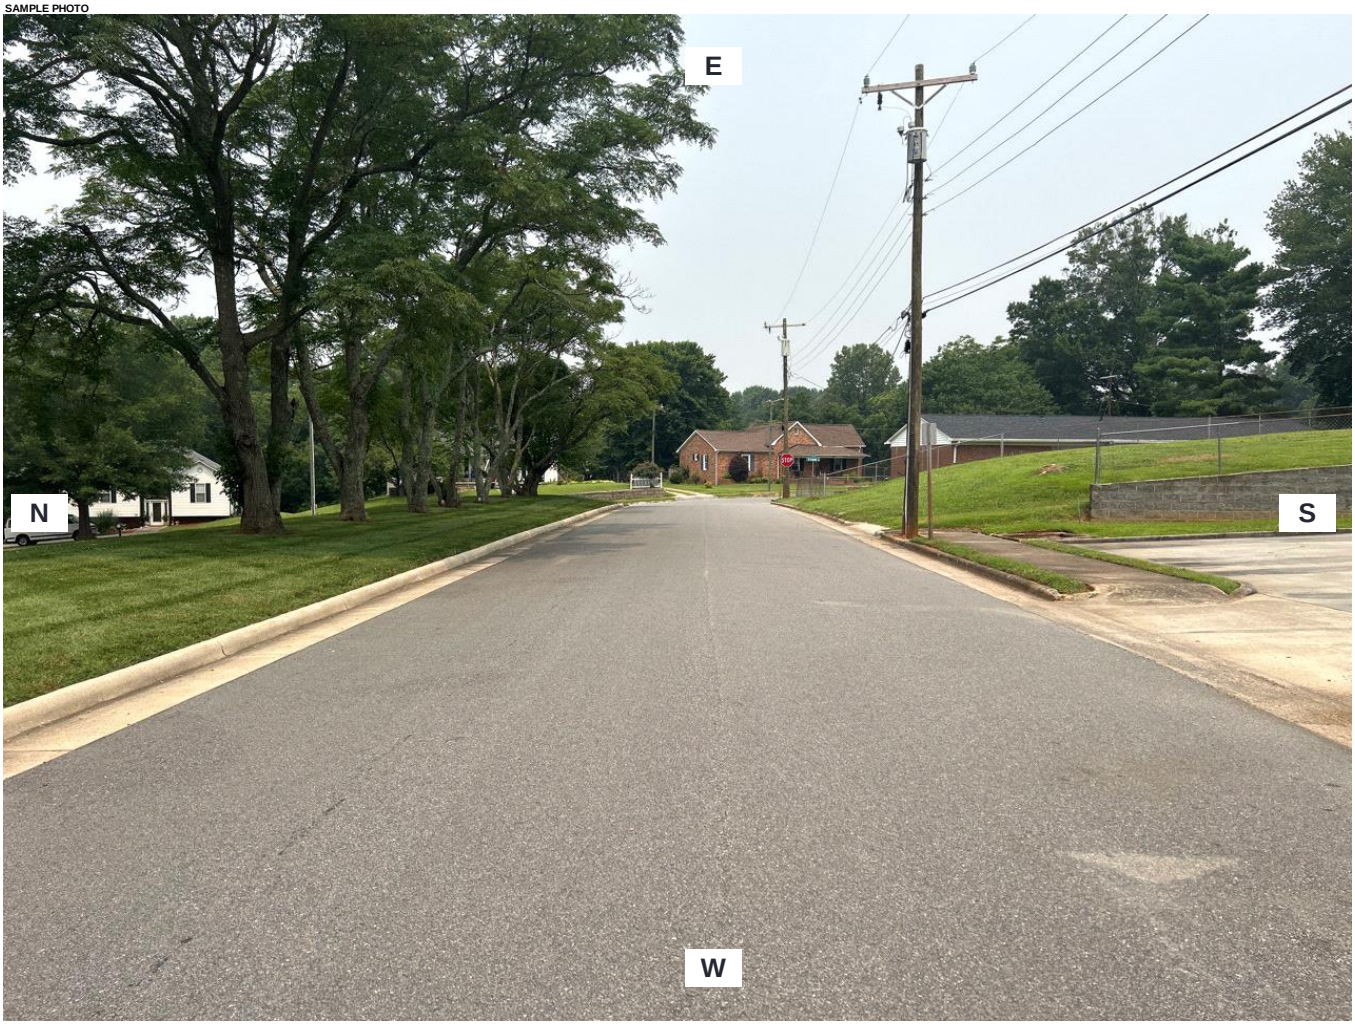
SAMPLE PHOTO

#	DISTRESS	SV	QUANT	UNITS
20	WEATHERING	L	2,400	SQFT

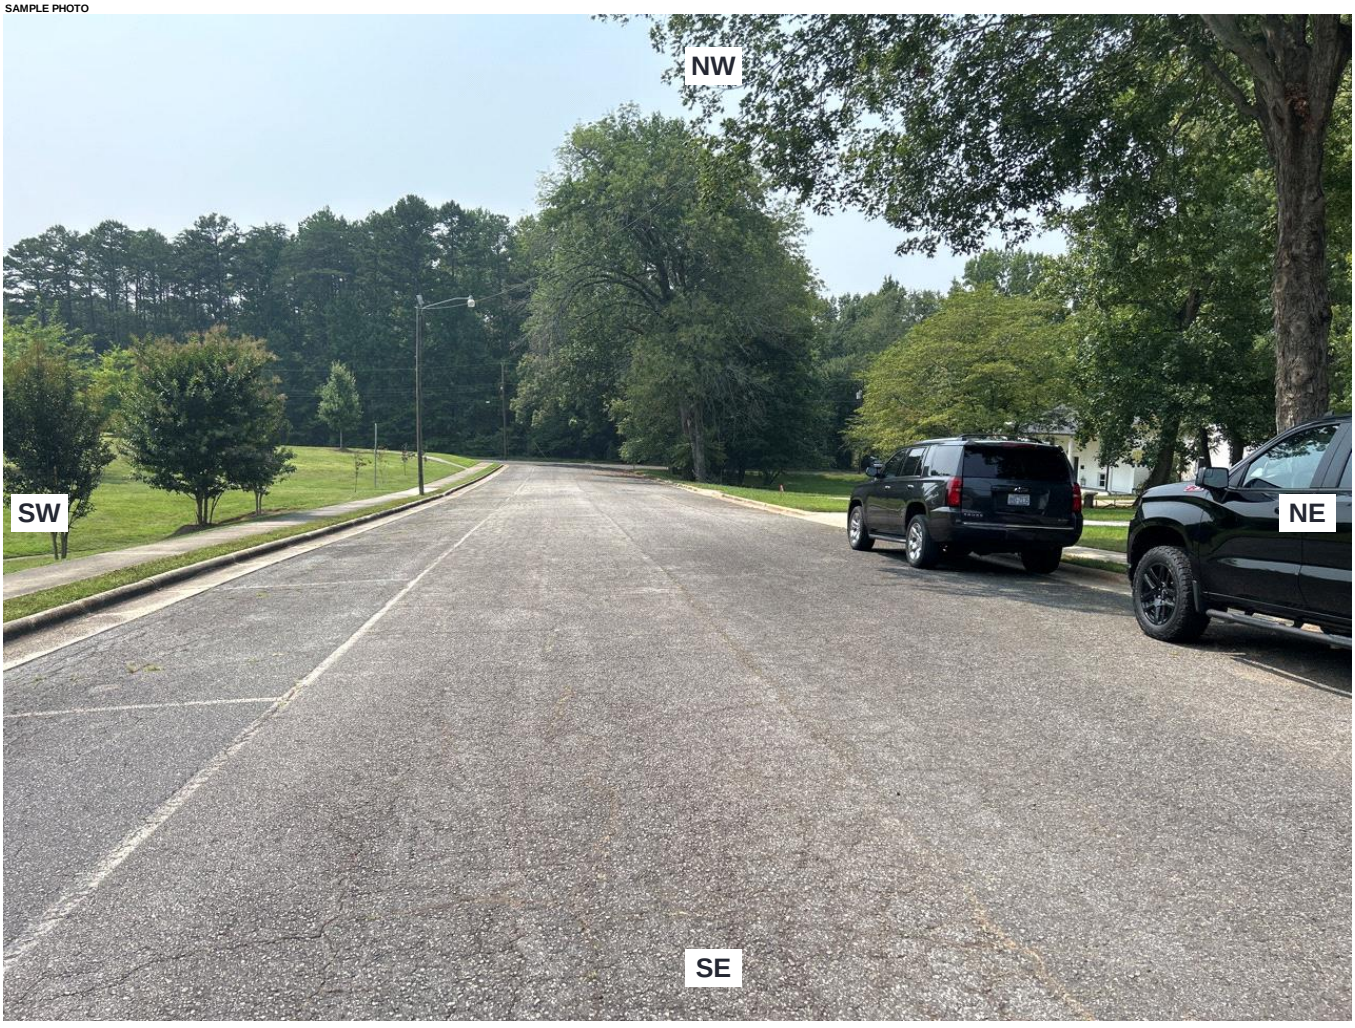
SAMPLE PHOTO

#	DISTRESS	SV	QUANT	UNITS
1	ALLIGATOR CR	H	100	SQFT
1	ALLIGATOR CR	L	100	SQFT
1	ALLIGATOR CR	M	100	SQFT
3	BLOCK CR	H	400	SQFT
3	BLOCK CR	L	400	SQFT
3	BLOCK CR	M	800	SQFT
20	WEATHERING	M	1,800	SQFT

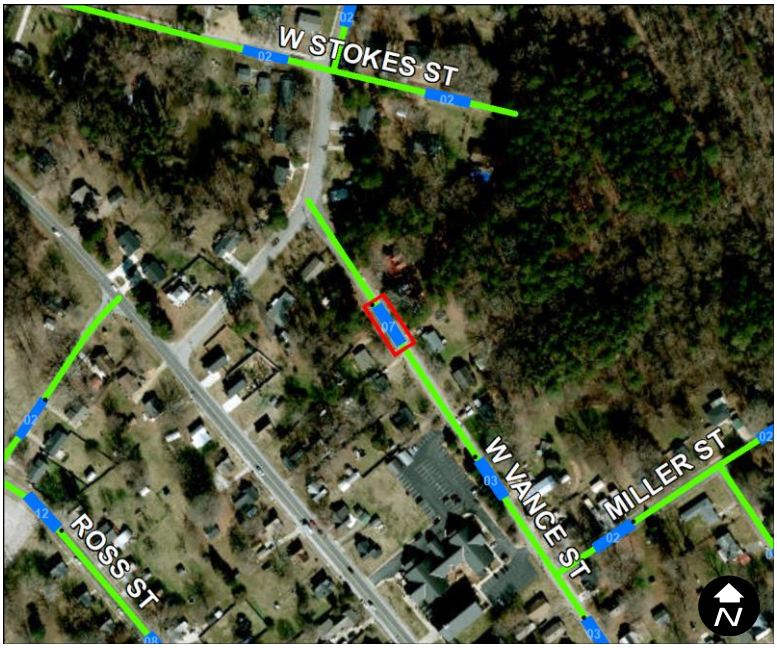
SAMPLE PHOTO

#	DISTRESS	SV	QUANT	UNITS
1	ALLIGATOR CR	L	180	SQFT
10	L & T CR	L	420	FT
20	WEATHERING	L	2,600	SQFT
