**CITY OF ALLEGAN
CITY COUNCIL STUDY SESSION MEETING
Monday, October 9, 2023, 5:30PM
City Council Chambers - 231 Trowbridge Street
Allegan, Michigan**

SUBJECT: PaSER 10-Year Road Strategies Reports

**DAM SAFETY INSPECTION REPORT
ALLEGAN CITY DAM – DAM ID NO. 489
KALAMAZOO RIVER
ALLEGAN COUNTY – SECTION 28, T 02N, R 13W**

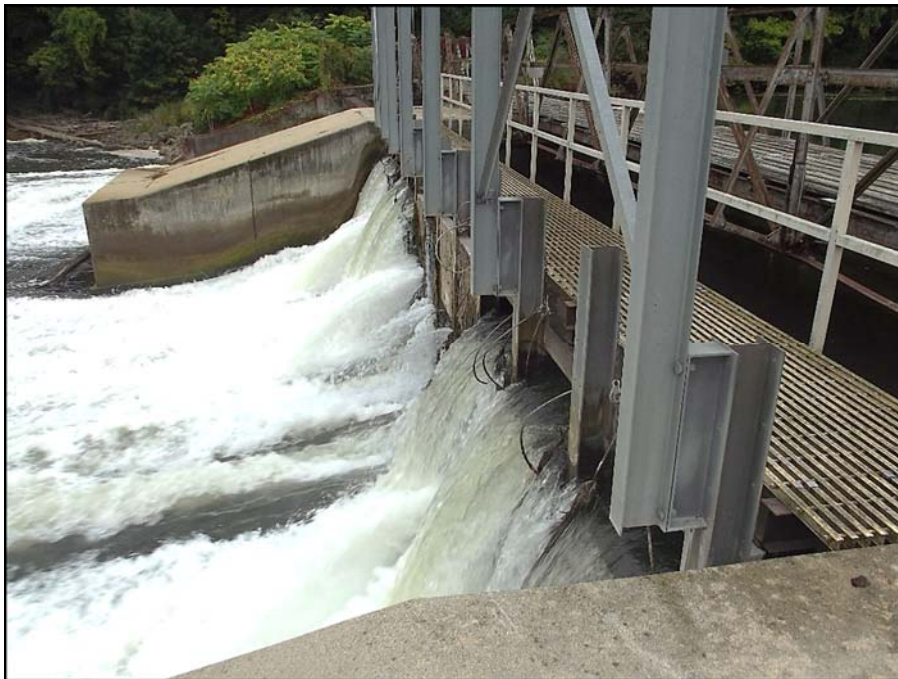
Photograph 16 – Spillway Bay #2, stoplog crests

The principal spillway structure, shown in Photographs 10 through 24, is also in satisfactory condition. No misalignment, differential settlement, or major cracking or deterioration was observed. The spillway gates and stoplog hoist were not operated during this inspection, but City staff indicated that both radial gates and the stoplog hoist system are operated regularly to pass flood flows and are in sound working order. No remedial action is required at this time.

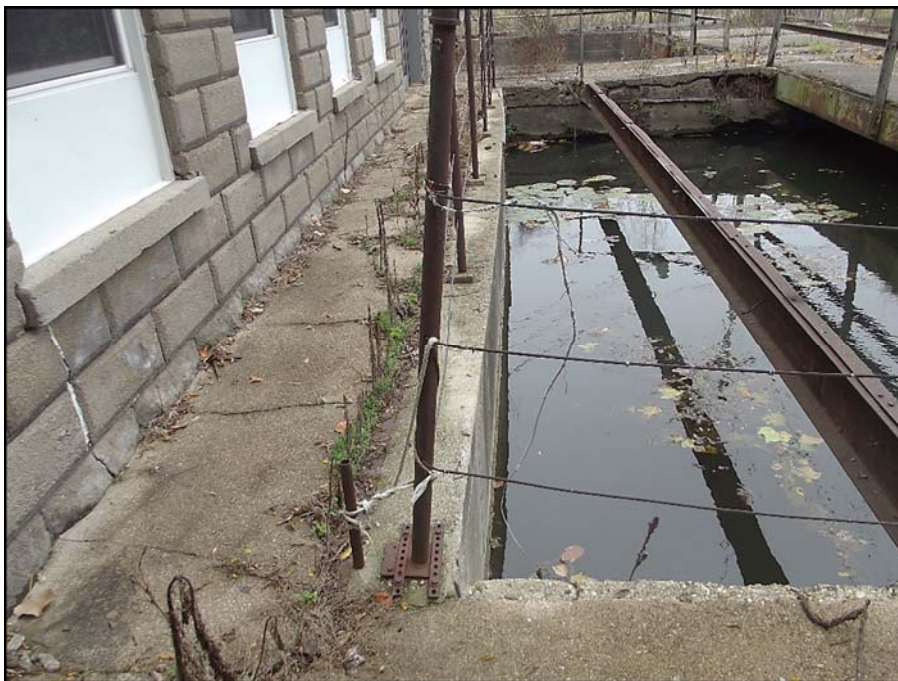
Photograph 26 – Concrete bulkhead at inlet to west section of powerhouse

The abandoned powerhouse structure, shown in Photographs 25 through 27, is in poor condition. Deteriorated concrete and masonry is present throughout the older western section of the structure. A detailed structural inspection of the powerhouse structures was performed by LFA in 2017. This report indicates that failure of the western section of the building could happen suddenly. However, since the western section has a

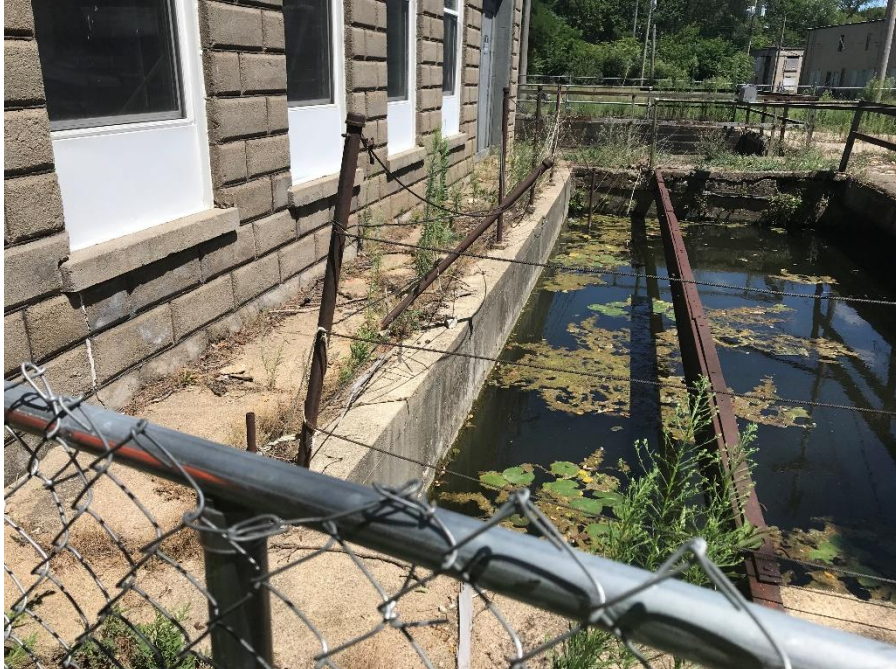
Photograph 26 – Concrete bulkhead at inlet to left section of powerhouse

The abandoned powerhouse structure, shown in Photographs 25 through 28, is in poor condition. Deteriorated concrete and masonry are present throughout the older left section of the structure. A detailed structural inspection of the powerhouse structures
