## REGULAR MEETING OF THE LAKEPORT CITY COUNCIL

- VI. **PUBLIC HEARING:**
  - A. Vista Point Shopping Center: Hold a nuisance abatement hearing and adopt a Resolution declaring the primary structure (872-896a Lakeport Blvd) of the Vista Point Shopping Center a public nuisance, order the property owner to abate all identified nuisance conditions within 30 days, and, in the event the nuisances are not timely abated, empowering staff with authority to abate the nuisances, the costs of which may become a special assessment upon the parcel.

Vista Point Shopping Center (Vista Point), situated at 872-896a Lakeport Boulevard, has been under the ownership of Donica LLC since its acquisition in 2007. On July 14, 2022, City staff initiated a Code Enforcement Case (#2022-00046) to address a series of code violations at the property. While items from the initial Code Enforcement case remain outstanding, City staff has presented subsequent code enforcement matters to Donica LLC for resolution. Unfortunately, over the past eighteen months, City staff's persistent efforts to bring Vista Point into compliance have yielded minimal progress in addressing a growing list of violations.

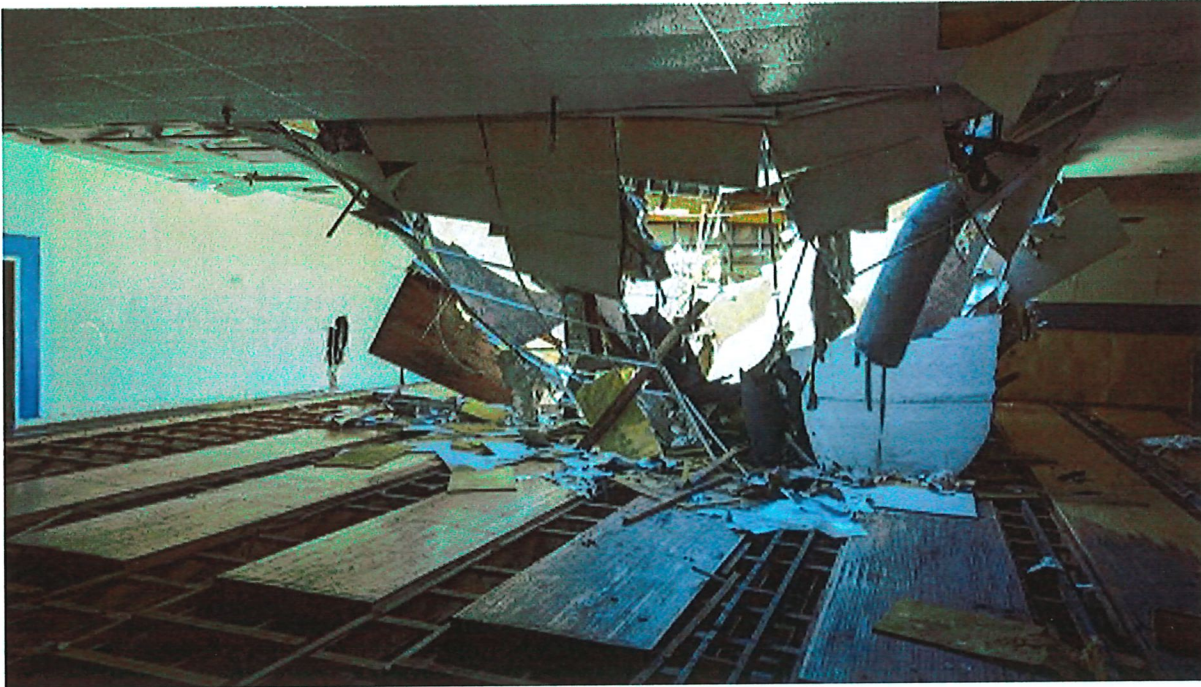
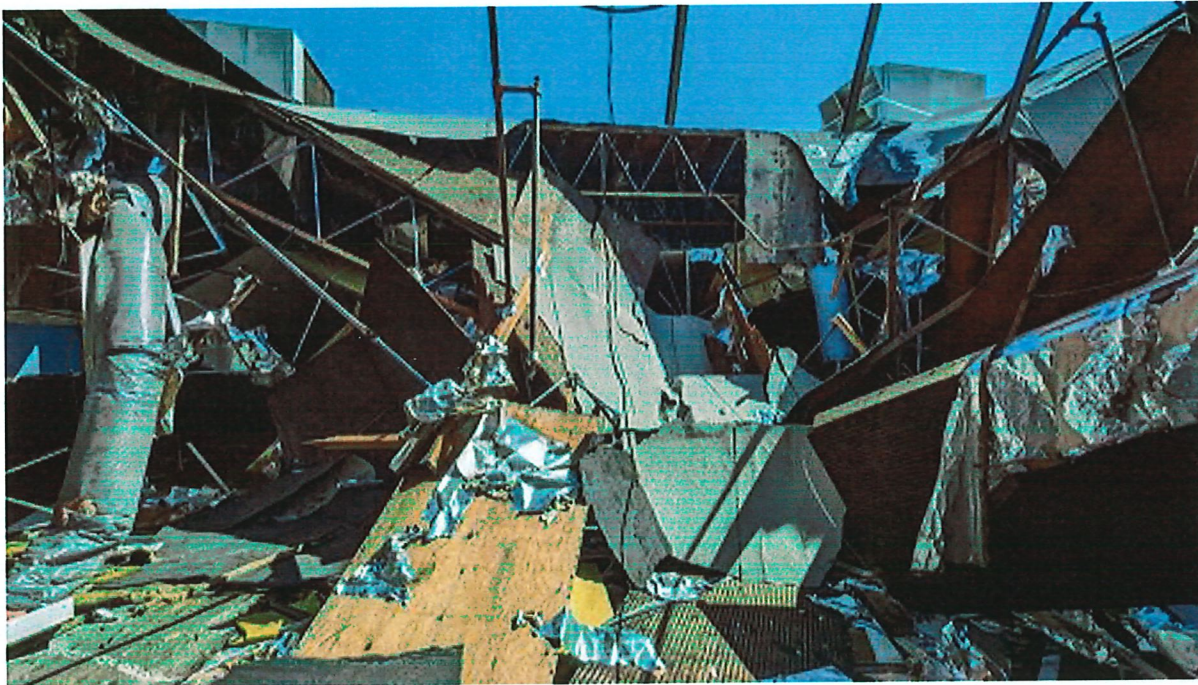
Building A has an overall condition rating of Poor. Building A is the largest structure and the location of the roof collapse. The collapse occurred in the northwest area of the building per Figure 2, between Grids 3 and 4 and Grids E and D. The collapse consisted of three (3) bays of decking and sub-framing; and the supporting two (2) truss joists. The truss joists were supported by glulam beams running east-west. The collapse area is therefore approximately 24'-0" by 40'-0" (Photos 1 and 2).

Photo 1 – Collapsed Roof, Building A

Photo 2 – Collapsed Roof, Building A

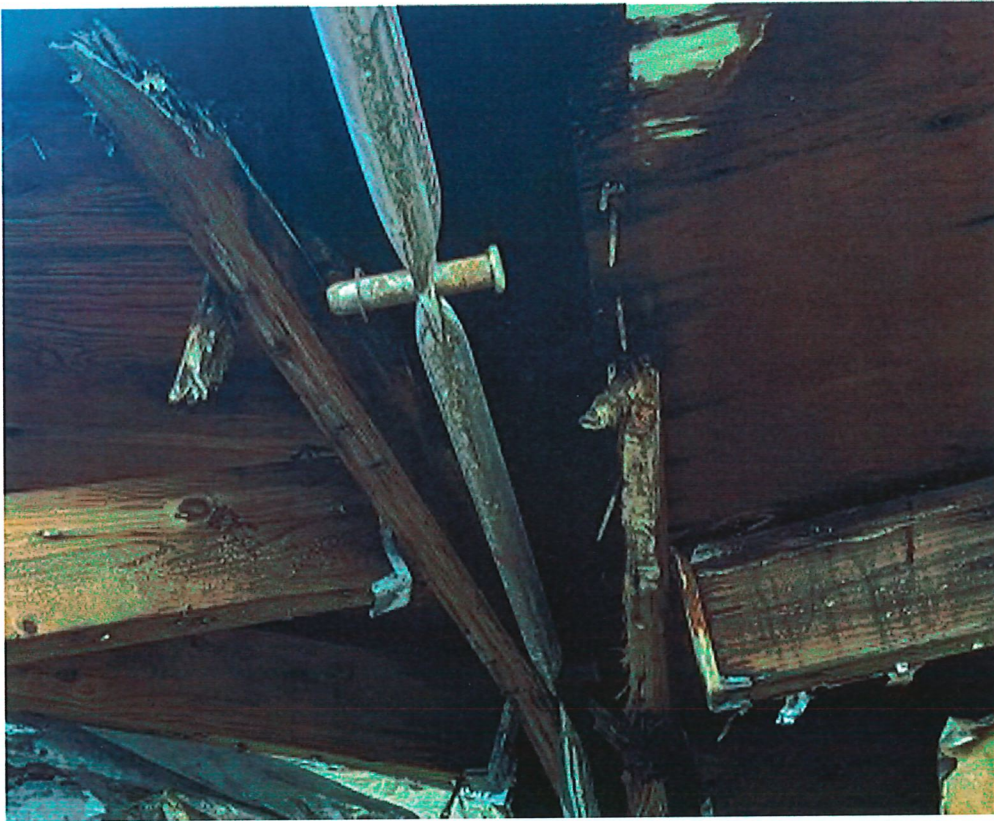
The collapse appears to have initiated in the top chord of the truss joist; at the end near the support at the junction of the chord, the second and third steel bar diagonal web elements (Figures 3 and 4). The diagonal elements were embedded in the chord and connected with a steel pin (Photo 3). The steel pin is required to bear against the wood chord to transfer the imposed load between the web members. Deterioration and material strength loss due to long term water exposure and saturation caused a bearing failure against the top chord, causing it to break apart (Photos 4 and 5); leading to a shear-type failure in the truss joist and initiating the collapse. This failure type was observed in both truss joists in a similar location, at opposite ends. Photo 6 shows visible deteriorated wood fibers on the first top pin with the split top chord visible above; indicating the likely failure point. The collapse is therefore considered to be caused by a reduced capacity of the truss joist members due to deterioration and wood rot; coupled with an increase over the typical loading the trusses had previously experienced due to higher-than-normal snow and wind loads during a storm event. This failure is likely only able to occur when the roof framing has been subjected to long-term saturation and water exposure; and not due to a defect in the truss manufacturing or installation.

Photo 3 – Steel pin connecting truss diagonals, Building A

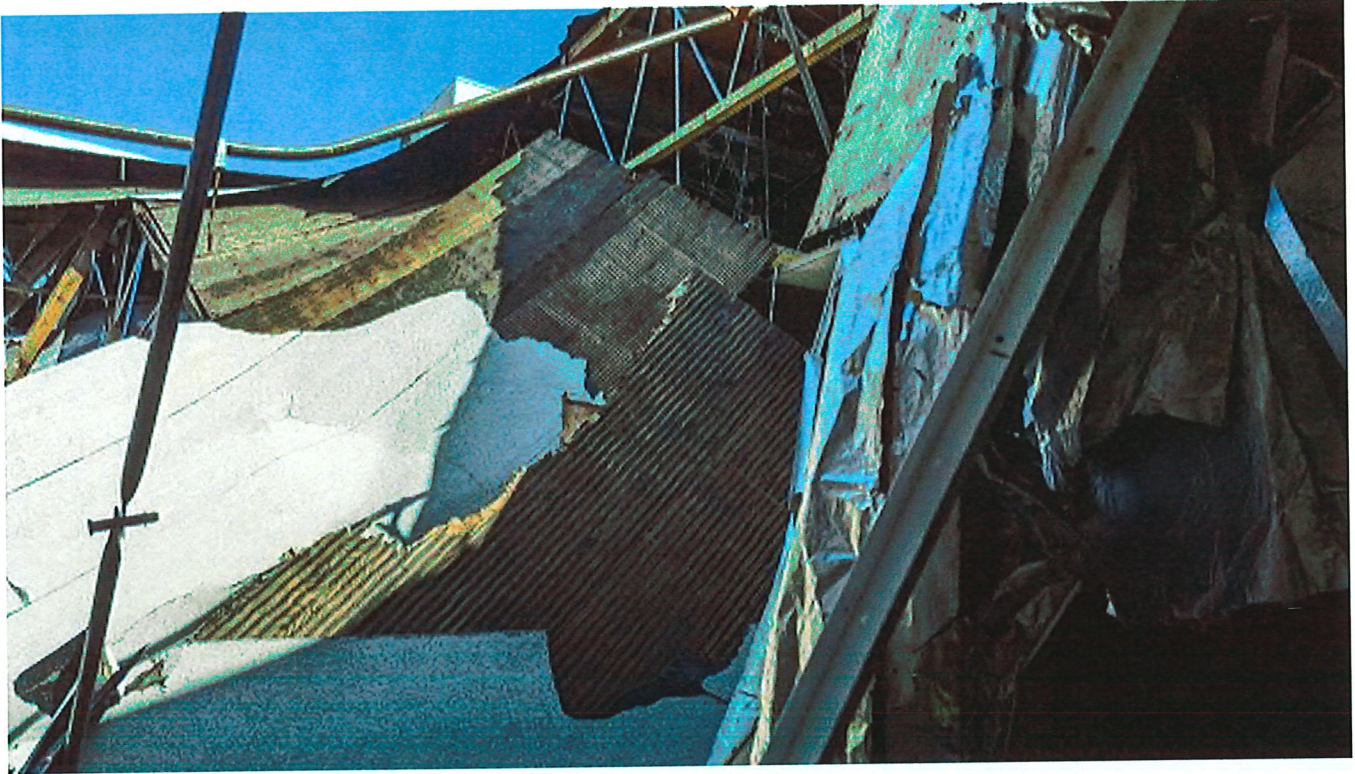
The plywood decking similarly showed signs of severe deterioration in and around the collapsed portion. The sheets of collapsed plywood remained largely intact (Photo 7); with the failure occurring at the nailed connections around the perimeter. Two primary failure types were noted: a bearing failure of the wood under the nail head (Photo 8), or an edge bearing failure (Photo 9). Withdrawal and severe rusting of nails from the nailer (a 2x member placed over the trusses or glulam beams to provide a uniform surface for the plywood) was also observed (Photo 10). These three failures are considered a brittle type failure in a seismic event; and can occur without warning and lead to a sudden loss of strength in the structure diaphragm and increase the likelihood of a partial or total collapse. The deterioration of the plywood observed throughout the structure is therefore also considered a seismic vulnerability.

Photo 7 – Plywood decking, Building A

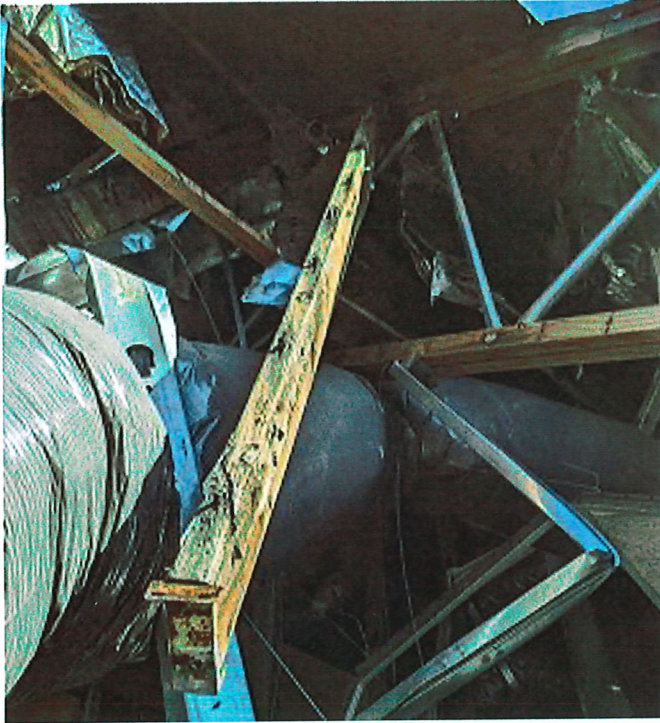
No direct failure of the 2x6 sub-framing was observed; with the elements appearing to remain largely intact (Photo 11). Connection failures due to nail withdrawal in either the nailer seat or hanger seat were typically observed (Photo 12).

Photo 11 – 2x6 Sub-framing, Building A

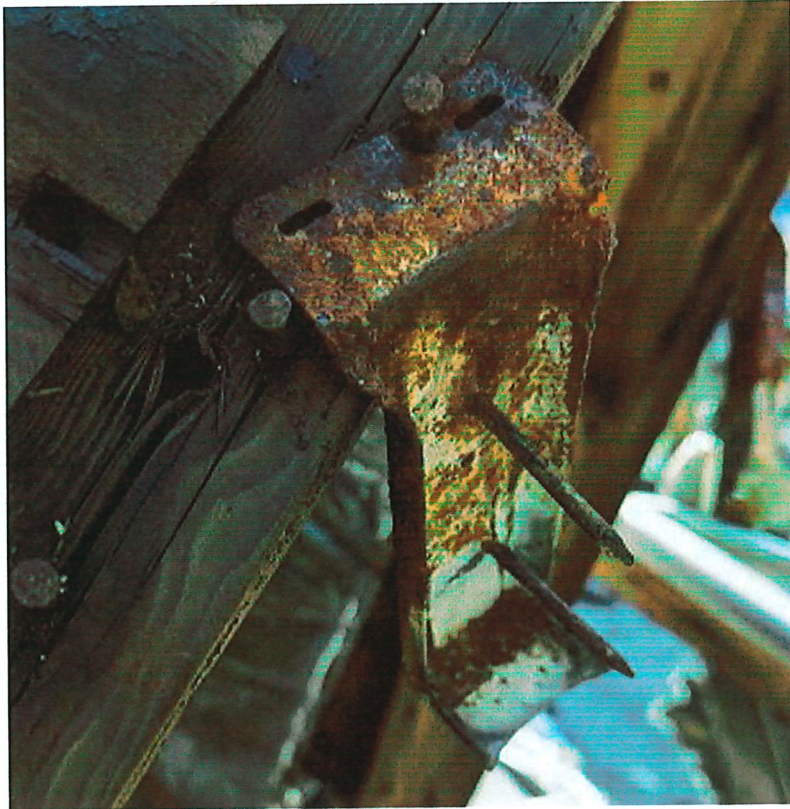
Photo 12 – Sub-framing hanger, Building A

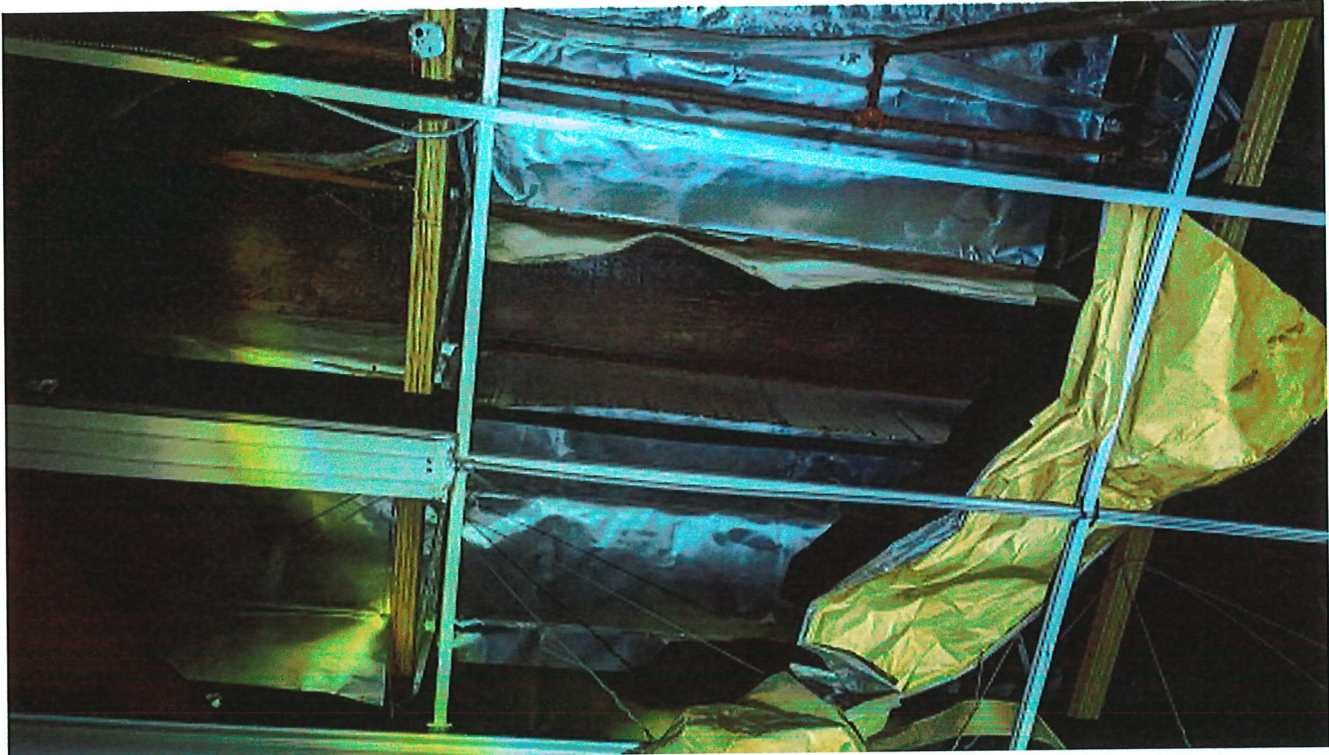
Observations of exposed areas throughout the structure showed similar signs of deterioration due to water exposure; and in several cases the framing was visibly saturated (Photos 13 and 14). Leaking is expected to be extensive during rain events; as significant puddling was observed on the floor (Photo 15). Visible deterioration and rot were observed in the same location as the suspected failure location of the collapse as described previously (Photos 16 and 17); indicating that the roof is susceptible to a similar type of collapse in other locations. Deterioration at glulam beam seats was also observed (Photo 18). The bearing capacity of the beam toe may be compromised; which reduces the load bearing ability and increases the likelihood of a shear failure collapse similar to the truss joist failure mechanism described above.

Photo 13 – Saturated framing, Building A

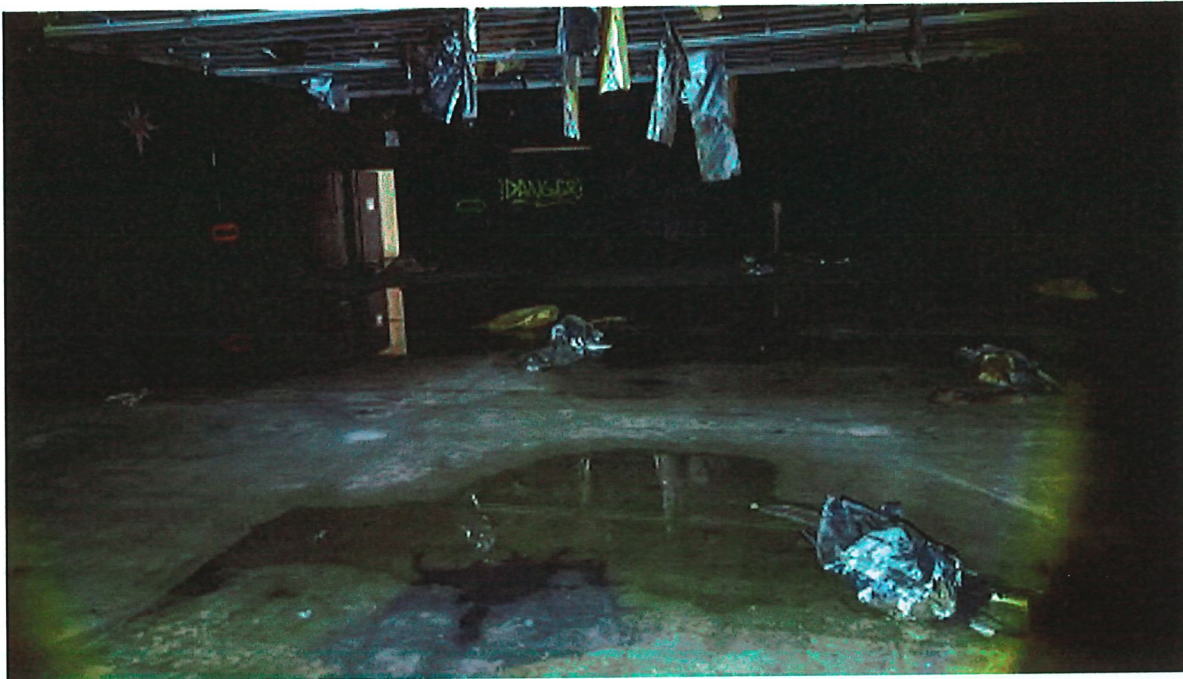
Photo 15 – Water collection at floor, Building A

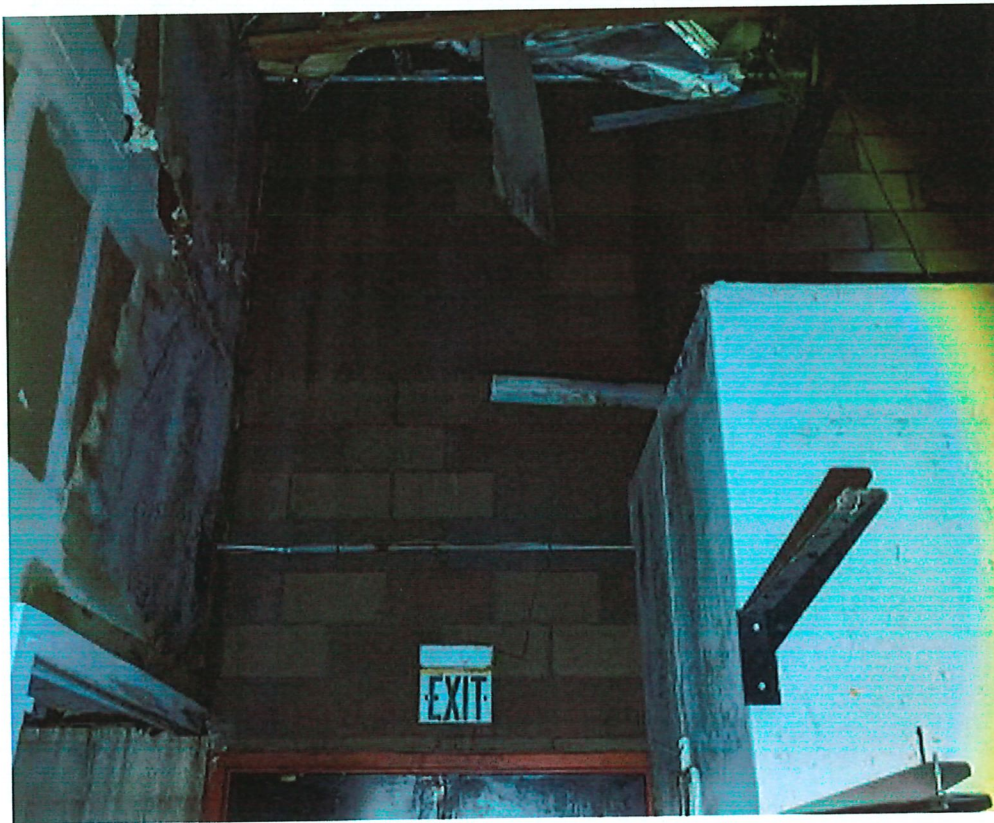
Photo 20 – Saturated back wall, Building A

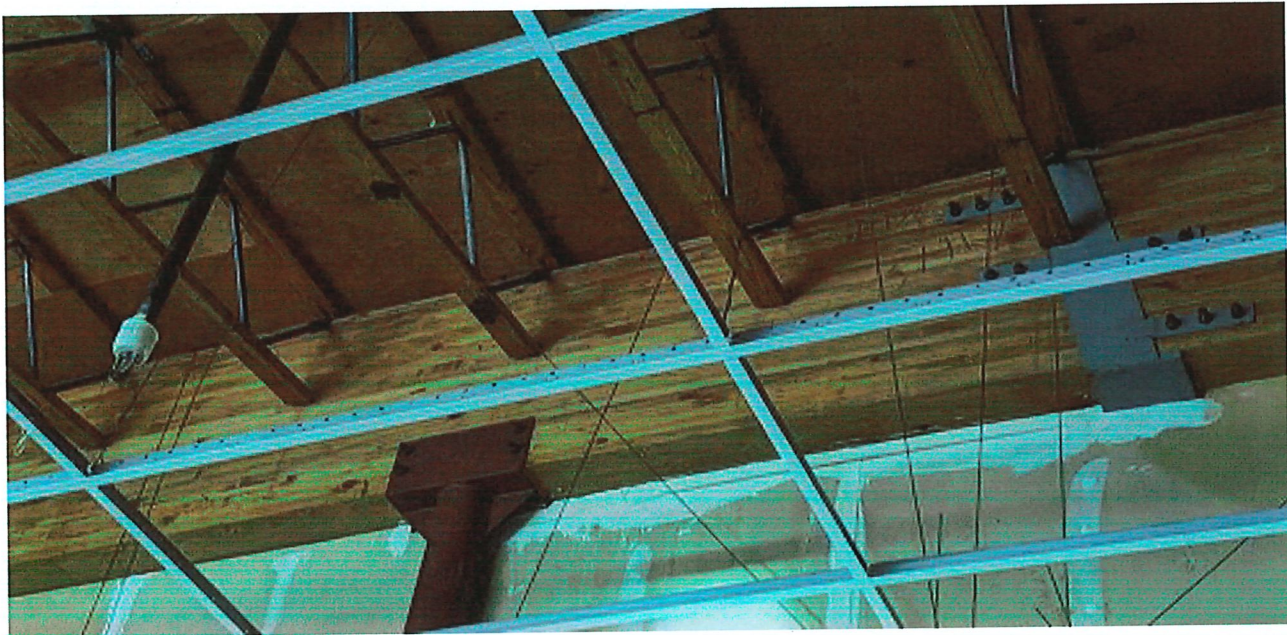
Building C has an overall condition rating of Poor. The roof of Building C differs in construction from the other buildings; as it lacks the 2x6 sub-framing. Instead, the deck is supported directly on the truss joists; which are shallower and are spaced approximately 3'-0" on center; rather than the 8'-0" standard spacing of the other buildings (Photo 22). The glulam and ledger wall supports; as well as the columns, are similar to the adjacent buildings.

Photo 22 – Typical framing, Building C

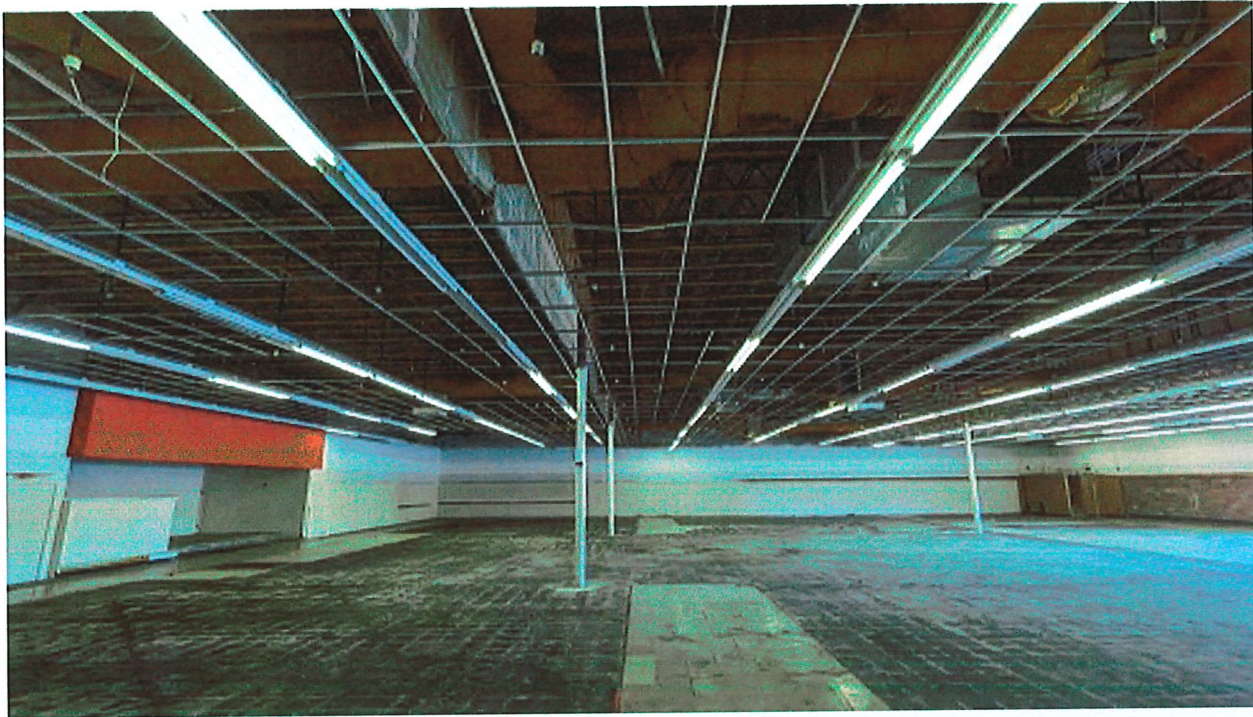
The roof of Building C was largely exposed (Photo 23), with visible signs of water intrusion and deterioration (Photo 24). An area of concern includes the glulam beam supports in the shared wall on Grid 8, the formerly shared wall between Buildings B and C. Waterproofing of the removed sections was not provided, with visible daylight behind several glulam beams (Photo 25). Long-term water exposure appears to have deteriorated the toe of the glulam at the steel support (Photo 26), potentially compromising the load-carrying capacity. It was noted in Building A that the ceiling insulation appeared to trap moisture, which could lead to severe deterioration. The roof framing in the southwest corner adjacent to the shared wall with Building D is covered by a similar ceiling insulation (Photo 27). Cracking and signs of water intrusion were observed at the top of the CMU wall (Photo 28); however, it was not

Photo 23 – Main area, Building C

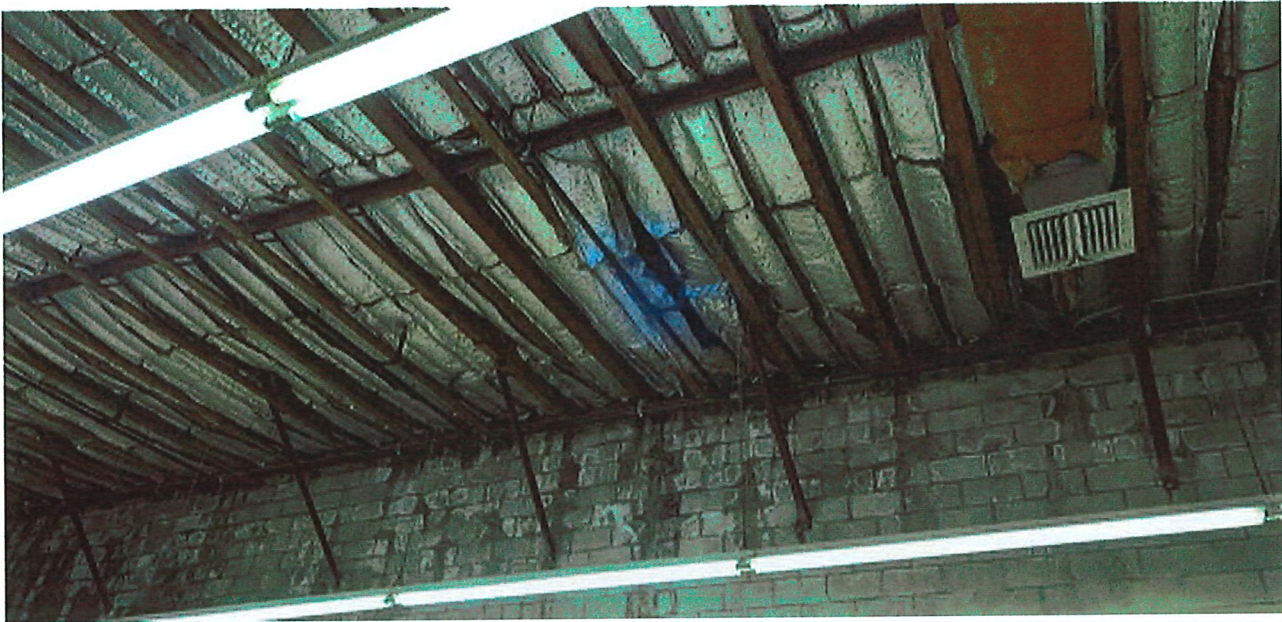
Photo 27 – Roof framing obstructed by insulation, Building C

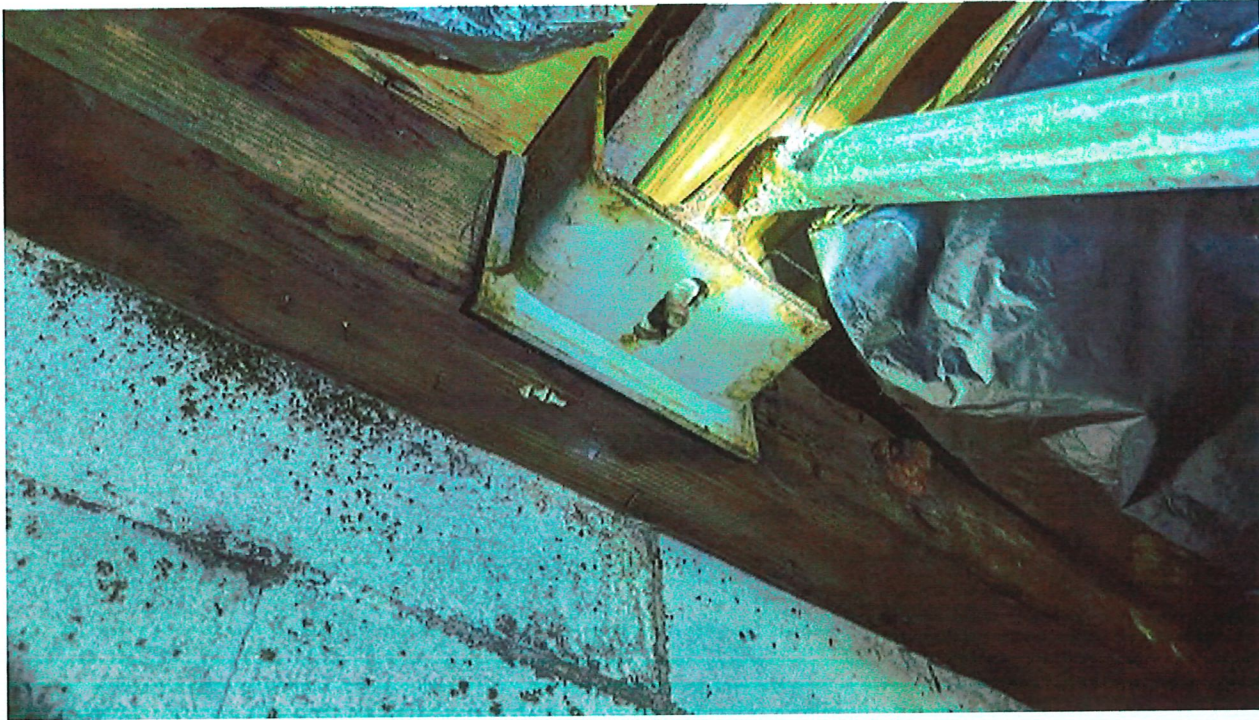
Photo 29 – Evidence of previous water intrusion, Building D

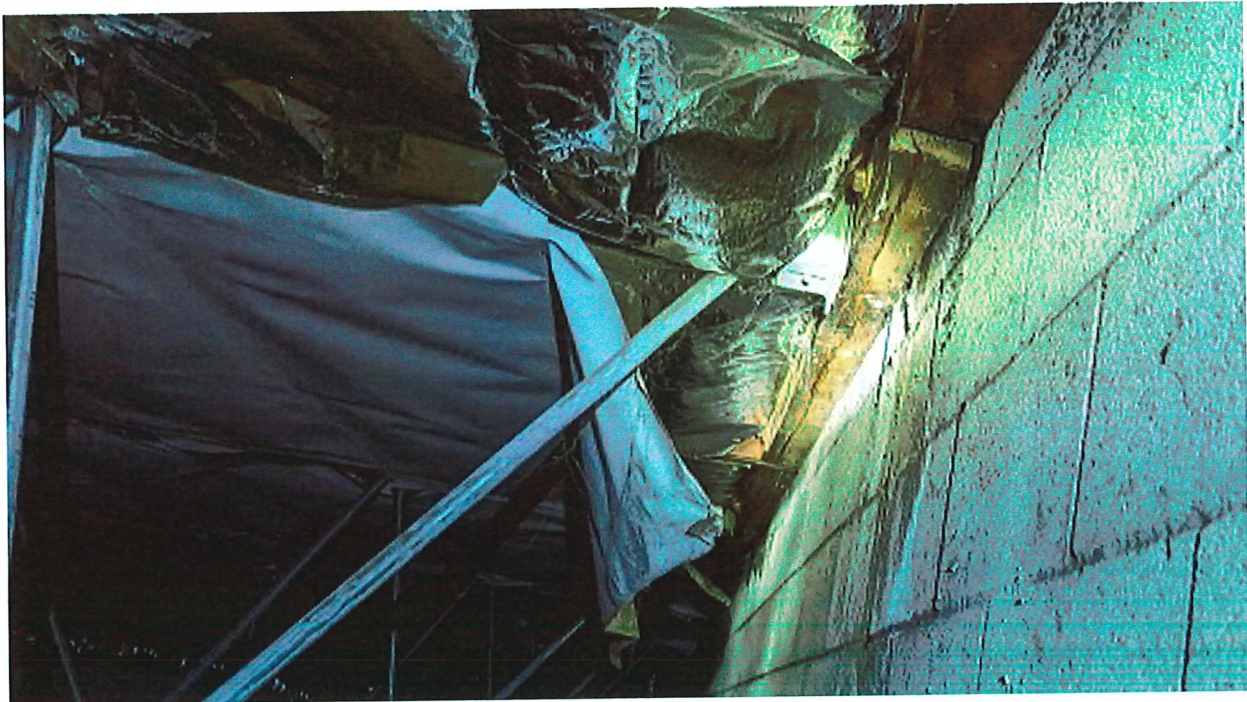
Photo 31 – Efflorescence at shared wall, Building D

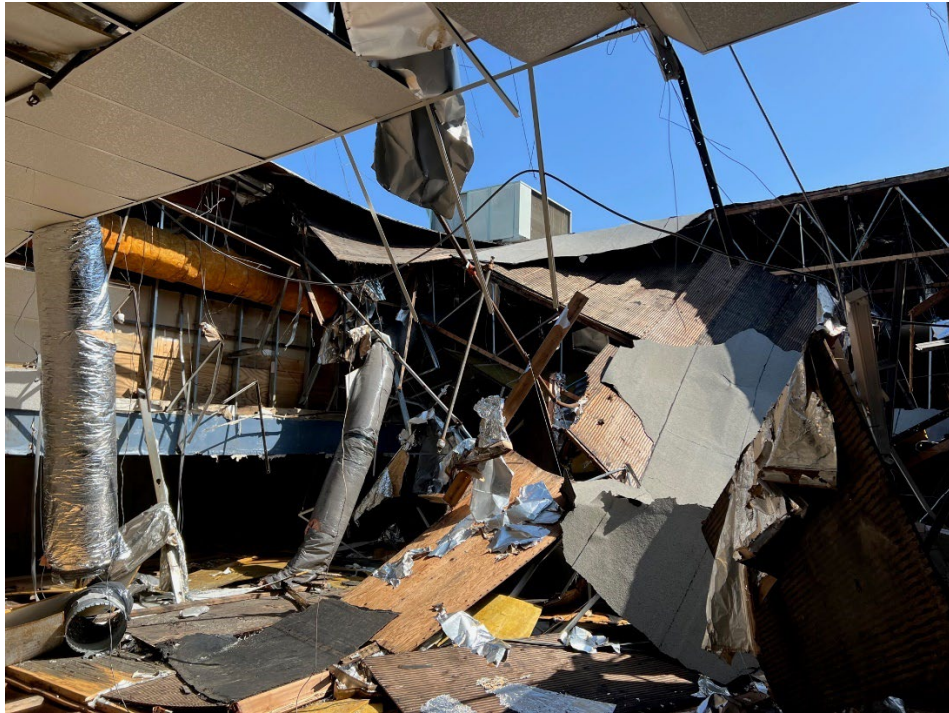
***Unit A - Roof Collapse***

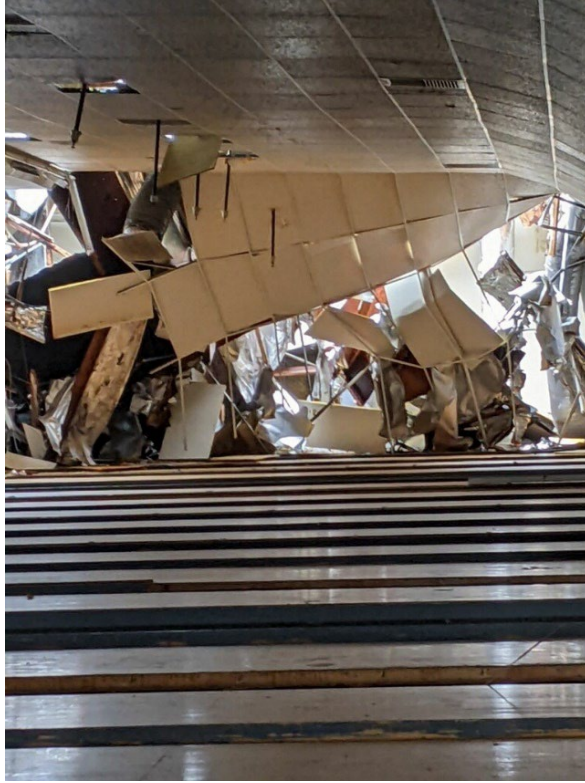
***Unit A - Roof Collapse***

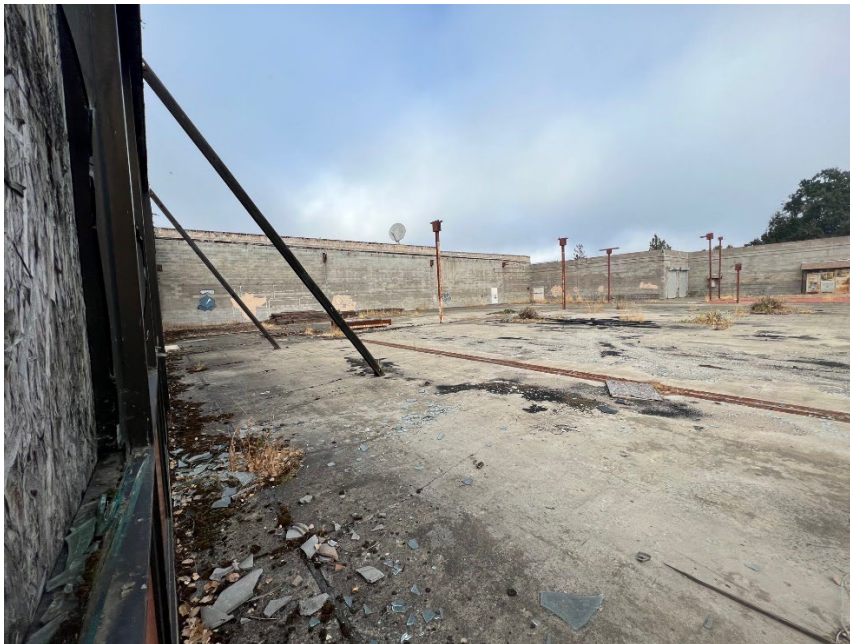
***Unit B – Freestanding walls post initial roof collapse***

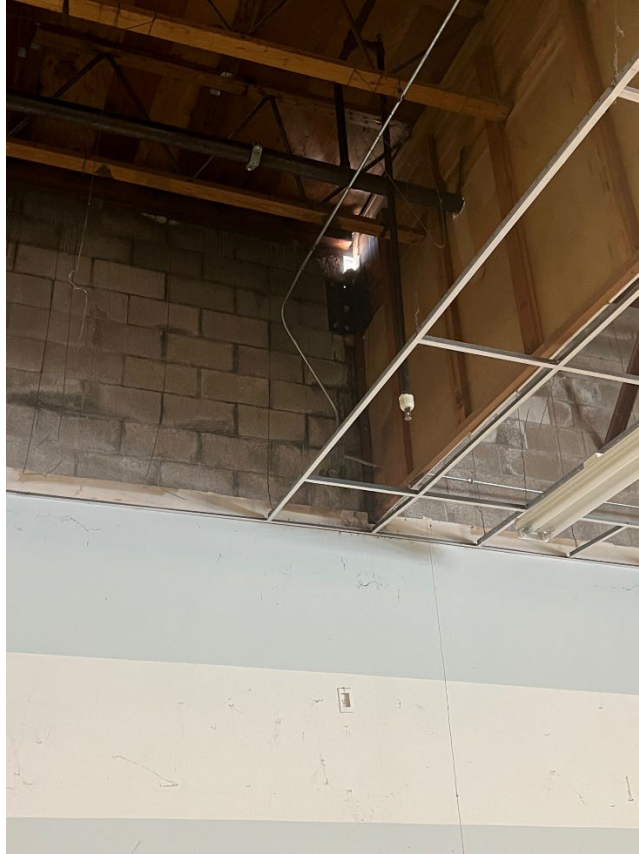
***Unit C – Holes in shared wall with Unit B, exposing structural elements to weather exposure since initial roof collapse***

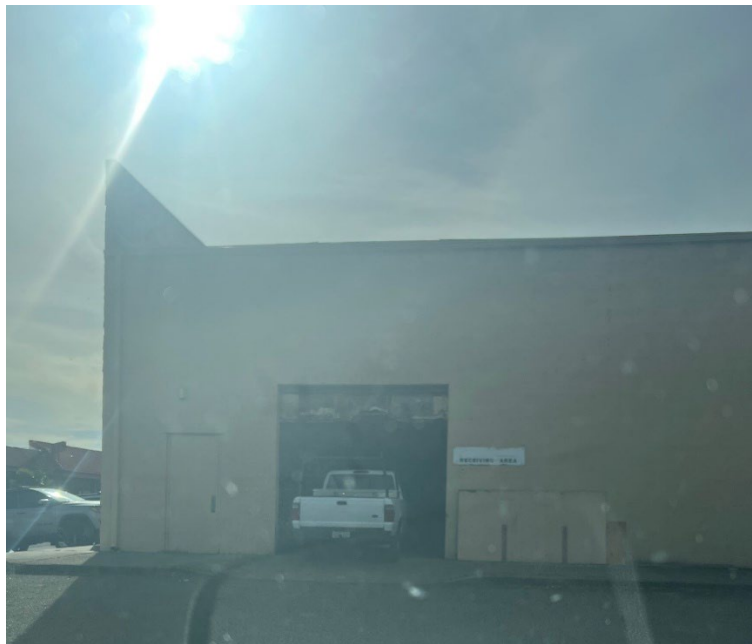
***Unit A – Unpermitted demolition to enable vehicles to enter into the building***
