## **Playground Assessment Report New Bern, North Carolina**

05-17-18

Kidsville New Bern

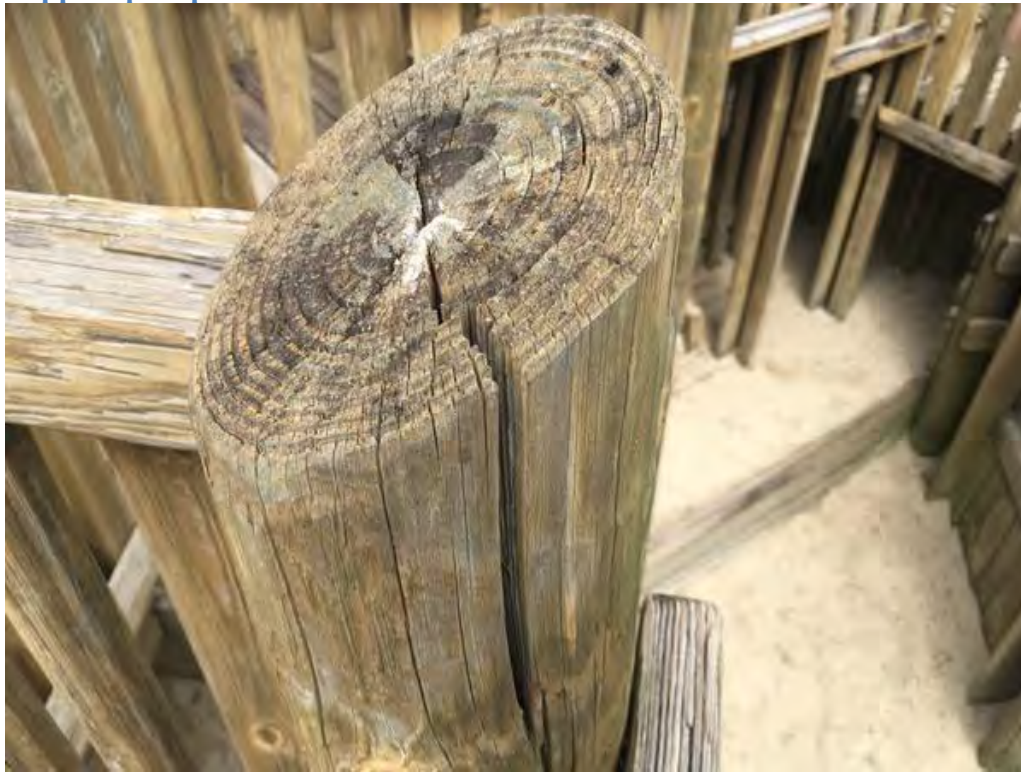
Support post picture #2

Medium= Some visible damage / deterioration / decay observed. Does not appear to be structural at this time.

2. Needs corrective action.

Replace with low maintenance recycled structural plastic where needed.

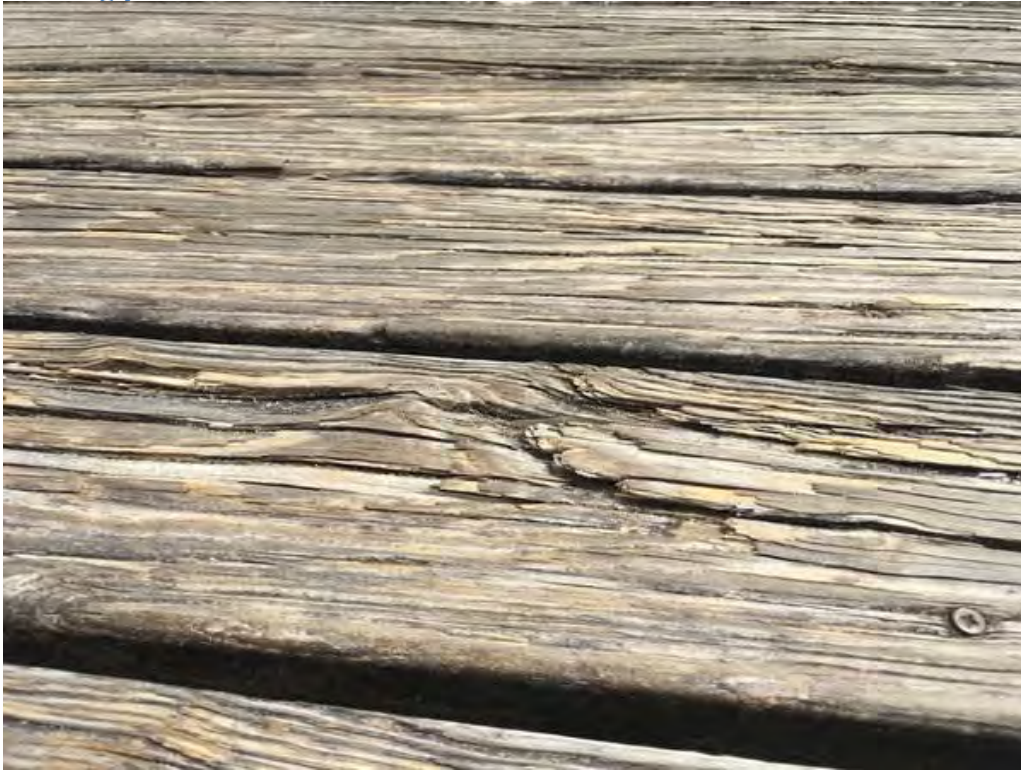
Decking picture #2

Poor= Visible damage / deterioration / decay observed. Structural issues imminent.

The decking on this playground is showing its age. Deterioration, splitting and rot are evident everywhere. A small area of decking has been replaced with a composite decking.

Replace with recycled plastic.

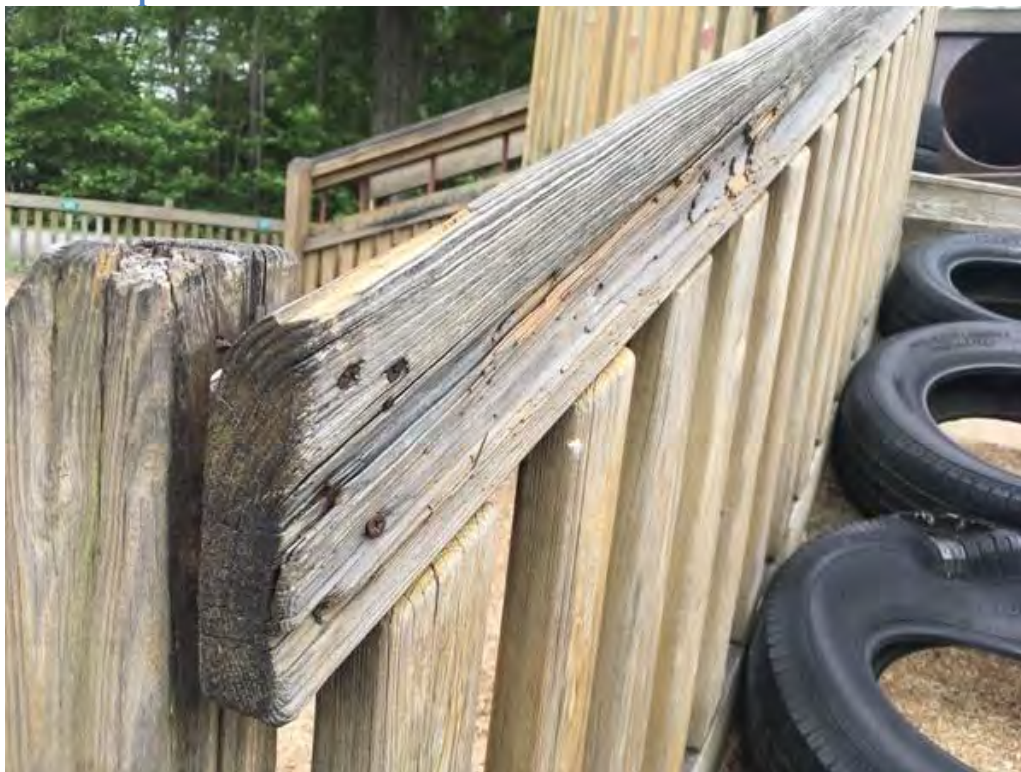
Handrail picture #2

Poor= Visible damage / deterioration / decay observed. Structural issues imminent.

Most of the handrails are splitting, and many have become loose

Replace with composite to reduce the amount of pressure treated lumber on the structure.

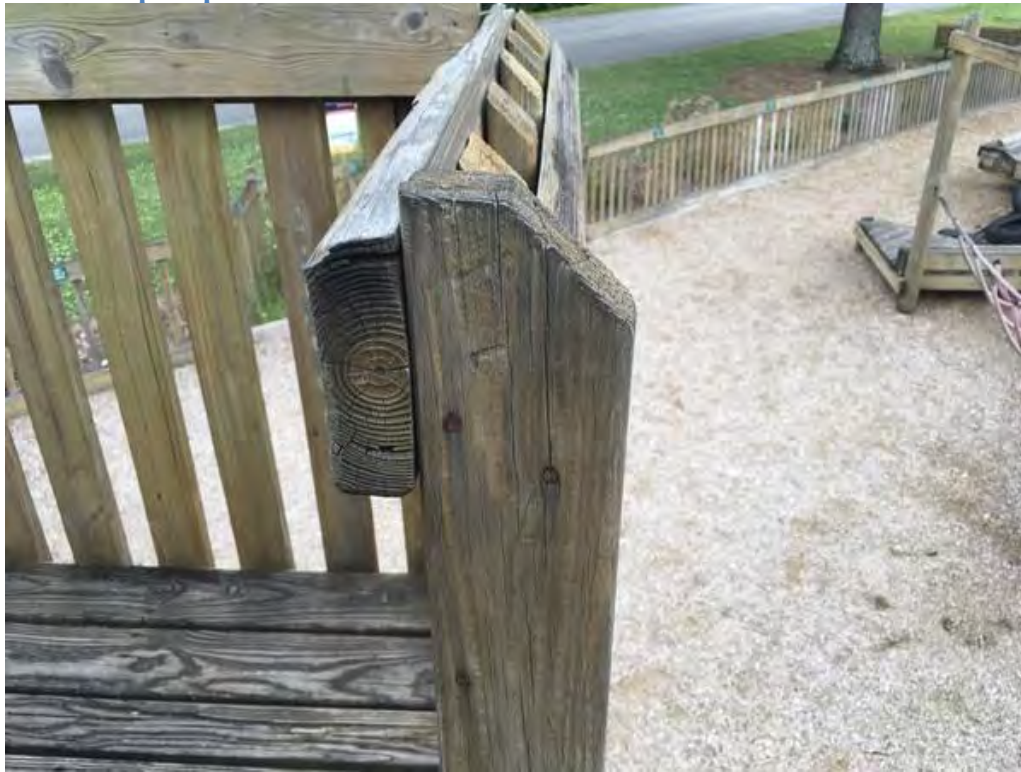
Handrail post picture #2

Poor= Visible damage / deterioration / decay observed. Structural issues imminent.

Handrail posts have become loose and wiggly.

Replace with low maintenance recycled structural plastic.

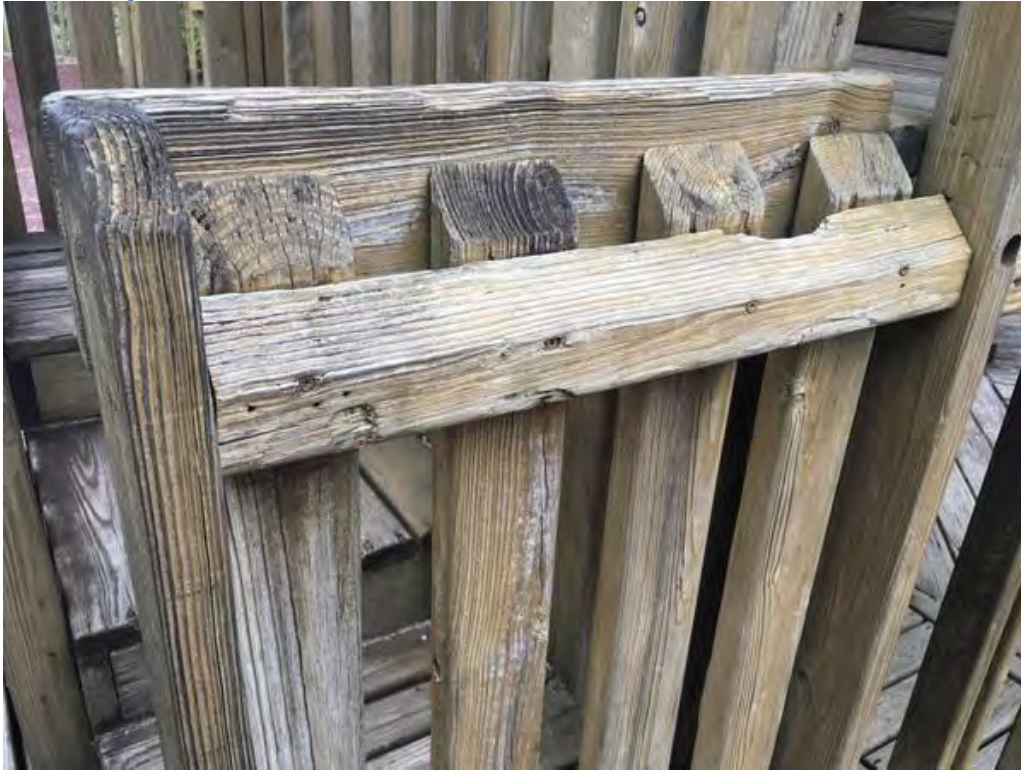
Baluster picture #2

Medium= Some visible damage / deterioration / decay observed. Does not appear to be structural at this time.

Replace with recycled plastic 2x2 balusters to increase visibility.

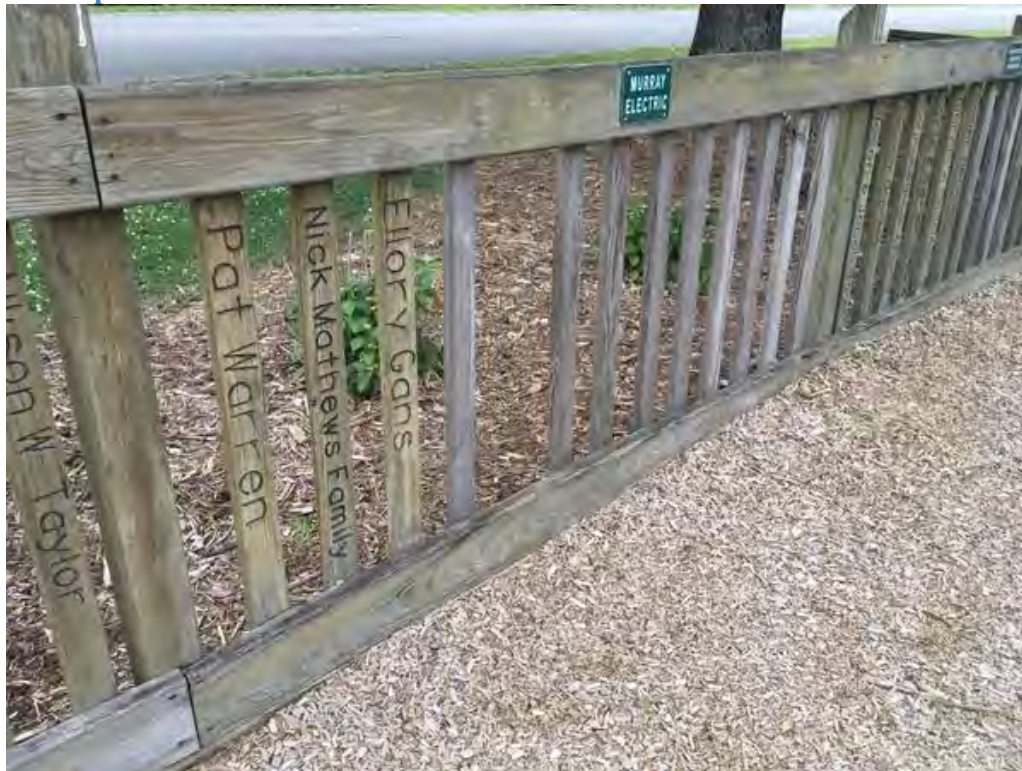
Fence picture #2

Medium= Some visible damage / deterioration / decay observed. Does not appear to be structural at this time.

The fence is in medium condition (minor splintering - missing pickets and wear).

Replace with a new all plastic fence.

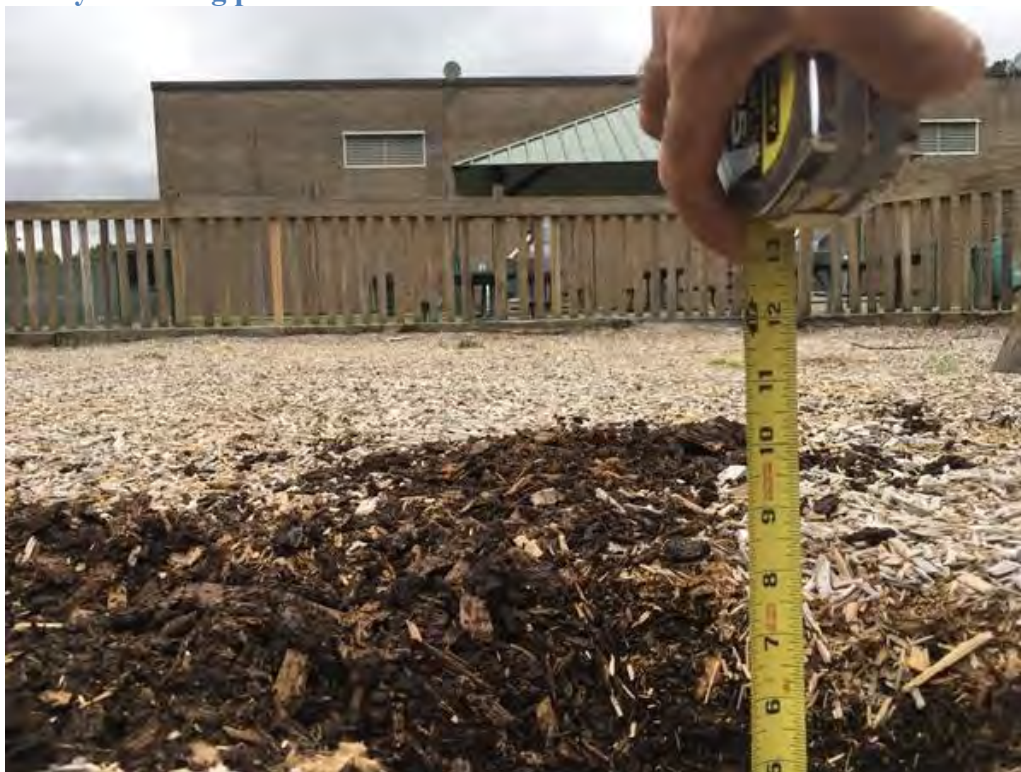
Safety surfacing picture #2

Medium= Some visible damage / deterioration / decay observed. Does not appear to be structural at this time.

4"to 6" Deficient throughout

Safety surfacing is in poor condition several areas need more surfacing added. There is an area in the tot lot which has poured in-place rubber surfacing. This needs to be touched up or replaced as it is showing its age.

Add additional engineered wood fiber to a total depth of 12" throughout. The poured in place rubber in the tot lot needs to be touched up or replaced as its showing its age.

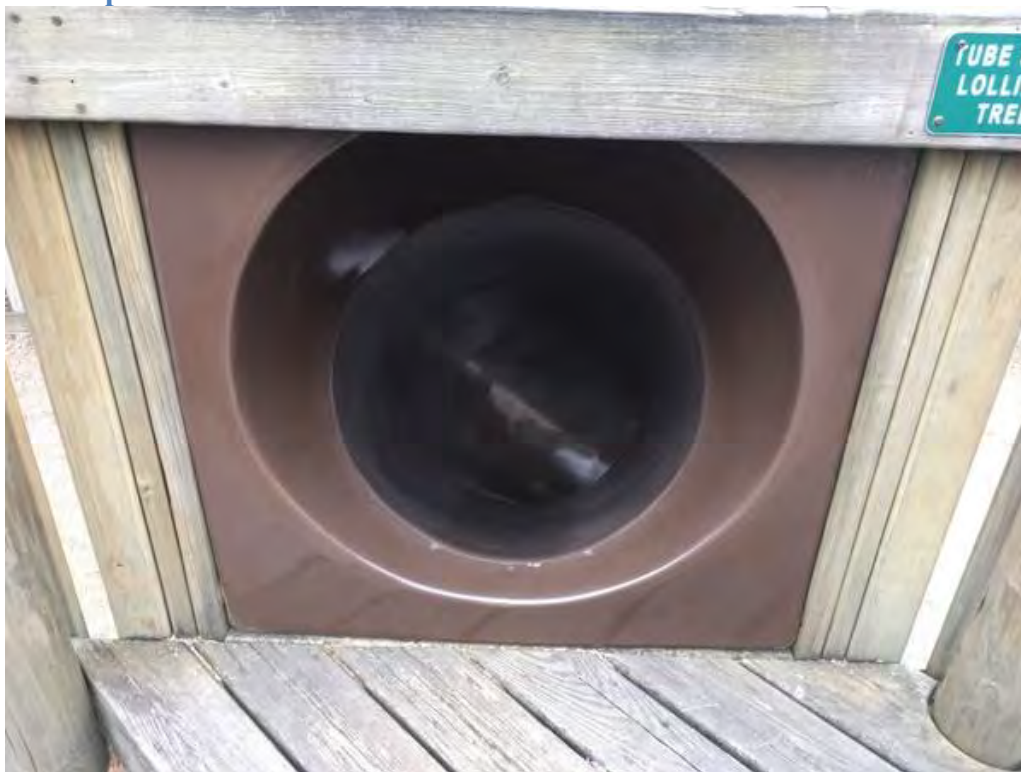
Slide 1 picture #2

Medium= Some visible damage / deterioration / decay observed. Does not appear to be structural at this time.

The framing around the slide is deteriorating. The deck at the entrance has got splintered boards and gaps between the boards. The top of the slide features an unintended platform

Replace with new.

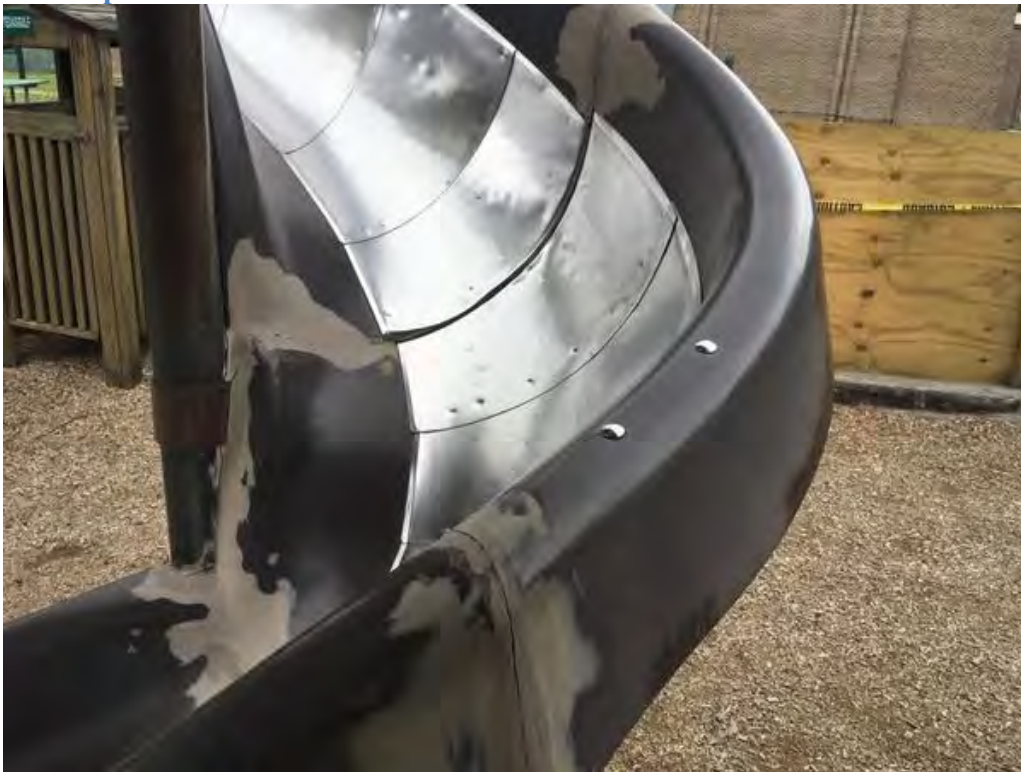
Slide 2 picture #2

The framing and decking at the top entrance of the slide are in poor condition, leaving a few hazards, entanglements being the most serious.

Replace with new.
