Section04 FireStationNo.1

Background for Shawnee Fire Station No. 1

Assessment Commentary

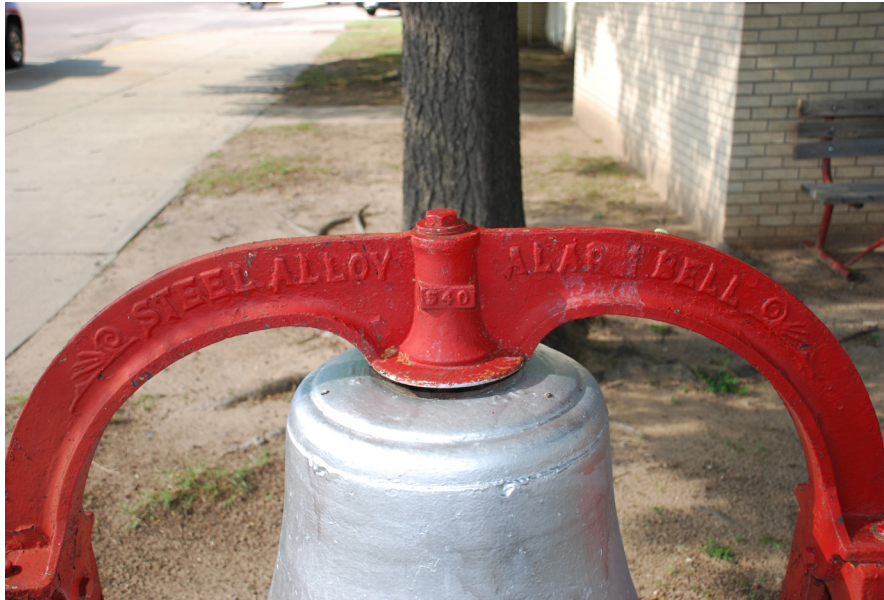
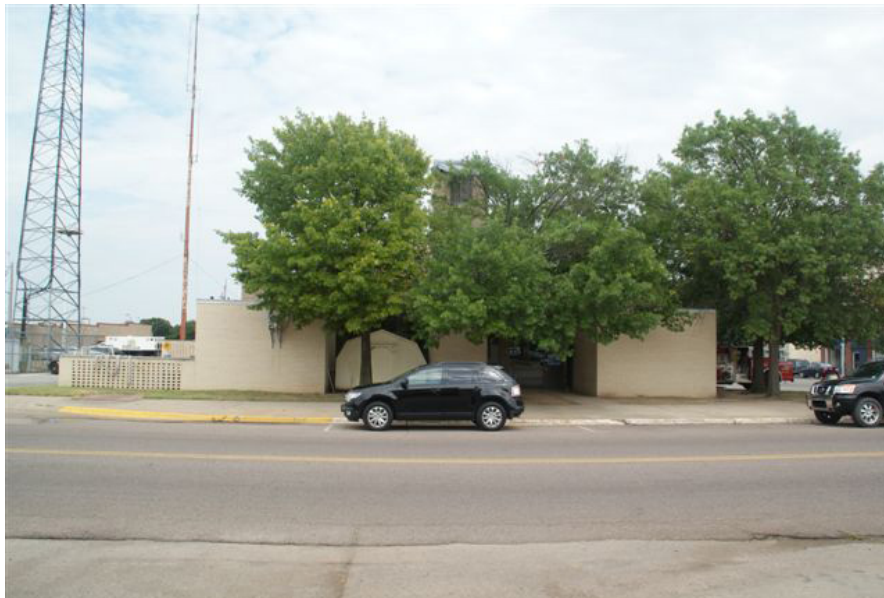
This Shawnee Fire Department bell on the corner was removed from an earlier station. The bell was the alarm system for the city. It was used to alert volunteer or on-call firefighters. While its current location is acceptable, in an ideal situation it would be outside the public entrance (along with a flag pole) to clearly call attention to everyone about where to approach the station for a visit or business. In the near future, it would be advisable to have the bell and frame soda blasted and repainted to enhance the details.

Moving around Station 1 clockwise to the west side reveals a pair of large floor to ceiling windows, barely visible in this view. These windows could, if not obscured by an outside storage shed and large, stationary equipment inside, showcase the fire apparatus positioned next to the windows.

This could be especially intriguing in a nighttime reveal. I am sure that was the original intent of the architects in their design layout. Facing west, these expansive windows had to be shaded by trees to soften the effect of the sun. Today, glass coatings can effectively block the sun's rays. The way the trees have been allowed to grow has further compromised the view into the apparatus floor.

When asked what was in the storage unit, most respondents said “mostly junk.” Perhaps some housekeeping duties are in order to restore the original intent of the west side windows by removing the deteriorated storage shed.

The trees do add a welcome bit of shade to the windows on the west side. If any additions are ever made to the west side, great care should be taken to insure the roots of the trees are not damaged. Efforts should be undertaken to find a suitable non-climbing shade and sun tolerant ground cover for the bare ground under the shade trees. Consult a local plant nursery for suggestions.

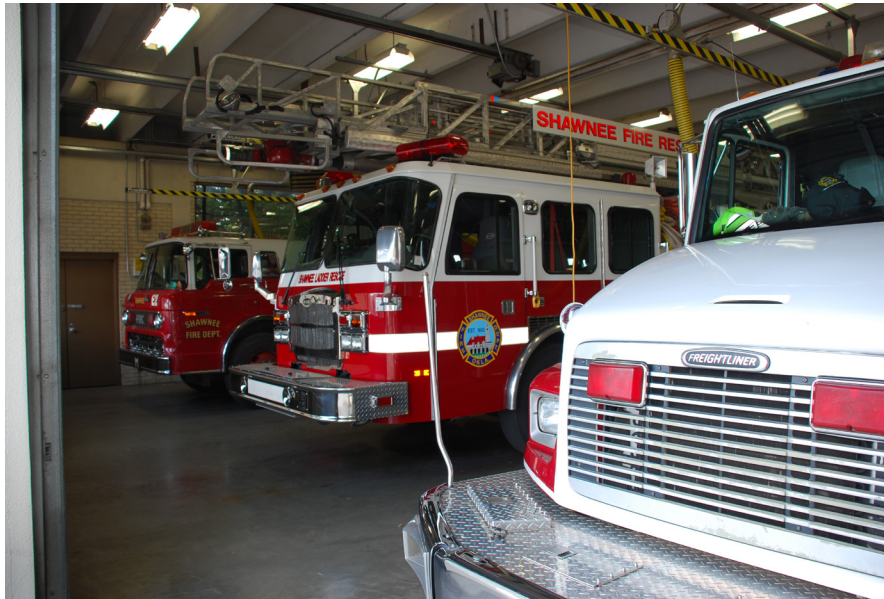
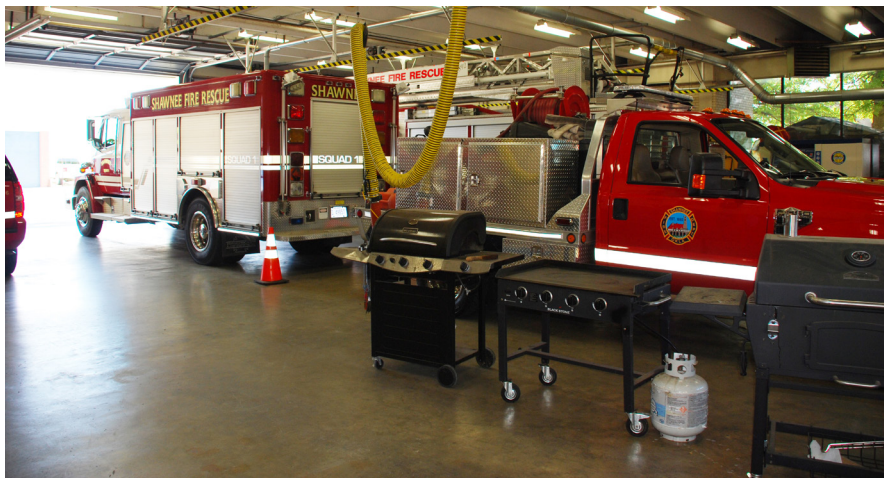
This image on the bottom left reveals a common truth about firefighters everywhere - they like to grill out. It is surprising how many fire stations get constructed without acknowledging that the grilling equipment has to go somewhere when it is not in use. Shawnee is no exception. One grill or three, it does not matter, they should not be stored on the apparatus floor where they become impediments to circulation going to the apparatus in answering an alarm.

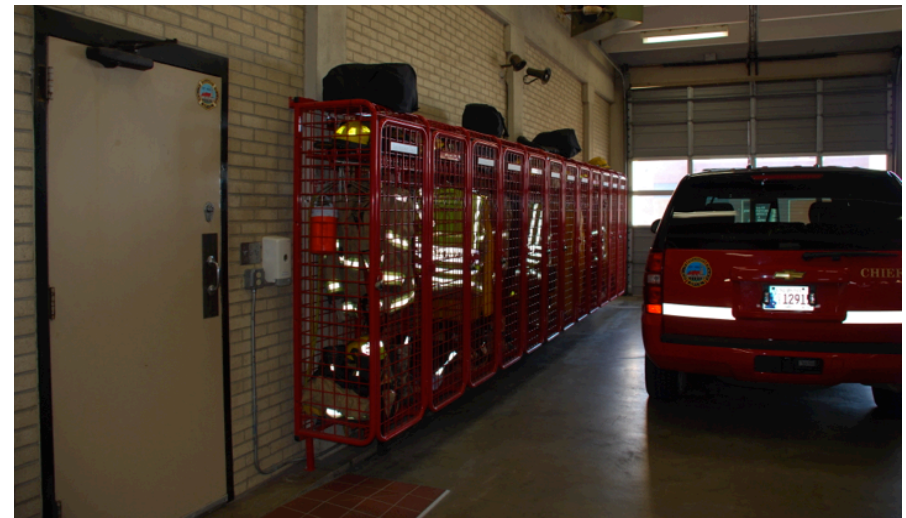
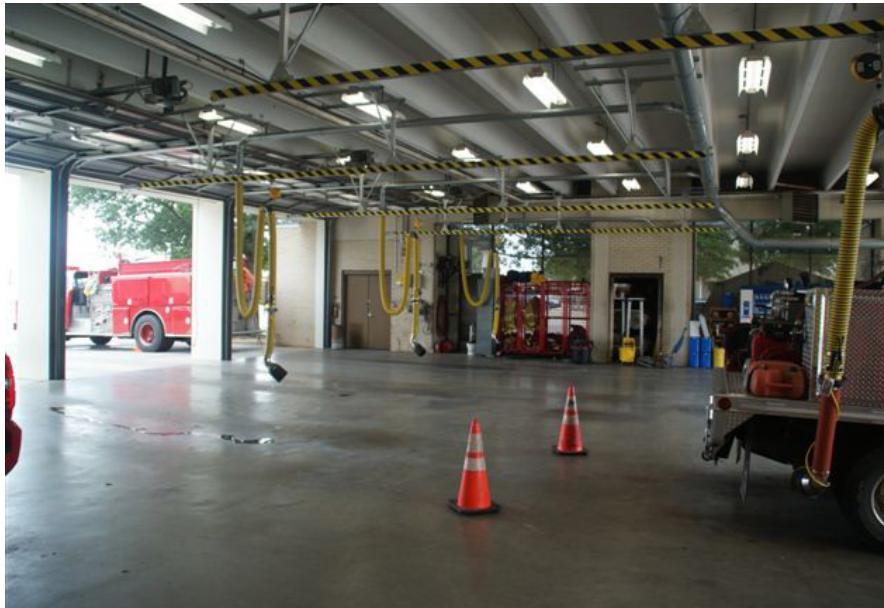
The red "cage" lockers are fine for storage of PPE, but these are too close to the bay door opening allowing direct sunlight on the garment. Sunlight will prematurely weaken the fabric. All PPE for off-duty personnel should be stored in lockers in a room located off the apparatus floor in a space that does not receive direct sunlight. The lockers here should be mounted higher on the wall to facilitate wash-down of the floor without wetting PPE on the bottom. The conduit running under the locker is subject to being wetted.

With all mobile equipment assigned to Station 1 in place, the station does not function as a drive-through as was the original intention. Few stations designed as a drive-through functions as a drive-through. You will find the drive-through potential often blocked by reserve apparatus, equipment trailers, training props and other stored items. SFD's Station No. 1 is no exception.

All of SFD's stations were designed as drive-throughs but none of them functions completely as designed. The drive-through option for any future stations should be questioned. It might be worthwhile questioning the validity and current commitment in Shawnee's existing stations. Negating the drive-through options at all SFD stations presents great opportunities for the additional of much needed apparatus floor support spaces at the rear.

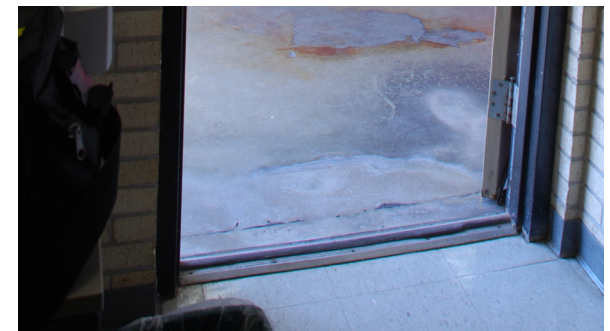
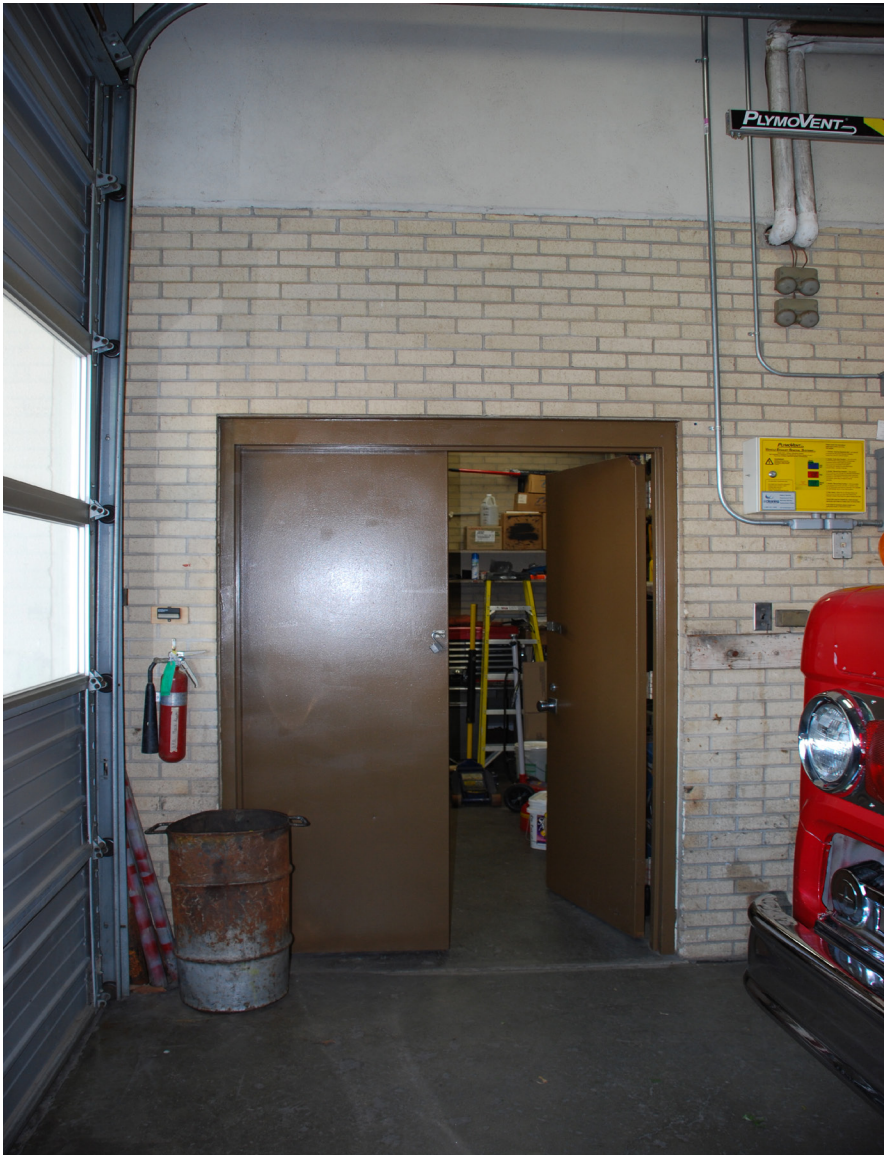
The apparatus floor at Station 1 slopes from the front of the building to a trench drain at the rear along the inside edge of the bay doors. Trying to clear the apparatus floor of water by sloping the floor front to back created a 3" step down at the door leading from the dayroom, a depth not easily perceptible to the human eye under some light conditions. As a result people often stumble walking out of or into the dayroom.

A "fix" for the step down/step up problem has been attempted with a tile patch. The fix helped but a trip edge remained caused by the thickness of the tile and the tile setting bed. This lip could have been prevented by sawing a line in the concrete corresponding to the size of the tile ramp and removing enough concrete to allow the tile ramp to fit flush with the floor.

The fix is possibly too steep to meet ADA standards which requires a maximum slop of 1 inch in 12 inches. The ramp should be 2 to 3 feet long.

The door at the front end of the apparatus floor leading from the battalion chief's office and sleeping room also appears to have had the step down modified.

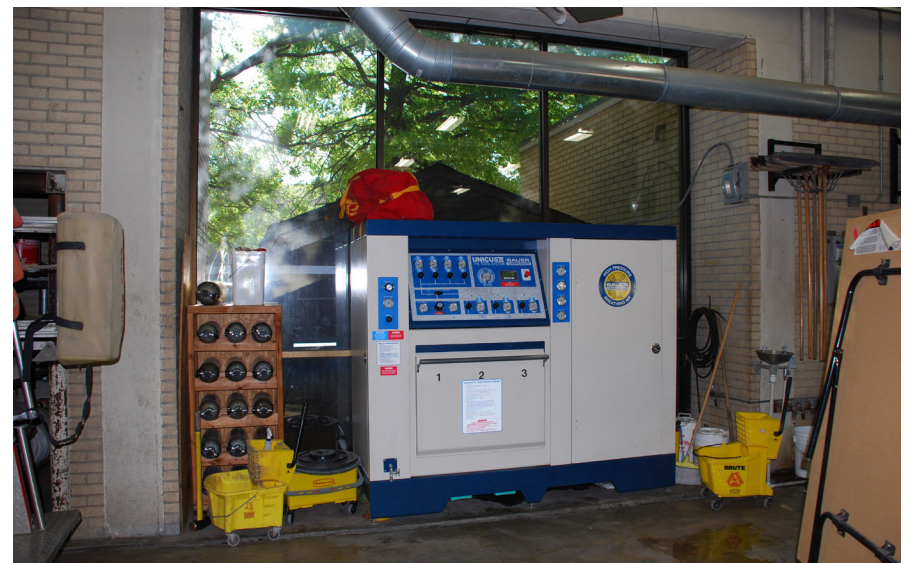
Moving toward the back along the west side of the apparatus floor we find the SCBA cylinder fill station and more clutter in the form of apparatus floor cleaning supplies and equipment. Moving the folding table out of the way reveals a rack for spare SCBA cylinders. These cylinders should be in a "clean" room. Should any debris get in the threads or on a seal, a firefighter's SCBA could be compromised. The view out is marred by the SCBA station.

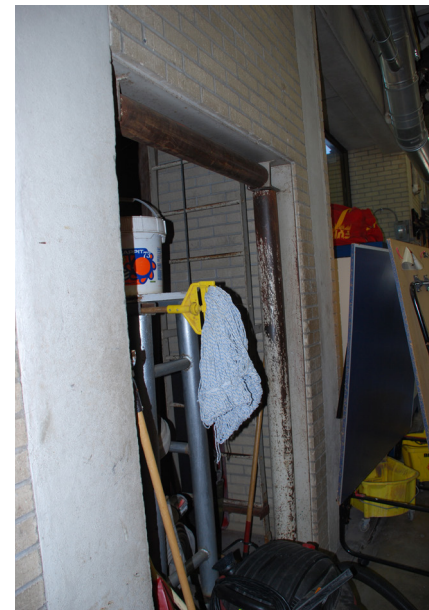
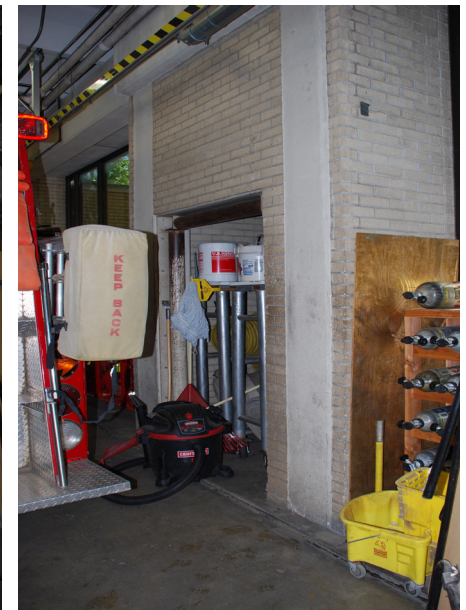
Before Station 1's hose tower can be properly used as designed, the items

stored there will have to be relocated. This includes a rolled-hose rack, a shop vac, floor mops and other items.

Even if the SFD maintains its current policy of not washing attack hose after use before reloading, the hose tower should be emptied of the items stored

there and the tower used as a focal point for any tours of the station by school children or any other customers. It can always be a place to hang old hose that has been taken out of service because it failed a pressure test or was damaged in a fire. Anyone looking up into a hose tower full of “drying” hose “understands” a fire station just like they “understand” that a fire station has a fire pole.

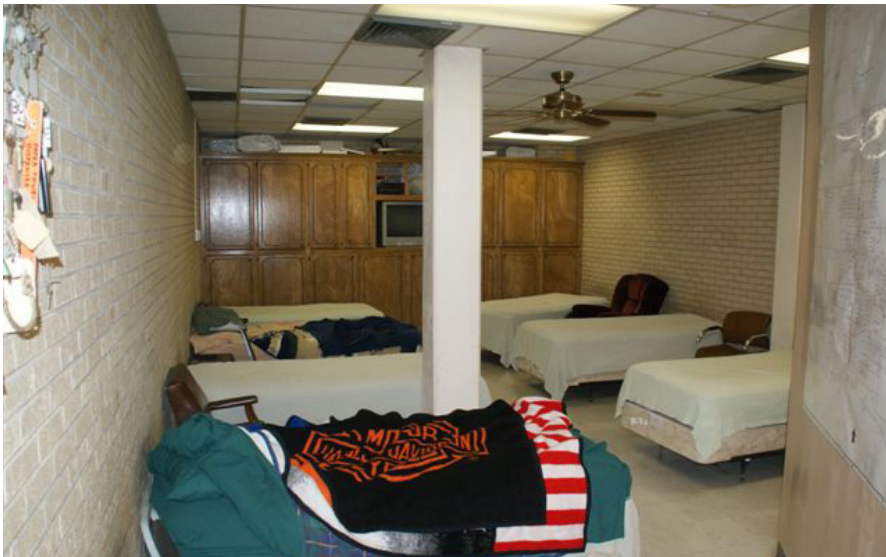
Note in the image below how the BC's office-bedroom restricts the aisle width leading out of the dorm space. This is something you do not want to do in a space that needs to have unimpeded flow to the apparatus floor in responding to an alarm. Compounding the flow is the requirement to go through the Battalion Chief's office/bedroom in getting to the apparatus floor. Also note how the structural columns intrude into the dorm floor space. The intruding columns create compromised bed spaces. All bed spaces should be exactly the same. Chairs between the beds do not match. Beds could be over 3-drawer "linen" cabinets for storage of bed gear.

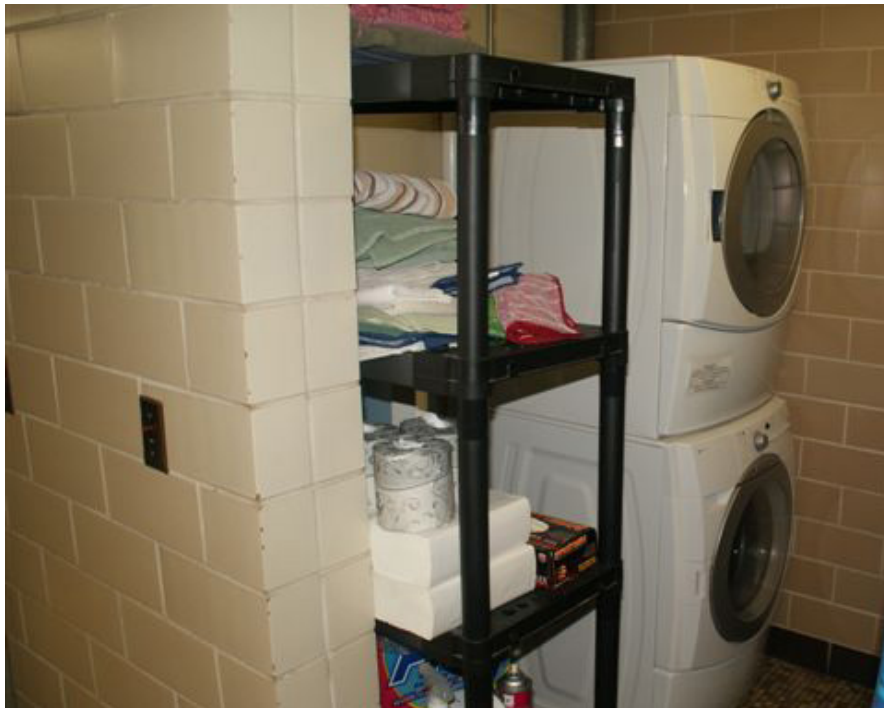
No “domestic” laundry was provided in the original station design. Towels, sheets, cleaning rags and the like had to be laundered by a vendor or taken home to laundry. The laundry area shown in the image above is the second attempt to address the station’s domestic laundry need. It is located opposite the two shower stalls. This location required the installation of a drain, power source and vent for the dryer. The recommendation now is for no domestic laundry to be taken home for cleaning.

The first attempt to add a domestic laundry was at the expense of one of the two crew showers located opposite of the current laundry location. Lost in the new location was a niche for a “changing” bench and place to hang items while using the shower. In the first attempt to have a domestic laundry, the left shower stall’s plumbing was modified for the hot and cold water hookups while the shower’s floor drain functioned as the washer drain. The modifications done to the shower stall have not be restored, leaving only one shower for the entire Station 1 crew.

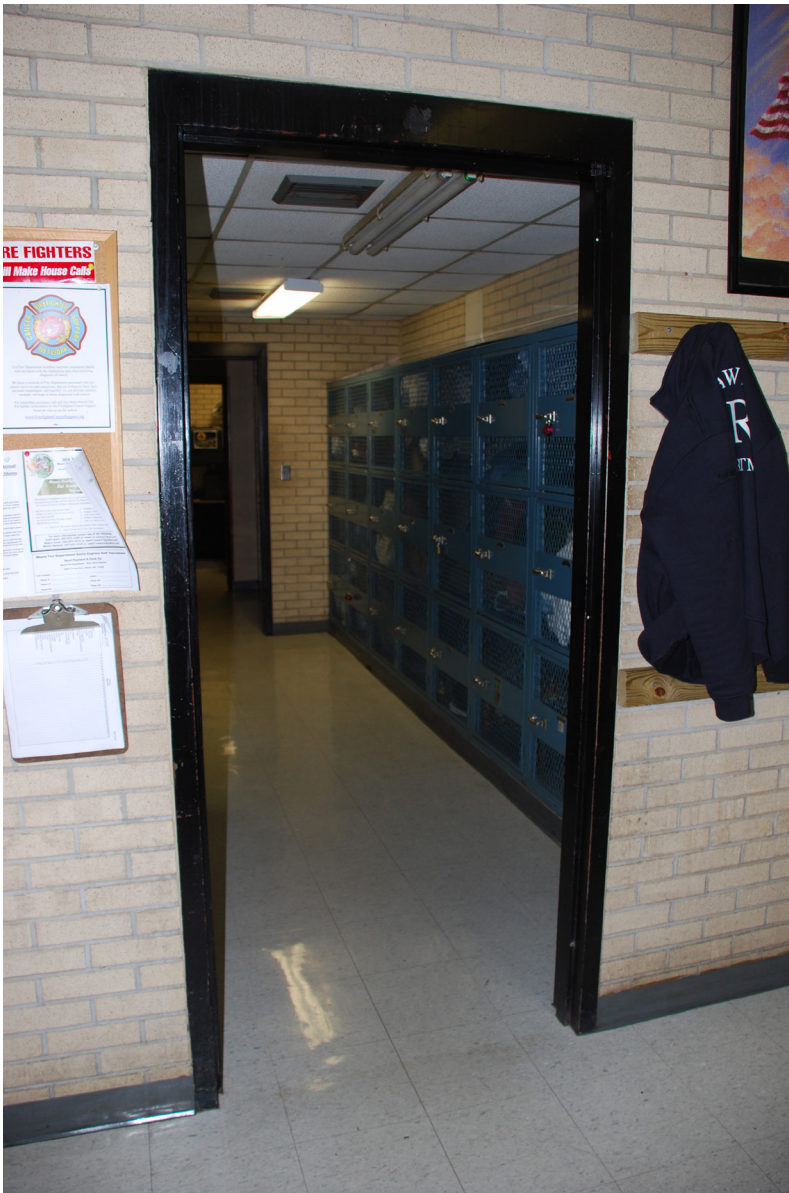
The image above shows the door into the locker room from the dayroom. The door on the opposite side connects to the sleep area for the firefighters and to the office/sleep area for the Battalion Chief. The bank of small locker on the right are used by the firefighters to store personal items.

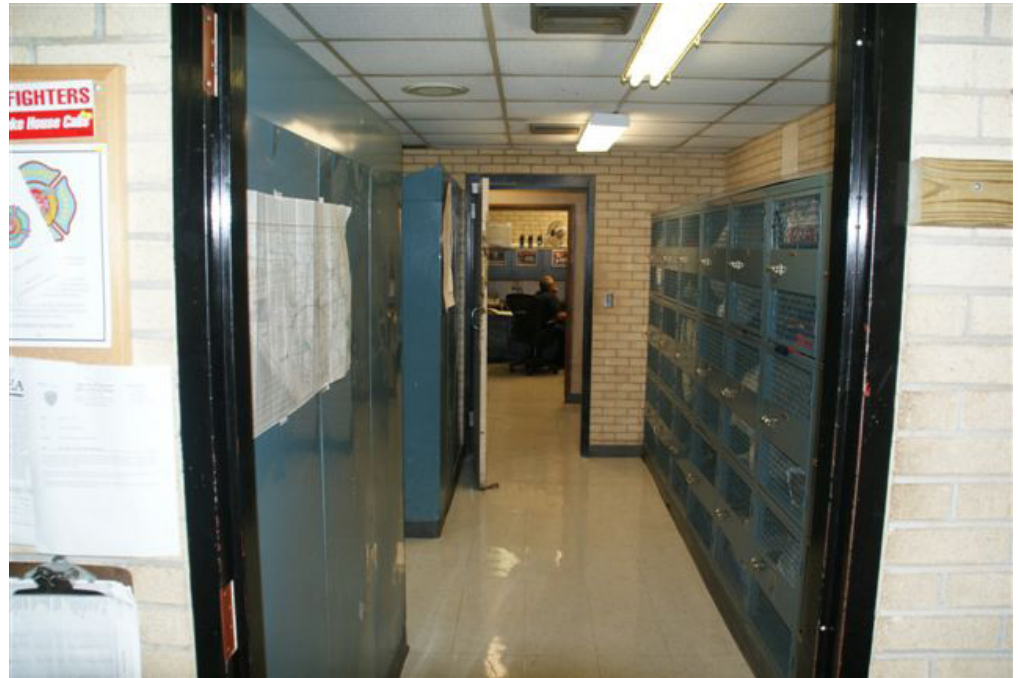
A corridor has been formed across the locker room linking the dayroom and the sleeping bay by the backside of two banks of lockers. The gap between the two banks is centered on the door opening to the toilet/shower/laundry areas.

Lockers, while old, are adequate in number. They are inadequate in other ways. They could be larger. Not many changes of clothing can be hung in the lockers. Fire fighters may have to change station duty clothing more than once in a day. Fifteen runs and a working fire or two in a day can take a toll on personal hygiene and a day uniform's condition.

The major problem with the lockers is that they do not offer "equal" treatment to each firefighter assigned to the station. One bank of lockers has a "dress" bench. The other bank does not have the bench. The bank of lockers without the bench is a second-class tier of lockers.

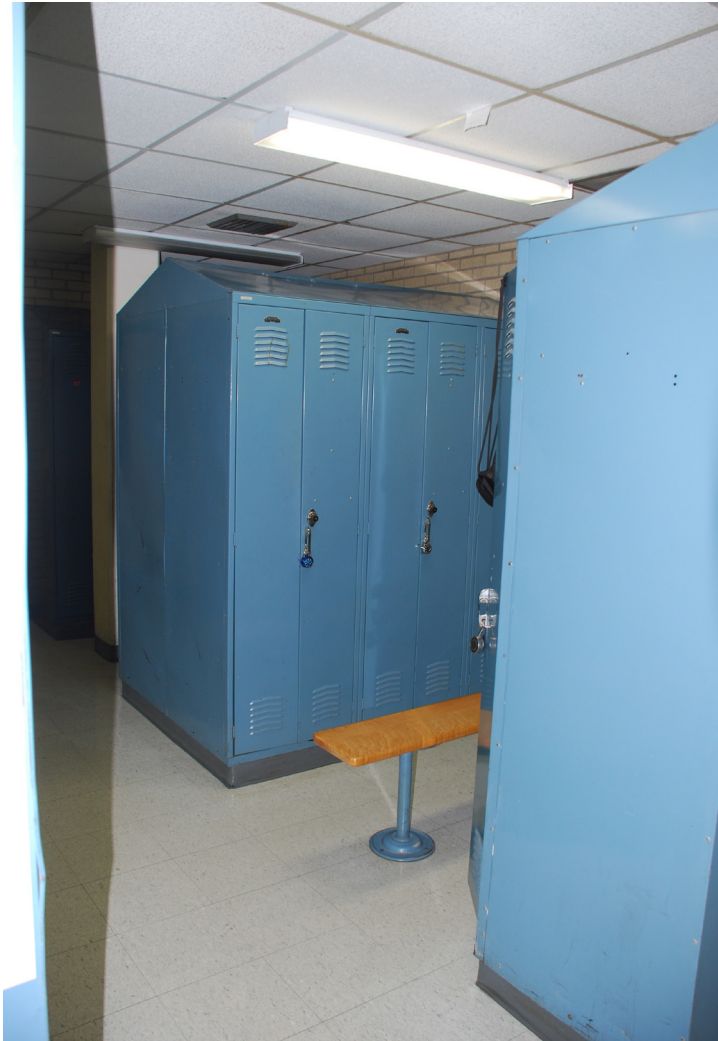
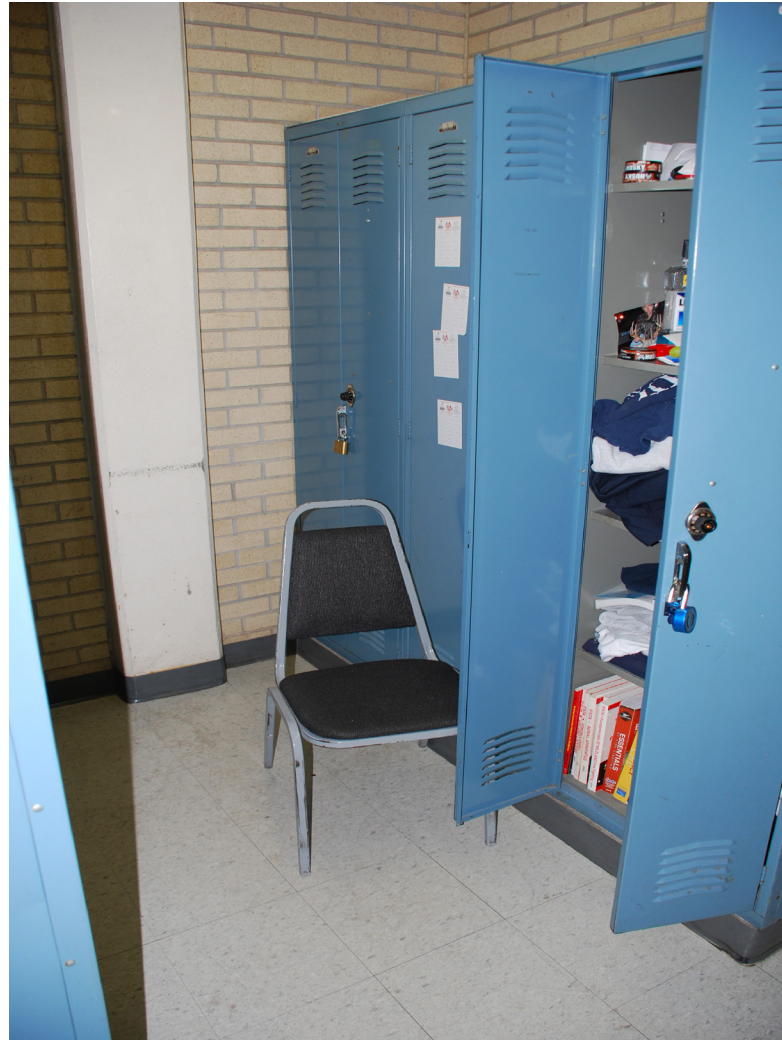
In the locker banks on the left side of the locker room there is no service bench. A resourceful locker owner has appropriated a stackable chair from the dayroom and brought it into his space to provide desired seating. Imagine this locker aisle space if each firefighter were to bring in a chair to use. Each firefighter should have exactly the same locker situation. The layout of any commonly assigned space should be exactly the same for all. This applied to personal lockers, food lockers, PPE lockers or even beds. If one fire fighter has a window over his/her left shoulder in the bunk room, then every fire fighter assigned to sleep there should likewise have a window over their left shoulder.

To the credit of all shifts at Station 1, it appears that the locker room is being well maintained.

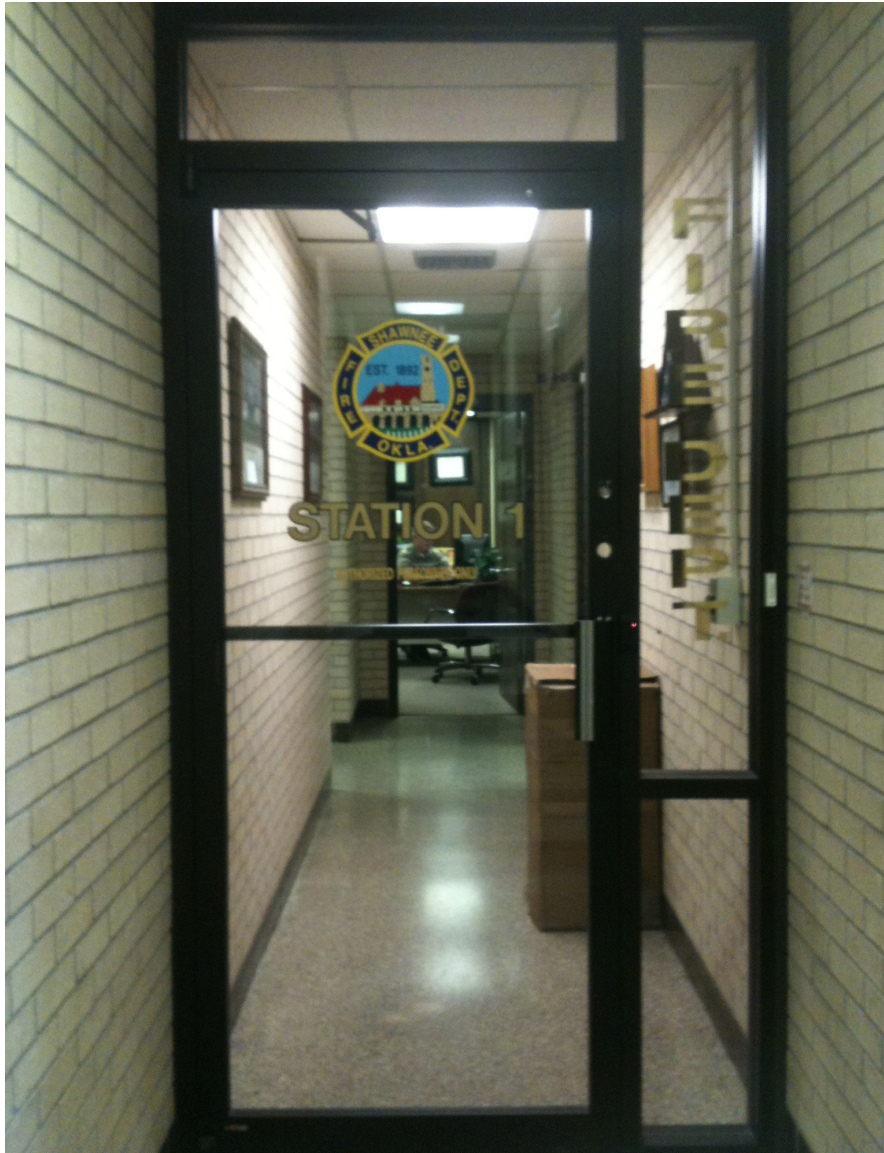
entering the fire department’s “administrative corridor” must have first passed through the outer control door at the City Hall lobby. To get through the outer control door visitors must first get the administrative assistant’s attention to have the outer control door’s lock remotely released. If the administrative assistant is away from the office for any reason then visitors at the entry portal to the station must wait. Not good customer service.

The fire department’s administrative assistant’s office, once a conference room, is too remote from the chiefs’ offices and hinders somewhat any desired quick face-to-face working relationship. The image shown above is looking back toward the City Hall Lobby. The door to the left is the fire department’s administrative assistant’s office. To the left side of the FD’s Administrative Assistance office is a Police Department Prisoner Holding room. Prisoners brought into the police station via the sally port potentially mix with fire department staff and visitors in getting to this room.

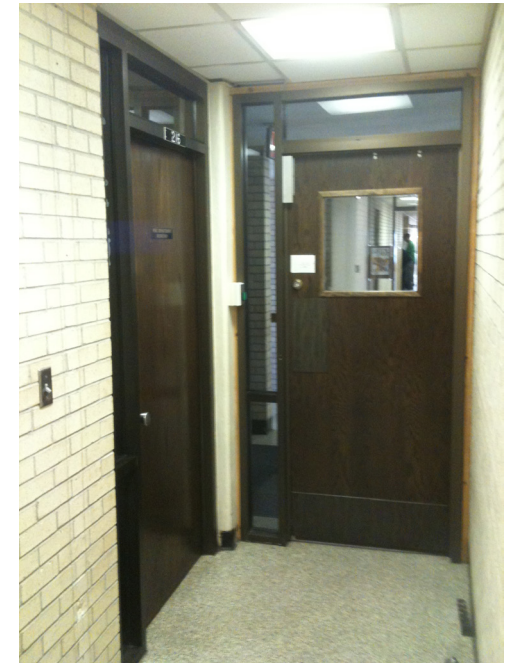
The open door in the distance is the doorway to the Fire Chief’s office.

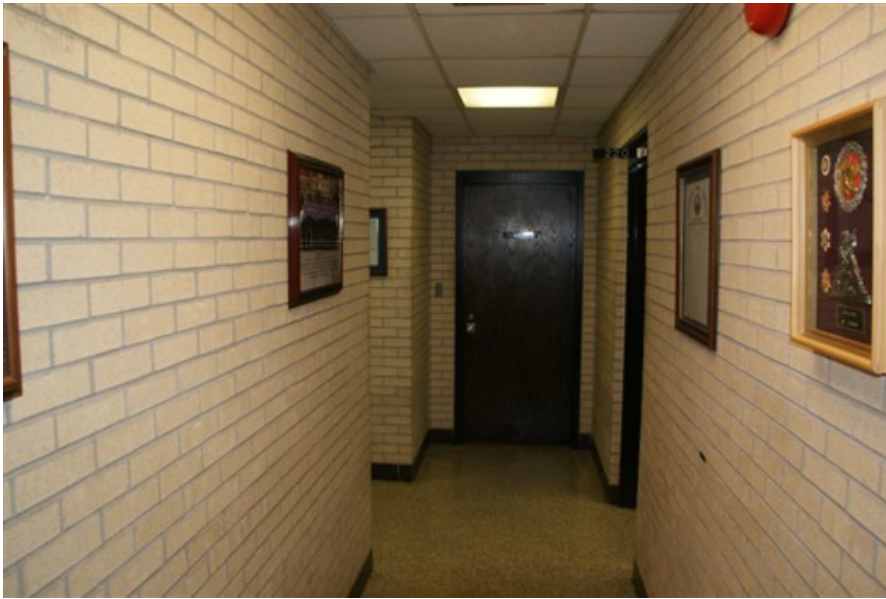
The inner hallway with the door to the Fire Chief's office closed.

The door on the right after passing the second control door was originally the Fire Marshal's office but is now the office of the Deputy Fire Chief. The same room serves as the "quartermaster" storage for the fire department. Stored there are firefighter uniforms and other personnel equipment and supplies for use by the department. The hallway to the left leads to the fire station's kitchen.

Memorabilia on the walls of the corridor is interesting and worthwhile to hang for visitors to enjoy, but you cannot stop to study the material without feeling you are blocking routine traffic flow in the corridor. Consequently, few visitors enjoy the display. The memorabilia would be great decoration for the walls of a receiving lobby.

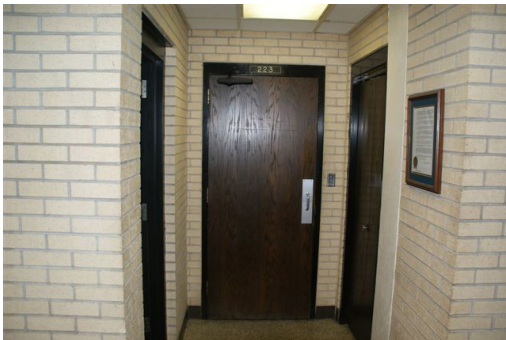
Turning left at the end of the "entry" hall is a short hallway to the door leading to the fire station kitchen and dayroom. The door on the right is a small coat closet. The door on the left is a small toilet/bathroom designed as a private facility for the chief officer. It is now used as the toilet facility for the administration area of the fire station.

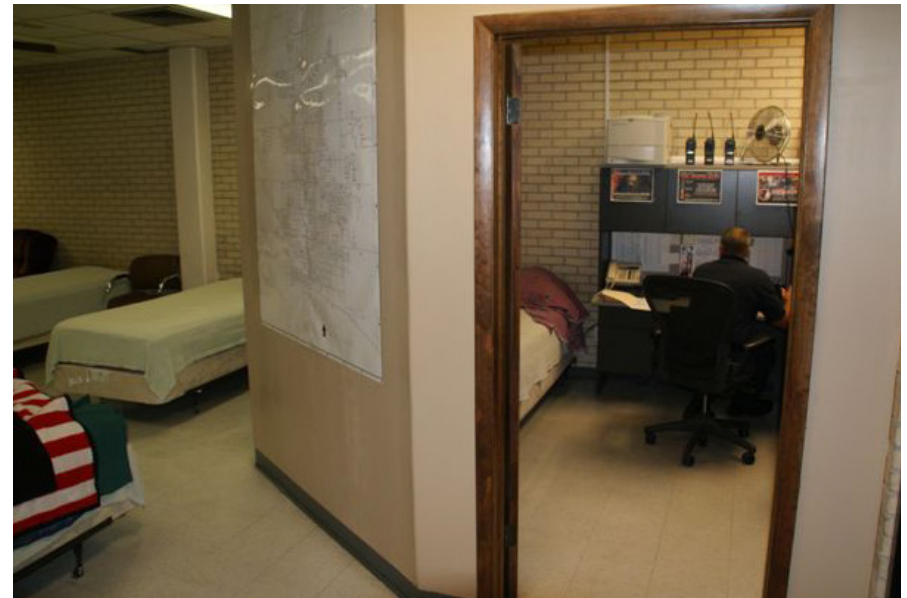
At some point in the history of Station 1, an office and sleep space for the Battalion Chief was "carved" out of the space that made up the dorm room.

At the time Station 1 was constructed, SFD did not even have Battalion Chiefs. Battalion Chief's typical duties most certainly require an office in which to perform the multitude of paperwork necessary for accountability issues and the required documentation necessary to track alarm response and actions taken, etc. For an alarm response, fire fighters must snake their way to the apparatus floor through the BC's office and out the door shown.

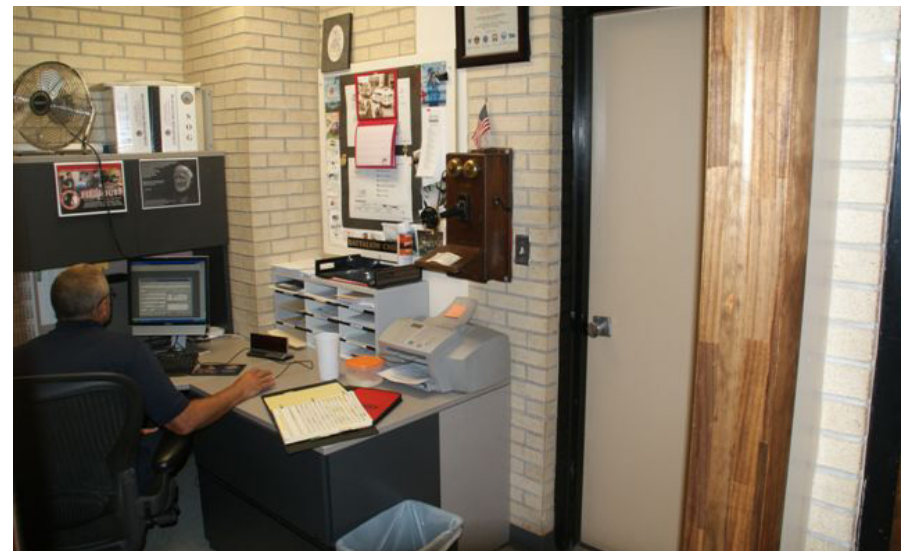
Traveling to the apparatus floor in responding to an alarm from anywhere in a station is all about the flow. The flow should be as straight and as uninterrupted as possible.

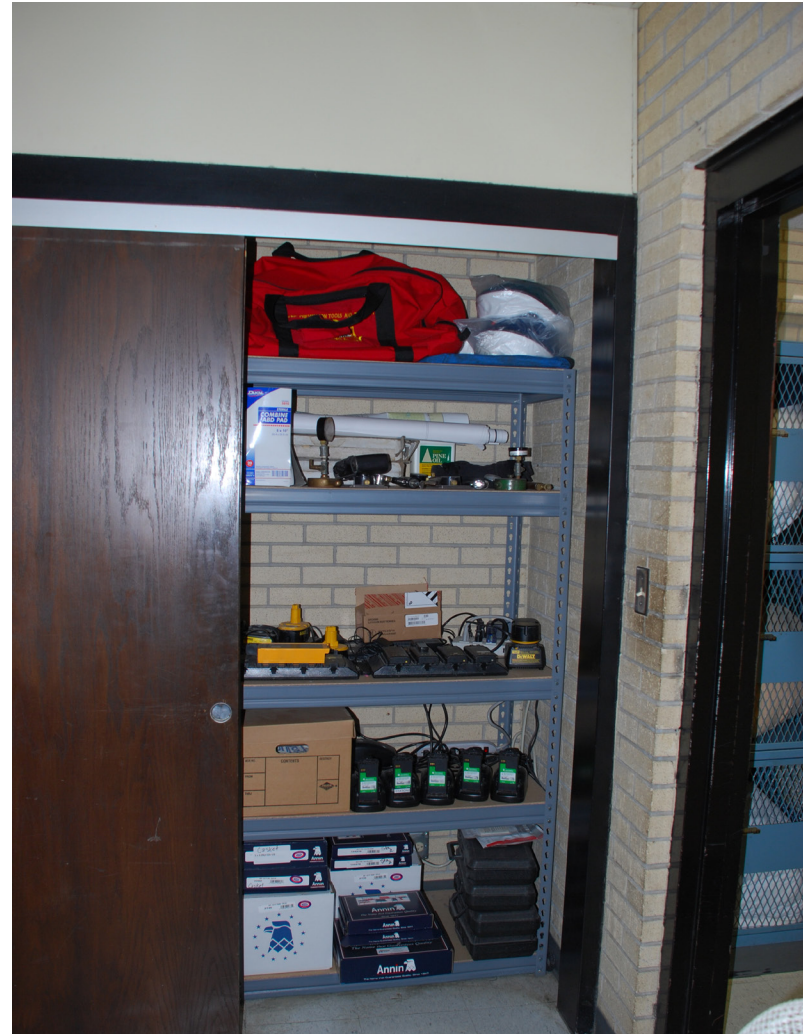
The radio rack for recharging portable radio batteries is now housed in what was originally intended to be a linens closet located on the west wall of the dorm. The closet is used to store other miscellaneous items. This adaptation further points to the almost total lack of storage and supply closets in the station.
