Section06 FireStationNo.3

Background for Shawnee Fire Station 3

Assessment Commentary

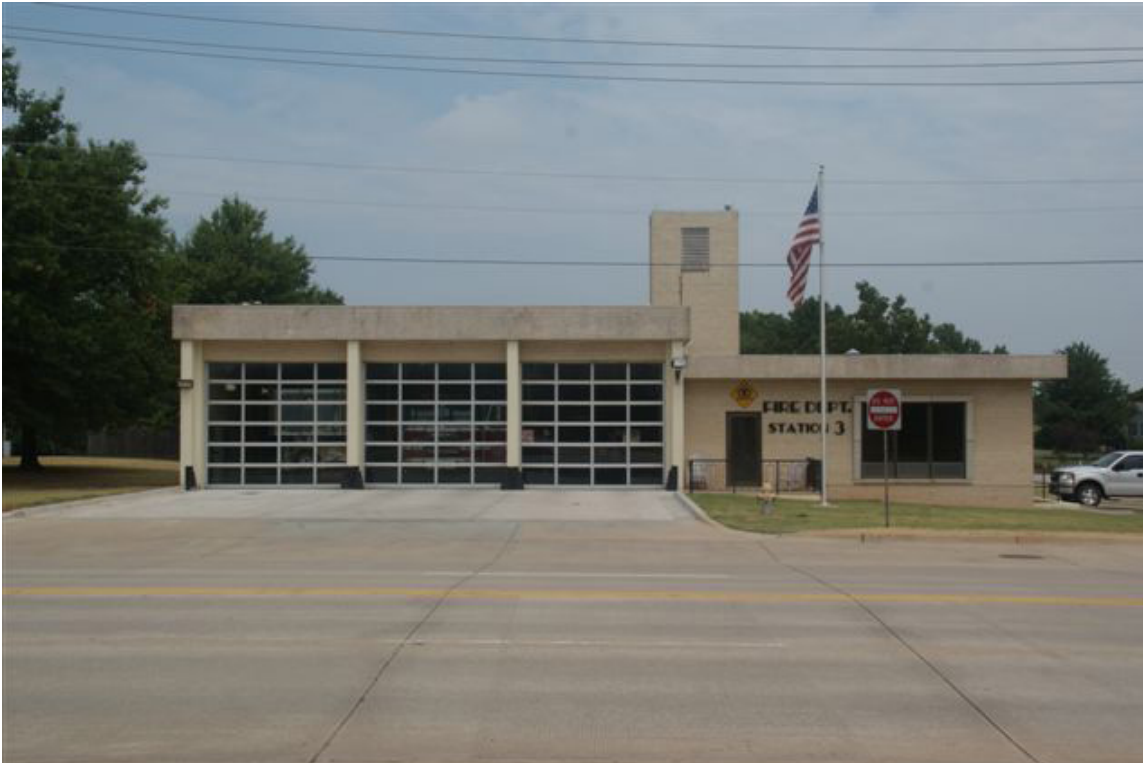
Unlike Stations 1 and 2, the visitor's entrance to Station 3 is visible to the passerby from MacArthur. From the Oklahoma Avenue side visitor's parking spaces, however, the entrance is not discernible. A sidewalk leading from the visitor's spaces does lead to the front entry, but in a roundabout way. Any user of the side parking spaces must walk past the front landing, step down at the apron's curb, twist around the entry pad rail and step back over the very same curb to reach the entry pad. Awkward, to say the least.

The "text" graphics applied to the facade at the entrance is a bit clumsy in that the Safe Place sign is in the shadow of the roof overhang while the letters used to identify the station are awkwardly mounted with respect to the "design relationships" created by the door, the window and the space between the door and window. While the front entrance has a "safe place" placard, the door is by necessity always locked, and blinds are drawn, creating an unwelcoming entrance for the "safe place."

Currently the public enters directly into the dayroom. As discussed before, this space is a semi-private living space for the firefighters. Only "invited" guest should gain access to the dayroom. The public should be able to enter the building via an unlocked control point easily accessible from a parking lot. They should be able to enter a small foyer or vestibule out of the weather. They should not be able to go no further into the station until contact is made with personnel manning the station. This "control" point will typically have a phone or a buzzer to gain the attention of on-

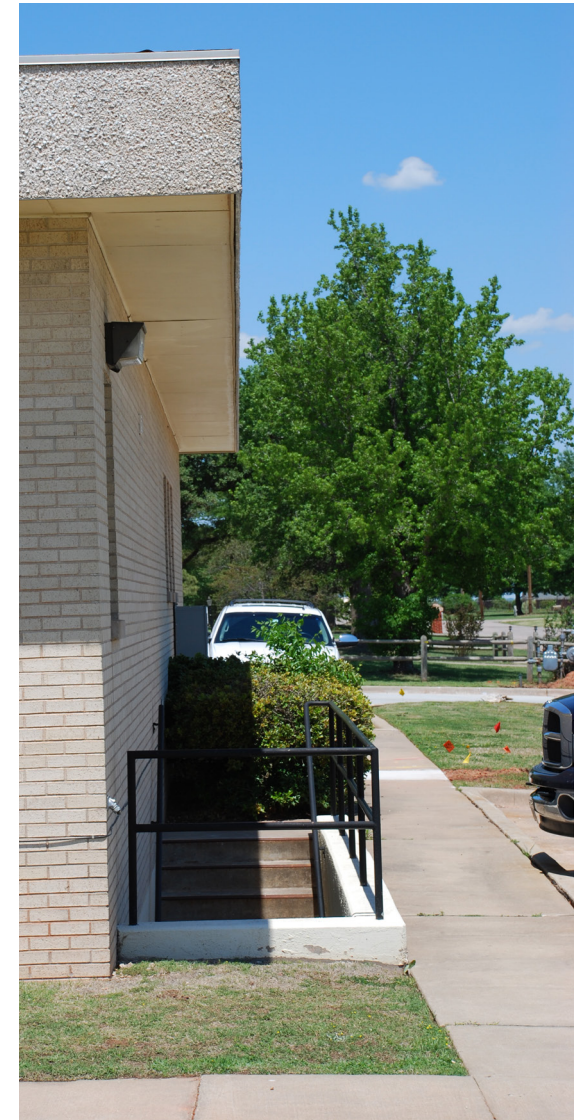
This staircase in the image above is the emergency exit from the basement and must be maintained.

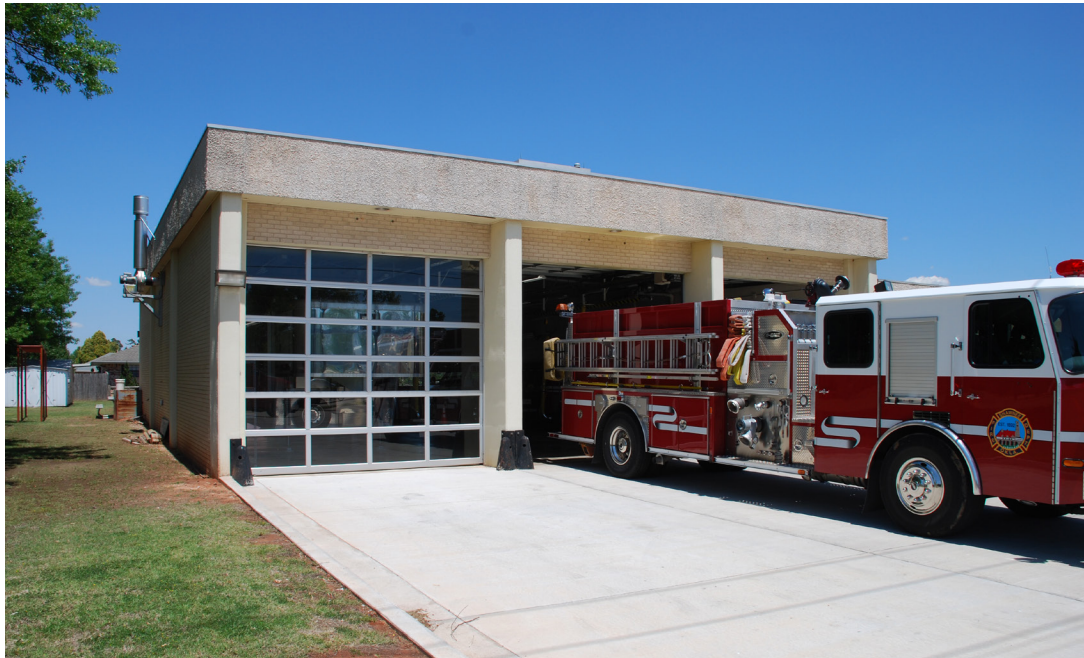
The image of the station could be embellished somewhat by putting apparatus numbers or the station number or name on the spandrel panels or façade above the bay doors. This would further identify the buildings purpose to those who pass by the front of the station. Station identification and location is important. Being constantly reminded of it presence makes for easy recall if a situation requiring immediate attention ever arises.

The light on the corner column should point down or be a sconce style wall-wash style light. Lighting designed to illuminate the apron should be either indirect on the building or pole mounted to illuminate from above.

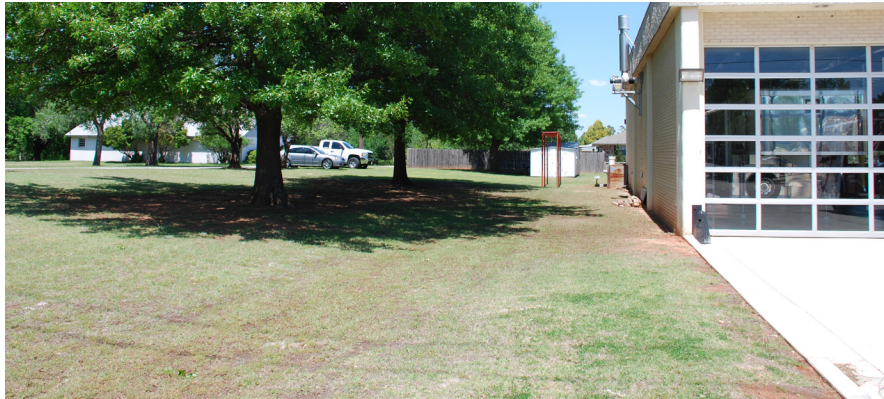
Space wise, the station can be easily expanded to the west. The support columns visible down the west side allow for the brick walls to be removed. Rooms for support functions such as a workshop, SCBA maintenance room, equipment storage, and facilities maintenance, could be added to the station without difficulty.

Note the car and truck in the picture. They belong to shift personnel. They are parked off an alley because there is not adequate parking for personnel at shift change within the defined parking areas.

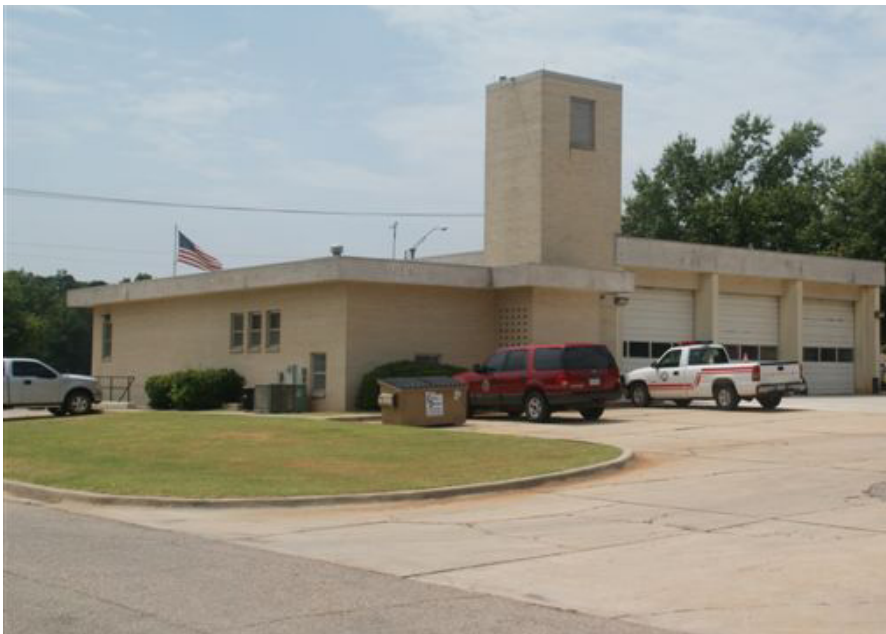
The image to the left was taken looking SW. A large generator has been added to the lawn area just off this NE corner. The 3 window set is at the dorm while the single window is in the kitchen area. The lone "foundation" planting serves no purpose. From this view of the visitor parking area one can barely discern the pathway to the "front" door of Station 3.

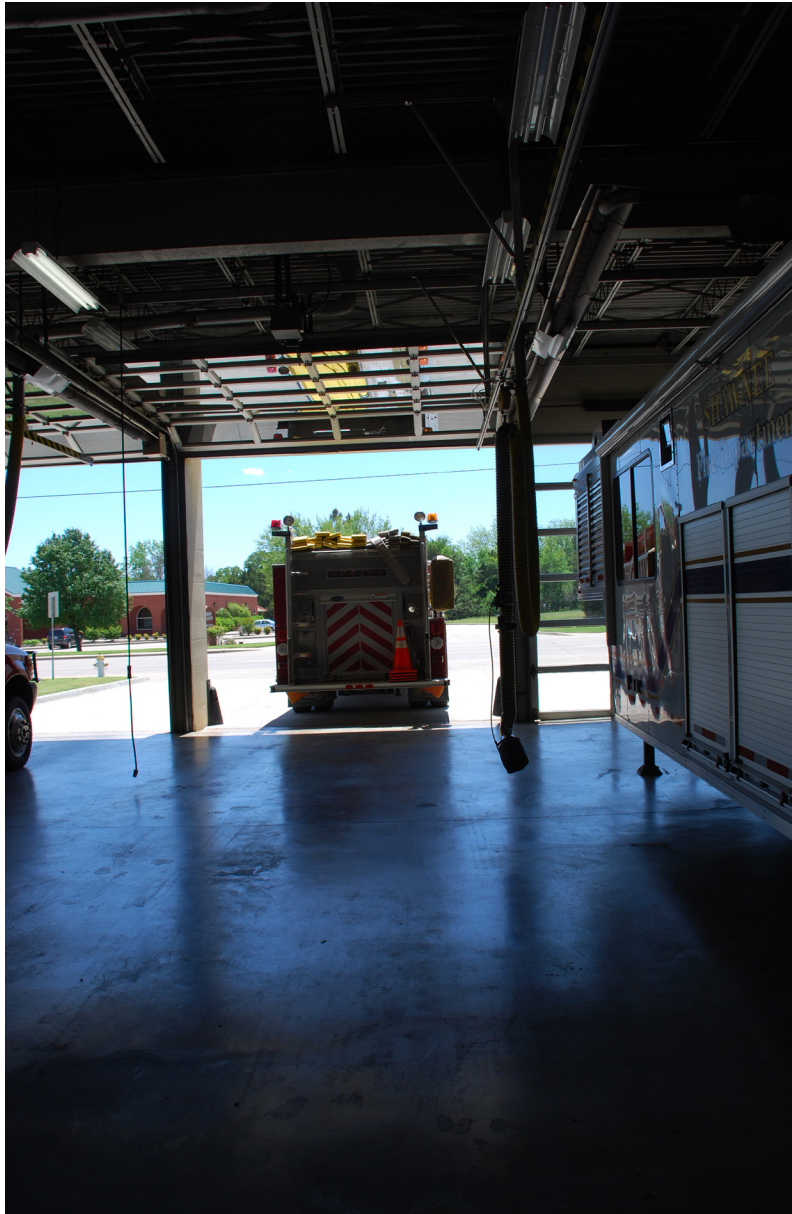
Above is an interior view of the center bay looking south showing Engine 3 positioned on the front apron. Station 3 houses the Shawnee Fire Department's Region 6 Disaster Response Trailer which can be seen to the right.

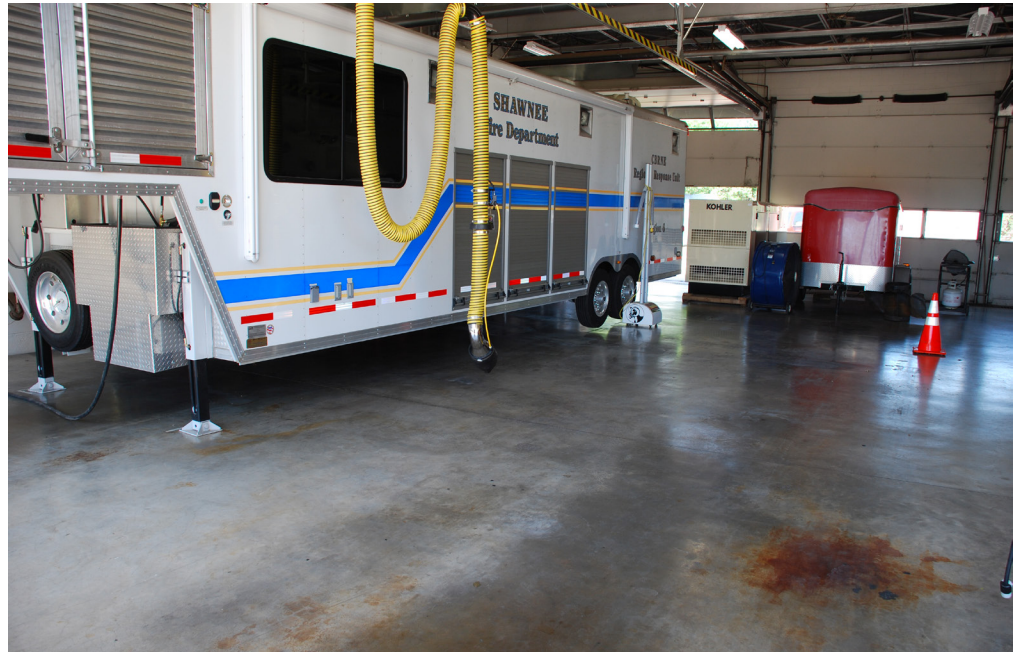
The trailer cannot be kept attached to the tow vehicle because the bay is not long enough to accommodate both the tow vehicle and the trailer. Extending this bay reward would alleviate this problem, allowing the tow vehicle and trailer to be stored in a response-ready state. Note the storage of equipment behind the trailer which will prevent it from being returned to its position in the station via a drive-thru return to quarters. The trailer is stored with the jacks down to prevent flat spots on the tires.

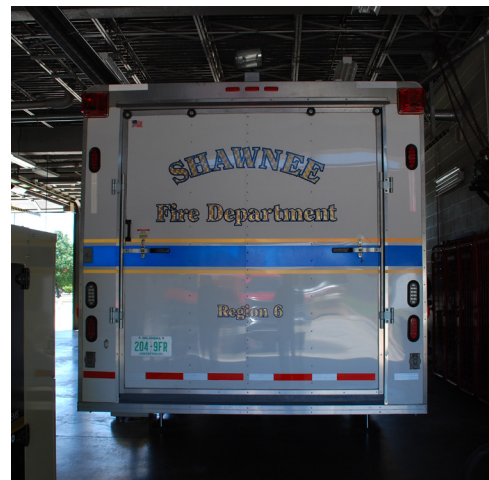
Note in the image above the small trailer blocking the drive-thru function of the center bay. It may be possible with the current station footprint to move the regional disaster trailer forward and put the training trailer behind it. It may, however, have to be turned sideways to the bay centerline. Turning the trailer sideways to the bay will require it to be hand jockeyed into position whenever it is used on an assignment.

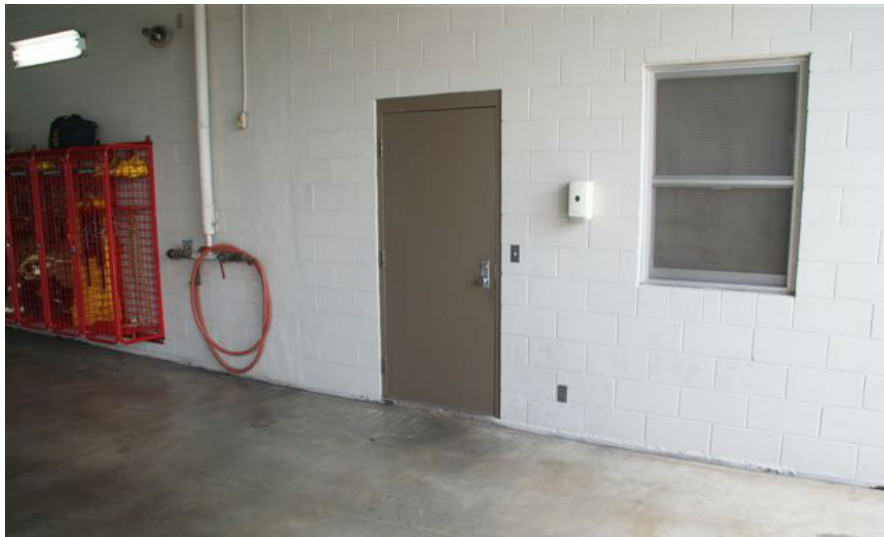
In the image above, the window to the right of the door to the dayroom was intended to serve as the “Watch Room” for the station as there is a built-in desk on the other side. At the time Station 3 was constructed, most stations had a Watch Room. The purpose of the Watch Room was to have someone man the room to insure the security of the apparatus floor and to insure the station personnel knew when there was a “Visitor in the House.” This Watch station fails because it is combined with the semi-private dayroom/kitchen area and in effect dissolves the privacy of these “home” areas. To deal with this shortcoming, drawn blinds block the window.

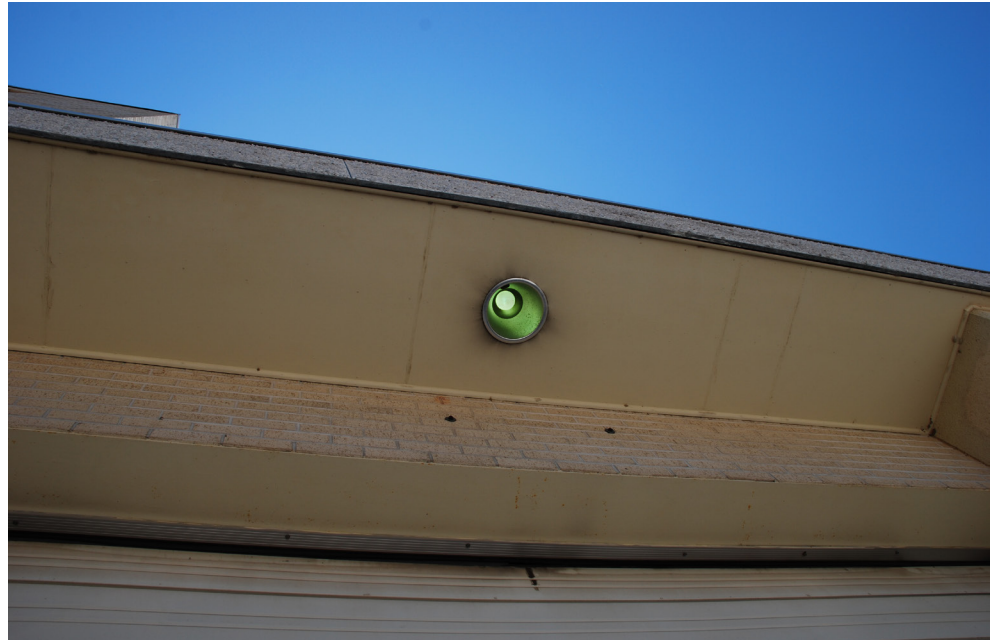
While this light fixture may be antiquated with respect to performance, recessed lighting such as this for illuminating bay doors is the way to do it. The recessed “can” light fixture used should be a design without a lens. A lensed fixture will simply create long term cleaning issues because insects will invariably fill the inside of the fixture on the top side of the lens and occlude the light.

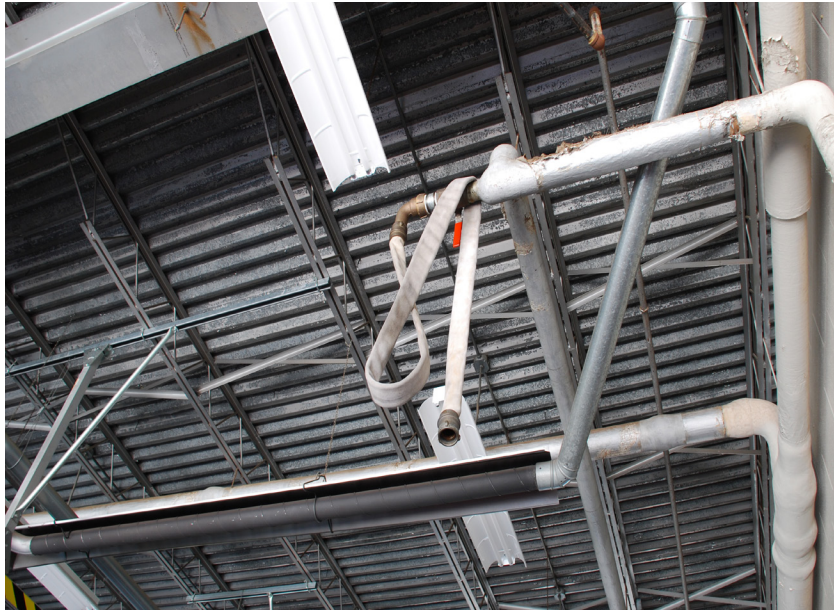
The purpose of the looped hose dangling overhead in the apparatus bay is to refill an apparatus' water tank from the top of the apparatus. All apparatus water tanks have a vent/surge stack on top. The stack has a hinged cover. The hose in the picture can be placed in the stack to refill the tank. But apparatus tanks can also be refilled from a inlet valve mounted on the pump panel.

Most fire departments are doing away with these overhead mounted fill stations. They are doing so in the name of personnel safety. There have been numerous accidents and even a few deaths from falls off apparatus resulting from firefighters trying to perform task, including tank refill, on top of fire apparatus.

Most stations today are being designed with at least one 1-1/2" connection on the apparatus floor at what amounts to fire hydrant level. Fire apparatus tanks can also be topped off at the fire station using the station's yard hydrant.

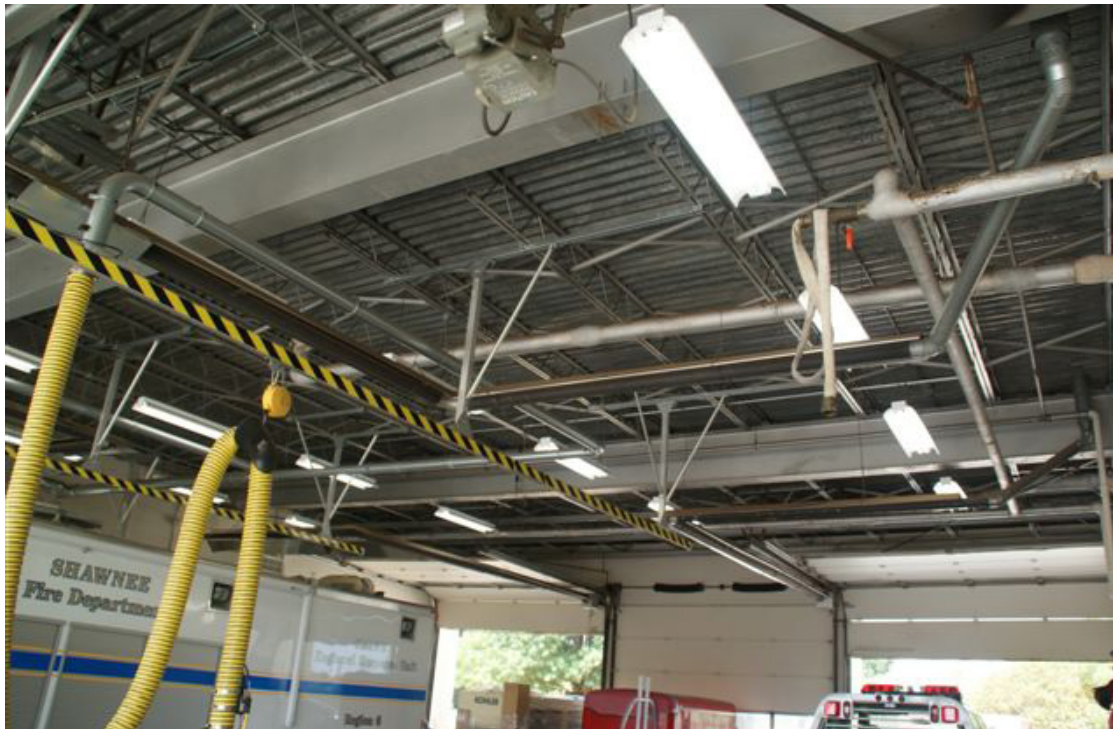
At Station 3 there are any number of head-banging opportunities for anyone performing a task on top of a fire apparatus.

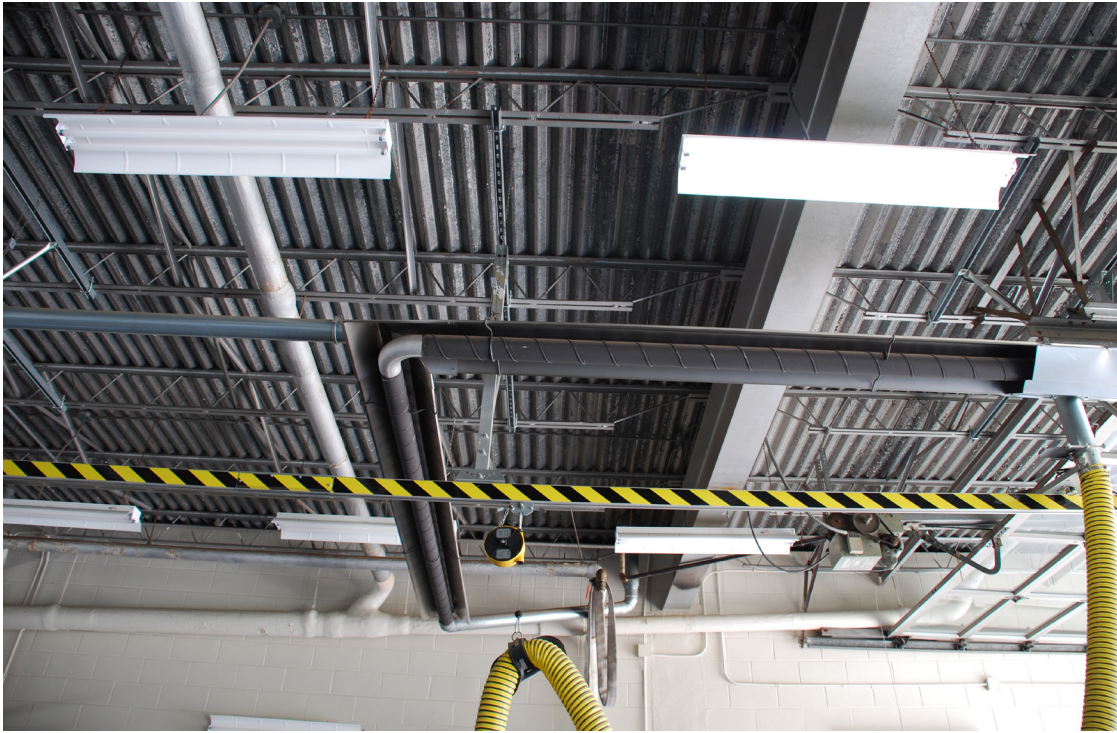
Station 3 is equipped with ceiling mounted gas-fired infrared heaters on the apparatus floor. Gas-fired infrared heaters are considered the most environmentally appropriate heat source for an apparatus floor as the technology method heats the objects on the apparatus floor rather than the air of the apparatus floor.

The system at Station 3, however, has a possible flawed layout in that the units are not mounted to hang between the apparatus stalls or between the apparatus stalls and flanking walk. I have never seen an infrared system where a heater unit is bent 90 degrees to cross over the apparatus position.

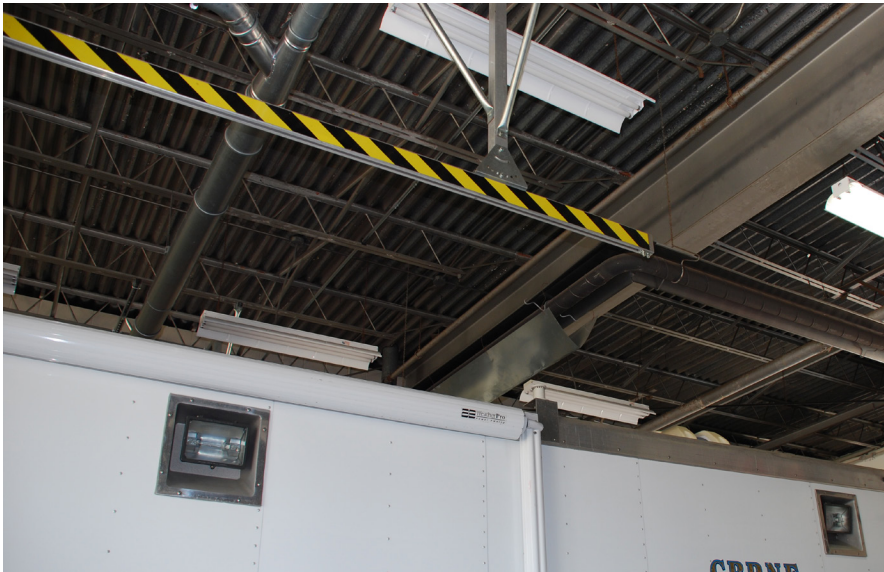
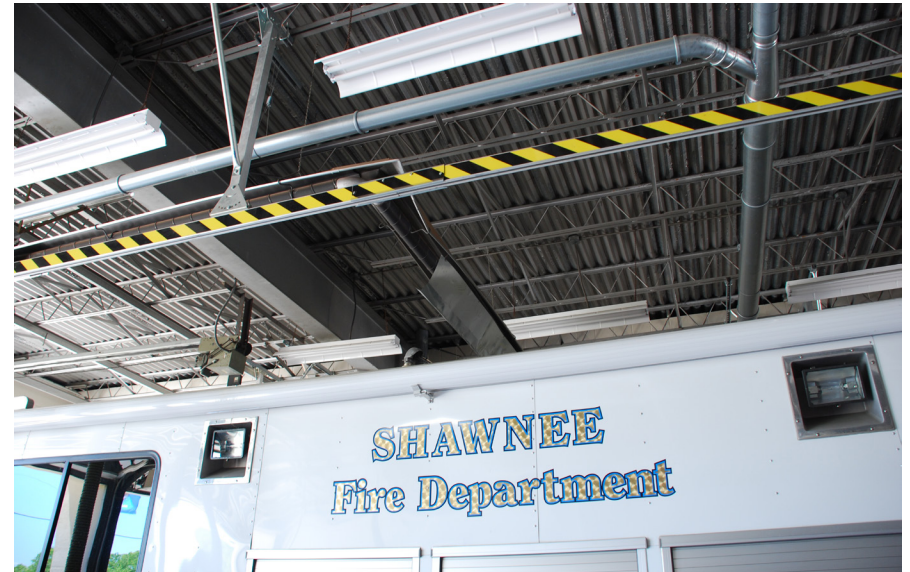
The two images below show a shield installed to the bottom side of the heater to protect the trailer from too much heat. While the shield might protect the trailer it reduces the efficiency of the heater segment.

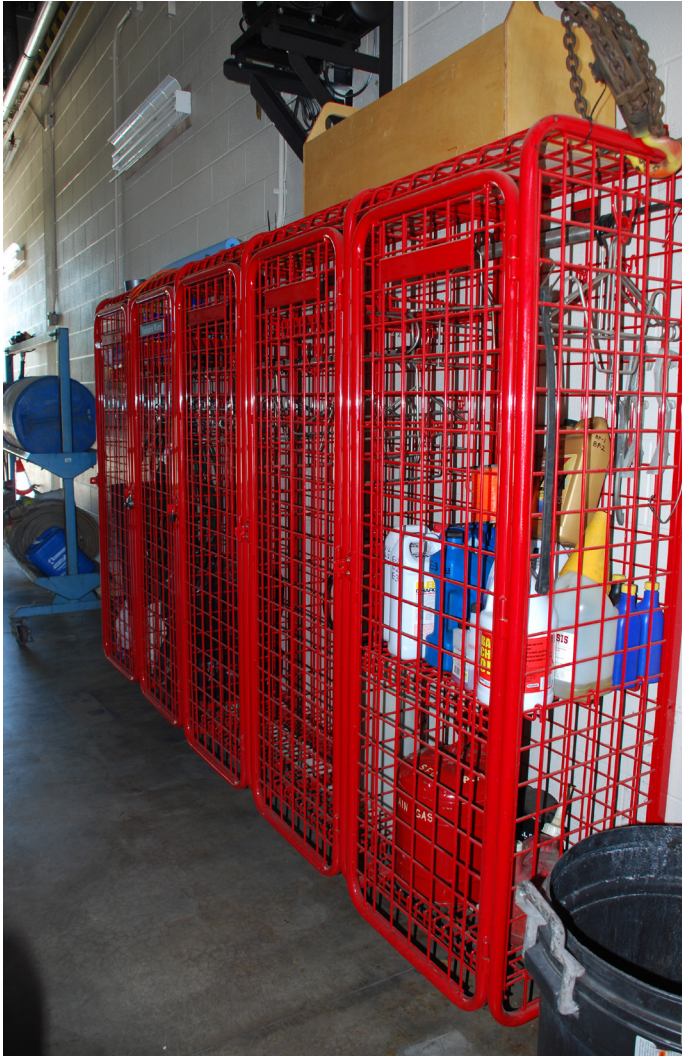
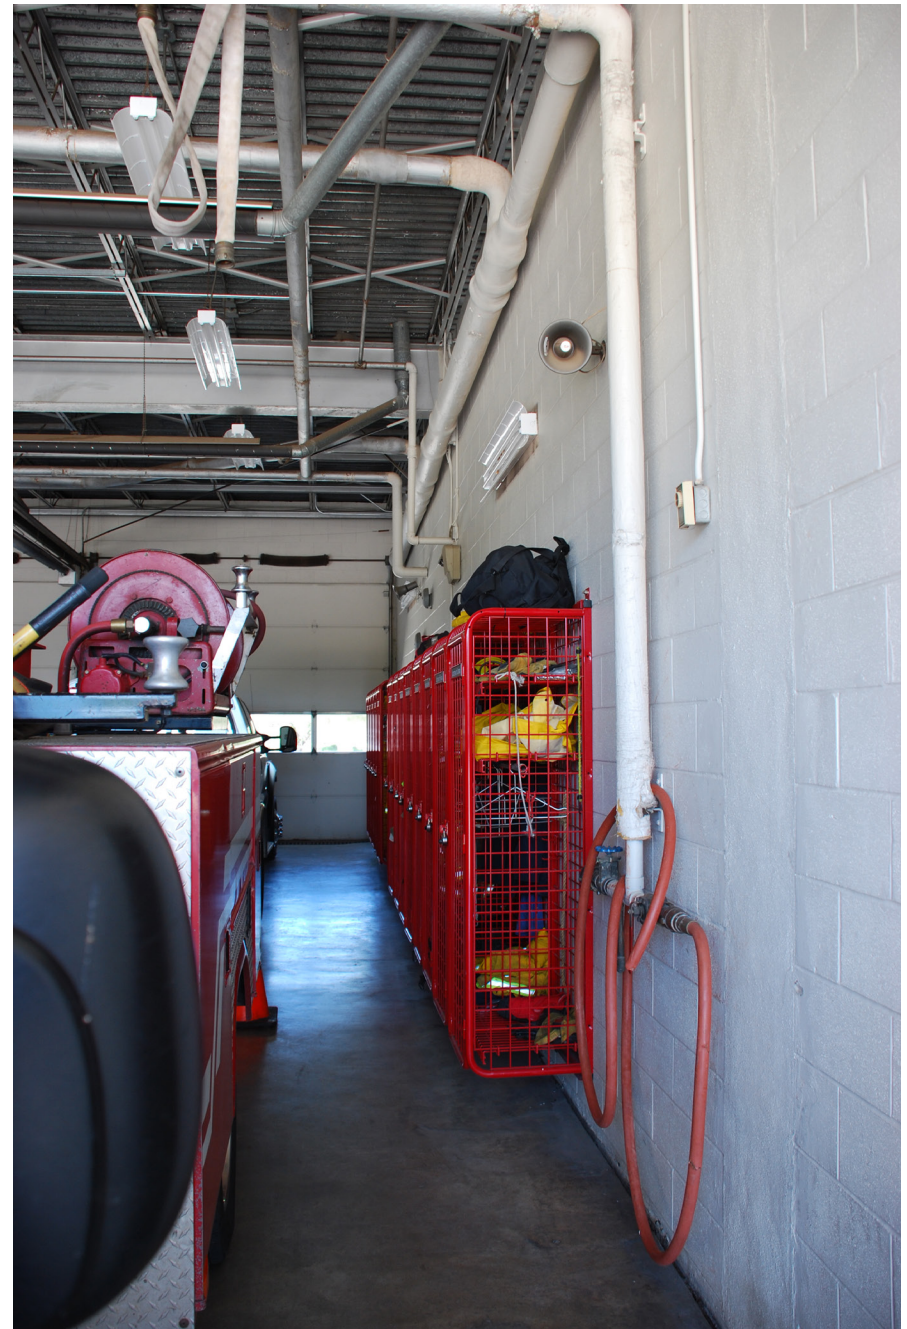
Mounting the PPE lockers on each sidewall of Station 3 has reduced the aisle width. Spotters engaged in backing the apparatus into the station must use extra caution least they inadvertently bounce themselves off the corner of the locker and into the path of the backing apparatus.

On the opposite wall, the PPE lockers are currently being used to store supplies that should be stored in an apparatus support room.

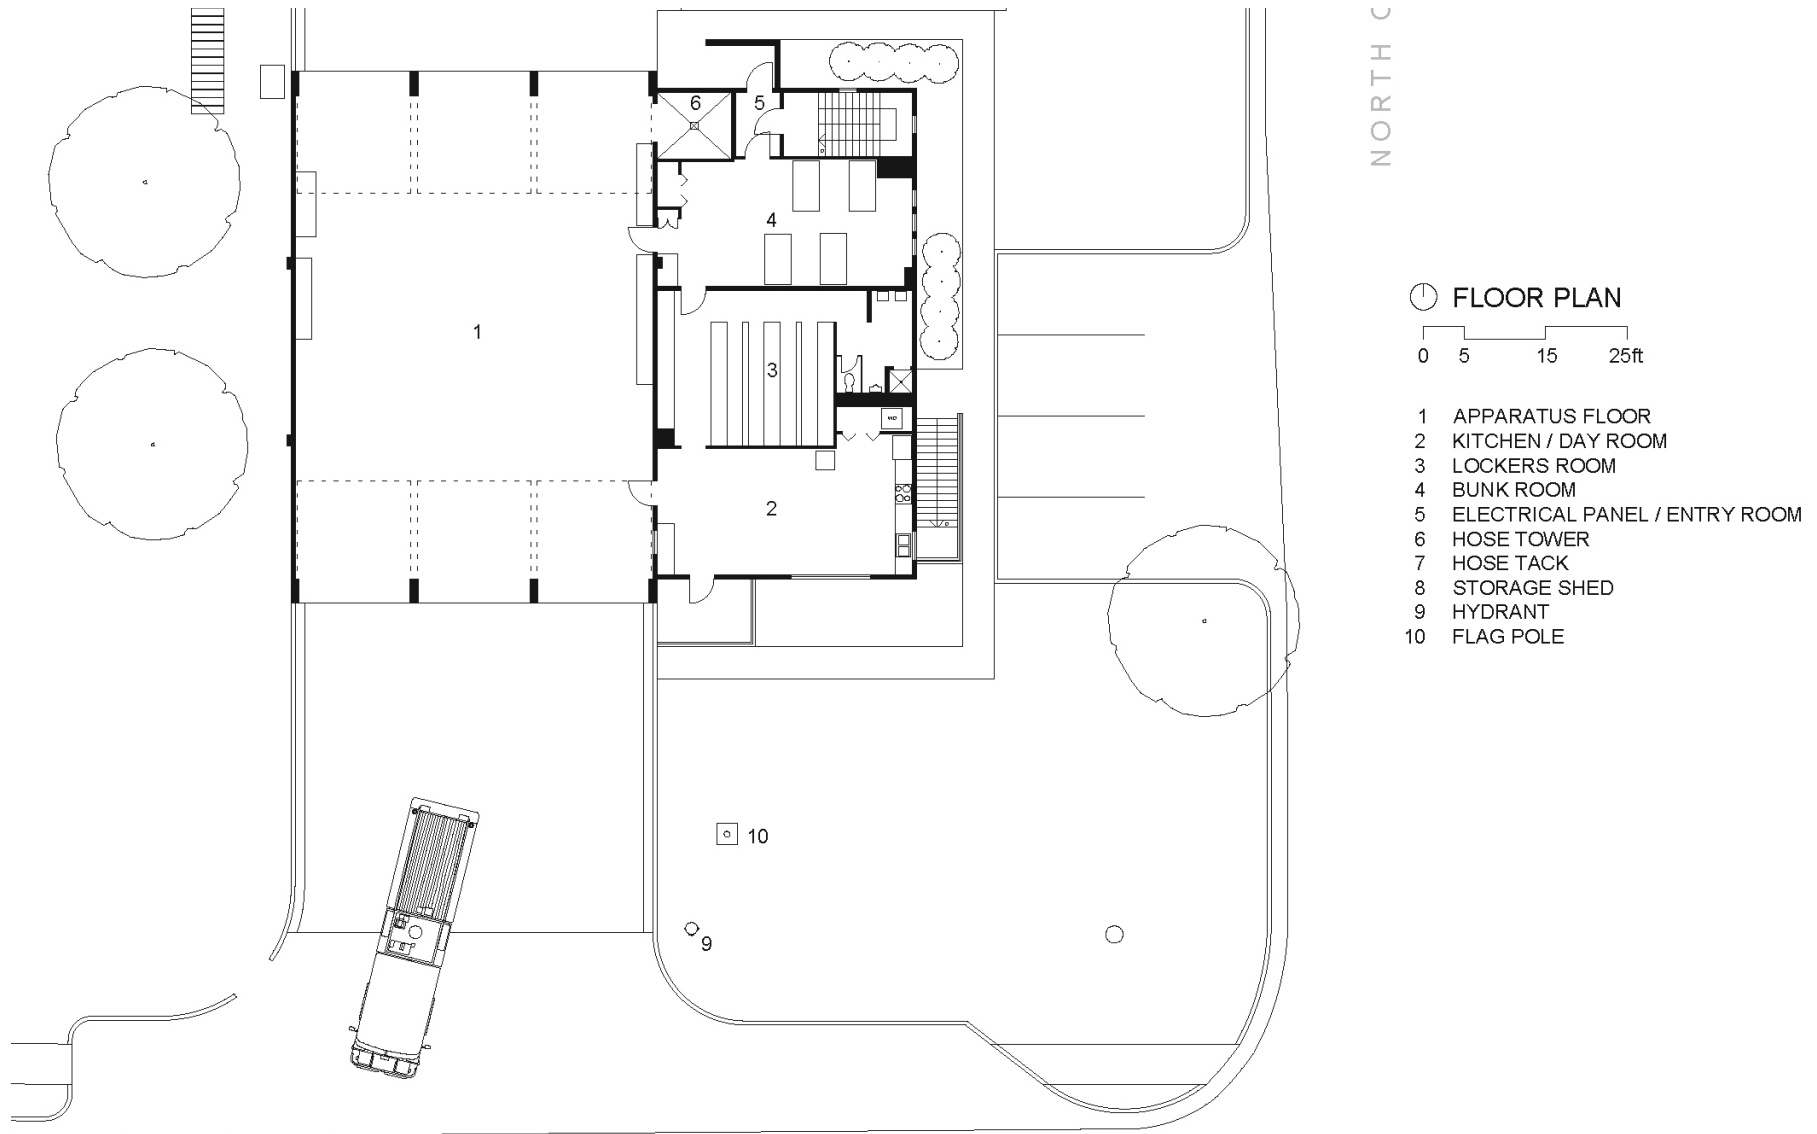
Fire Station 3 Apparatus Floor Support Space Commentary

Space 6 in the plan above, the hose tower, is the only apparatus support space at Station 3. More typically you will find spaces for DeCon, SCBA refill and service, vaults for off-duty personnel's PPE, small engine service and repair, site and building maintenance, a storage room for any training props use at the station, a room or space for radio charging stations, PPE

laundry equipment, toilet facilities, storage of supplies for the station and apparatus housed at the station. A Watch Room that doubles as a report writing space could also be considered as an apparatus floor support space. Federal law on patient privacy in effect requires a report writing room to insure confidentiality for EMT's filling out patient contact forms.

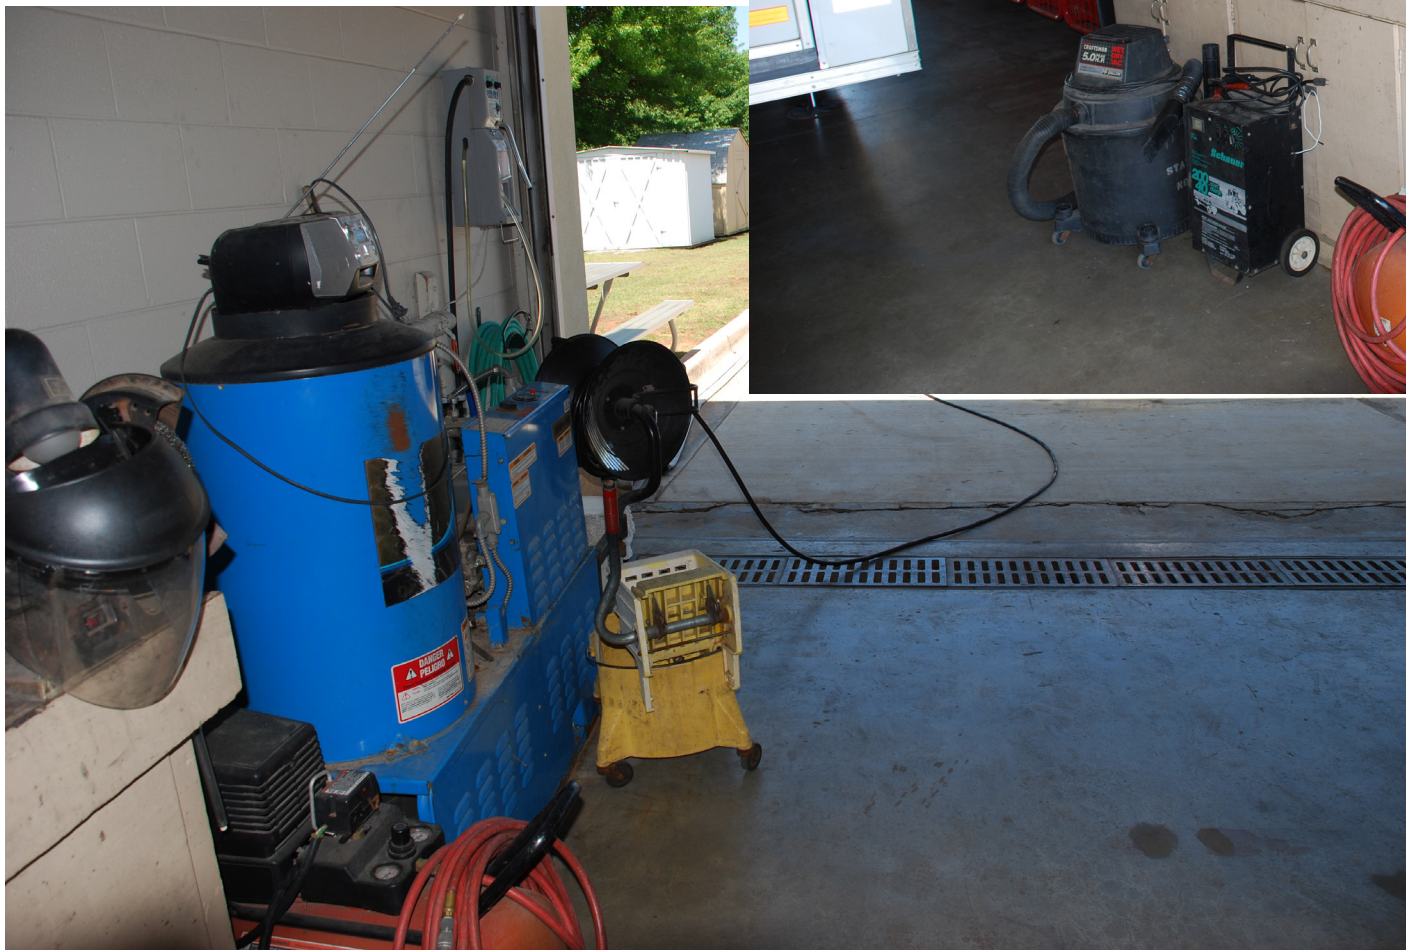
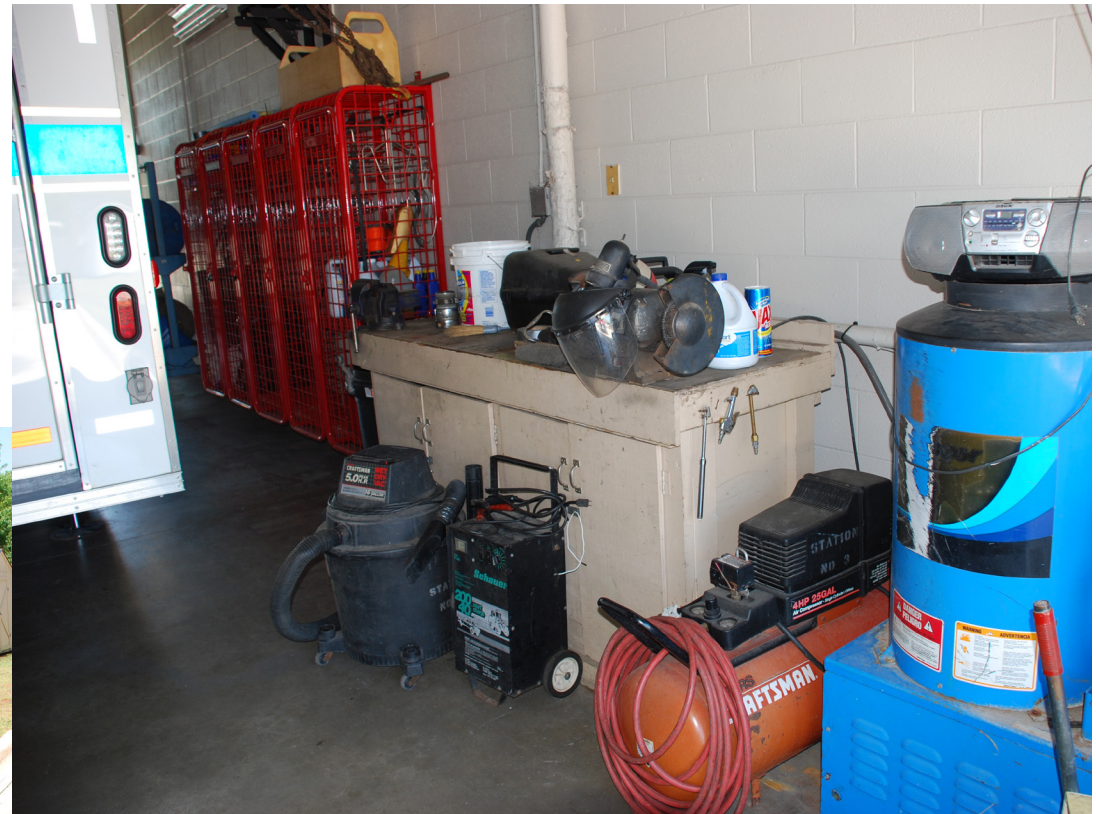
The lack of apparatus floor spaces at Station 3 is a cause of concern because of the large number of items stored on the apparatus floor that is potentially a trip hazard not only to firefighters at the station but also to any visitor.

In the images, we see a whole host of equipment used to maintain the apparatus, apparatus equipment, the station and the station's site cluttering the apparatus floor.

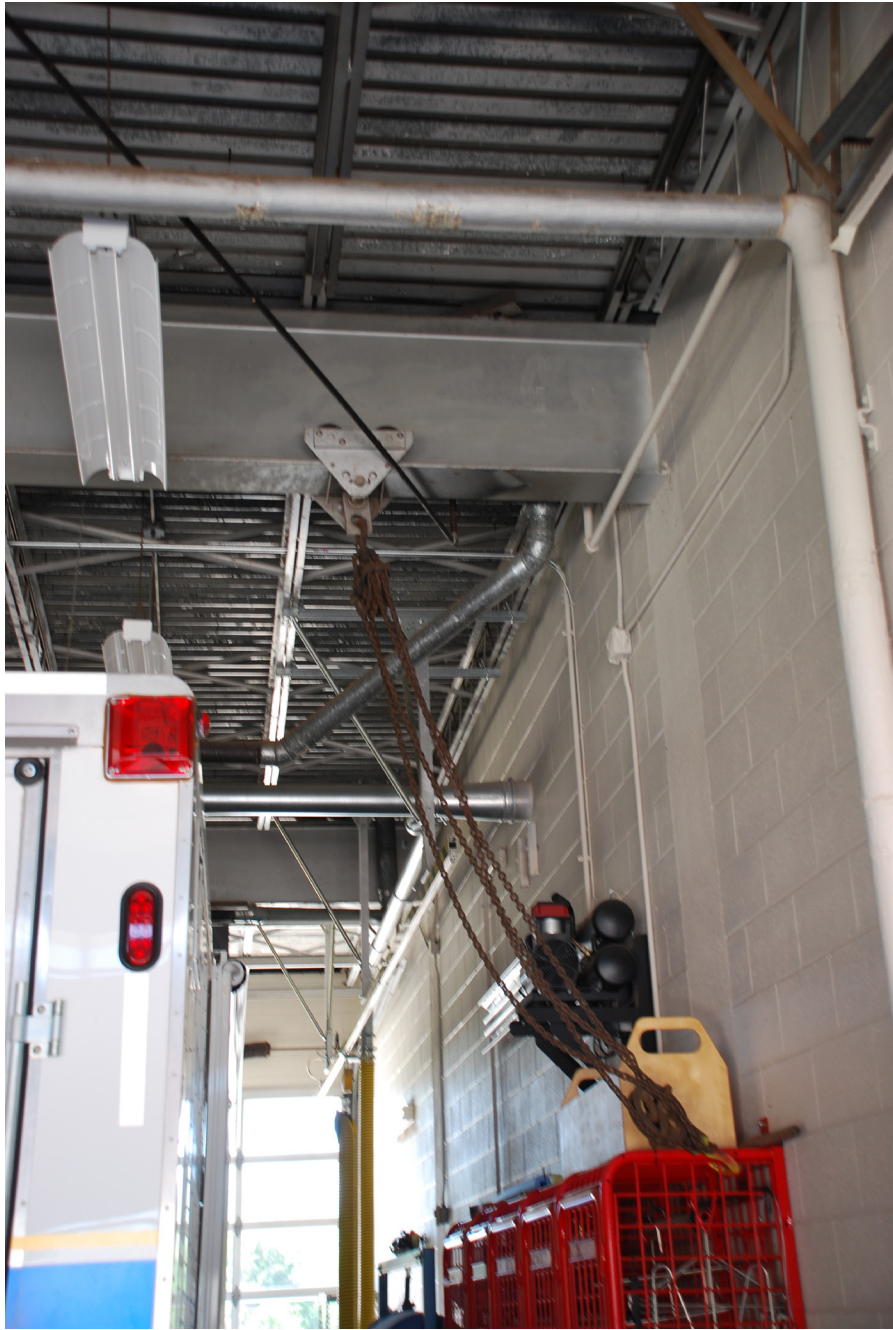
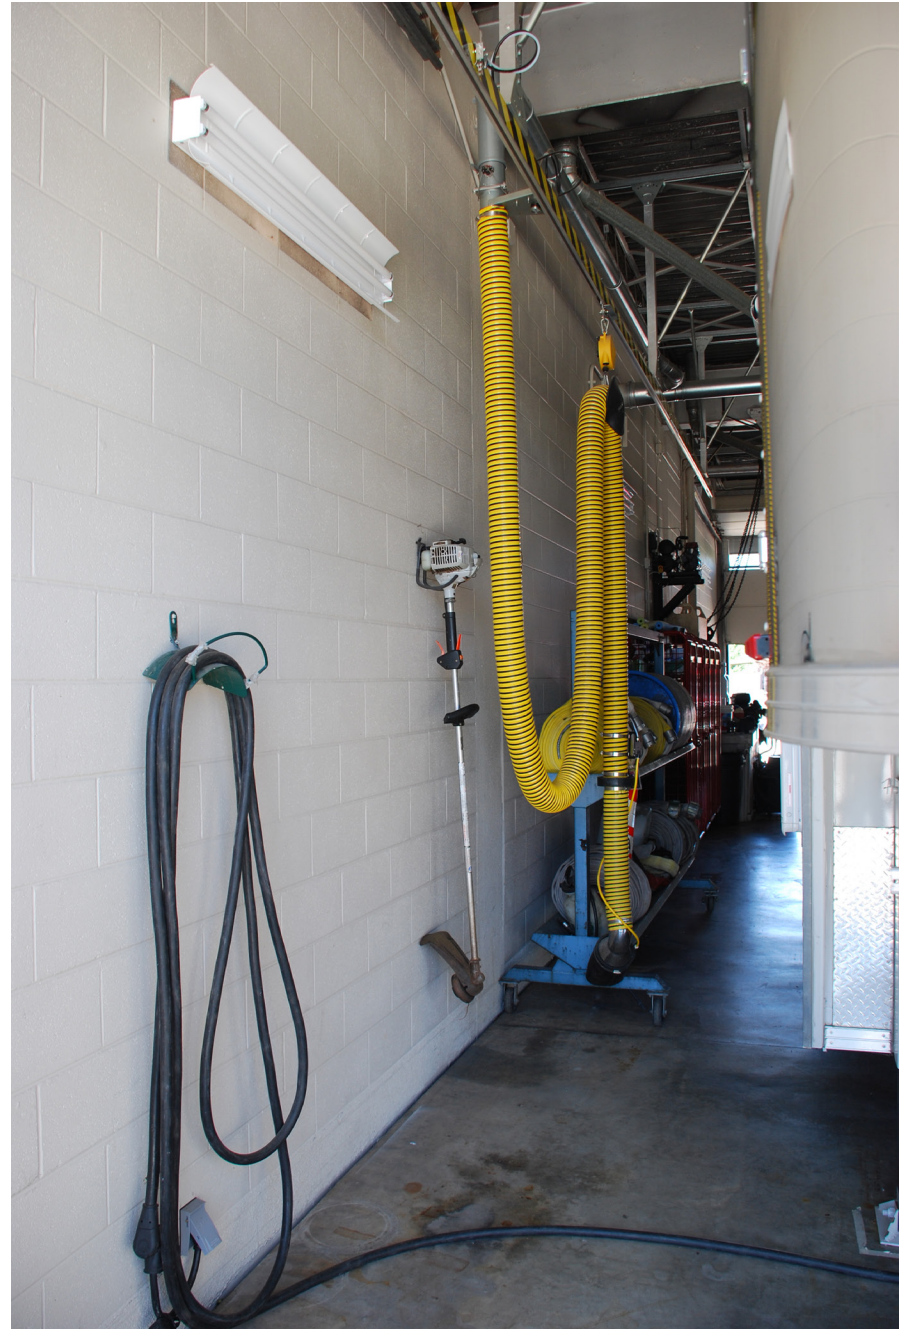
On the next page, note the unsecured chainfall on top of the locker.

Service hoses for air to maintain air brake pressures and power cords to maintain apparatus batteries are best on reels mounted to the ceiling with automatic "shore-line" disconnects on the apparatus.

This view also shows racks for rolled hose storage best placed in a niche or separate room and lawn maintenance equipment best stored in a room with outside access.

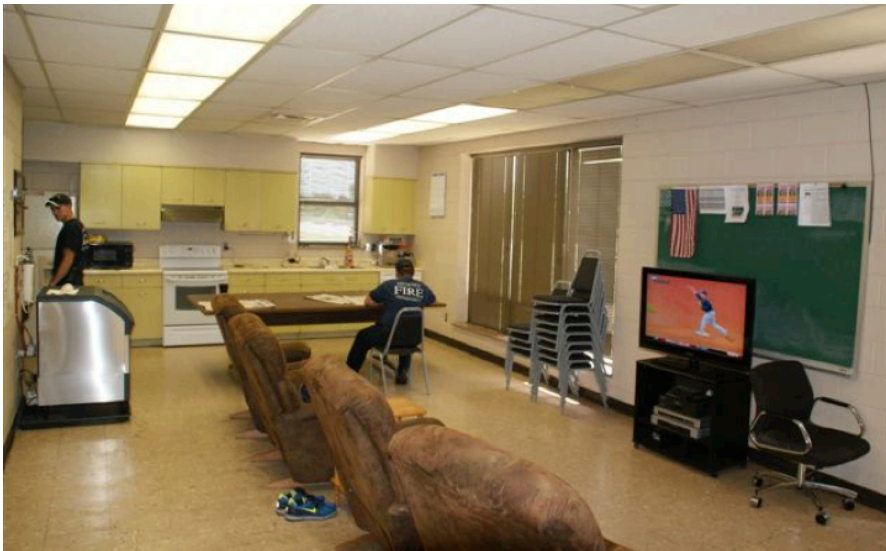
The ice-machine, which is usually very noisy, and dining table chairs when not arranged around the table should be in a closet space adjacent to the dayroom or kitchen. The blinds remain drawn in this room because the window faces south, bringing too much heat into the room.

The “Watch Room” functions intrude into the dayroom as can be seen by the Watch Desk and computer on the right in the image above.

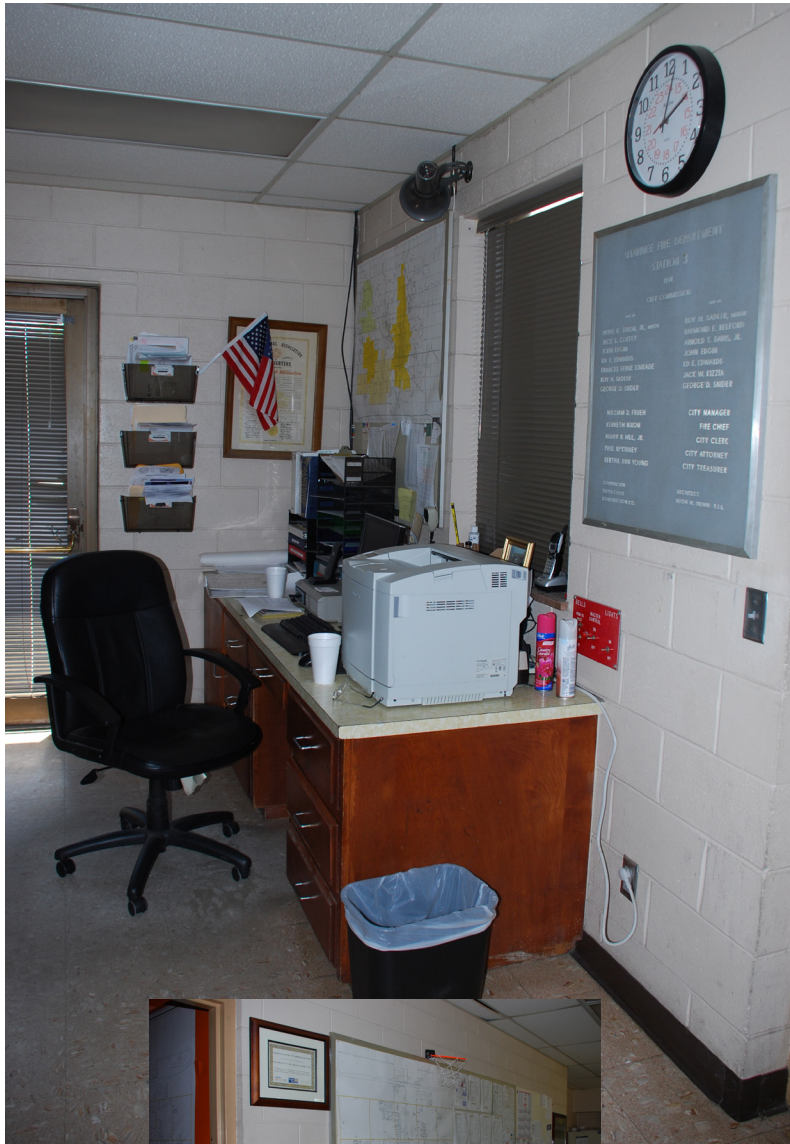
The wall space of the dayroom functions as a bulletin board.

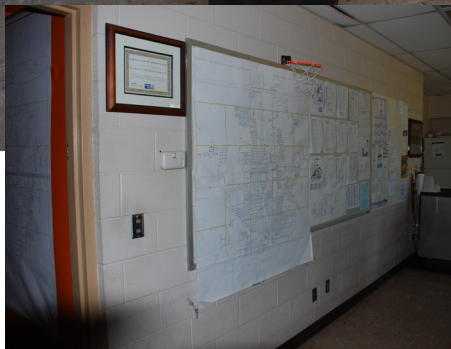
The wall-mounted “Dedication Plaque” is good to have politically and to commemorate the event, but it is best mounted in an separate entry lobby or vestibule. Short of a dedicated entrance space, it would be best mounted on the other side of the wall in the apparatus floor as the apparatus floor in the de facto “museum” and focal space for most fire station visitors.
