Section06 FireStationNo.3

Background for Shawnee Fire Station 3

Assessment Commentary

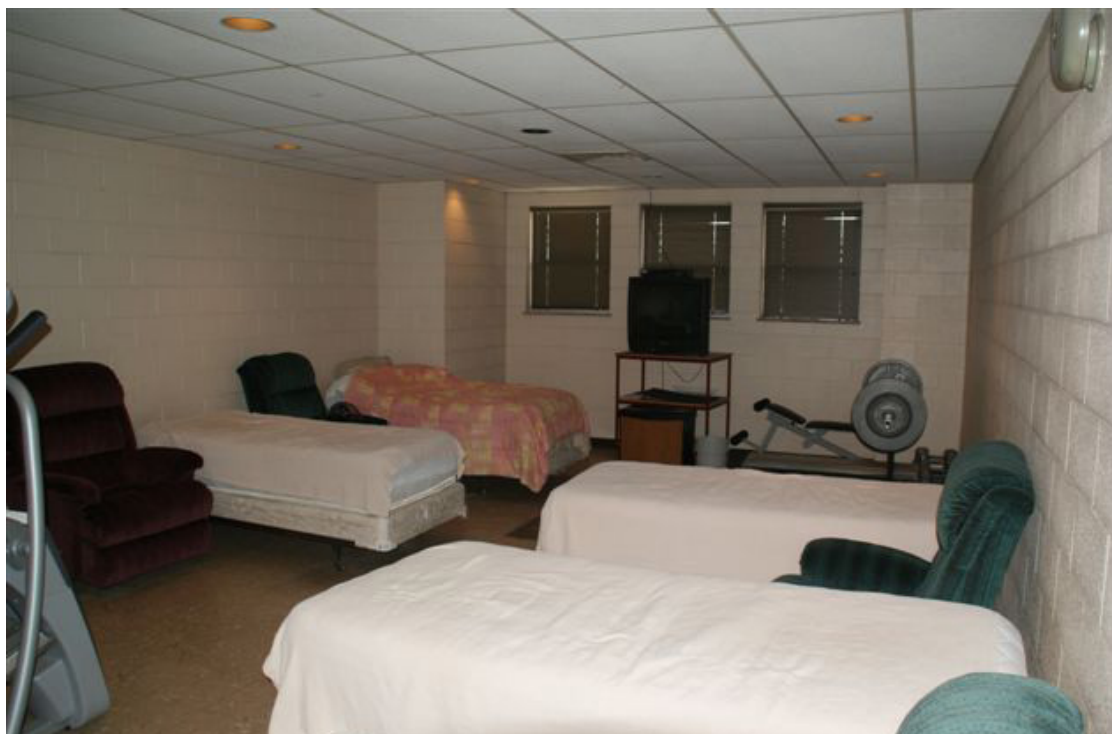
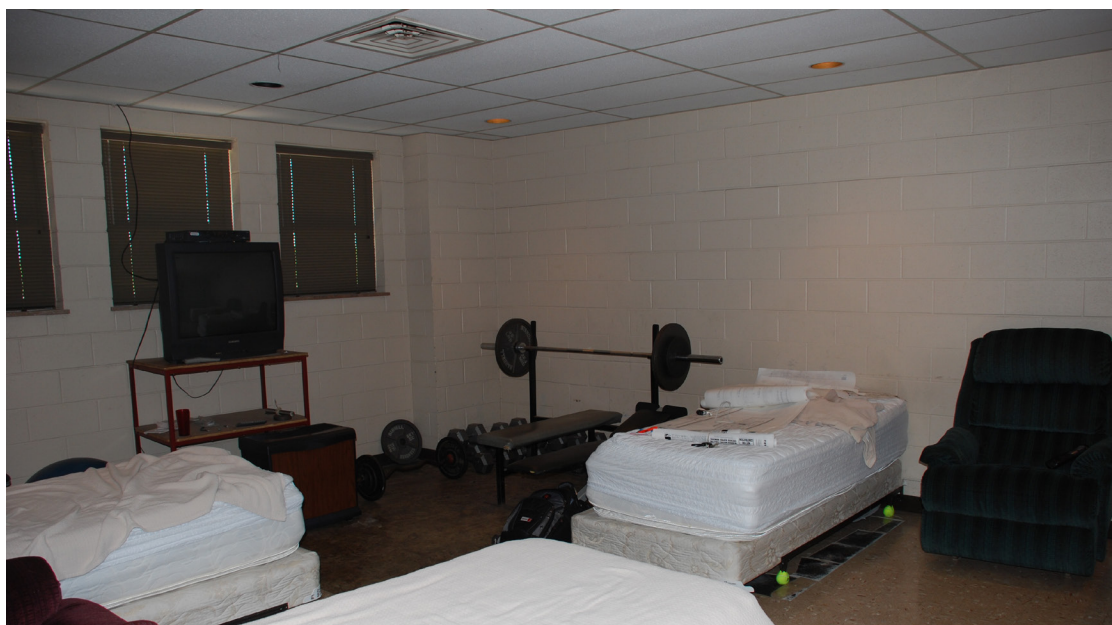
Use of the sleeping room to house workout equipment crowds the space, impeding movement to the apparatus floor responding to an alarm. It creates hazards for firefighters. A responding firefighter could hit his/her head on the end of the weight bar as he/she rolls out of bed.

Any remodel should incorporate a dedicated fitness room.

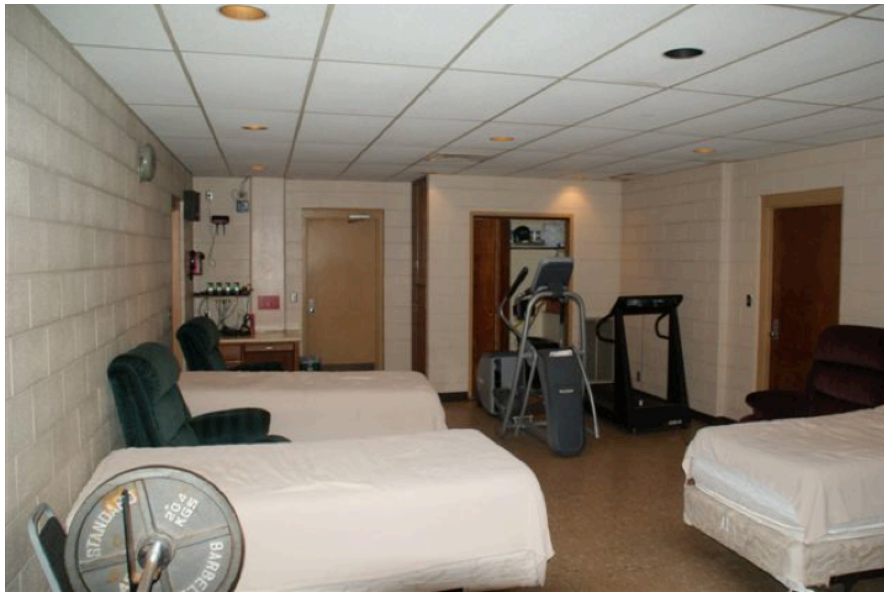
The door at the far end leads directly to the apparatus floor. There should be a transitional corridor to the apparatus floor. The door to the right is an unmarked exit door leading to a vestibule at the back entrance.

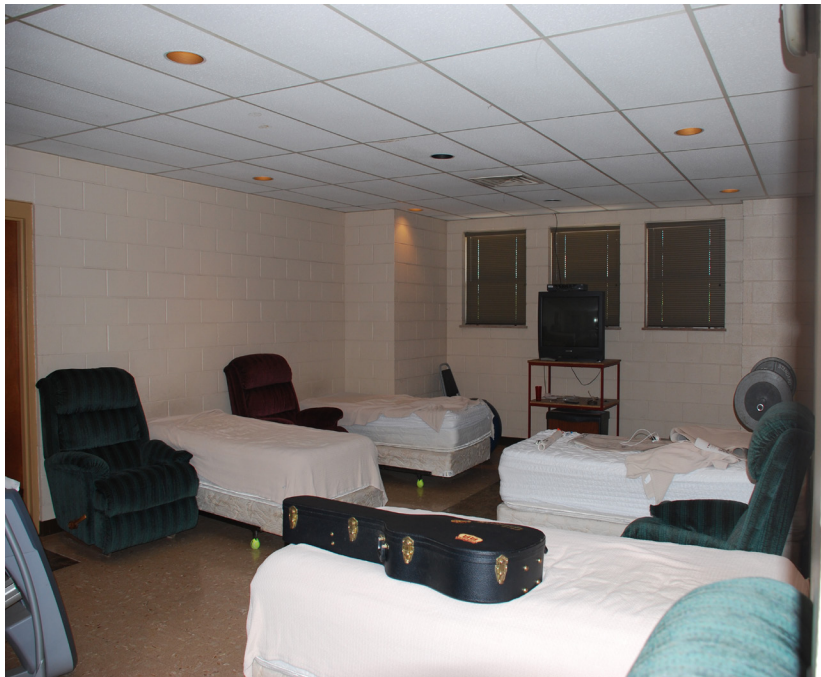
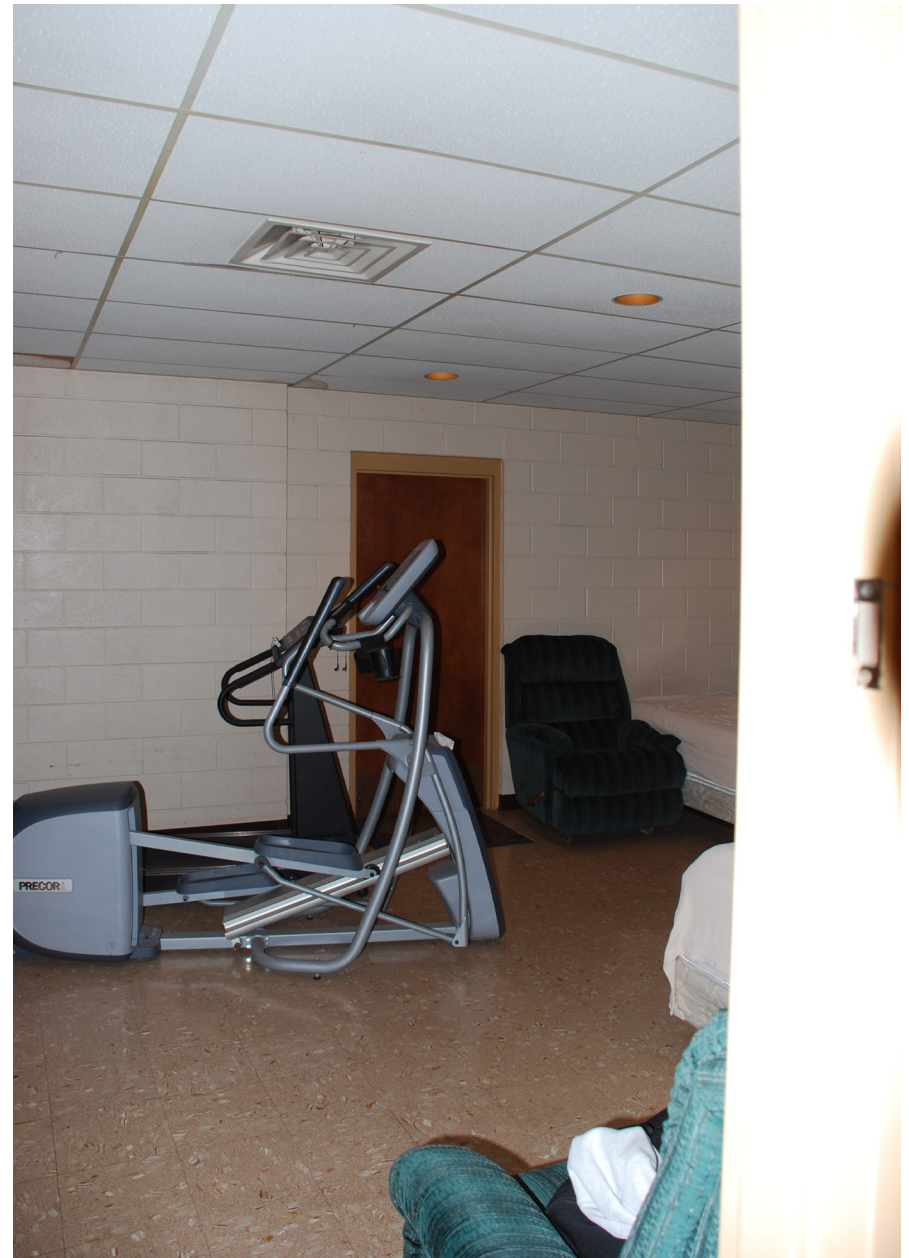
All foot traffic entering the station from the rear parking area must come through this door and cross the sleeping dorm to reach the hallway leading to the dayroom.

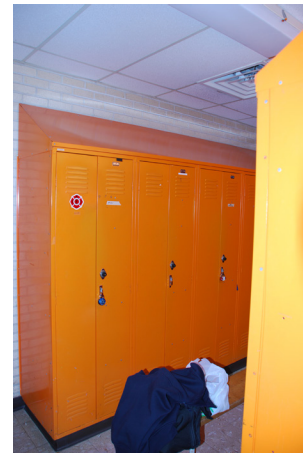
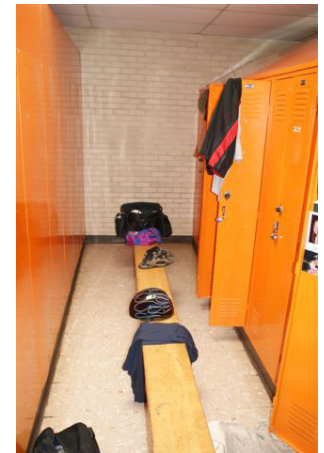
The lockers are adequate but a bit narrower than what is usual for a fire station. The lockers should be able to accommodate on hangers several changes of station wear including sweat shirts and duty jackets and a change of civilian clothes as well. This is where bedding will also be stored between shifts if there is not other bedding storage provided such as an under the bed drawer. Additionally, toiletries and other personal items should be accommodated.

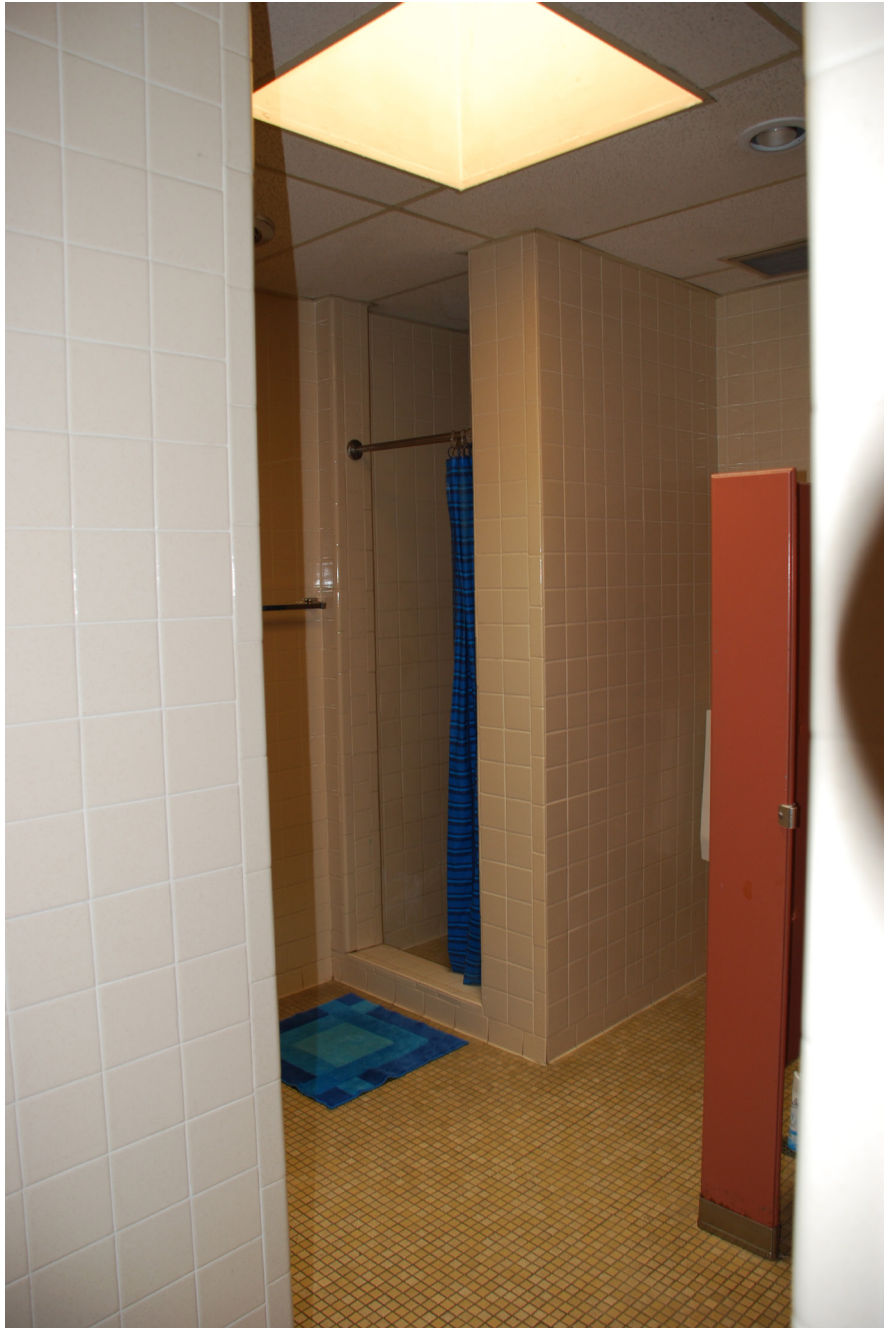
To the left is the view to the shower from the locker room. Above is the view to the single toilet provided at the station. The toilet and urinal lack automatic flush valves. It appears that ventilation is also inadequate. Lighting for the toilet stall and the shower stall is nonexistent. Two roll toilet paper dispensers are in order here.

The shower/toilet space is on an outside wall. A high window would have improved the space with natural lighting.

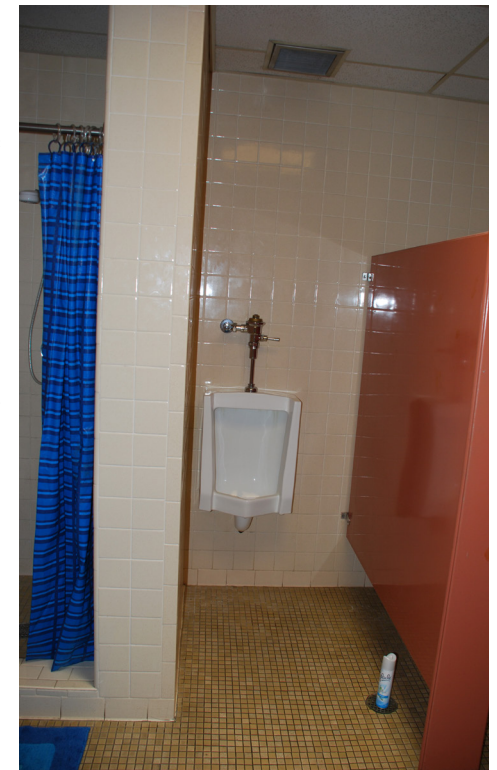
The shower is small by modern standards and lacks a toiletries shelf. Cleaning supplies should have a storage closet or cabinet. MSDS sheets should be on file for all chemicals found in the fire station including all the cleaning materials seen in the photo.

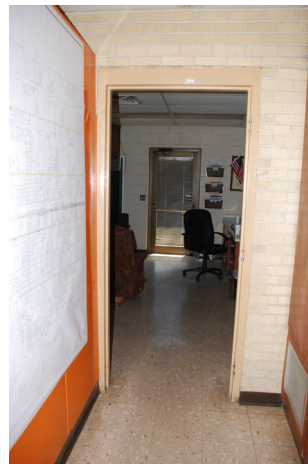
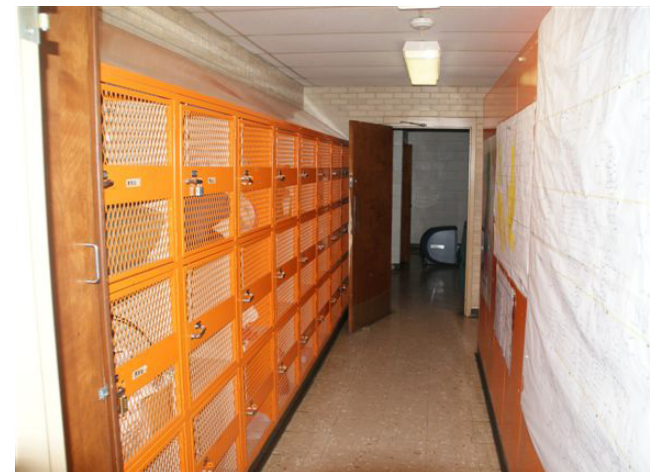
One wall of the corridor is lined with response maps while the other side is occupied with small personal lockers. Consideration should be given to consolidating all maps and map boards on the apparatus floor.

This view illustrates the need for the locker room door to remain closeable to maintain privacy. The front door to the station afford a view straight through the dayroom and the locker area directly into the dorm space.

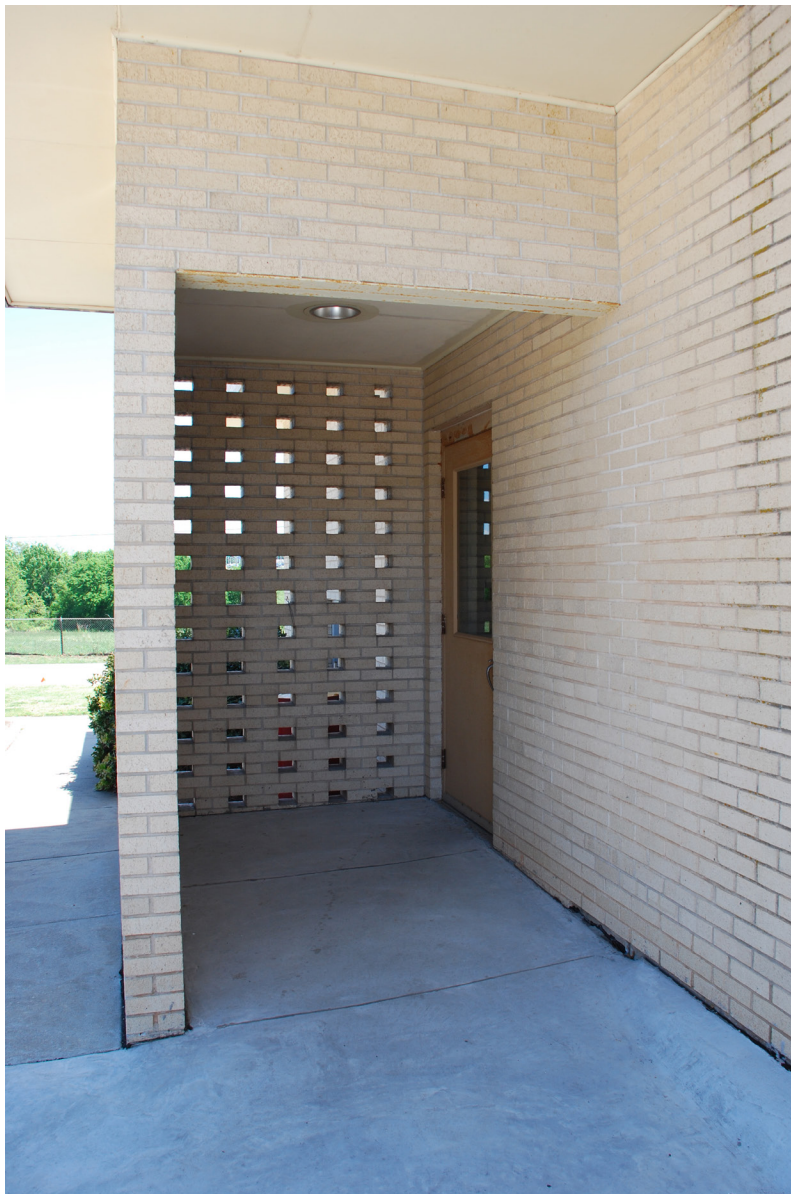
This view shows the obscured rear “staff” entrance to the station.

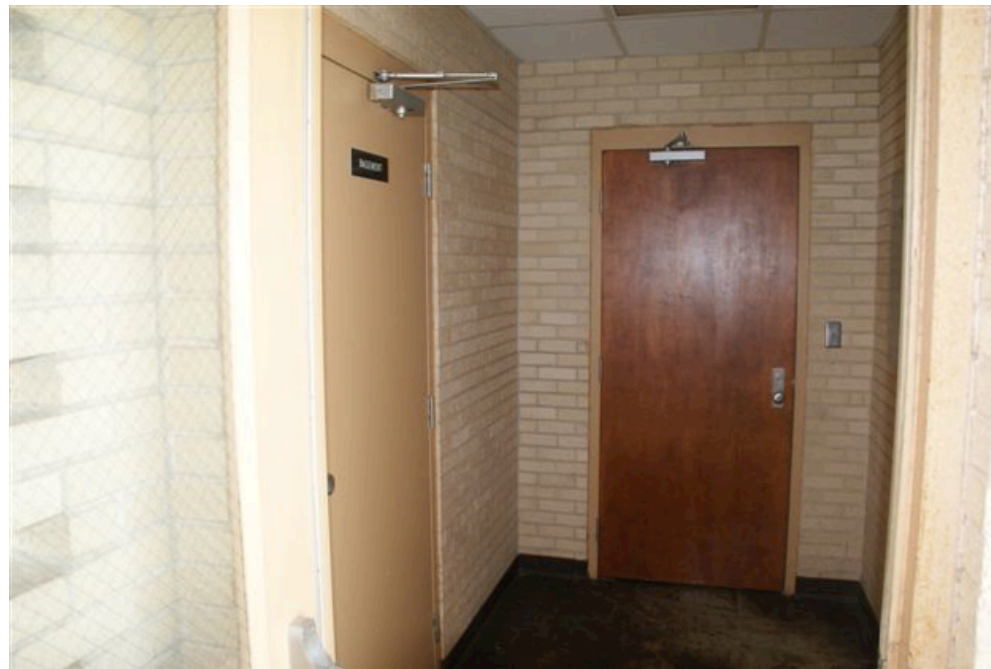
Civilians entering the station for shelter sometimes are confused in “reading” the doors. The wood door ahead reads as the primary path one should take. The metal door to the right leads to the stairwell to the basement of Station 3. The wood door leads directly into the sleeping area. Duty crews report that they have returned from an emergency run during a tornado warning to find civilians asleep on their beds rather than being in the basement classroom/shelter.

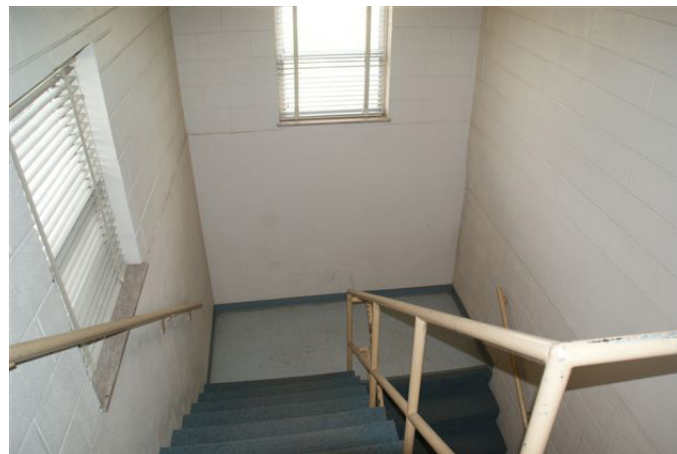
The interior basement staircase is a scissor stairs. The basement is not barrier free. An elevator is required.

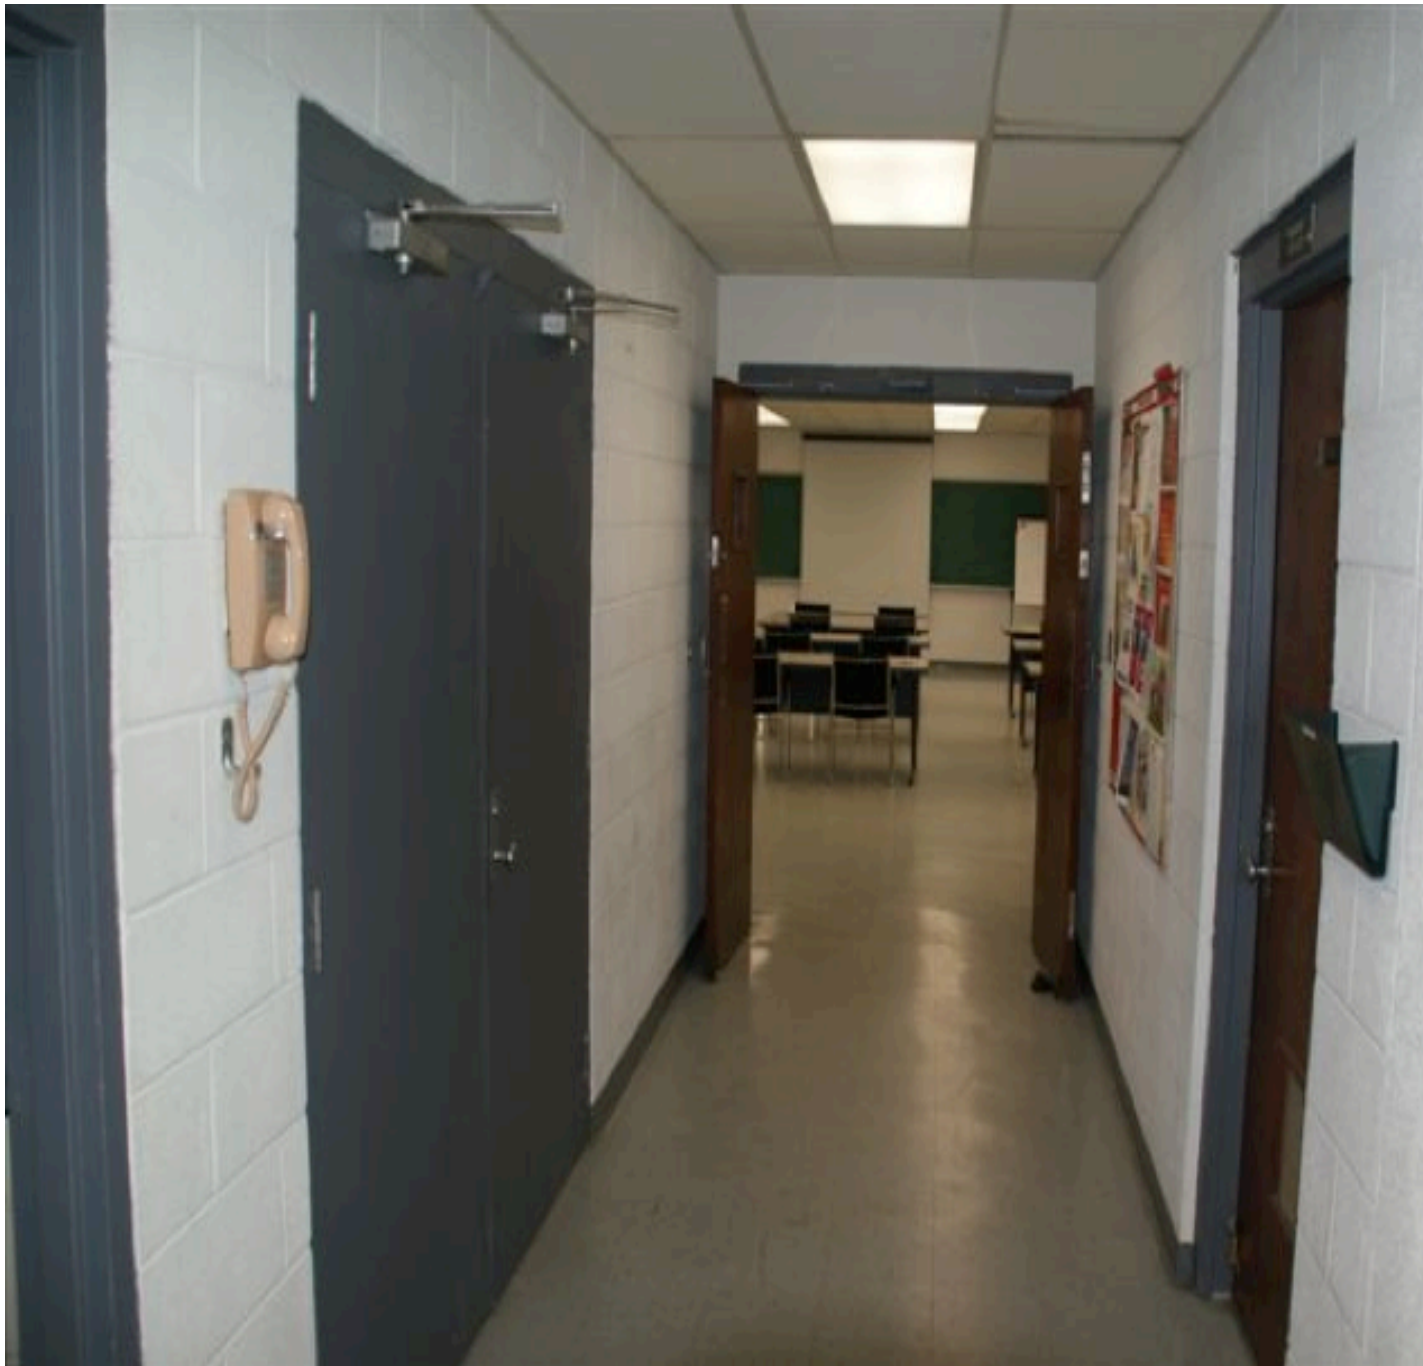
This view looks into the basement training room. The mechanical room is where the furnace for the station's heat system is located. Just inside this space to the right sits a very neglected toilet that is supposed to serve anyone seeking shelter in the basement of the station. It does not qualify for the "Public, but not public Toilet."

The door to the right is to the SFD Training Officer's office. It is a windowless room as are all other spaces on the lower level with the exception of the stairwell.

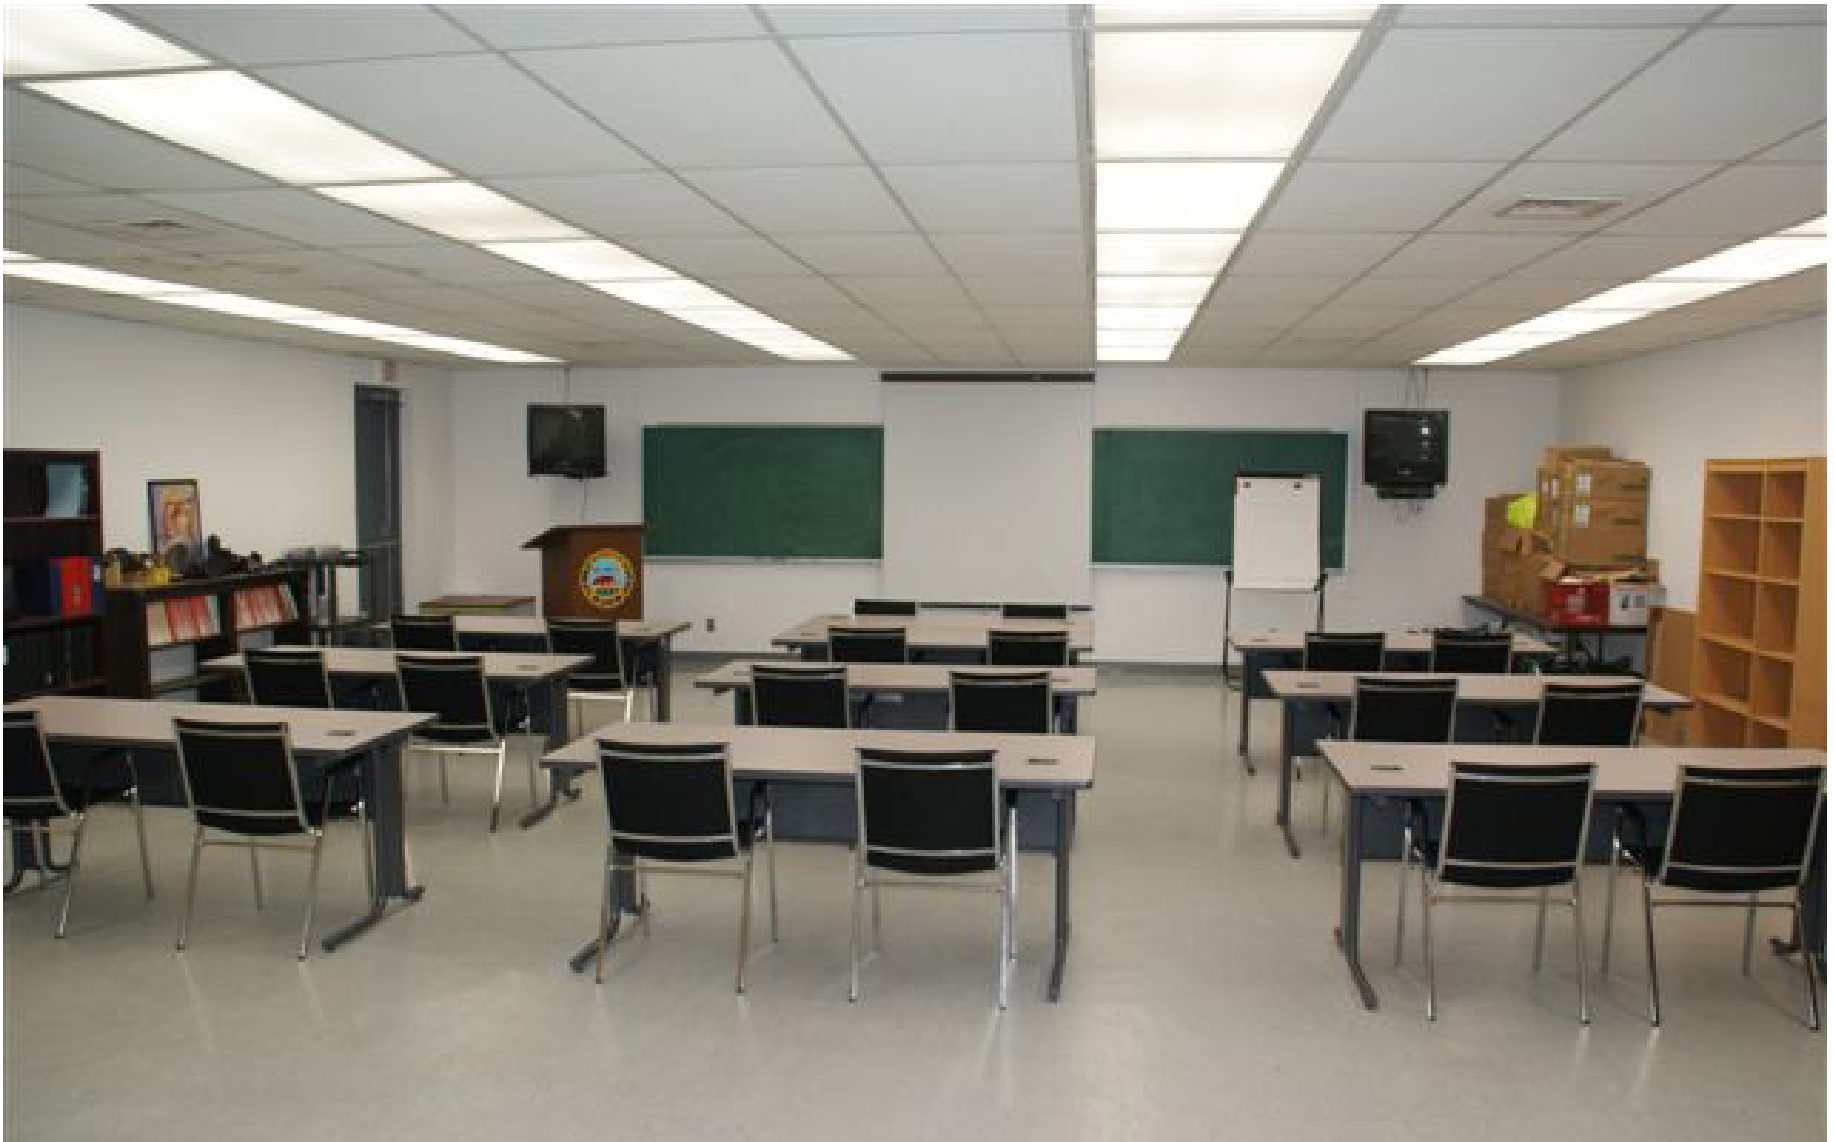
The training classroom at Station 3 is seen as a training asset for the entire Shawnee Fire Department. It has adequate space and facilities to conduct classes professionally without distraction.

The doorway on the far left is an exit door leading to the outside stairwell. The exit meets the code requirement for secondary means of egress from "a place of assembly."

As demonstrated by the materials and training props along the sidewalls, the room lacks adequate storage space. As a consequence, the training room always looks cluttered.

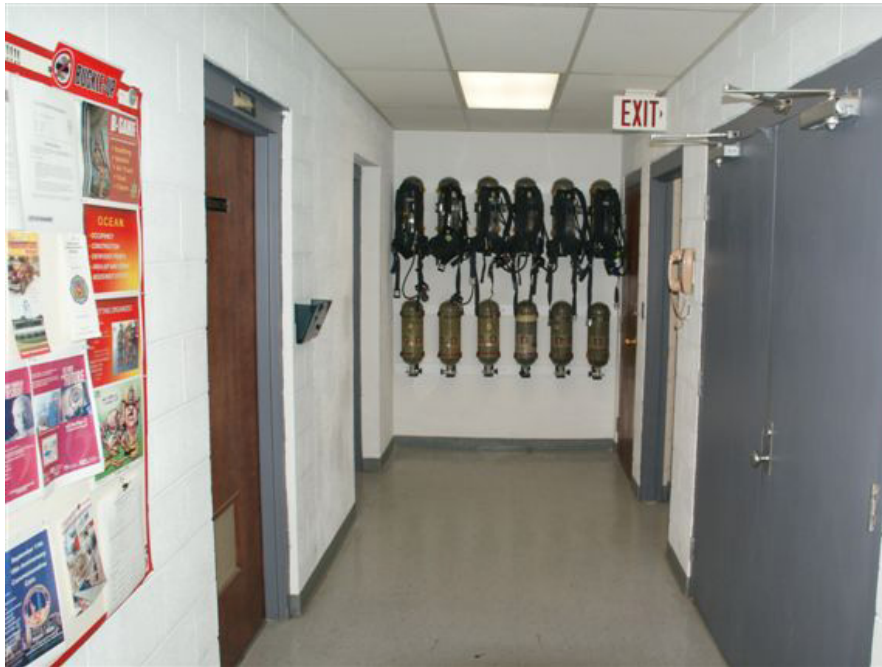
In this basement view looking north, the mechanical room, exit door, and a closet door are on the right side of the corridor. The closet under the stairwell is where the old station drawings for Stations 1 and 2 were uncovered by Chief Tischer. On the left side are doors to the Training Officer's office and the SCBA service and repair room. Serviced SCBA packs ready for use are stored in the basement hall.

The SCBA service and repair room at Station 3 serves as the SCBA maintenance point for the entire Shawnee FD. SCBA service and repair should not be in the basement. Nor should it be in a "clean" area. SCBA equipment in for service may be contaminated with debris from a working fire or chemicals from a HazMat incident. The SCBA area should be accessible from directly outside or directly off the apparatus floor or directly off the DeCon area. Moving this equipment up and down the steps creates inefficiency and an unnecessary hazard posed by carrying bulky equipment up and down stairs.

The SCBA work room could best be used for training purposes as a support room for the classroom. It could be designated for training props; office space for training materials, books and records; and additional storage for things currently kept in the training room.
