# Watertown

Main Street - Route 63 – Road Safety Audit

June 13, 2018

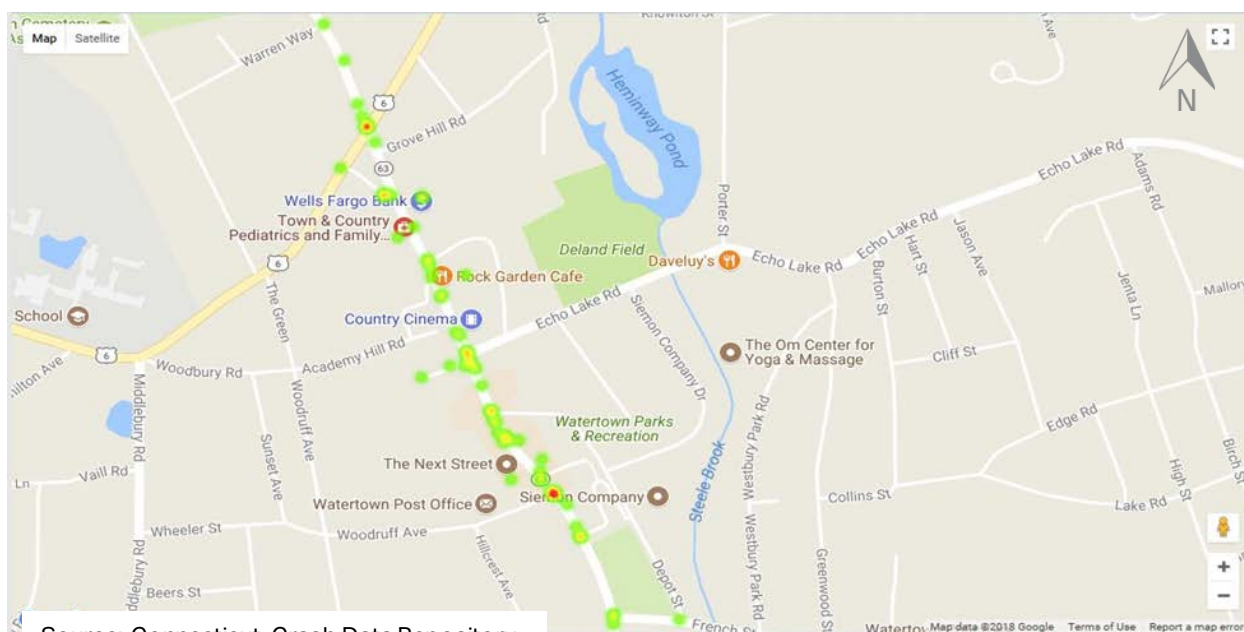
**Figure 3. Crashes Locations (2015-2017)(Connecticut Crash Data Repository)**

IN the three year period between 2015 and 2017 there were 73 crashes in the RSA Area. The majority of crashes (73%) reported in this area resulted in property damage only; however 25% of crashes did result in an injury and 2 crashes resulted in a fatality (Table 1 and Table 2). No crashes involved bicyclists, but both of the fatal crashes and one injury crash involved pedestrians. The crash types were primarily front to rear (rear-end) and angle collisions. Figure 3 displays the crashes graphically, and indicates a fairly wide dispersal of incidents, with clusters around the intersections.

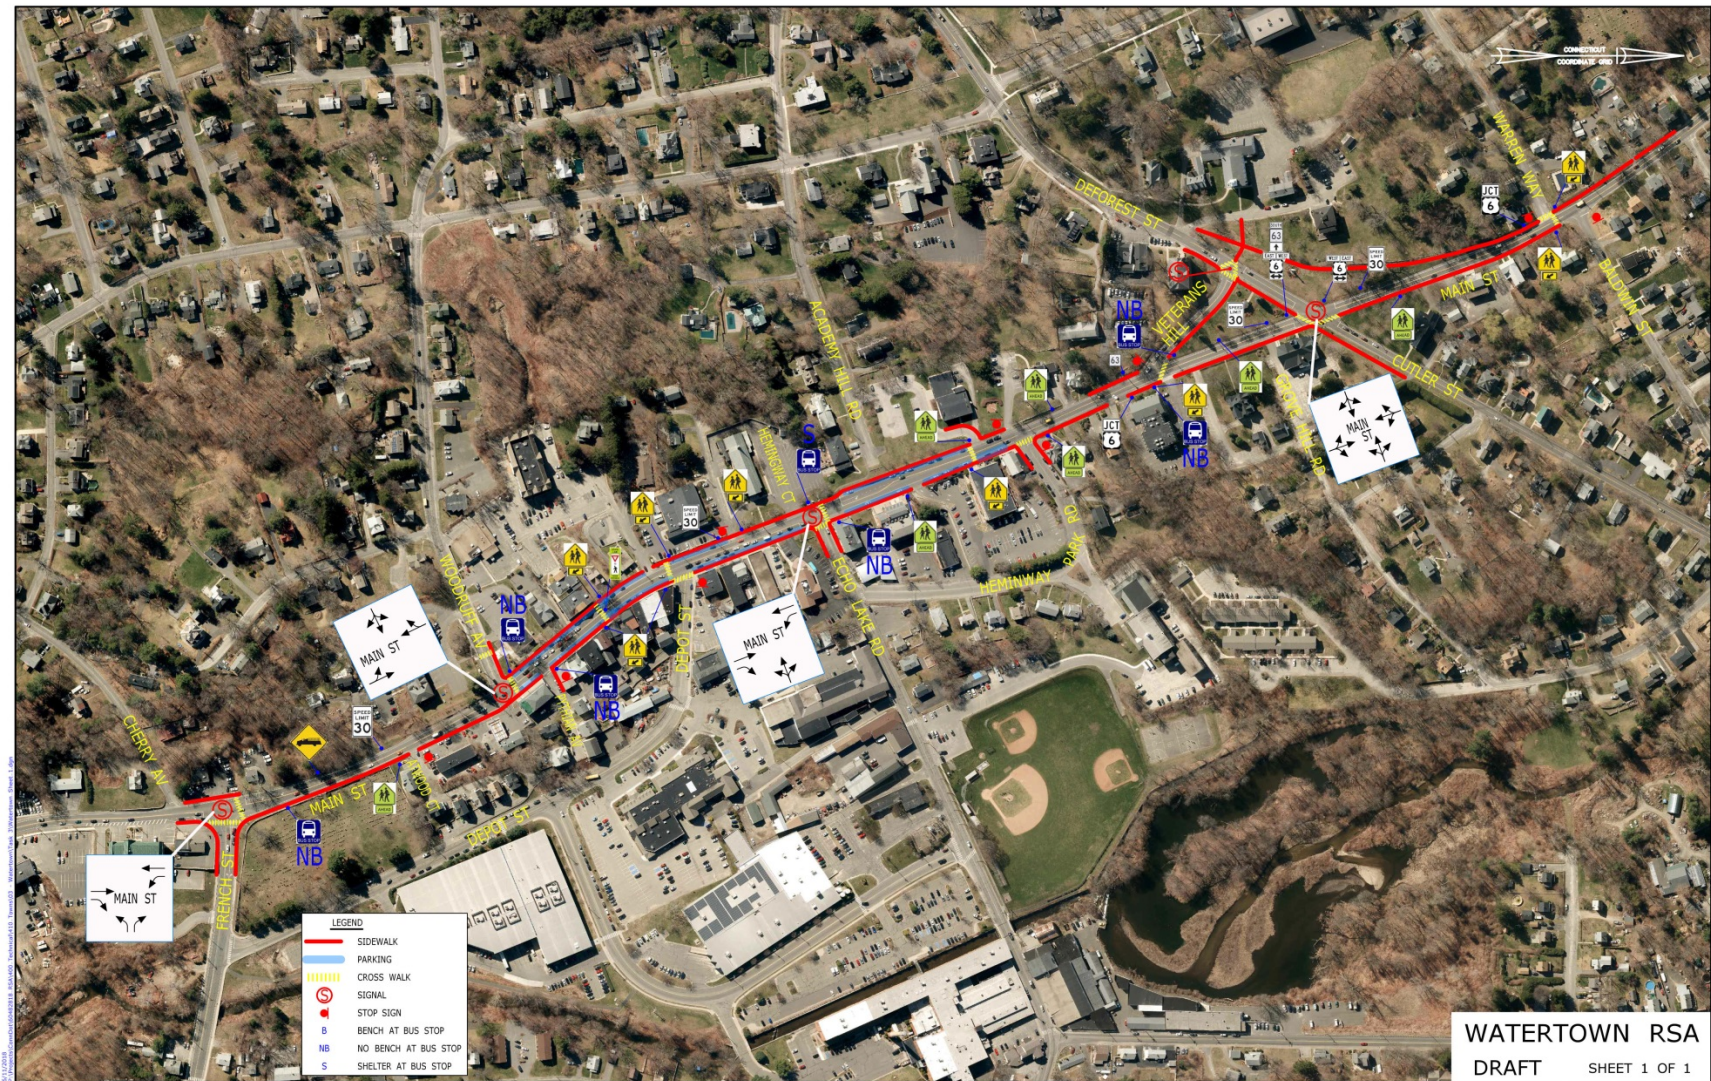
Figure 4. Main Street Road Geometrics

unsignalized intersections form T-intersections, so the crosswalk opposite the street appears to be a mid-block configuration. The geometry of the corridor is shown in Figure 4 and described in Table 3. The intersection configurations are as follows:

**#11 Intersection of Main Street and Warren Way/Baldwin Street** This is a 4-way unsignalized intersection, with the side streets separated by a 75 foot dog-leg. The side streets are stop sign controlled, and there is a single lane in each direction. The sidewalk on the east side of Main Street ends at this intersection, and a crosswalk is provided for pedestrians to access the sidewalk on the east side.

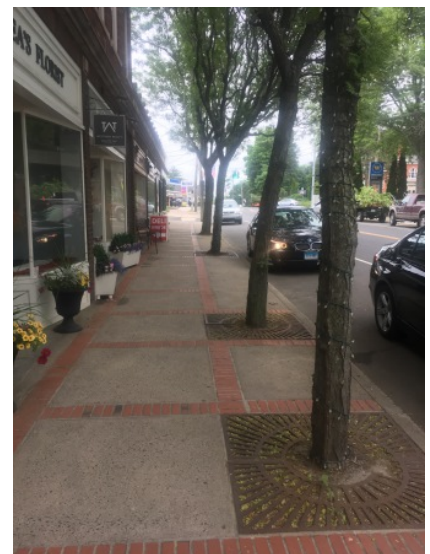
Figure 21. Wide, shaded sidewalk with benches

- There is a mid-block crosswalk located approximately 225 feet south of the Depot Street intersection.
- The sidewalk is shaded with benches and a wide sidewalk area. It is very pedestrian friendly (Figure 21).
- There is a pedestrian crossing sign in the road at this crossing (Figure 22).
- This is the potential site of a future parking lot across the street.

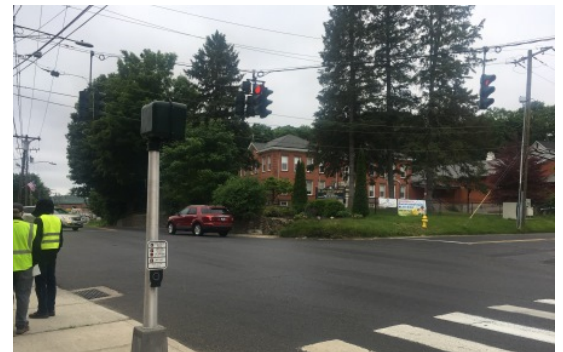
Figure 23. Woodruff Ave. and Main St.

- There is a Catholic elementary school on the southwest corner of the intersection (Figure 23).
- The pedestrian signal on the northern side of the intersection is broken.

- There is a convenience store/gasoline station driveway in the intersection and no signal head facing it.
- On Woodruff Avenue, there is sidewalk located on the north side of the street. It is a mixture of concrete and asphalt and is in fair-to-poor condition. There is no sidewalk on the south side of Woodruff Avenue, except for a small section of stepped sidewalk connecting to the school entrance.

- Approximately 100 feet west of the Main Street intersection, there is a mid-block crosswalk located in front of the sidewalk entrance to the school. This is used by students as well as visitors to the school. Although properly signed, it does not have ADA accessible ramps, and the sidewalk on leading to the school entrance has steps.

- The pedestrian signal at Woodruff Avenue needs to be repaired.
- Permanent speed indicators were suggested as a traffic calming measure.
  - The idea was refuted based on studies that show these indicators lose their effect over time.

8. Improve the sidewalk and ADA accessibility on Route 6 opposite Veterans Hill Road. This will complete the connection to interior walkways, as well.
9. Install a sidewalk on the south side of Woodruff Avenue between the entrance to St. John the Evangelist School and the new sidewalk on Main Street if warranted by evaluation.
