CITY OF CASSVILLE MO • 1 • 3A • Pre-Lining [13 • Apr • 2023] .....	1
Street: MILL ST Street: MILL ST	
CITY OF CASSVILLE MO • 12 • 9 • Pre-Lining [03 • May • 2023] .....	3
Street: HAROLD ST Street: HAROLD ST	
CITY OF CASSVILLE MO • 145 • 148 • Pre-Lining [19 • Apr • 2023] .....	5
Street: MAIN ST Street: MAIN ST	
CITY OF CASSVILLE MO • 15 • 14 • Pre-Lining [04 • May • 2023] .....	7
Street: HAROLD ST Street: HAROLD ST	
CITY OF CASSVILLE MO • 151 • 179 • Pre-Lining [19 • Apr • 2023] .....	9
Street: EAST ST Street: EAST ST	
CITY OF CASSVILLE MO • 152 • 151 • Pre-Lining [19 • Apr • 2023] .....	11
Street: EAST ST Street: EAST ST	
CITY OF CASSVILLE MO • 16 • 15 • Pre-Lining [04 • May • 2023] .....	13
Street: HAROLD ST Street: HAROLD ST	
CITY OF CASSVILLE MO • 17 • 68 • Pre-Lining [23 • May • 2023] .....	15
Street: FAIR ST Street: FAIR ST	
CITY OF CASSVILLE MO • 173 • 174 • Pre-Lining [02 • May • 2023] .....	17
Street: 7TH ST Street: 7TH ST

## Inspection Report

Street: MILL ST  
City: CASSVILLE MO  
Pipe Use: Sanitary Sewage Pipe  
Pipe Geometry: 8 in (Circular)  
Material: Vitrified Clay Pipe  
Map #/Plan File: 14  
Drainage Area:  
Flow Direction: ↓ South  
Surface: Asphalt

Customer: R

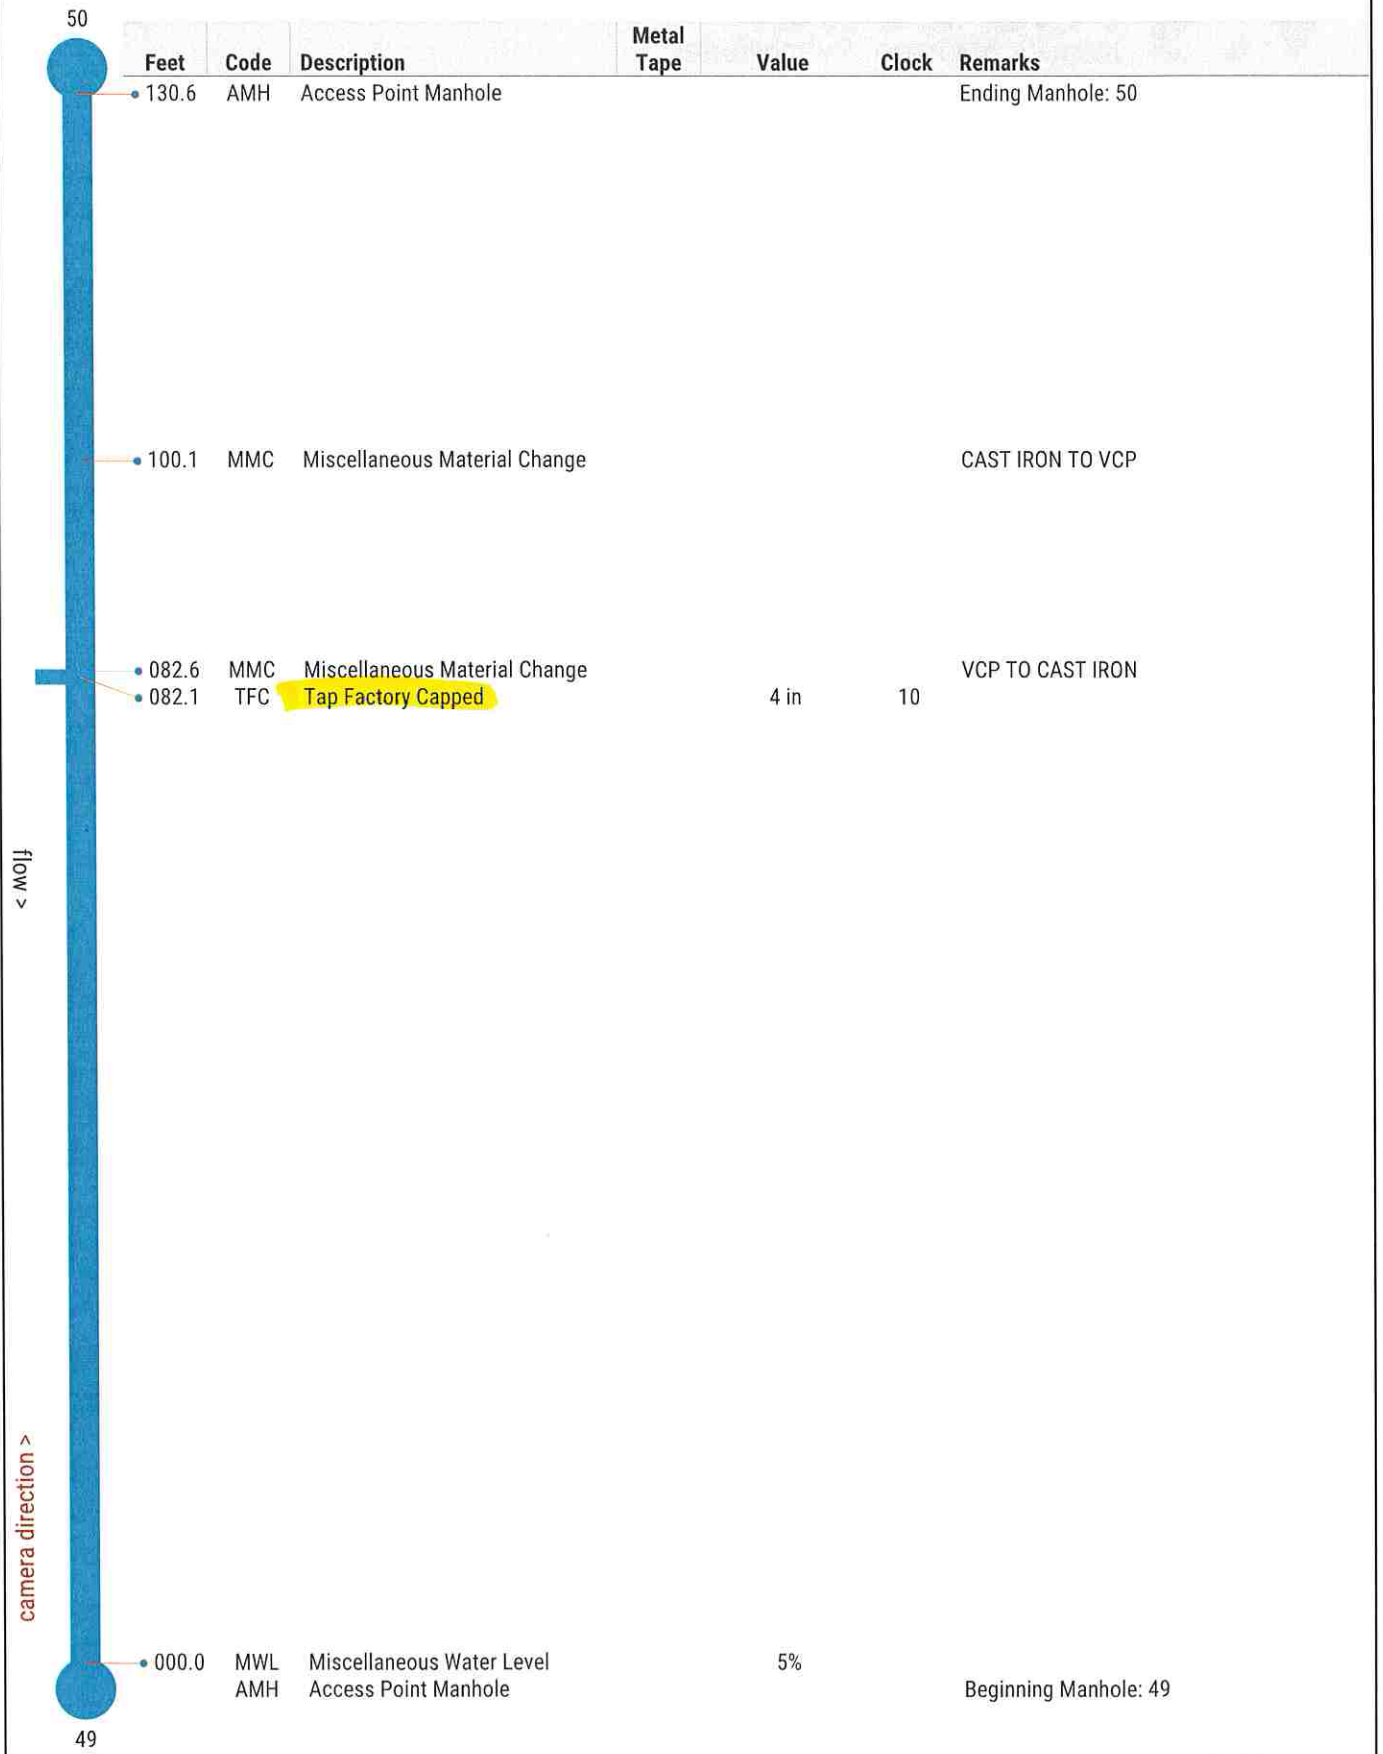
Street: TOWNSEND ST  
City: CASSVILLE MO  
Pipe Use: Sanitary Sewage Pipe  
Pipe Geometry: 8 in (Circular)  
Material: Vitrified Clay Pipe  
Map #/Plan File: 15  
Drainage Area:  
Flow Direction: ↗Northeast  
Surface: Asphalt

Customer: ROSETTA CONSTRUCTION  
Project:  
Job #: 23010MO-11  
Media Date/Time: 2023/04/18 04:19  
Surveyed By: TYLER (P0038607-072022)  
Supervisor: DOUG B  
Pre-Cleaning: Light Cleaning  
Truck: 211MO  
Weather: Dry - No Precipitation During Survey  
Additional Info: CAST IRON SECTION

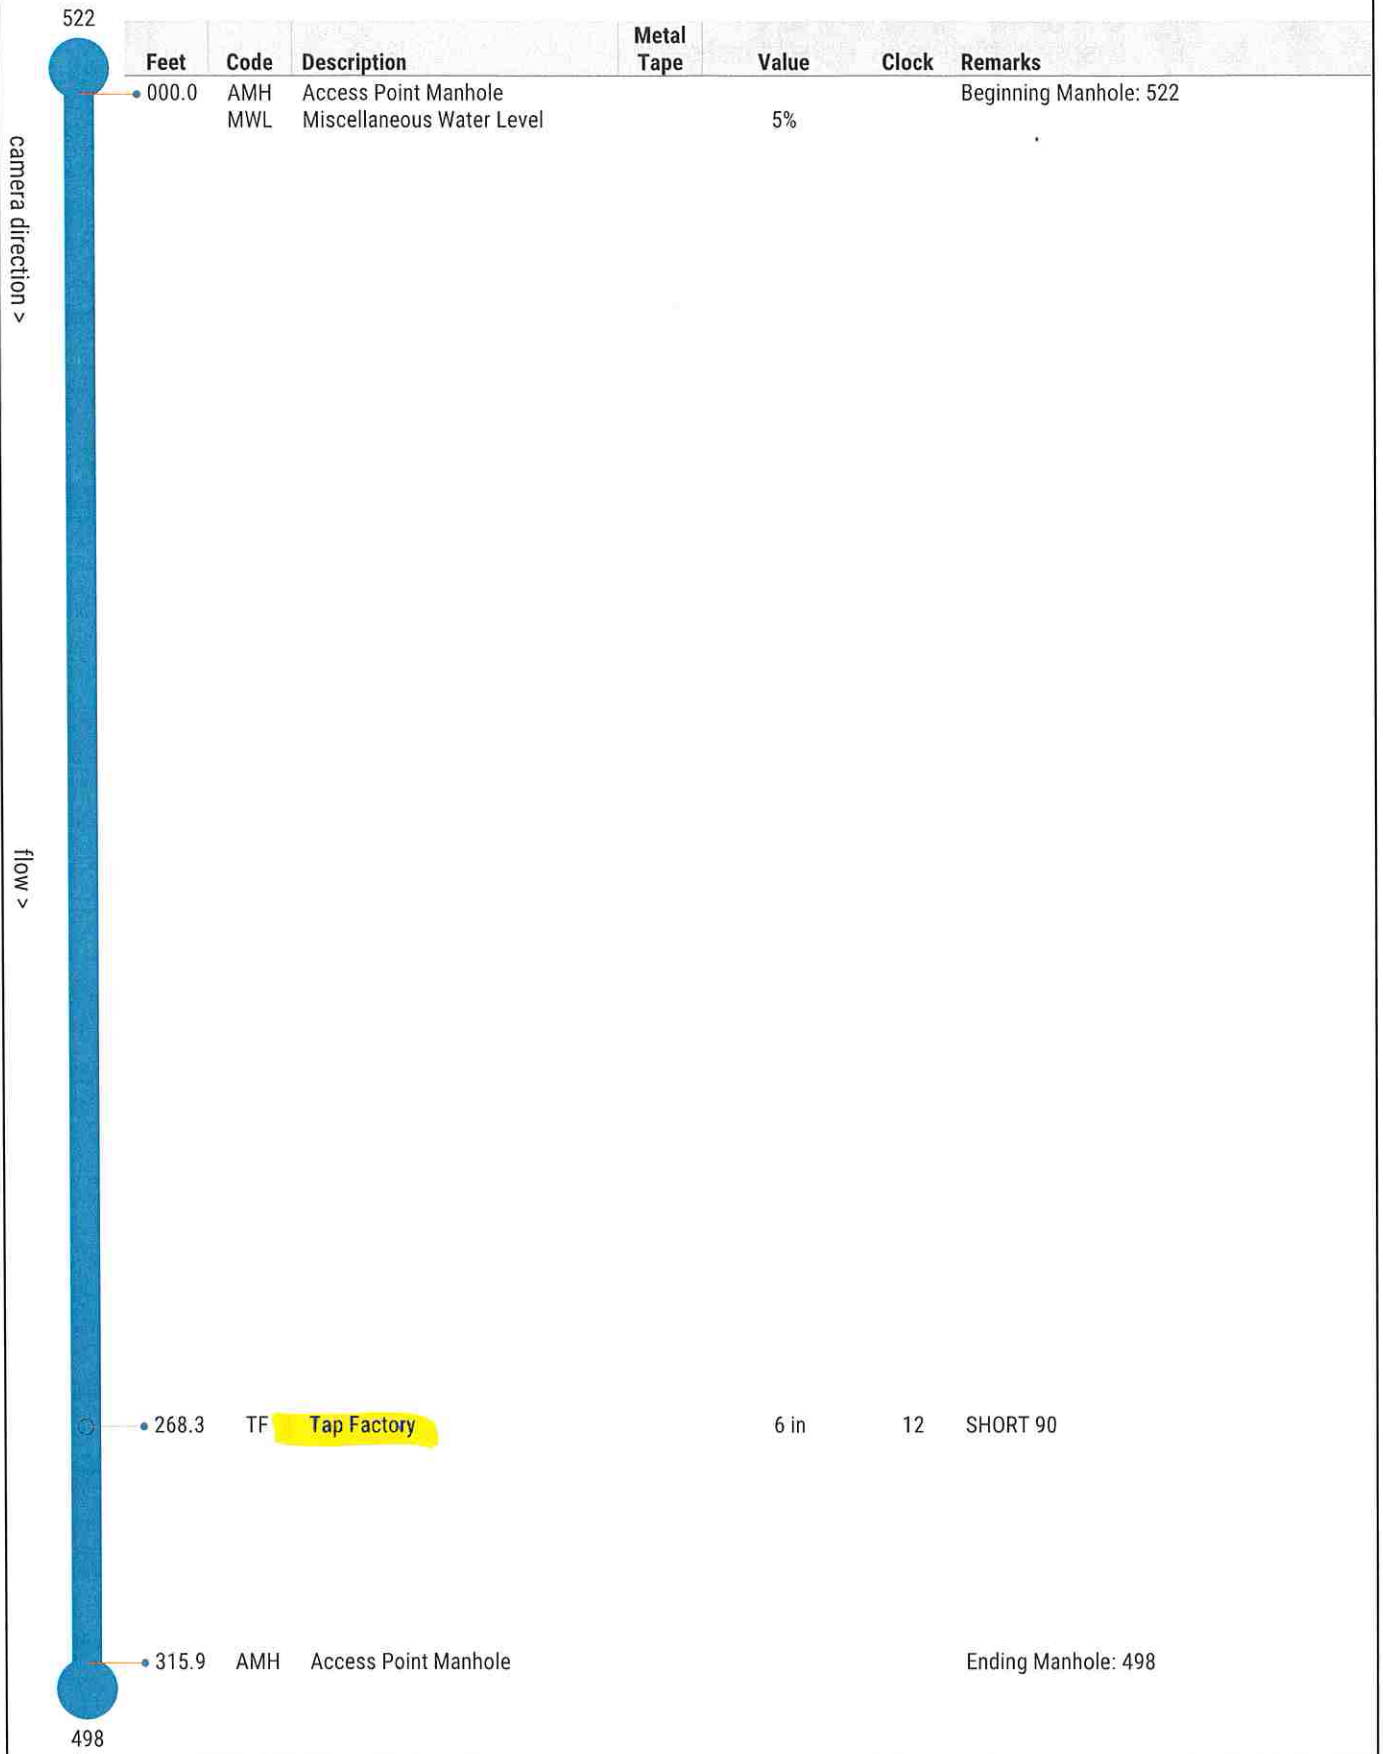
Street: FASCO RD  
City: CASSVILLE MO  
Pipe Use: Sanitary Sewage Pipe  
Pipe Geometry: 8 in (Circular)  
Material: Vitrified Clay Pipe  
Map #/Plan File: 17  
Drainage Area:  
Flow Direction: ↑ North  
Surface: Grass

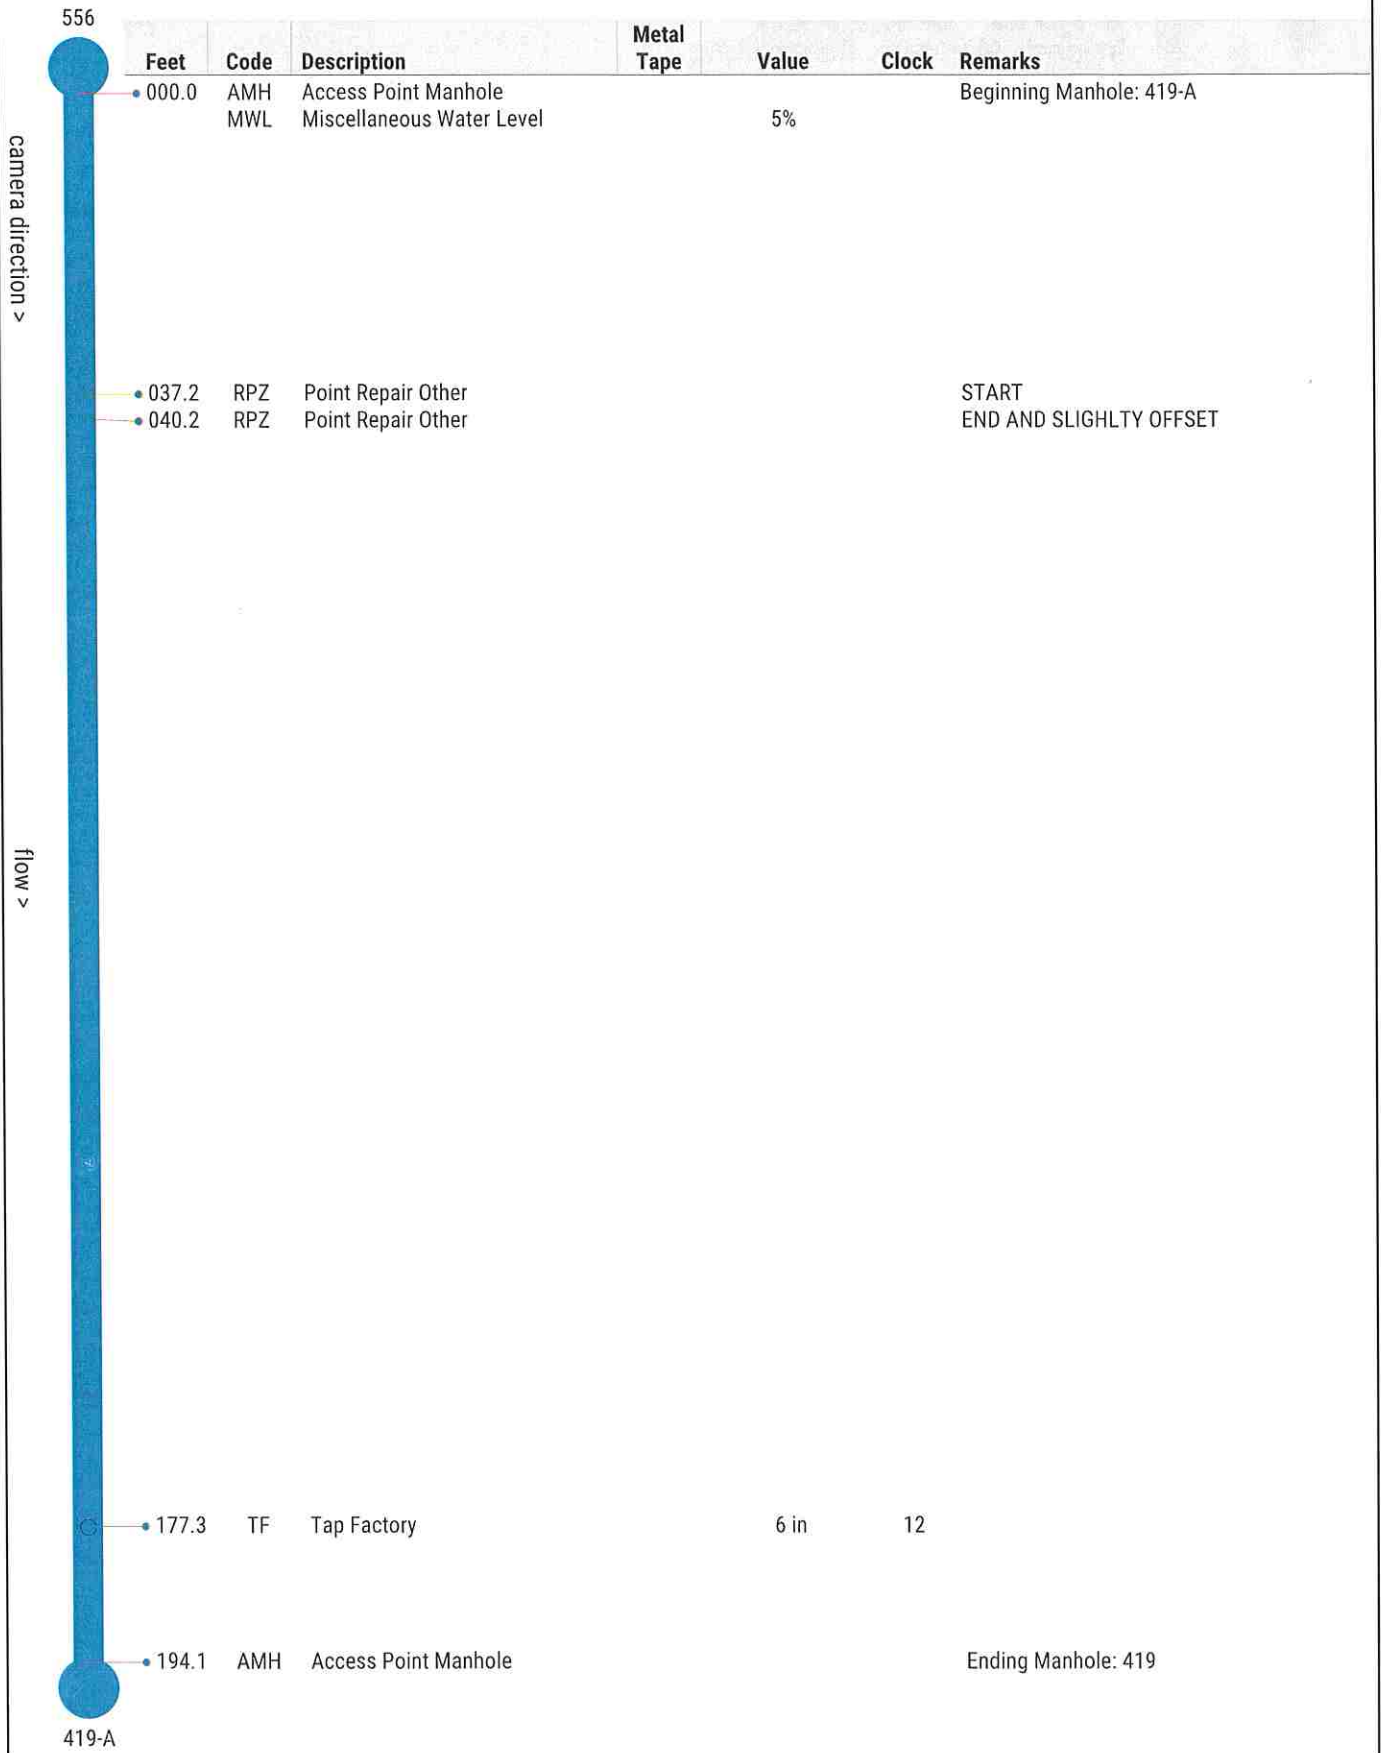
Street: COUNTY FARM ROAD  
City: CASSVILLE MO  
Pipe Use: Sanitary Sewage Pipe  
Pipe Geometry: 8 in (Circular)  
Material: Vitrified Clay Pipe  
Map #/Plan File: 14  
Drainage Area:  
Flow Direction: ↓ South  
Surface: Asphalt

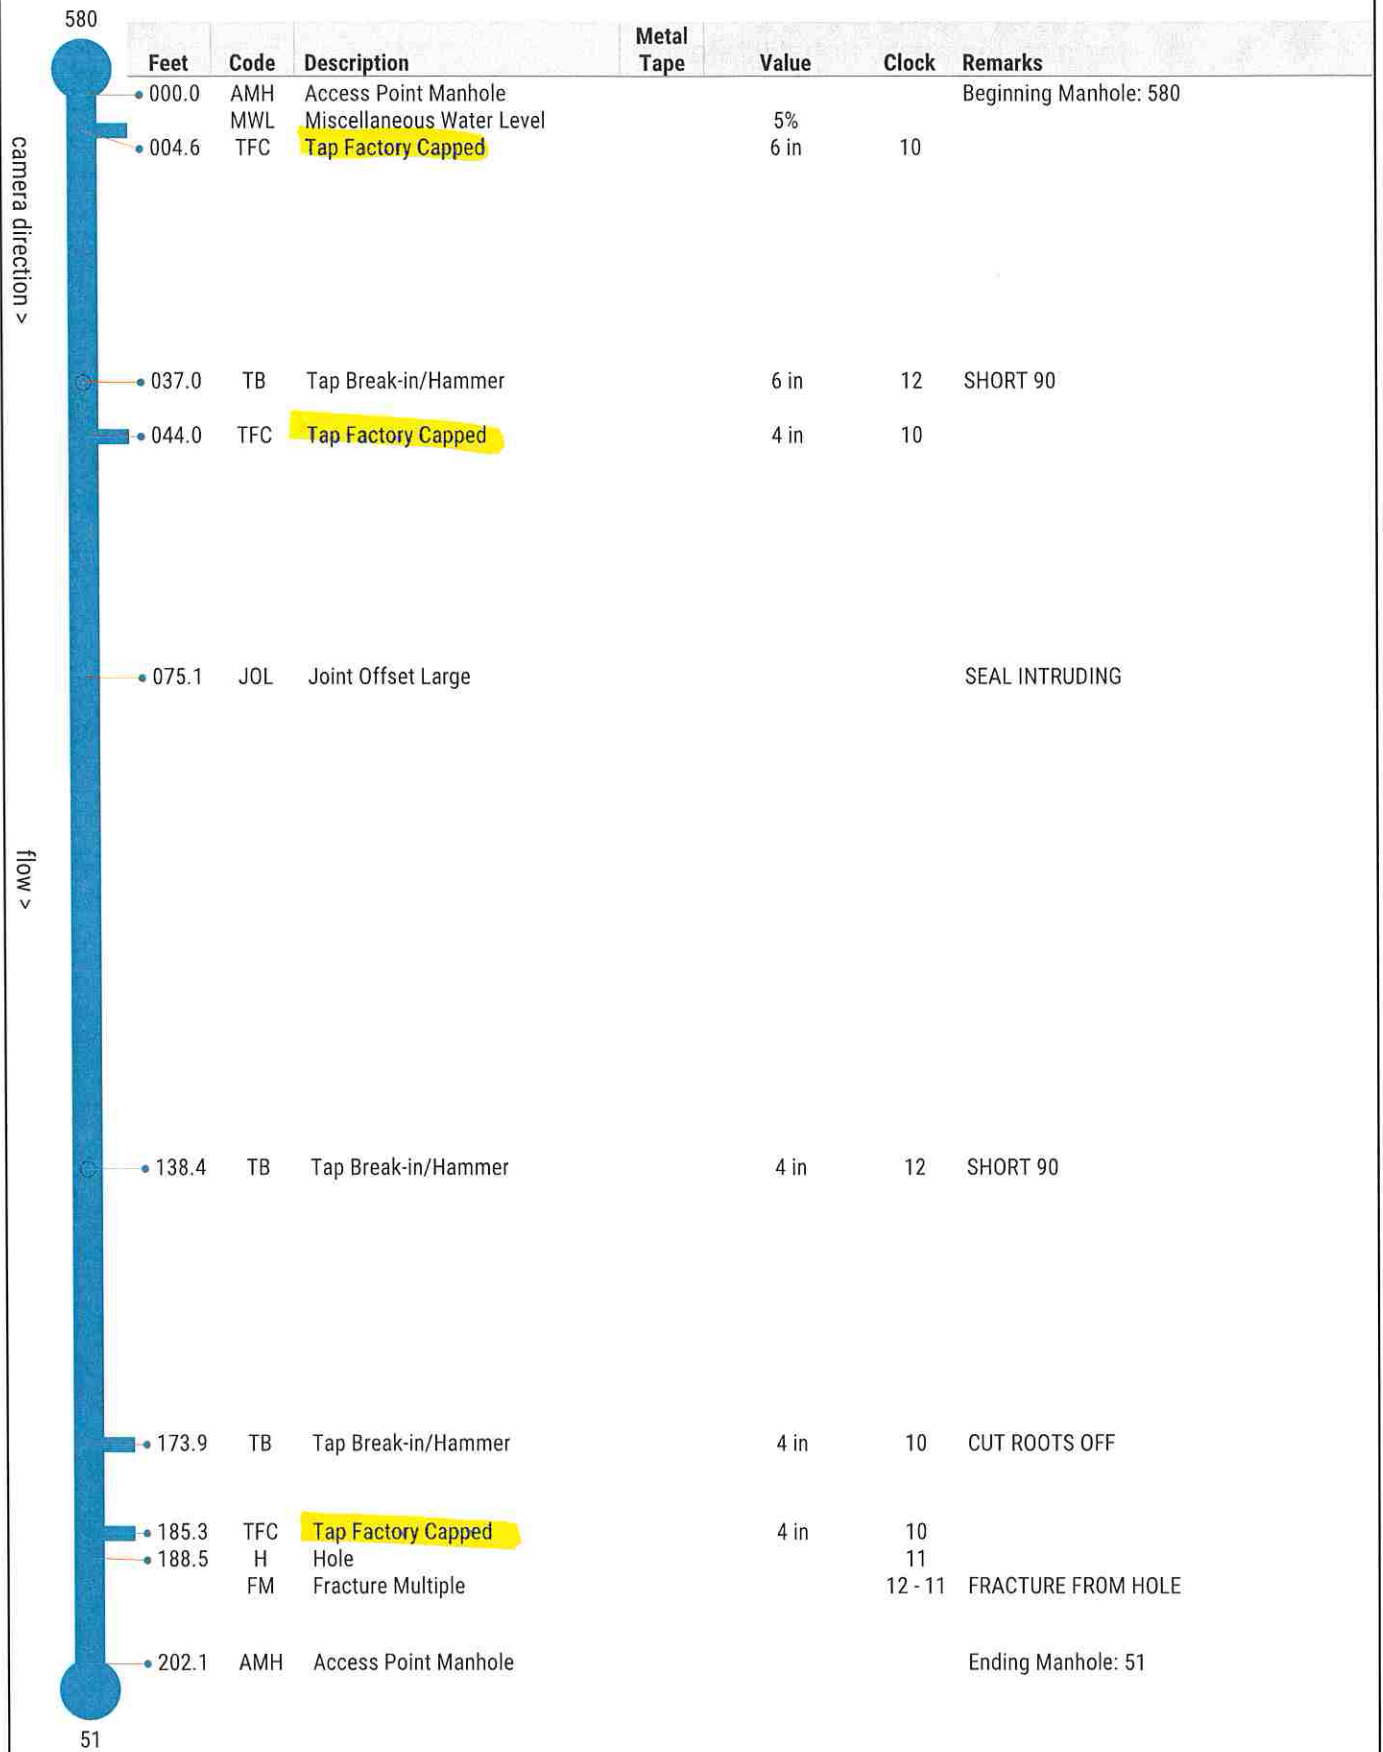
Street: GRAVEL ST  
City: CASSVILLE MO  
Pipe Use: Sanitary Sewage Pipe  
Pipe Geometry: 8 in (Circular)  
Material: Vitrified Clay Pipe  
Map #/Plan File: 15  
Drainage Area:  
Flow Direction: ↑ North  
Surface: Asphalt

Customer: ROSETTA CONSTRUCTION  
Project:  
Job #: 23010MO-11  
Media Date/Time: 2023/04/18 10:56  
Surveyed By: TYLER (P0038607-072022)  
Supervisor: DOUG B  
Pre-Cleaning: Heavy Cleaning  
Truck: 211MO  
Weather: Dry - No Precipitation During Survey  
Additional Info: RAN ROOT SAW

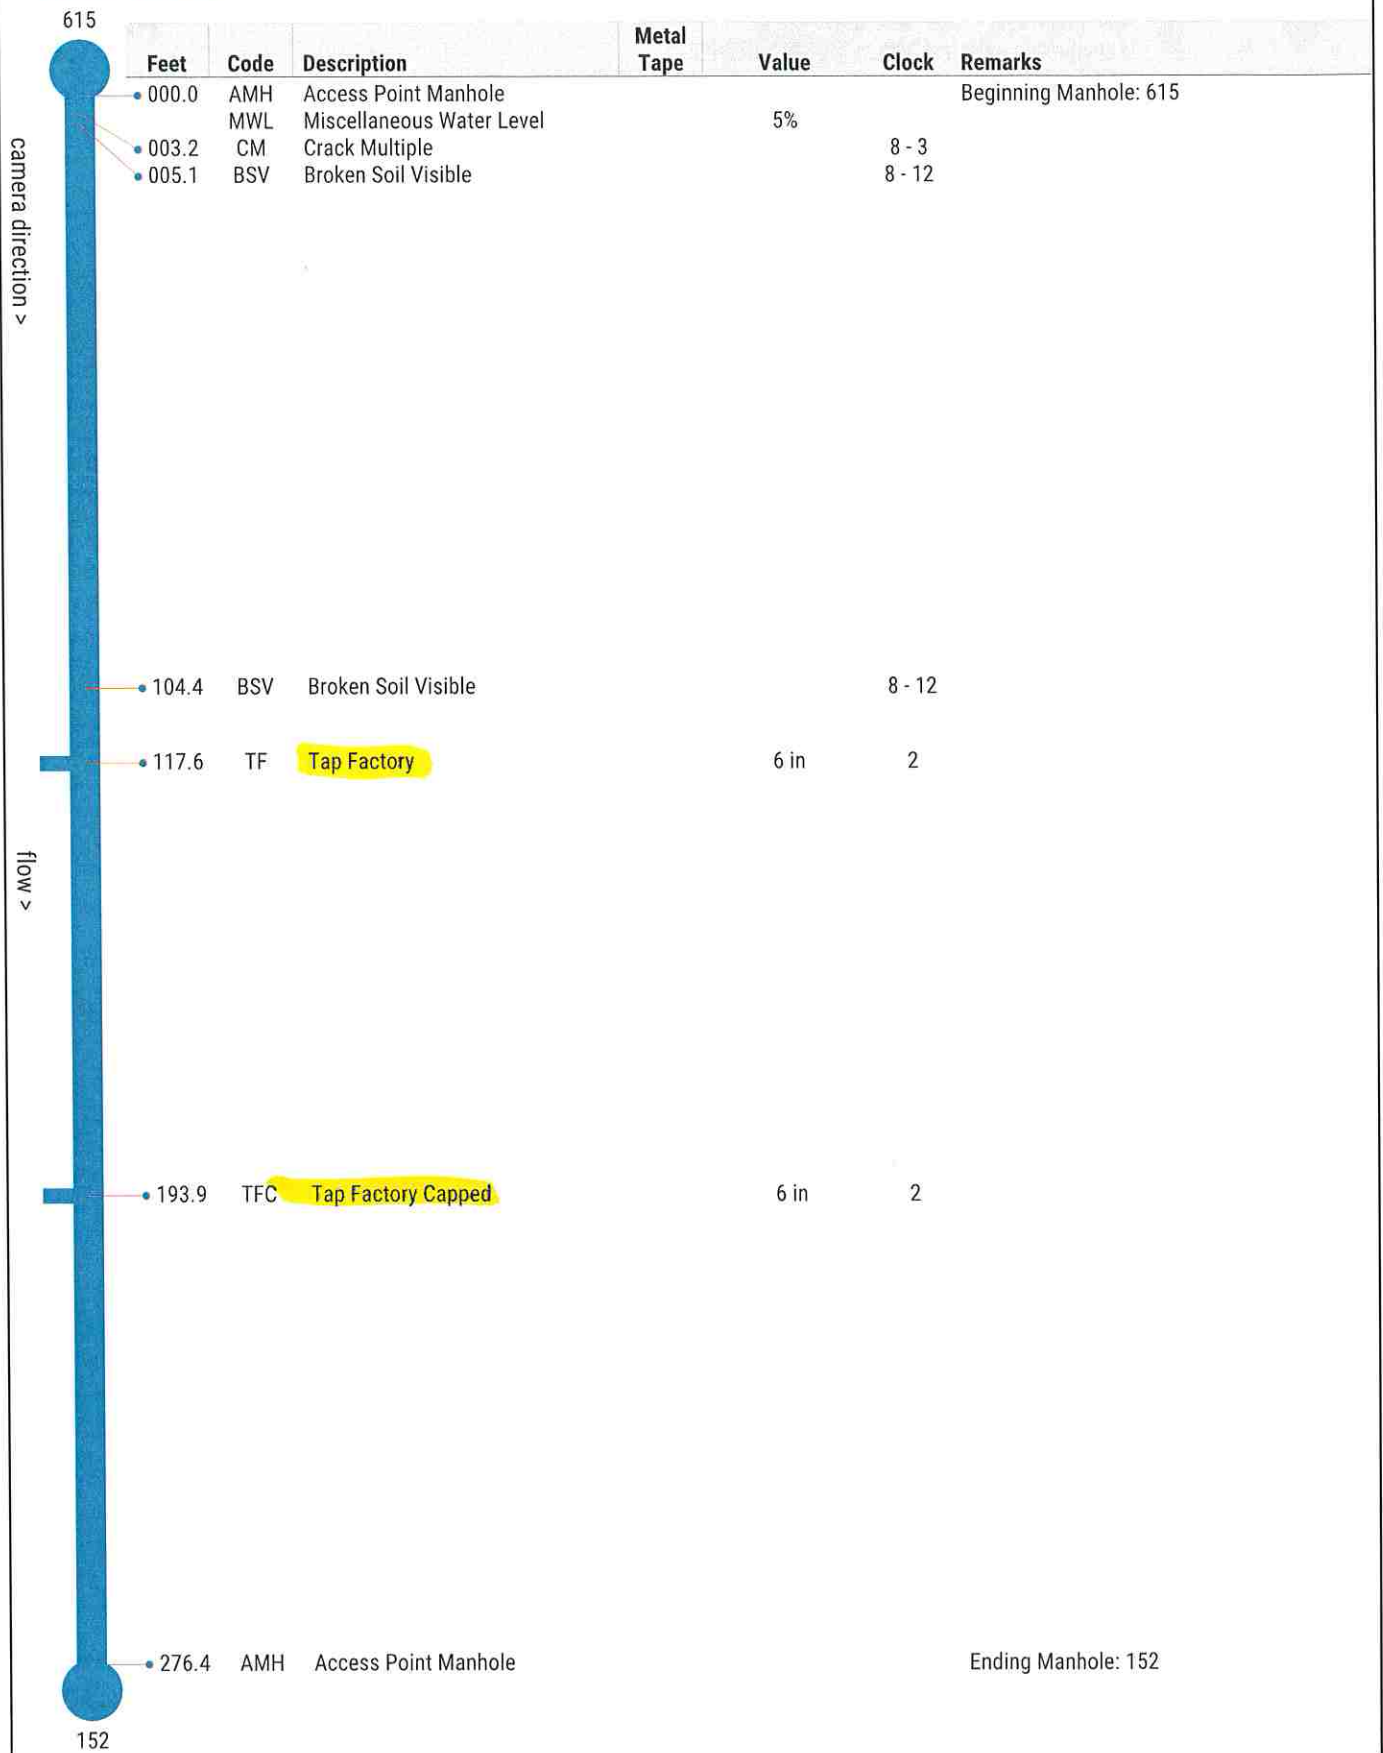
Street: 4TH ST  
City: CASSVILLE MO  
Pipe Use: Sanitary Sewage Pipe  
Pipe Geometry: 8 in (Circular)  
Material: Vitrified Clay Pipe  
Map #/Plan File: 17  
Drainage Area:  
Flow Direction: ↗Northeast  
Surface: Asphalt

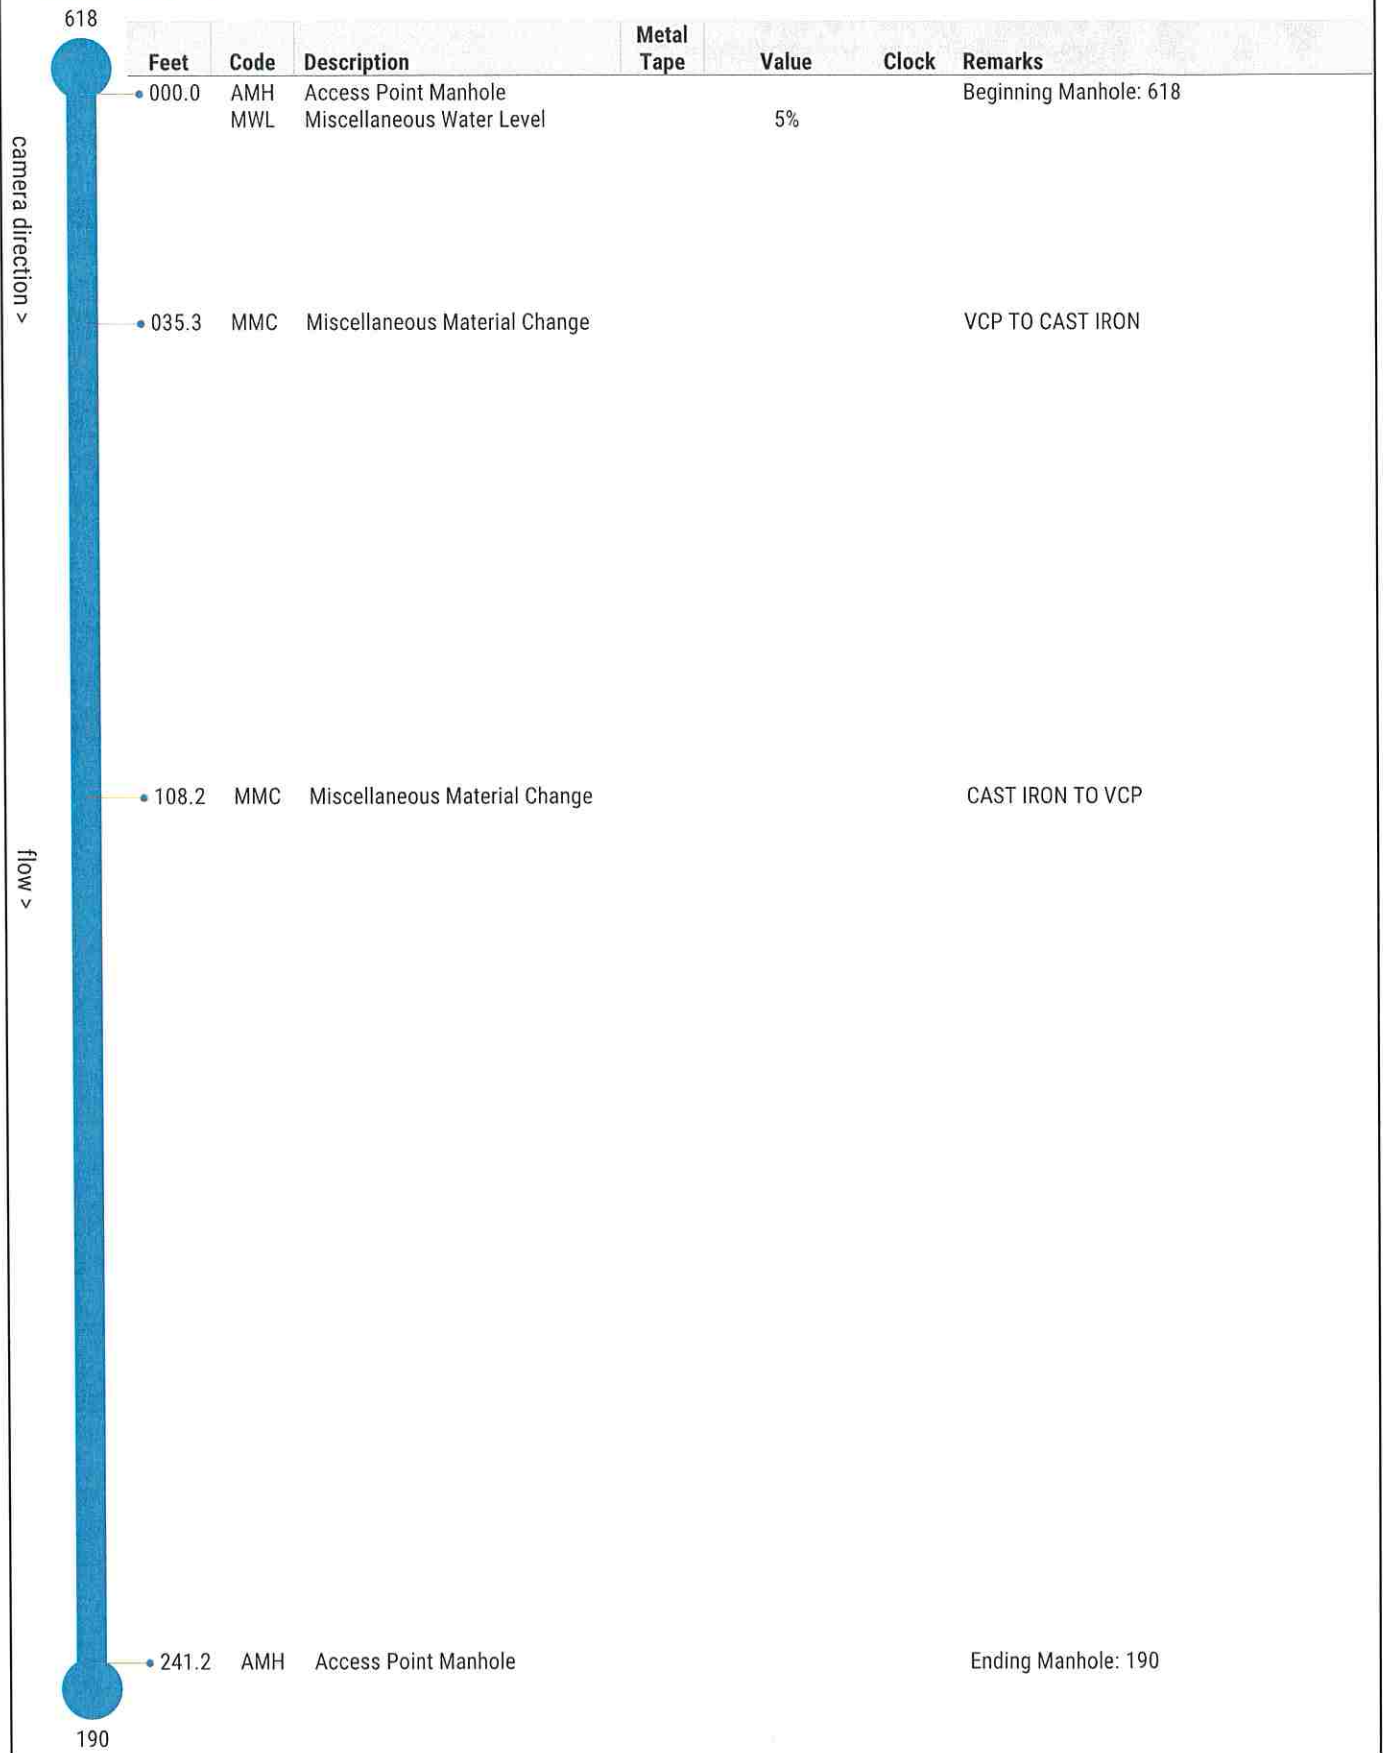
Street: HIGHWAY 86  
City: CASSVILLE MO  
Pipe Use: Sanitary Sewage Pipe  
Pipe Geometry: 8 in (Circular)  
Material: Vitrified Clay Pipe  
Map #/Plan File: 17  
Drainage Area:  
Flow Direction: ←West  
Surface: Grass
