Local Road Safety Plan

City of Yelm

SCJ Alliance

August 2023

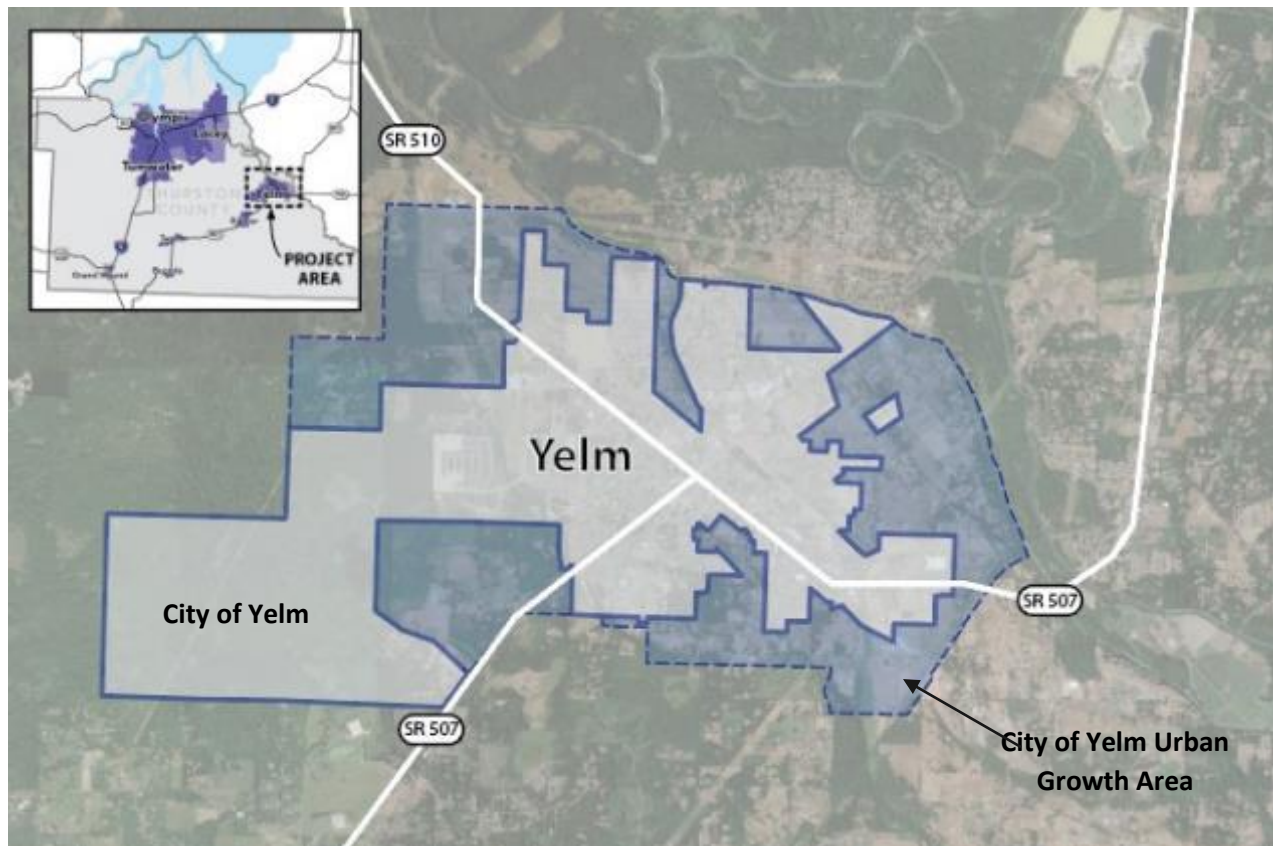
Figure 1. Study Area and Vicinity

Figure 1 illustrates the boundaries of the City of Yelm, its Urban Growth Area, and its general location in Western Washington. The figure also identifies key roadway corridors which include state highway facilities, some with limited access, including SR 507, SR 510, and SR 510 Alt (Yelm Bypass).

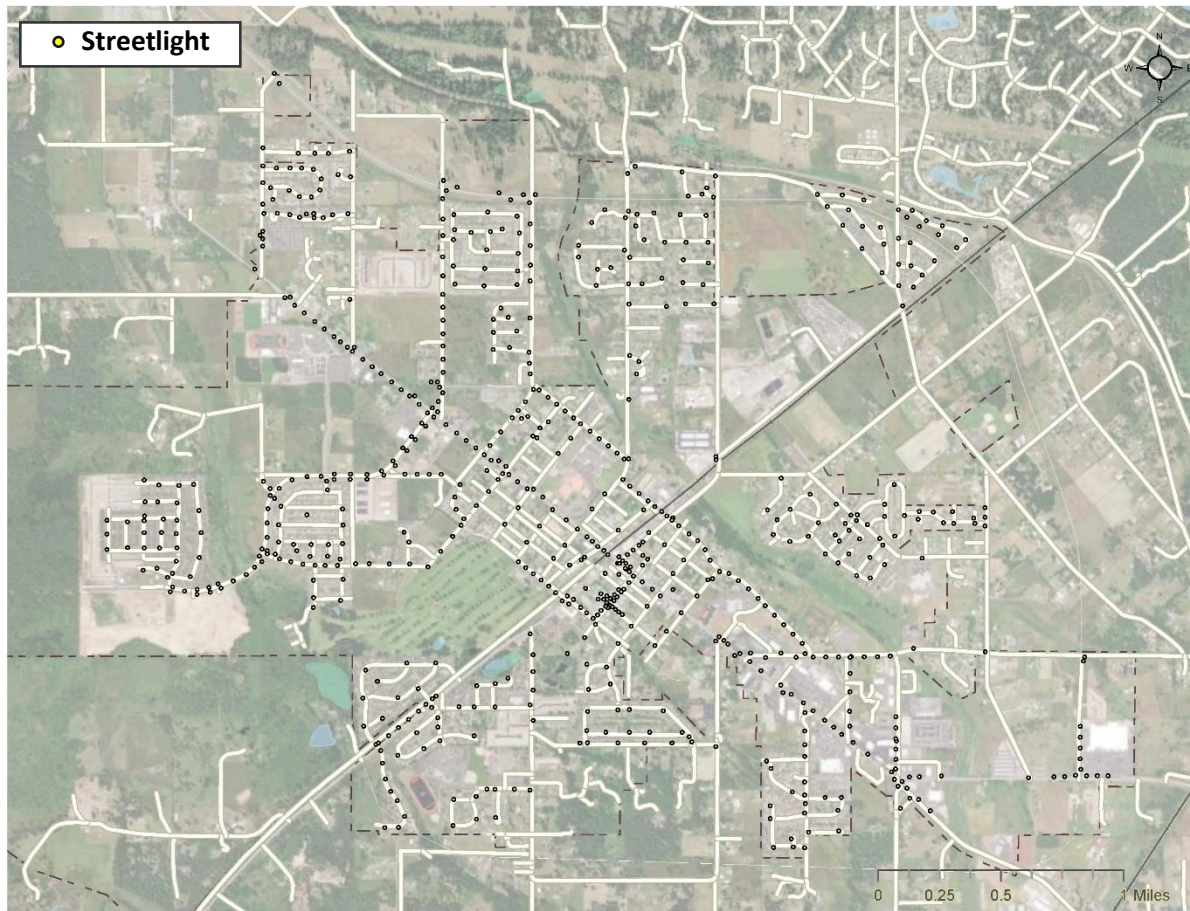
Figure 9. City-wide Streetlight Locations

Given the influence that sufficient lighting can have on safety for all roadway users, an assessment of the existing streetlights was performed. The city tracks its streetlight inventory in GIS and using that data **Figure 9** was prepared to depict all streetlight locations.

Based on a review of the existing streetlight locations on the primary City routes, which typically provide street lighting approximately every 200 feet, several roadway segments with substandard streetlighting were identified. These are:

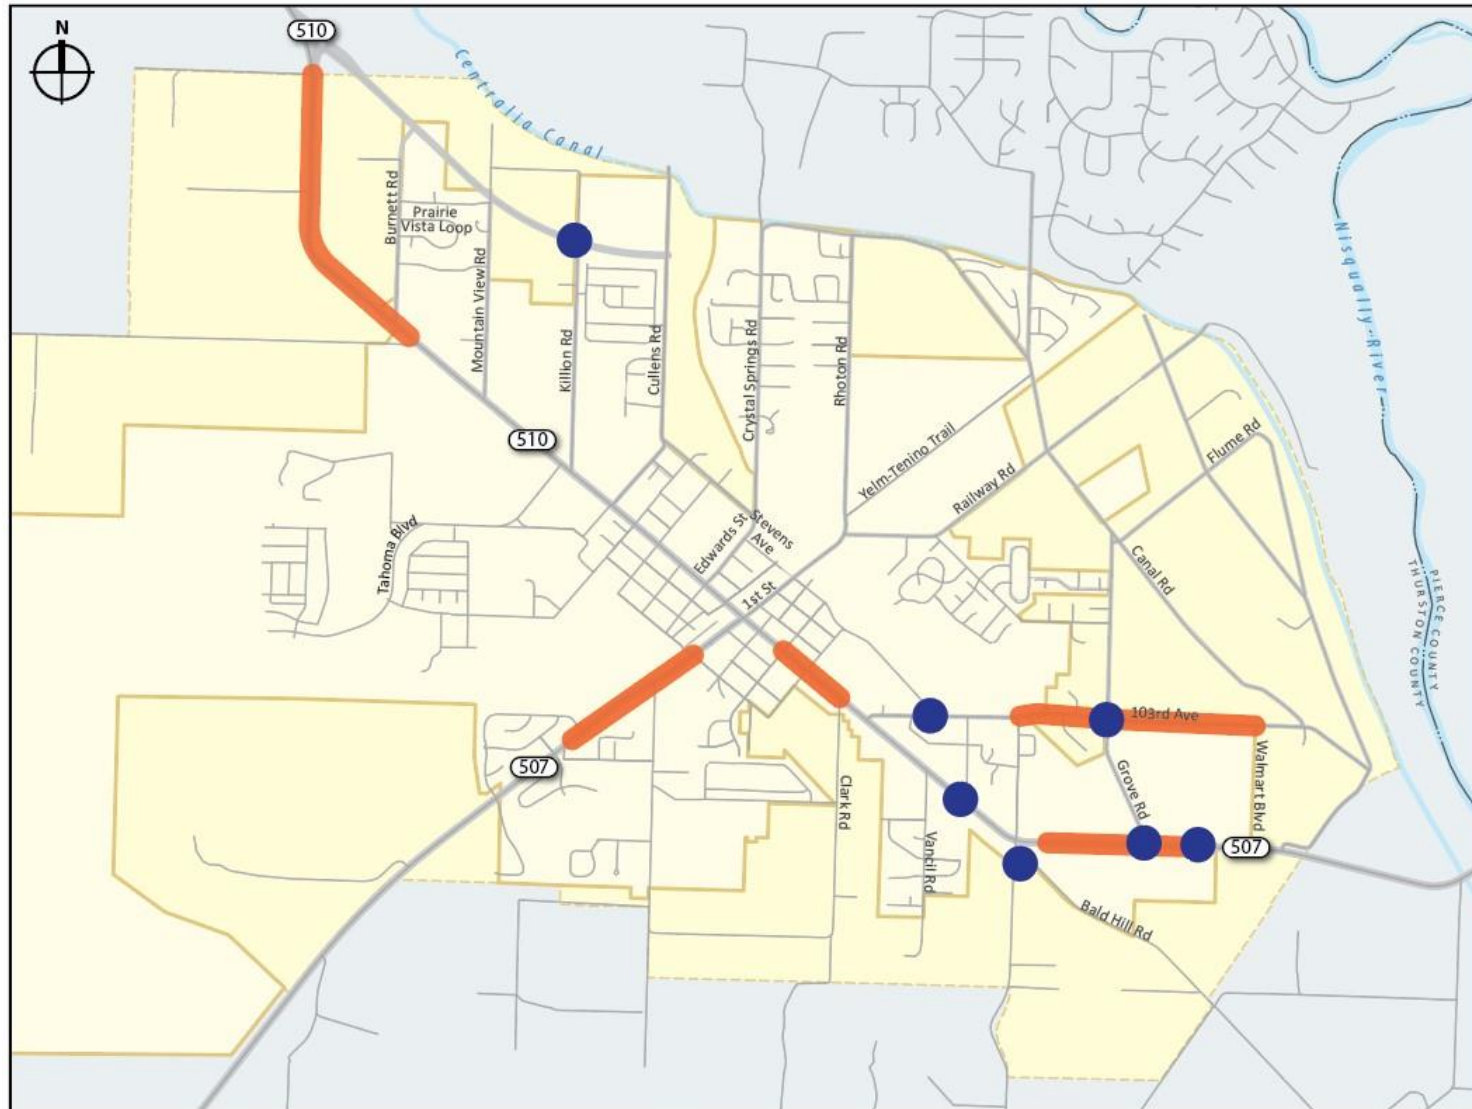
Figure 10. Priority Level 1 and 2 Locations for Improvement

Other locations are not recommended as high priorities to be carried into the evaluation or countermeasures and the development of improvement recommendations. **Figure 10** illustrates the highest Priority Level 1 and Level 2 locations including both spot and potential systemic improvements, those roadway segments with substandard street lighting.

When the project locations identified in Figure 10 are compared with the demographic data presented in Chapter 2, it is clear that there is a distribution of projects throughout much of the city. In particular, there is a concentration of improvements recommended for the southeast portion of the city which includes a higher than average percentage of person of color and low income population.

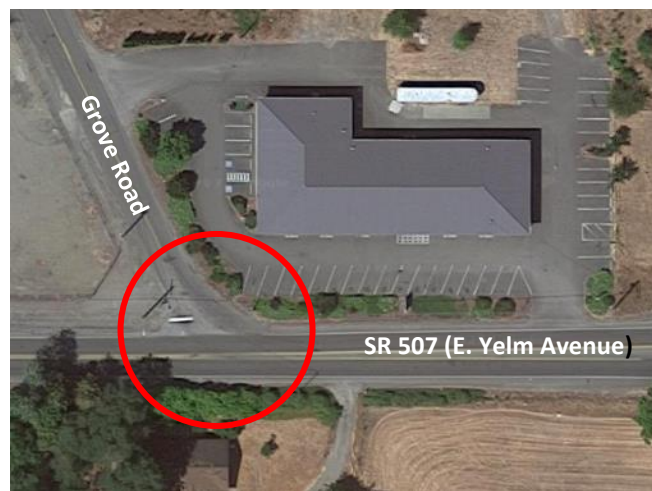
Figure 11. SR 507 at Grove Road

Figure 11 illustrates the existing layout of this intersection. Three severe crashes occurred at this location over the five-year planning period including two right turn angle crashes and one left turn angle crash. Two of the crashes involved turns from the stop-controlled side street (Grove Road) resulting from a failure to yield on the

part of the entering motorist. The third crash involved apparent illness. An additional non-severe injury crash involving a pedestrian occurred approximately 160 feet to the east of the intersection with Grove Road. Two of the crashes occurred during hours of darkness when it was raining and the pavement was wet. There is currently no illumination at this intersection.

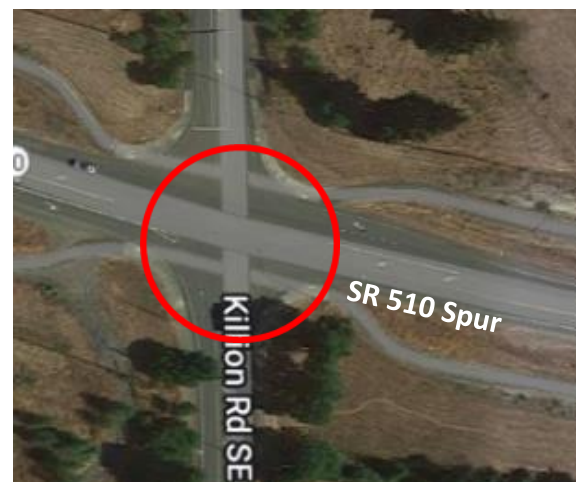
Figure 12. SR 510 Spur at Killion Road

Figure 12 shows the layout of this existing intersection. One severe crash occurred at this location over the past five years which involved an angle collision. 12 other angle crashes occurred here which represented 92 percent of all crashes at the intersection.

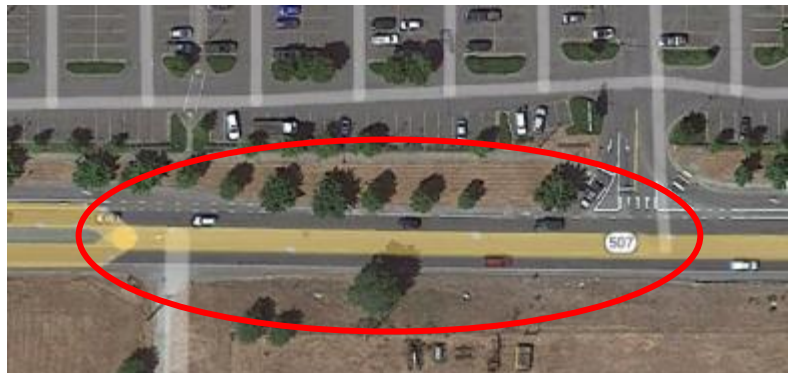
Figure 13. SR 507 at and Near Walmart Entrance

Figure 13 shows the location of the Walmart entrance driveway and the area within which the two other severe crashes occurred. It should be noted that this location will be reconstructed with a median curb as part of the SR 510 Yelm Loop phase 2 project, tentatively scheduled for 2024 construction.

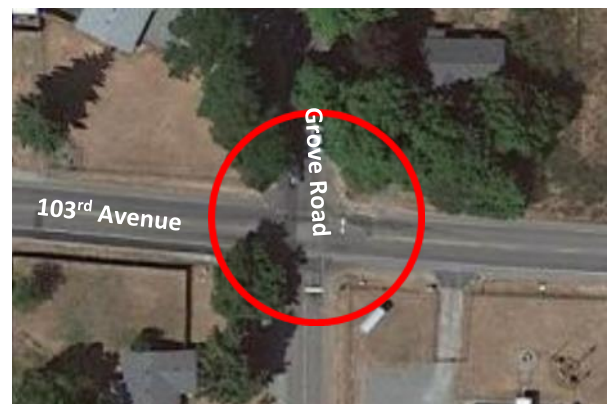
Figure 14. Grove Road at 103rd Avenue

Figure 14 illustrates the intersection of Grove Road with 103rd Avenue. One severe crash occurred at this location which involved an angle collision. This crash occurred on 2/21/2021 at 6:30 pm. It was raining and dark with streetlights on. Pavement was wet. The intersection was controlled by a four-way stop and caused by a motorist making a right turn from

southbound to westbound. The contributing causes was cited as illness. Nineteen total crashes occurred at this intersection during the five-year study period of which 13 involved entering at an angle.

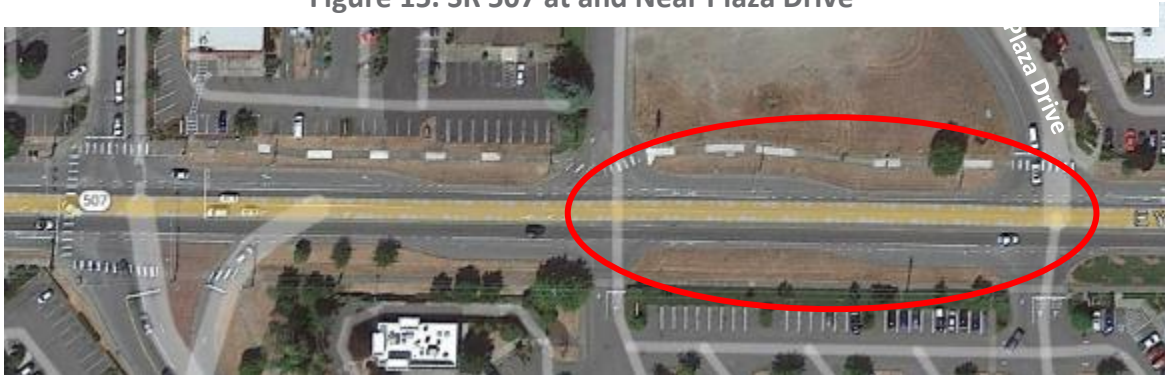
Figure 15. SR 507 at and Near Plaza Drive

Three non-severe crashes involving bicyclists or pedestrians occurred at the intersection of E. Yelm Avenue and Plaza Drive and one severe crash occurred in the vicinity. The severe crash occurred at milepost 28.98 at a driveway for a commercial business. This is 0.05 miles from the intersection with Vancil Road and 0.06 miles from the intersection with Plaza Drive and involved a pedestrian who was cited for failing to yield to the motor vehicle. The three crashes at Plaza Drive all occurred during daylight hours under good weather conditions. In some instances blame was attributed to the motorist and in others to the non-motorist. It should be noted that this intersection is not illuminated which could create an added safety hazard for pedestrians and bicyclists in the area. **Figure 15** shows the intersection of SR 507 with Plaza Drive and the vicinity where identified crashes occurred.

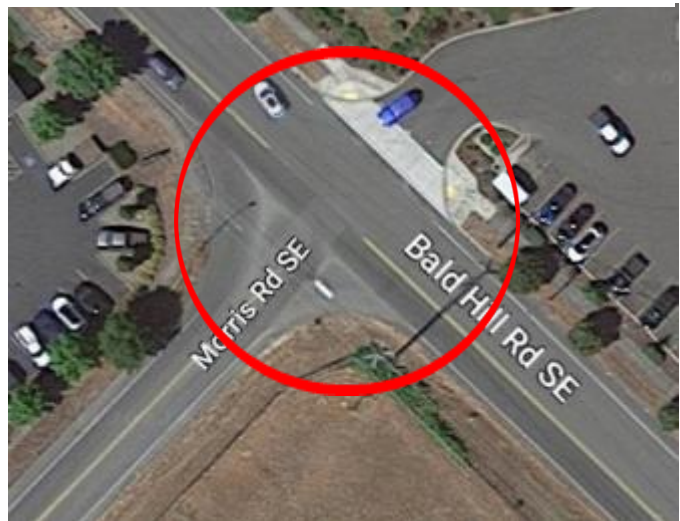
Figure 16. Bald Hills Road at Morris Road

Figure 16 presents the intersection of Bald Hills Road at Morris Road which lies just to the southeast of the intersection of SR 507 with Bald Hills Road, which is currently under design for installation of a multi-lane roundabout to address existing congestion and safety concerns.

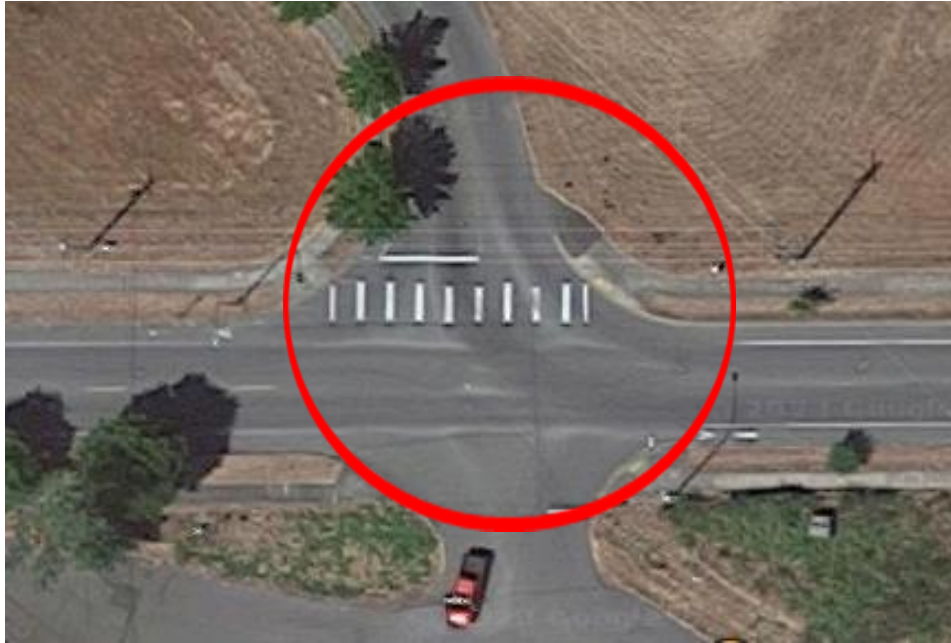
Figure 17. 103rd Avenue at West Road

Figure 17 shows the intersection of 103rd Avenue with West Road. No severe crashes occurred at this location but there were a total of 12 crashes of which five involved angle crashes.
