CITY OF YELM REQUEST FOR STATEMENT OF QUALIFICATIONS PROFESSIONAL SERVICES Prairie Line Trail Phase 2B

RE: Nisqually Trestle - Structural Inspection and Report Project No.: A20100.00

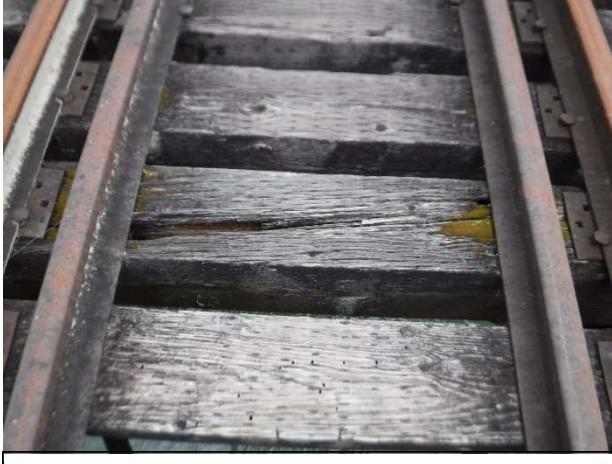
Image 01 – General Timber Deck

There are transverse timber railroad ties along the entire length of the trestle. The timber deck ties range from good to poor condition. Many of the deck ties have visible decay. See attached images 01 & 02.

- Remove loose delaminated concrete at the top of the pier walls.
- Remove and recast loose and/or delaminated concrete bearing pedestals.
- Replace timber tie deck with precast concrete panels.
- Install pedestrian fencing along the bridge, and along both trail approaches leading up to the bridge.

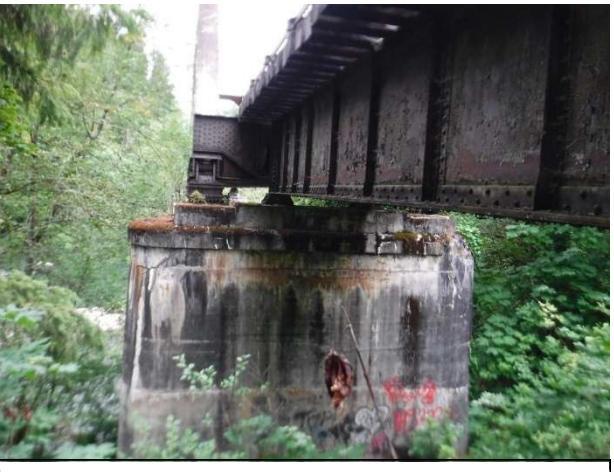
Image 03 – General Steel Girder

There are two painted steel girders in each approach span. The steel girders are in good to fair condition. Much of the paint along the girders is dull, chalky and peeling off. The worst areas for exposed steel are along the bottom and top flanges. The steel is surface rusting where the paint has failed. However, there are no indications of section loss in the rusted areas. See attached image 03 & 04.

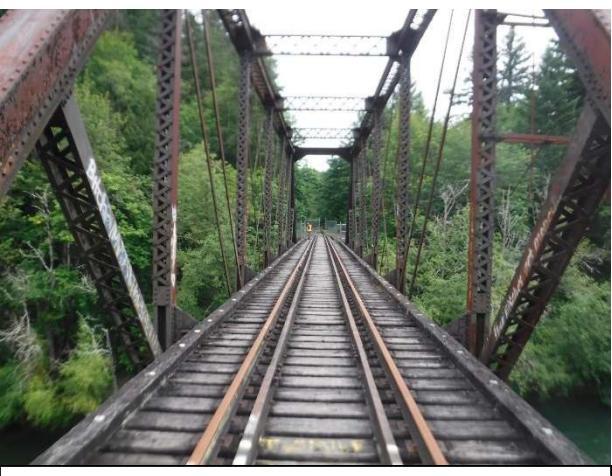
Image 05 – General Steel Truss

There are two painted steel thru-truss main spans. The paint along all the truss members is dry, chalky and peeling off. The steel is surface rusting where the paint has failed. However, there are no indications of section loss in the rusted areas. Dirt and debris are collecting at the lower panel points where horizontal wind plates are present. See attached images 05 & 06.

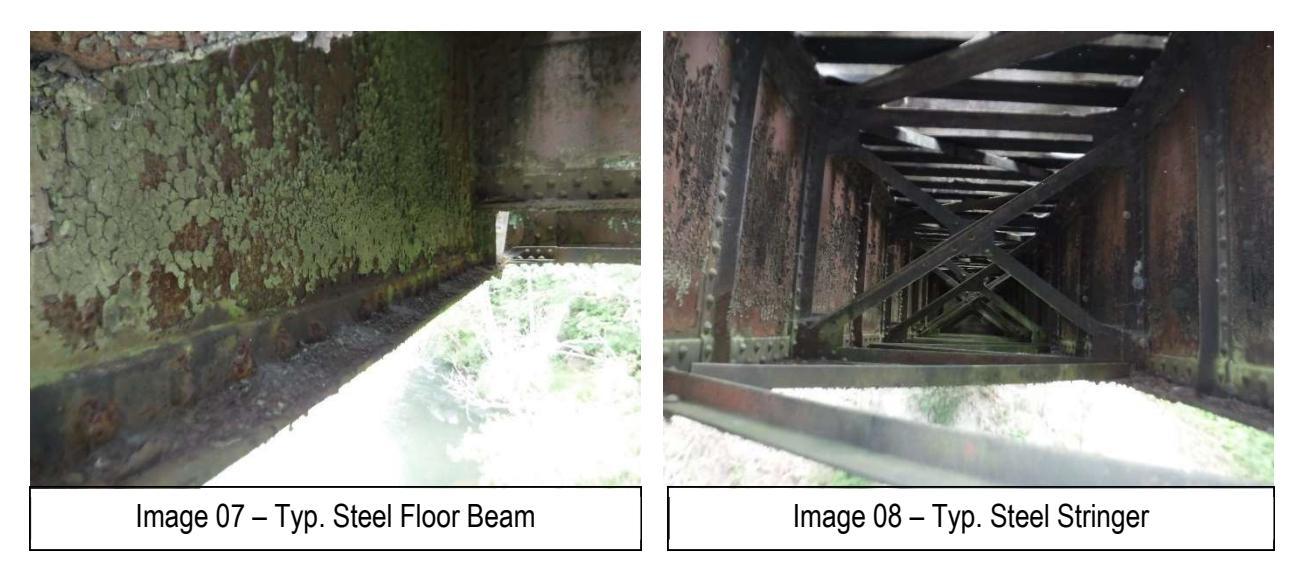
There are painted steel floor beams at each truss panel point along the main spans. The steel floor beams are in good to fair condition. Much of the remaining paint along the girders is dull, chalky and peeling off. The worst areas for exposed steel are along the bottom and top flanges. The steel is surface rusting where the paint has failed. However, there are no indications of section loss in the rusted areas. See attached image 07.

There are painted steel stringers spanning between floor beams. The steel stringers are in good to fair condition. Much of the remaining paint along the girders is dull, chalky and peeling off. The worst areas for exposed steel are along the bottom and top flanges. The steel is surface rusting where the paint has failed. However, there are no indications of section loss in the rusted areas. See attached image 08.

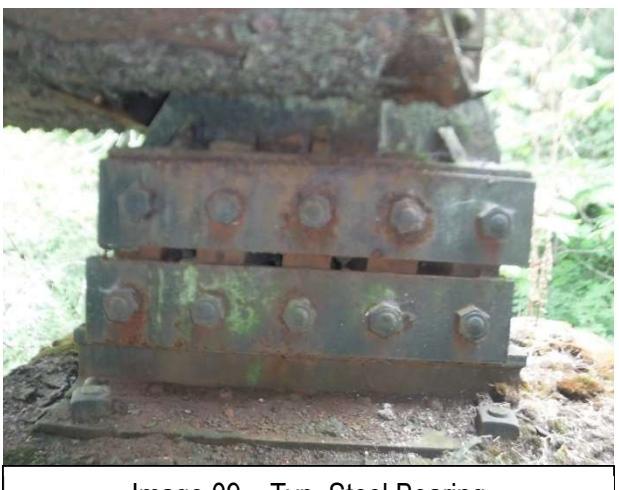
Image 09 – Typ. Steel Bearing

There are fixed or moveable bearings below girders and trusses. The steel bearings at the interior piers are surface rusting. The roller nests at the movable truss bearings are relatively clean of debris, but it could not be determined if they remain functional. The concrete pedestals supporting the truss bearings are heavily cracked and delaminating. Soundings indicated that the delamination's are deep. Concrete pedestal repairs may be warranted. See attached images 09 & 10.

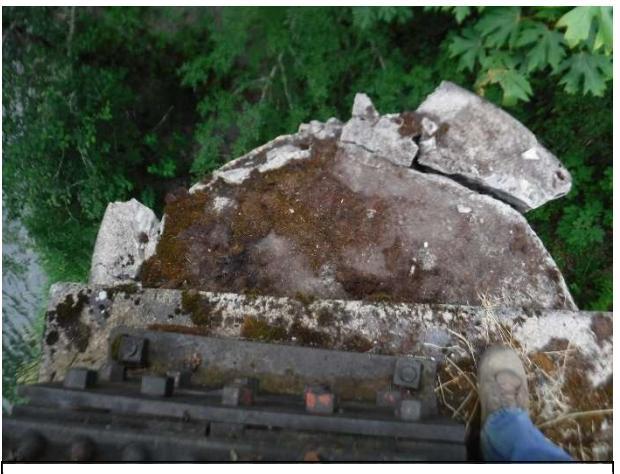
Image 11 – Typ. Top of Pier Wall

The interior substructure elements consist of concrete pier walls. The concrete pier walls are in fair to poor condition. The concrete is heavily cracked with moderate leaching efflorescence. Rust staining efflorescence is scattered throughout, but worst along the top sections of the wall. Decorative cap details at the top of the pier walls are heavily delaminated with large sections spalling off. Removing loose concrete along the upper sections of the pier walls may be warranted. See attached images 11 & 12.

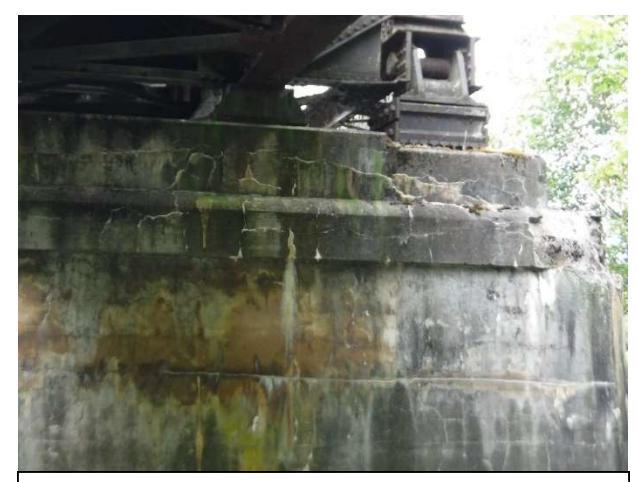
Image 12 – Typ. Pier Wall

The center pier wall supporting both main spans is in the river channel. A coffer dam is visible along the north and downstream sides. Aggradation around the pier indicates that there is not a scour concern. However, access to the base of the wall was not possible at the time of inspection, and all observations were made from the trestle deck and channel banks.

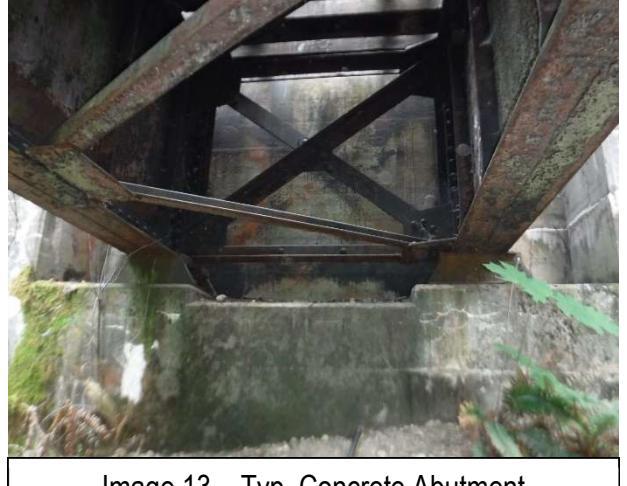
Image 13 – Typ. Concrete Abutment

The abutments at the trestle ends consist of concrete walls. The concrete abutments and wing walls are in fair condition. The wingwalls and abutment sections below the bearing seats are heavily cracked with moderate leaching efflorescence. See attached imagers 13 & 14
