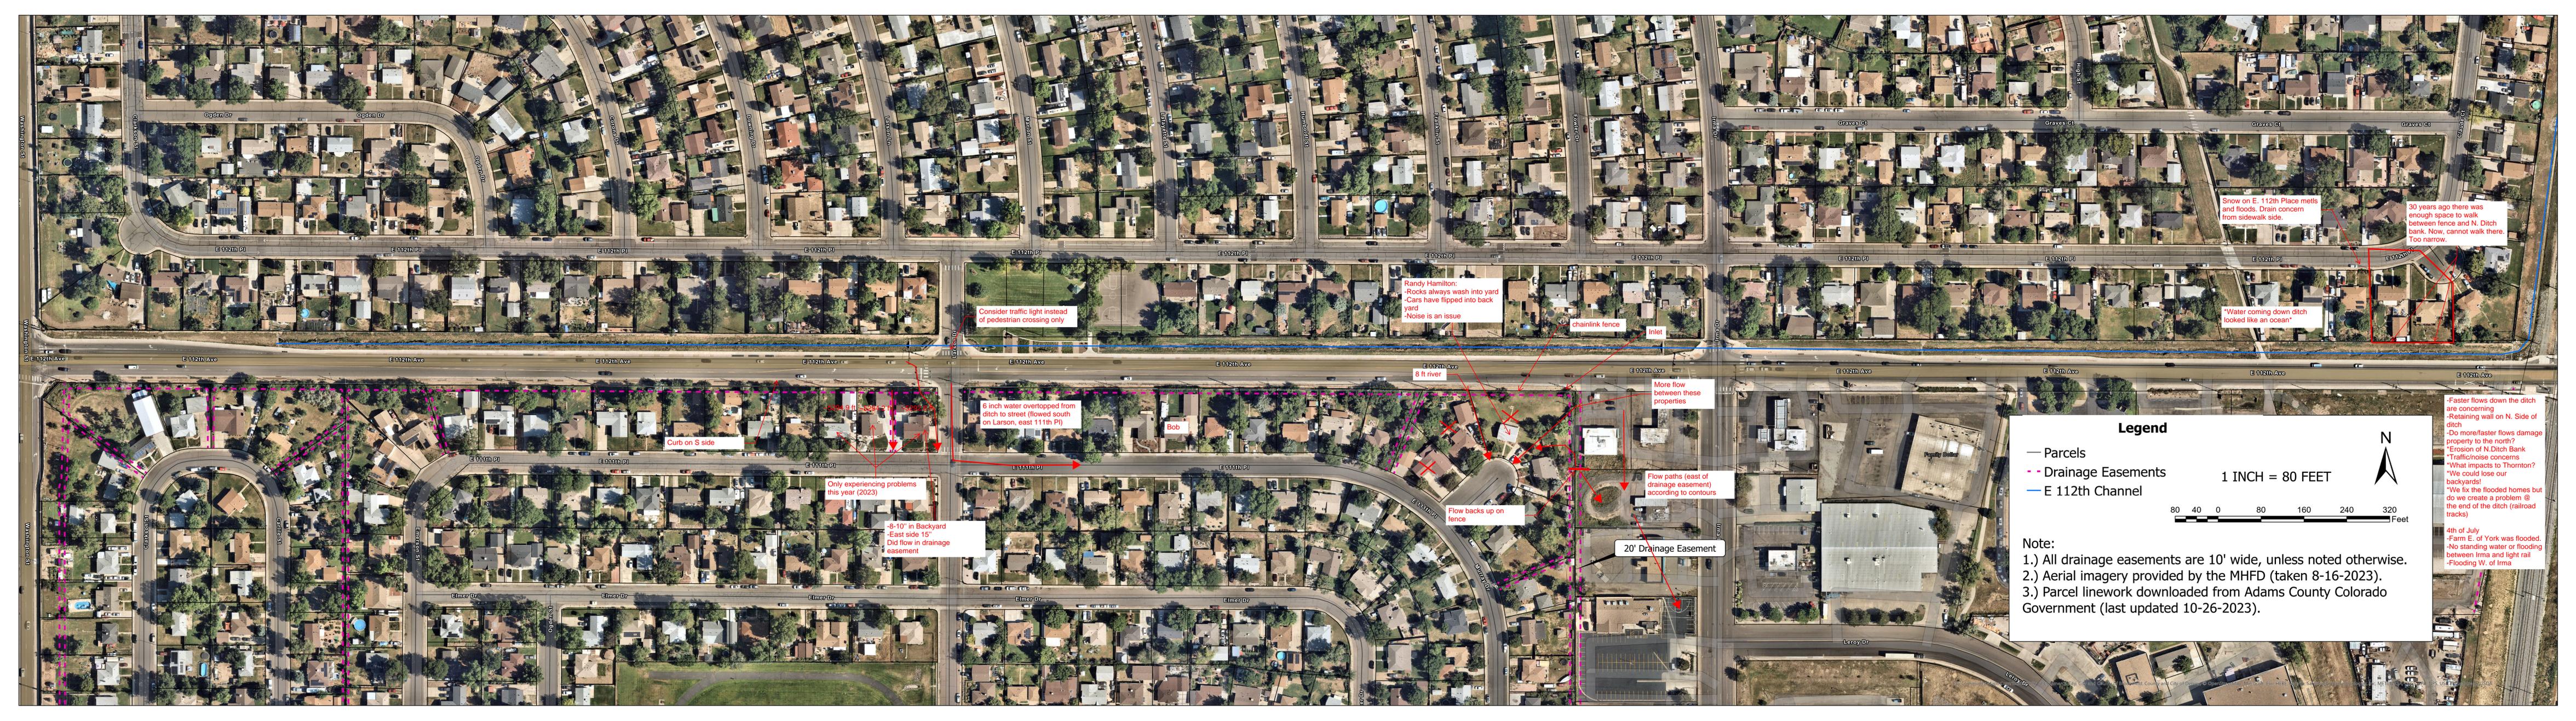
Randy Hamilton:
 -Rocks always wash into yard
 -Cars have flipped into back yard
 -Noise is an issue

"Water coming down ditch looked like an ocean"

Snow on E. 112th Place melts and floods. Drain concern from sidewalk side.

30 years ago there was enough space to walk between fence and N. Ditch bank. Now, cannot walk there. Too narrow.

6 inch water overtopped from ditch to street (flowed south on Larson, east 111th Pl)

8 ft river

More flow between these properties

Flow paths (east of drainage easement) according to contours

Flow backs up on fence

Only experiencing problems this year (2023)

-8-10" in Backyard
 -East side 15"
 Did flow in drainage easement

-Faster flows down the ditch are concerning
 -Retaining wall on N. Side of ditch
 -Do more/faster flows damage property to the north?
 -Erosion of N. Ditch Bank
 -Traffic/noise concerns
 -What impacts to Thornton?
 -We could lose our backyards!
 -We fix the flooded homes but do we create a problem @ the end of the ditch (railroad tracks)
 4th of July
 -Farm E. of York was flooded.
 -No standing water or flooding between Irma and light rail
 -Flooding W. of Irma

Consider traffic light instead of pedestrian crossing only
