**CITY OF ALLEGAN
CITY COUNCIL STUDY SESSION MEETING
Monday, October 9, 2023, 5:30PM
City Council Chambers - 231 Trowbridge Street
Allegan, Michigan**

SUBJECT: PaSER 10-Year Road Strategies Reports

**DAM SAFETY INSPECTION REPORT
ALLEGAN CITY DAM – DAM ID NO. 489
KALAMAZOO RIVER
ALLEGAN COUNTY – SECTION 28, T 02N, R 13W**

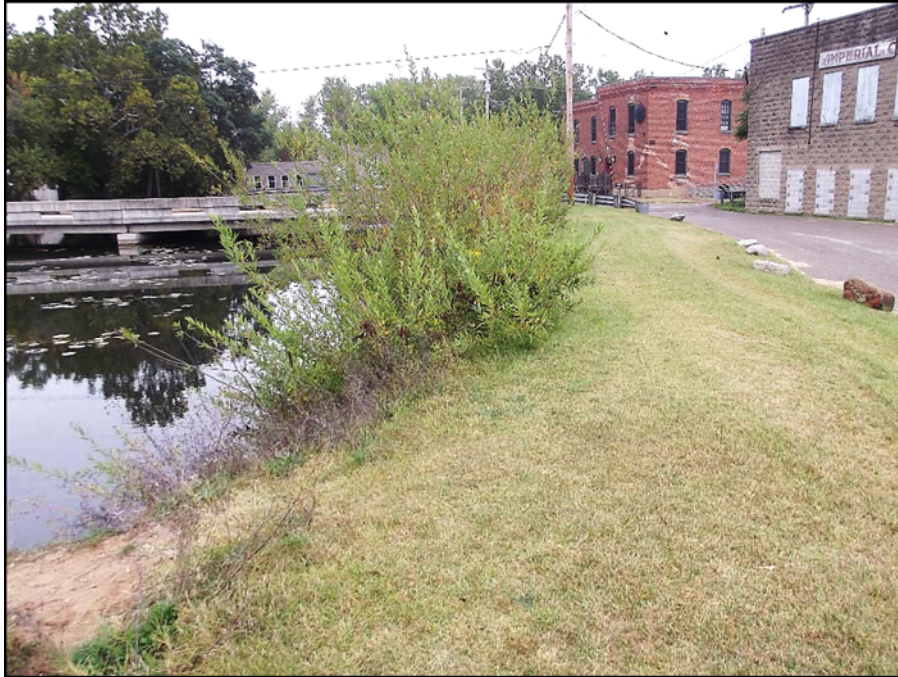
The dam's earthen embankments, shown in Photographs 1 through 9, are in satisfactory condition. No sloughs, slumps, cracking, differential settlement, or major erosion were observed. The crest of the left embankment is largely covered in dense, well-maintained grass. The upstream and downstream faces are lined with large riprap. Brush was observed to be growing from voids in the riprap lining the upstream face of the left embankment, as shown in Photographs 1 and 4. This condition does not currently pose a threat to the stability of the embankment, however, trees and brush can provide shortened seepage pathways along their root systems, resulting in internal erosion (piping) of embankment materials and large section loss in the event of a blow down. They can also provide a haven for burrowing animals and obscure underlying deficiencies. As such, all brush should be removed from the left embankment by January 1, 2019.

**Photograph 1 – Upstream face of left embankment viewed from right
Note the brush along the waterline**

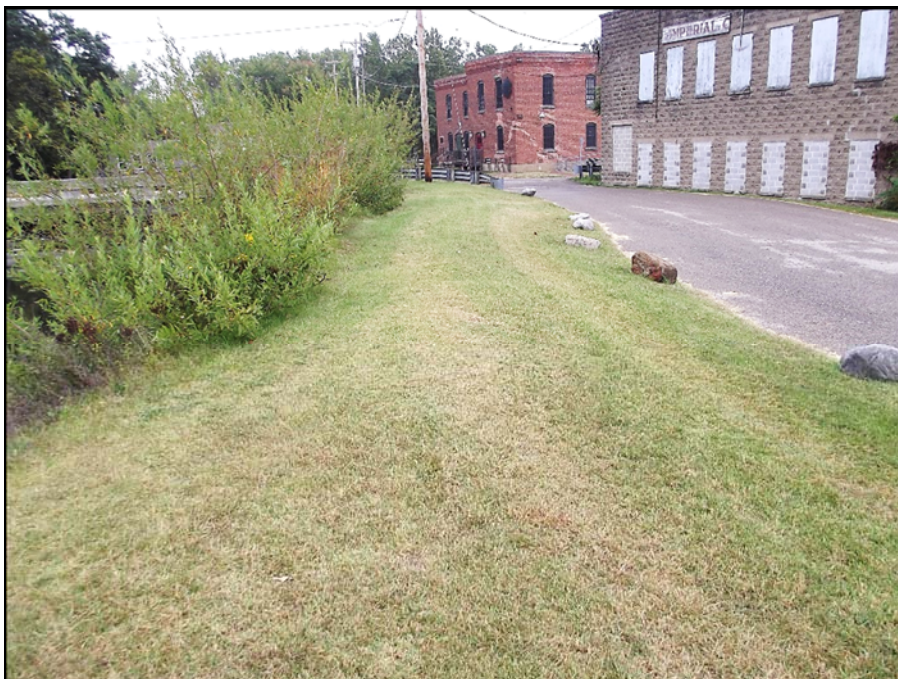
Photograph 2 – Left embankment crest viewed from right

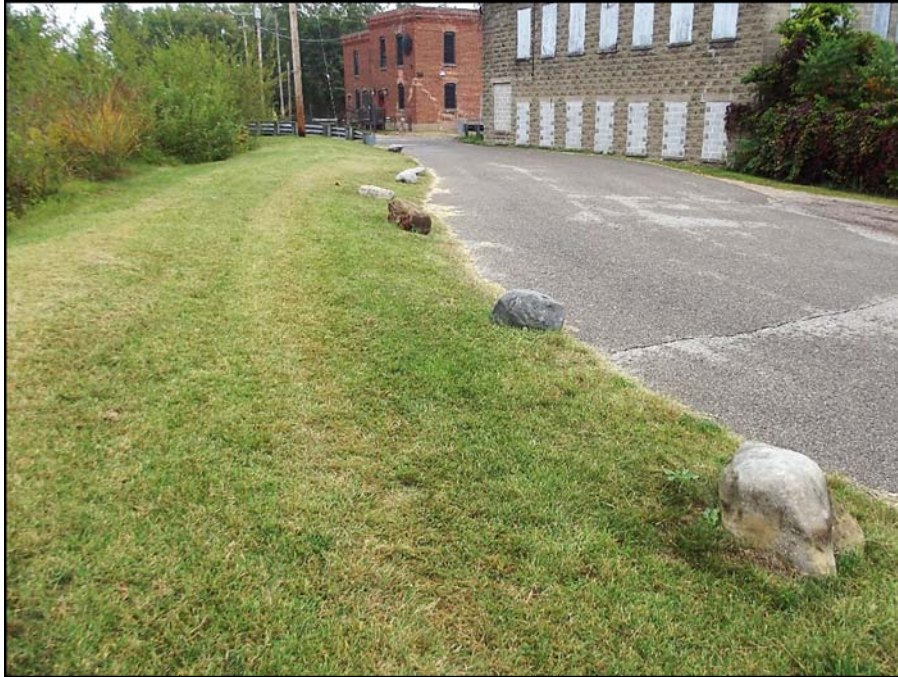
Photograph 3 – Downstream face of left embankment viewed from right

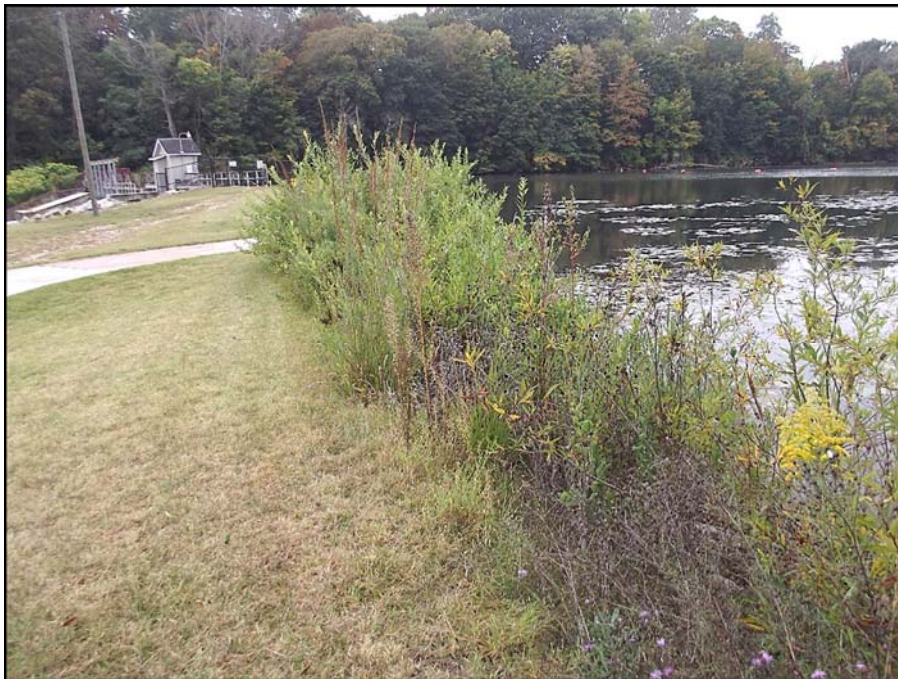
**Photograph 4 – Upstream face of left embankment viewed from left
Note brush along the waterline**

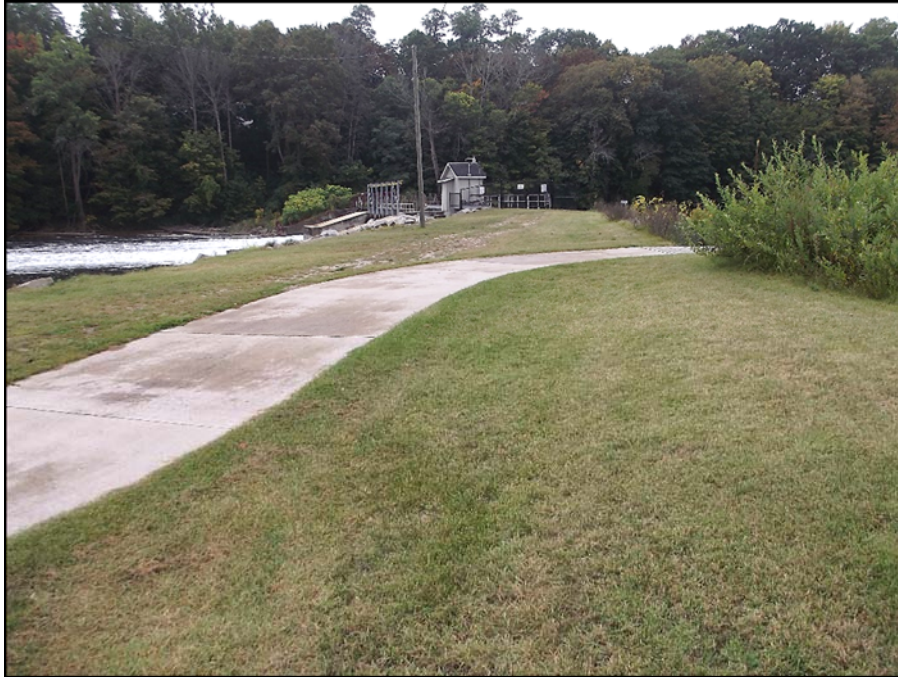
Photograph 5 – Left embankment crest viewed from left

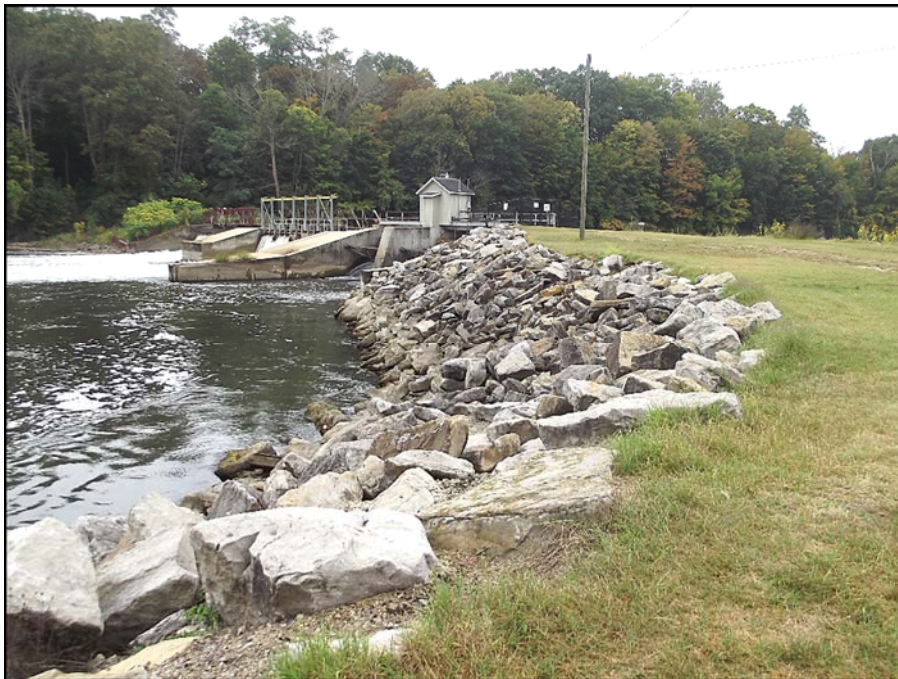
Photograph 6 – Downstream face of left embankment viewed from left

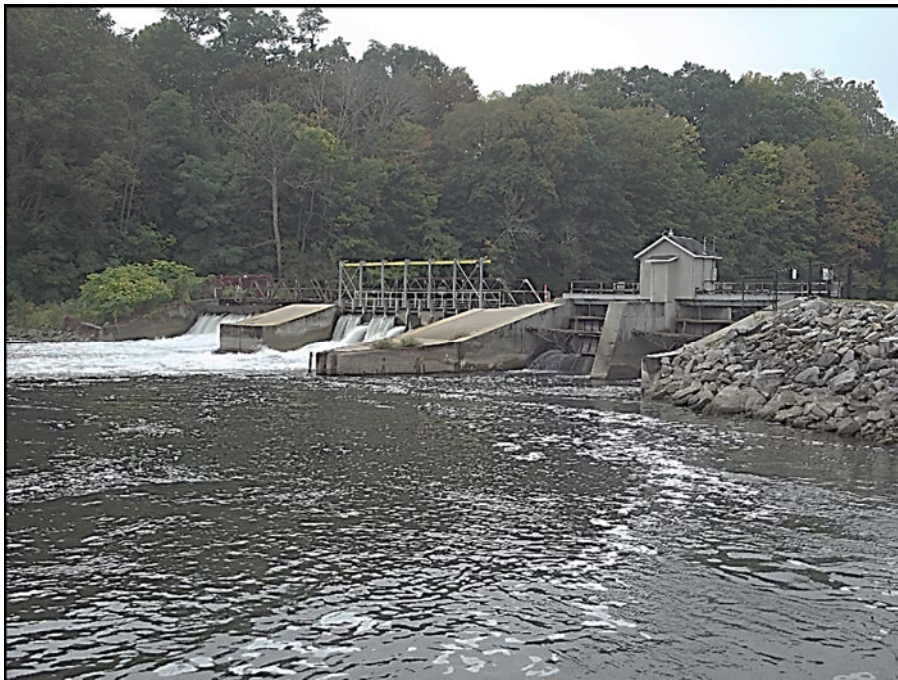
The principal spillway structure, shown in Photographs 10 through 24, is also in satisfactory condition. No misalignment, differential settlement, or major cracking or deterioration was observed. The spillway gates and stoplog hoist were not operated during this inspection, but City staff indicated that both radial gates and the stoplog hoist system are operated regularly to pass flood flows and are in sound working order. No remedial action is required at this time.

Photograph 10 – Principal spillway viewed from downstream

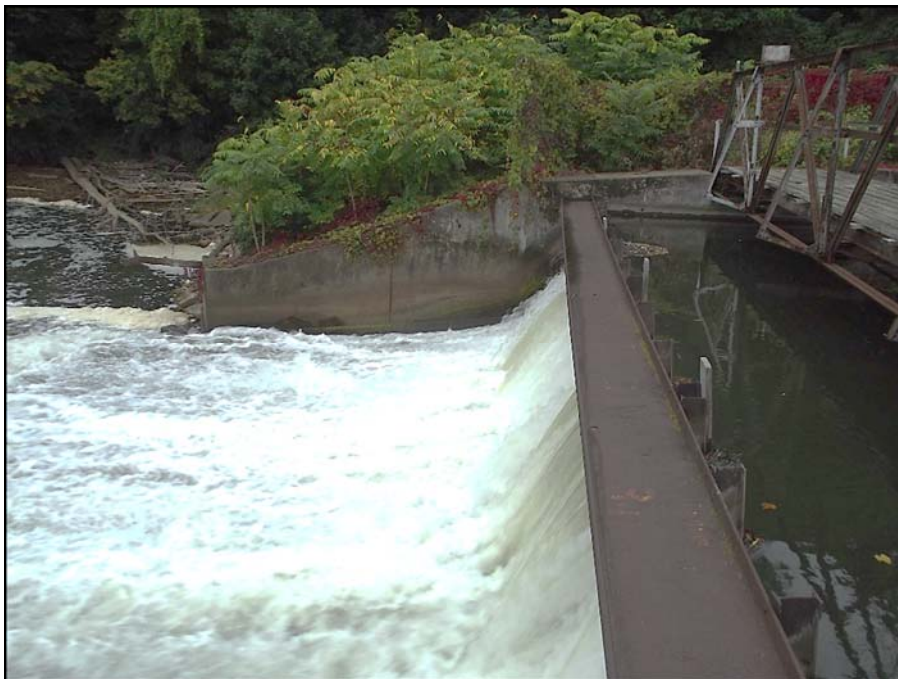
Photograph 12 – Downstream right abutment wall

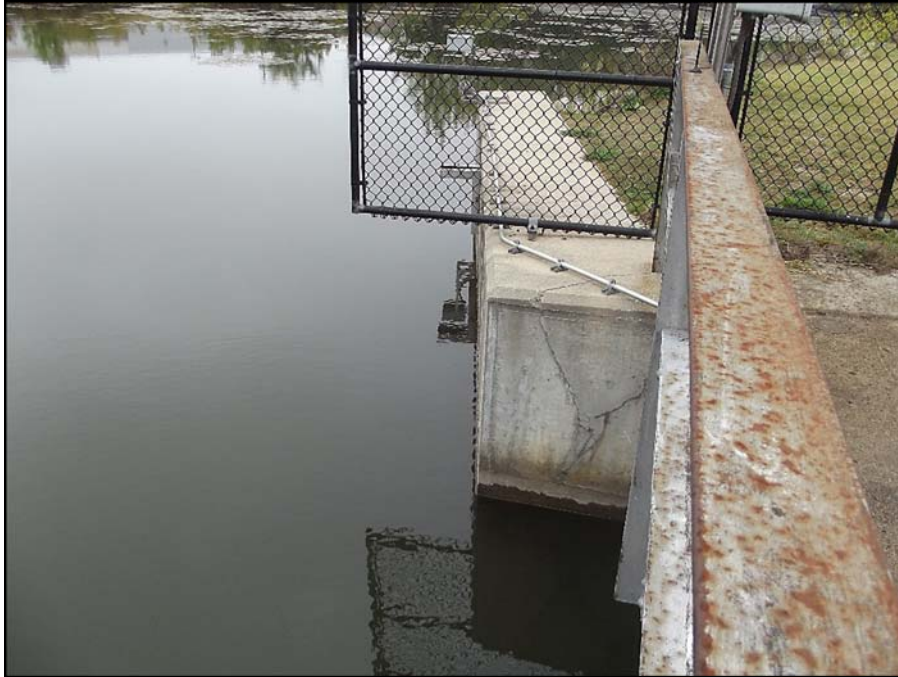
Photograph 13 – Upstream left abutment wall

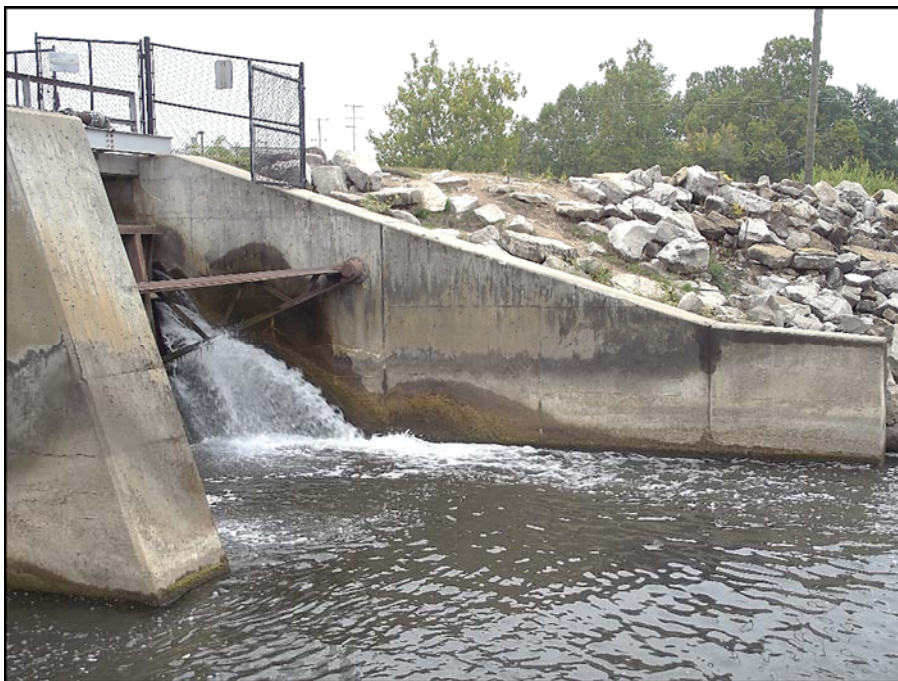
Photograph 14 – Downstream left abutment wall

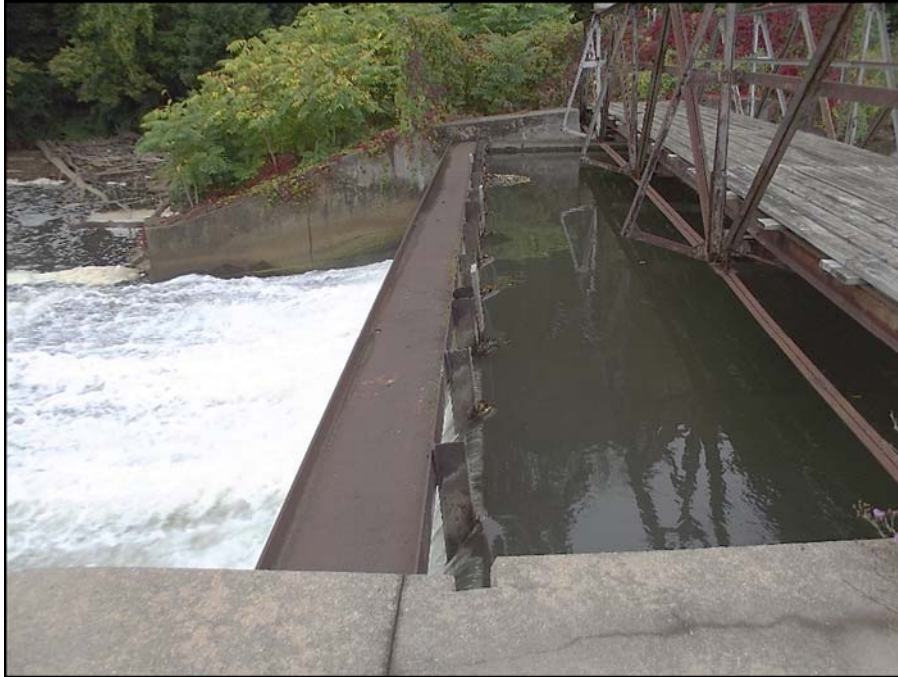
Principal Spillway Bay #2 has a separate catwalk system for operation of the stoplog hoist system, as shown in Photograph 17. As such, operation of Bay #2 stoplogs is easily achieved when needed. However, Spillway Bay #1 does not have its own catwalk system. Rather, it relies on access from the shared catwalk which was closed off in 2017, as shown in Photograph 18. As such, operation of Spillway Bay #1 stoplogs could be difficult or impossible during a flood. Repairs or replacement of the catwalk system should be implemented as soon as possible such that access to Spillway Bay #1 and the right earthen embankment are restored.

Photograph 15 – Spillway Bay #1, stoplog crests

1. Repair or replace the catwalk structure over Spillway Bays #1 and #2 as soon as possible so the right embankment can be properly maintained and thoroughly inspected. City staff stated that there is no reasonable access to the right embankment since the catwalk has been closed off.

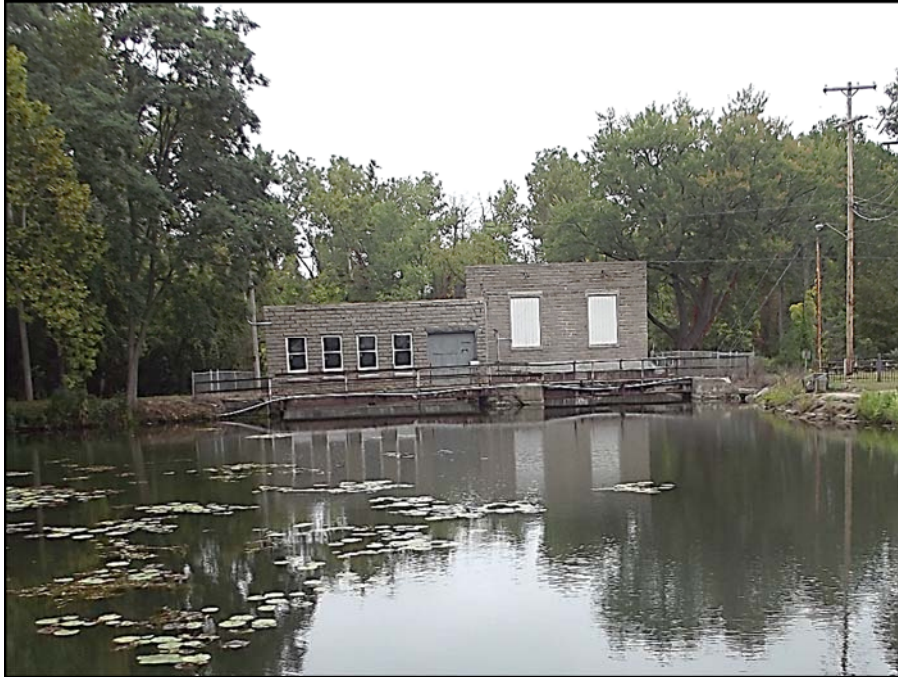
Photograph 25 – Abandoned powerhouse viewed from upstream

The abandoned powerhouse structure, shown in Photographs 25 through 27, is in poor condition. Deteriorated concrete and masonry is present throughout the older western section of the structure. A detailed structural inspection of the powerhouse structures was performed by LFA in 2017. This report indicates that failure of the western section of the building could happen suddenly. However, since the western section has a

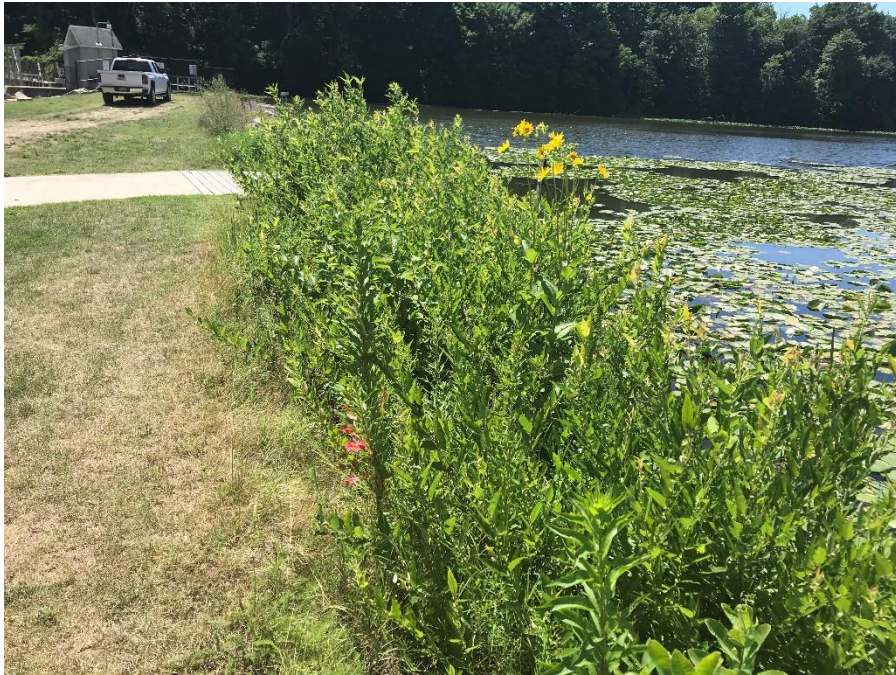
The dam's earthen embankments, shown in Photographs 1 through 9, are in satisfactory condition. No sloughs, slumps, cracking, differential settlement, or major erosion were observed. The crests and downstream slopes of the left and right millrace embankments are largely covered in dense, well-maintained grass and riprap. City staff have done a great job in removing small trees and brush previously observed along the upstream slope of the embankments, however, some tall weeds and brush have regrown, as shown in Photographs 1 and 7. All large trees have been removed from the right embankment, however tall weeds, brush, and small trees remain, as shown in Photographs 4 through 6. This condition does not currently pose a threat to the stability of the embankment; however, trees and brush can provide shortened seepage pathways along their root systems, resulting in internal erosion (piping) of embankment materials and large section loss in the event of a blow down. They can also provide a haven for burrowing animals and obscure underlying deficiencies. As such, the City should continue current efforts to remove all remaining trees and brush from the embankments. The 2017 inspection report recommended that this be completed by January 1, 2019. Keeping with this timeframe, the embankments should be cleared as soon as possible. After clearing, all embankments should be mowed a minimum of two times per year to prevent further establishment of woody vegetation and to facilitate visual inspection.

**Photograph 1 – Upstream face of left embankment viewed from left
Note the tall weeds along the waterline**

1. Continue current efforts to clear all trees and brush from the earthen embankments. This recommendation is repeated from previous inspection reports and should be completed as soon as possible. After clearing, the embankments should be mowed a minimum of two times per year to prevent future establishment of woody vegetation and to facilitate visual inspection.

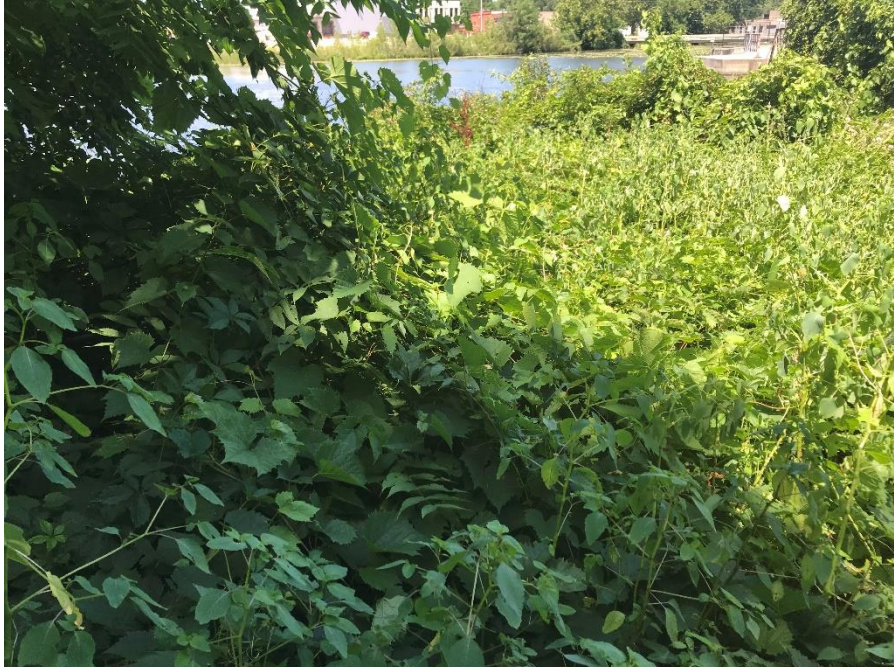
**Photograph 4 – Upstream face of right embankment viewed from right
Note the tall weeds, brush, and small trees**

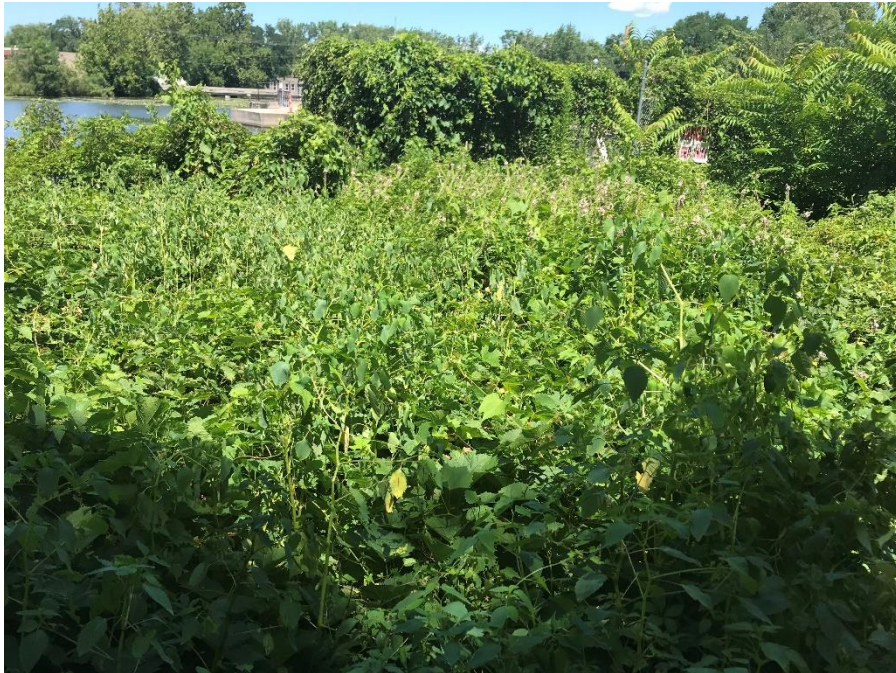
**Photograph 5 – Right embankment crest viewed from right
Note the tall weeds, brush, and small trees**

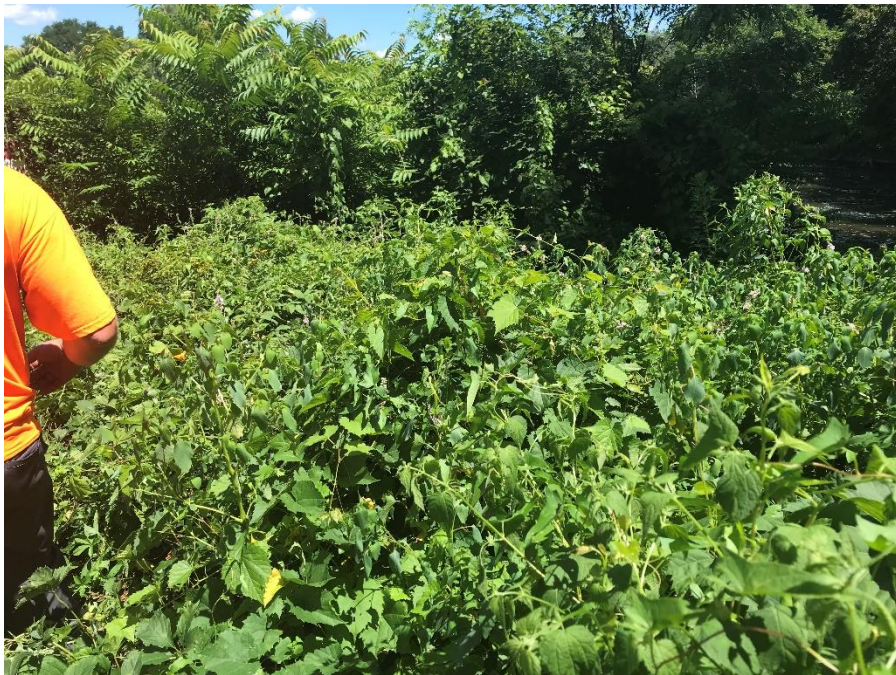
**Photograph 6 – Downstream face of right embankment viewed from right
Note the tall weeds, brush, and small trees**

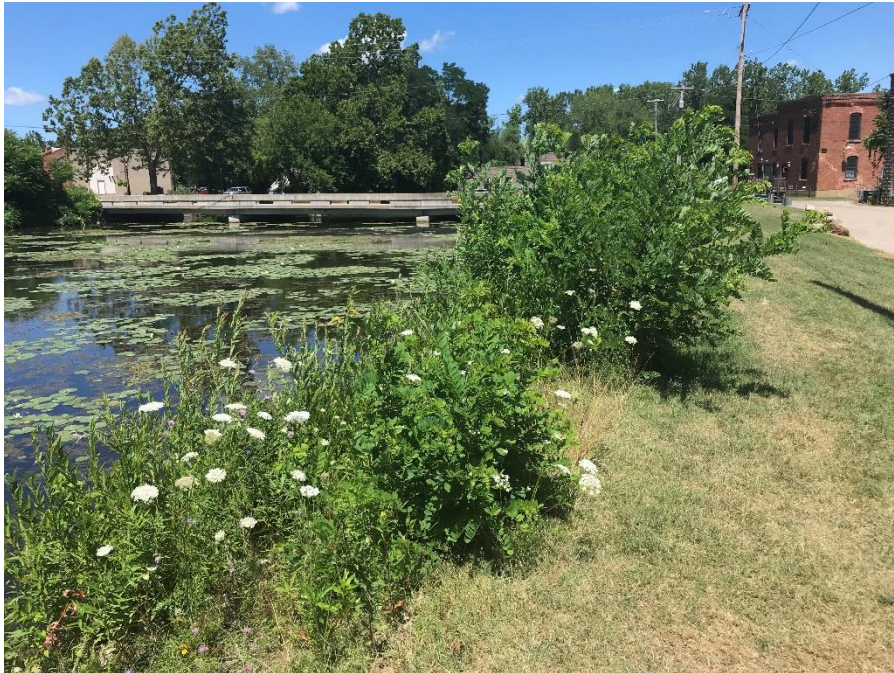
**Photograph 7 – Upstream face of millrace embankment viewed from right
Note the tall weeds and brush near the waterline**

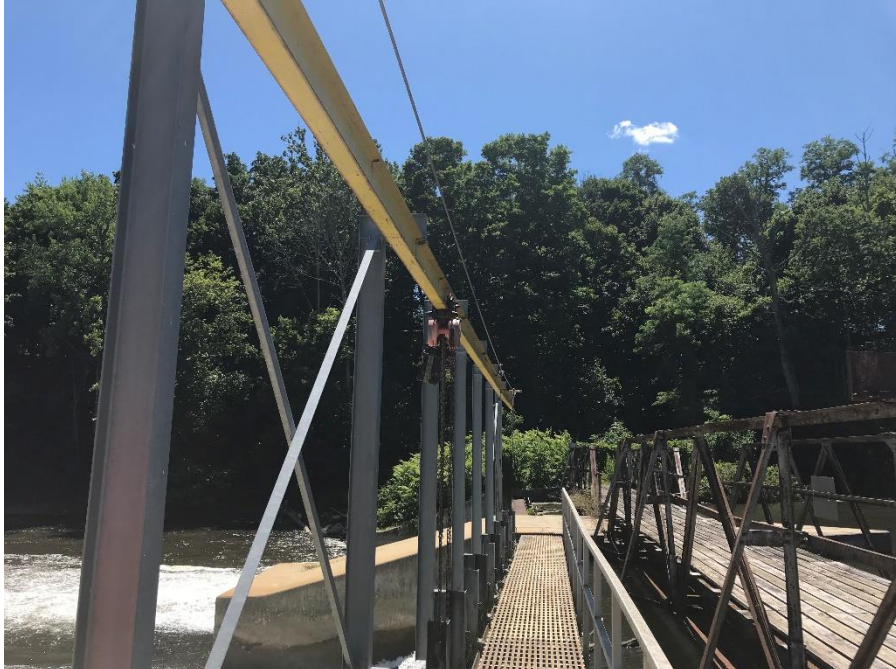
Photograph 20 – Catwalk and stoplog hoist system of center spillway

The central stoplog spillway section has a separate catwalk system for operation of the stoplog hoist system, as shown in Photograph 20. As such, operation of these stoplogs is easily achieved when needed. However, the right stoplog spillway section does not have its own catwalk system. Rather, it relies on access from the shared catwalk which was closed off in 2017 due to deterioration of the steel structural members, as shown in Photographs 23 and 24. As such, operation of these stoplogs could be difficult or impossible during a flood. Repairs or replacement of the catwalk system should be implemented as soon as possible such that access to the right stoplog spillway section and right earthen embankment are restored.

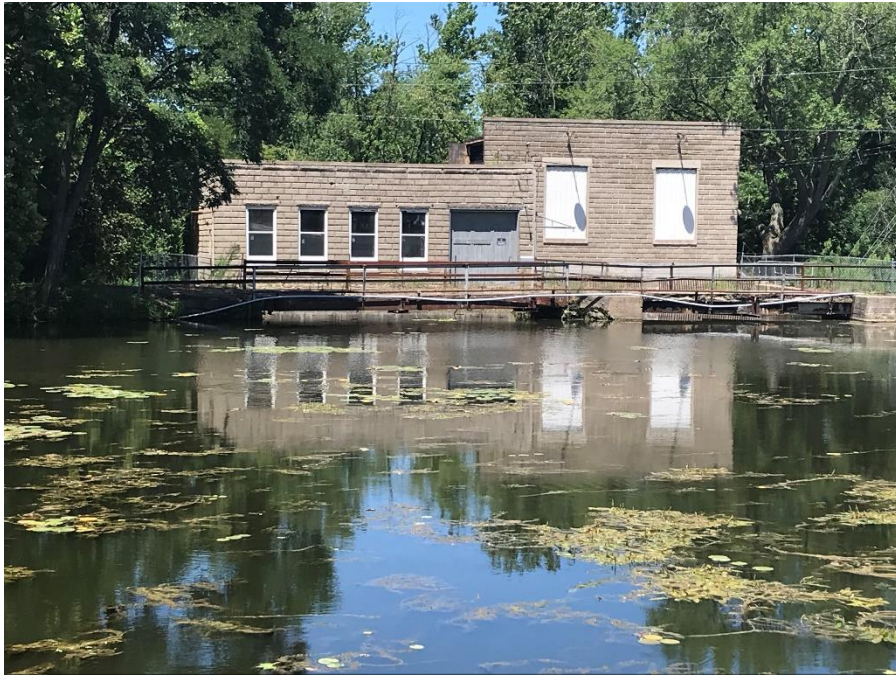
Photograph 25 – Abandoned powerhouse viewed from upstream

The abandoned powerhouse structure, shown in Photographs 25 through 28, is in poor condition. Deteriorated concrete and masonry are present throughout the older left section of the structure. A detailed structural inspection of the powerhouse structures

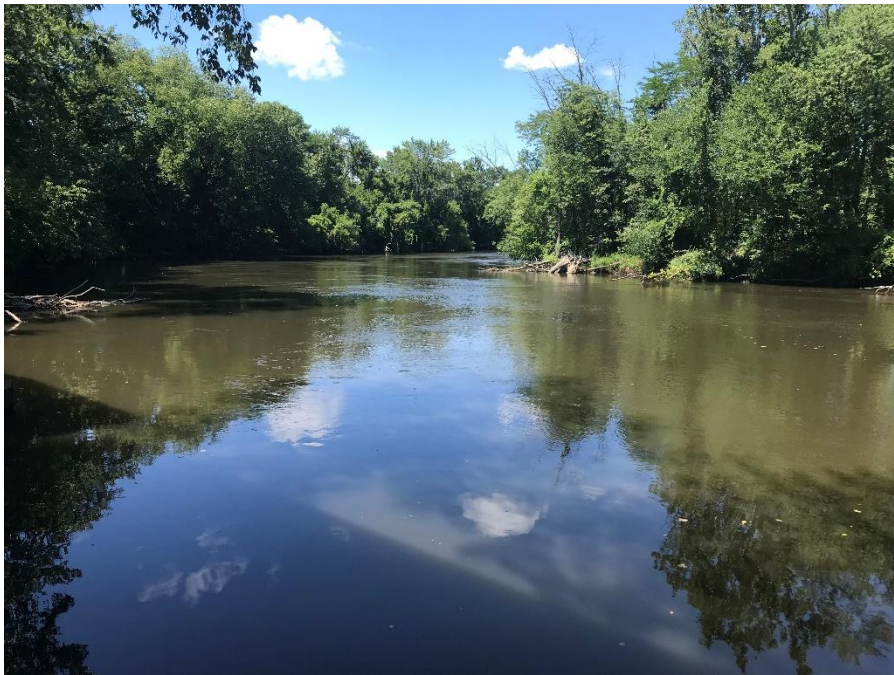
**Photograph 32 – Downstream tailrace and Kalamazoo River
viewed from former powerhouse**

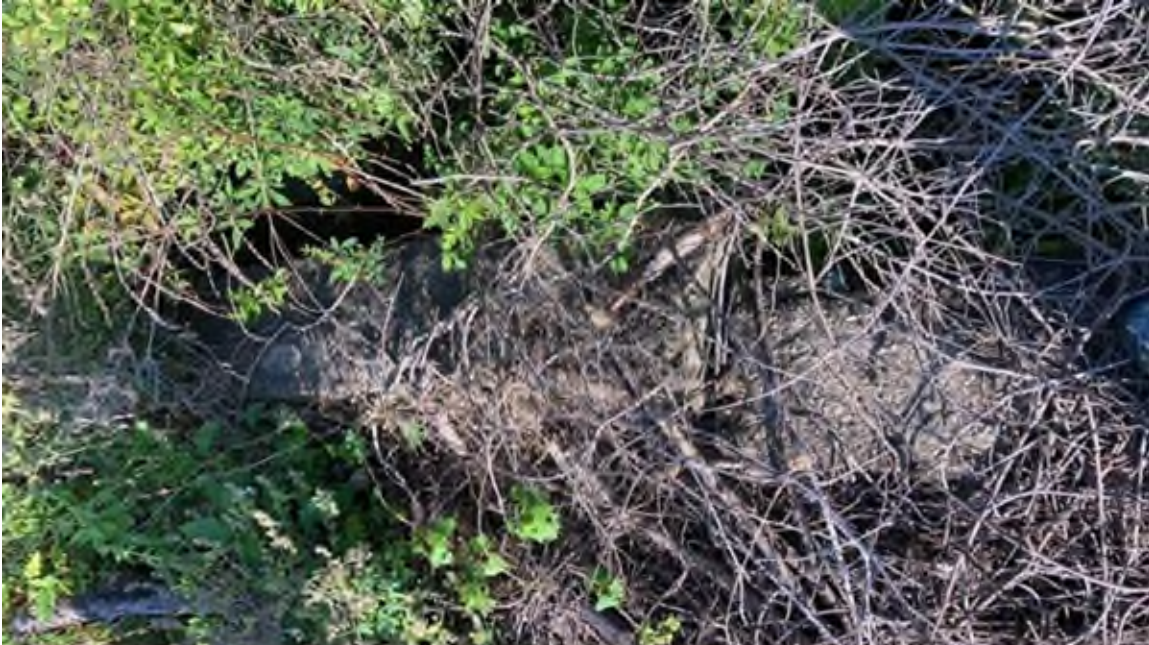
Photo #9 - Upstream slope of right embankment, top of concrete wall. Note displaced joint

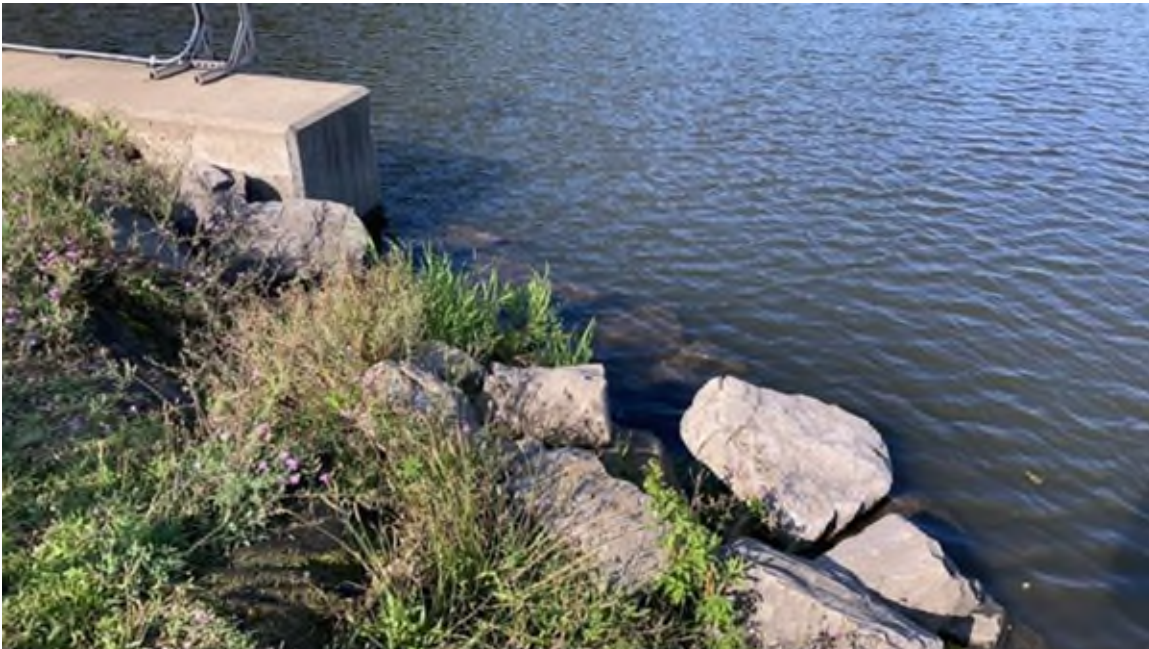
Photo #10 - Right end of left embankment upstream slope. Note riprap armoring

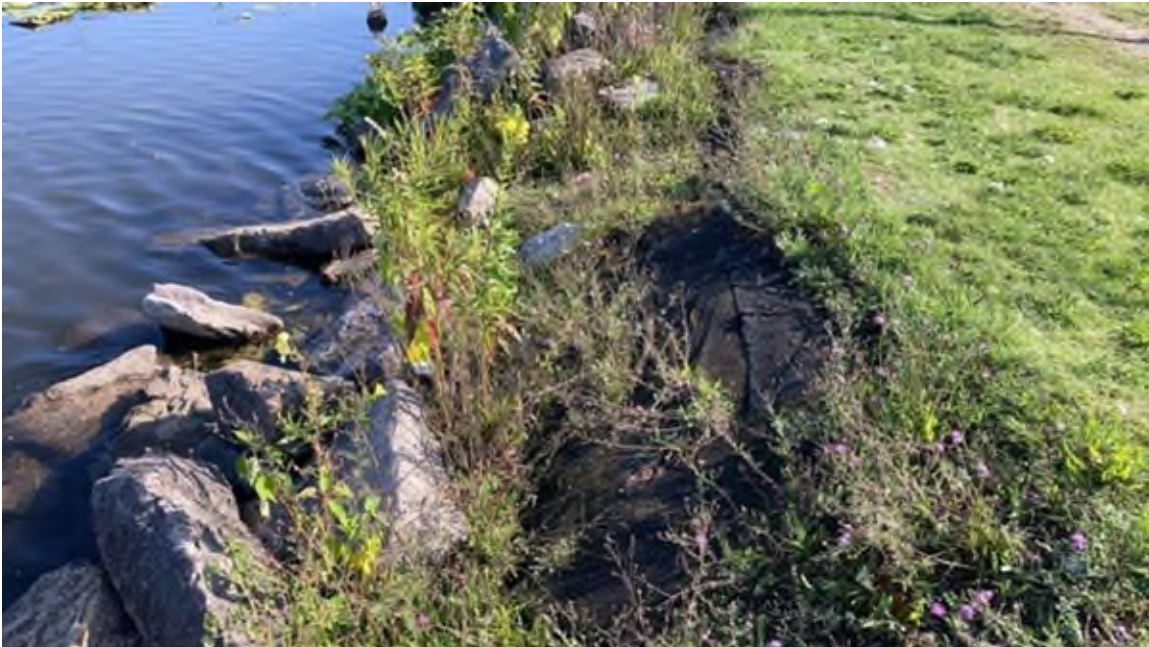
Photo #11 - Upstream slope of left embankment near spillway. Note exposed fabric where riprap is displaced

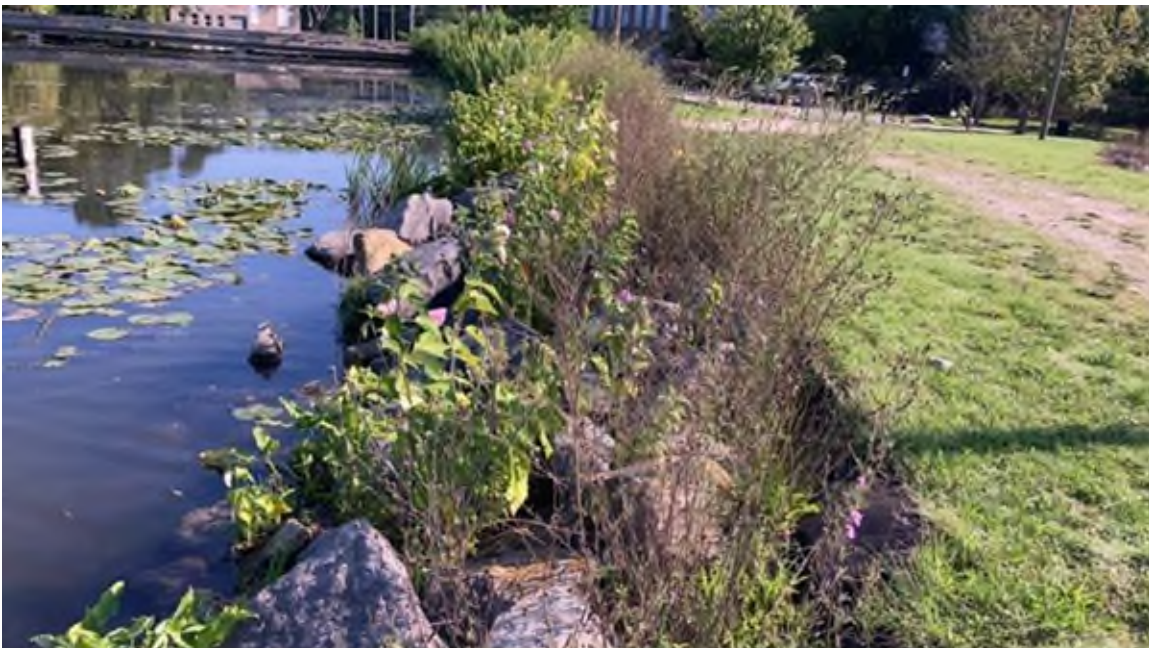
Photo #12 - Upstream slope of left embankment. Note brush near waterline

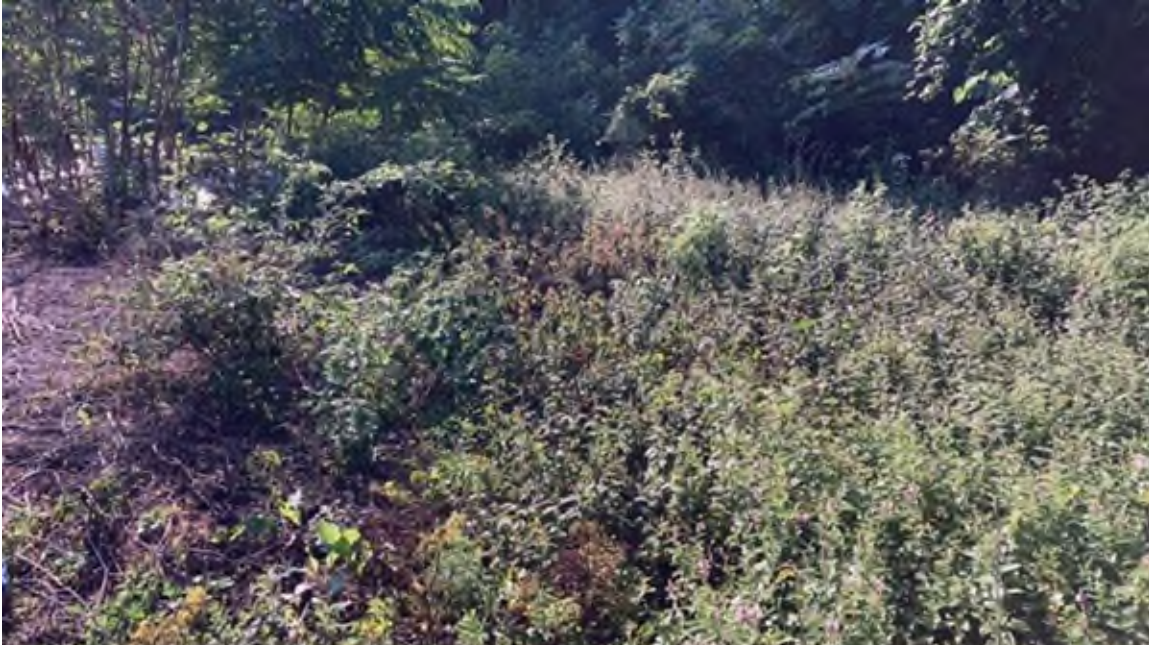
Photo #17 - Crest of right embankment. Note brush growth

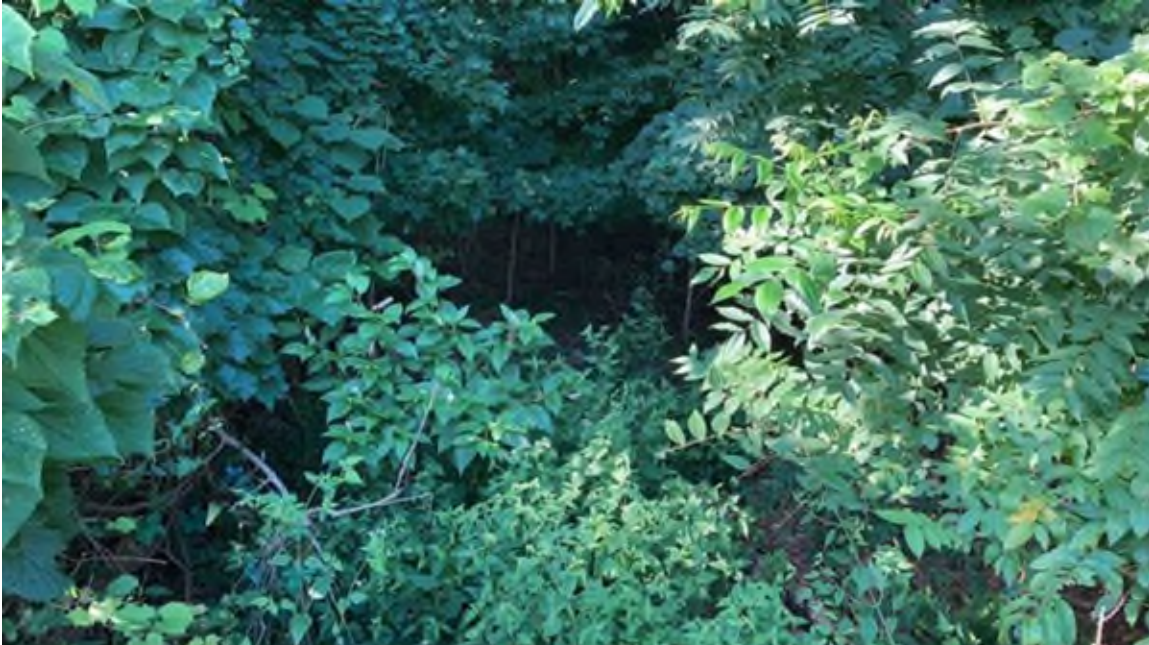
Photo #19 - Crest of right embankment where tree growth starts

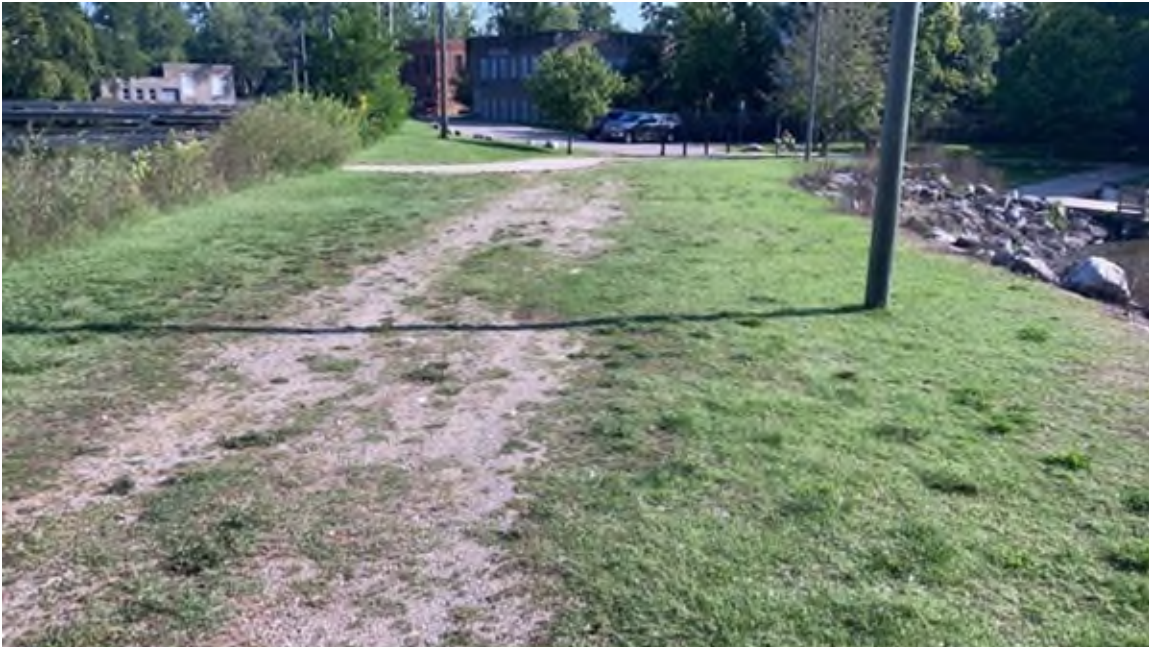
Photo #23 - Crest of left embankment. Note access trail on crest

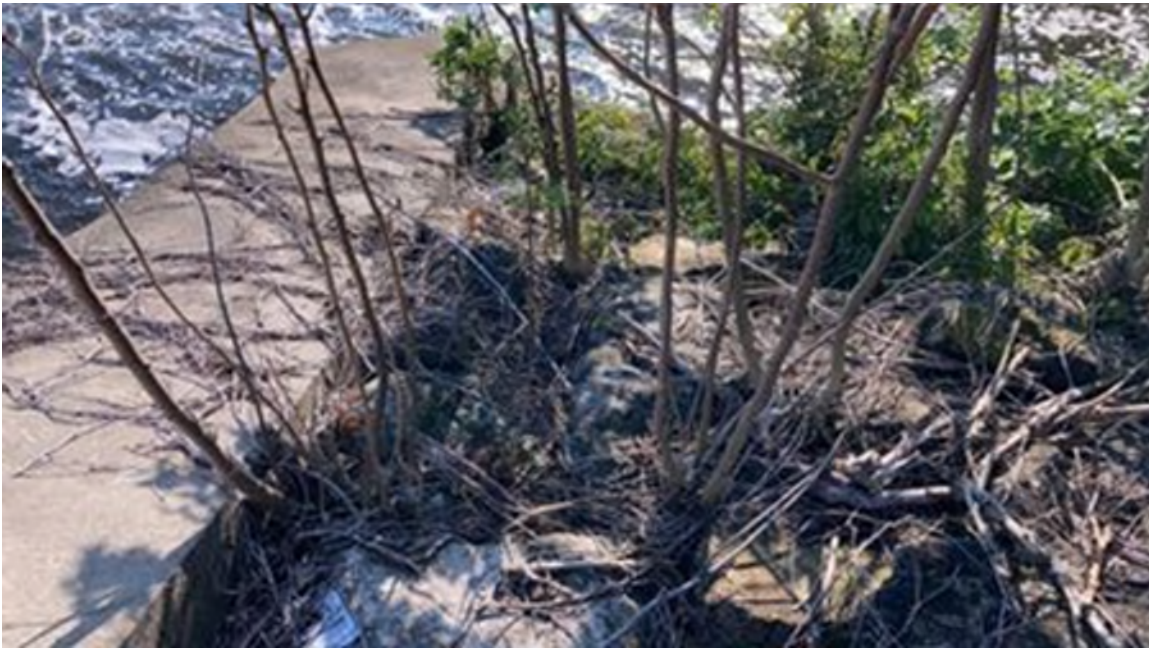
Photo #30 - Downstream slope of right embankment adjacent to spillway. Note brush growth

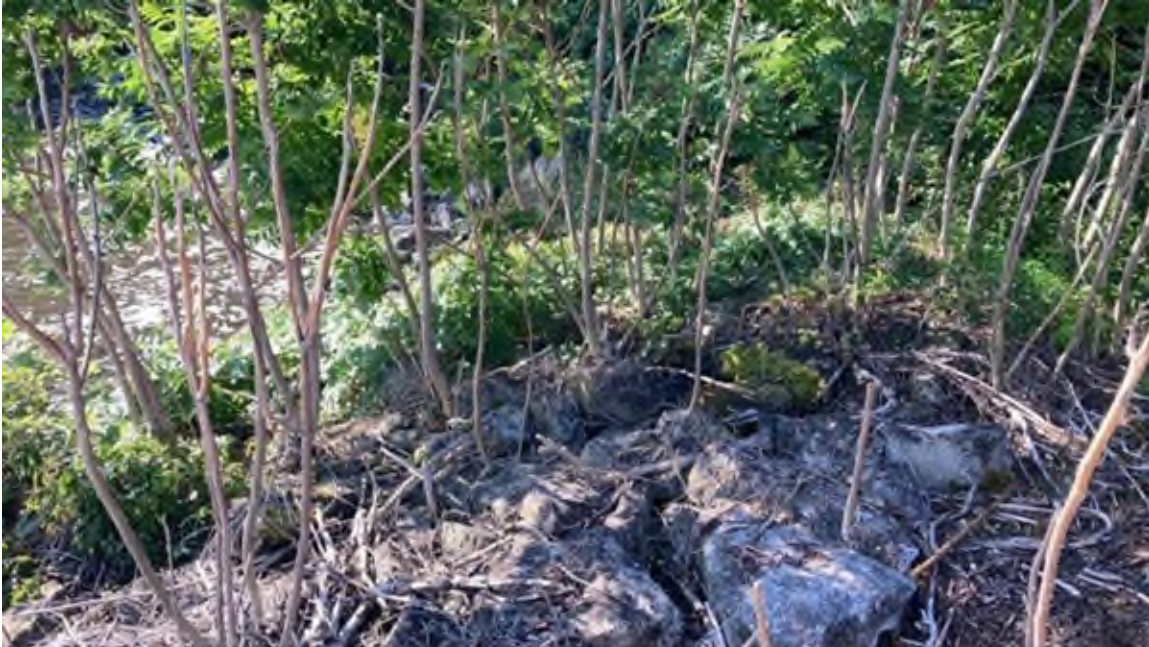
Photo #31 - Downstream slope of right embankment. Note brush growth within armoring

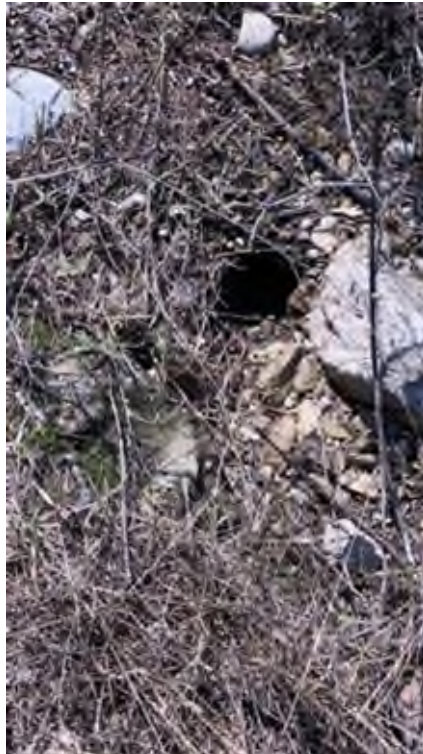
Photo #45 - Small animal burrow on left embankment

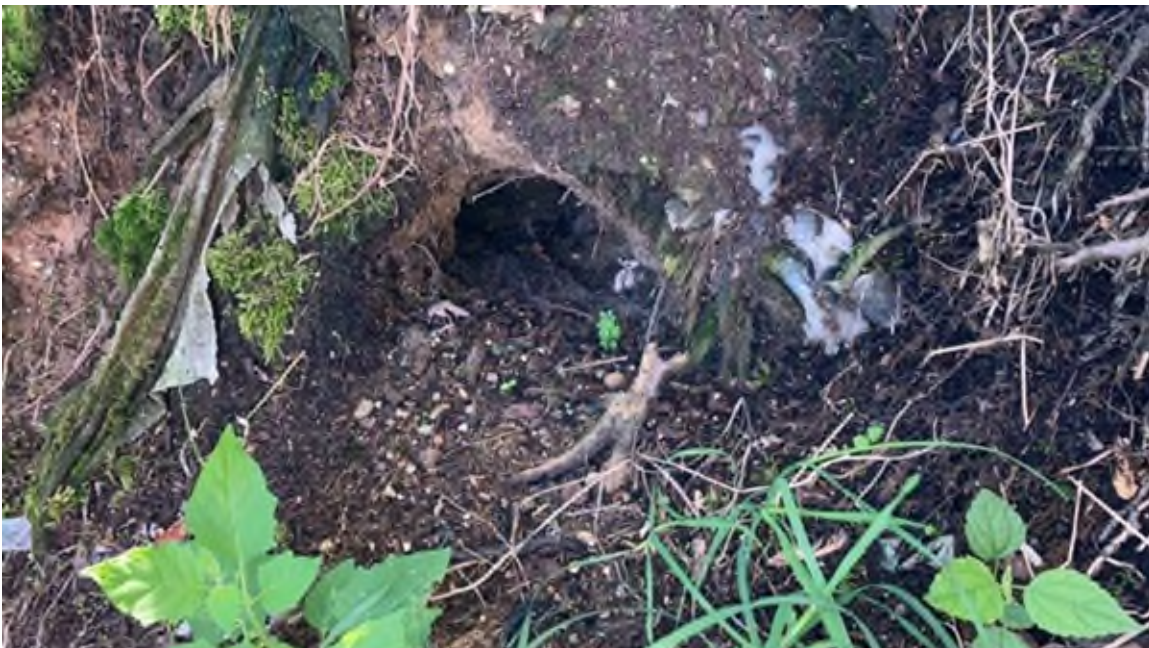
Photo #50 - Burrow on embankment near powerhouse outlet

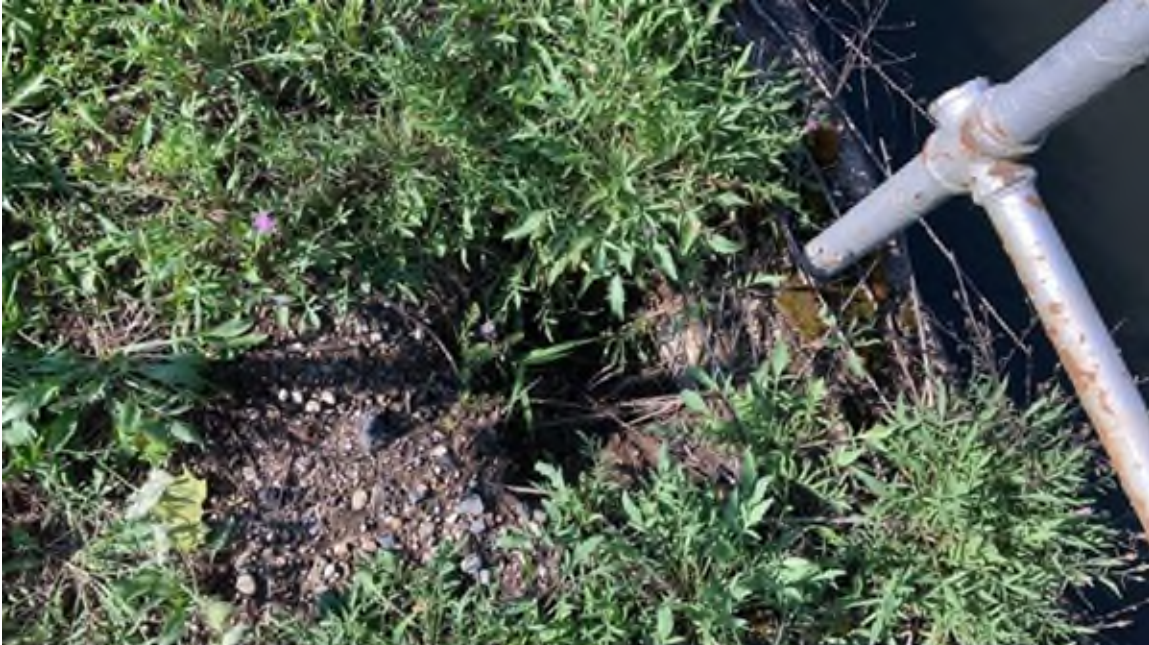
Photo #51 - Burrow or sinkhole on left embankment adjacent to millrace
