**CITY OF ALLEGAN
CITY COUNCIL STUDY SESSION MEETING
Monday, October 9, 2023, 5:30PM
City Council Chambers - 231 Trowbridge Street
Allegan, Michigan**

SUBJECT: PaSER 10-Year Road Strategies Reports

**DAM SAFETY INSPECTION REPORT
ALLEGAN CITY DAM – DAM ID NO. 489
KALAMAZOO RIVER
ALLEGAN COUNTY – SECTION 28, T 02N, R 13W**

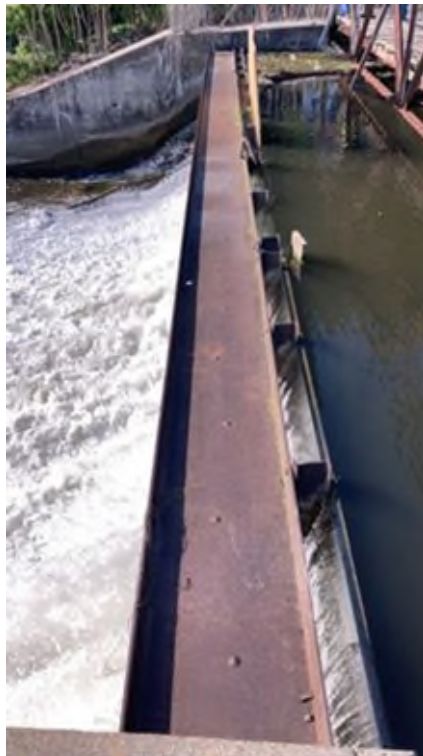
Photo #72 - Spillway bay #1, very slight deflection in beam over crest

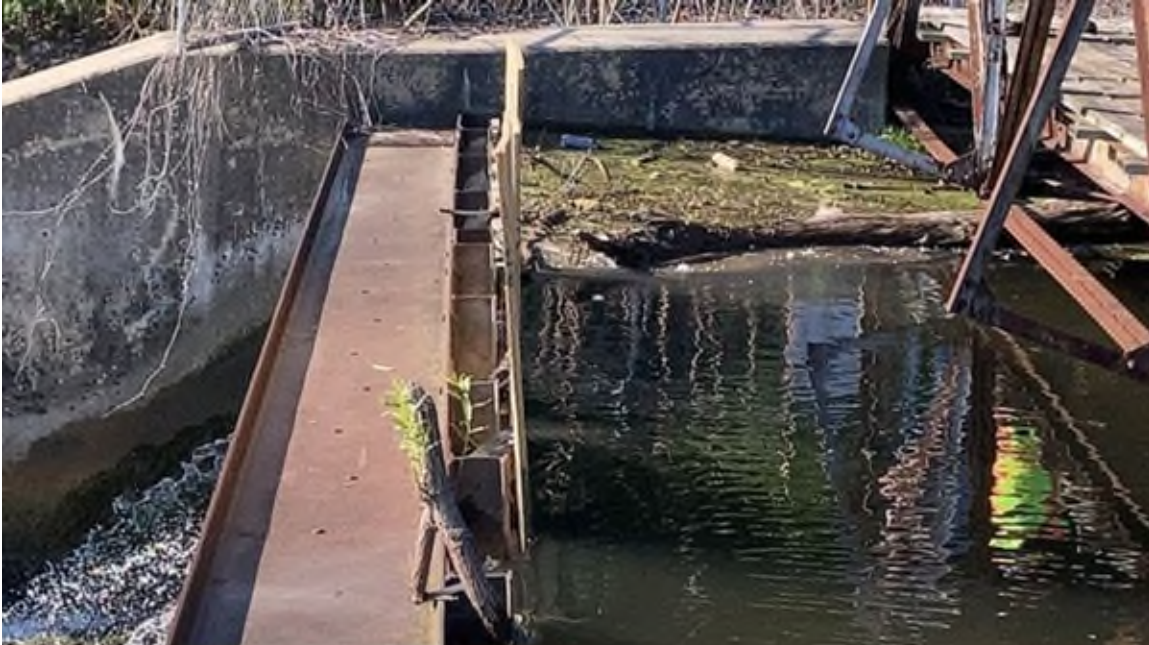
Photo #73 - Spillway bay #1, minor deflection downstream

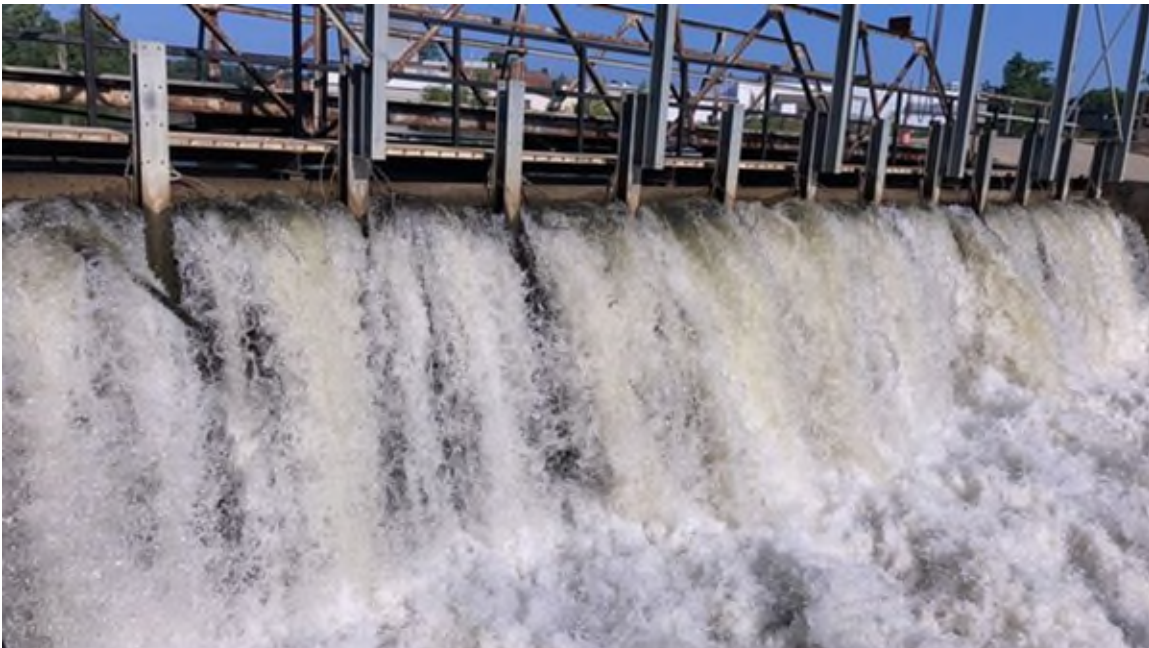
Photo #80 - Spillway bay #2

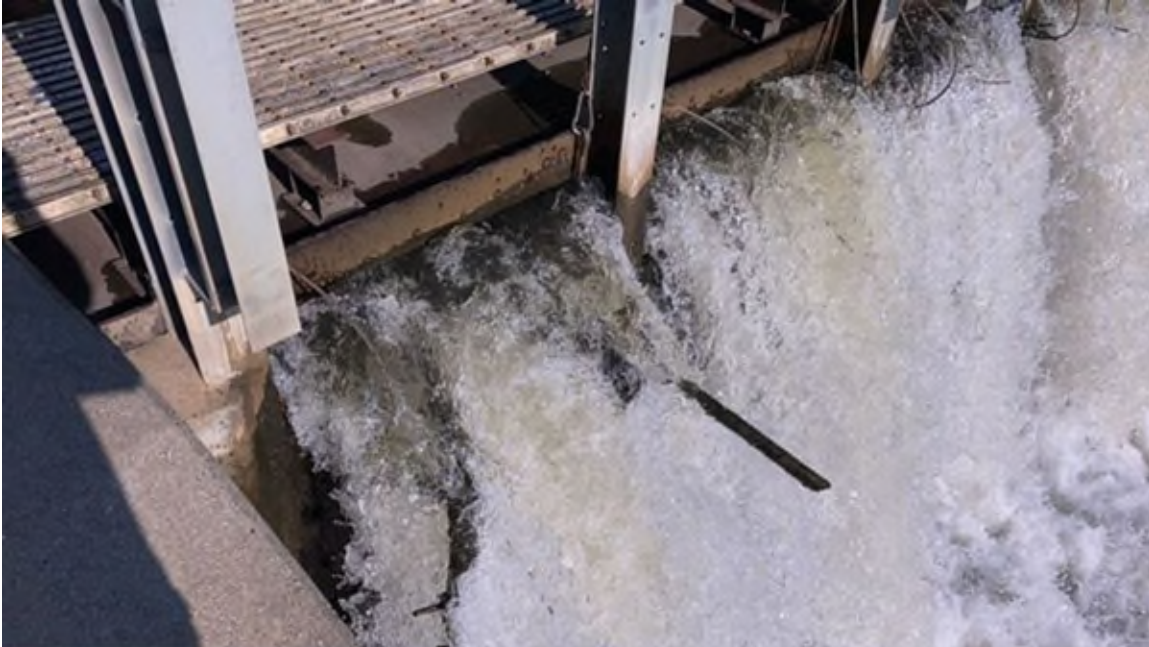
Photo #81 - Crest of spillway bay #2

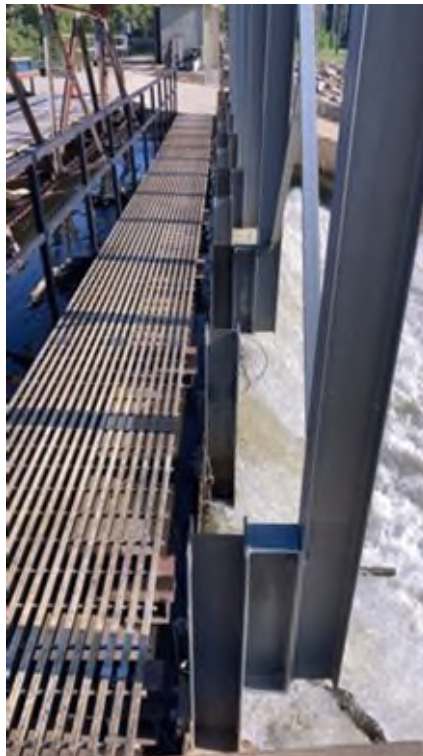
Photo #82 - Spillway bay #2 crest

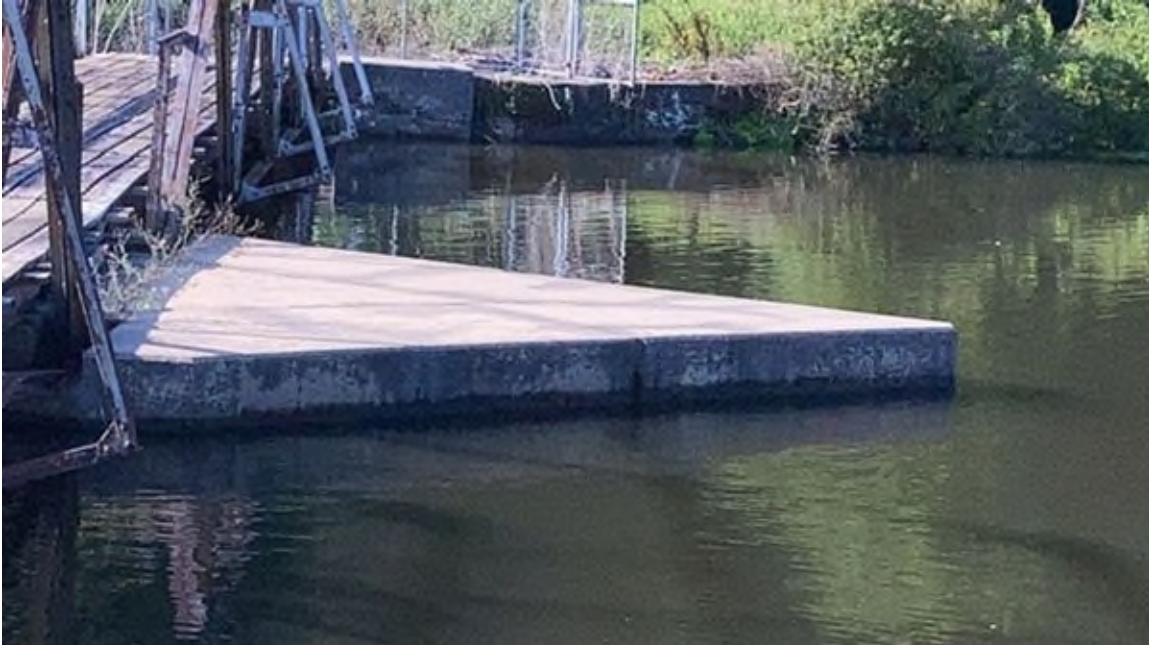
Photo #83 - Pier between spillway bays #1 and #2

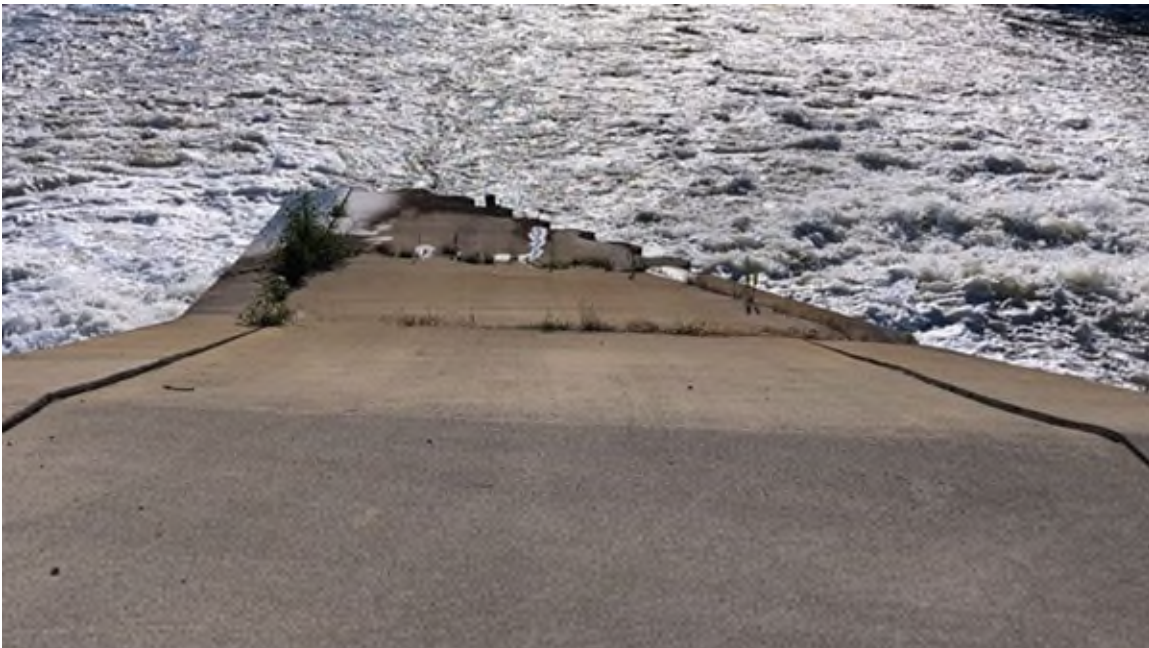
Photo #84 - Downstream needle section of abutment between spillway bays #2 and #3

Action required for the issue	<i>Monitor</i>
Describe action required	<i>Monitor the water and vegetation growth in the needle section for presence of water. If it remains constant if it is determined that the splashing is not responsible for that, consider investigating a potential seepage path through the concrete pier.</i>
Stoplogs	
What type of stoplog is in use?	<i>Metal stoplogs in bay #2 and wooden stoplogs in bay #1</i>
Describe the condition of the stoplogs	<i>Bay #2 stoplogs are in good shape. One stoplog was removed and set aside during the inspection. It appeared to be in satisfactory condition. The wooden stoplogs in bay #1 are in poor condition. Significant leakage already exists through the stoplogs and they are visibly bowed.</i>
Action required for the stoplogs	<i>Maintenance</i>
Describe action required	<i>Replace stoplogs in the next six months. Review options to complete this project with your engineer. New stoplogs may be able to be added downstream of the existing stoplogs to avoid potential sediment and water management issues with other alternatives.</i>

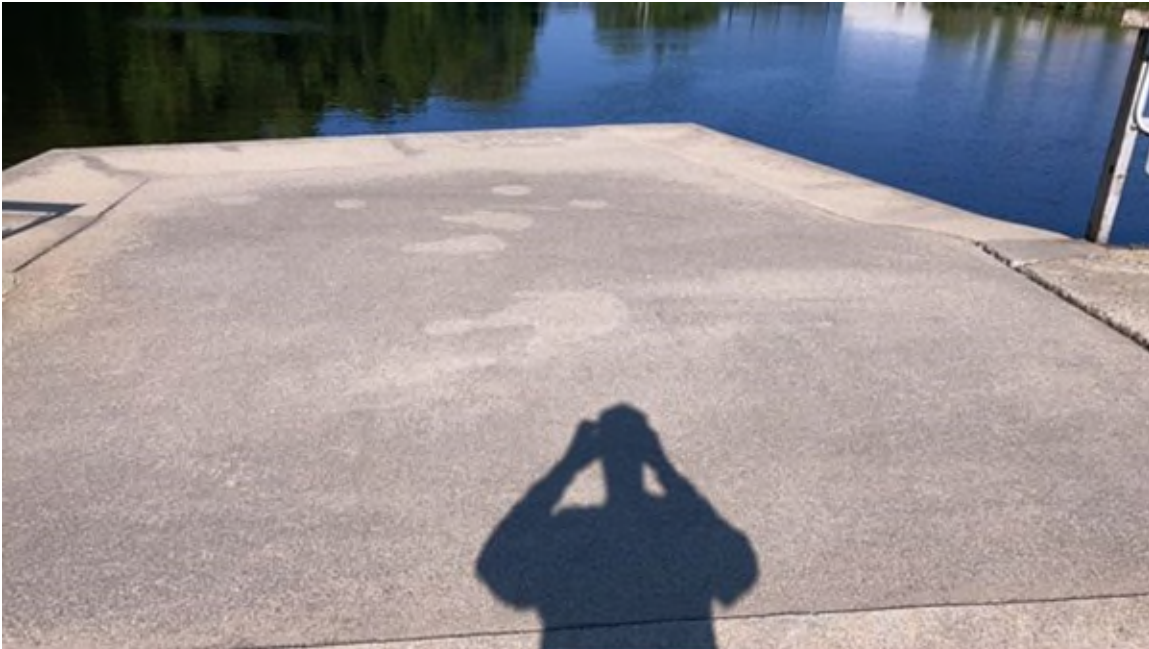
Photo #85 - Concrete pier and abutment section between spillway bays #2 and #3

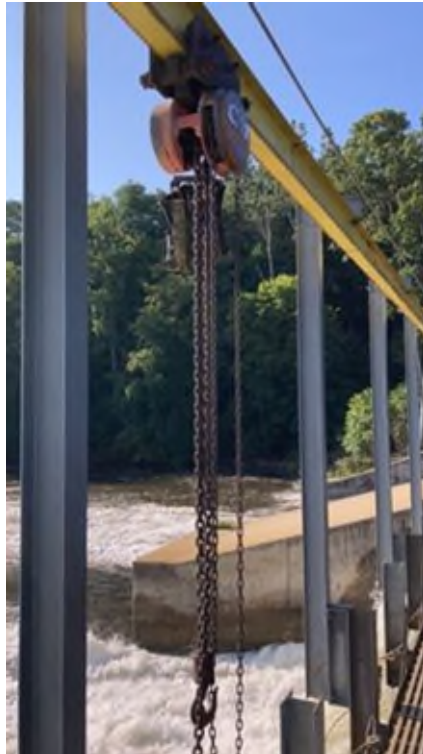
Photo #87 - Lifting mechanism for stoplogs of bay #2

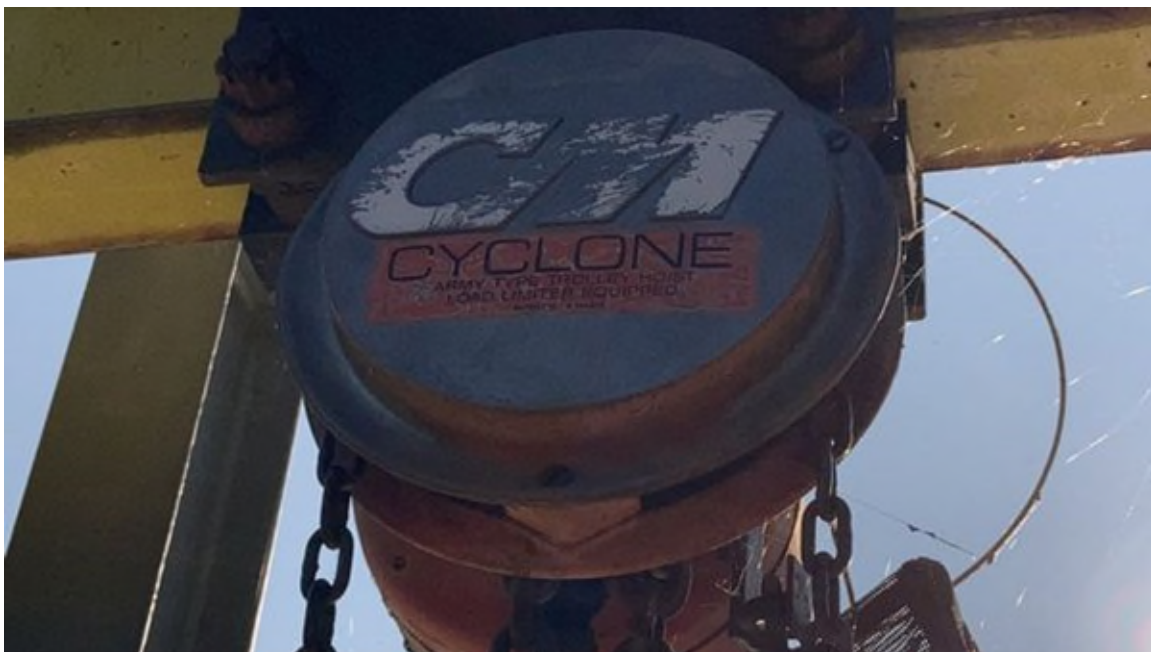
Photo #88 - Lifting mechanism for stoplogs of bay #2

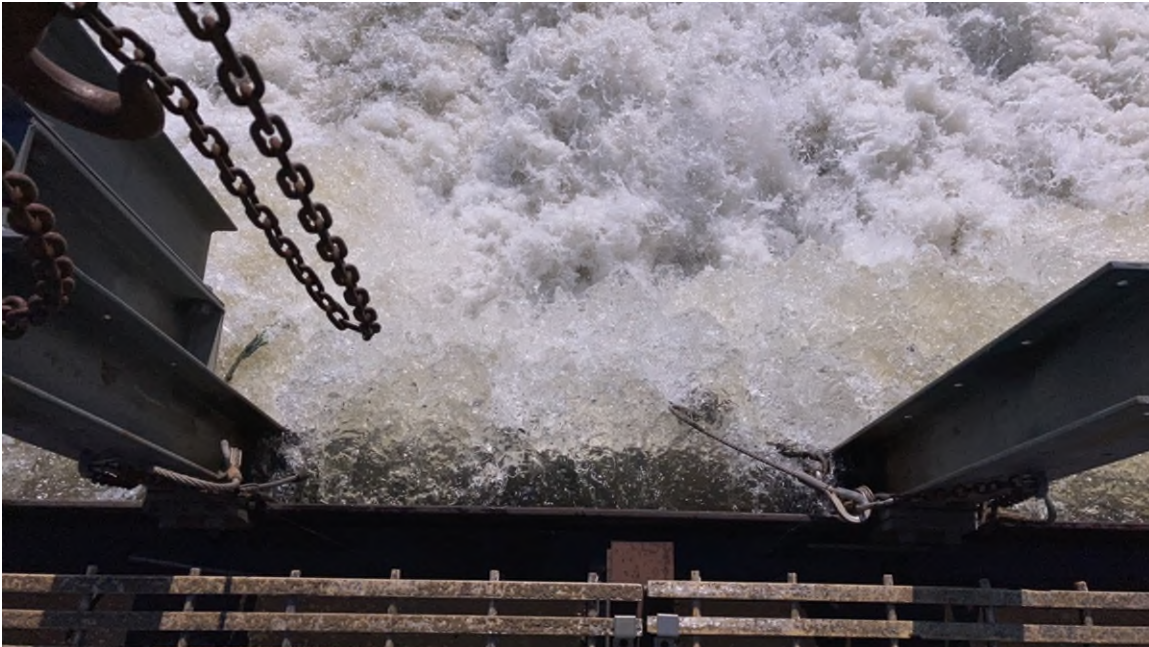
Photo #89 - Individual stoplog bay of spillway bay #2. Bays consist of three logs on top of one another that can all be removed

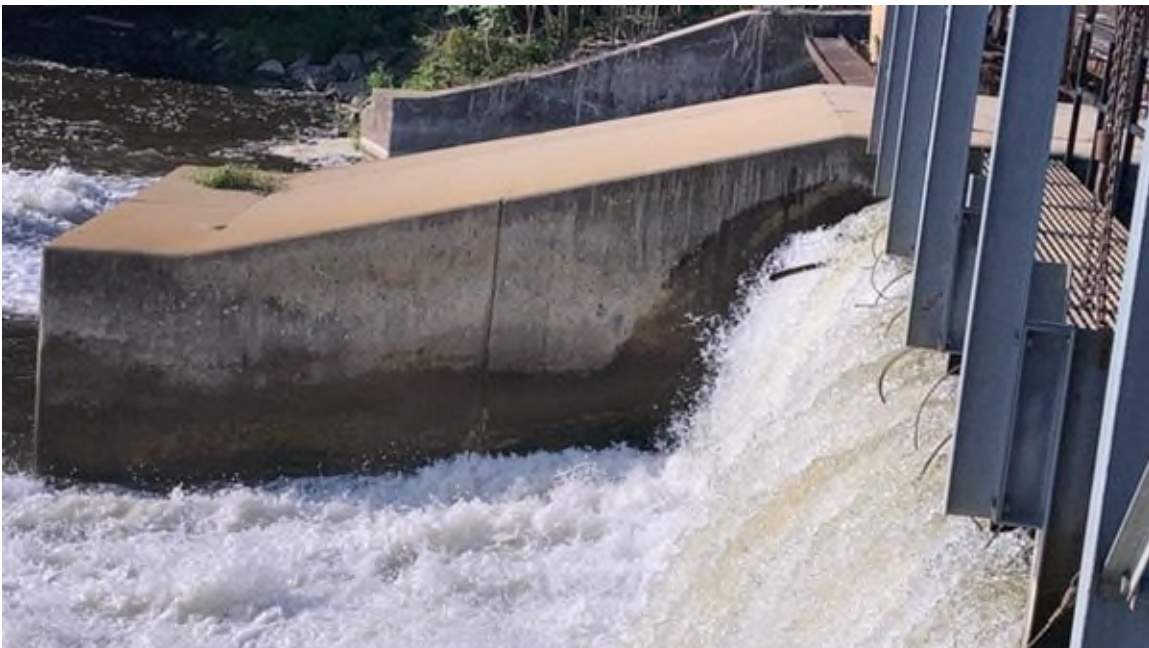
Photo #90 - Spillway bay #2 right downstream abutment

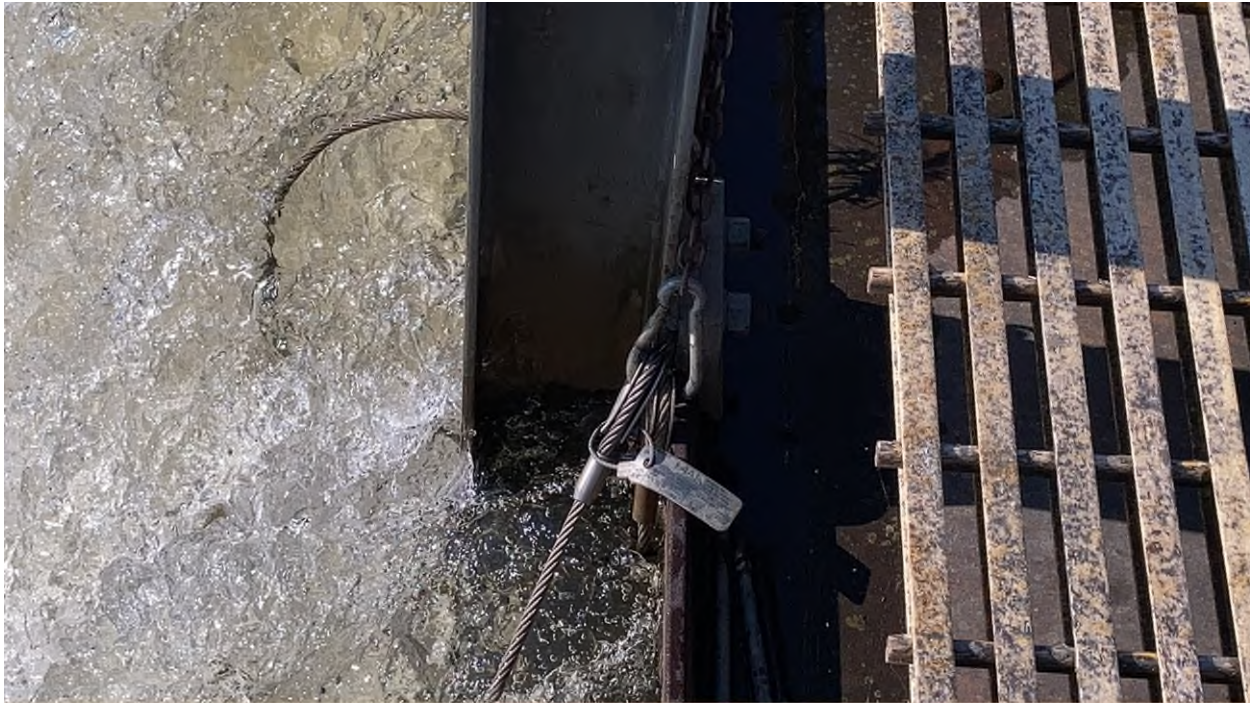
Photo #91 - Lifting cables on spillway bay #2 stoplogs

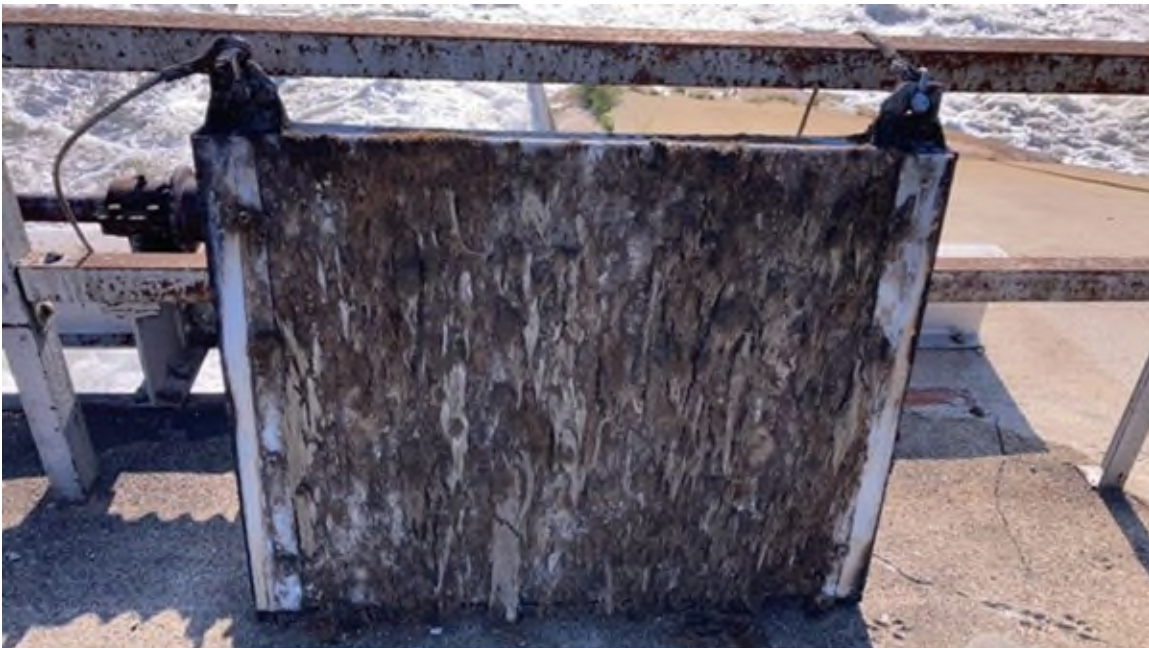
Photo #92 - Typical stoplog from spillway bay #2

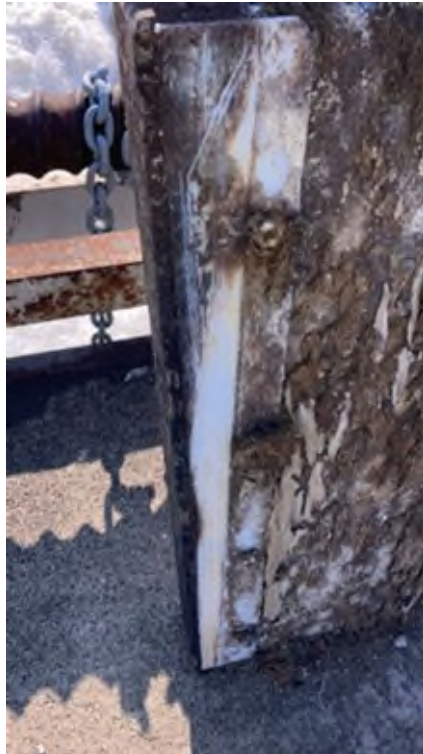
Photo #93 - Teflon strip along edge of spillway bay #2 stoplogs

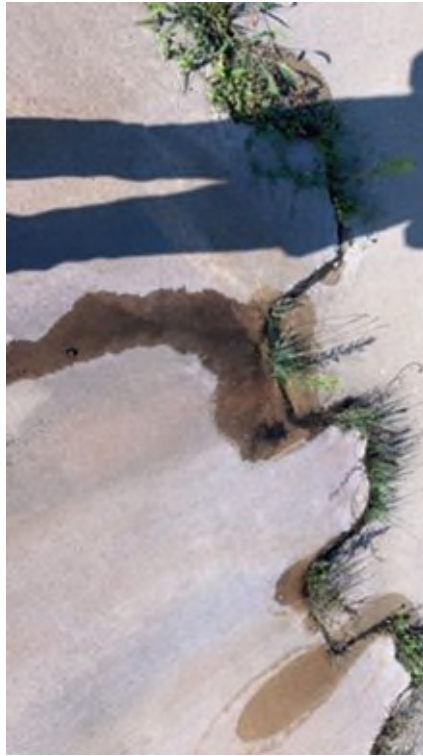
Photo #95 - Vegetation and water at sheetpile and concrete interface

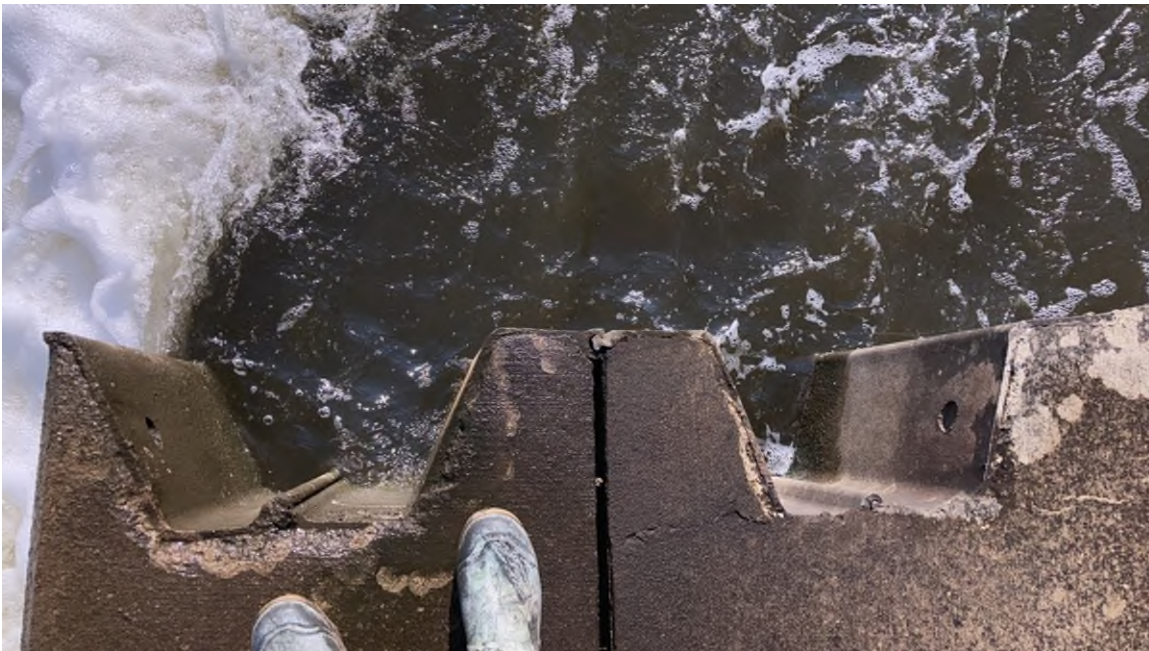
Photo #96 - Downstream face of needle section between spillway bays #2 and #3

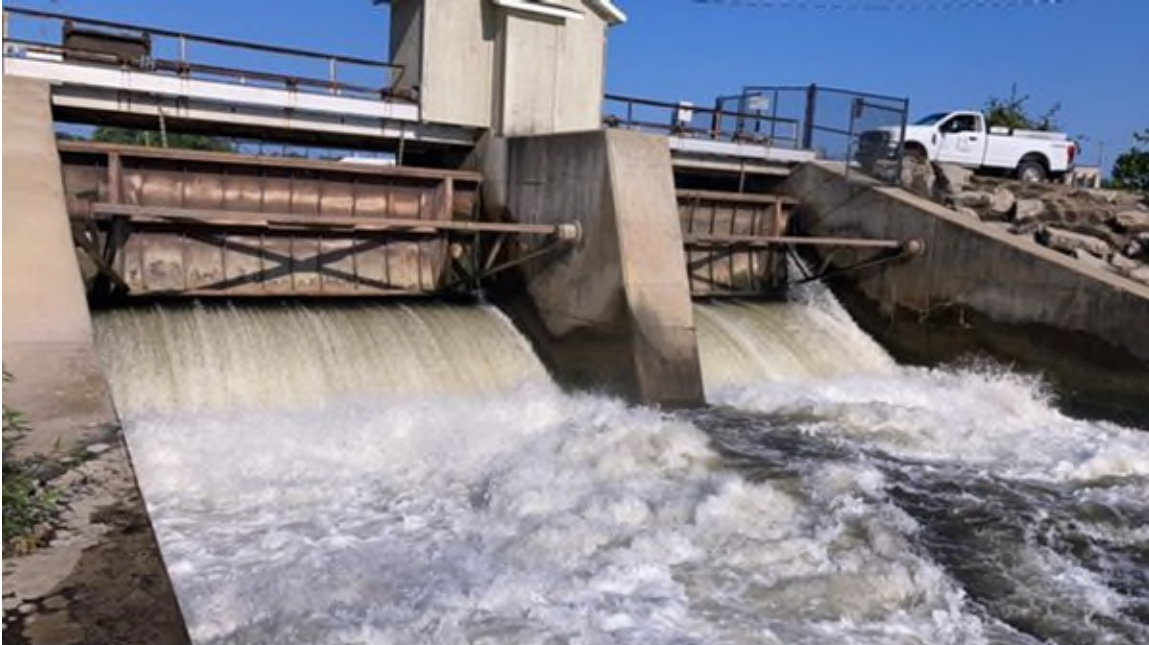
Photo #97 - Downstream view of two radial gate bays

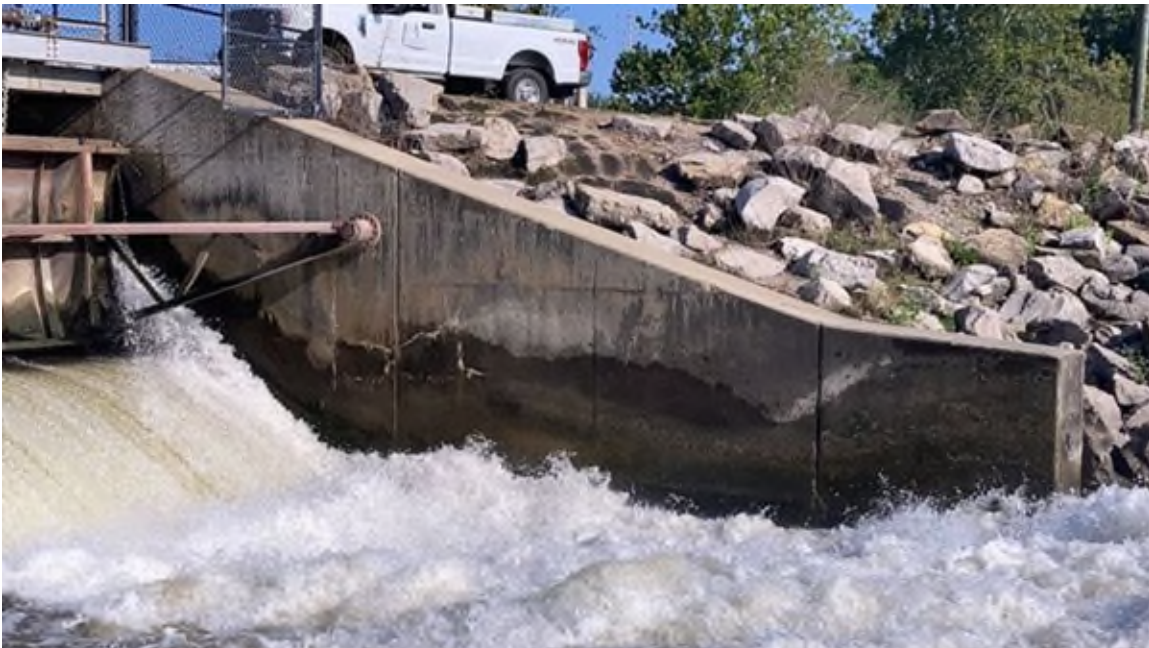
Photo #98 - Left downstream spillway abutment wall

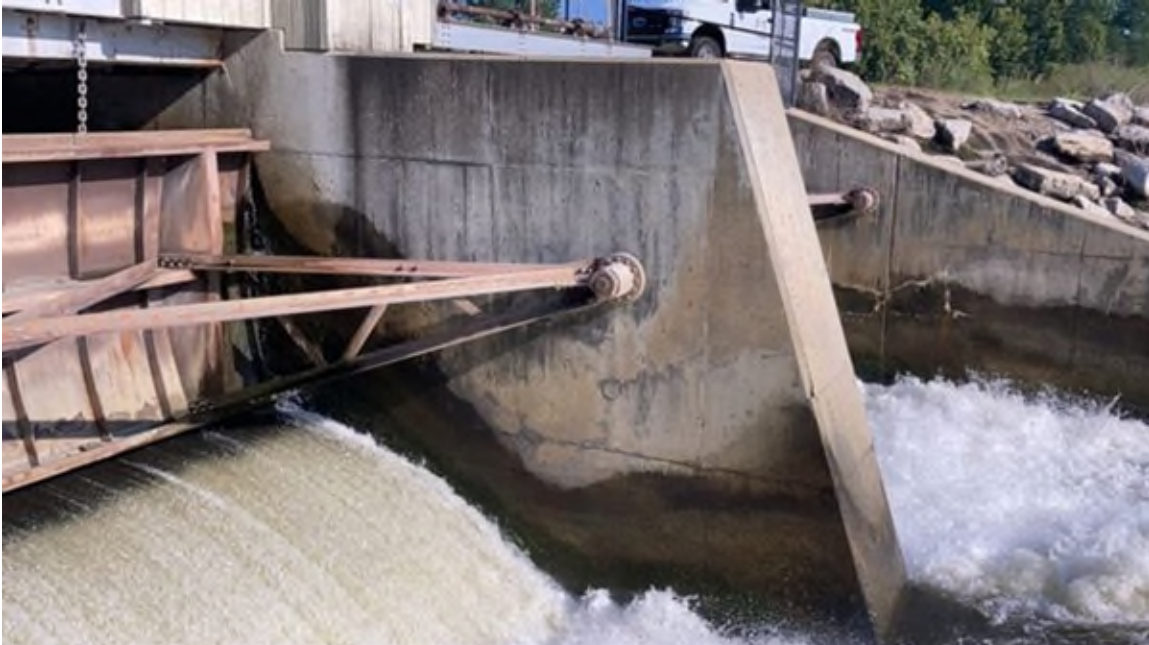
Material Deterioration	
What materials are deteriorating in the spillway?	<i>Concrete</i>
What issues are noted with the concrete components?	<i>Popouts, Other</i>
Specify issues.	<i>One larger chunk of concrete has popped out of the left wall of spillway bay #3, the right radial</i>

Photo #99 - Left downstream abutment of spillway bay #3

Where are the issues located?	See description above
Action required for concrete components of the spillway	Maintenance
Describe action required	Repair the hole on the left downstream abutment wall of spillway bay #3 before the winter when freeze-thaw conditions could significantly worsen the issue. Monitor the rest of the concrete deficiencies and repair as necessary. Since the dam is to be removed in the near future, consult with your engineer to determine if the other concrete deficiencies are stable enough to only monitor, or only partially repair in the interim time until removal can occur.
Erosion Control / Energy Dissipation	
What type of erosion control structure is in place?	Apron present downstream of spillway
Are there any issues with the outlet erosion control structure?	None observed, although flow obscured most of aprons
Does the outlet erosion control structure include any drains?	None observed

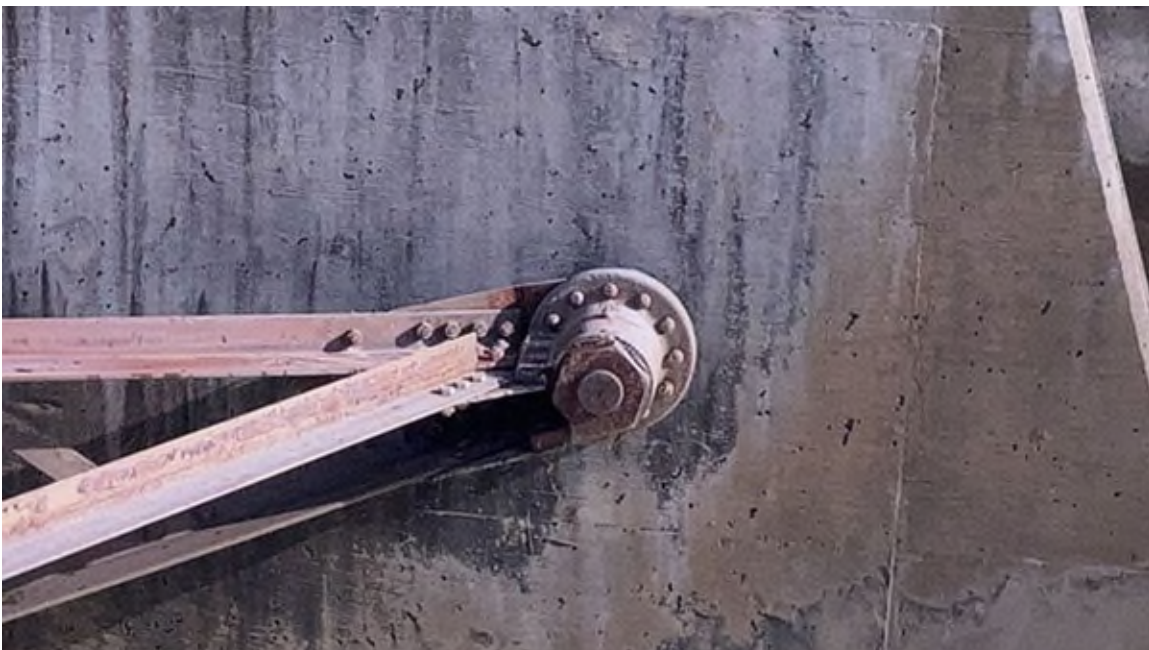
Photo #100 - Spillway bay #3 left pin

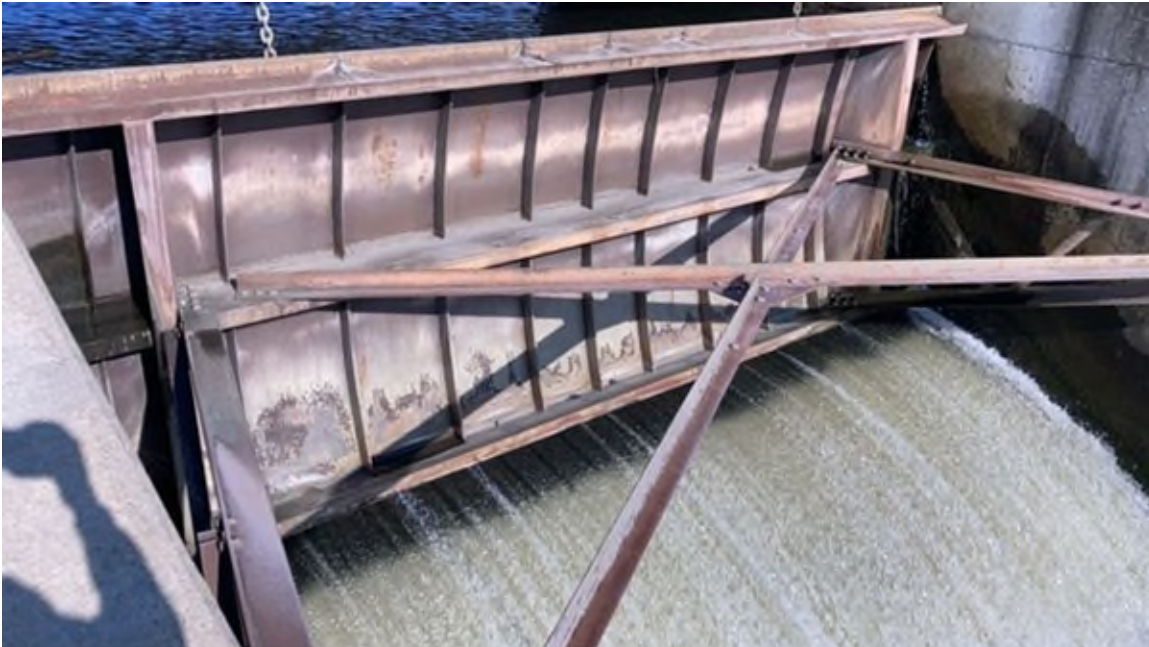
Photo #101 - Spillway bay #3 gate

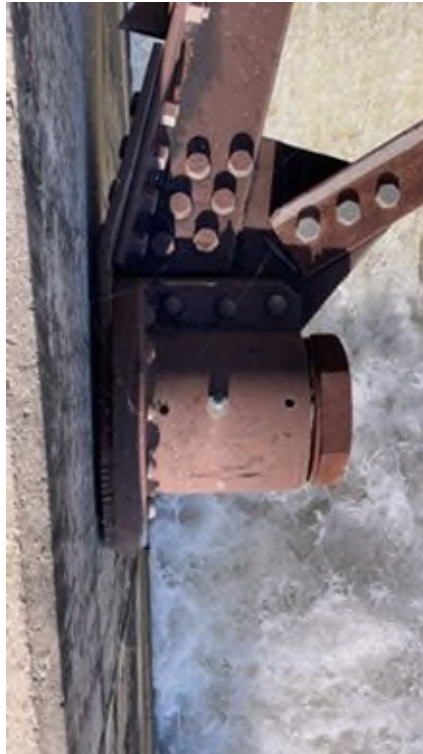
Photo #105 - Spillway bay #3 right pin

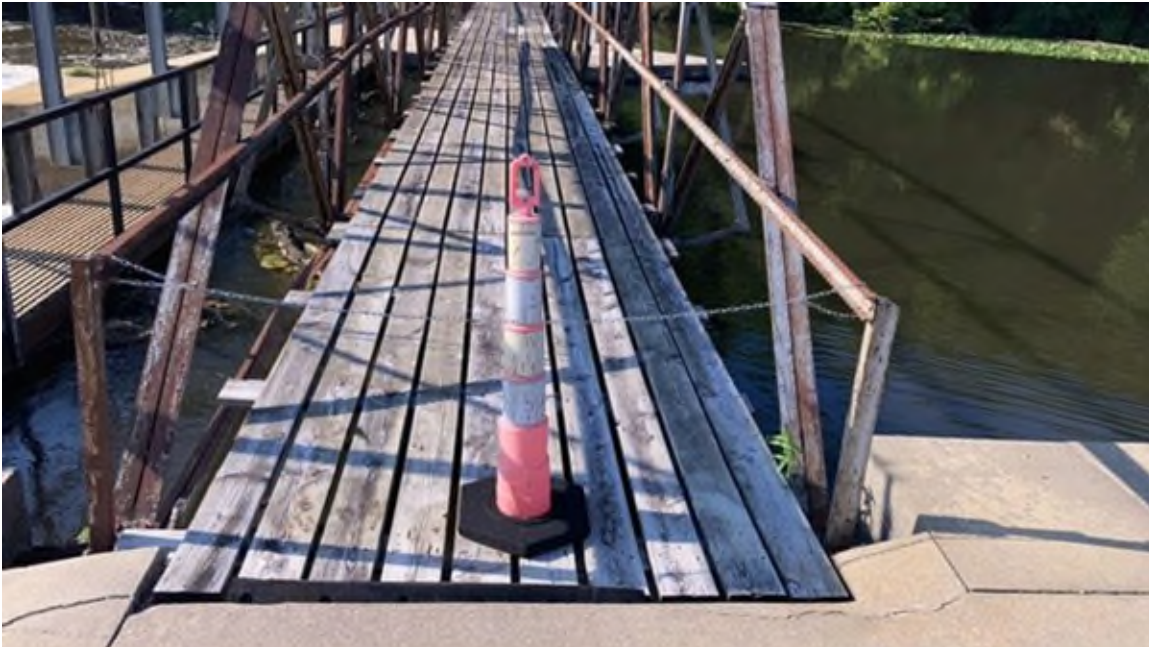
Photo #107 - Left end of walkway bridge over spillway bays #1 and #2

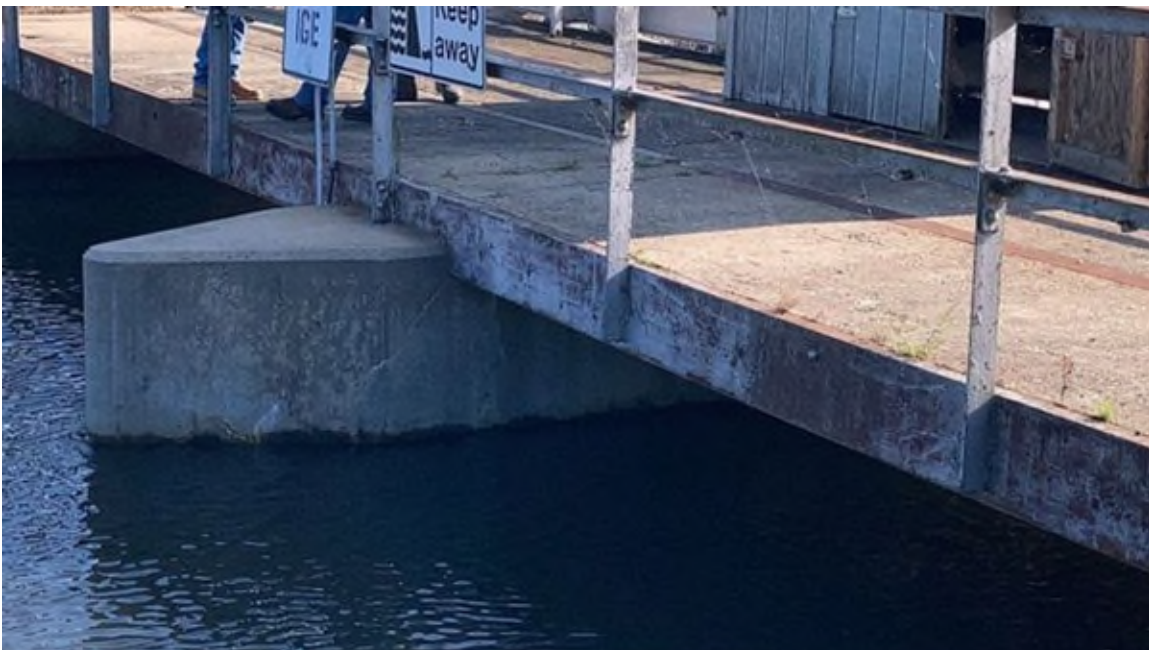
Photo #108 - Upstream pier between radial gate bays

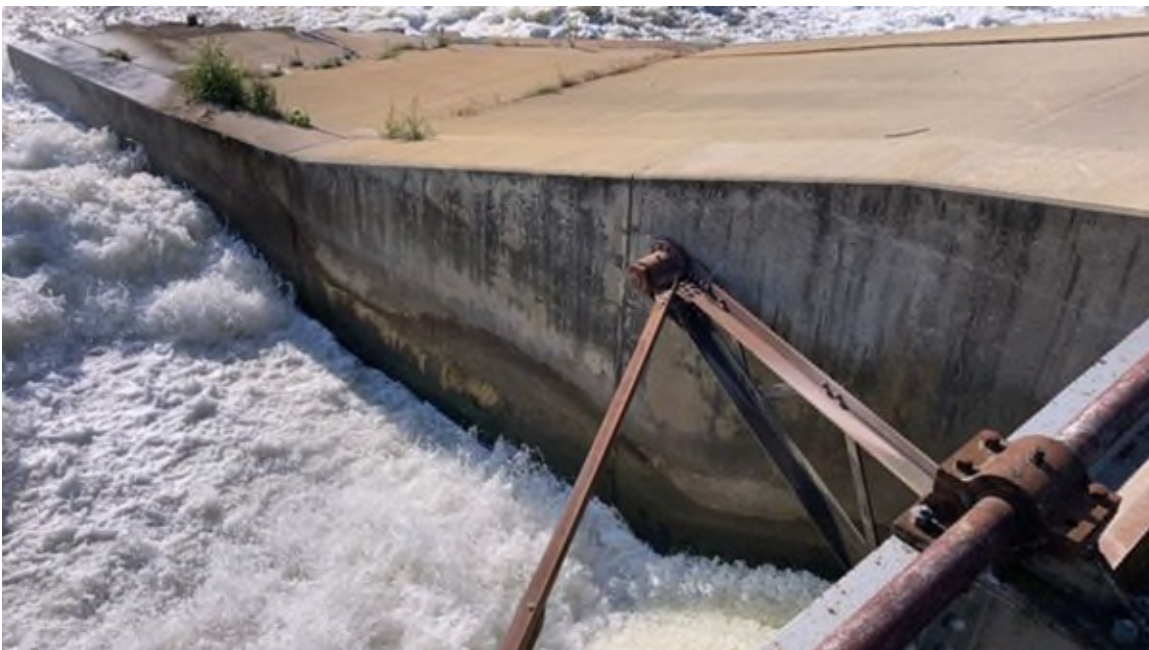
Photo #110 - Spillway bay #3 right downstream abutment and right gate pin

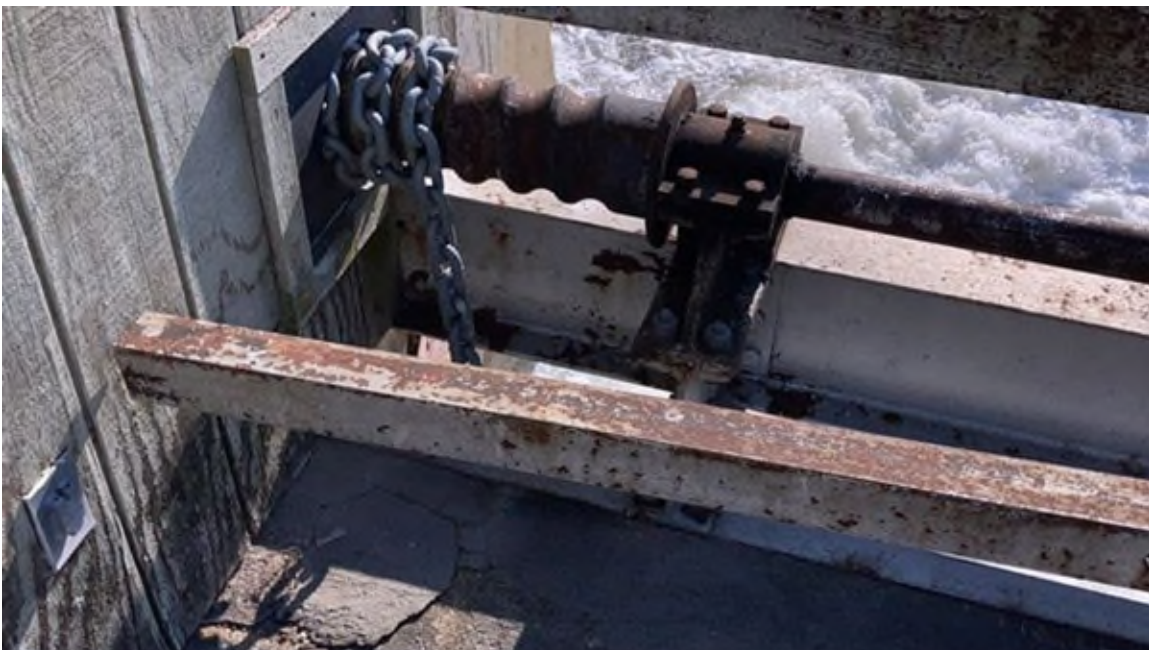
Photo #112 - Radial gate lifting chain and shaft

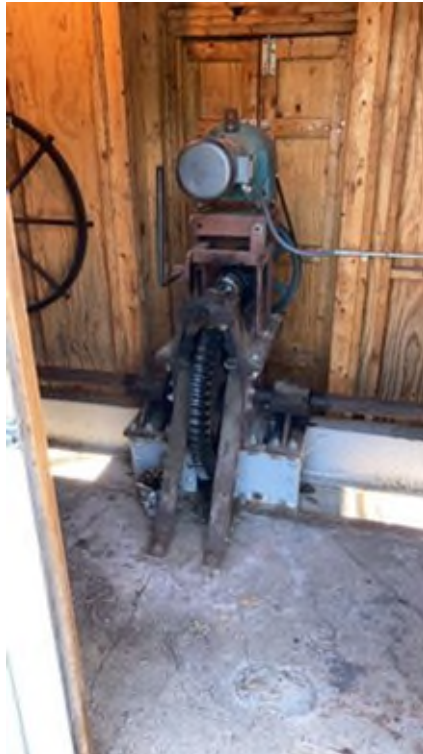
Photo #113 - Radial gate lifting motor

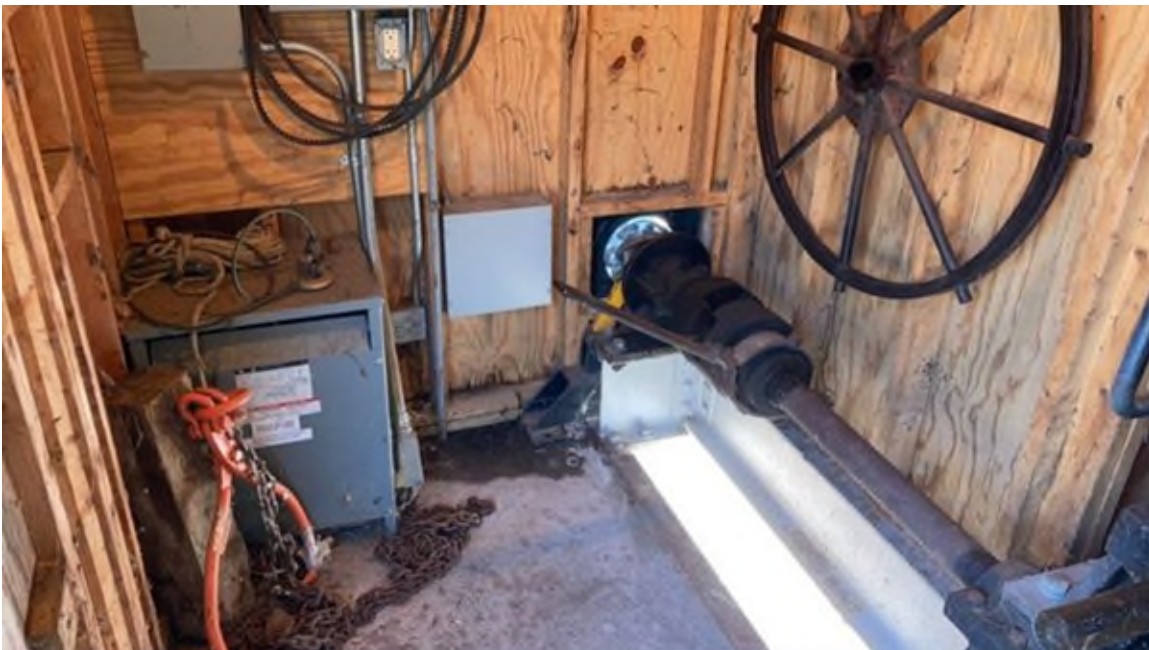
Photo #114 - Radial gate lifting shaft

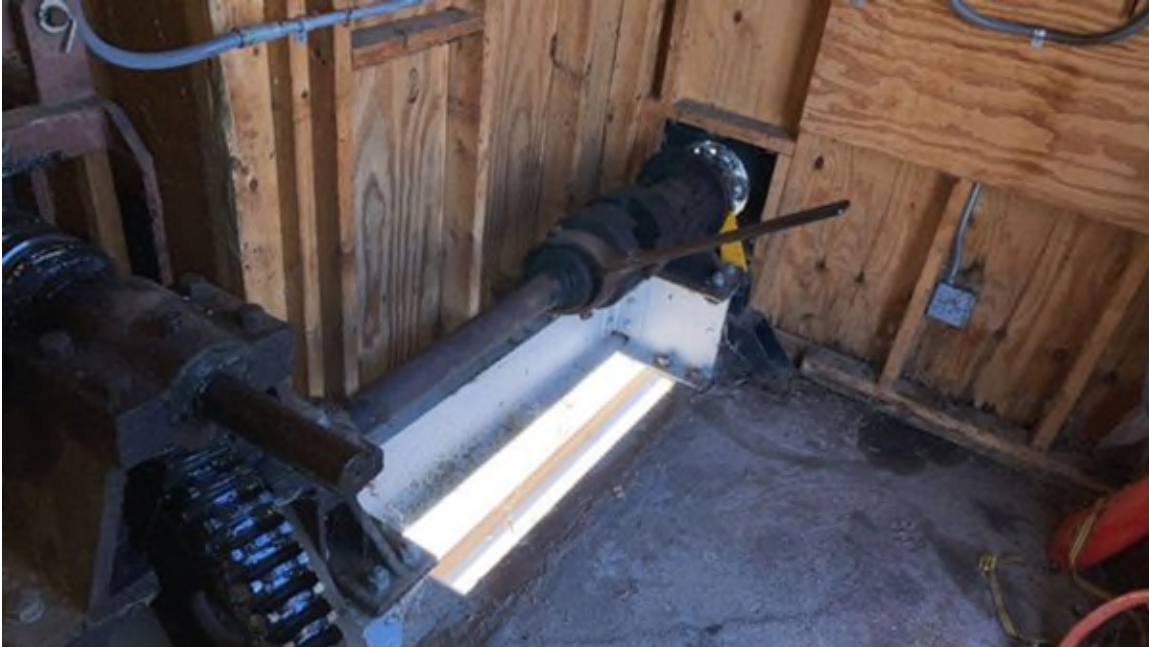
Photo #115 - Radial gate lifting shaft

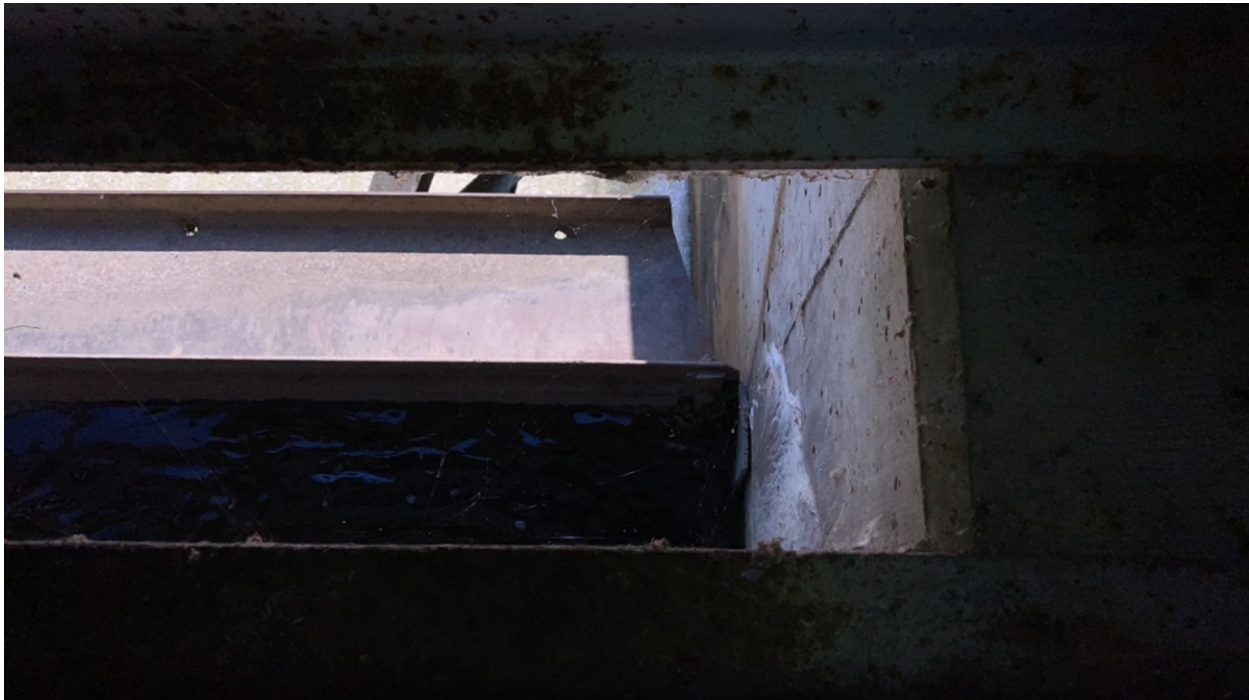
Photo #116 - Right edge of spillway bay #4 radial gate

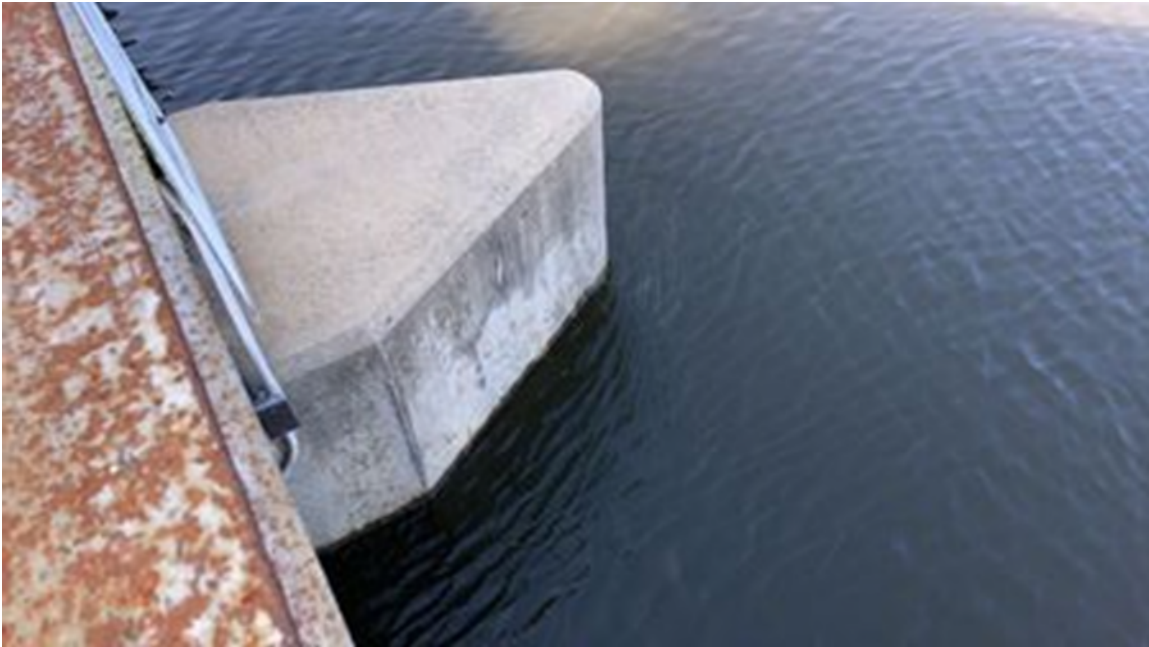
Photo #117 - Upstream pier between radial gate bays

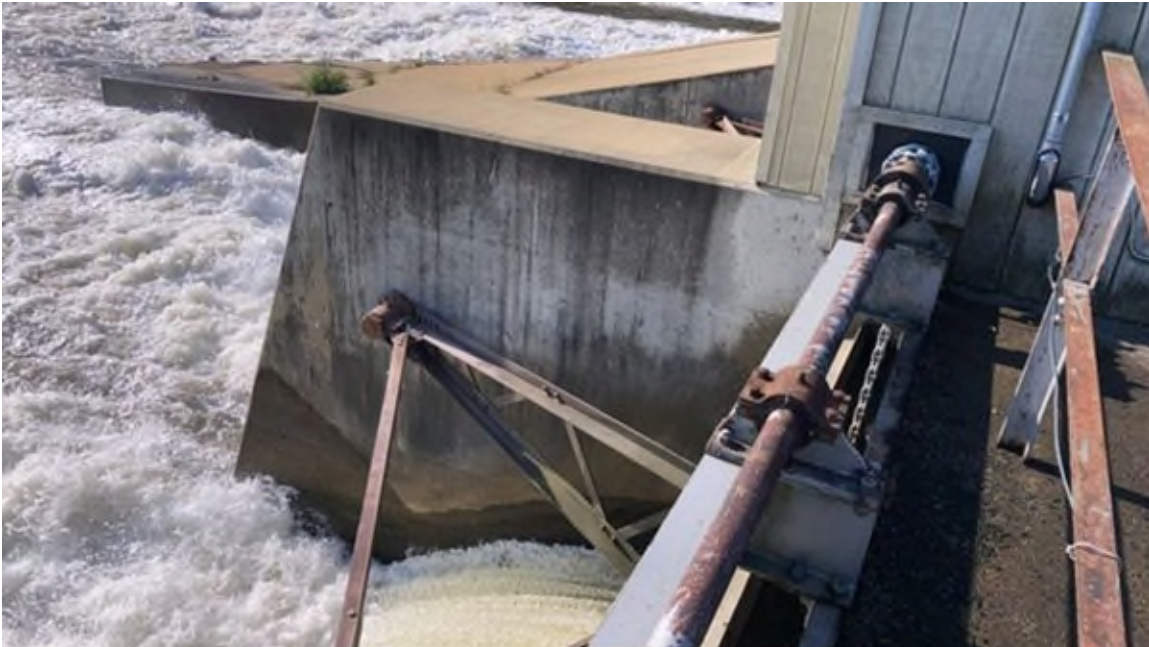
Photo #119 - Spillway bay #4 right downstream abutment wall and gate shaft
