**CITY OF ALLEGAN
CITY COUNCIL STUDY SESSION MEETING
Monday, October 9, 2023, 5:30PM
City Council Chambers - 231 Trowbridge Street
Allegan, Michigan**

SUBJECT: PaSER 10-Year Road Strategies Reports

**DAM SAFETY INSPECTION REPORT
ALLEGAN CITY DAM – DAM ID NO. 489
KALAMAZOO RIVER
ALLEGAN COUNTY – SECTION 28, T 02N, R 13W**

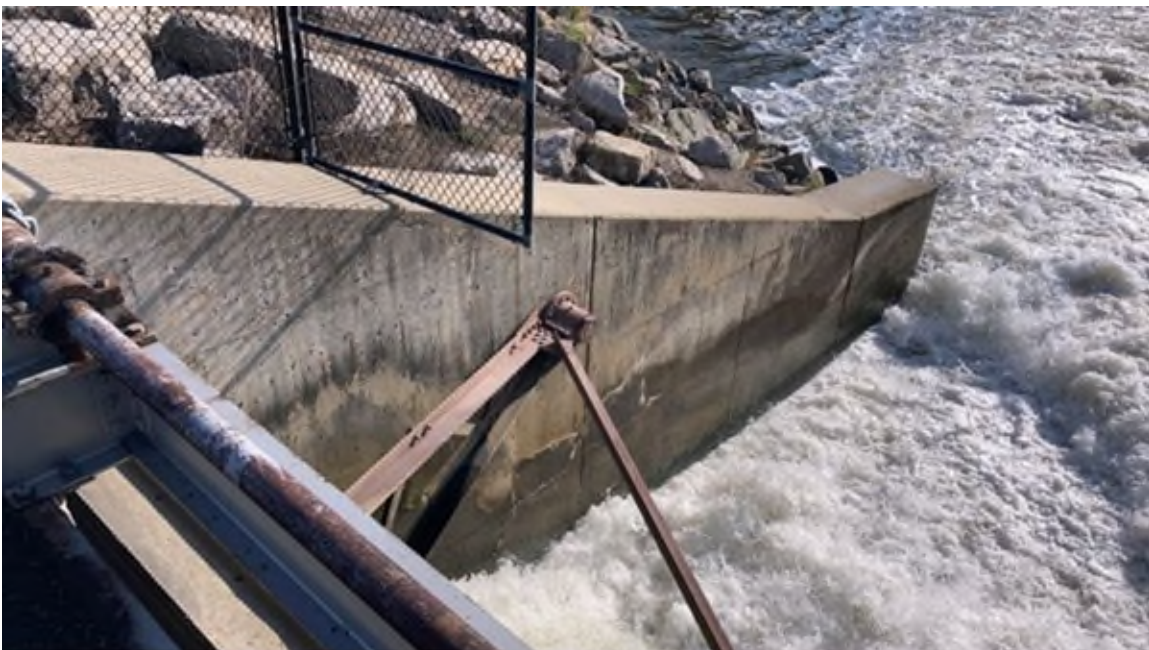
Photo #120 - Spillway bay #4 left downstream abutment wall

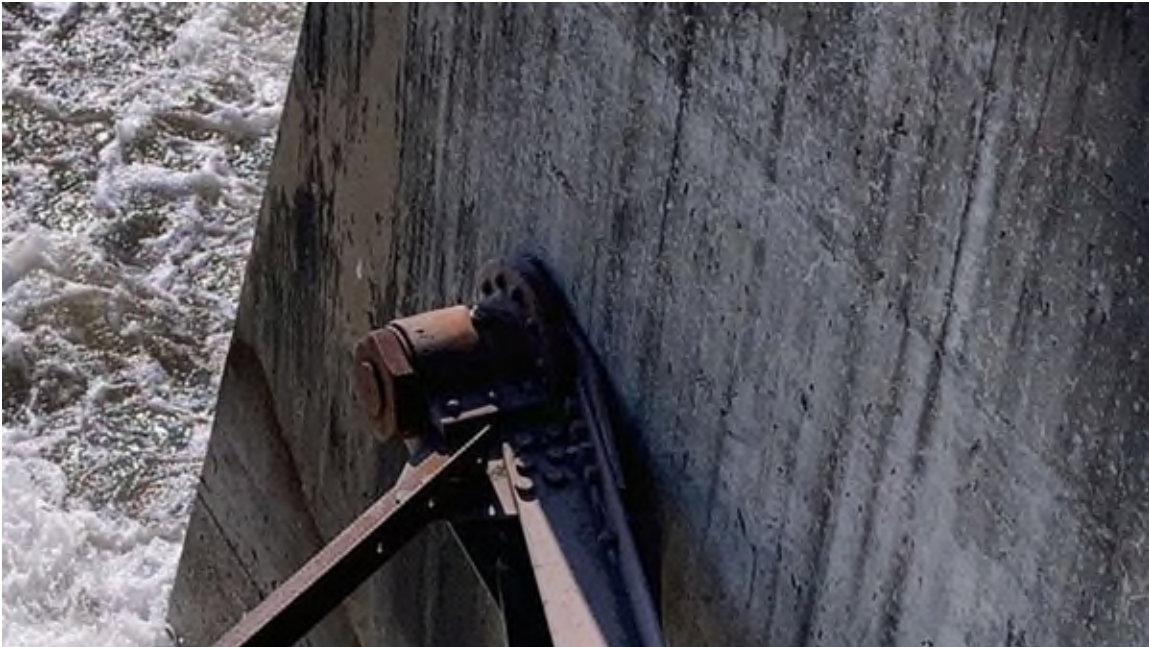
Photo #121 - Spillway bay #4 gate's right pin

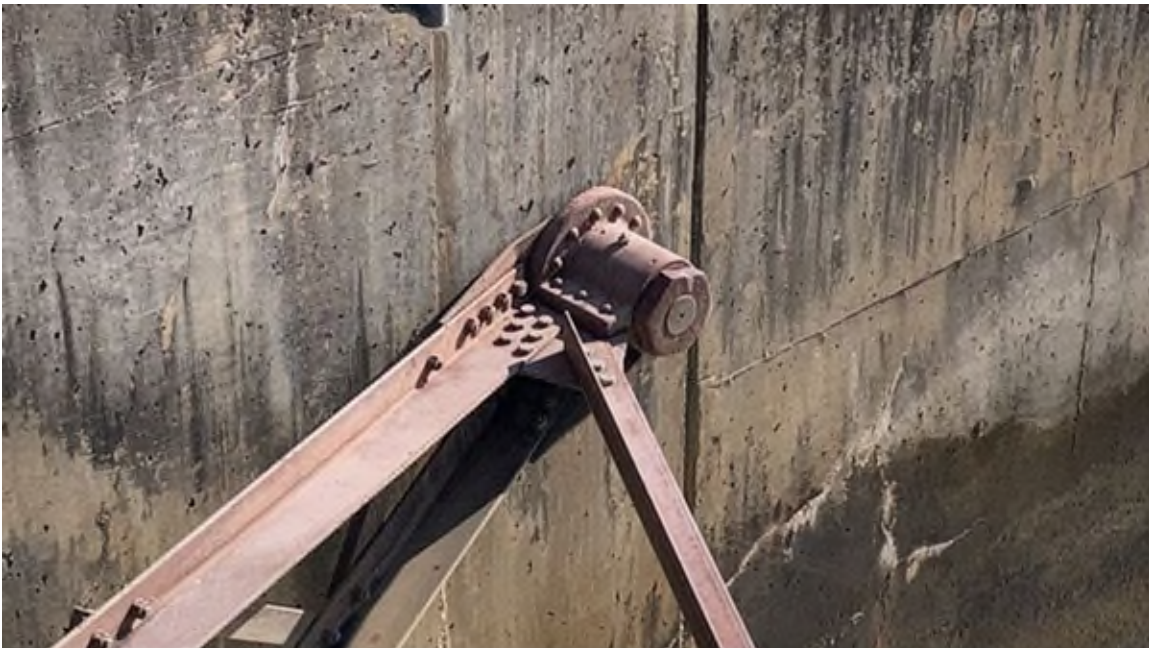
Photo #122 - Spillway bay #4 gate's left pin

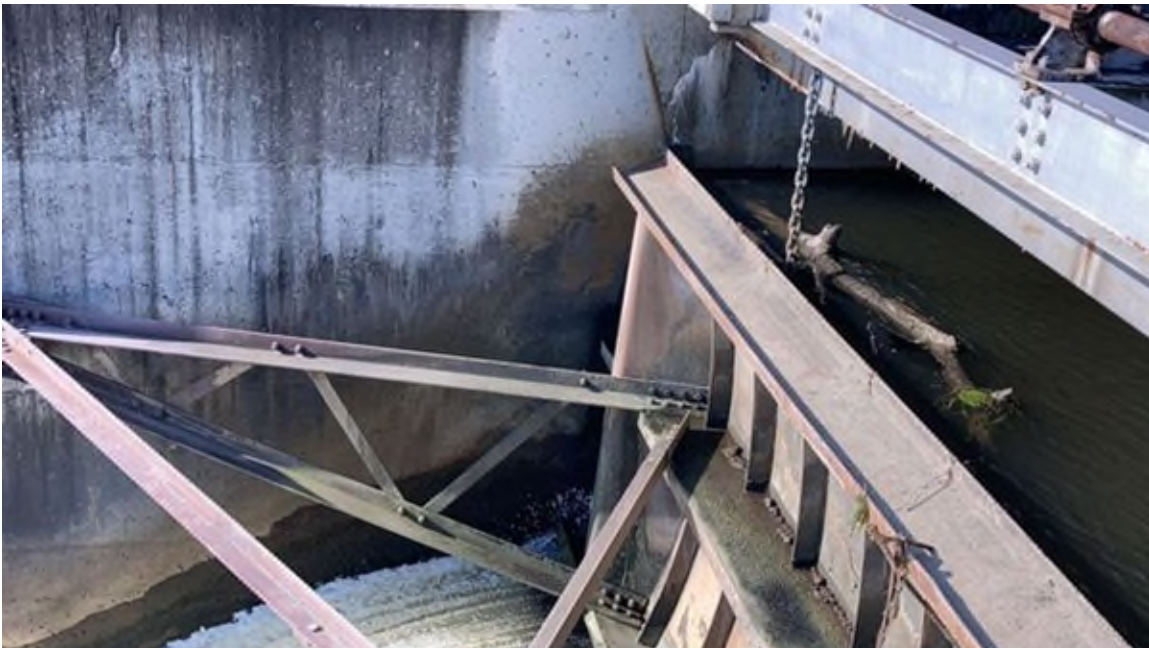
Photo #124 - Spillway bay #4 gate

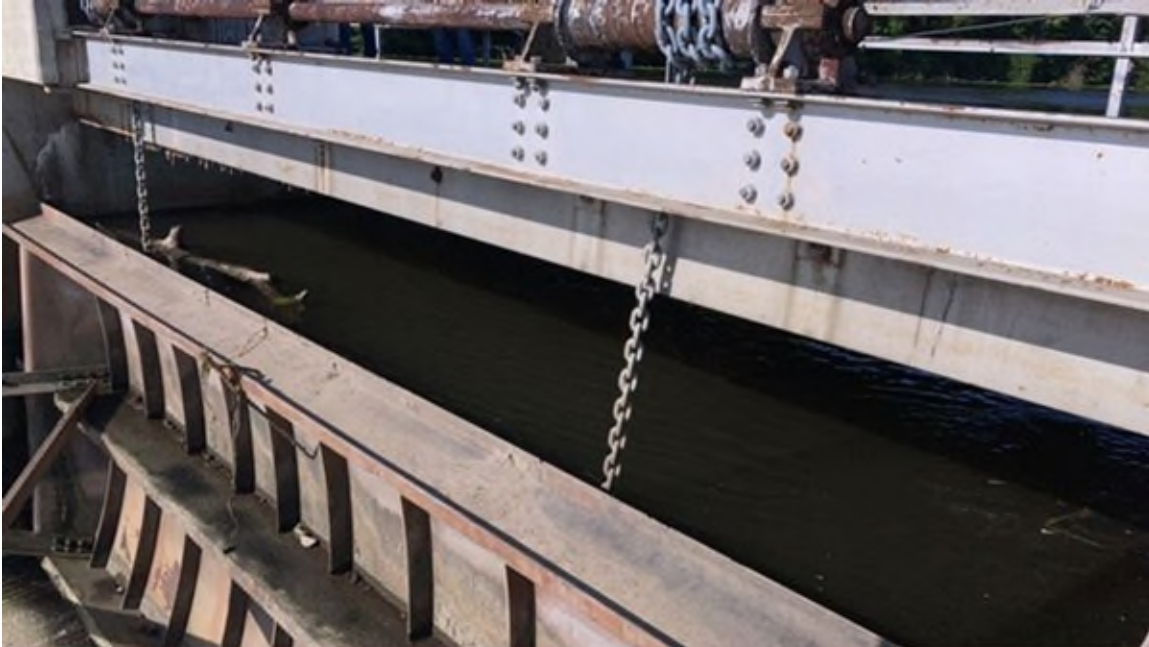
Photo #125 - Spillway bay #4 gate

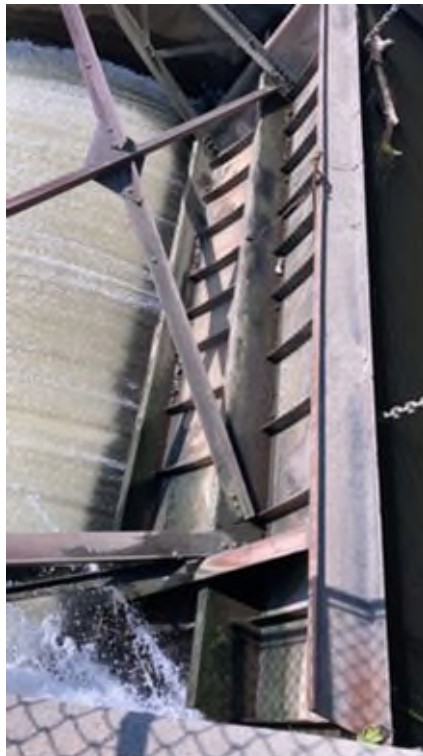
Photo #126 - Spillway bay #4 gate

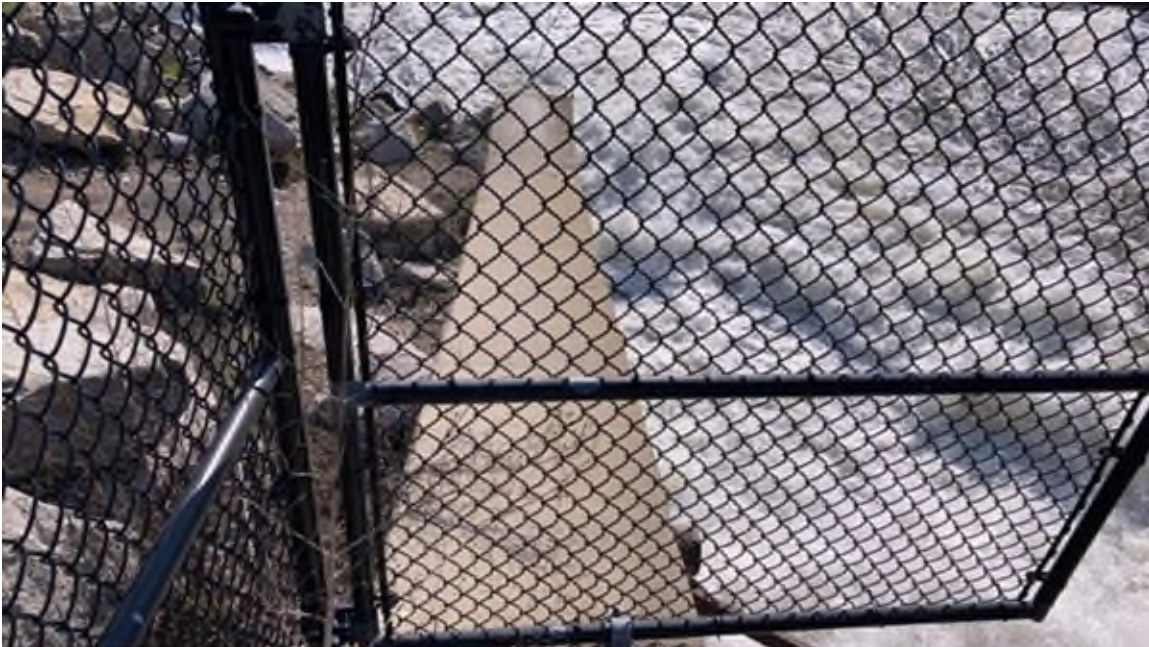
Photo #127 - Spillway bay #4 left downstream abutment wall

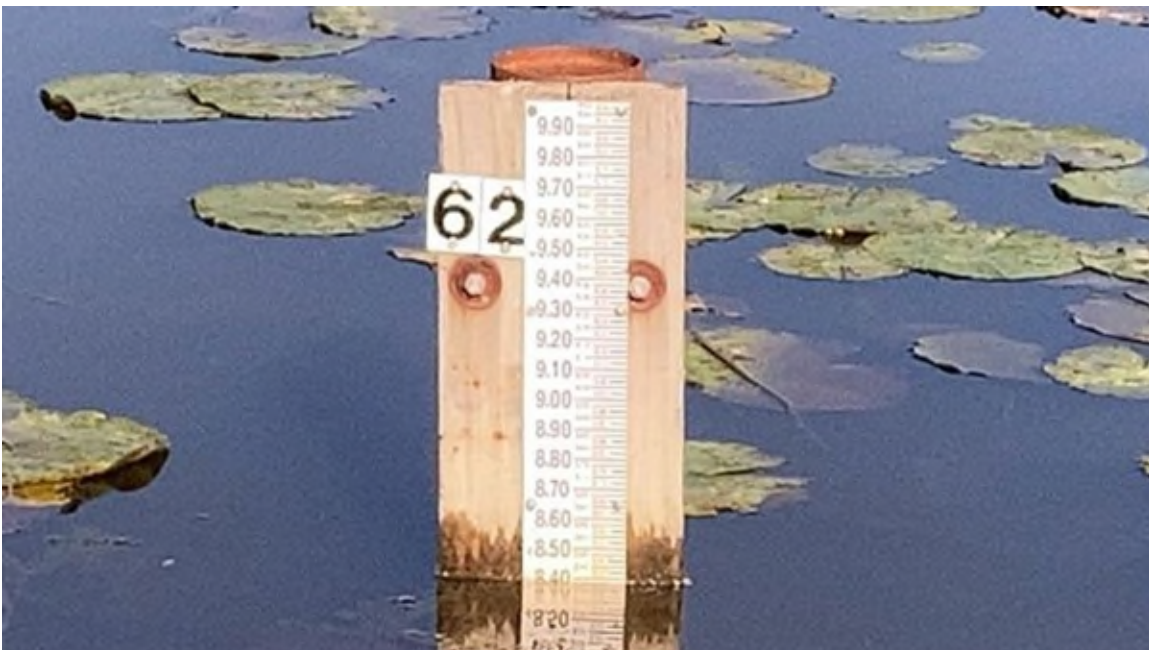
Photo #128 - Staff gage

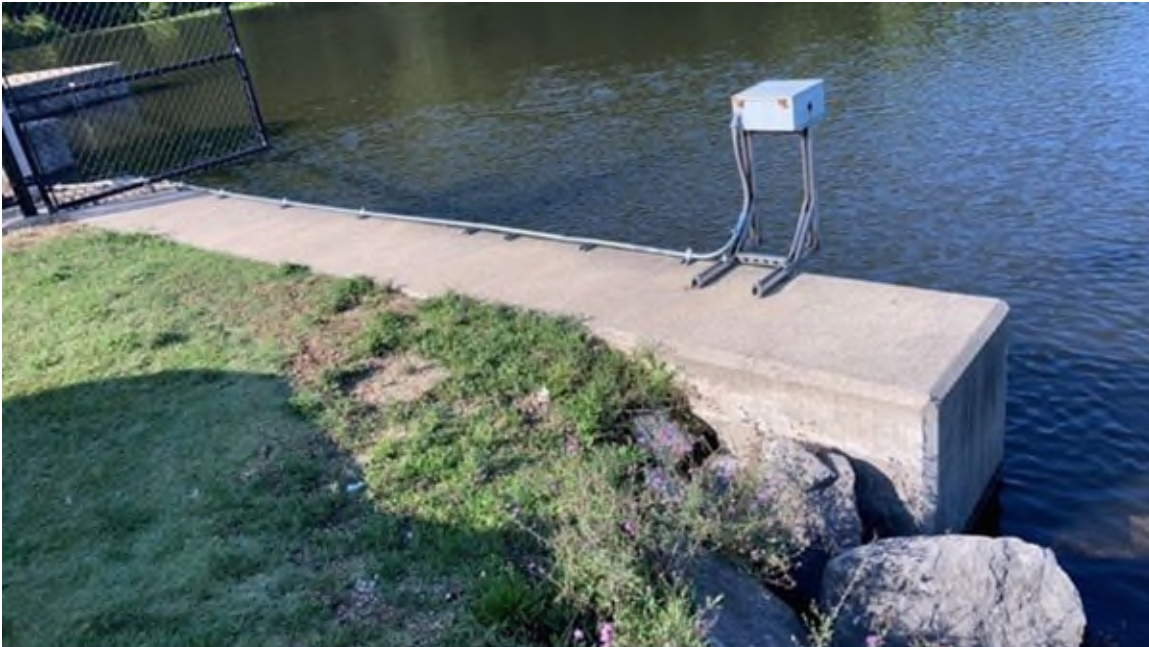
Photo #129 - Left upstream abutment wall of spillway

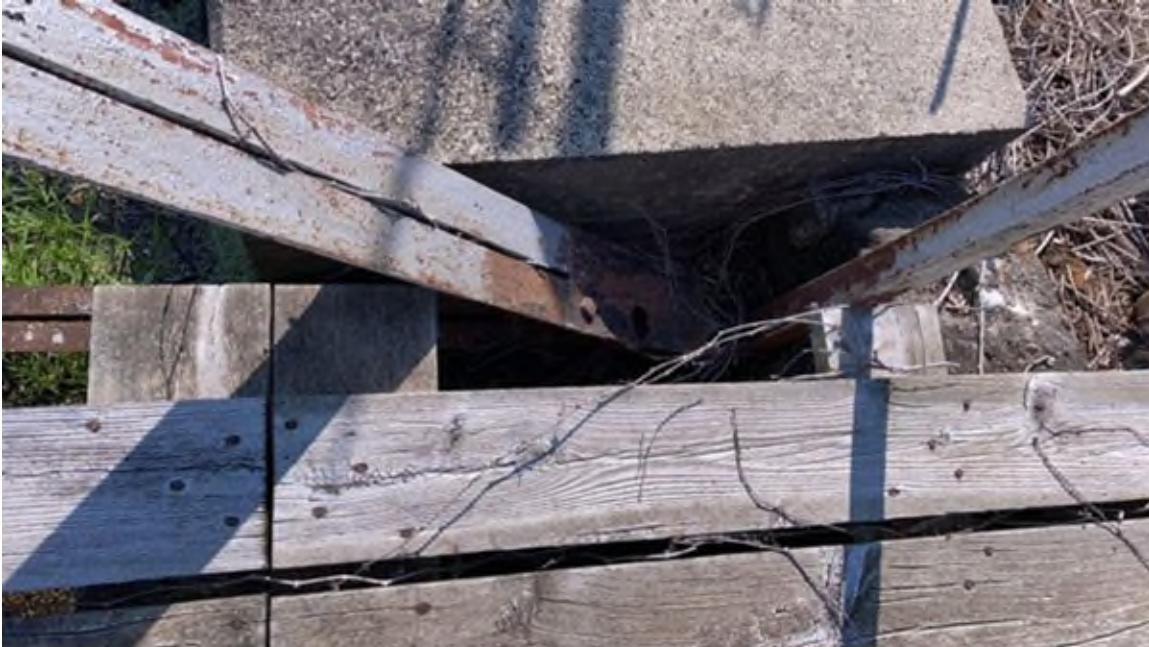
<p>13" of freeboard between at pier between spillway bays #1 and #2</p> <p>16" at right spillway abutment. There is a lower notch in the right abutment where the walkway truss joins the concrete abutment where water would overtop before overflowing the abutment wall, although it would only be able to convey a very small amount of flow. Low spot is approximately 13" of freeboard – see photo #131</p> <p>Per City staff, water has only reached near the bottom of the catwalk bridge over bays #1 and #2, around 13" of rise</p>
--	---

Photo #131 - Right end of walkway deck over spillway bay #1. Note this truss joint area is lower than the abutment walls, and water would overtop here first

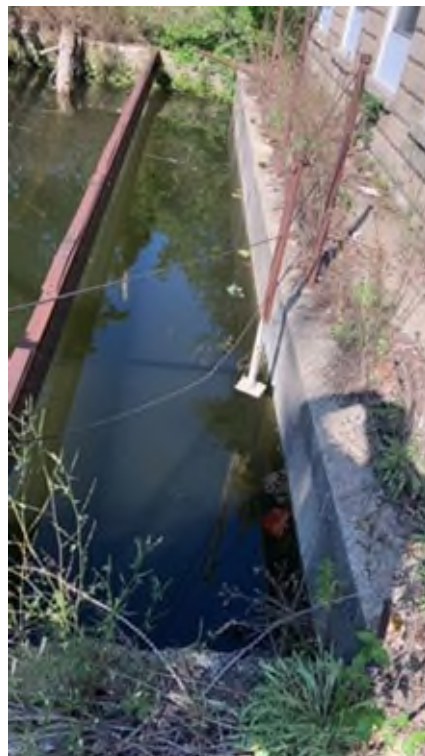
Photo #142 - Concrete bulkhead at left side of powerhouse

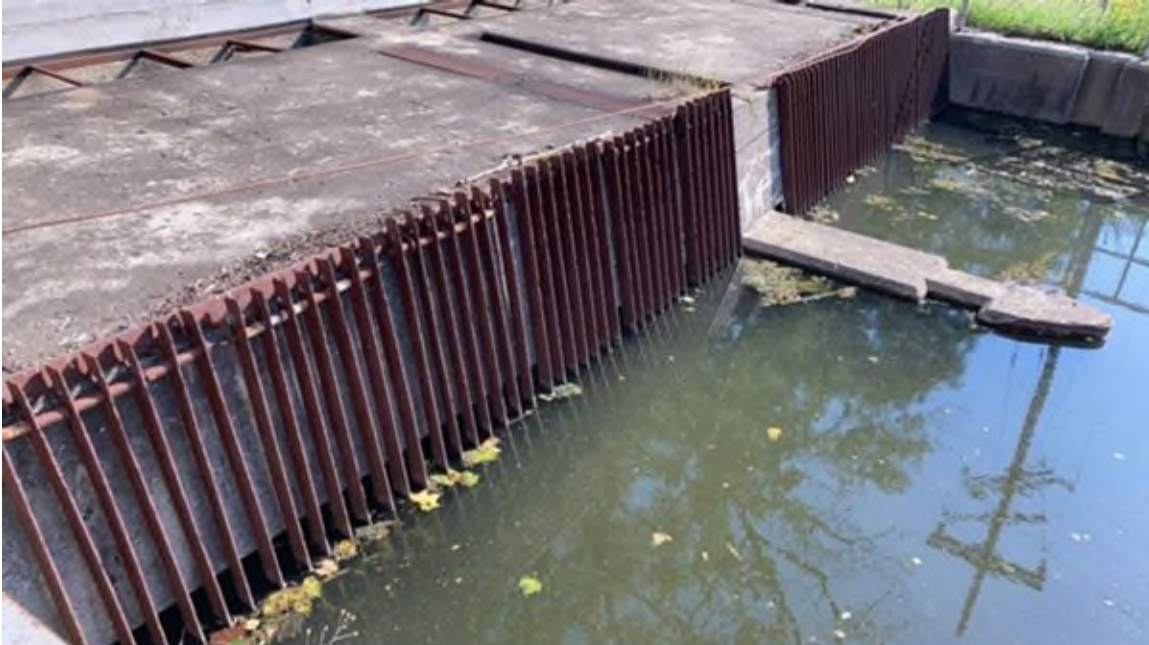
Photo #143 - Right side of powerhouse, inlet. No bulkhead exists

Action required for auxiliary spillway	<i>Monitor, Investigate, Maintenance</i>
Describe action required	<i>To the extent possible, investigate the state of the powerhouse's right headgates and repair as necessary. Or, simply plan to bulkhead the spillway off completely like the left side and reduce the risk of failure during the interim time until removal can occur. Monitor the concrete components and repair as necessary as directed by your engineer so that the risk of failure ahead of removal can be reasonably reduced.</i>

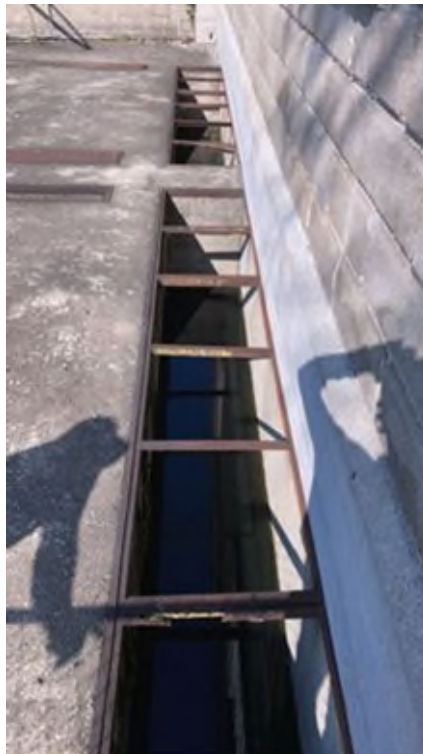
Photo #144 - Right side of powerhouse, inlet upstream of gates inside powerhouse

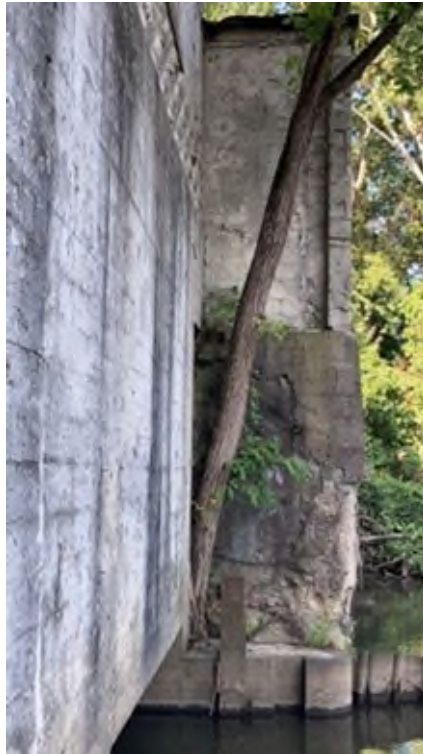
Photo #149 - Downstream face of powerhouse. Note tree growing between old and new portions of powerhouse

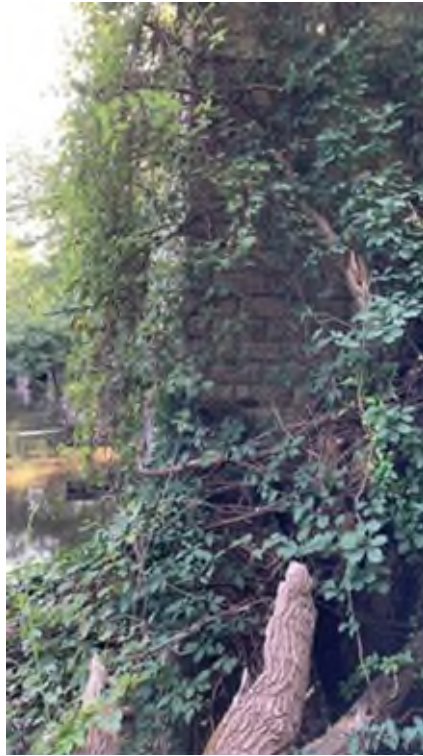
Photo #161 - Powerhouse left face. Note significant vegetation growth up wall
