## REGULAR MEETING OF THE LAKEPORT CITY COUNCIL

- VI. **PUBLIC HEARING:**
  - A. Vista Point Shopping Center: Hold a nuisance abatement hearing and adopt a Resolution declaring the primary structure (872-896a Lakeport Blvd) of the Vista Point Shopping Center a public nuisance, order the property owner to abate all identified nuisance conditions within 30 days, and, in the event the nuisances are not timely abated, empowering staff with authority to abate the nuisances, the costs of which may become a special assessment upon the parcel.

Vista Point Shopping Center (Vista Point), situated at 872-896a Lakeport Boulevard, has been under the ownership of Donica LLC since its acquisition in 2007. On July 14, 2022, City staff initiated a Code Enforcement Case (#2022-00046) to address a series of code violations at the property. While items from the initial Code Enforcement case remain outstanding, City staff has presented subsequent code enforcement matters to Donica LLC for resolution. Unfortunately, over the past eighteen months, City staff's persistent efforts to bring Vista Point into compliance have yielded minimal progress in addressing a growing list of violations.

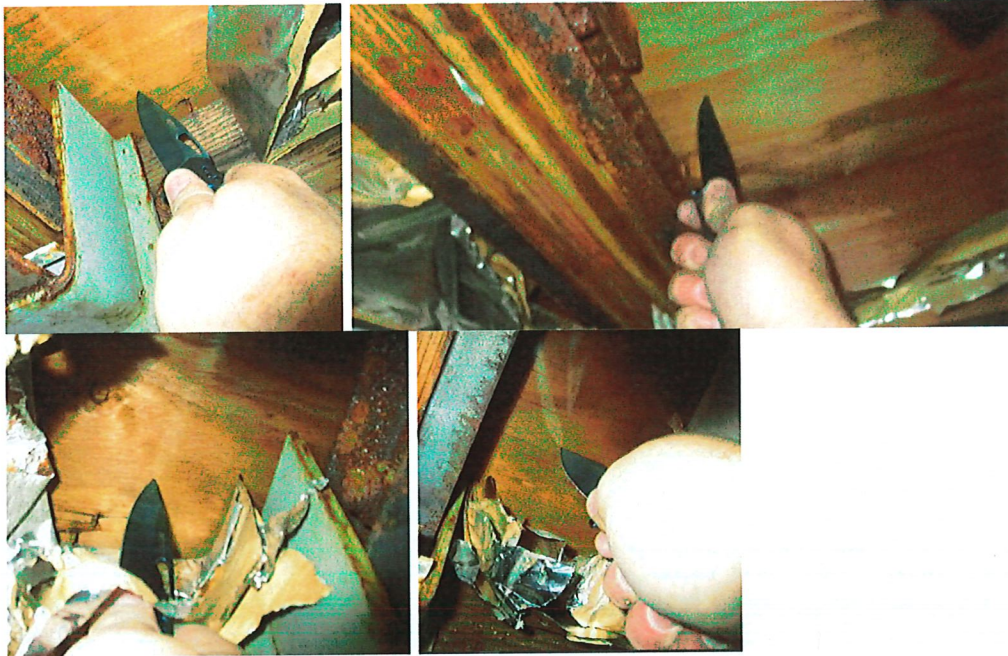
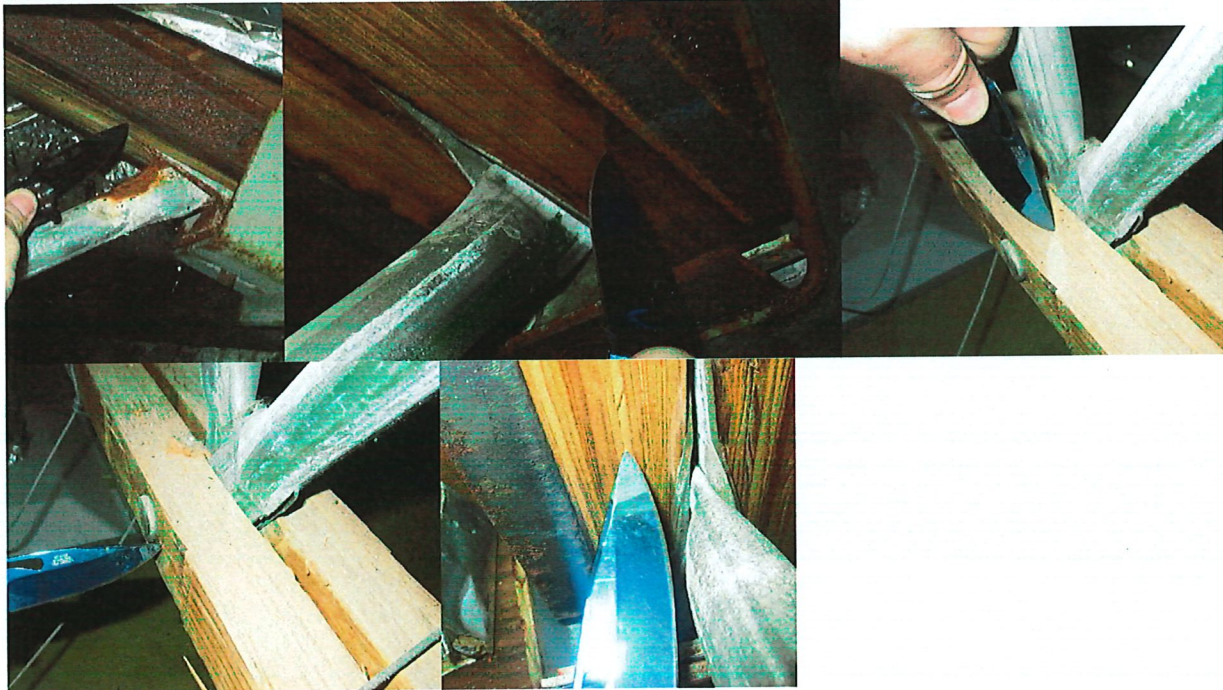
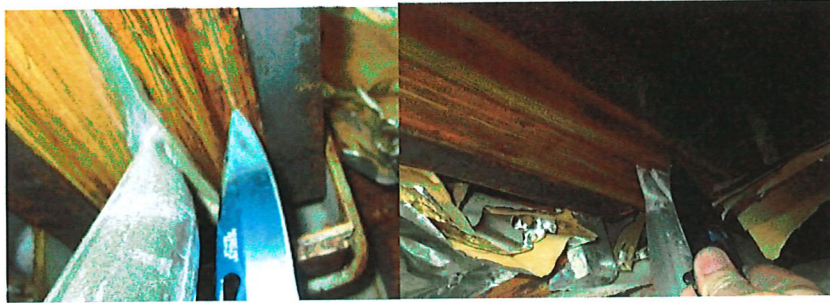
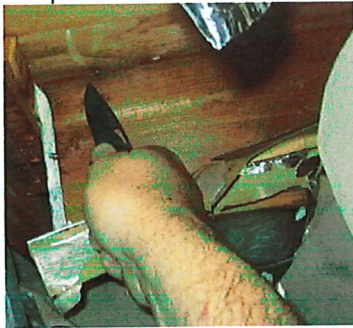
**Location #1**

Ledger check – all spots found with solid hard wood with no water damage

Roof sheathing check - all spots found with solid hard wood with no water damage

Checked trusses- all spots found with solid hard wood with no water damage. All trusses along this line have 1"x2" "C" channel each side of top chord from the bearing point to the first pin placement 42" from end of truss.

Subpurlin check

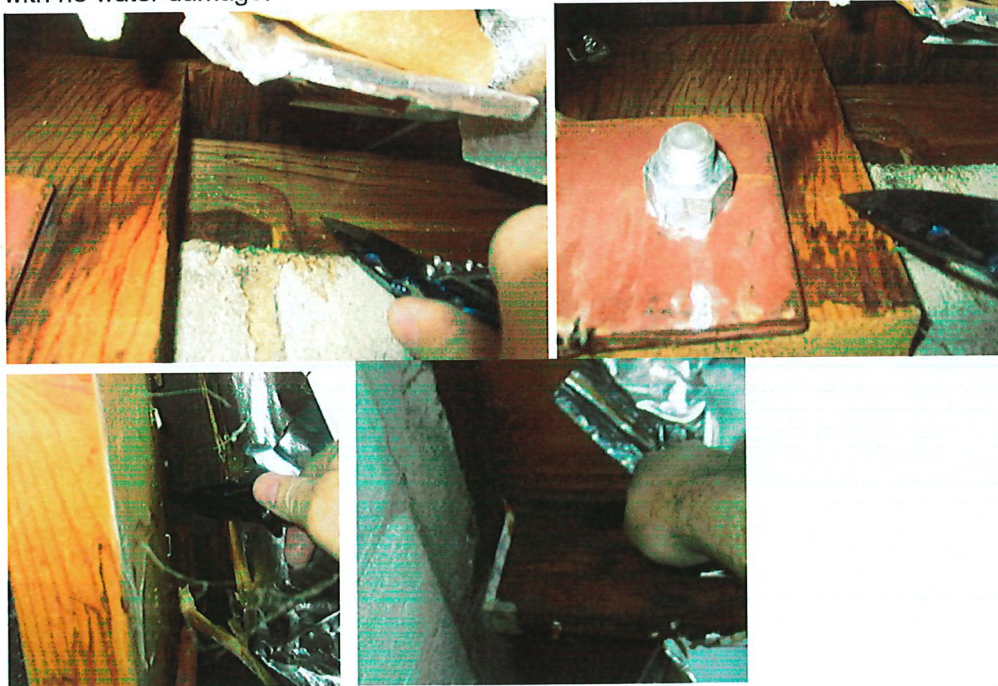
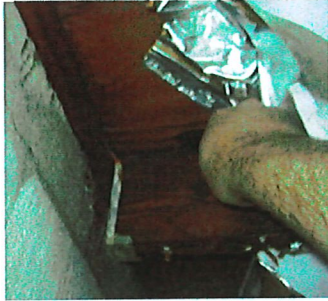
### Location #2

Checked plate on top of the wall, the blocks, purlins and sheathing. All spots found with solid hard wood with no water damage.

Found small leak and checked wood and found it to still be hard. Leak is probably recent.

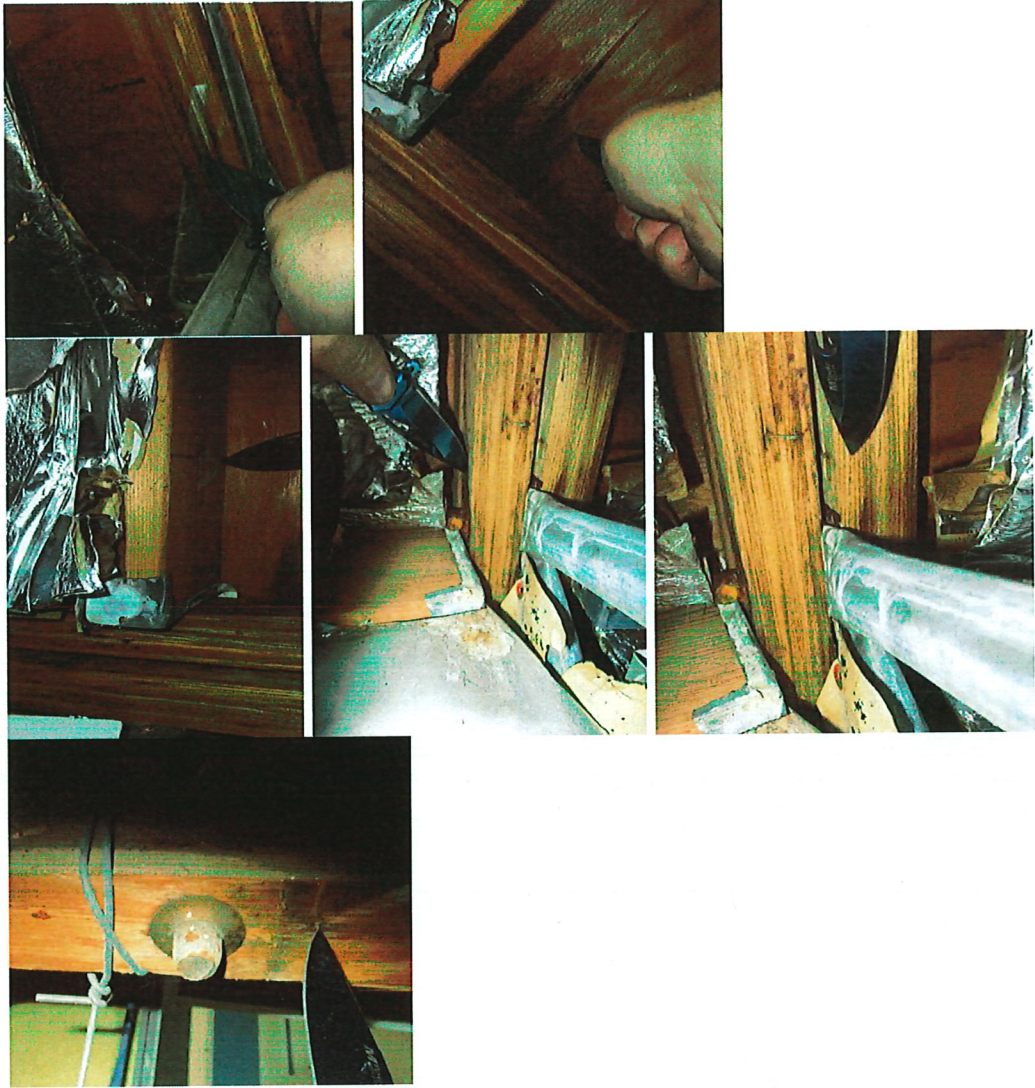
### Location #3

Checked ledger, truss, purlins and sheathing. All spots found with solid hard wood with no water damage.

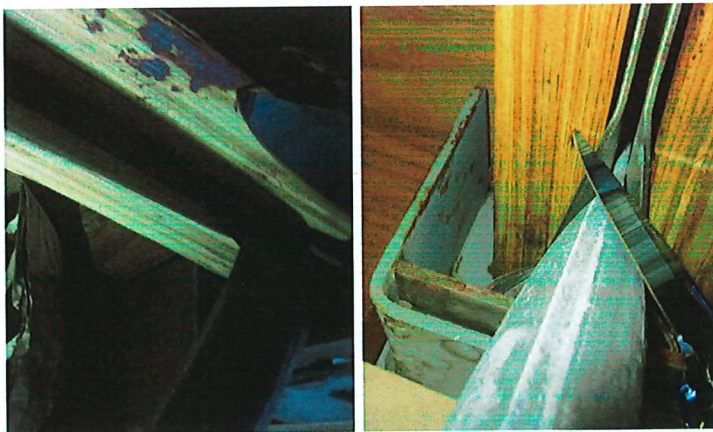
**Location #6**

Checked wood framed wall top plate, trusses, and sheathing. All spots found with solid hard wood with no water damage.

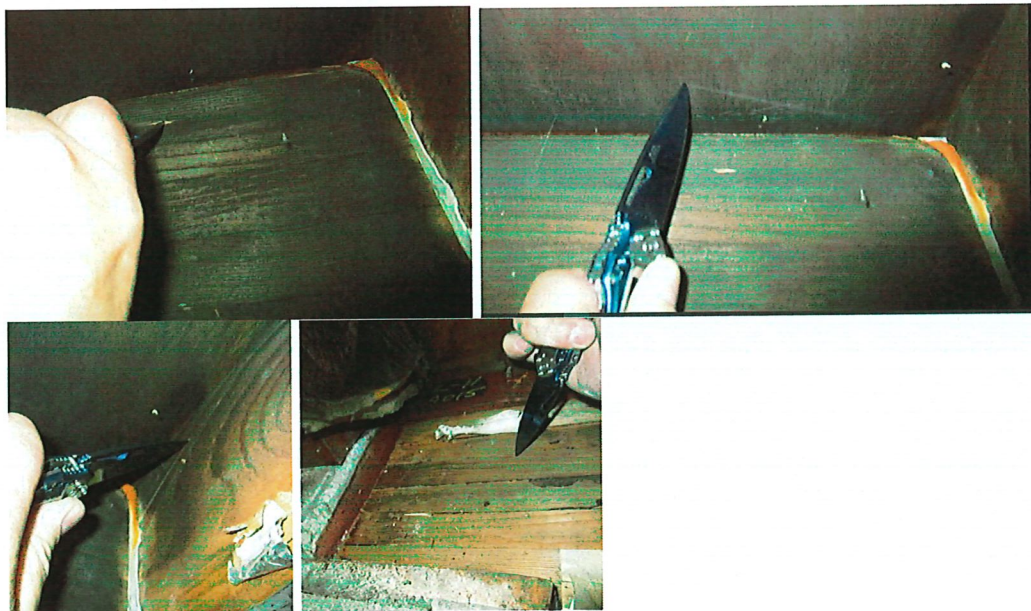
**Location #8**

Checked glulam, purlins, and sheathing. All but one purlin found with solid hard wood with no water damage.

Owner to sister 2x6 to existing purlin with 16d @ 6" o.c. and clip to glulam with A34.

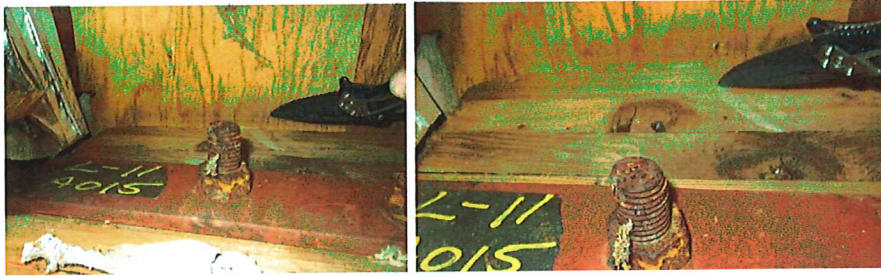
Checked end of glulam beam found with solid hard wood with no water damage.

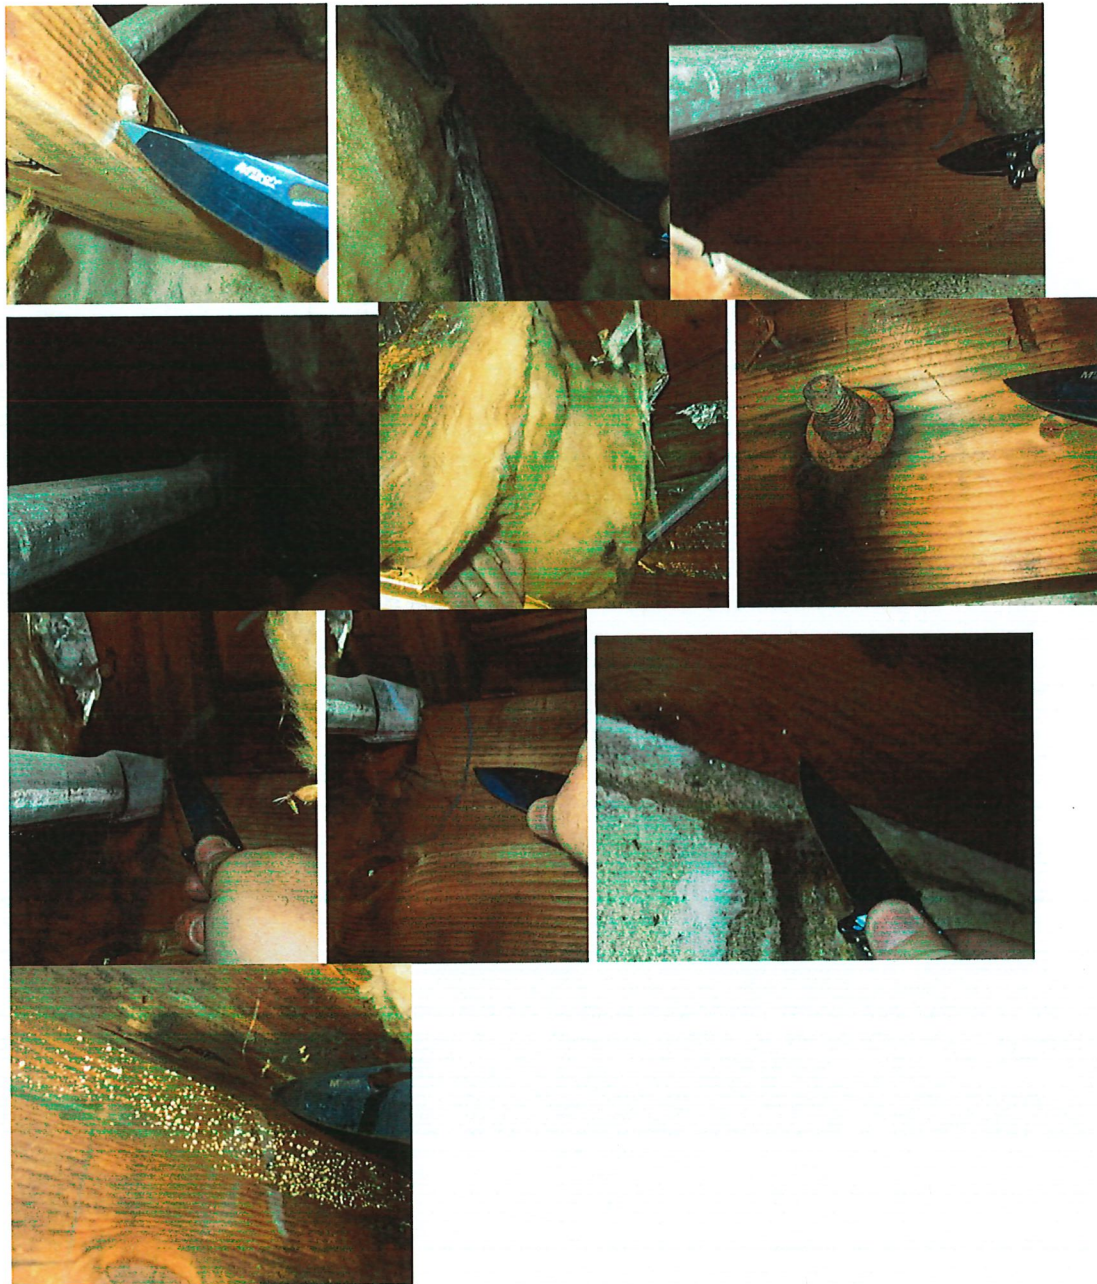
### Location #10

Checked ledger, truss, insulation and sheathing. All spots found with solid hard wood with no water damage. The insulation was dry the entire length of the wall.

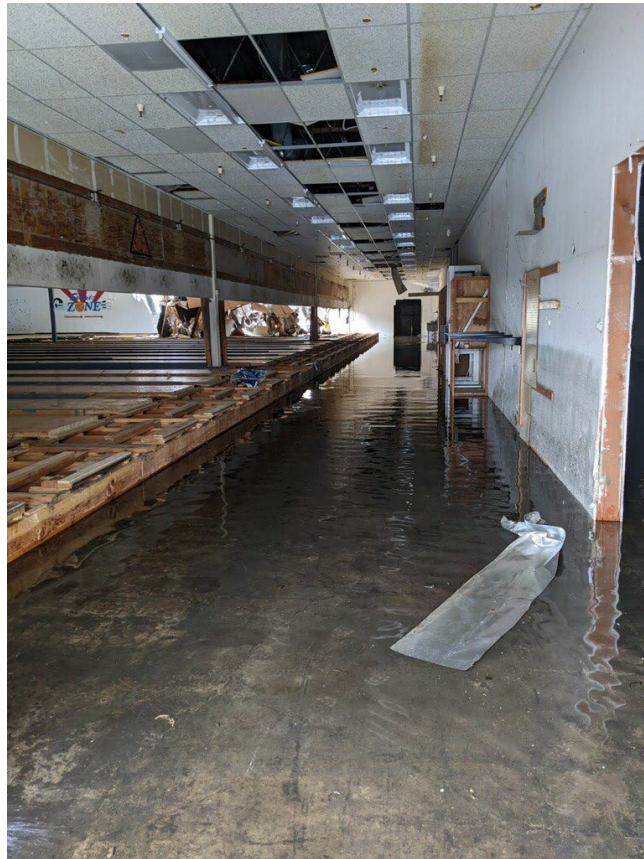
***Unit A - Extensive Water Damage Post-Collapse***

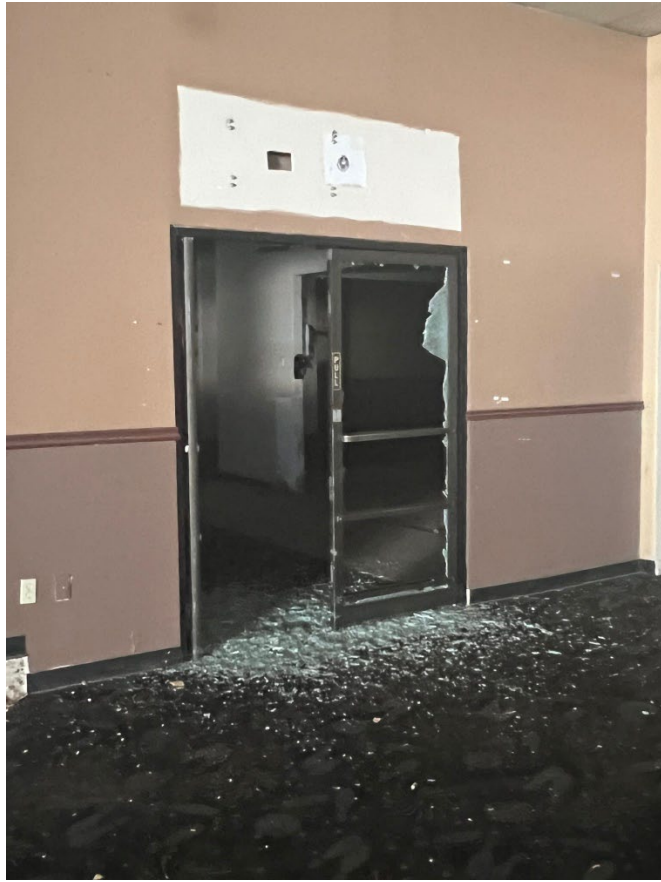
***Unit A - Vandalism post roof collapse due to unsecured building***

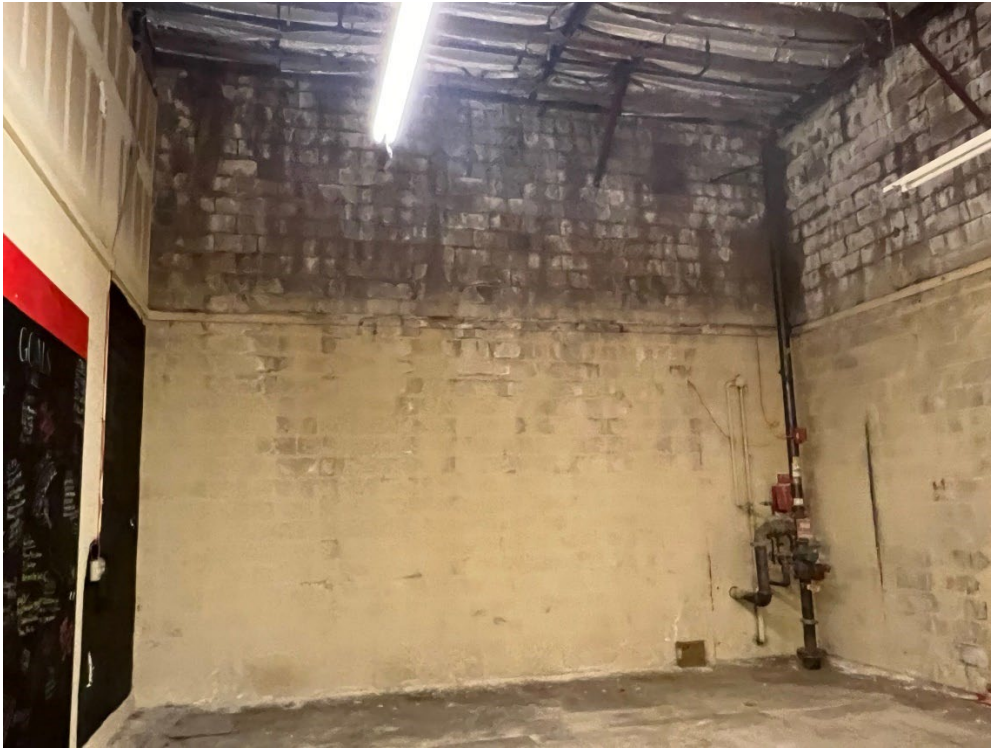
***Unit C – 888 Lakeport Blvd.  
Southwest corner, water intrusion***

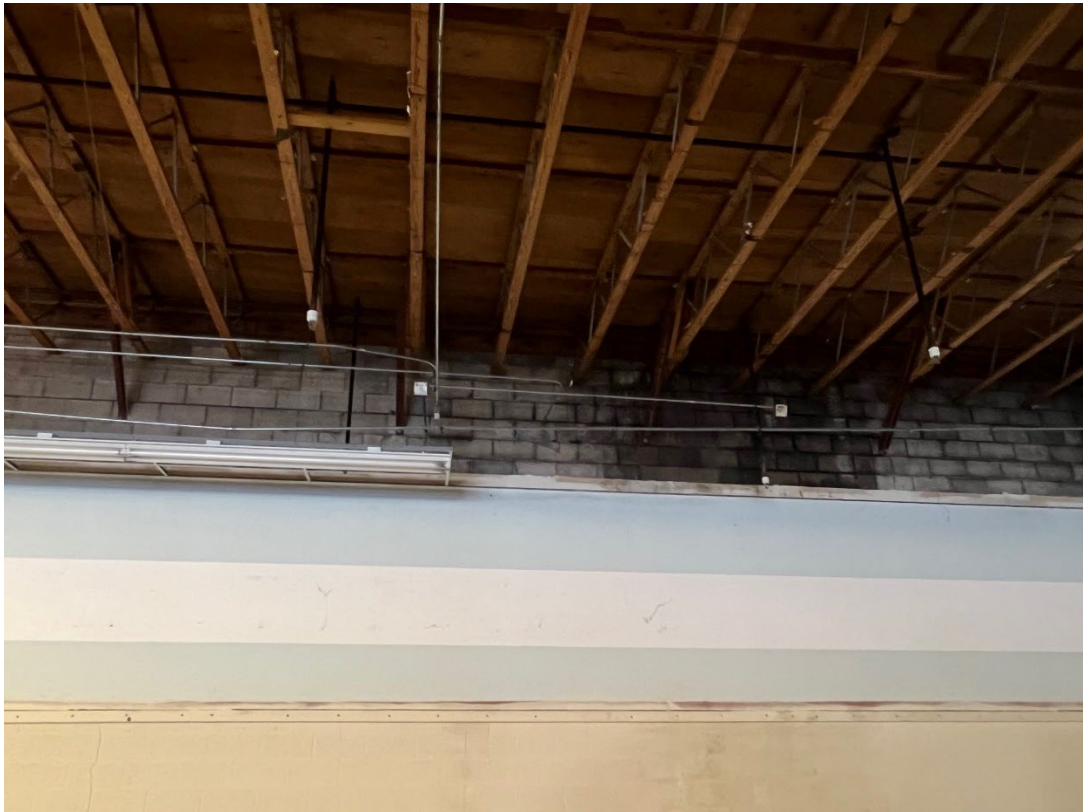
***Unit C – North West wall, water intrusion***

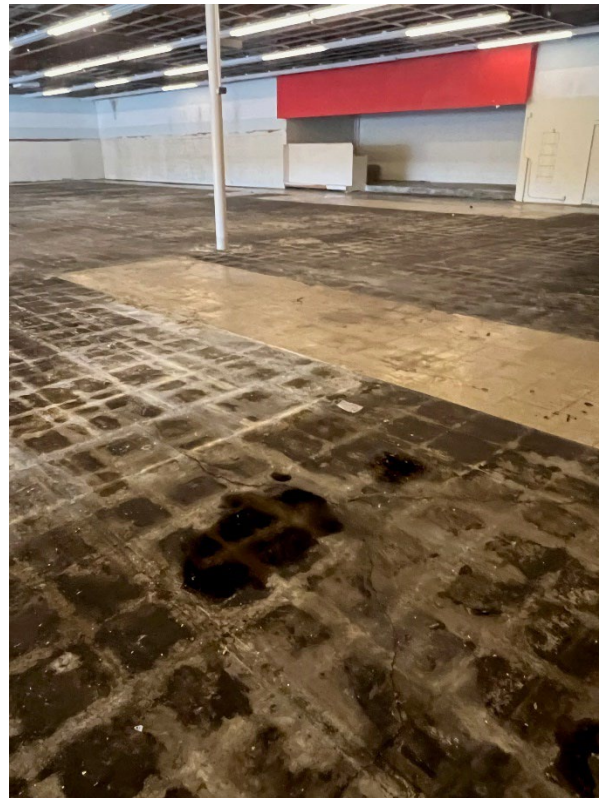
**Unit C – Water intrusion in center of unit**

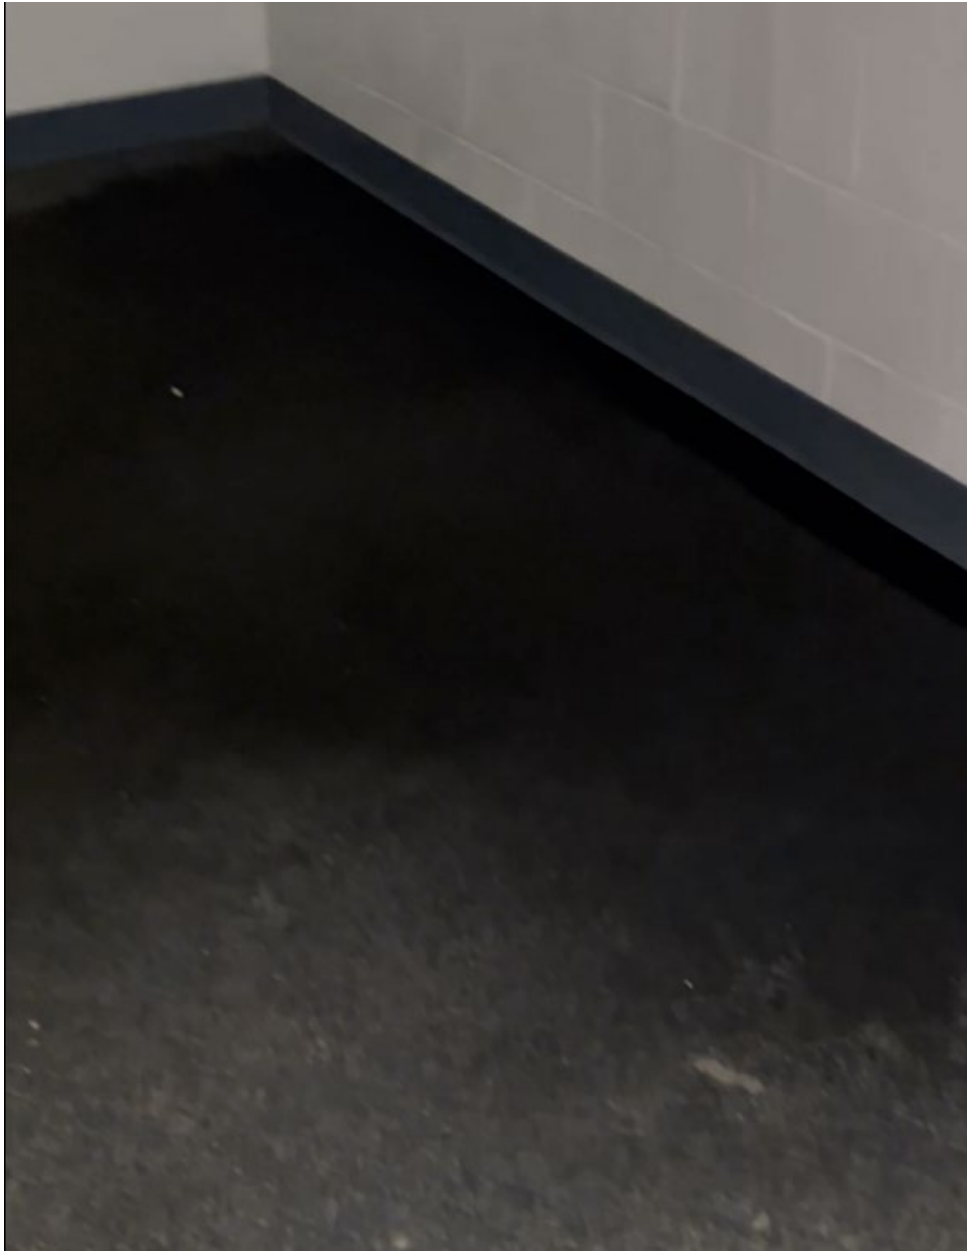
*Unit F-G – Saturated carpet*

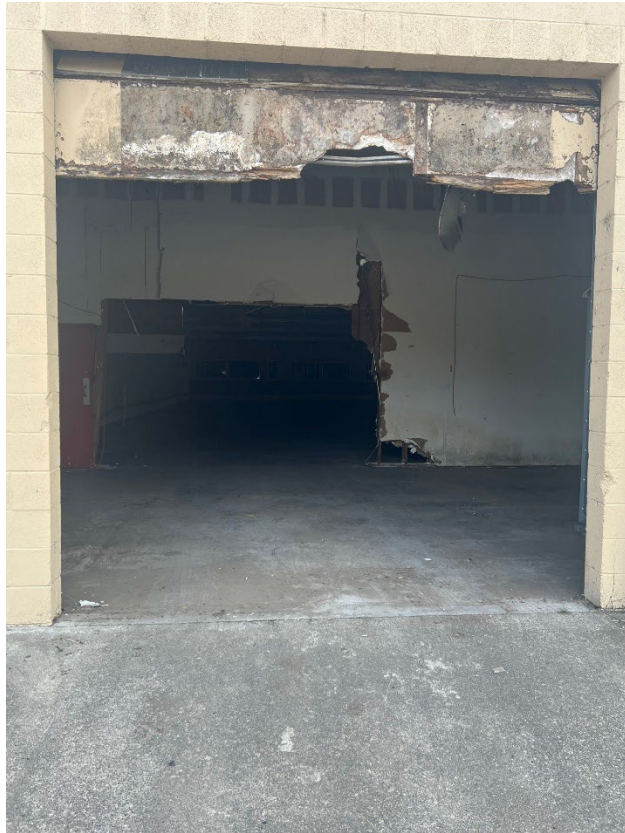
***Unit A – Unpermitted construction***
